MT HOOD HIGHWAY ROAD SAFETY AUDIT

Timberline Rd to Nottingham

Road Safety Audit (RSA)

Mt Hood Highway (US-26 and OR-35)
Mile Point 54.20 – 70.20

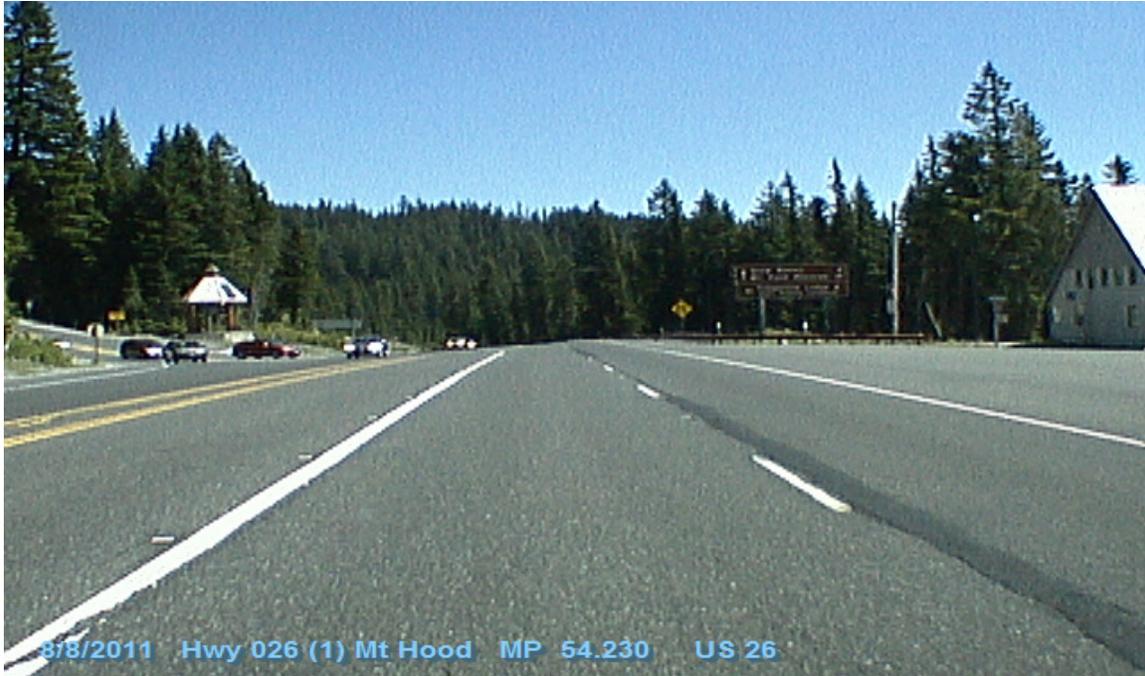
An existing Timberline Rd condition/issue is the restricted sight distance for right turns from Timberline Rd (2009 RSA finding). A related finding was that some drivers making right turns from Timberline Rd are using the US 26 right shoulder area like an extra WB lane. There is no striping or signing showing this traffic movement that is being made as mitigation for the sight distance restriction for right turning drivers. The picture that follows illustrates stopped vehicles waiting to turn on to US 26 from Timberline Highway with a stopped vehicle waiting to turn left and oncoming WB traffic on US 26.

- Consider installing a Variable Speed Limits (VSL) system adjusted to the traffic/weather/road conditions to help mitigate the speeds too fast for conditions safety issue.
- Consider applying for additional funding for better OSP coverage and enforcement by making available additional personnel during the winter. This is to make up for a recent OSP staffing decrease.
- Investigate the feasibility of US 26 widening and signing/striping to add a short additional WB traffic lane/merge area west from Timberline Rd. This is to mitigate the restricted sight distance issue for drivers making right turns from Timberline Road on to US 26 WB.

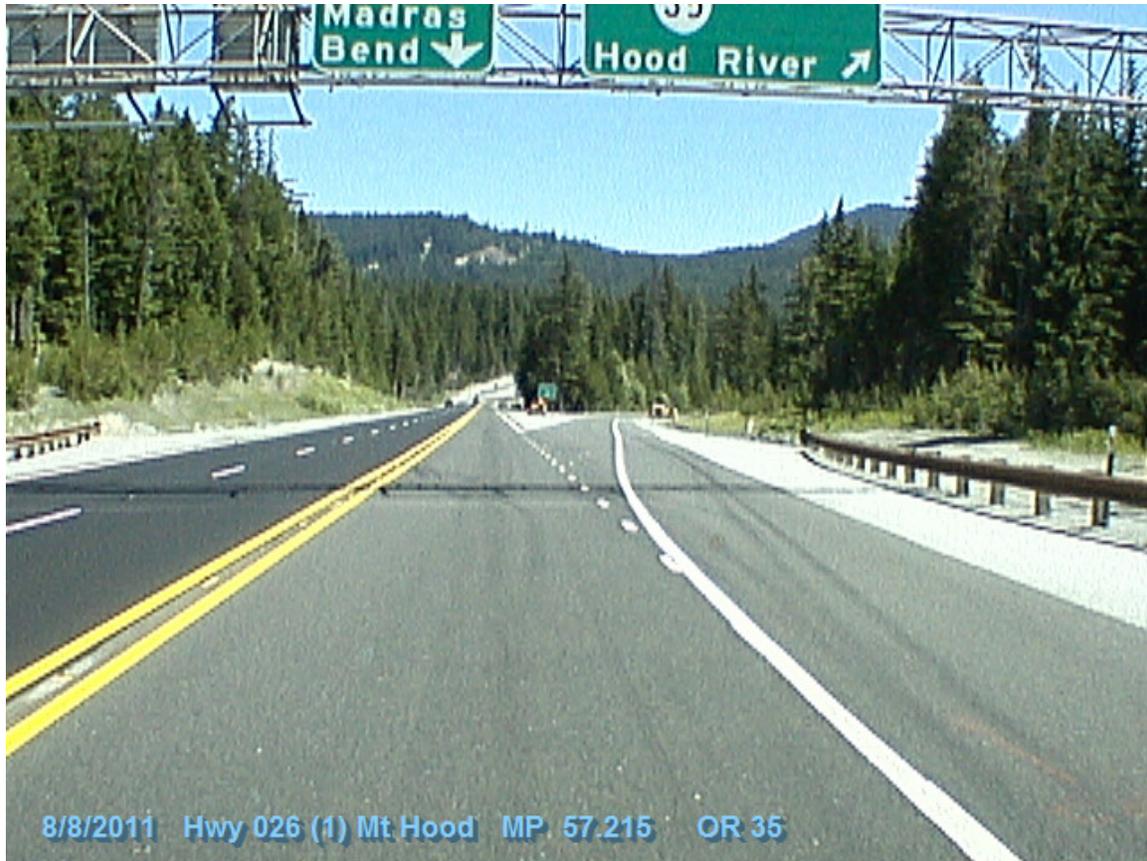
The EB ramp connection to OR 35 NB is difficult to see especially during the winter. The NB OR 35 connection alignment is not normally expected because it veers off to the right and then crosses back across/under US 26 (grade separated) to go north on OR 35 on the left side of US 26. This ramp with the conventional overhead sign is shown on the picture that follows.

- Consider an additional chain on/off area WB near OR 35. This is needed for both WB traffic on US 26 and NB traffic on OR 35 to install tire chains to safely travel over the high elevation summits.
- Prepare an up to date communications plan with the ski areas and other stakeholders. This is needed to provide real time routing (at ski areas, internet & VMS signs) and travel information to the winter recreation area users.
- Consider installing an overhead EB Diagrammatic sign for the ramp connection to OR 35 NB showing the alignment for the US 26 EB connection to OR 35. This will help drivers follow the alignment particularly when it is more difficult to see during winter road and weather conditions.

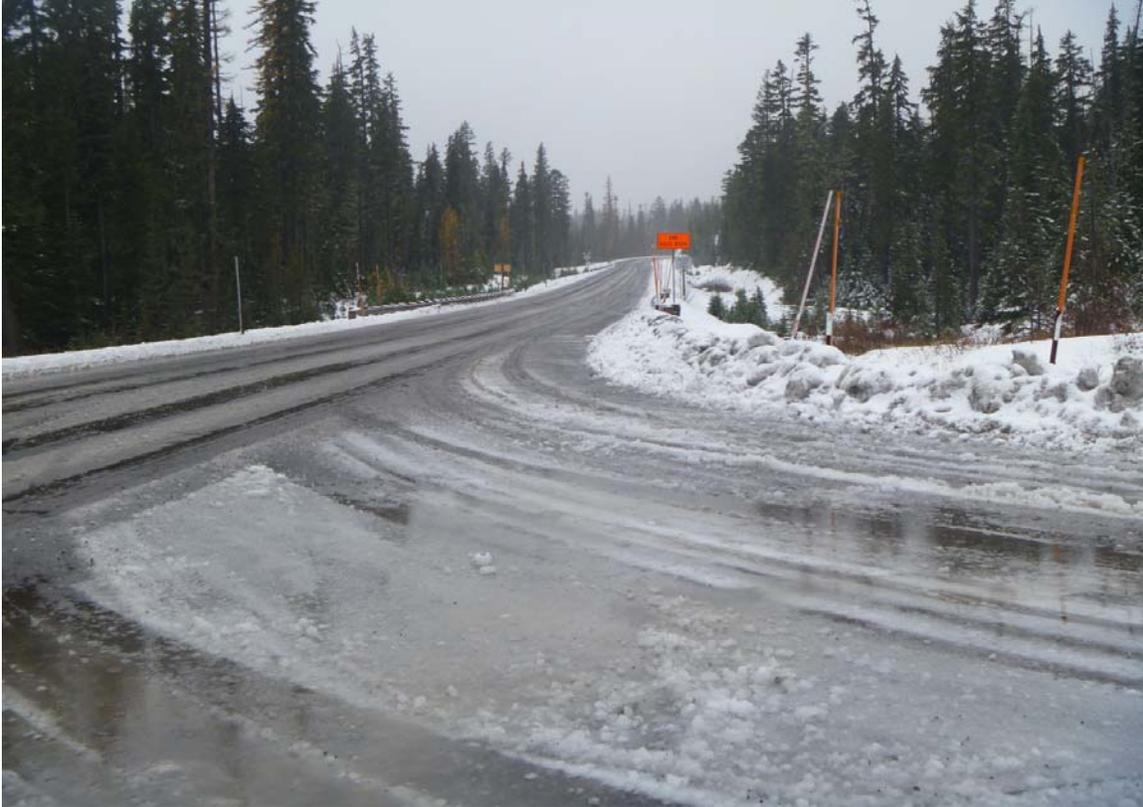
There are two FHWA projects on OR 35 that currently under construction that will result in horizontal curves with spiral transitions and paved shoulders that will be 8 feet wide. These will be major improvements from MP 61.1 to MP 62.14 (White River) and MP 65.32 to MP 68.23 (Clark Creek). There is also a left turn lane installation project (MP 64.81 to 65.07) planned for construction at Sahalie Falls Loop Road to Mt. Hood Meadows shown on the following photo.

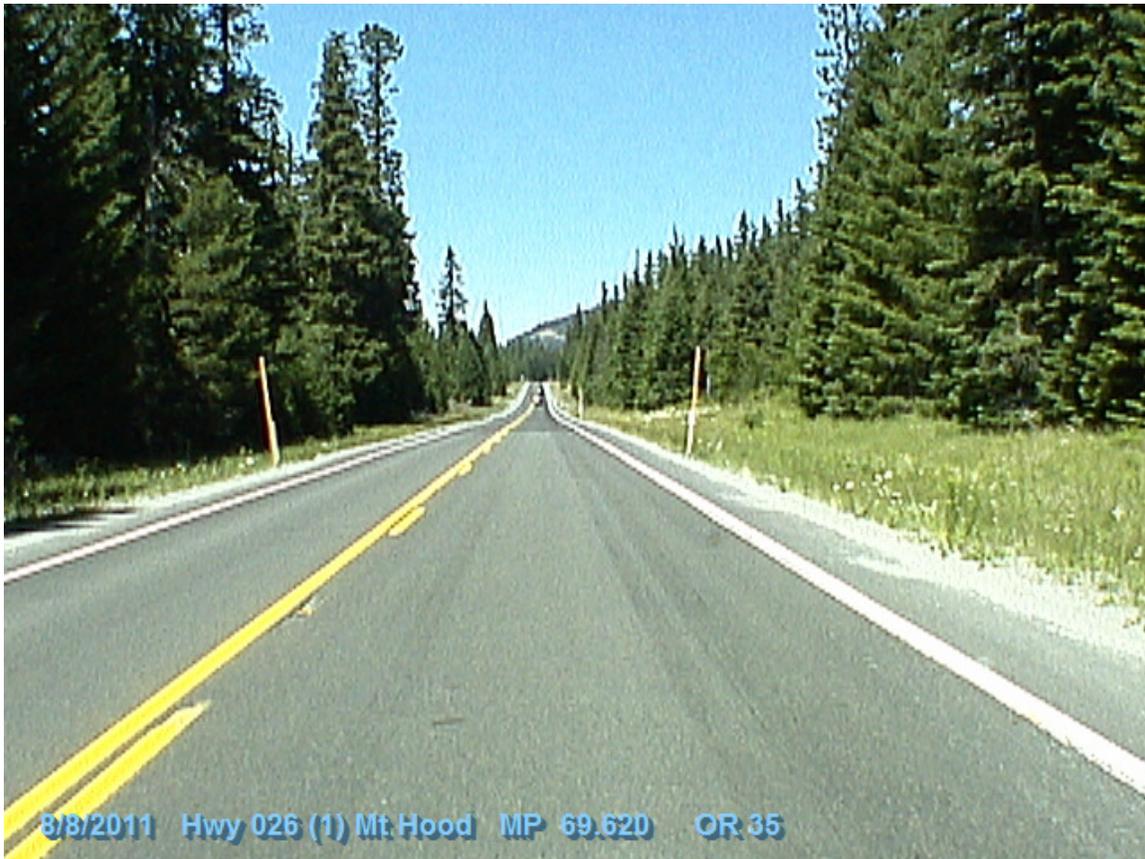
The 4 SPIS sites all had winter related crashes during the day. The first location from MP 58.92 to 59.09 was in a long horizontal curve. The second site was from MP 63.91 to 64.09 in the curves at the Mt. Hood Meadows Interchange. The third site was from MP 64.90 to 65.08 involving left turning and Fixed Object crashes at the Sahalie Falls Loop Mt Hood Meadows access road. The fourth site was from MP 69.57 to 69.75 in a straight section of road with a mild vertical grade in a no passing zone. The 2009 severe crash with 2 fatalities and 5 injury A's involved a SB 16 year old driver that had apparently just completed passing another vehicle then lost control on ice and struck a NB vehicle in the NB travel lane head on at MP 69.66. The 16 year old had a restricted drivers license not allowing the two young passengers in his vehicle. A picture of this location follows.

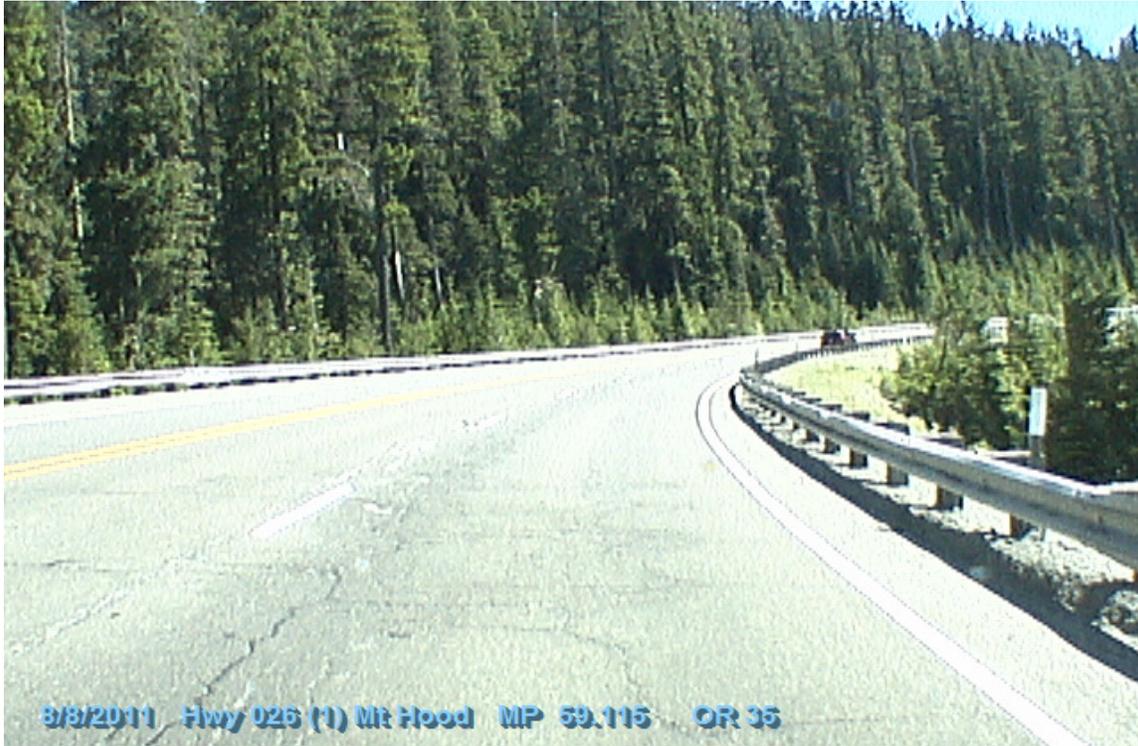
issue is especially a concern with the winter ice and or snow conditions when vehicles slide on the curves. The sharp curves at MP 59(SPIS), 60, 63 & 64(SPIS) are particular concern locations in the winter with passing lanes, trees and steep supers. Three of these curves are shown in the following pictures. The other one near MP 64 is shown later in the Mt Hood Meadows Interchange area issues discussion.

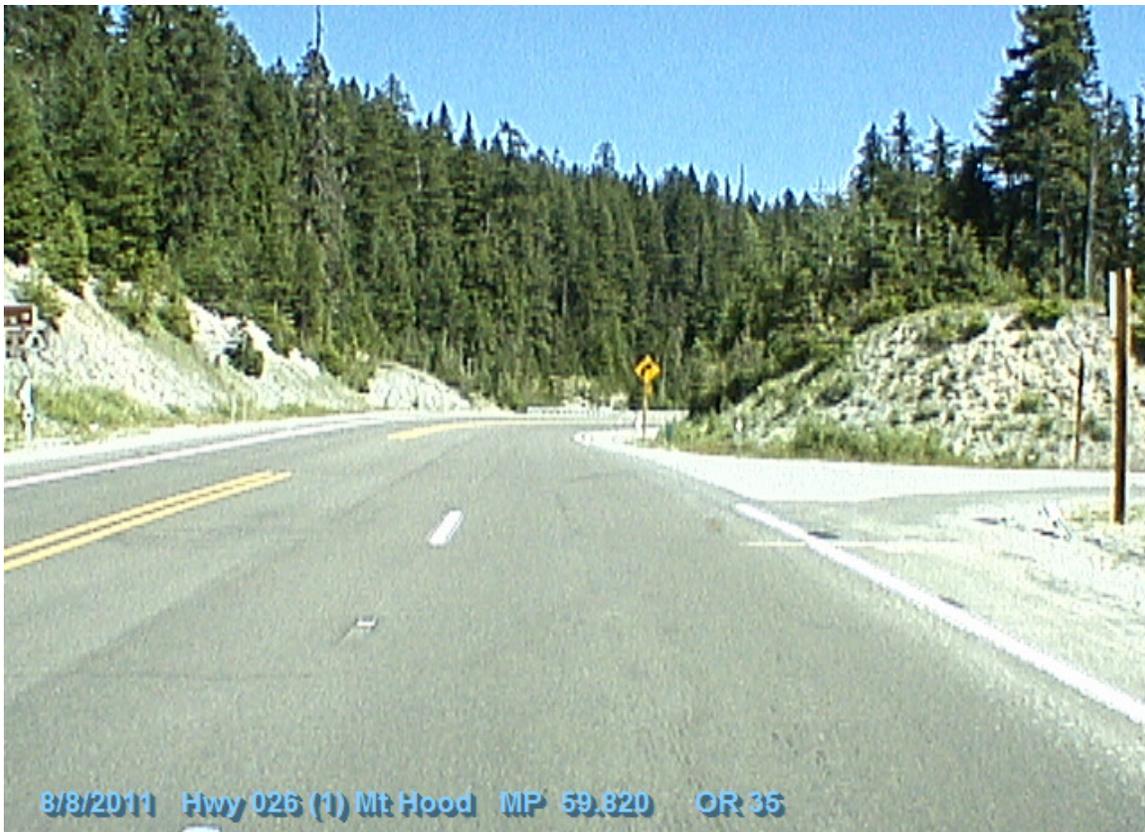
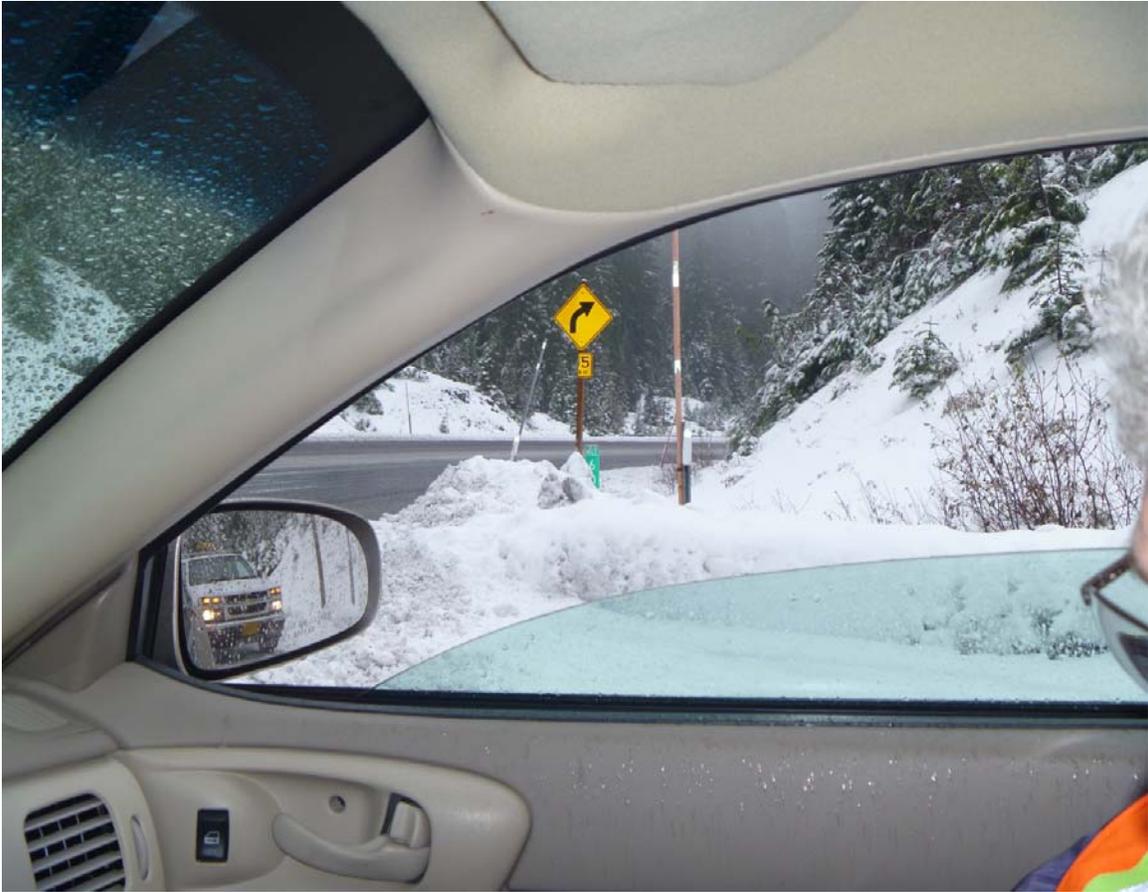
- The cut bank/trees in the NE quadrant of the side street approach restrict sight distance to the north. This makes drivers pull forward beyond the stop bar to see SB approaching vehicles as illustrated in the 2 pictures on the next page. The first picture is looking NB at the intersection. The second picture illustrates the restricted sight distance looking north for a driver stopped on Barlow Road. This picture was taken on November 16 after the snow overnight. With heavier snow and larger snow banks the sight distance would be more restricted.

- The restricted sight distance is also a safety concern for drivers and hikers crossing OR 35 on the trail.
- The crossing/intersection is located in a curve that also contributes to the restricted sight distance with the cut bank in the NE quadrant.
- The trail crossing and road intersection are located close to the Barlow Pass Summit (4160) with lower winter temperatures.
- The SB pedestrian crossing warning sign was down (missing).

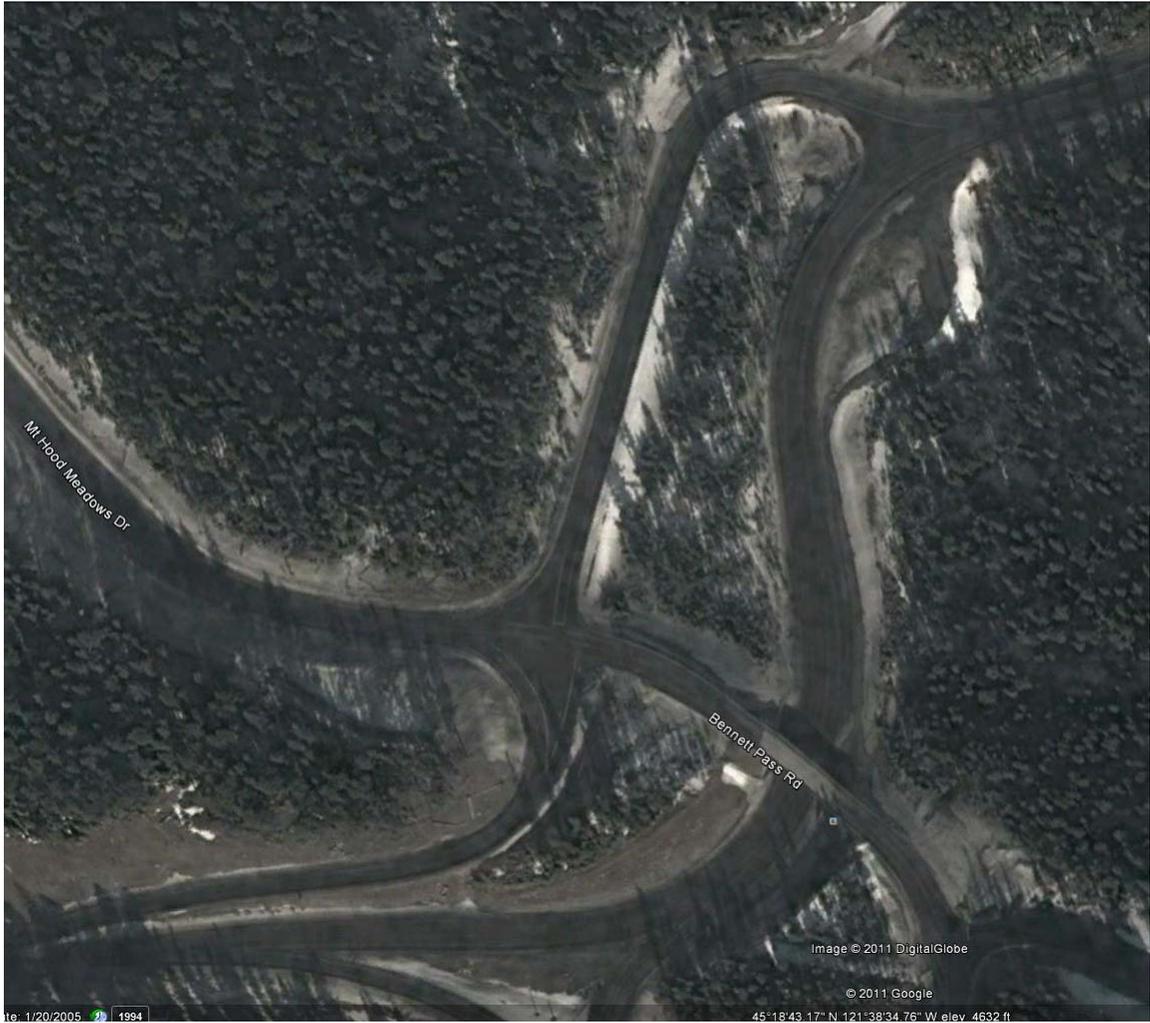
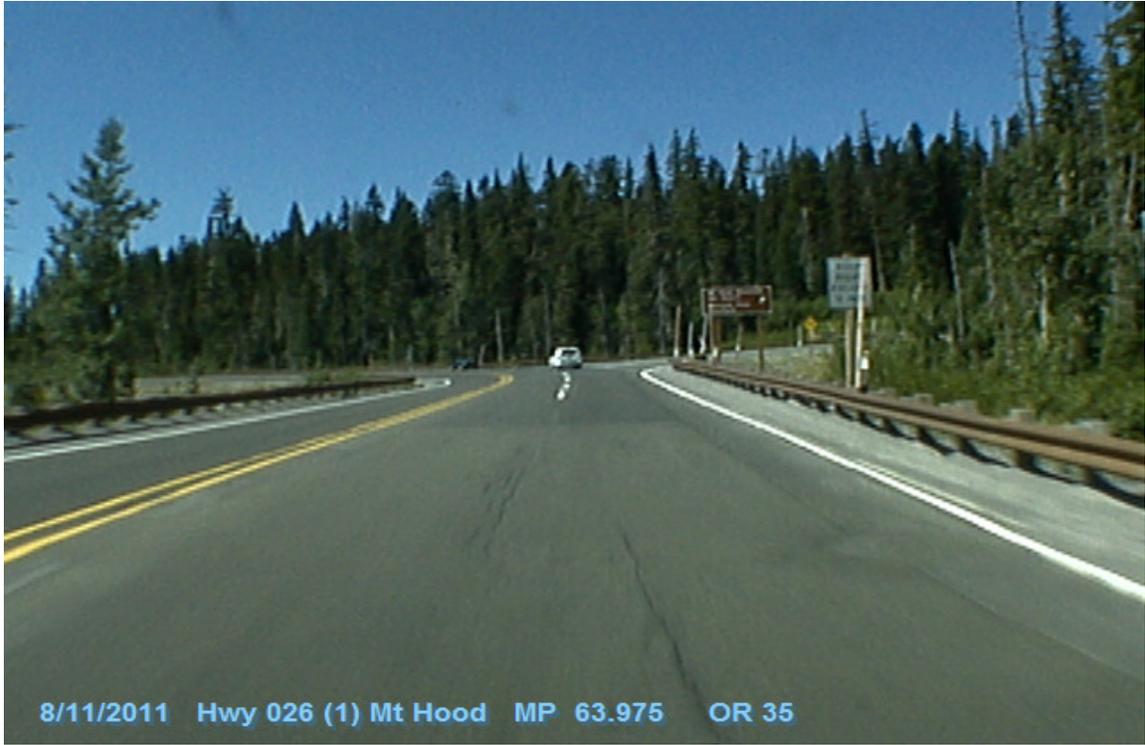
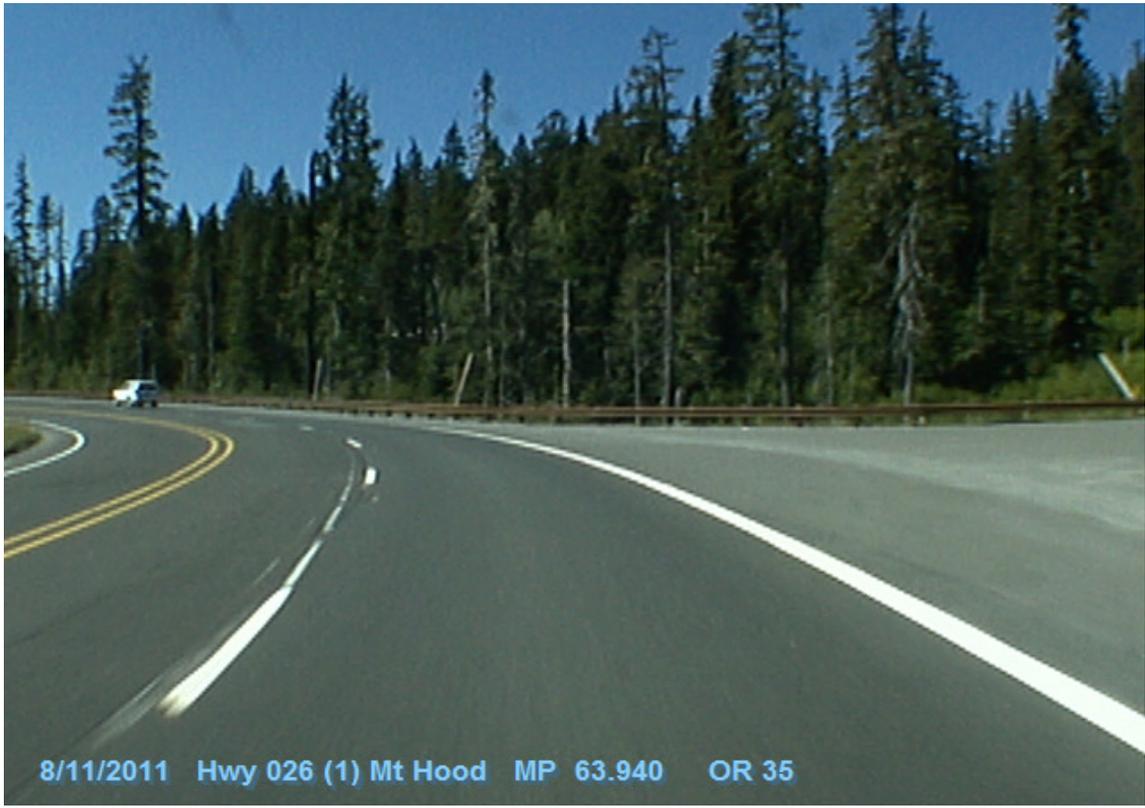
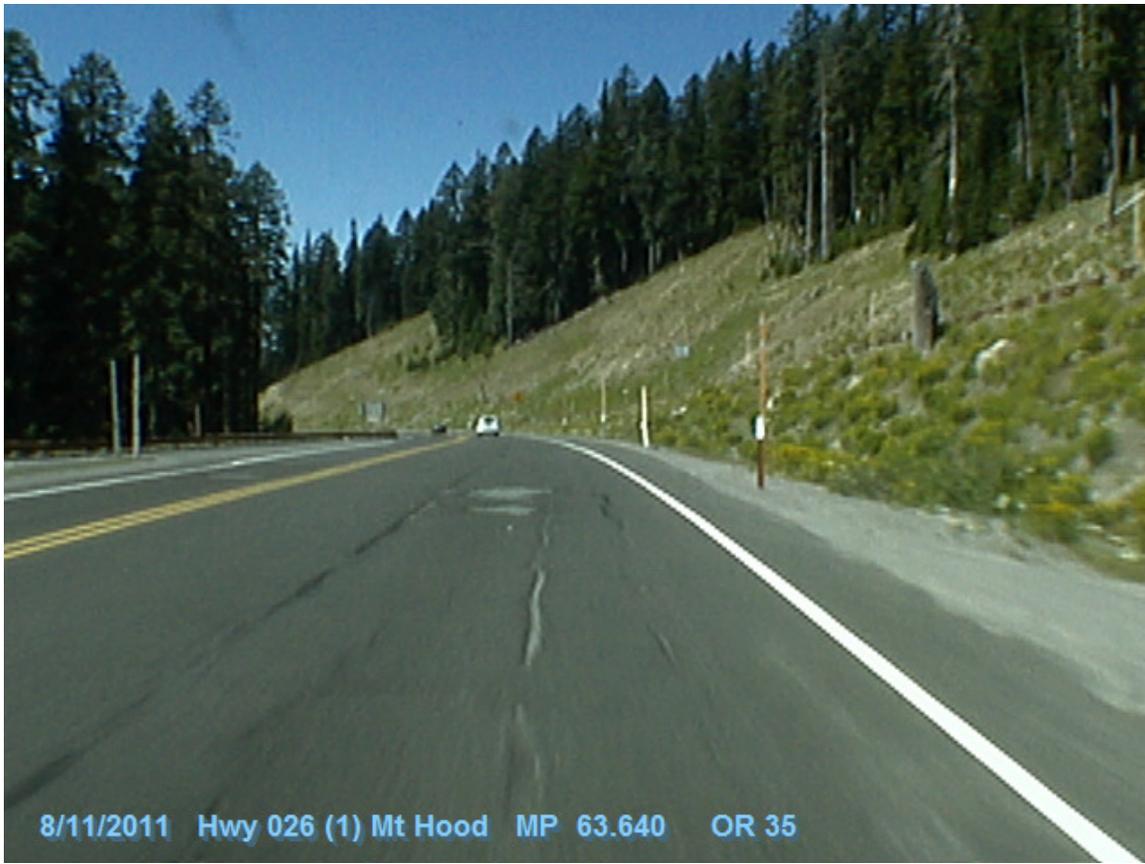
- The short passing lane combined with sharp horizontal curves, winter peak traffic congestion and high elevation for Bennett pass (4650) in the Mt Hood Meadows Interchange are issues.
- Some drivers are making a sharp U-turn type maneuver across the gore area from NB to SB on to the Meadows off-ramp.
- The curve signing needs to be upgraded and have distance riders.
- An additional VMS sign is needed facing traffic leaving Mt Hood Meadows directing drivers to go NB or SB on OR 35.
- The delineation at the ends of widened/taper sections may be easier to follow with chevron signs.

Typical views of the interchange area from the air and on OR 35 SB are shown in the following pictures:

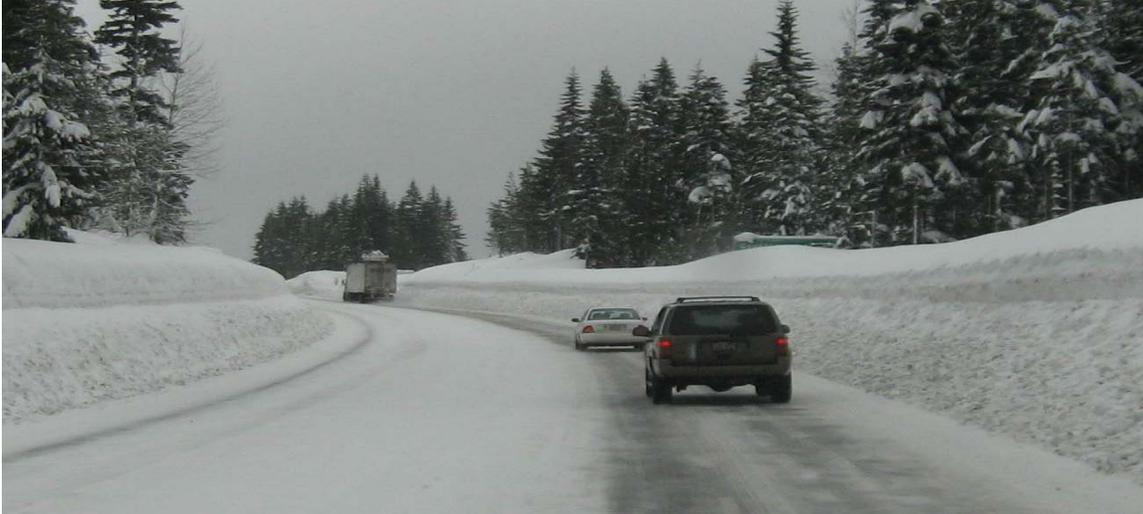
pavement deformation areas. Based on this February review the pavement condition definitely is poor showing a number of pop out areas (holes in the surface). As a result the pavement condition rating has been revised in the final RSA report to poor. Sight distance is significantly more restricted in the winter due to the snow banks along the road.

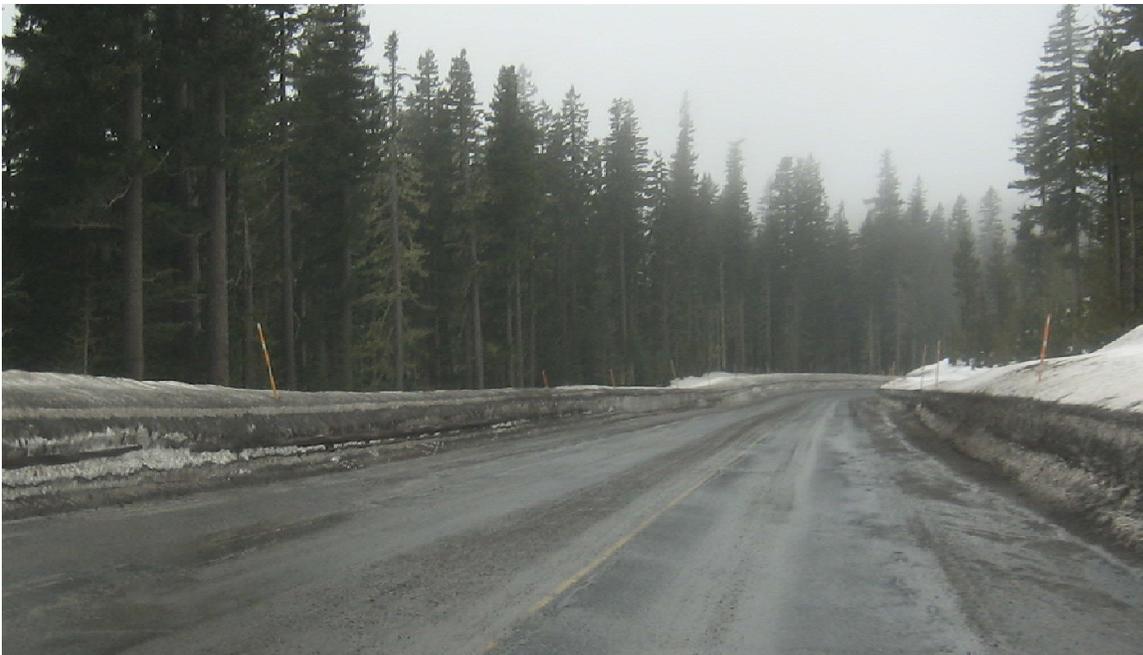
Pavement markings that were described as good during the November, 2011 review were for the most part not visible throughout the RSA section during this winter review. The recessed marker pavement slots were mostly filled with sanding material and the painted pavement lines were either worn out (mostly gone) or covered with sanding material. The signing was in much worse condition with numerous broken off sign supports close to the road and signs further from the road buried in the snow with the signs not visible at all. In addition there were many sheet aluminum signs observed in this winter review, that were bent back and not legible to drivers. These winter signing visibility issues were particularly evident on OR 35. This illustrates the need for additional winter mitigation curve warning sign mitigation on OR 35.

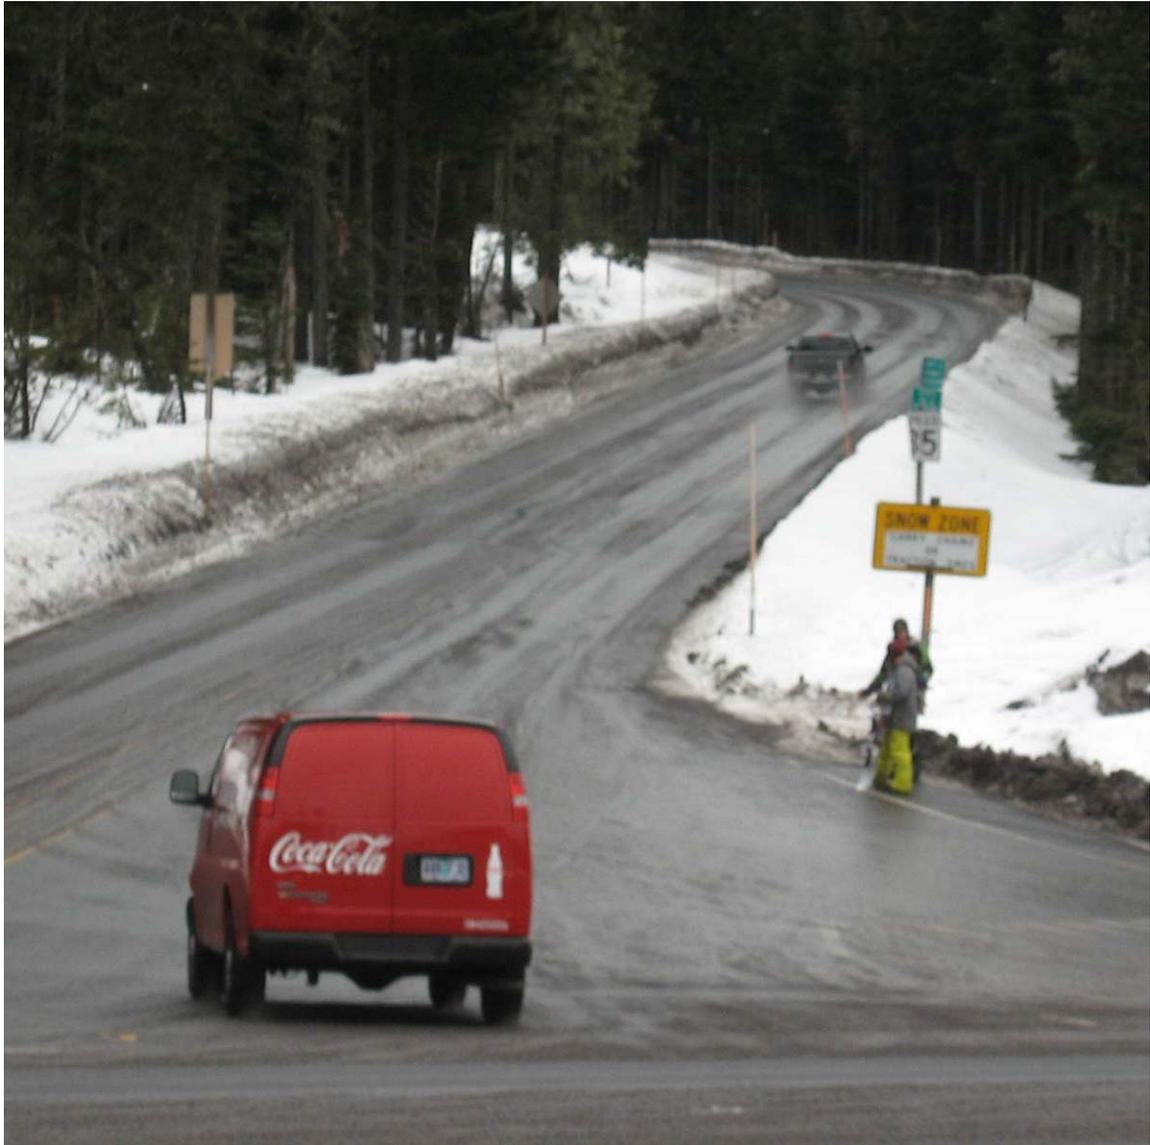
Winter operations were observed at the west end of the RSA section at Timberline Road. In addition to the November safety concerns, it was found that there are a number of pedestrians crossing US 26 and hitchhiking on Timberline Road to the ski areas. Another observation was fast moving traffic eastbound on US 26 turning north on Timberline Road across the worn off painted island on the Timberline Road approach. It was also found that Timberline Road from US 26 to Timberline Lodge has some of the same winter condition safety concerns as the RSA section with no pavement markings visible and many signs also not visible.

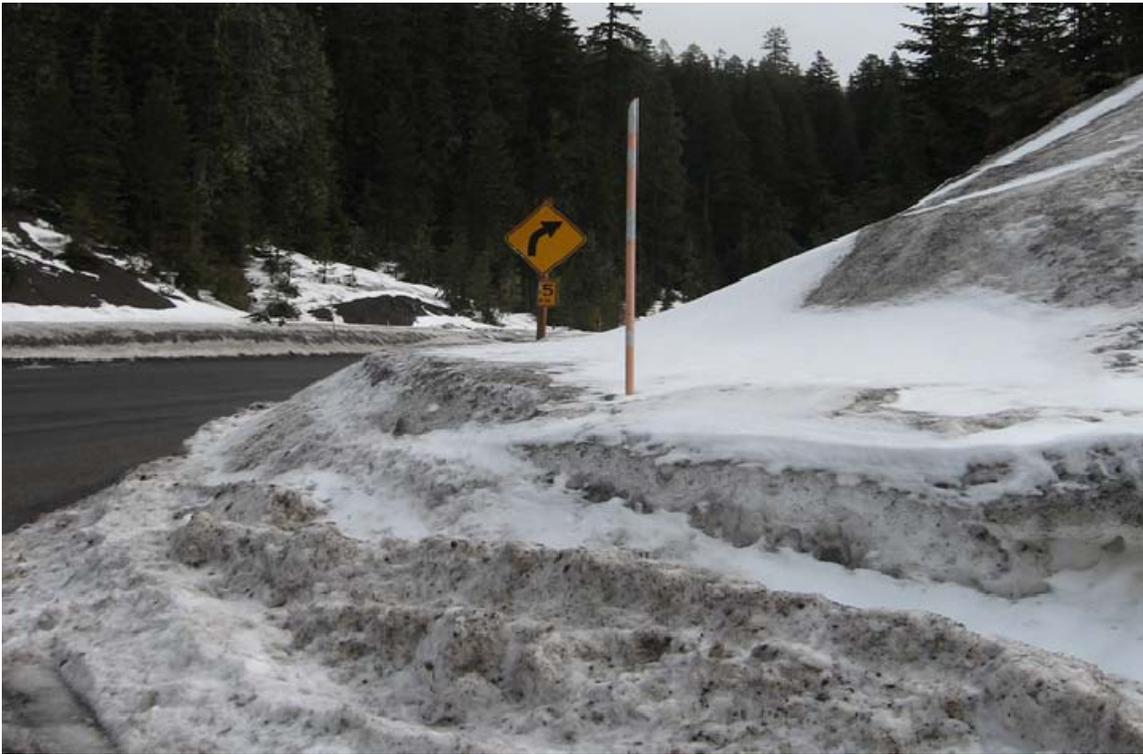
Sight distance at the OR 35/Barlow Road intersection (small Sno-Park) location was also more restricted with the snow bank in the northeast quadrant. This requires drivers on the Barlow Road approach to pull up even further beyond the “STOP” sign to see SB traffic approaching from the North on OR 35. The curve sign speed rider is also bent.

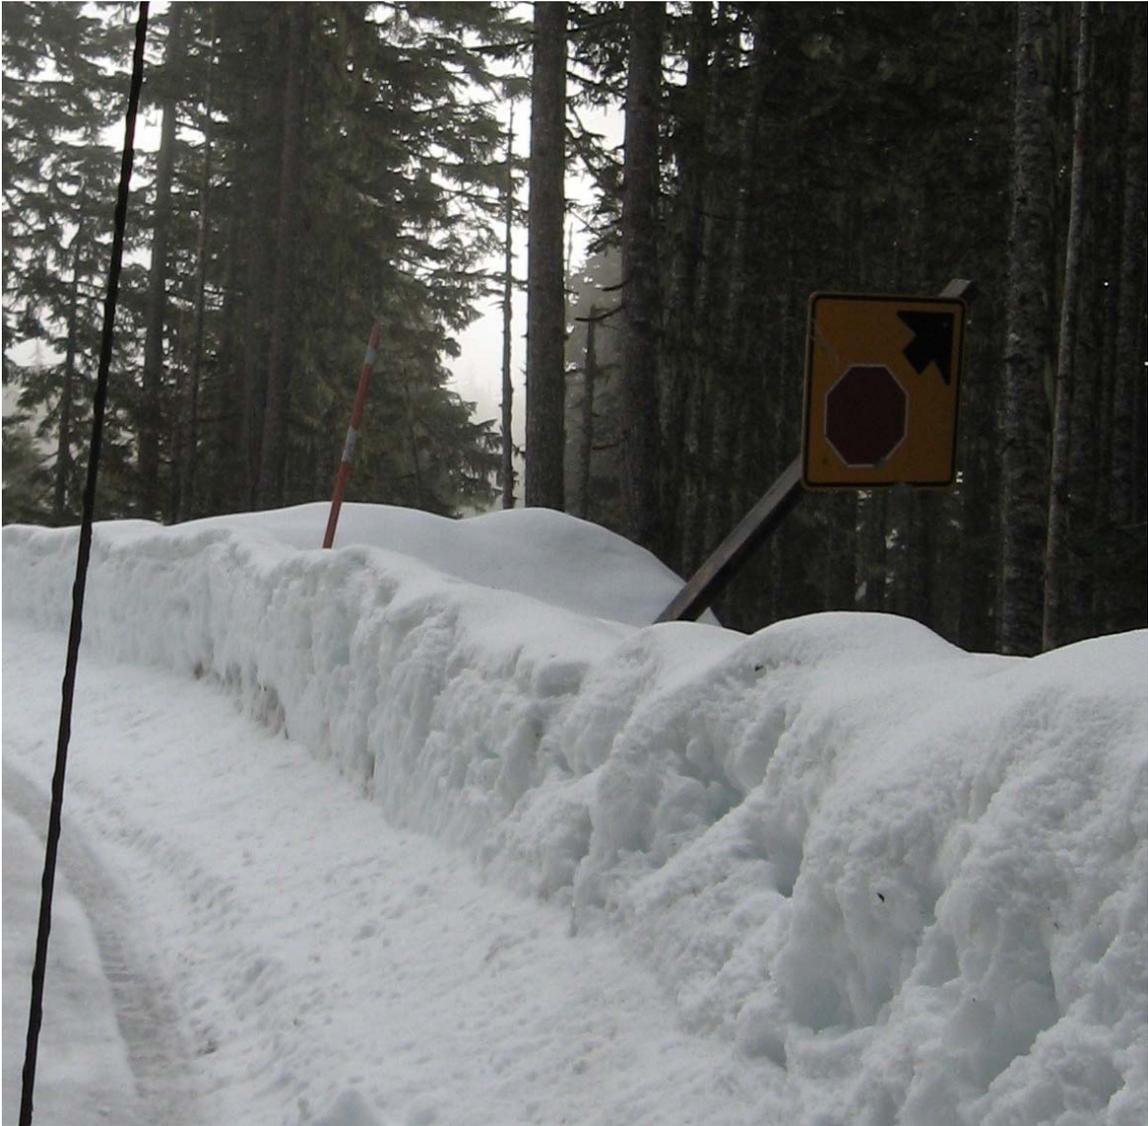
Another example of sign visibility issues was the Stop Ahead symbol sign was laying over on the snow bank on the Barlow Road approach to OR 35.

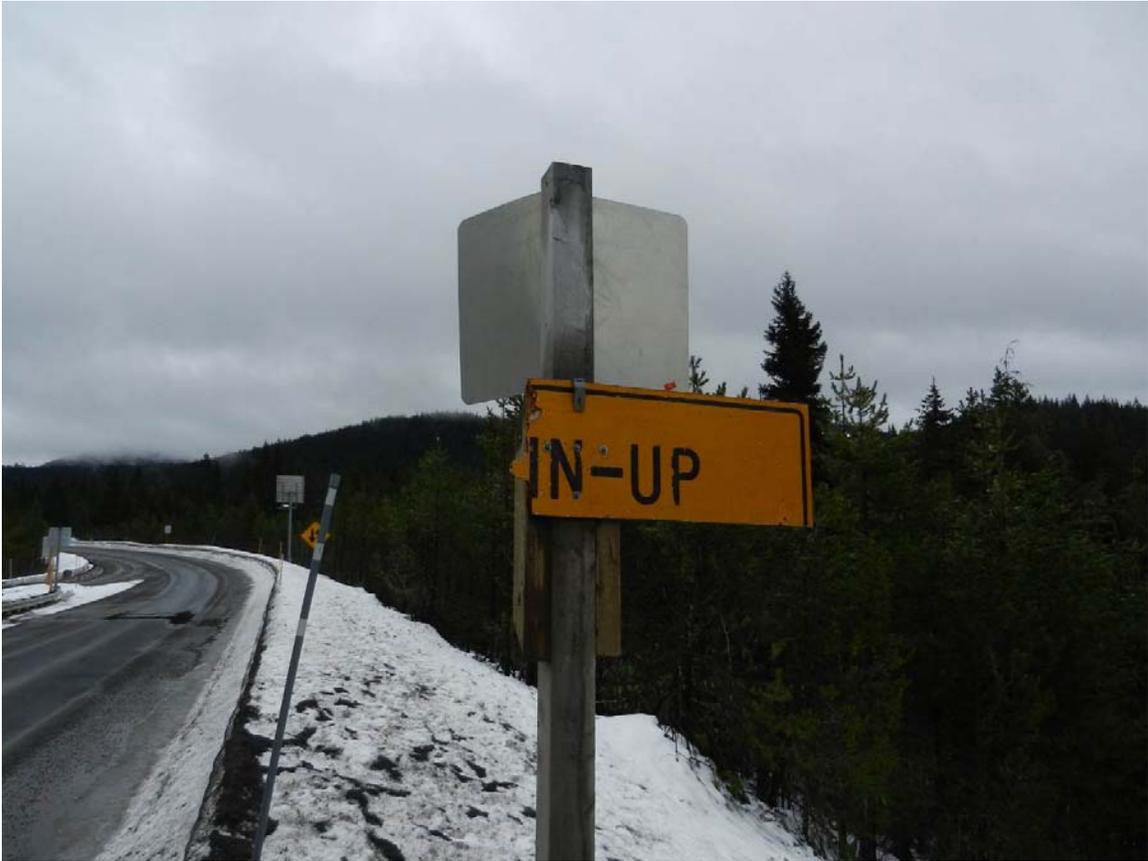
There were numerous signs down with broken wood supports, bent signs and signs covered with snow in the OR 35 Mt Hood Meadows Interchange area. This included curve warning signing and some major intersection guide signs. These signing safety concern issues further support the RSA signing proposals for warning signs on steel supports higher above the ground and for the VMS sign proposal on the Mt Hood Meadows Road approach towards OR 35 to inform and direct traffic leaving the Mt Hood Meadows winter recreation area. The only type of sign substrate not bent or broken was extruded aluminum. As previously stated, there were many sheet aluminum signs that were bent and there were wood rectangular signs that were broken. A broken wood sign along US 26 is shown in the following picture.

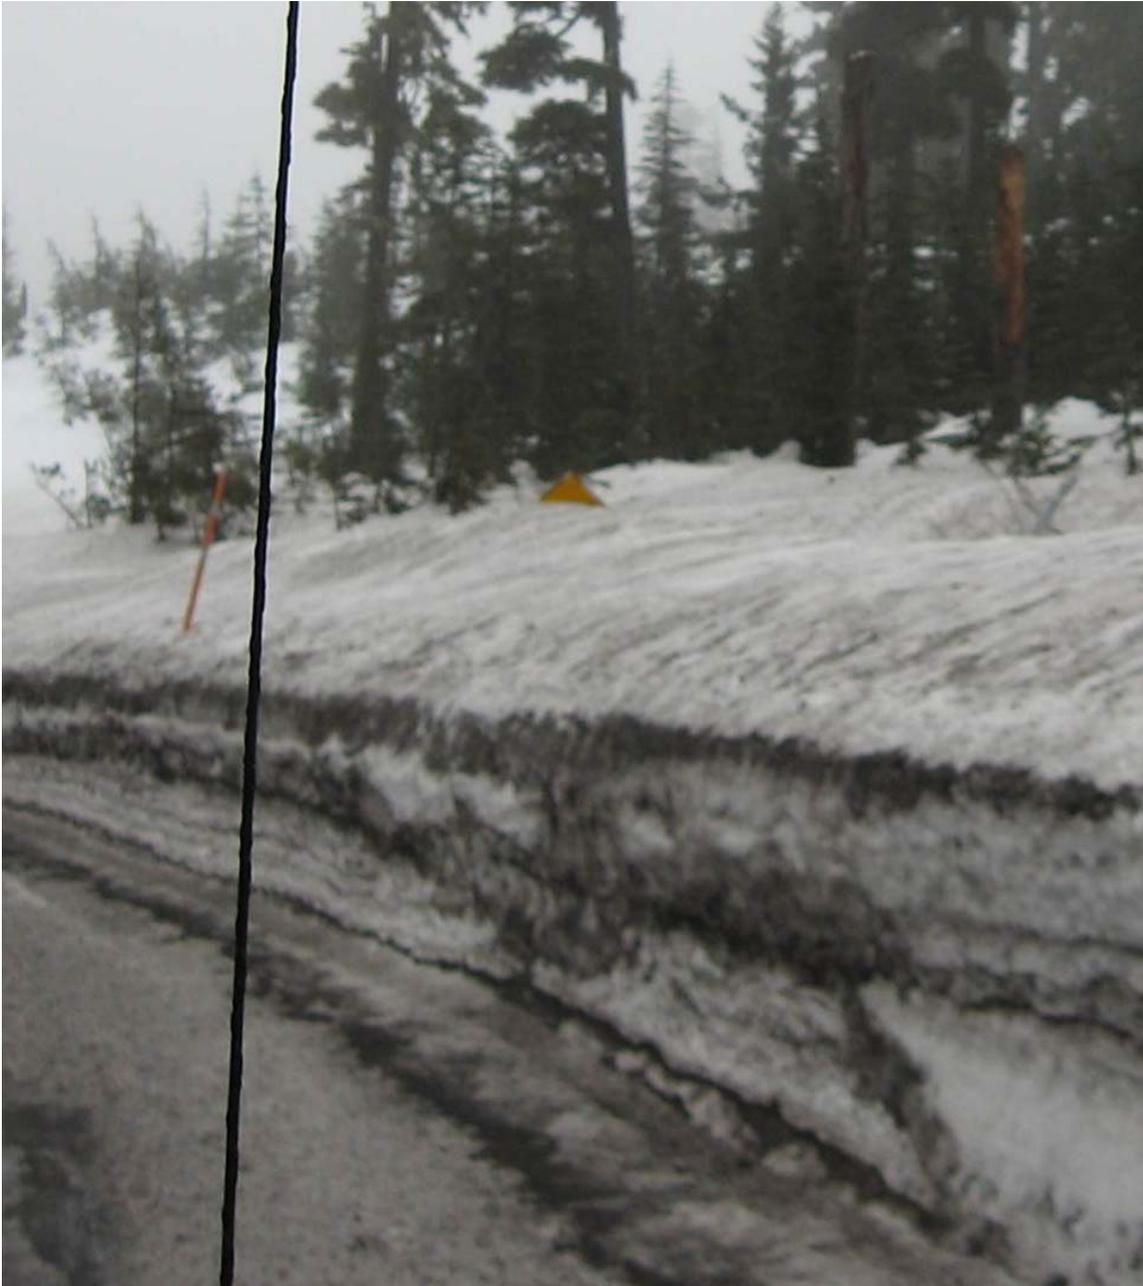
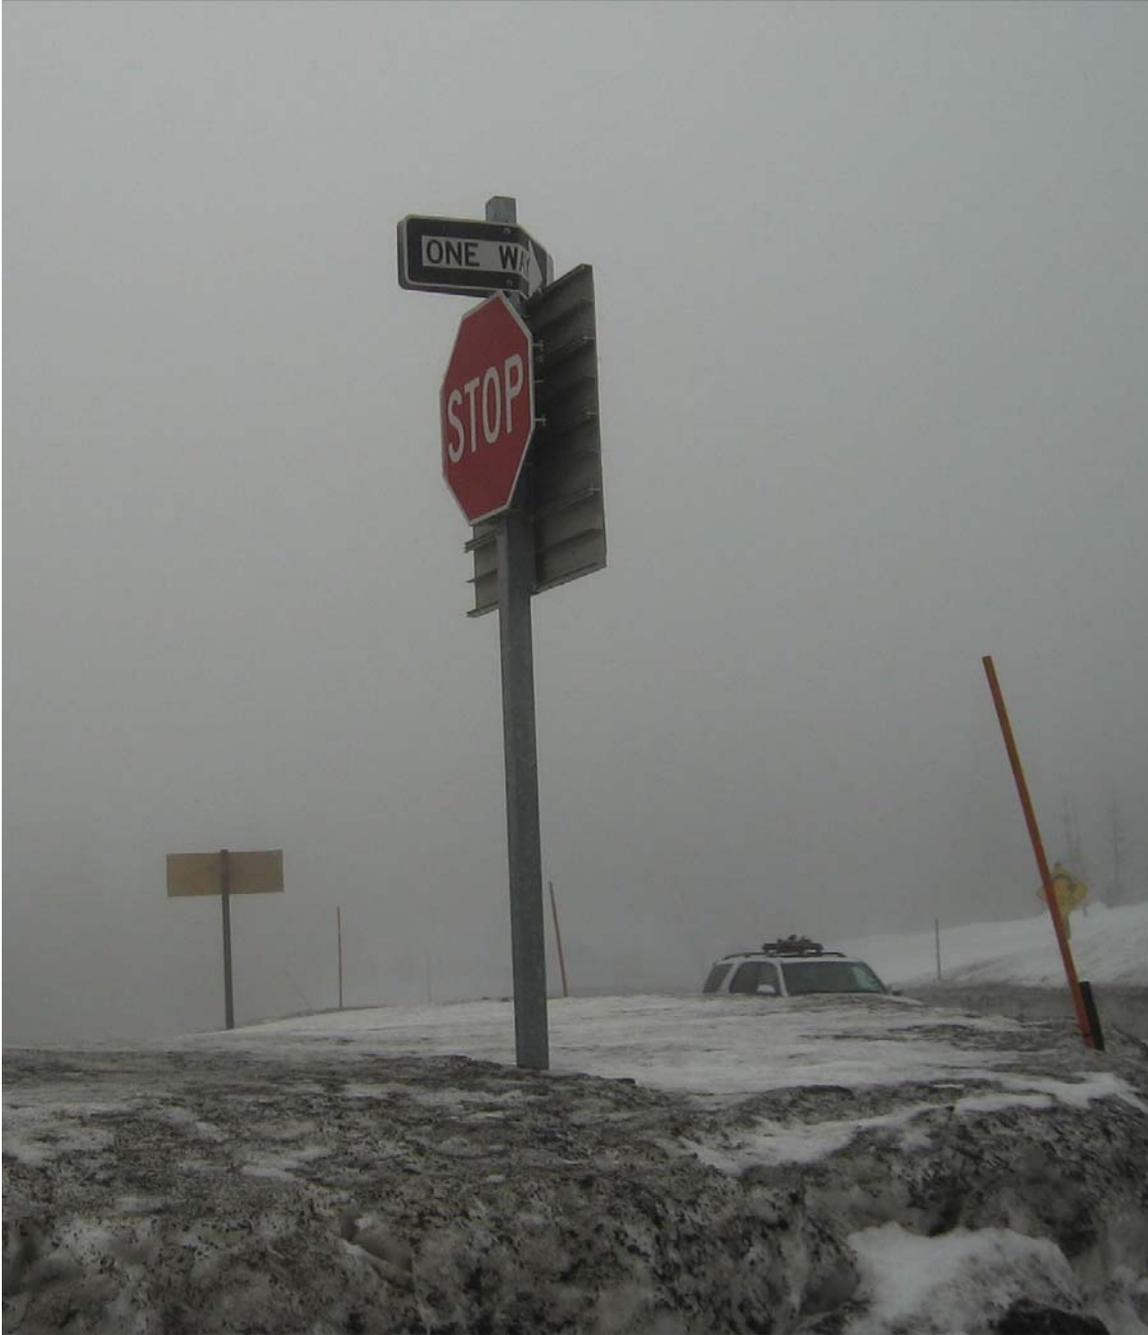
Pictures of a covered OR 35 warning sign and an Mt Hood Meadows Interchange intersection sign assembly at OR 35 follow.
