MT HOOD HIGHWAY ROAD SAFETY AUDIT

Timberline Rd to Nottingham

Road Safety Audit (RSA)

Mt Hood Highway (US-26 and OR-35)
Mile Point 54.20 – 70.20

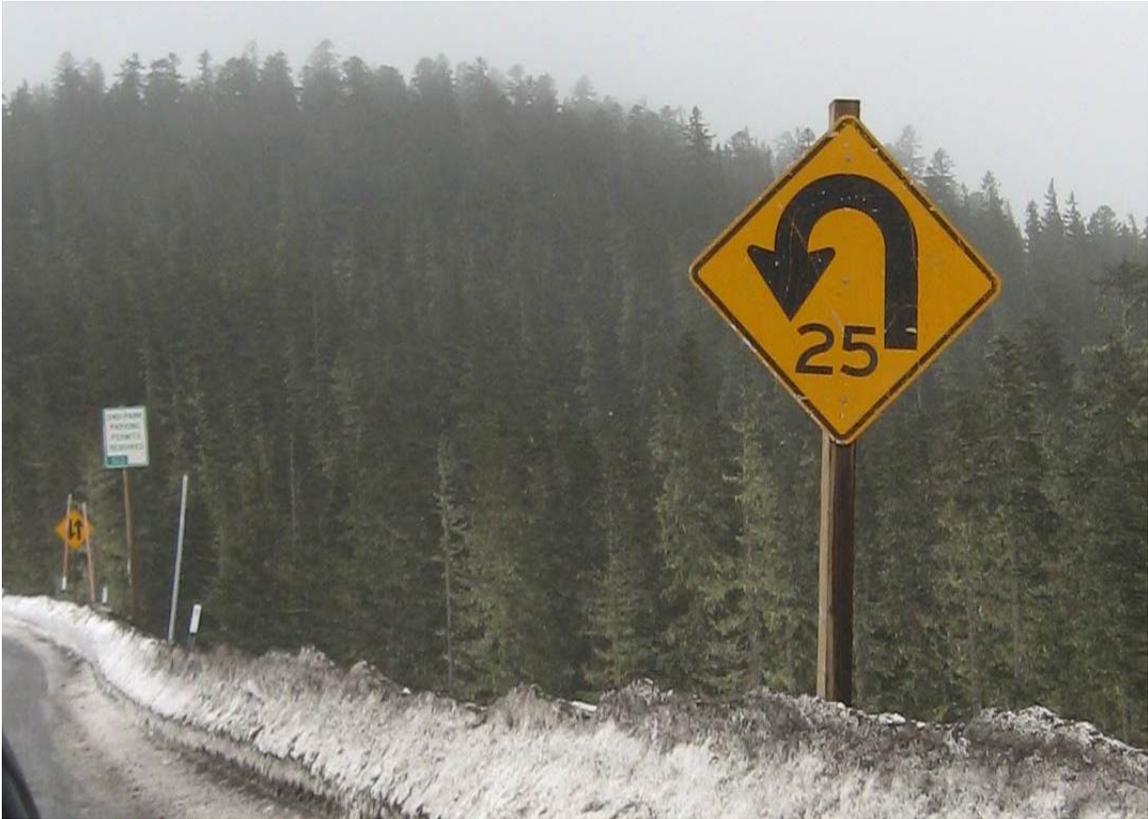
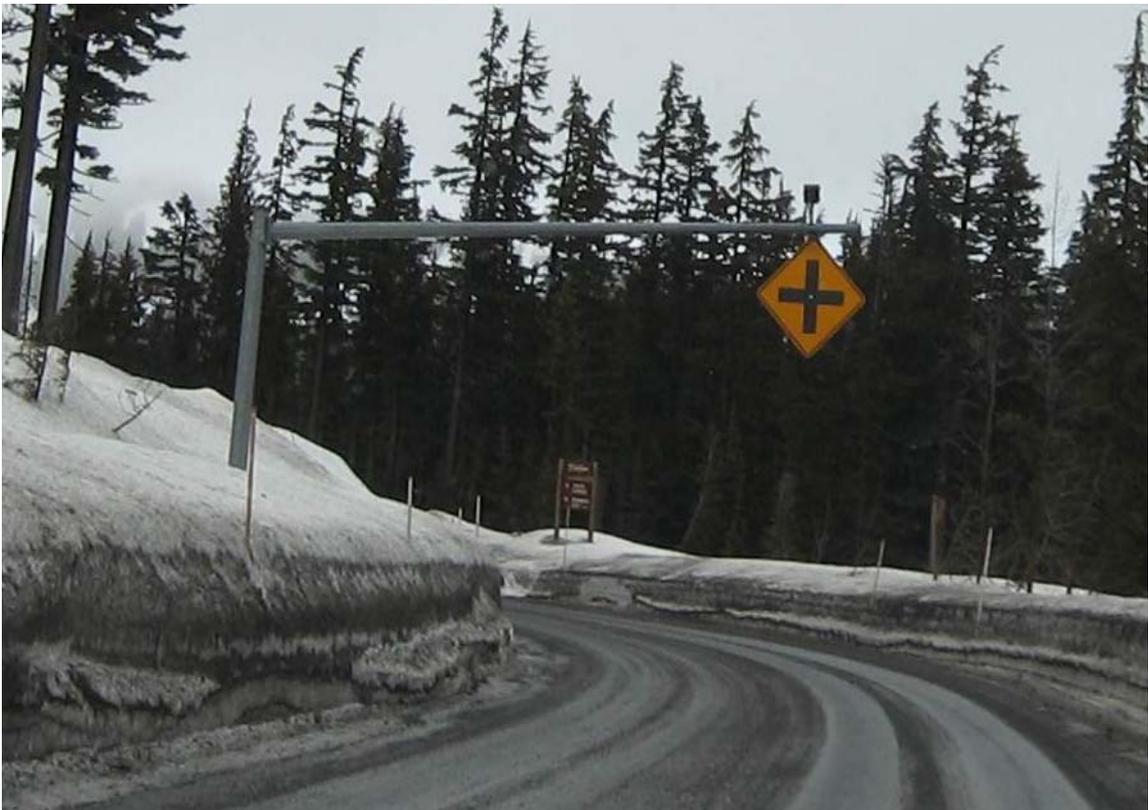
The observations on US 26 illustrated the crucial need for the overhead diagrammatic sign recommended in the RSA for EB traffic at the OR 35 interchange. Overhead signing is also needed on OR 35 for both crucial guide and warning signs. Many of the signs are not visible in the winter. The winter crash history on OR 35 showed the need for better warning signing with the majority of crashes during the winter involving vehicles leaving their traffic lane or running off the road. This supports the recommendation in the RSA for the VMS sign for guidance at Mt Hood Meadows interchange for traffic leaving Mt Hood Meadows. This also supports the mitigation measure in this addendum for the overhead and the supplementary curve warning signs on OR 35. Examples of the proposed curve signing and an overhead warning sign installation are shown in the pictures on the next page.

- Consider installing supplementary combination horizontal alignment/advisory speed signs (W1-1a, W1-2a) warning signs for the curves at MP 59, MP 60, MP 63 and Mt Hood Meadows interchange (example shown on the next picture).
- Install an overhead "CURVES" warning sign with a "6-MILES" advisory plaque for NB traffic at approximately MP 58.5 and for SB traffic at approximately MP 64.5 (example of overhead warning sign installation on the next page).
