## OR-8 ROAD SAFETY AUDIT Tualatin Valley Highway at SW 185<sup>th</sup> Avenue

Mile Point 6.45 – 6.73

Audit Date: December 5-7, 2011

# DRAFT Road Safety Audit Report

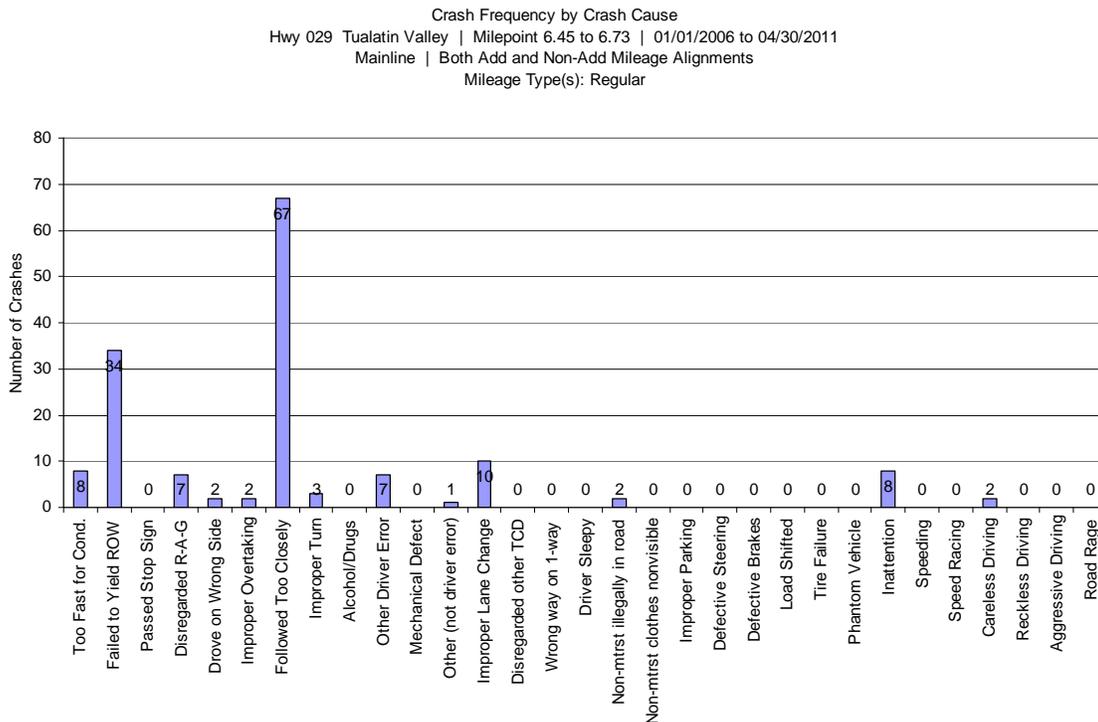
**Exhibit A – Crash Frequency by Crash Cause**

Exhibit A shows the causes for crashes in the project area. The Team found the 44% of crashes resulting from a driver following too closely to be particularly significant. This cause usually translates to rear-end crashes. The second highest crash cause shown is failure to yield right-of-way, accounting for 22% of crashes. This cause cannot be directly translated to one specific crash type. Field observation was necessary to surmise why drivers are not yielding right-of-way.

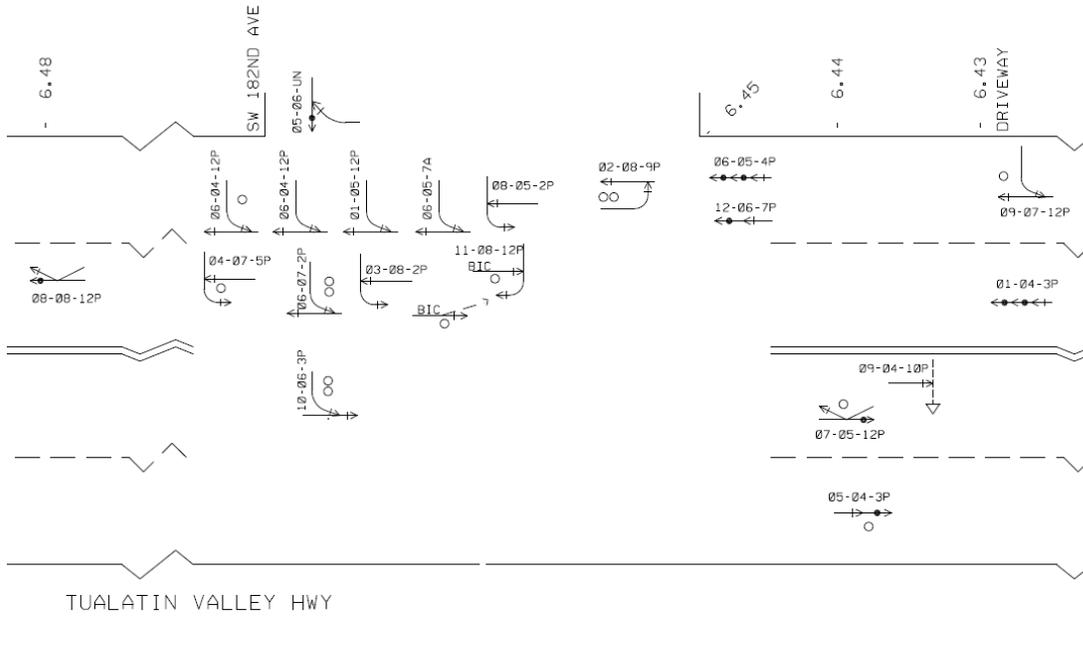
**Exhibit B – Crash Diagram (OR-8 & SW 182<sup>nd</sup> Ave)**

- Heavily congested intersection
- The most serious crashes occurred at SW 182<sup>nd</sup> Ave and SW 187<sup>th</sup> Ave from left-turn movements
- Many incidents due to left-turn conflicts at accesses
- Not many crashes within the SW 185<sup>th</sup> Ave intersection
- Number of crashes probably under reported
- Most pedestrians on SW 185<sup>th</sup> Ave
- Many jaywalkers
- Likely increased driver frustration/agitation due to proximity of schools

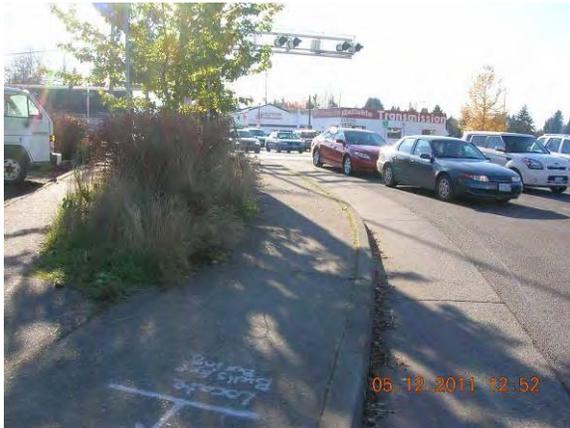
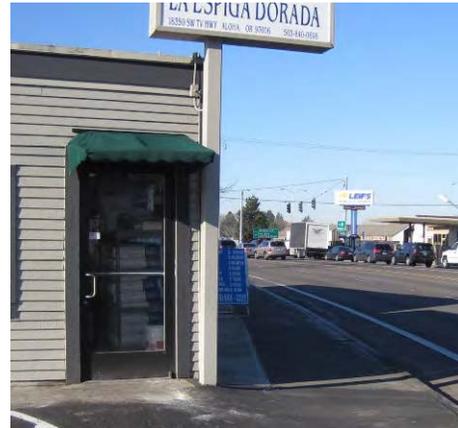
Visibility for roadway users is limited or compromised in several locations. Views are diminished by vegetation near the northbound slip lane on SW 185<sup>th</sup> Ave and at the Aloha Mall accesses on the north side of the highway to the west of SW 185<sup>th</sup> Ave. At least one business was observed to have a portable sign near a driveway that limited the view of exiting motorists. Large parked vehicles in the Aloha Mall parking lot limit intersection sight lines at SW 187<sup>th</sup> Ave.

| Safety Risk Assessment | |
|---|---|
| Consequence | Medium |
| Resulting Road Safety Risk: | MEDIUM |

Examples of sight distance restrictions in study area.

- Consider relocating portable signs and maintaining vegetation to improve sight triangles consistent with county ordinances or state highway access permits. RSA team recommends addressing in an ongoing fashion.

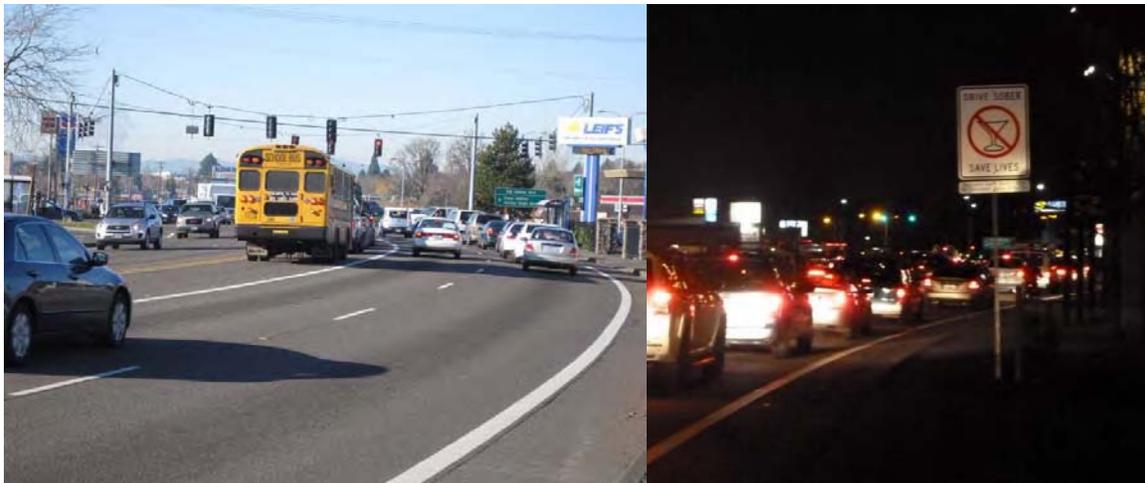
| Safety Risk Assessment | |
|---|---|
| Consequence | Medium |
| Resulting Road Safety Risk: | HIGH |

Westbound approach at SW 185<sup>th</sup> Ave noting limited visibility of signal heads.

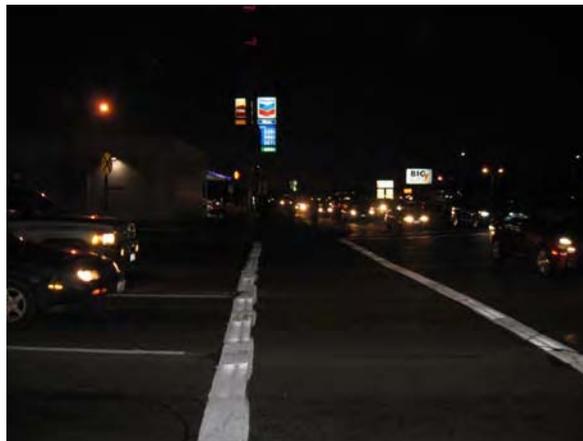
The approaches and intersection of SW 185<sup>th</sup> Ave and TV Highway are currently not illuminated. There are numerous conflicts created by driveways, bus stops, pedestrian crossings, and the traffic signal operation. The conflicts may not be as readily apparent under ambient light or vehicle headlights. Drivers may have reduced time to react to conflicts. The lack of illumination may contribute to a failure by drivers to recognize the changing roadside character of the area.

South crosswalk at SW 185<sup>th</sup> Ave.

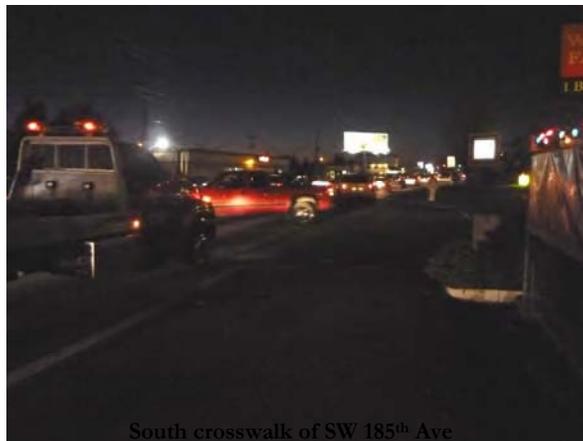
| Safety Risk Assessment | |
|---|---|
| Consequence | High |
| Resulting Road Safety Risk: | HIGH |

South crosswalk of SW 185<sup>th</sup> Ave  
Left turning vehicle crossing pedestrian path.  
Note: picture brightened to show conflicts

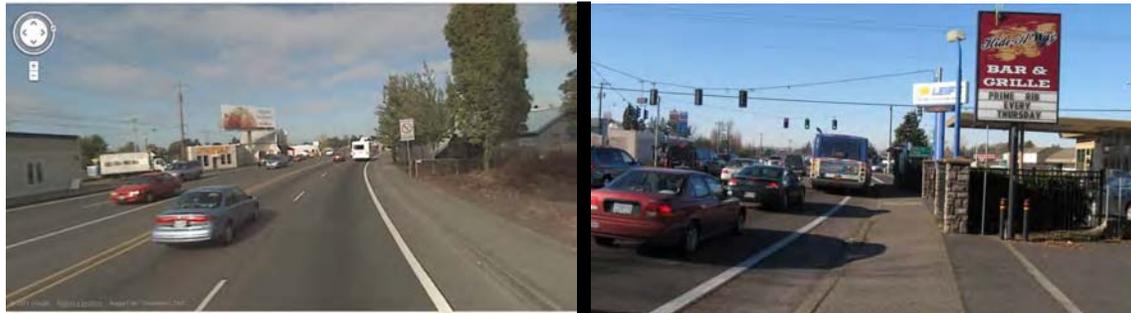
| <b>Safety Risk Assessment</b> | |
|---|---|
| Consequence | Low |
| Resulting Road Safety Risk: | HIGH |

(Left) TV Highway at mile point 6.47 noting lower density of conflicts and suburban character.  
(Right) TV Highway at mile point 6.58 noting higher density of conflicts and urban character.

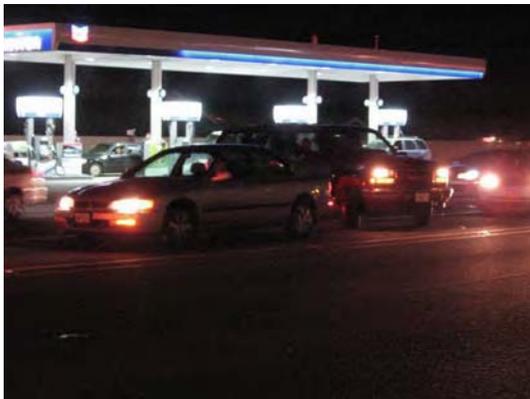
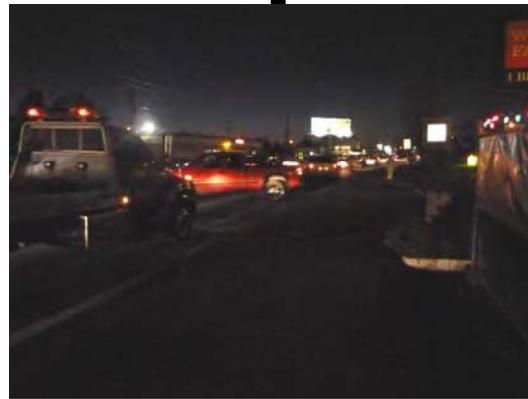
Traffic conditions are complex in the subject area. During off-peak conditions, vehicles exiting driveways and cross streets were observed to accept narrow gaps in traffic to execute left turns. The density of driveways causes gaps in traffic flow to be filled and drivers' wait times may be longer than anticipated. Eventually, drivers become impatient and accept narrower gaps that may result in mainline traffic needing to slow down to avoid a crash. Traffic speeds during mid-day conditions may result in serious injury crashes. During peak conditions, vehicles cut between stopped cars to execute turns. However, even when one lane of traffic is stopped, the other may be moving. The RSA team concluded that the left-turn movements at SW 182<sup>nd</sup> Ave have a particularly high safety risk due to the severity typically associated with these crashes.

| Safety Risk Assessment | |
|---|---|
| Consequence | High |
| Resulting Road Safety Risk: | HIGH |

Vehicle cuts between stopped cars to execute turn.

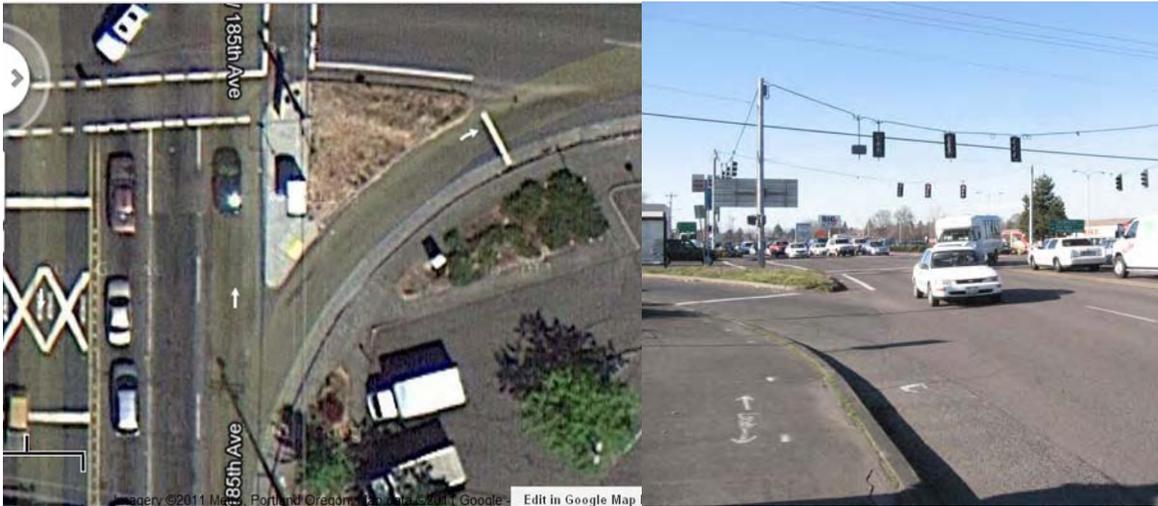
| Safety Risk Assessment | |
|---|---|
| Consequence | Medium |
| Resulting Road Safety Risk: | MEDIUM |

Northbound right turn slip lane.

| Field Observation | Risk Potential | Suggestion | Suggested Time Frame |
|---|---|---|---|
| Northbound 185th traffic turning right has a skewed channelized right-turn lane, resulting in poor sight distance for drivers scanning for a gap and high speeds on green. Improper use of stop bar and lack of crosswalk striping. | Current geometry of the northbound right turn slip lane results in poor scanning behavior and varying points where motorists stop before entering TV Highway. The design of the slip lane encourages higher speeds and unpredictable driver behavior that presents additional safety concerns related to pedestrian movements across the slip lane. | Improve the island geometry or install a typical right turn lane. | Project |

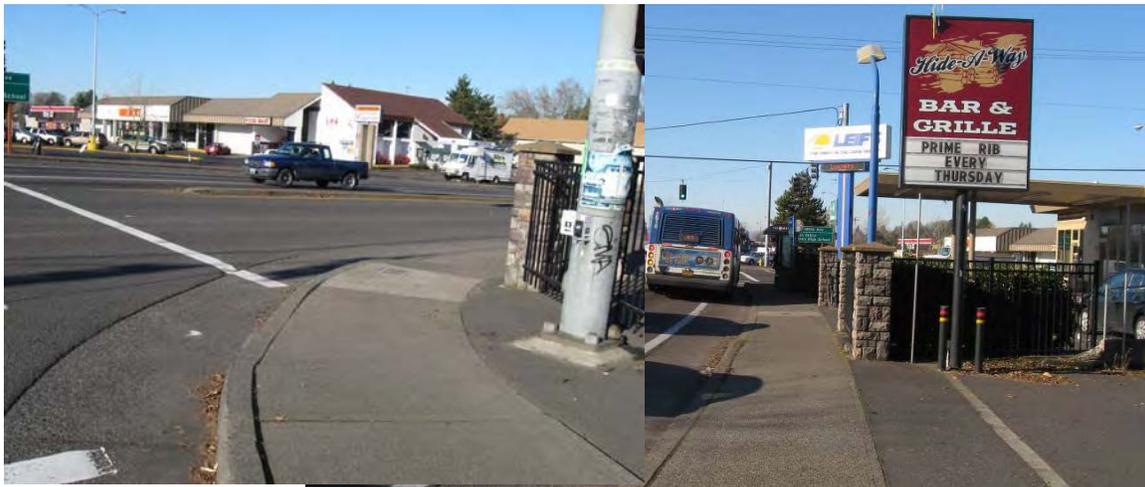
The intersection design and nearby obstructions limit motorists' ability to see pedestrians waiting to cross the northern crosswalk. The primary hazard is for westbound TV Highway traffic turning right. The near-side bus stop shelter and tall fence on Leif's property limit drivers' view of pedestrians in the crosswalk. The result is drivers stopping suddenly when pedestrians are present. There has been one pedestrian crash reported at this location, but an employee at the nearby auto-repair shop reported seeing numerous near-misses and minor incidents.

| Safety Risk Assessment | |
|---|---|
| Consequence | High |
| Resulting Road Safety Risk: | MEDIUM |

Limited visibility of crosswalk in NE corner.

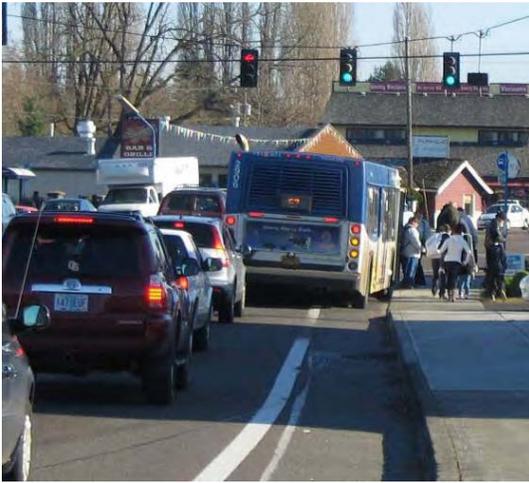
| Safety Risk Assessment | |
|---|---|
| Consequence | Medium |
| Resulting Road Safety Risk: | MEDIUM |

Near-side bus stop (eastbound) at SW 185<sup>th</sup> Ave.

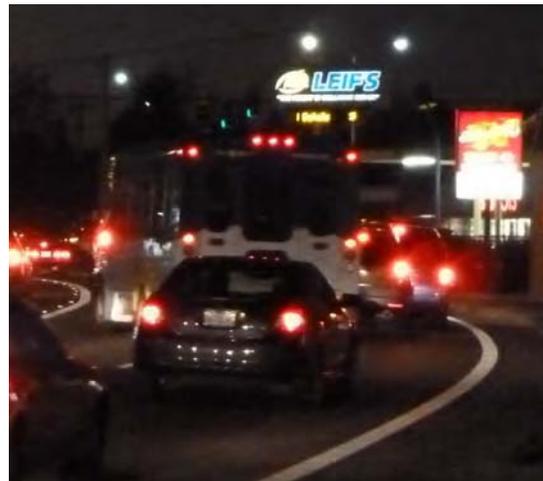
Lane changes due to near-side bus stop.

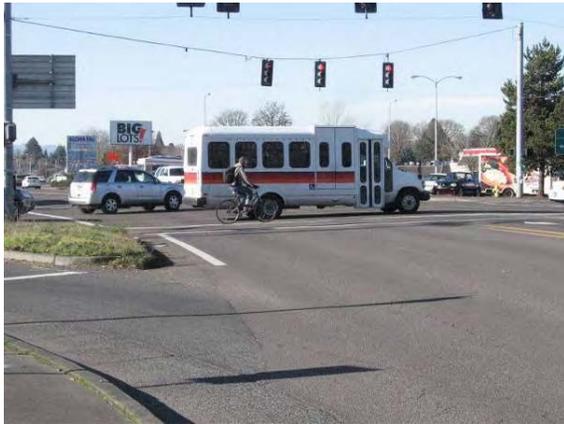
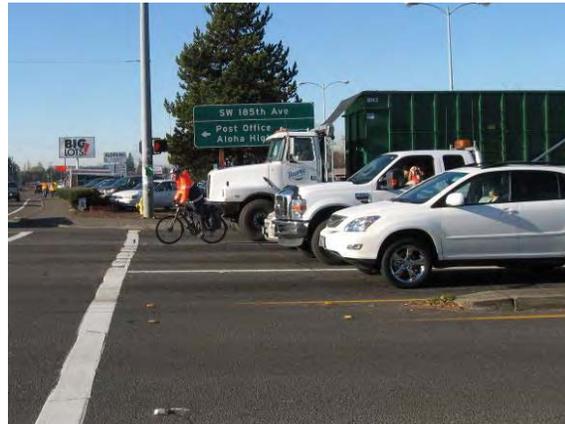
People on bicycles are required to share the general travel lanes (or ride on the sidewalks) with heavy motorized vehicular traffic. Under these conditions, riders may be unpredictable and may not be as visible if they are riding on the sidewalks. There are bike lanes on SW 185<sup>th</sup> Ave both north and south of the intersection, but the bike lanes are missing in the immediate vicinity of the intersection. SW 185<sup>th</sup> Ave is the only place to cross the adjacent railroad tracks between SW 170<sup>th</sup> Ave and SW 198<sup>th</sup> Ave, creating a high need for bicycle facilities at this location. Additionally, this intersection is a vital crossing for students that bike to nearby Aloha High School, less than one mile to the south. Many high school students currently ride on the sidewalks and cross this intersection, riding their bikes in the crosswalk.

| <b>Safety Risk Assessment</b> | |
|---|---|
| Consequence | High |
| Resulting Road Safety Risk: | MEDIUM |

**Bicyclists traveling on SW 185<sup>th</sup> Ave through intersection.**
