THE WAR ON REFLECTIVE CRACKING

HISTORY

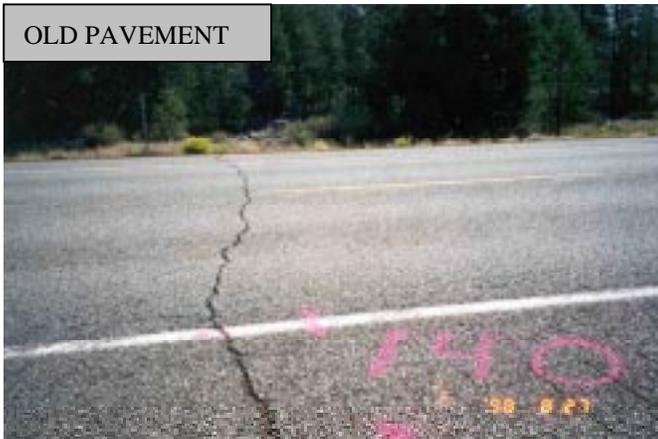
Crack 140 (transverse) in September 1998 before overlay

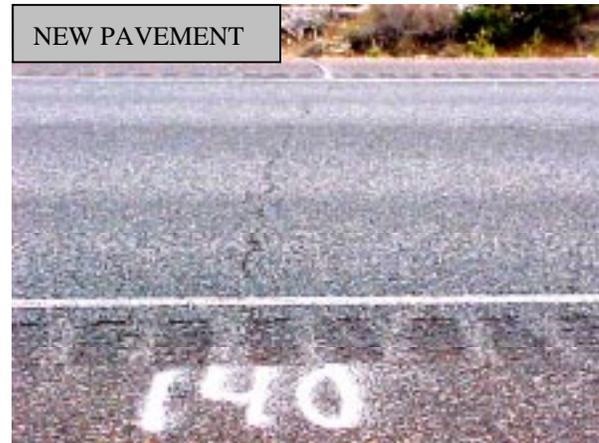
Crack 140 (reflective) in May 1999 after overlay

Crack 140 (treated with a geosynthetic) is shown above. The figure below is a crack covered with a geosynthetic prior to overlay.

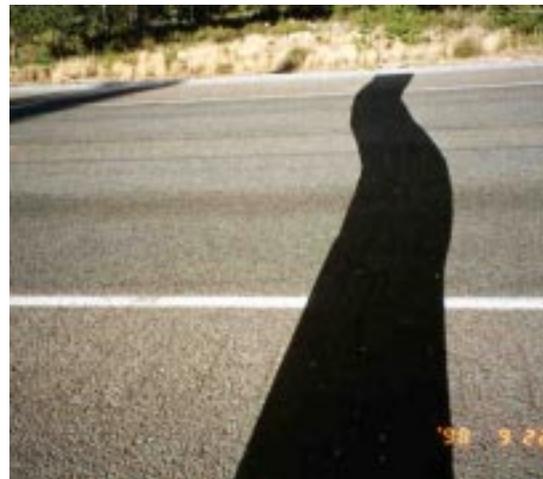
Geosynthetic over crack before overlay

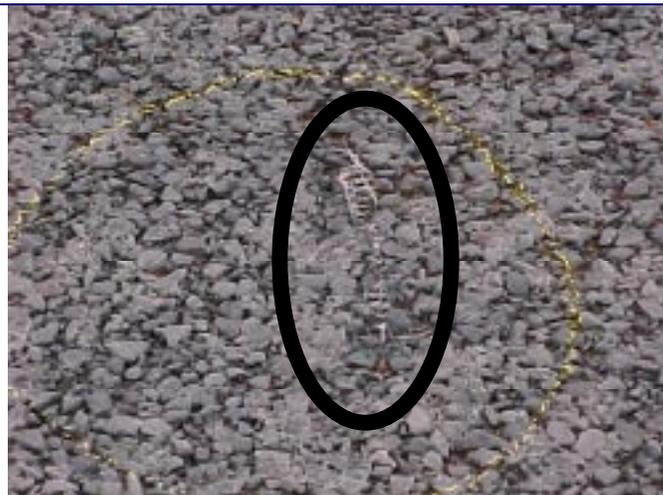
There appeared to be patterns in the asphalt overlay that could be the start of reflecting cracks. However, since the overlay is an open-graded mix, the voids seem to form lines and play tricks on your eyes, as shown above. So, for this inspection, only the cracks that are obvious were noted.

Glasgrid 8502® exposed at surface of overlay
(Note: patterns apparent in mix)

Overall, the overlay is in good condition. Of the installation problems noted in the construction report, the Glasgrid 8502® geosynthetic at crack 30 is exposed as seen above. When the paver paved over crack 30, the paver ski hooked the material and pulled about 2 m of it from the southbound shoulder. The end of the remaining material was not buried under the overlay, but left exposed at the surface. There does not appear to be any impact to the pavement so far.
