Indian Creek Aquatic Restoration

Oregon Wildlife Heritage Foundation

Narrative Summary:

Photographs:

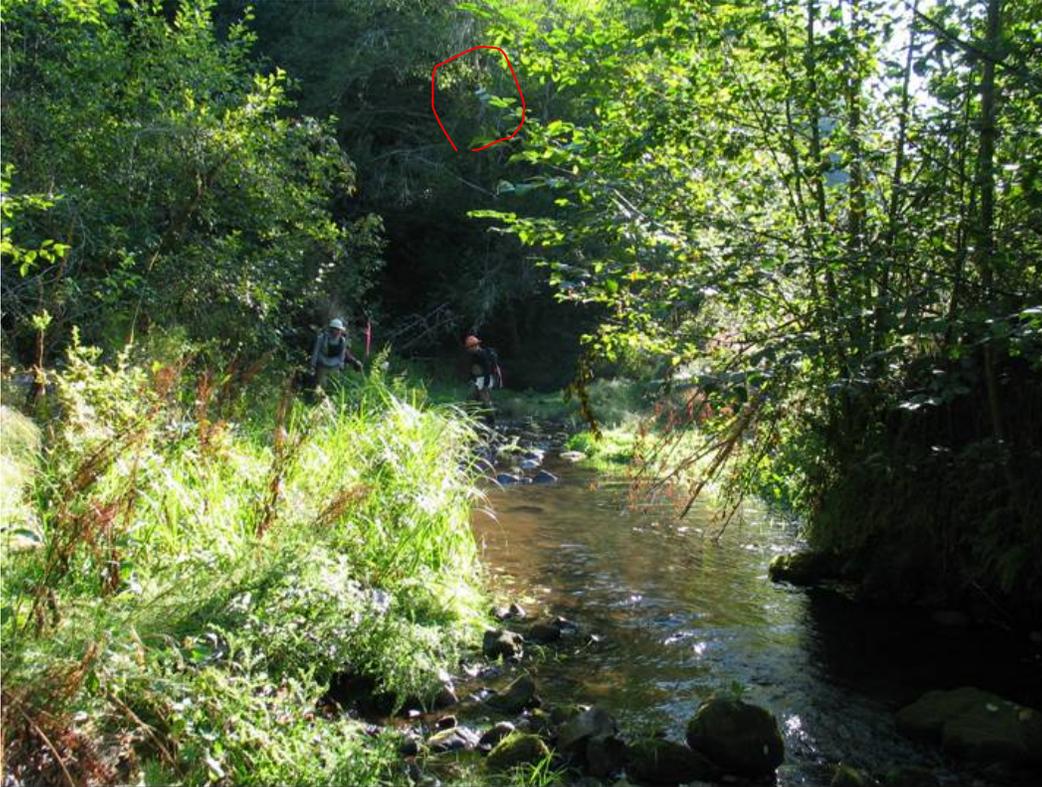
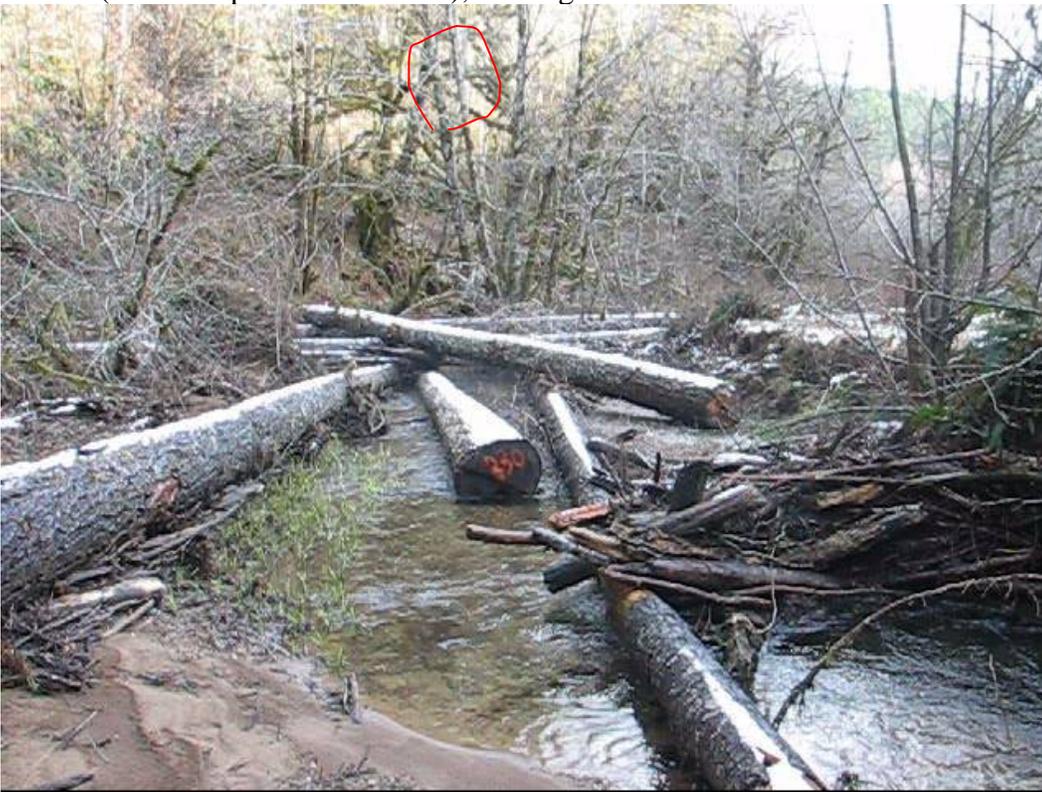
New Comments: The structure has helped collect small woody debris and sediment, scour pools, and encourage the high water to inundate the low-level floodplain on the left side.

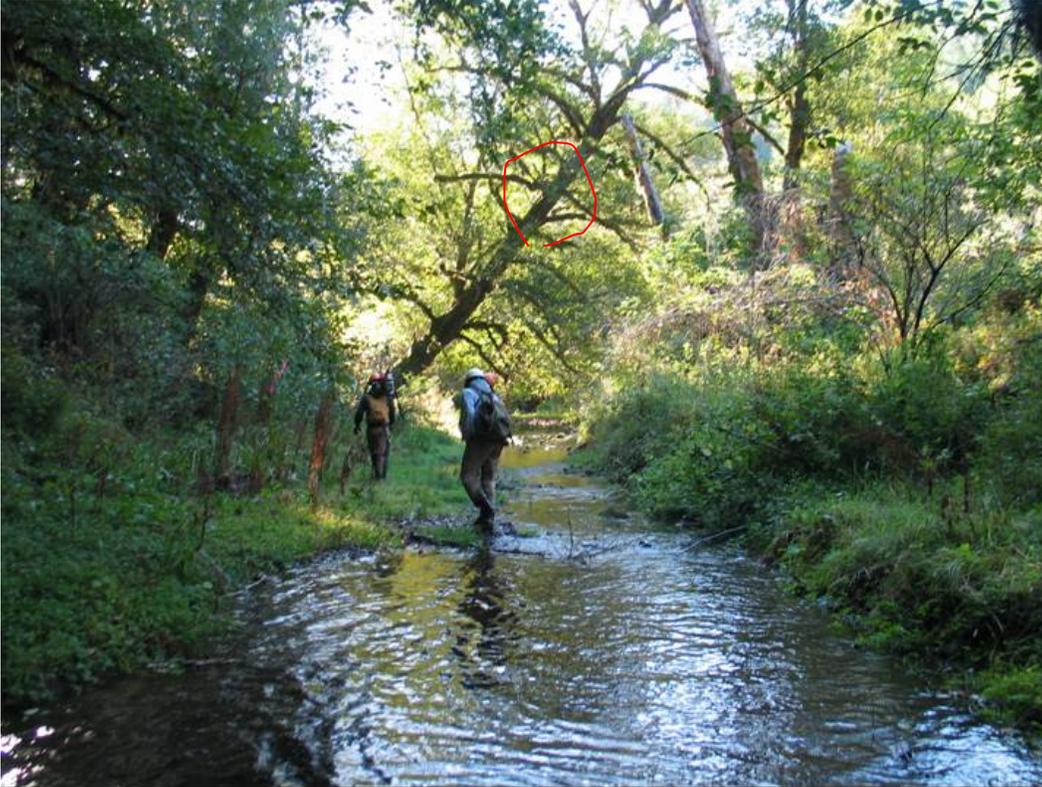
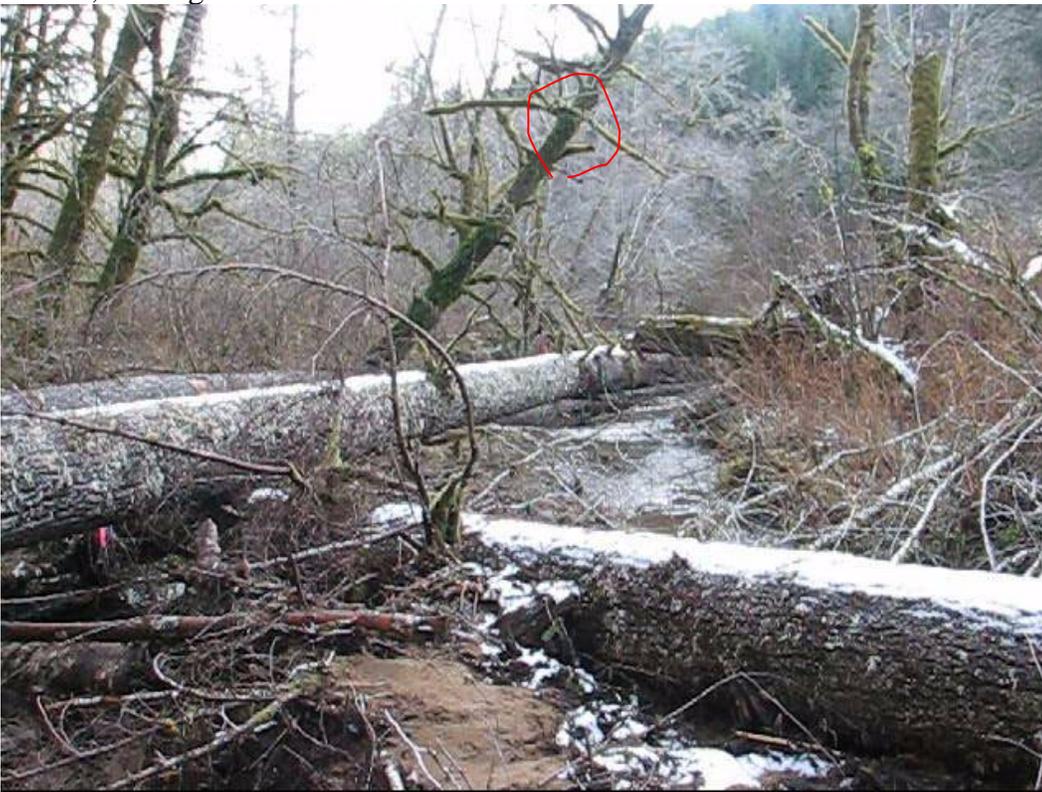
New Comments: Recent fine sediment accumulation appears to have occurred extensively around the structure.

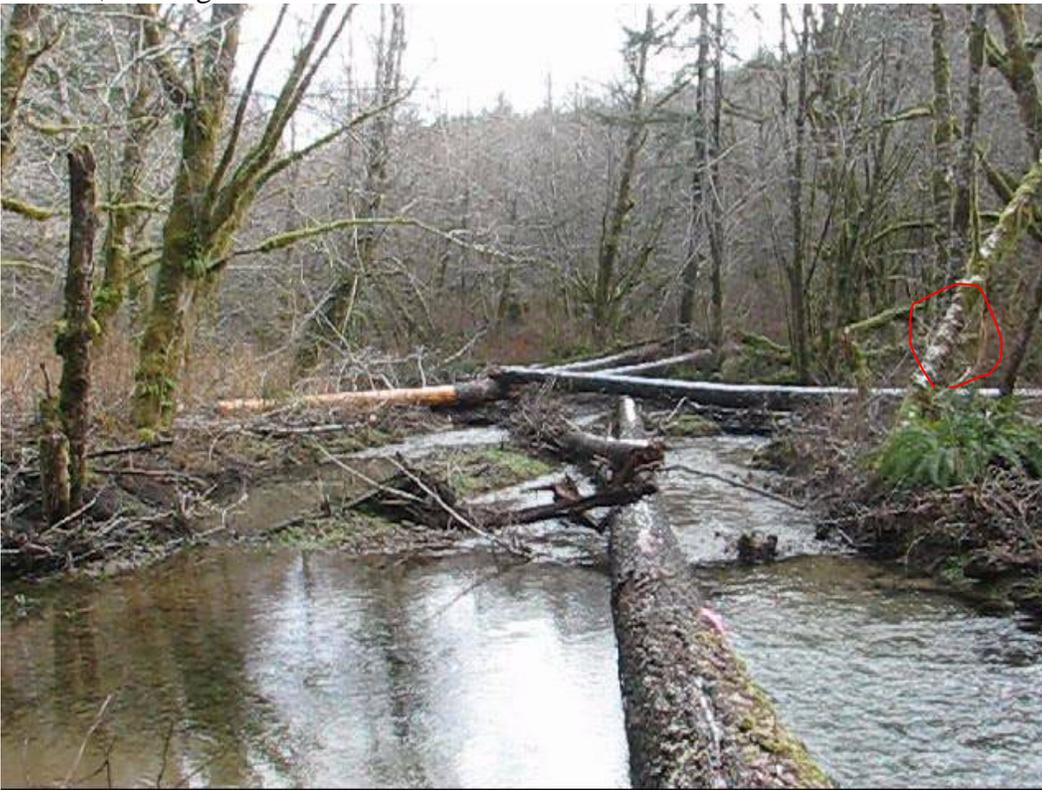
Site # 8, looking downstream - 2007

New Comments: Recently formed side channel habitat and channel braiding around the structure was observed.

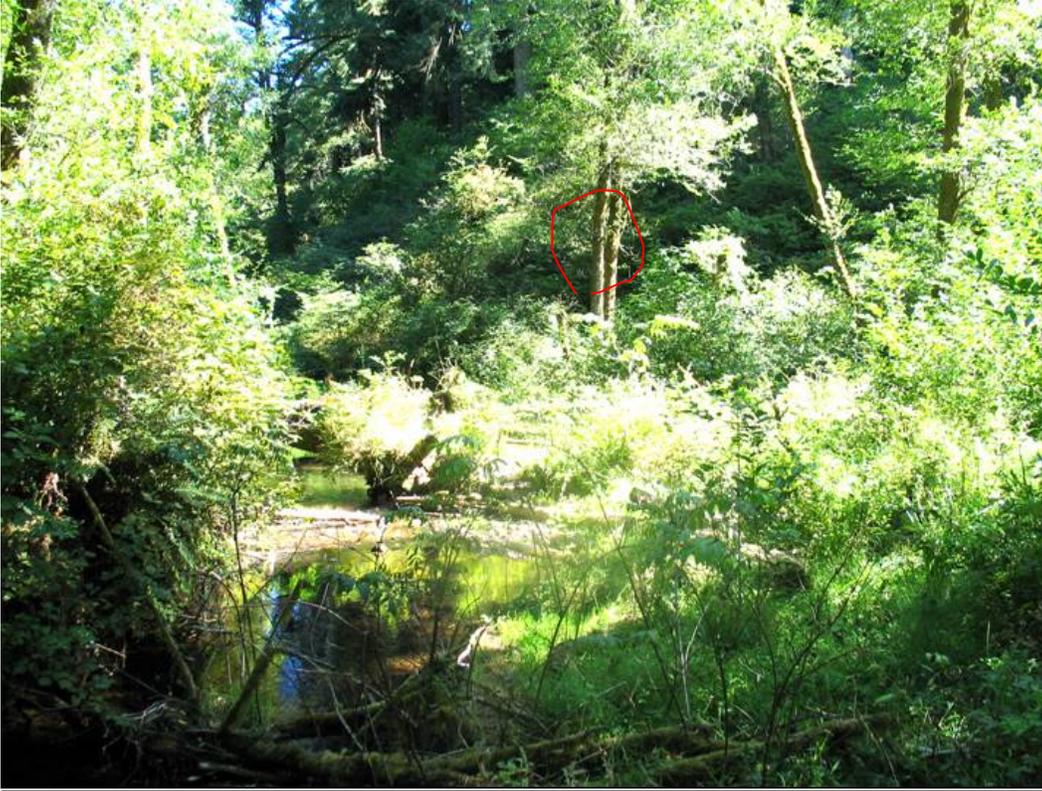
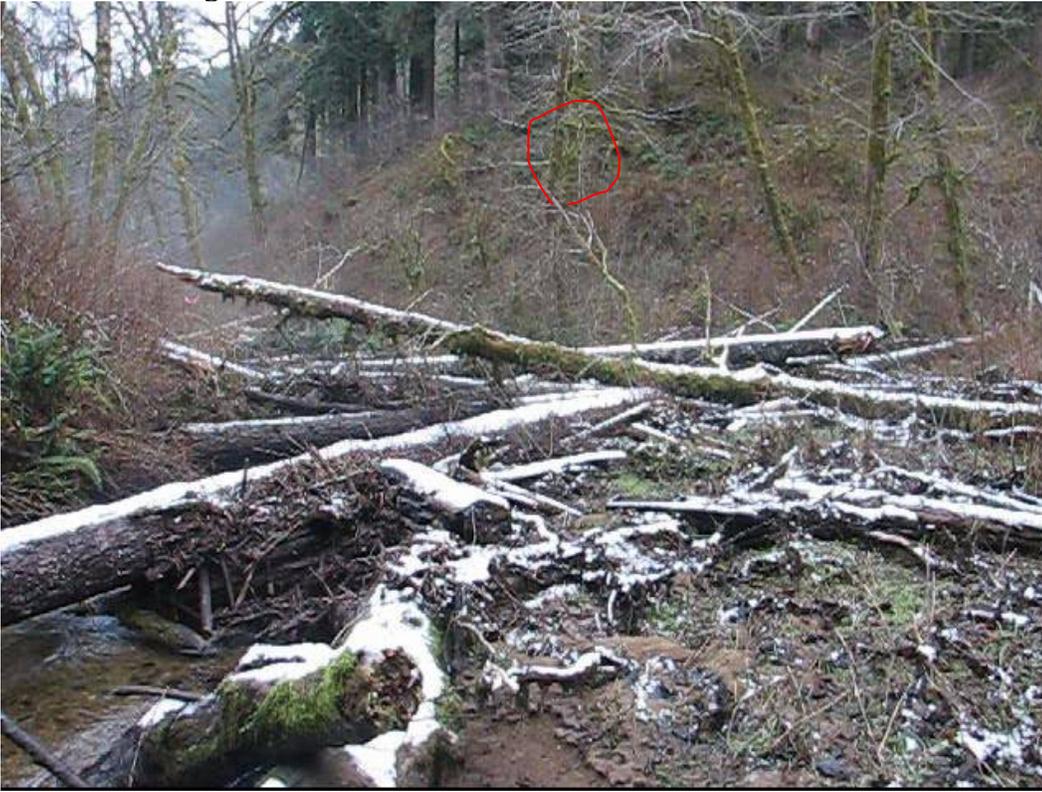
New Comments: Good collections of small woody debris around the structure was observed along with a new gravel bar which formed above the structure.

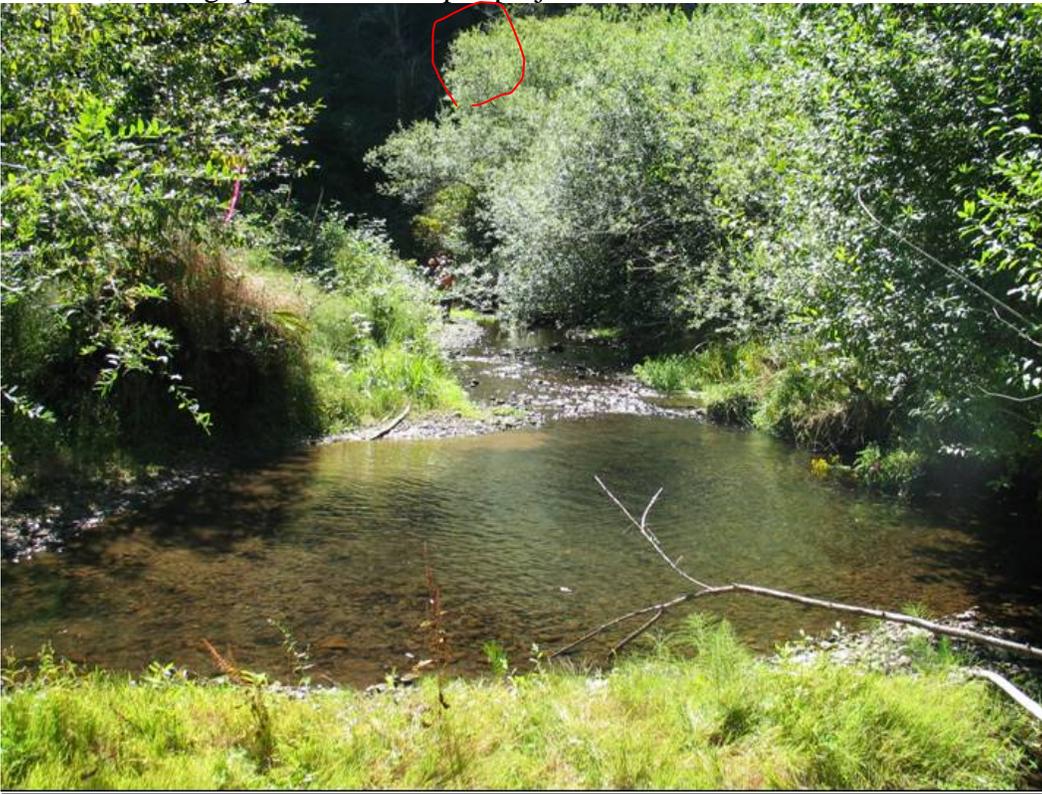
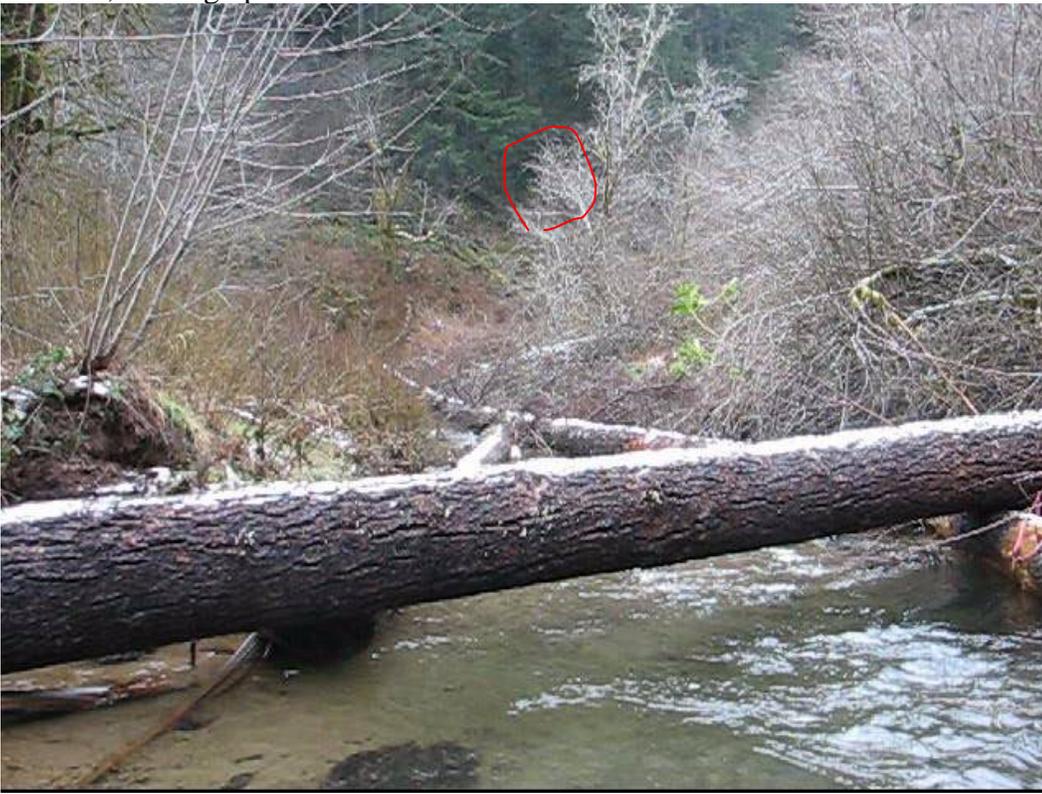
New Comments: Some recent scour was observed from newly placed logs.

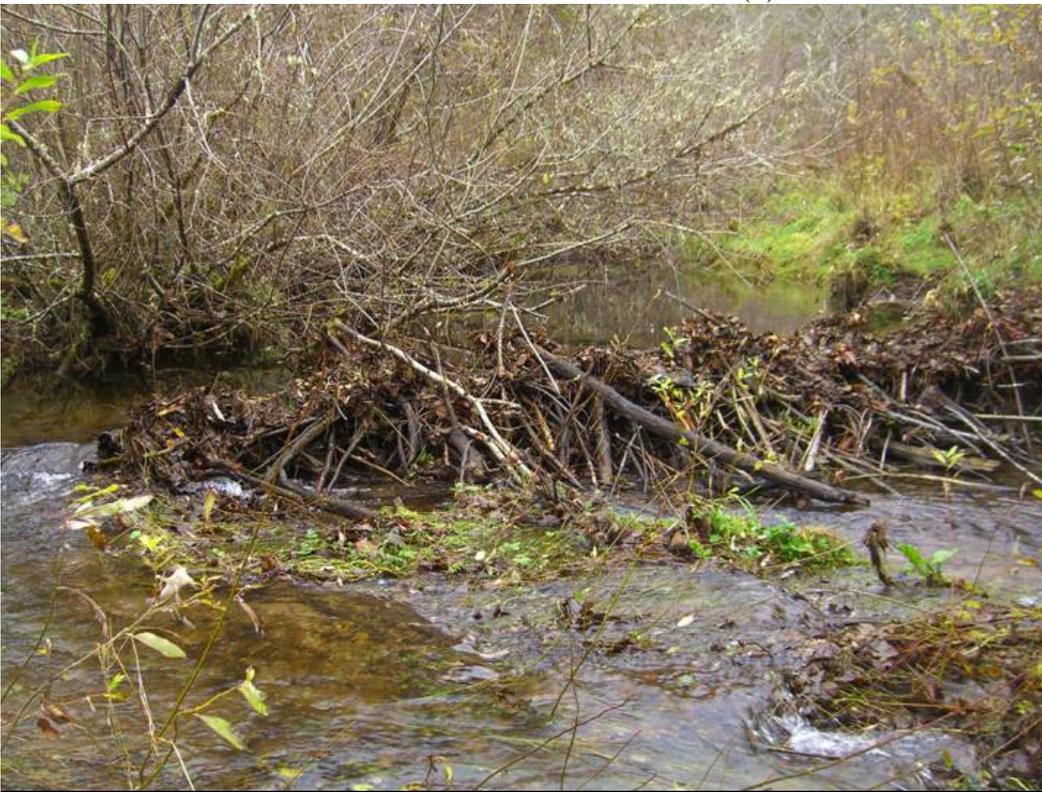
New beaver dam found between Site #18 and #19 – 2007 (2)

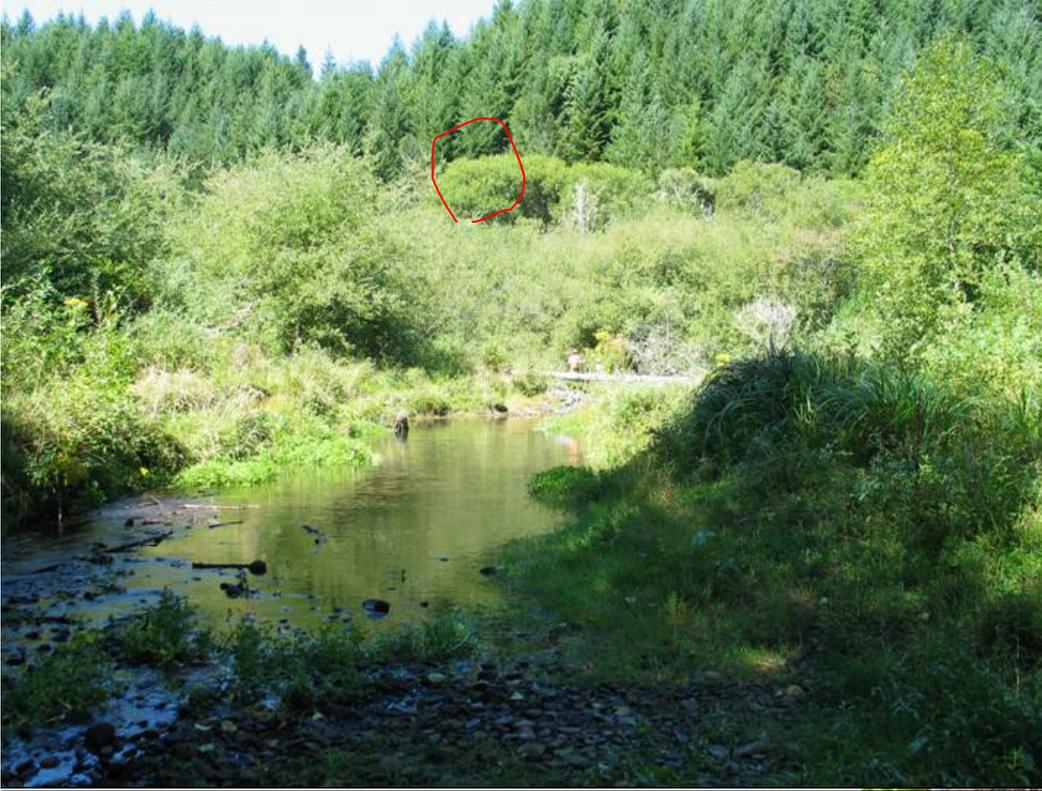
New Comments: A couple of existing logs from a previous habitat project located on the right bank have swung downstream since the reference photos were taken.

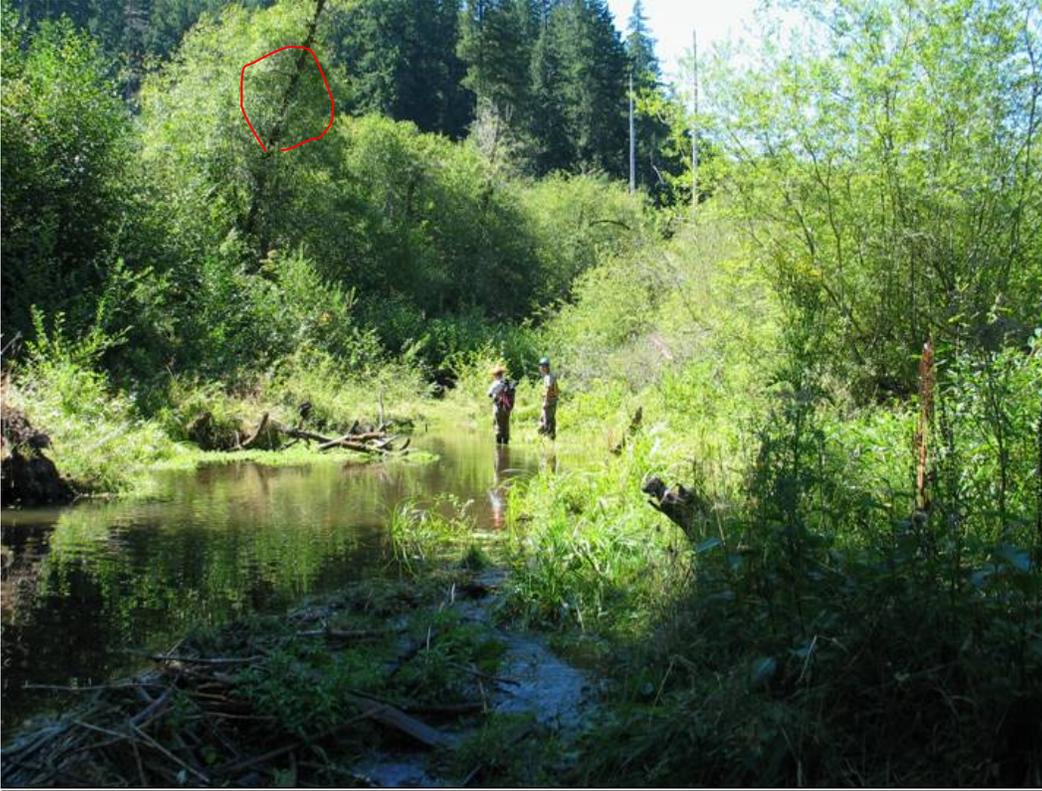
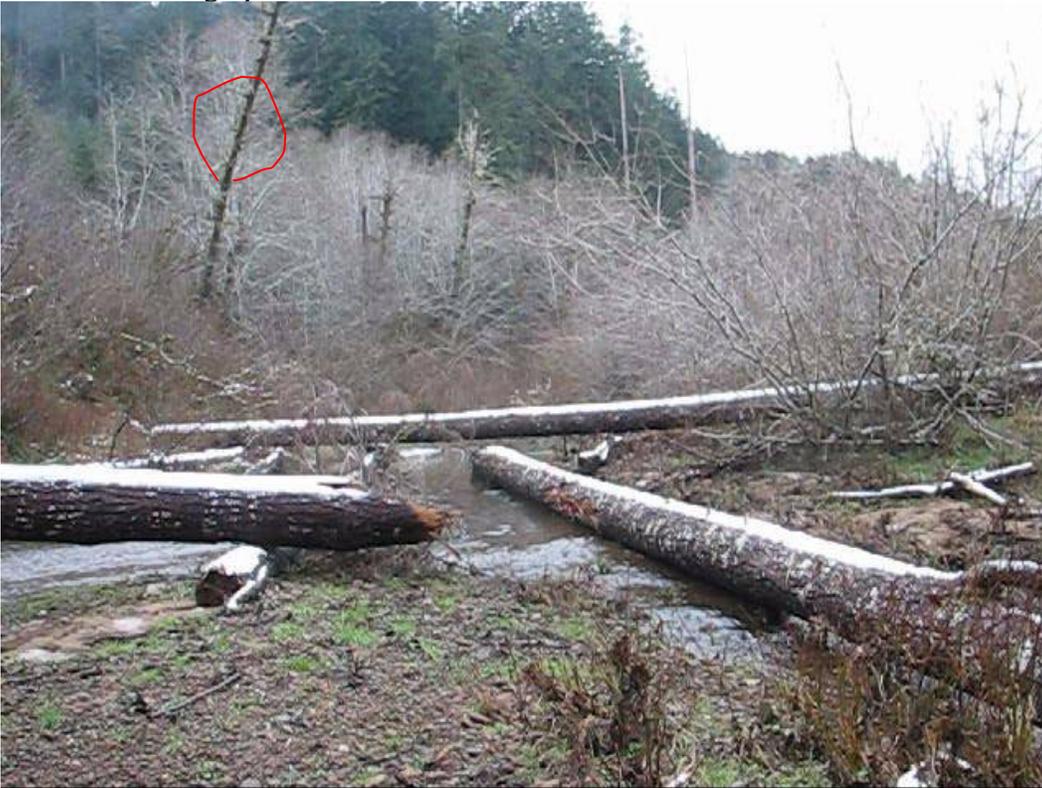
2006 Comments: The placed trees have already altered the stream enough to build up gravel in the center of the channel and create side channels going around the gravel pile.

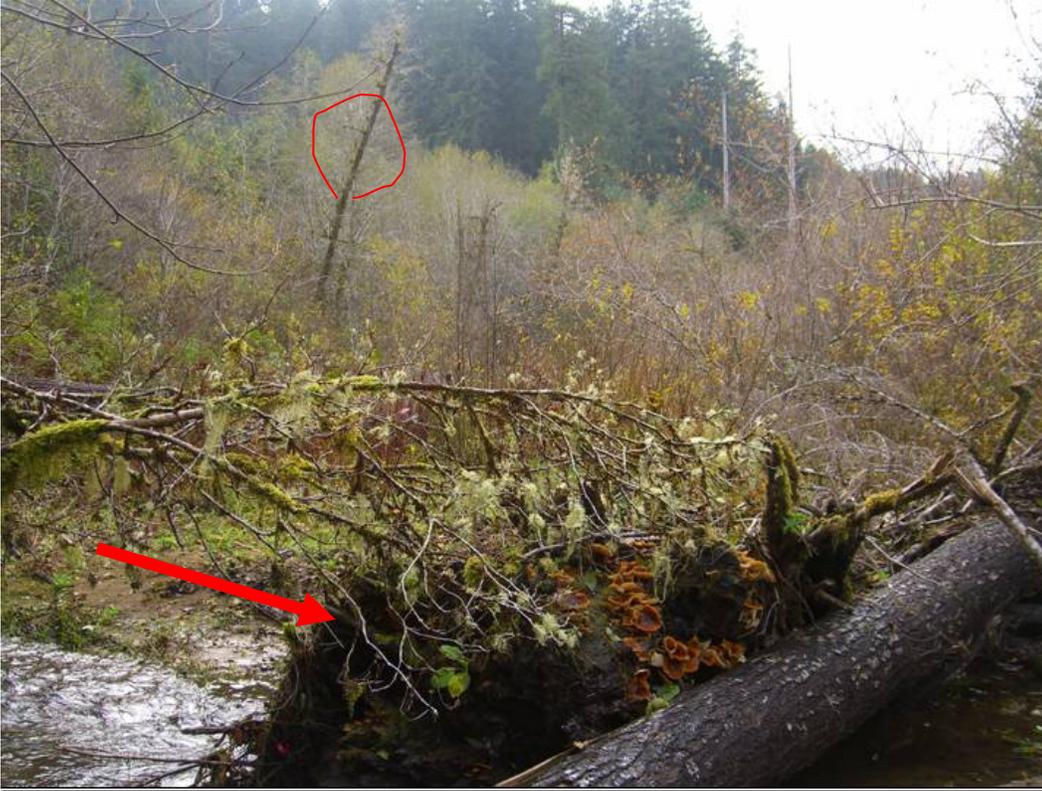
Site #20 looking upstream – 2007 (2)

New Comments: Now the majority of the flow is coming from the left side of the photo as a result of the gravel/sediment island that started developing since 2006 (see previous photo). The root wad that was upstream got caught partially by the tree in the photo here. On the upstream end of the structure, the placed tree is helping scour a deep pool in the middle of the channel.

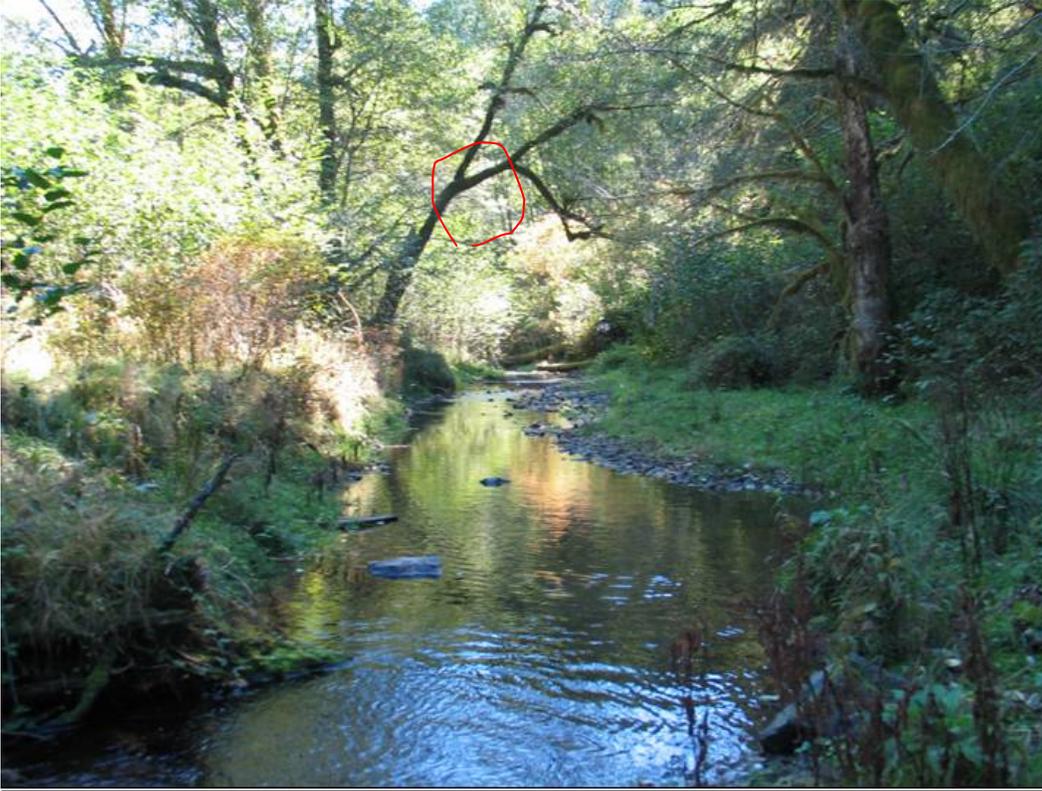
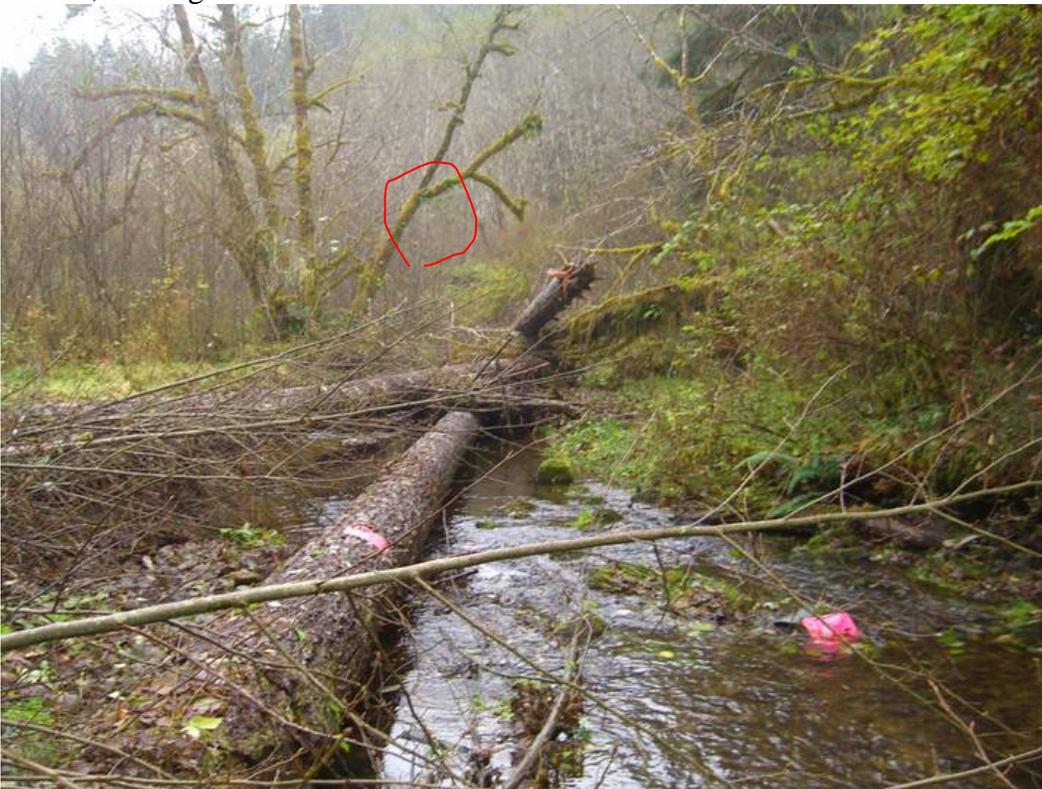
New Comments: A high number of juvenile fishes (particularly coho and cutthroats) were observed throughout the entire Maria Creek, and a large portion of them seemed to be taking advantage of the pools associated with the these new structures.

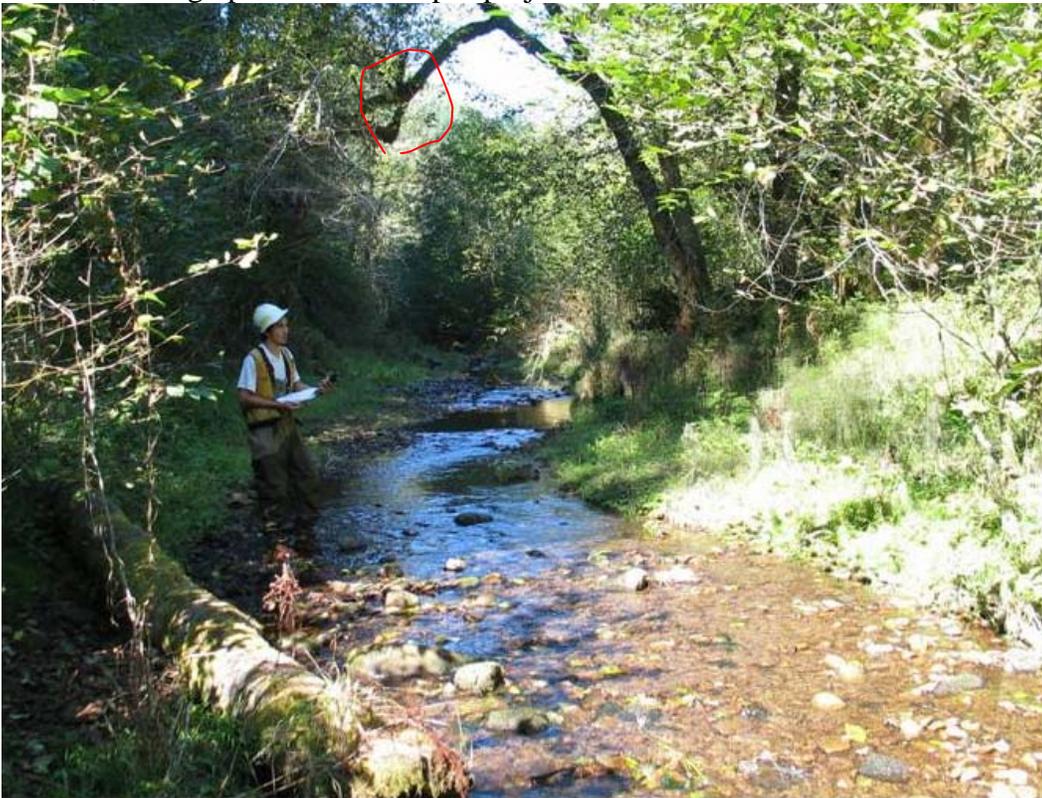
Site #4, looking upstream – 2005 pre-project

New Comments: The structure has affected the channel enough to develop a point bar at the downstream end of this structure, causing the stream to become more sinuous.

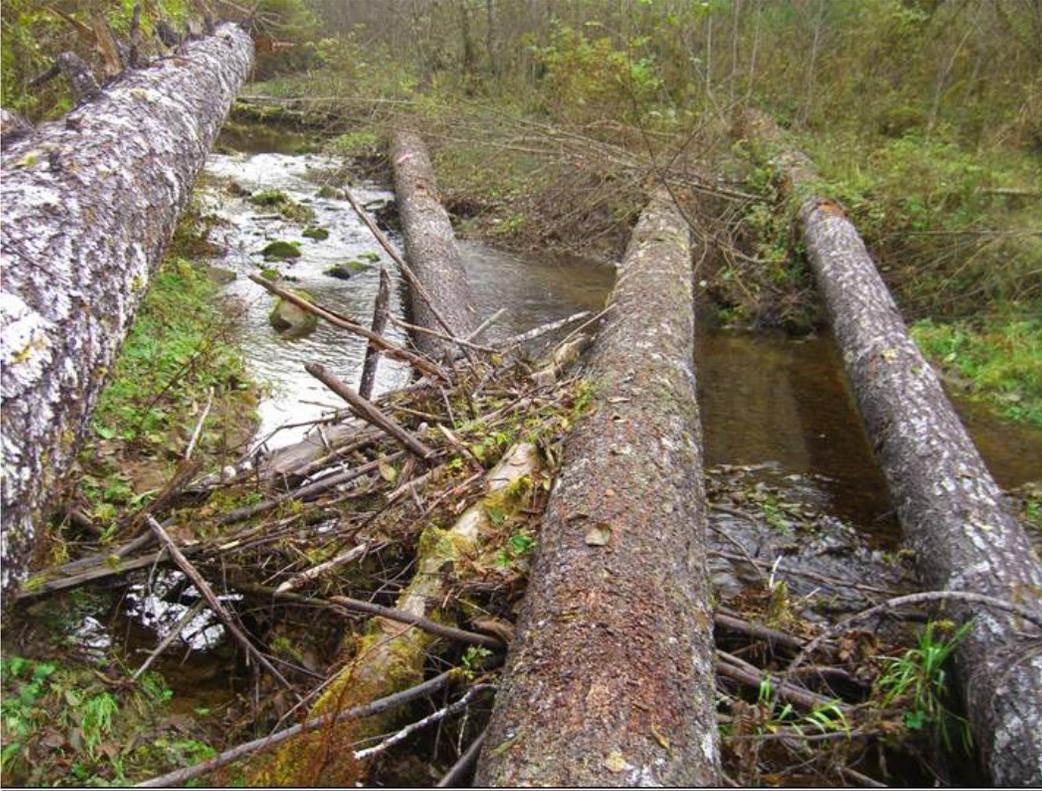
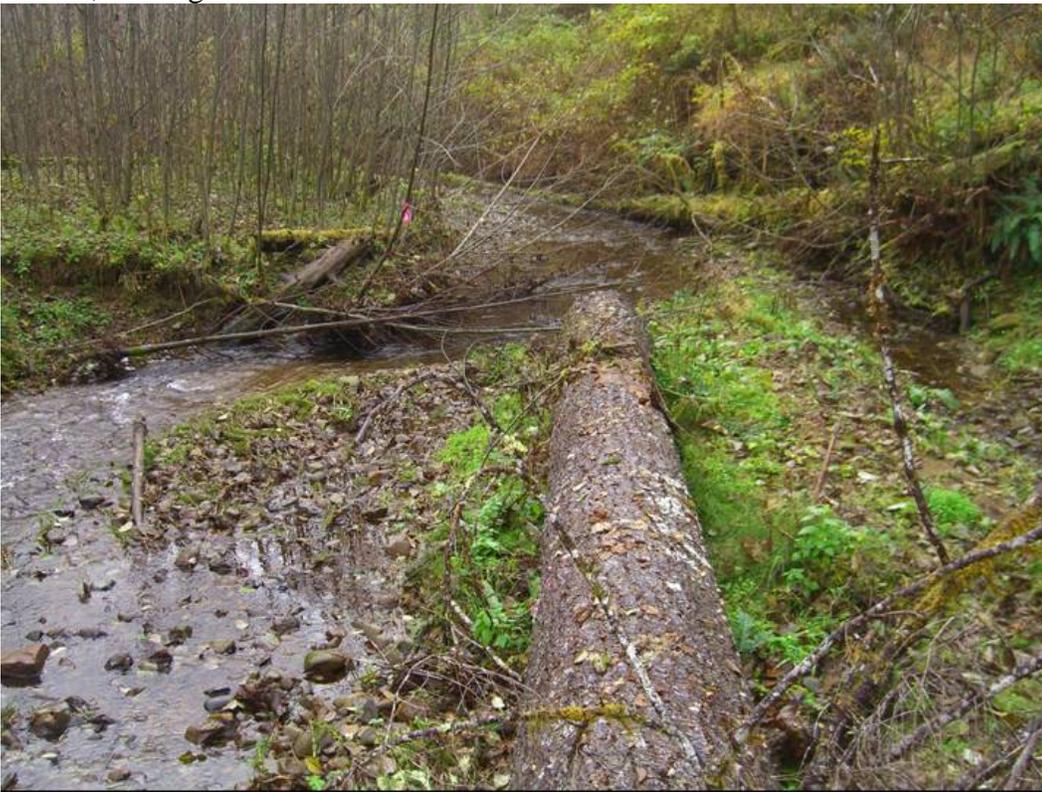
New Comments: The trees configuration with a tree holding on top of the lowest tree helped collect the small woody debris that would have otherwise flushed out of the system. The bottom picture shows how the downstream end tree helped form the gravel bar and caused the stream to meander.

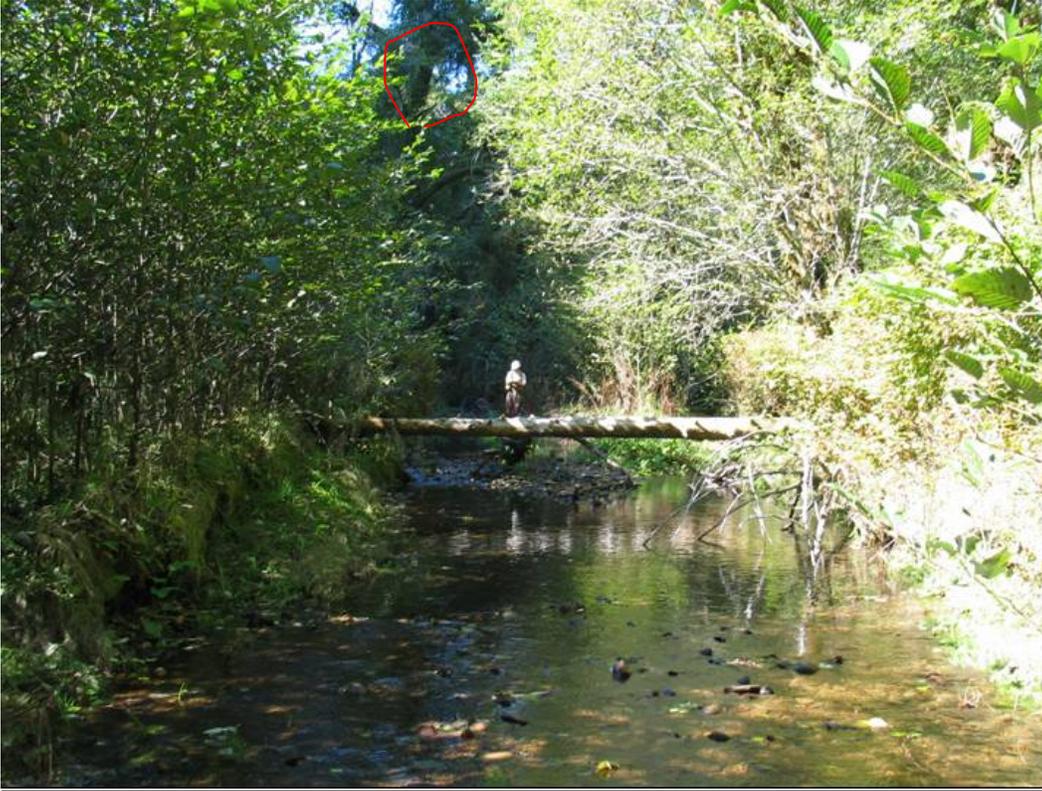
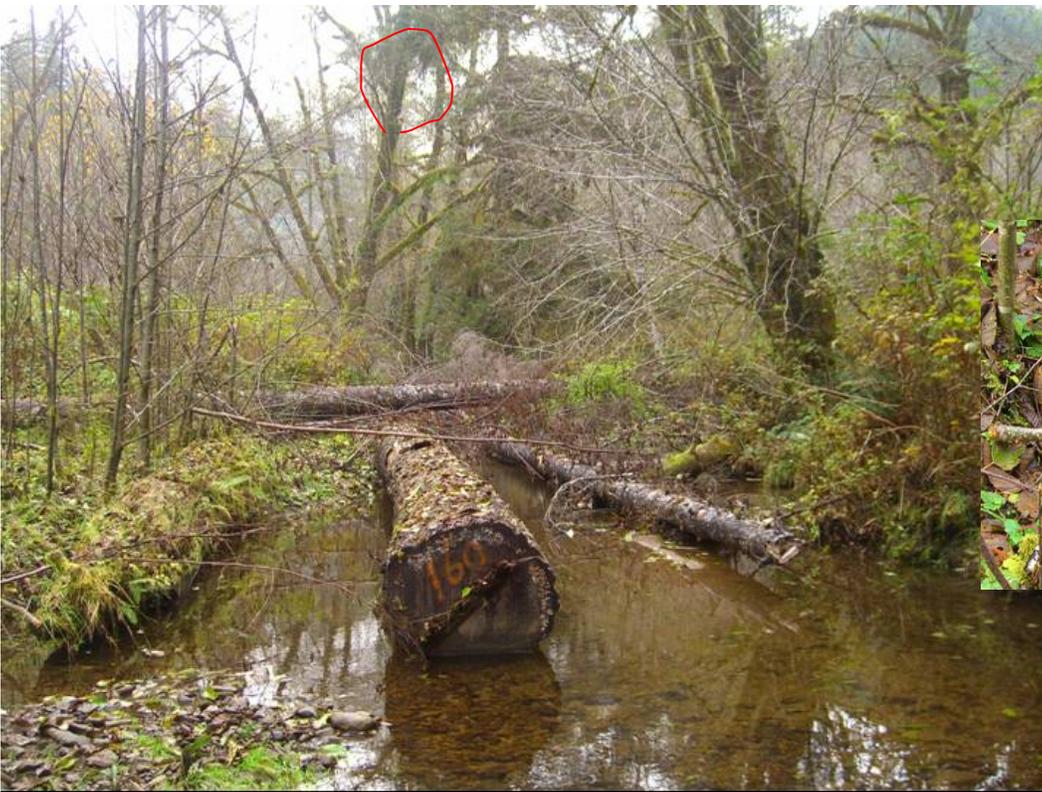
The photo above shows the 6 inch DBH alder that the eager beaver munched down right below this structure site.

New Comments: The structure is helping the water seep out into the low-level floodplain zone (covered with small alders) during high water events. It's also adding various scour depths in the channel unit.

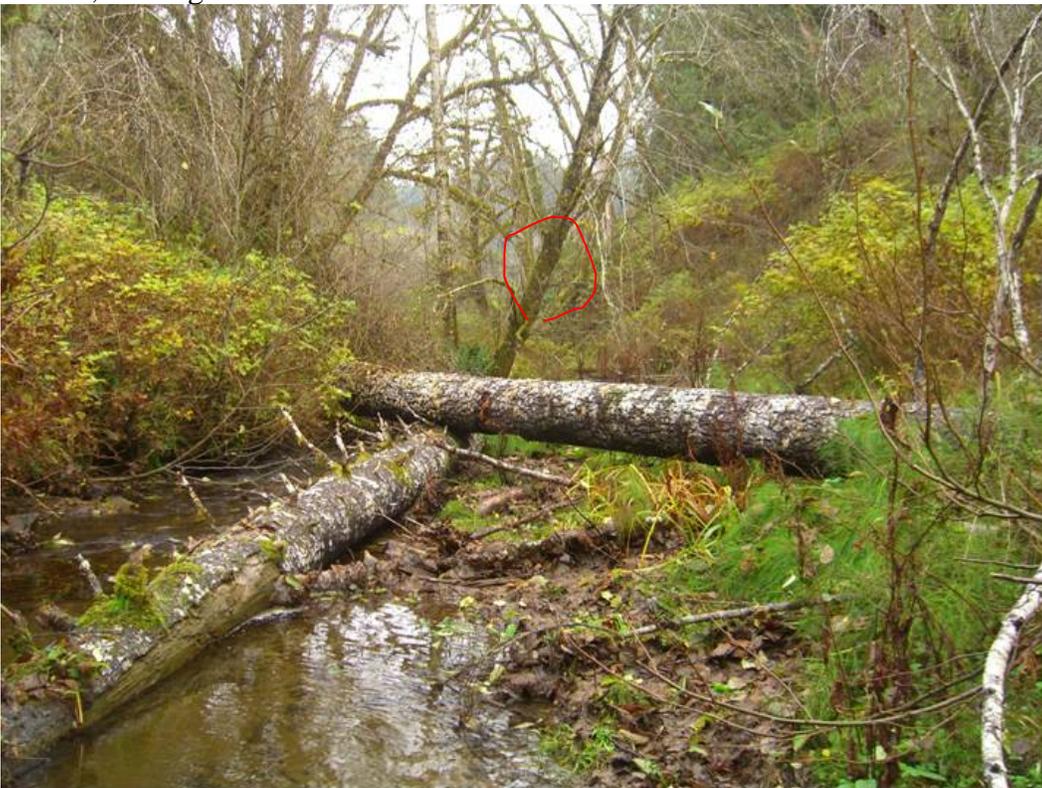
Site #6, looking downstream – 2007

New Comments: Collected small woody debris and sediment, and helped create more scour holes in the channel unit.

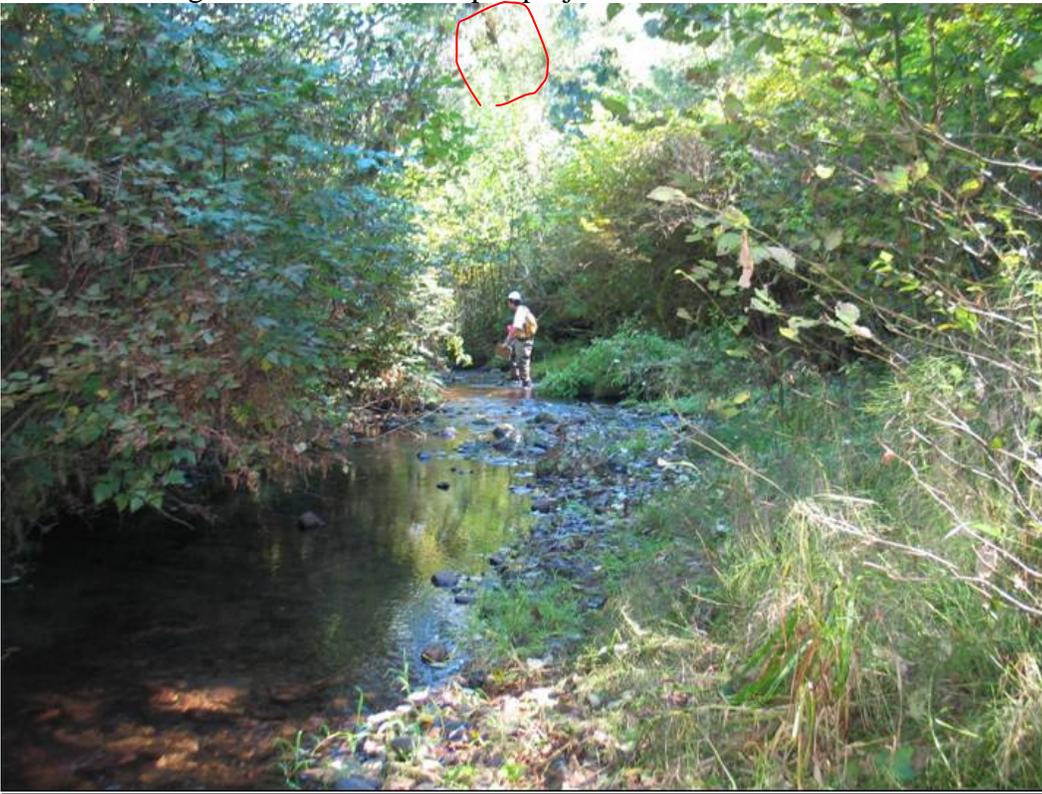
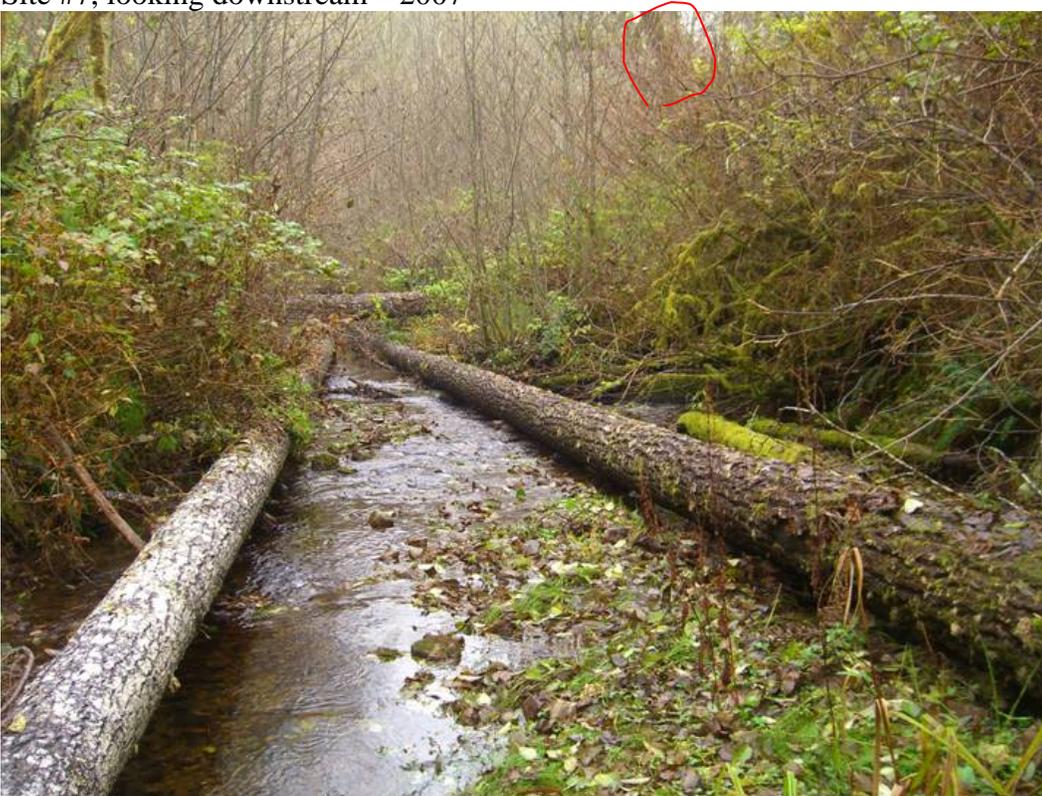
New Comments: This structure hasn't brought about major changes yet on the upstream end, but we should see more changes over time, considering how low the trees are placed in the stream.

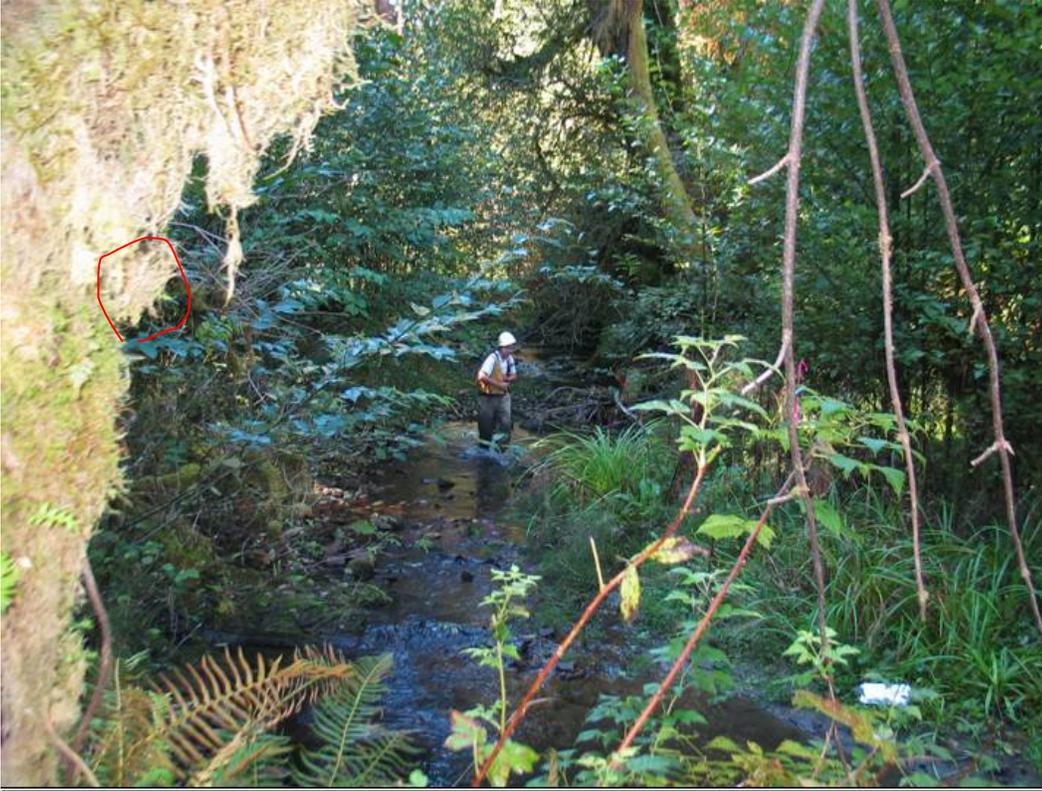
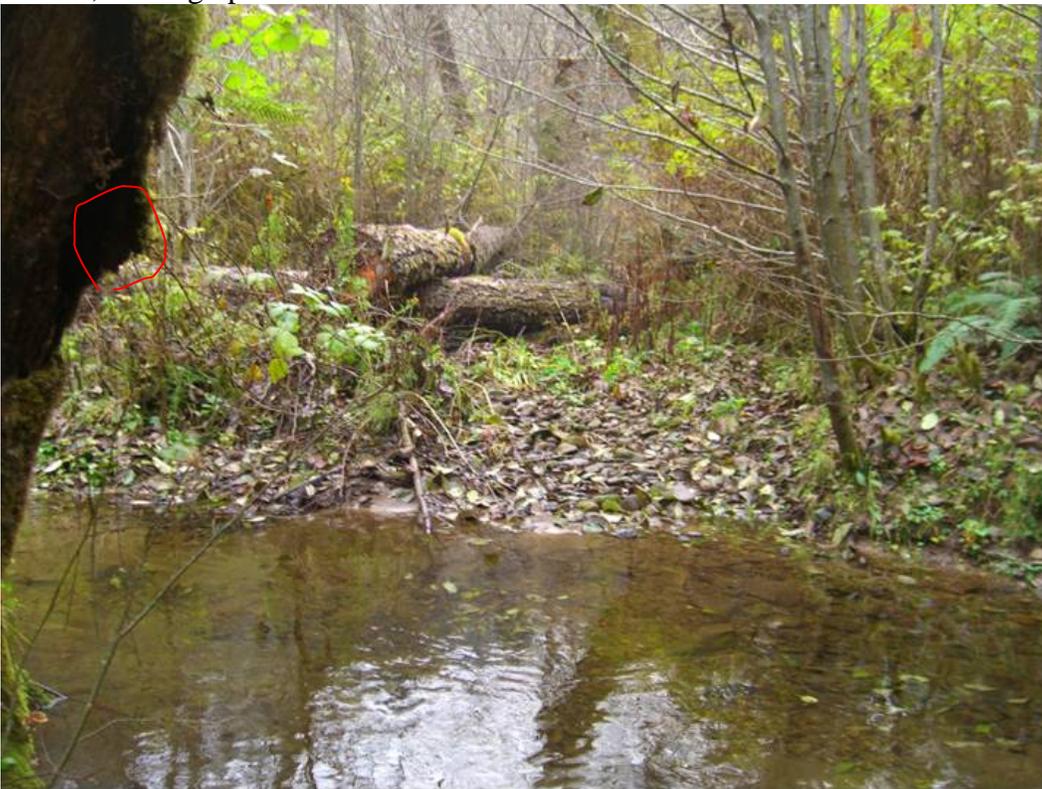
New Comments: This site has changed tremendously. The structure has caused the channel to meander around the trees, leaving a prominent point bar at the downstream end of the structure (center of the picture). This has increased the channel flow to slow down quite a bit, and created a nice pool.

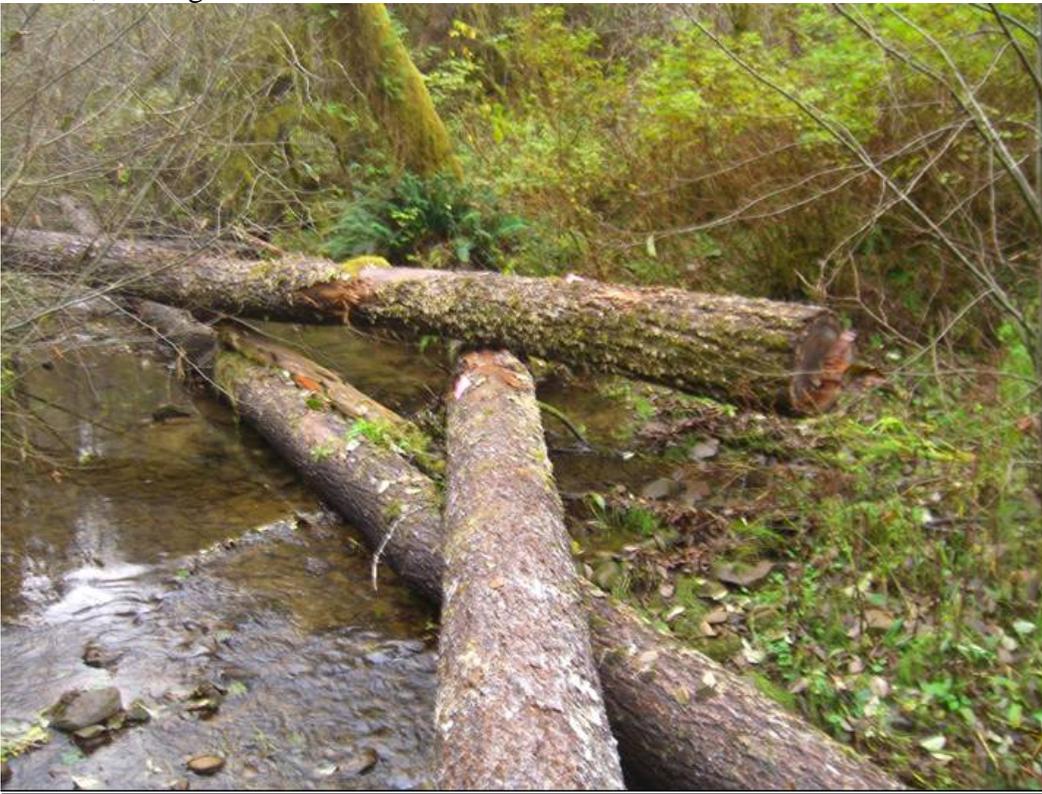
Site #8, looking from side – 2007

New Comments: This photo shows the configuration of the trees that helped create the point bar creation and the meander in the stream.
