Indian Creek Aquatic Restoration

Oregon Wildlife Heritage Foundation

Narrative Summary:

Photographs:

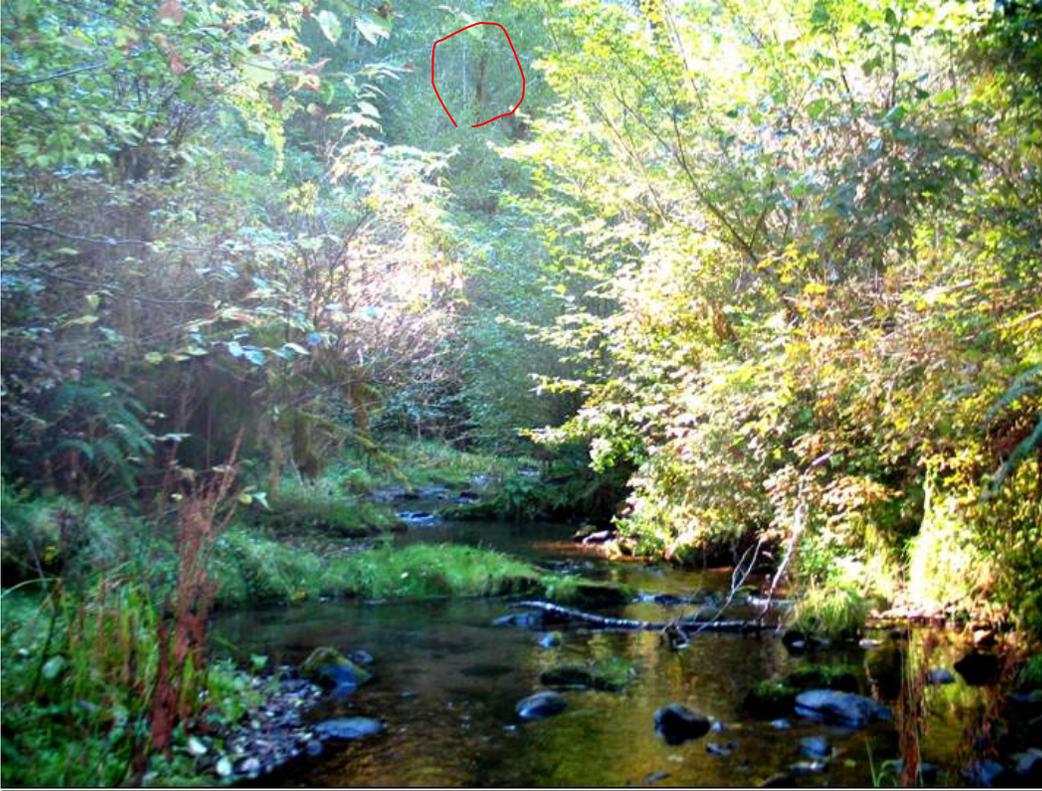
Site #9, looking upstream – 2005 pre-project

New Comments: There was small woody debris collected around the new trees in addition to some beaver cuttings that were scattered in here. There is tributary that comes in on the left side, so we look forward to see future debris collection at this site.

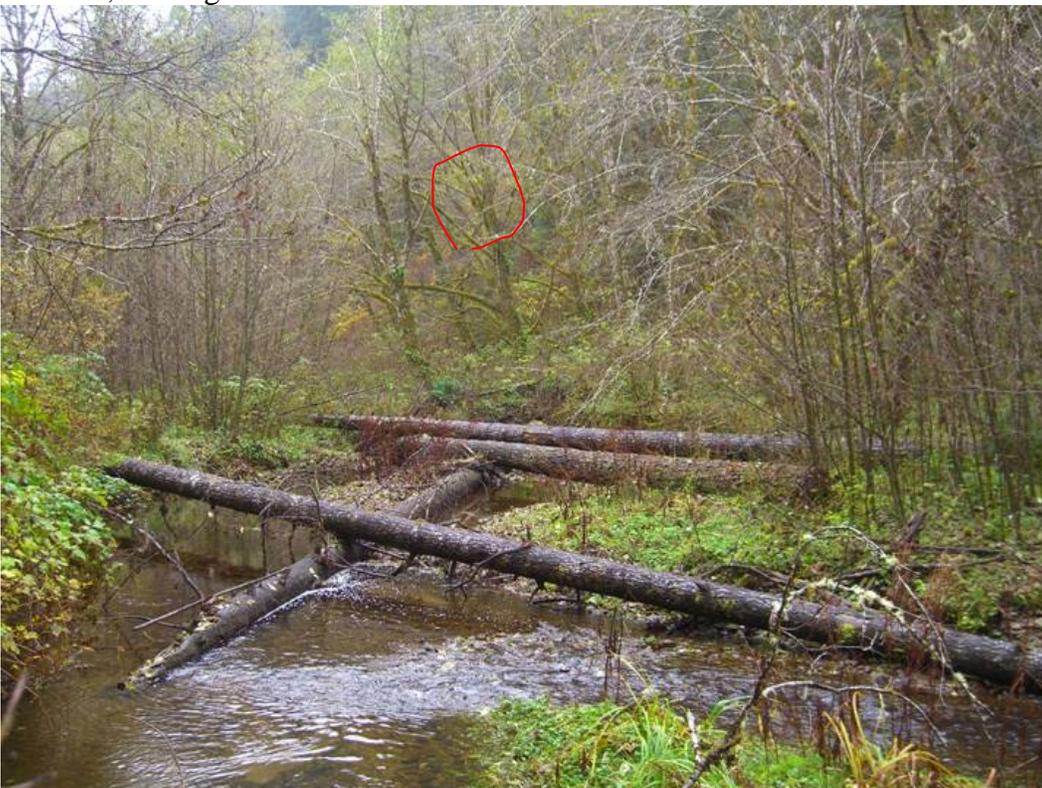
Site #24, looking downstream – 2007

New Comments: The jam has collected some new sediment over the winter and the mid-channel island seems to be enlarging towards the structure as a result of that. The structure trees are nicely staggered, yet laying very low on the ground, so we expect to see more changes in the future.

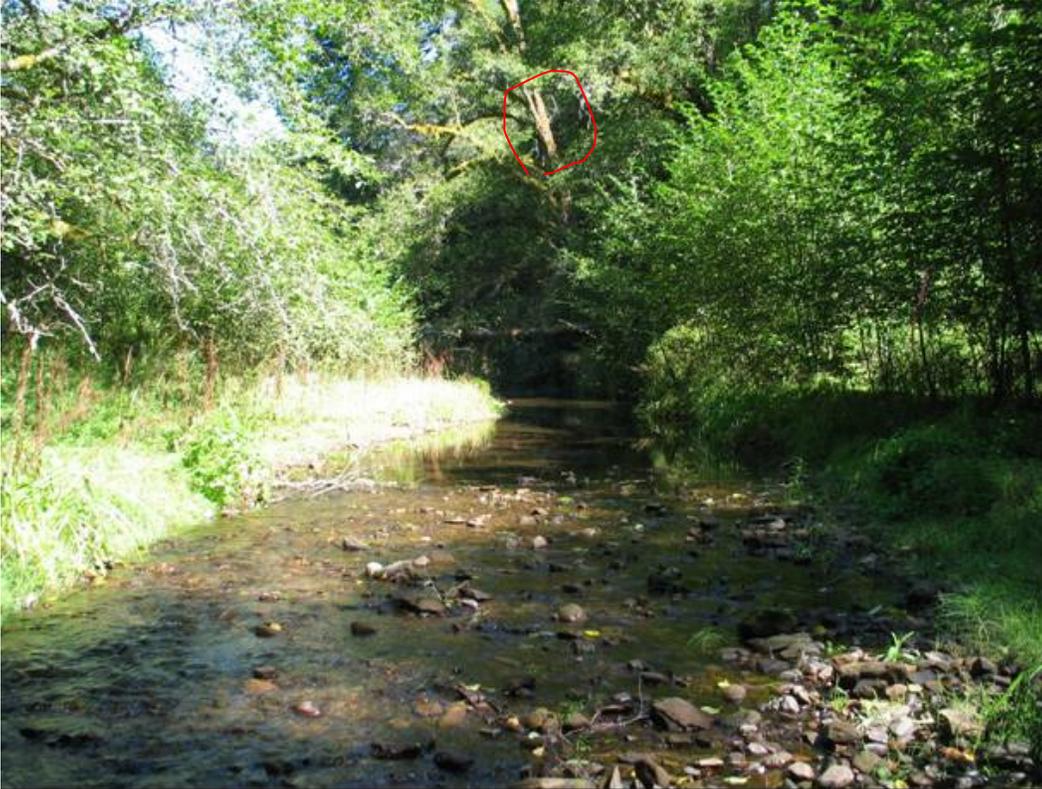
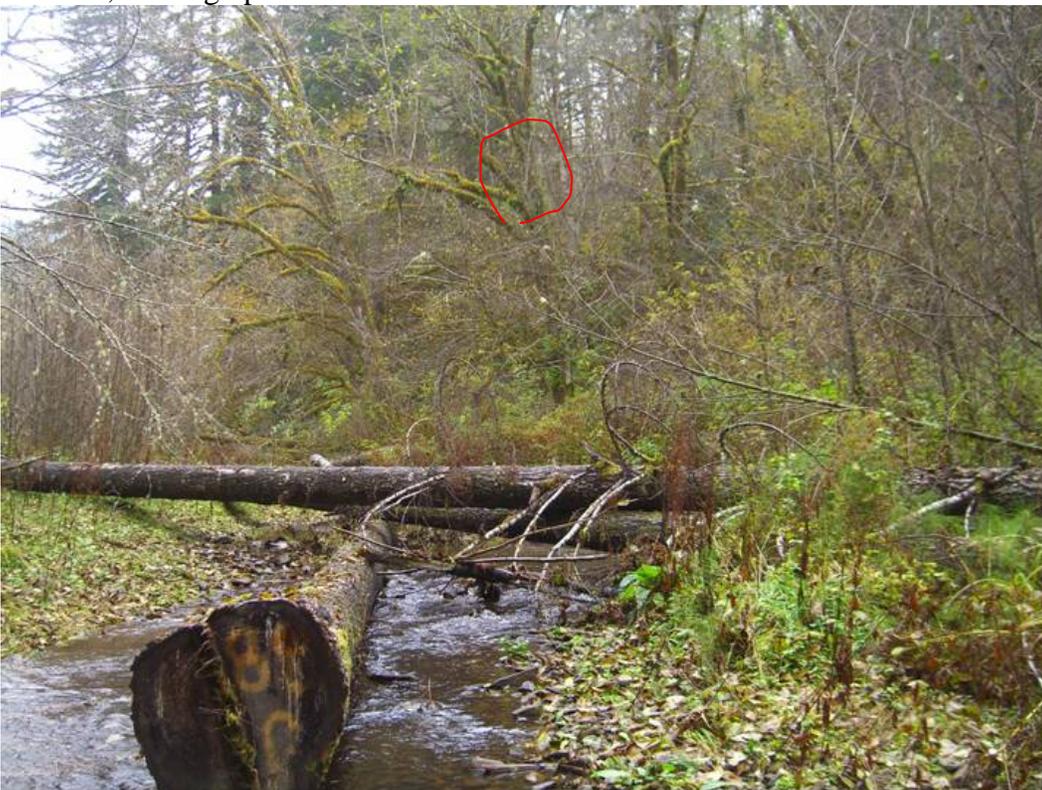
New Comments: Very nice configuration of the structure: a low lying tree in the center of the channel and more trees staggered on top of each other, which added elevation to collect small woody debris / sediment.

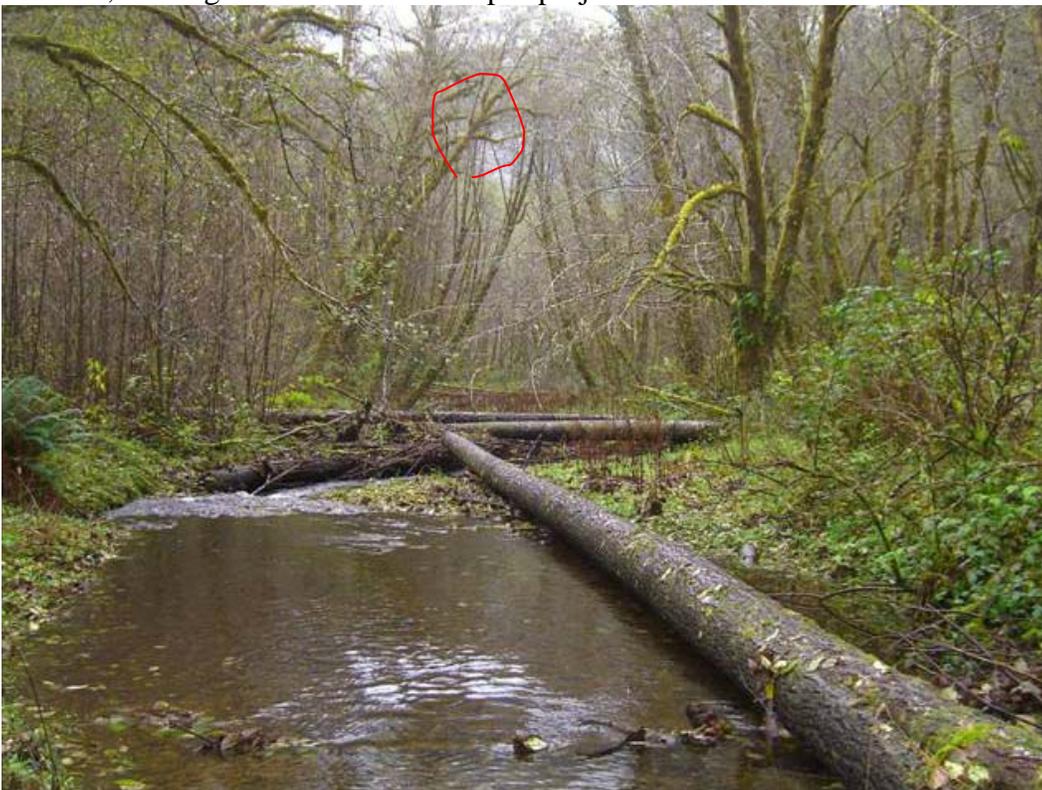
Site #25, looking downstream – 2005 pre-project

New Comments: The jam seemed to have caused the stream to become more sinuous. Because Rogers Creek has a wide floodplain, it was easier to work the trees in right to the bottom of the stream.

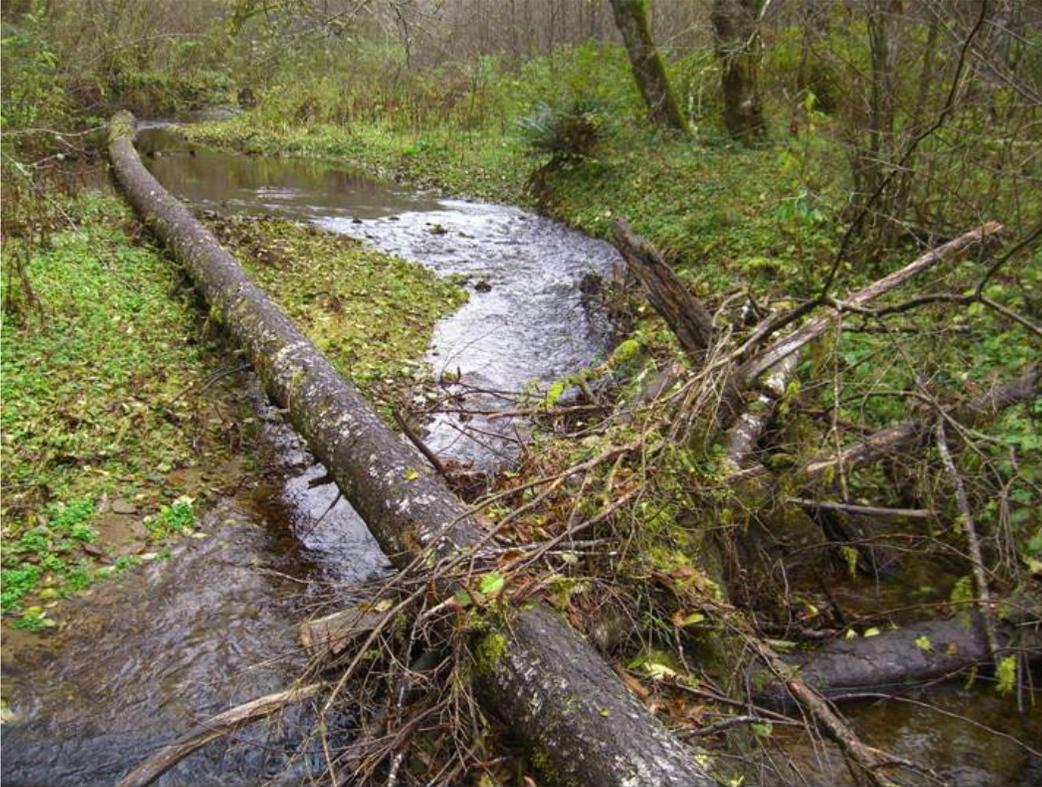
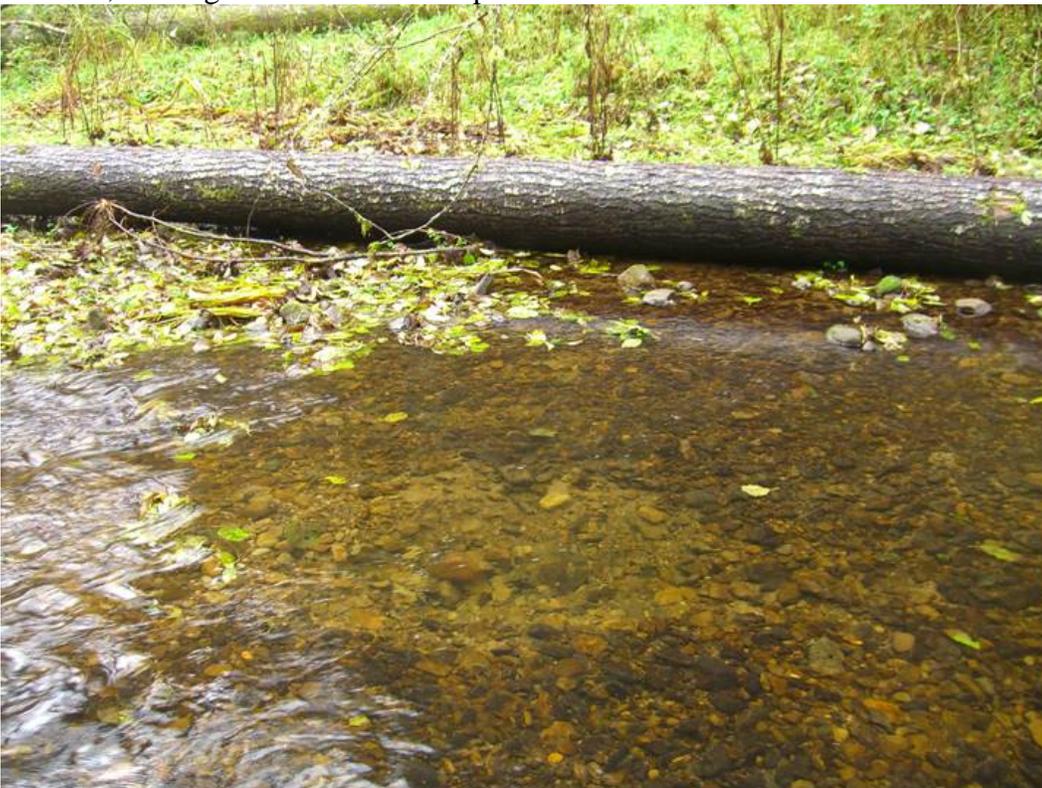
New Comments: The photo above showcases the small woody debris collection that was observed at the site, which is hard to grasp from the photo on the previous page. The tree also helped scour a pool underneath. The photo below shows the salmon redd (probably a Coho) created this winter right by the structure tree.

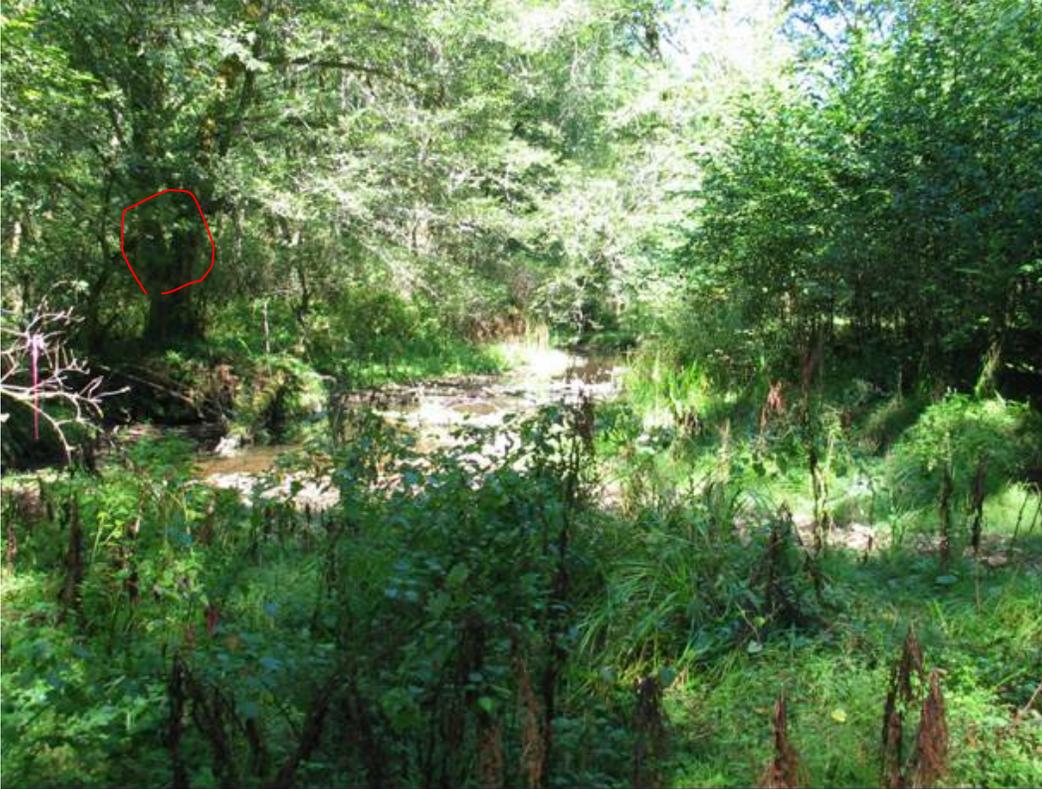
Site #25, looking upstream – 2005 pre-project

New Comments: The structure is helping regain the floodplain interaction by causing the high flow water to move into the low-level floodplains on both side of the bank.

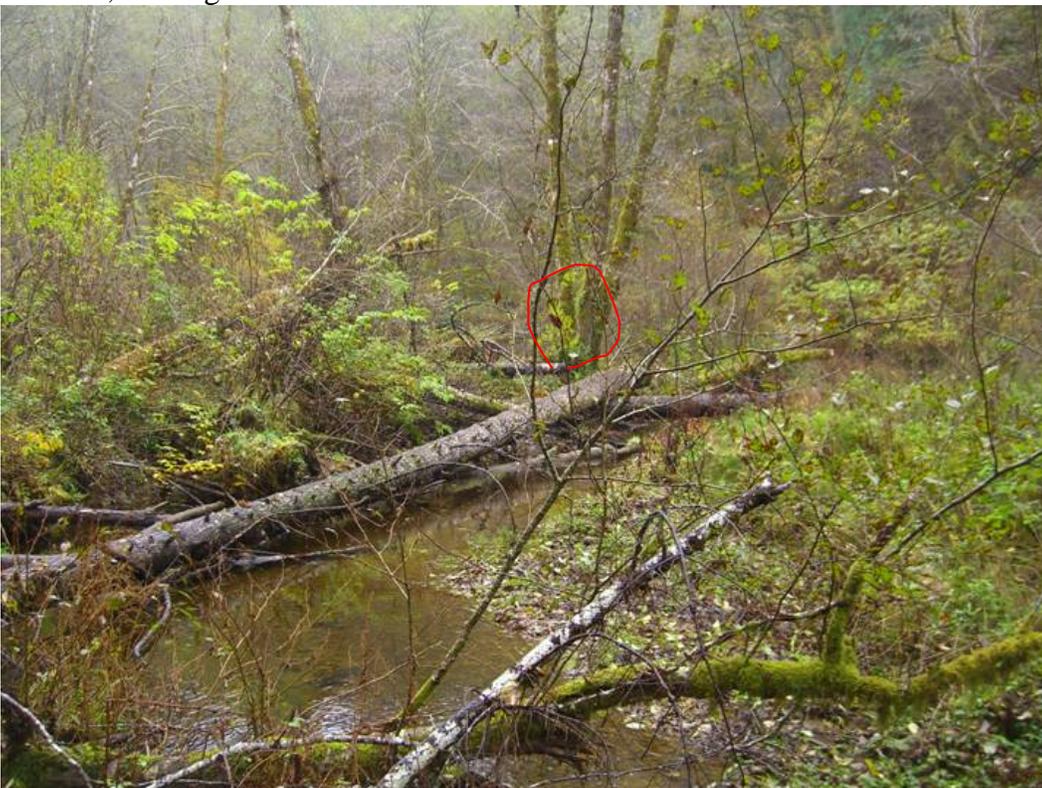
Site #27, looking downstream – 2007

New Comments: Collecting more small woody debris and sediment, helping maintain and increase the channel meander.

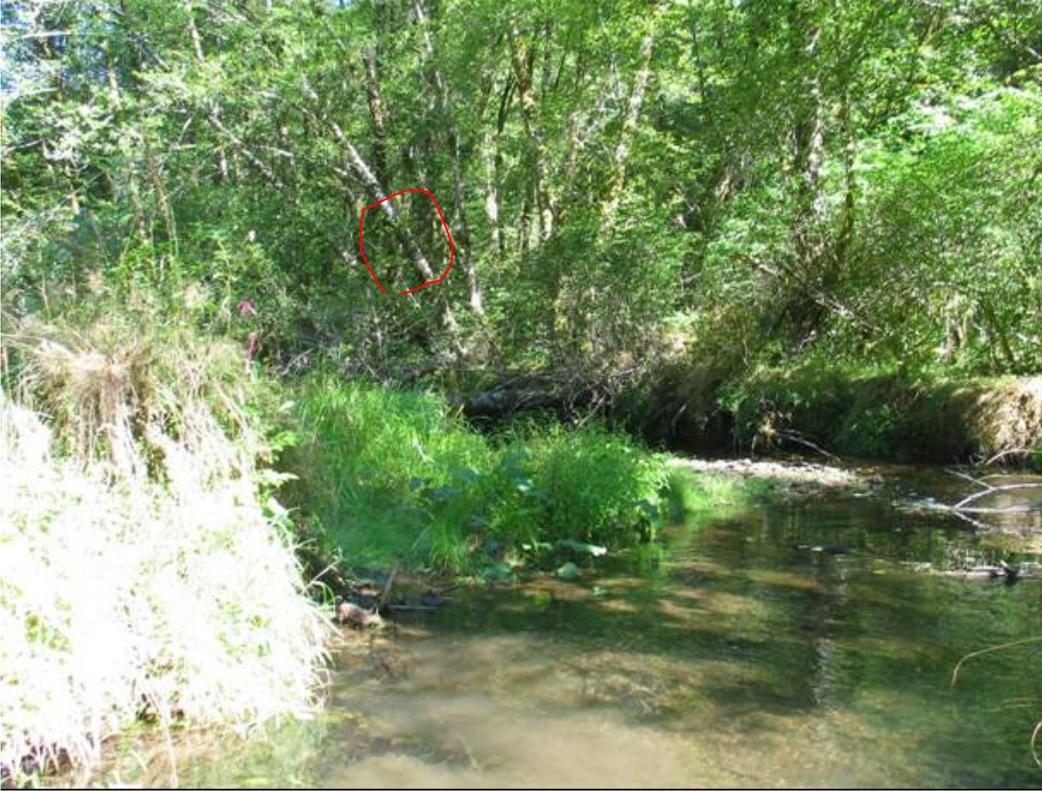
Site #27, looking upstream – 2005 pre-project

New Comments: The tree in the center here has helped scour deep pools in this channel unit. The amount of gravel decreased from this site downstream; in future years, we'll monitor how much gravel will be added to these downstream sites. The angle of the photo is slightly different, but it shows the same general area.

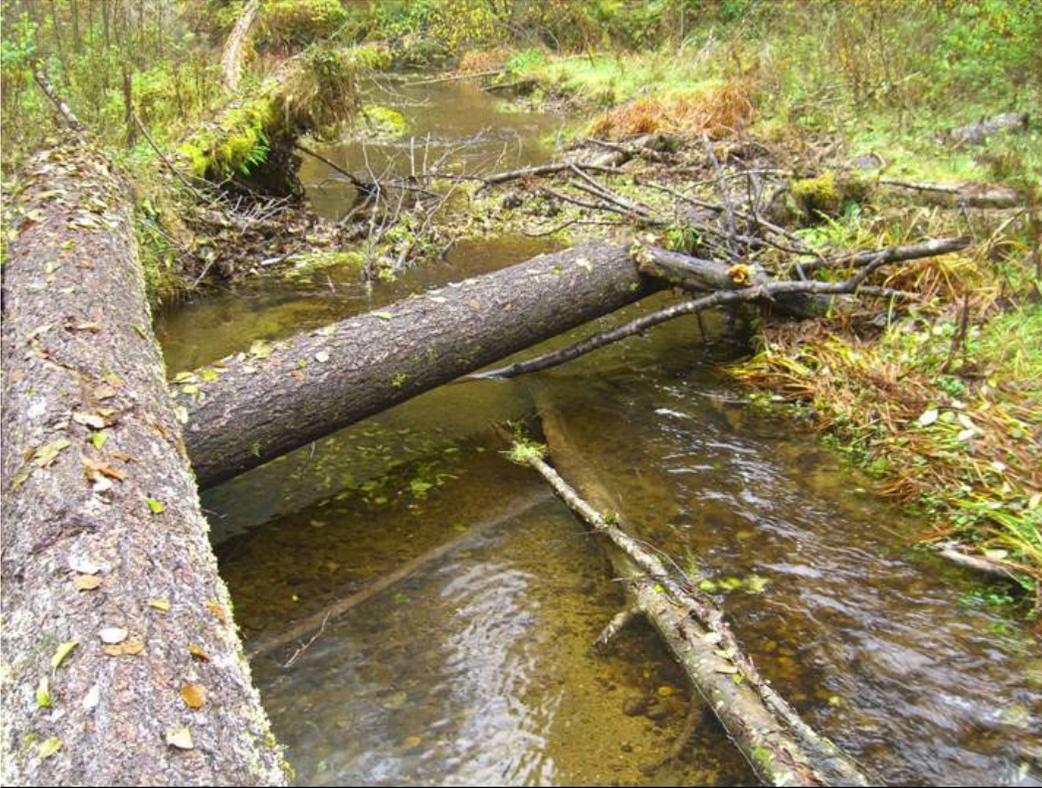
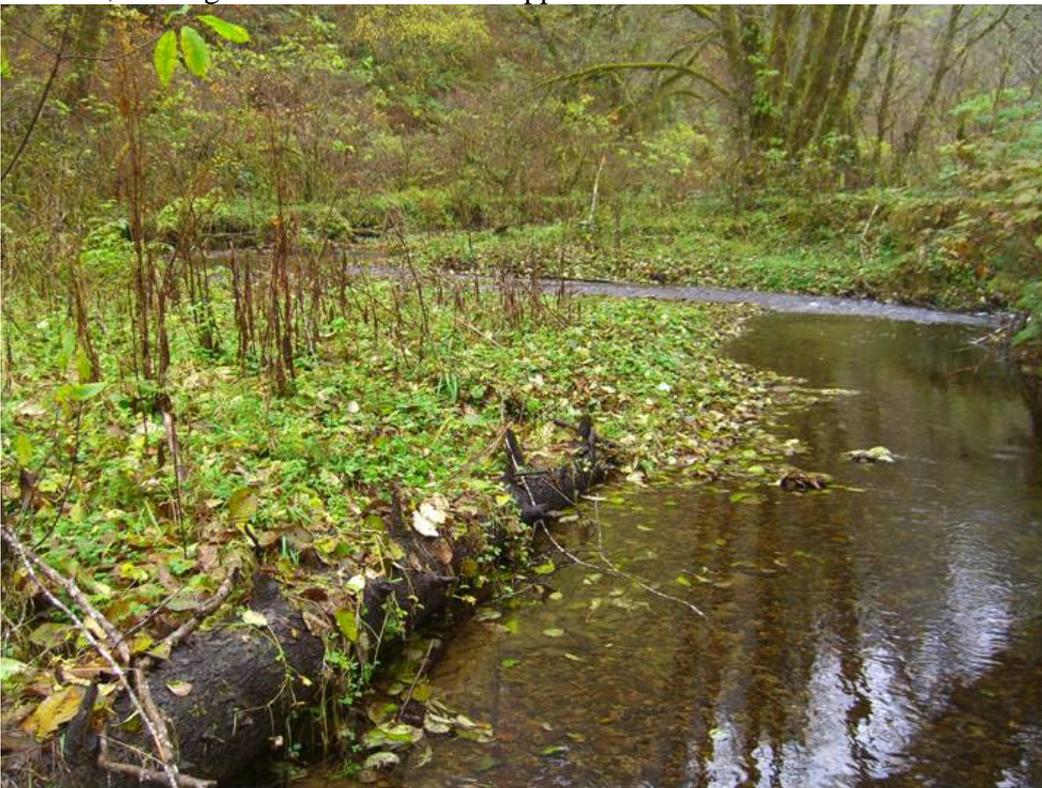
New Comments: The photo above shows the deep scour pool created in this channel unit. The photo below shows how the upstream end tree is encouraging the formation of a pronounced point bar.

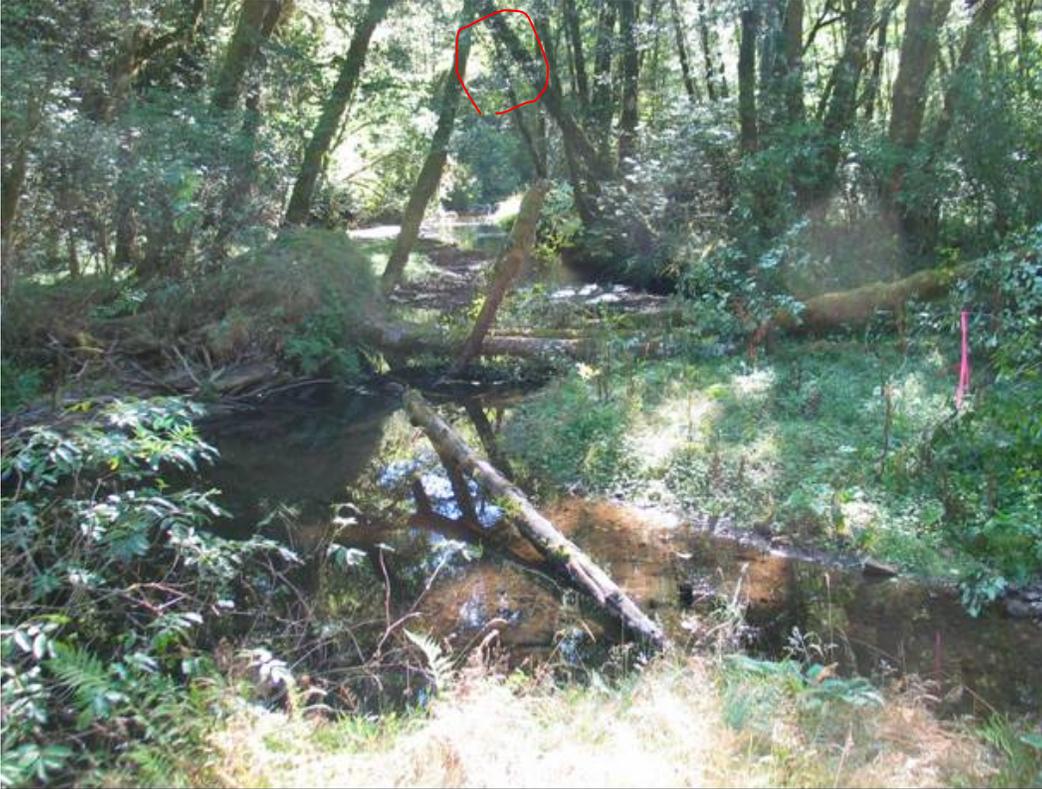
Site #28, looking downstream – 2005 pre-project

This photo above shows the wood that are helping scour the deep pool.

New Comments: There is a mid-channel island that is forming under the right hand tree and the deep pool under the left hand tree is maintaining and increasing its depth as a result of the wood scouring.

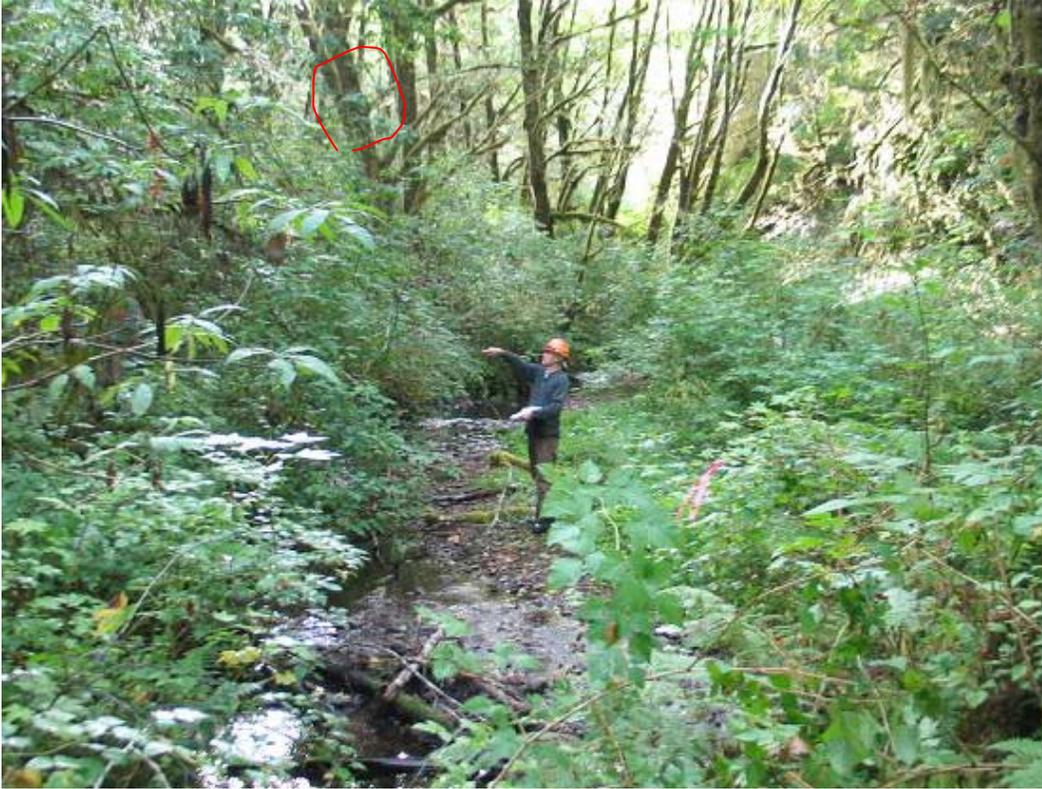
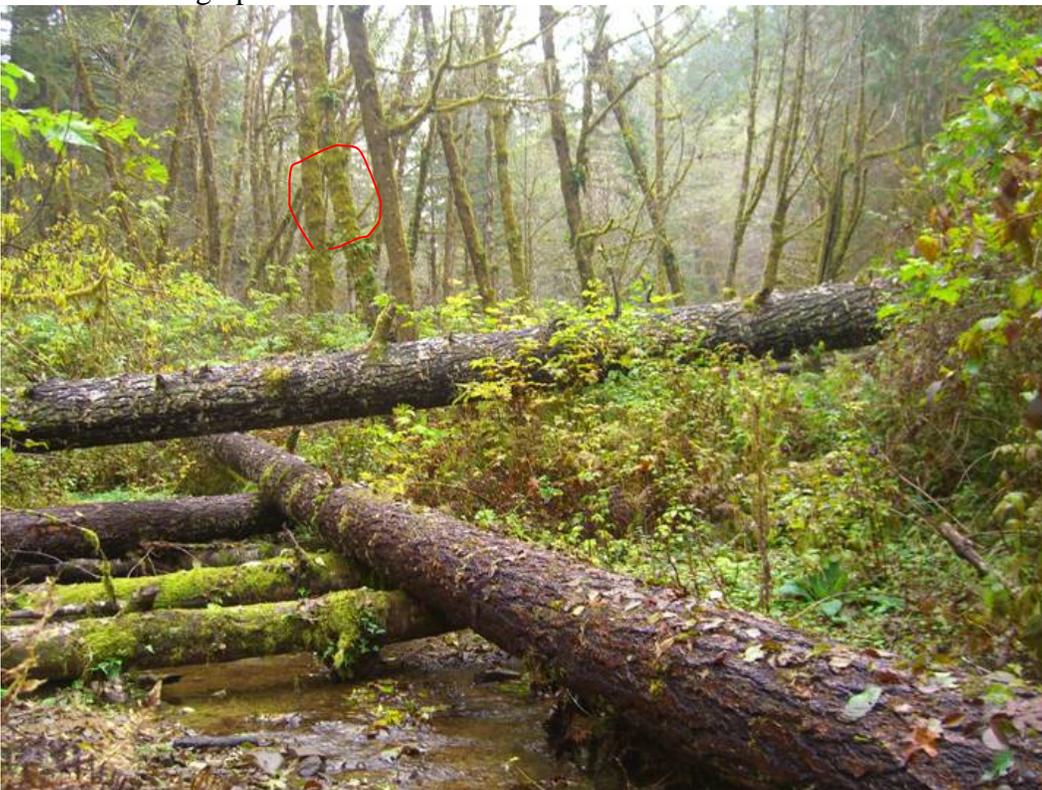
New Comments: Although a majority of the site was covered with bedrock, gravel and fine sediment accumulation is starting to take place in the upstream and downstream end of this structure.

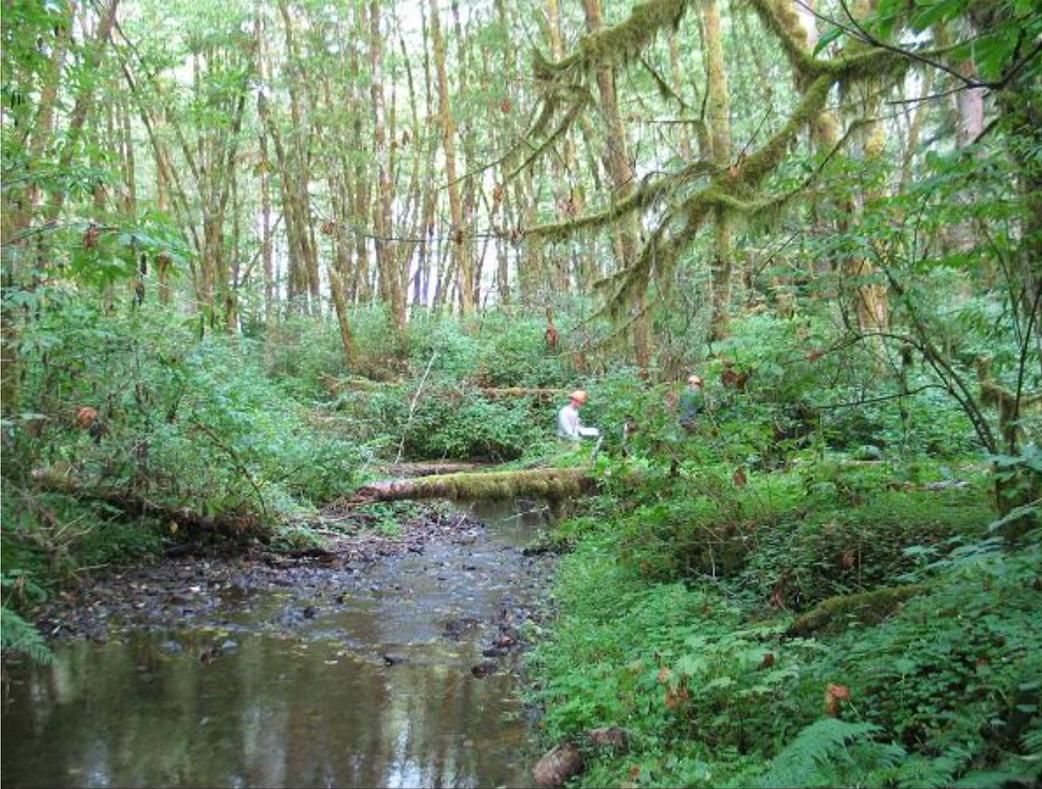
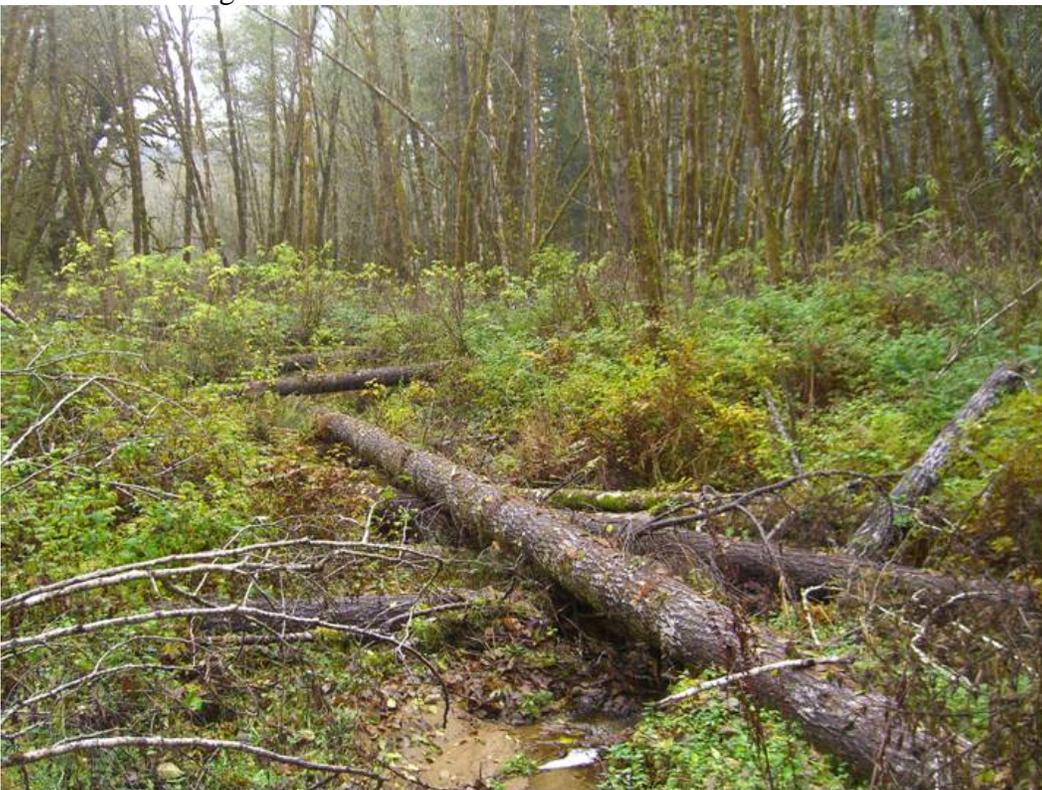
New Comments: Looking at the amount of fine sediment that was collected above the gravel layer, there might have been a small debris slide that deposited all the sand and clay into the structure sites.

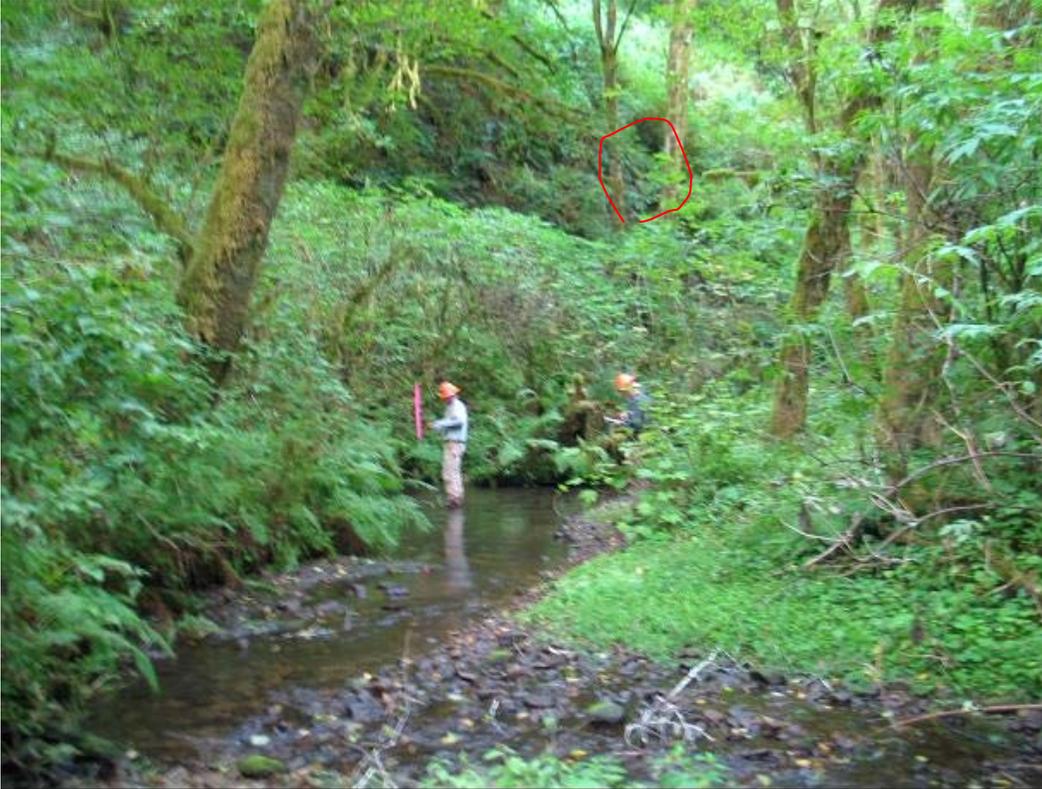
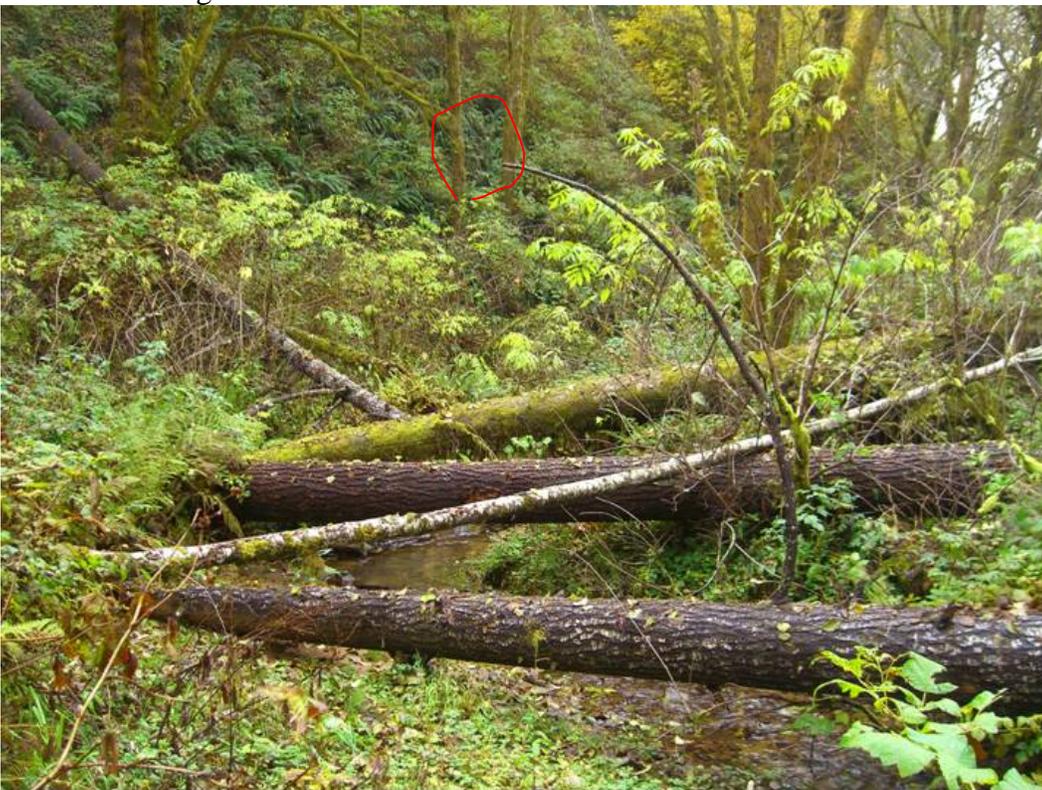
New Comments: The large standing alder on the left fell down into the stream, so that is why you don't see it in the more recent photo. The trees are right on the bottom of the stream, so we look forward to see future changes.

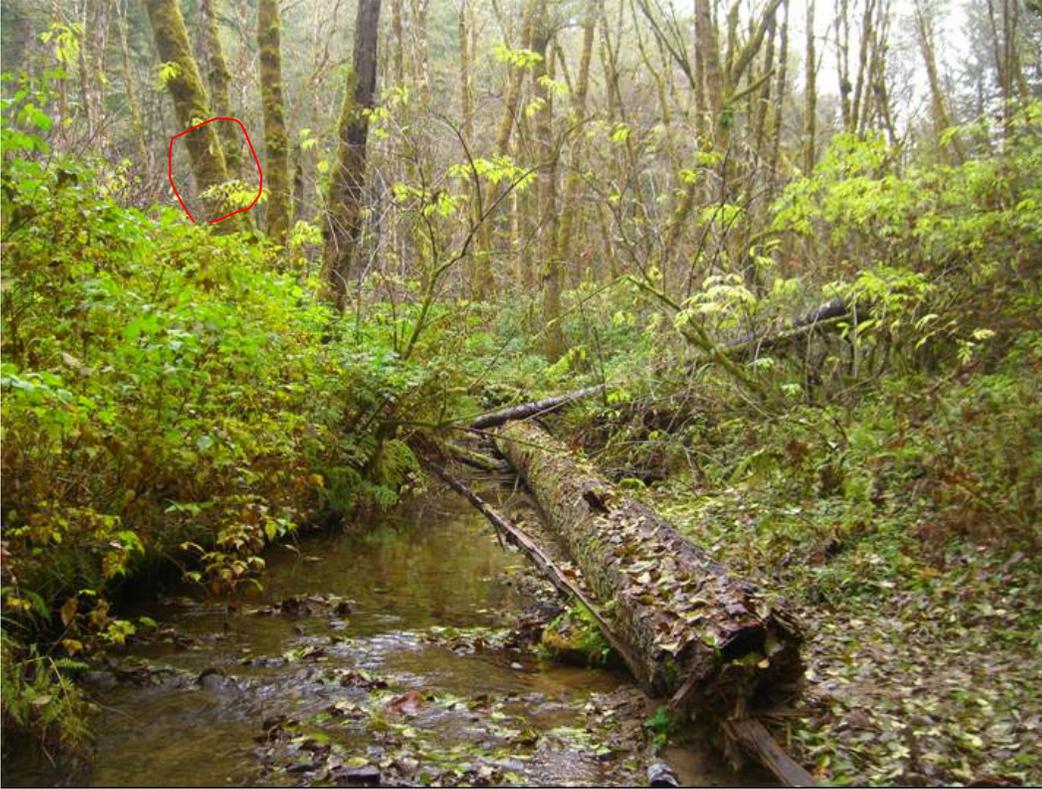
Site #13 looking upstream – 2007

New Comments: Gibson Creek seems to collect a lot of leaf litter and other coarse organic material, and as a result the structure is collecting that and sediment actively around the placed trees.

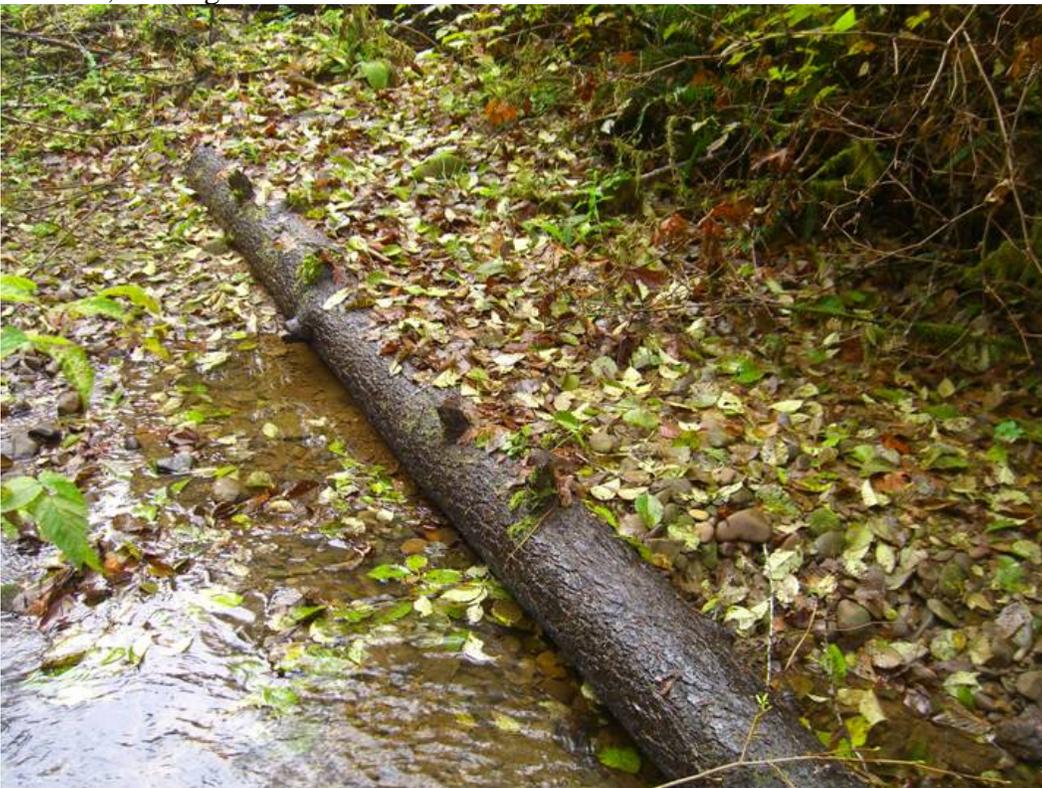
Site #14, looking from side – 2007

New Comments: The two photos above show how much gravel has accumulated by the large wood projects, making the trees blend in with the habitat very well.

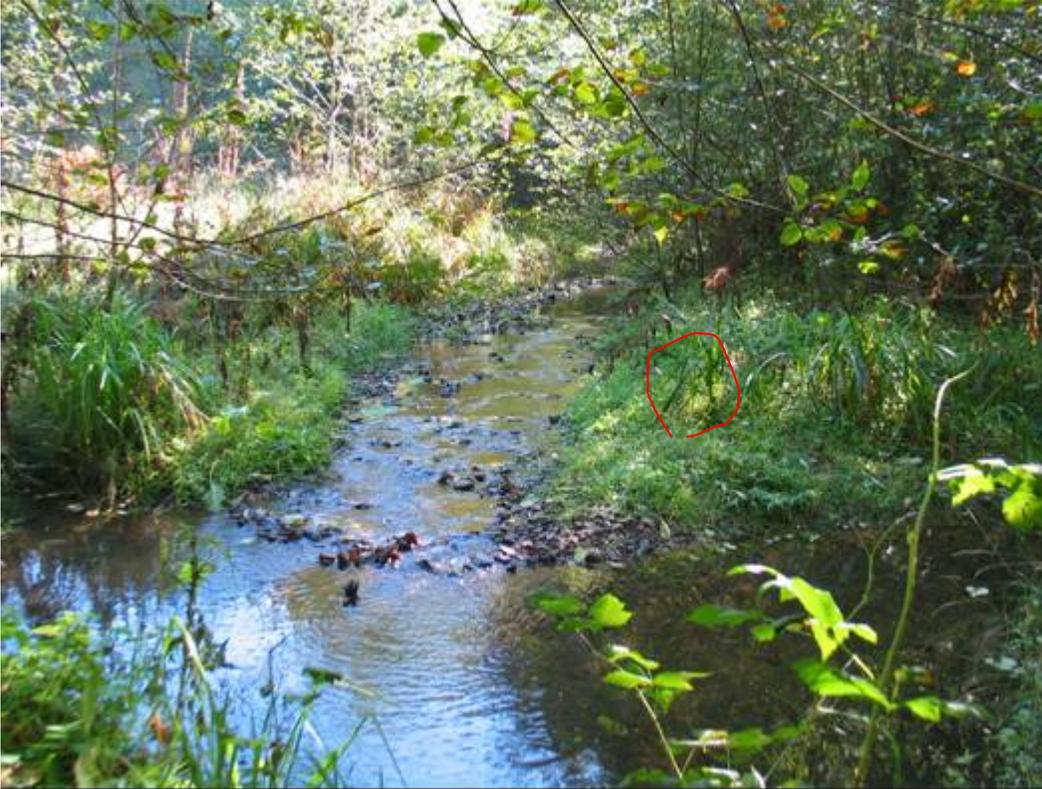
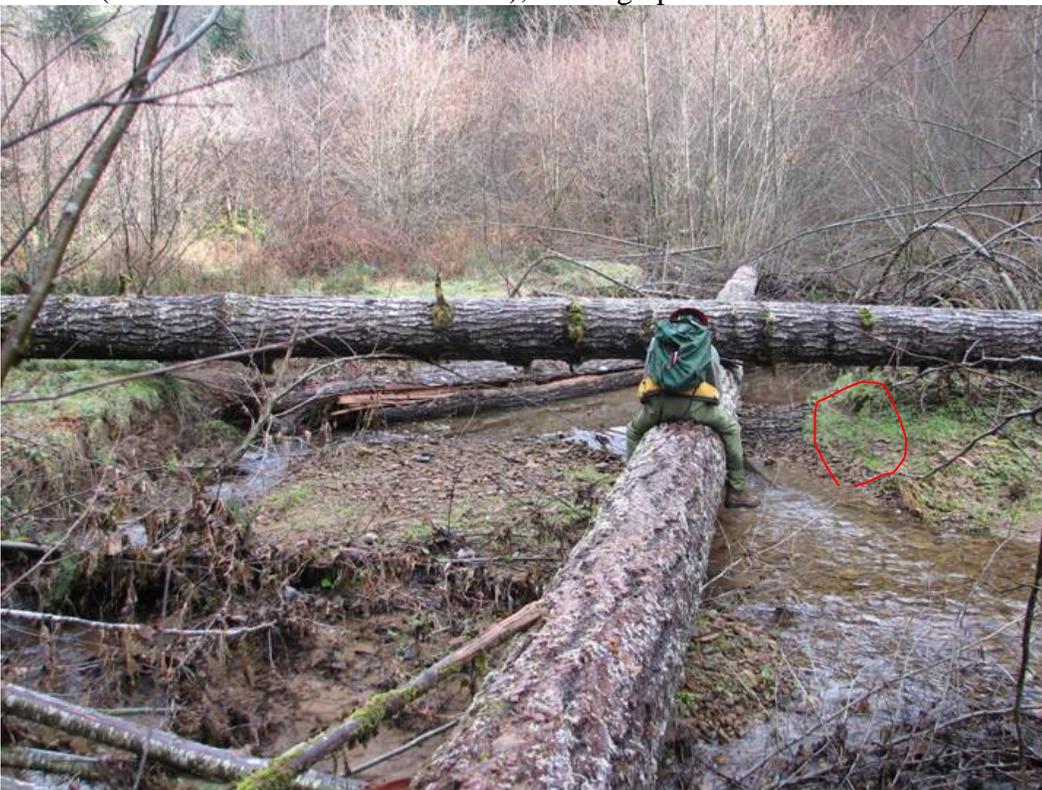
New Comments: Considering the size of the watershed (~1,000 acre watershed = smaller), I was surprised to see the amount of changes as I observed on Taylor Creek from the 2006-2007 winter storms. Newly collected gravel, fine sediment, and small woody debris were observed around virtually all of the 15 structures.

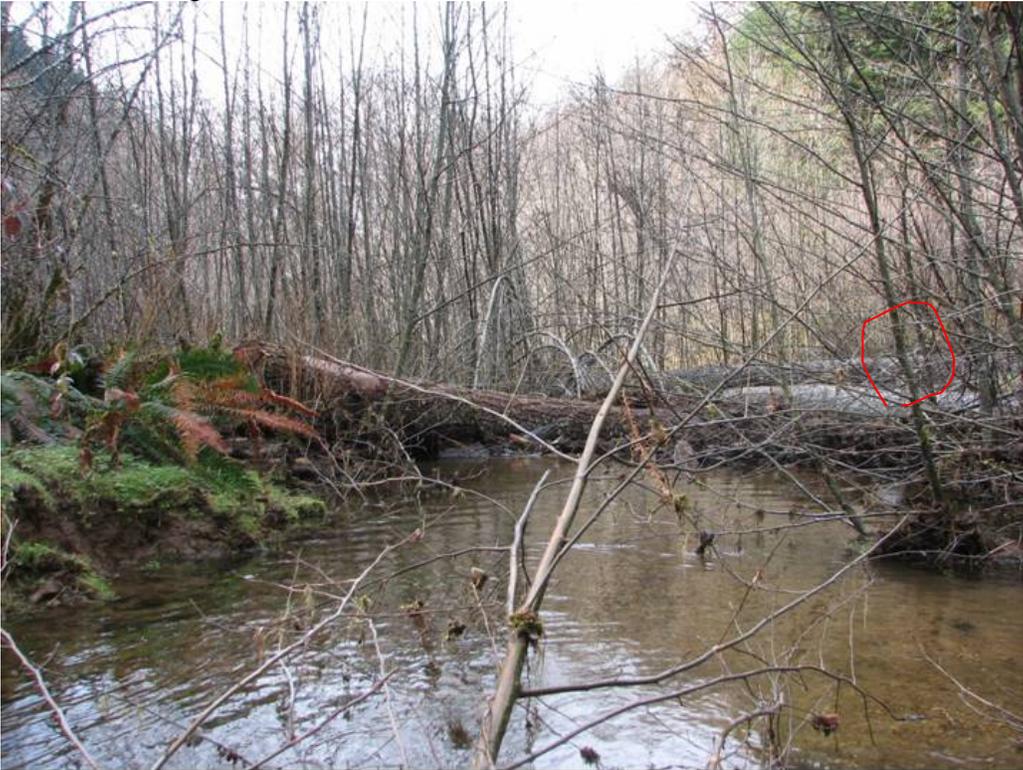
Site #1, looking downstream – 2007

New Comments: Lots of small woody debris collected at upstream end made a new side channel on right side (looking upstream) of the channel going through alders. Scour pools created by logs. Sediment deposited on upstream side. Overall floodplain width increased from new gravel collection dispersing onto the banks. Coho carcasses were found at Site #1 and immediately downstream by some of the cabled tie-down structures.

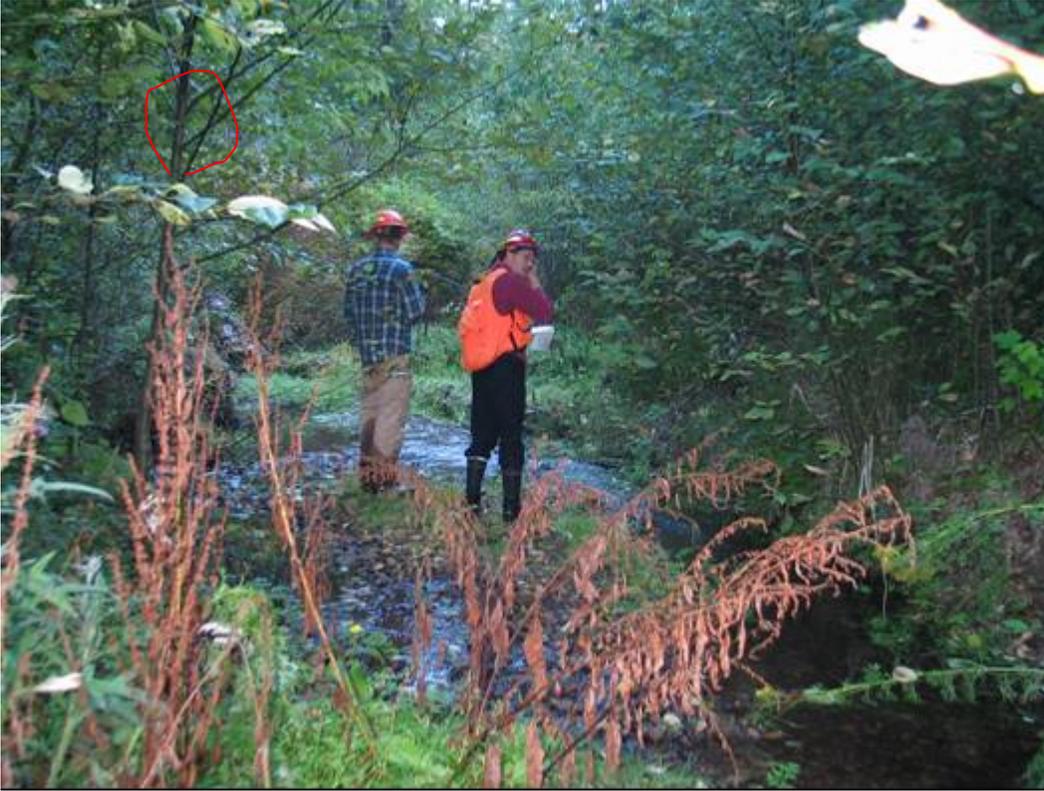
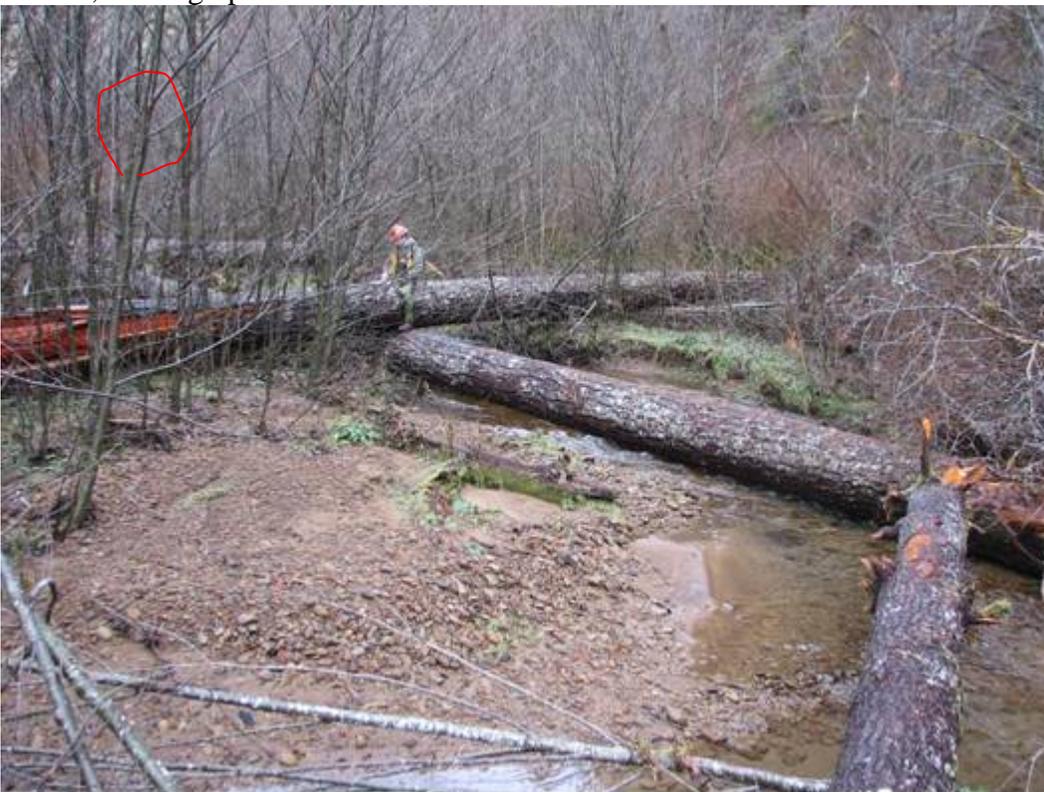
New Comments: Design made on the spot. More gravel found along the structure. Site has increased complexity in terms of the channel formation from the placement trees (stream forced to move through the multiple trees).
