Indian Creek Aquatic Restoration

Oregon Wildlife Heritage Foundation

Narrative Summary:

Photographs:

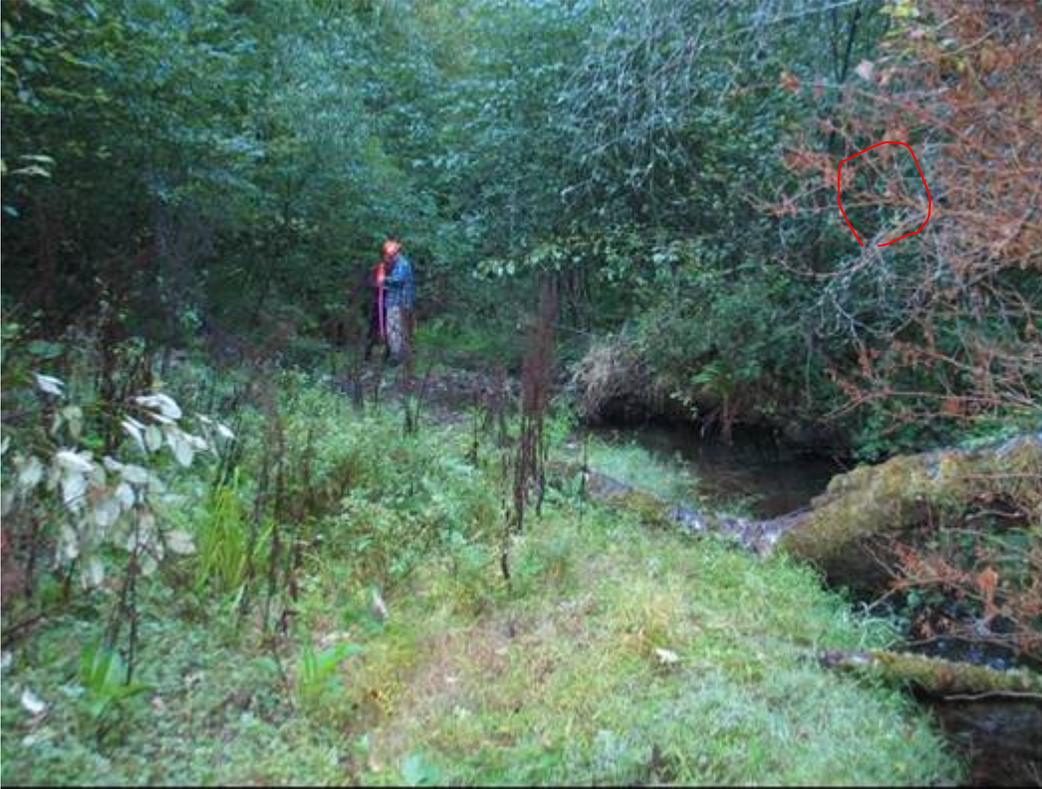
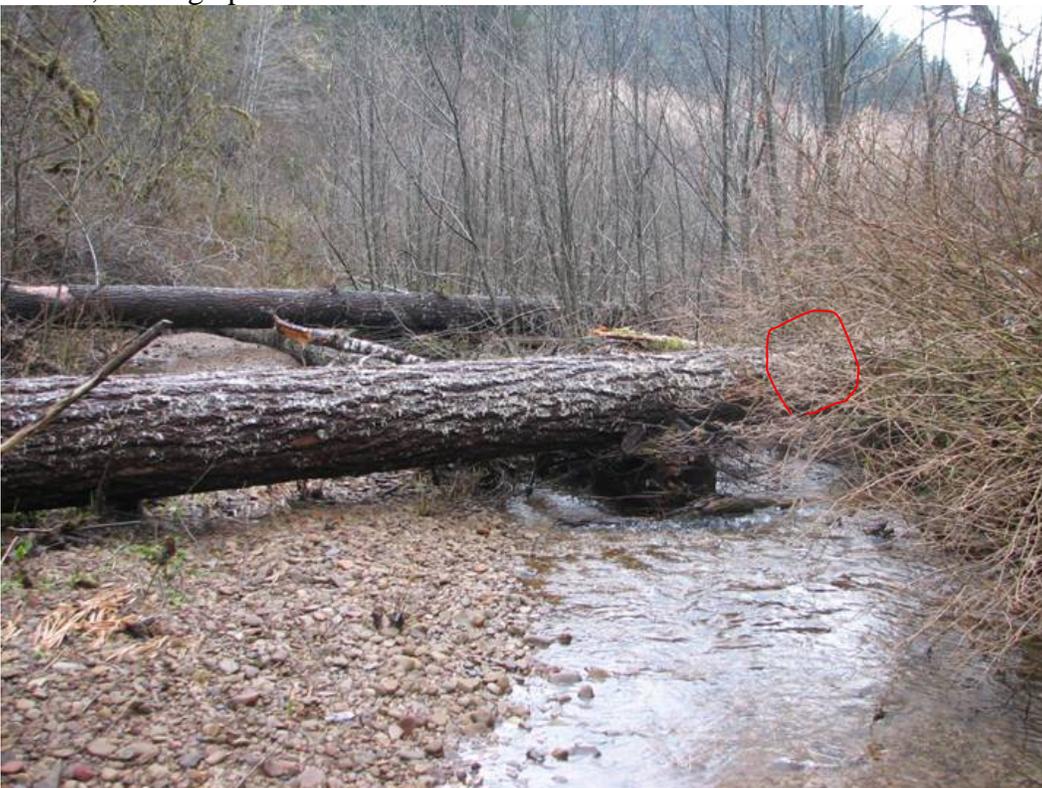
New Comments: Biggest changes (in terms of channel complexity) were observed in the lower 5 structures. Widened channel floodplain from newly derived gravel, side channel formation / channel alteration (with more sinuosity), and additional scour pools were observed throughout the structure sites in these lower reach.
