Pavement
Evaluation/
Maintenance
Management Program
2014

Boardman Airport

**2014 Pavement Evaluation / Maintenance
Management Program**

**Final Report – Individual Airports
Functional Category 4, Eastern Climatic Zone**

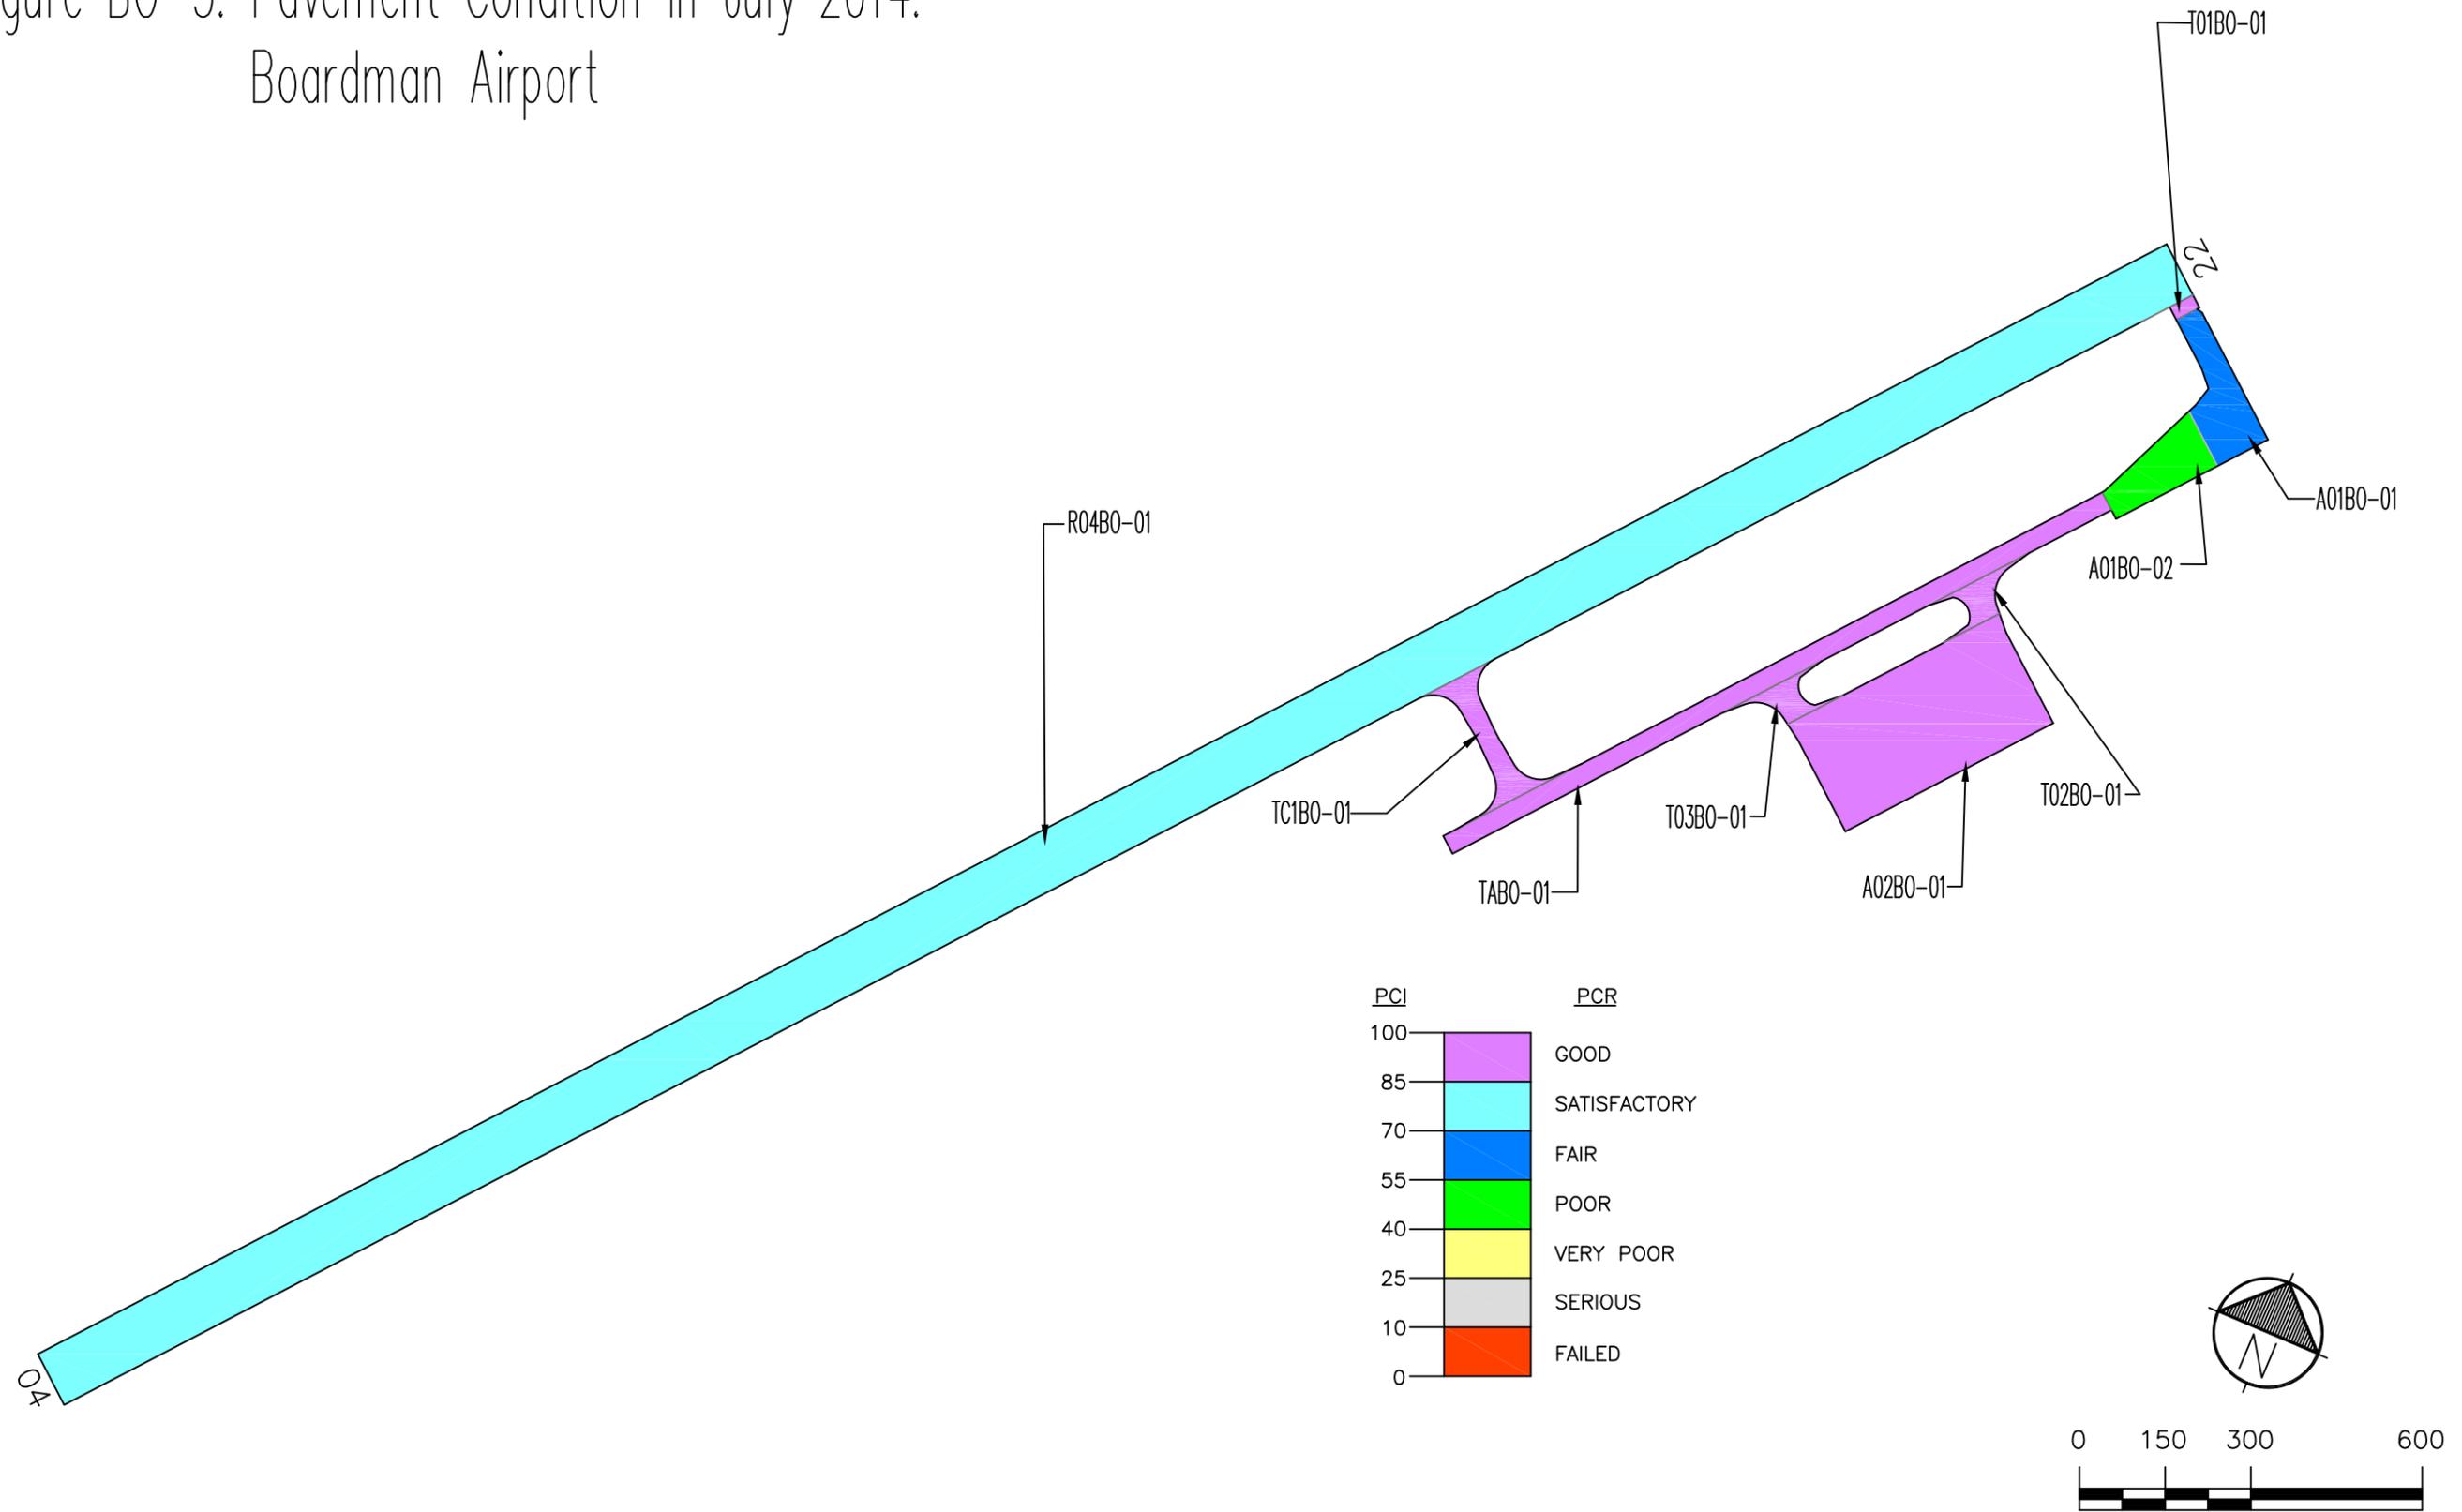
Figure B0-3. Pavement Condition in July 2014.
Boardman Airport

The Branch Condition Report in Appendix 1 summarizes current pavement condition by branch while the Section Condition Report in Appendix 2 lists pavement condition by section. The current PCR is shown graphically in Figure BO-3.

Section PCIs at Boardman Airport range from a low of 54 (a PCR of “Poor”) to a high of 100 (a PCR of “Good”). The area-weighted average PCI for all airport pavements is 87, corresponding to an overall PCR of “Good”. Figure BO-4 shows how much pavement area is associated with each Pavement Condition Rating category and also shows pavement condition distribution from the inspections conducted in 2006 and 2011.

The primary distresses observed during the inspection were: longitudinal and transverse cracking, block cracking, weathering, and with isolated occurrences of patching and alligator cracking.

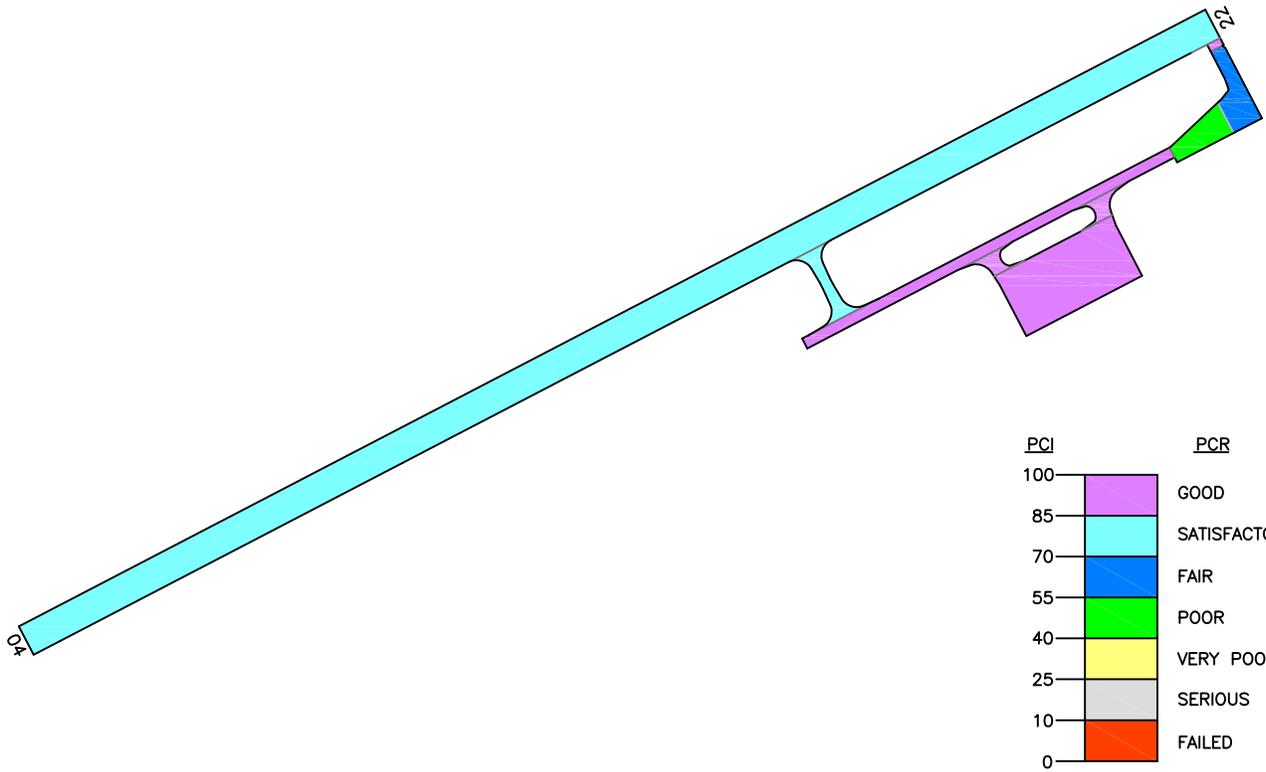
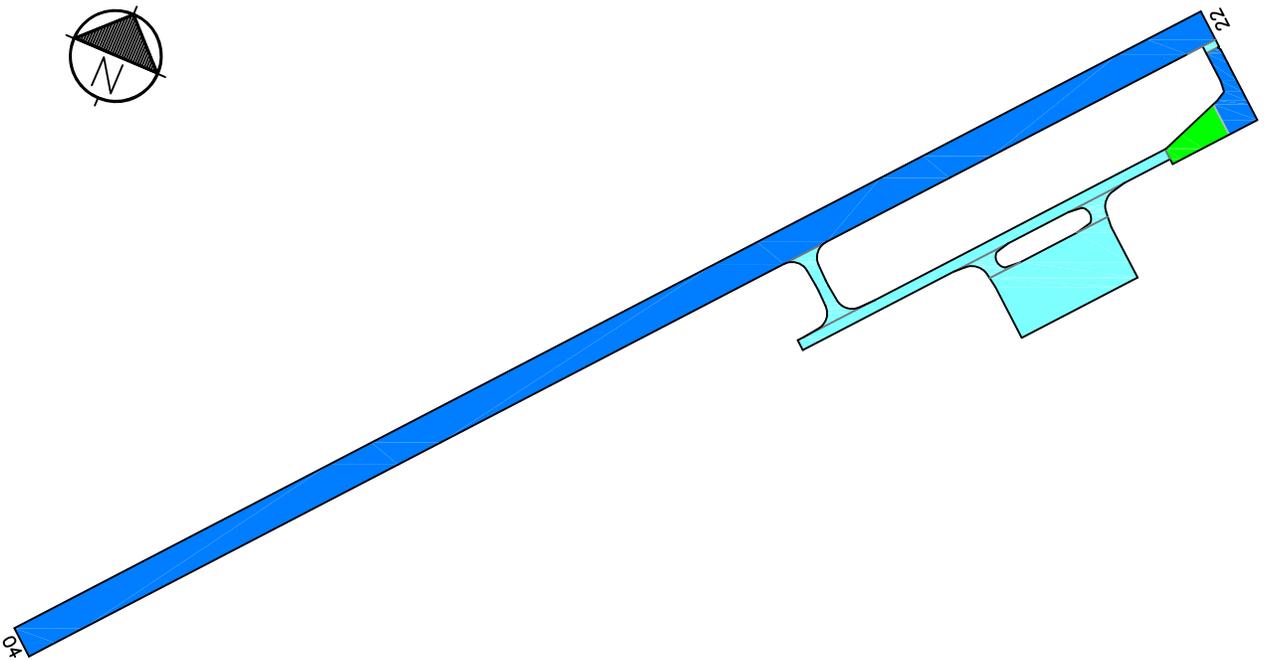
Figure BO-5. Future Pavement Condition.

A graphical representation of the projected PCIs listed in Table 1 is shown in Figure BO-5.
