Pavement
Evaluation/
Maintenance
Management Program
2014

Burns Municipal
Airport

**2014 Pavement Evaluation / Maintenance
Management Program**

**Final Report – Individual Airports
Functional Category 3, Eastern Climatic Zone**

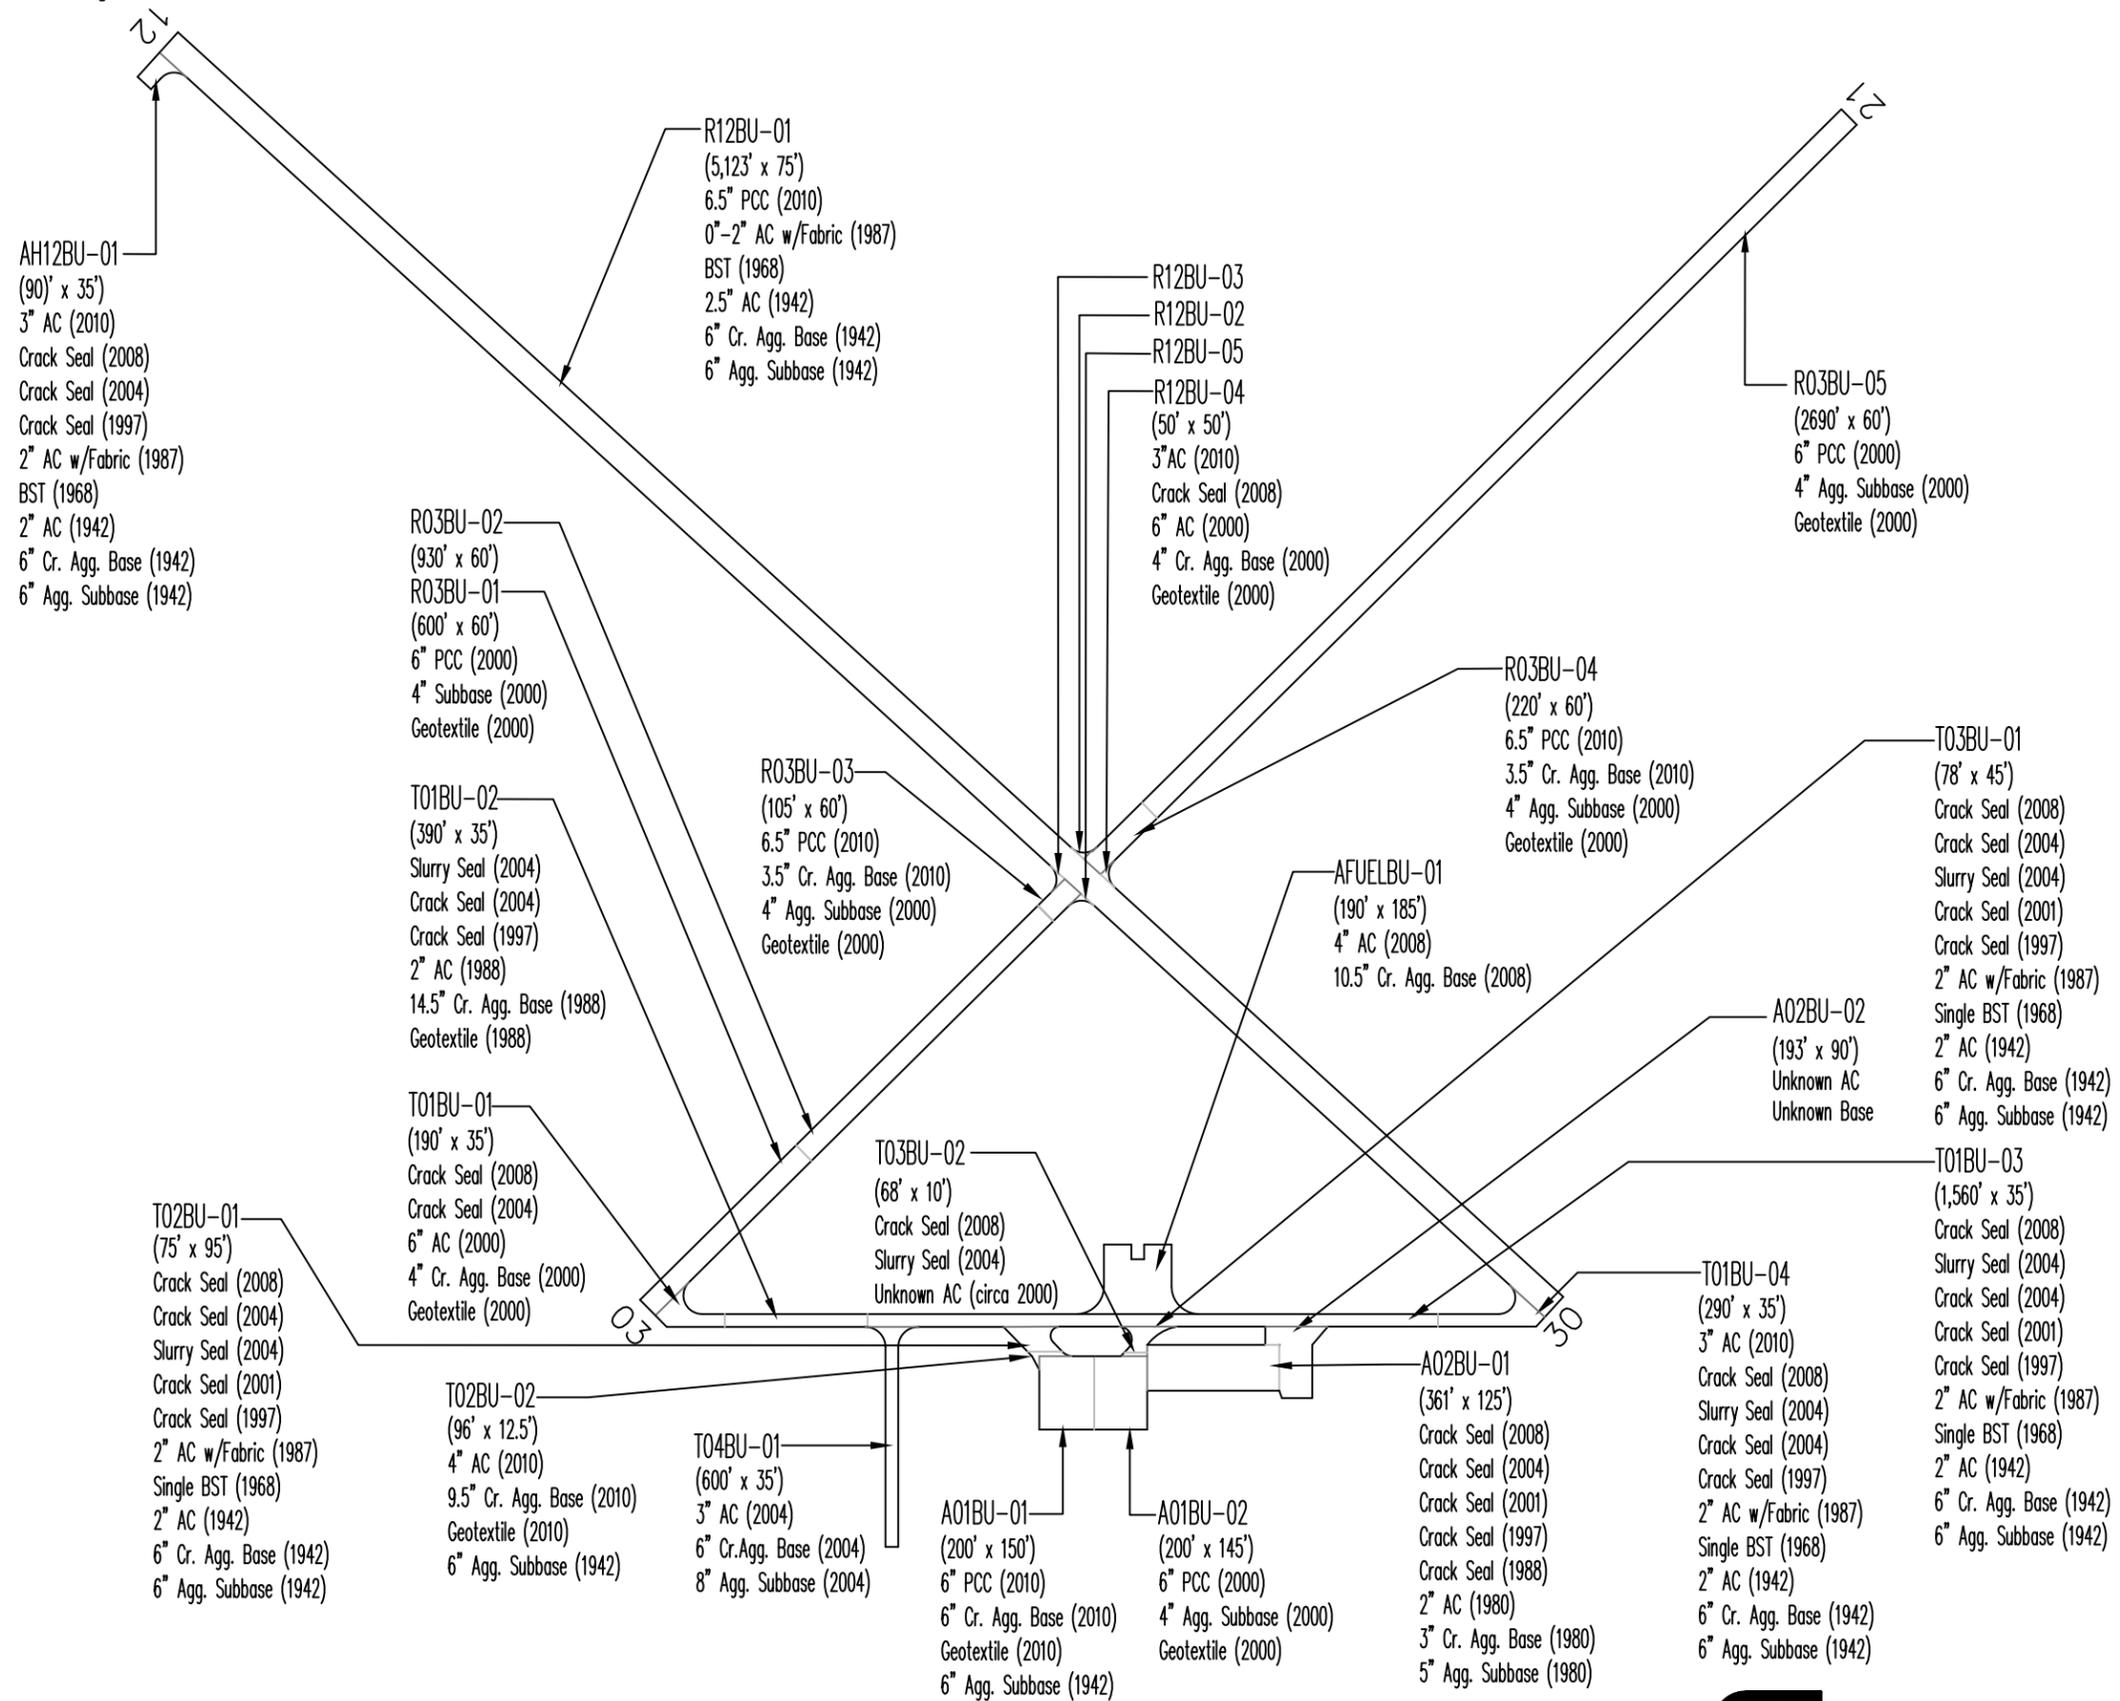
Figure BU-1. Airport Layout, Dimensions and Pavement Cross-Sections.

To determine how your pavements were constructed and their age, a records review was conducted. Figure BU-1 shows the records review results. This figure identifies pavement boundaries, dimensions, pavement layer types, thicknesses and dates of construction. The most recent construction date for each pavement can also be found in the Section Condition Report in Appendix 2. Figure BU-1 and the information contained in Appendices 1, 2 and 4 ensure that your airport complies with the “pavement inventory” requirement of FAA’s PMMP guidelines.

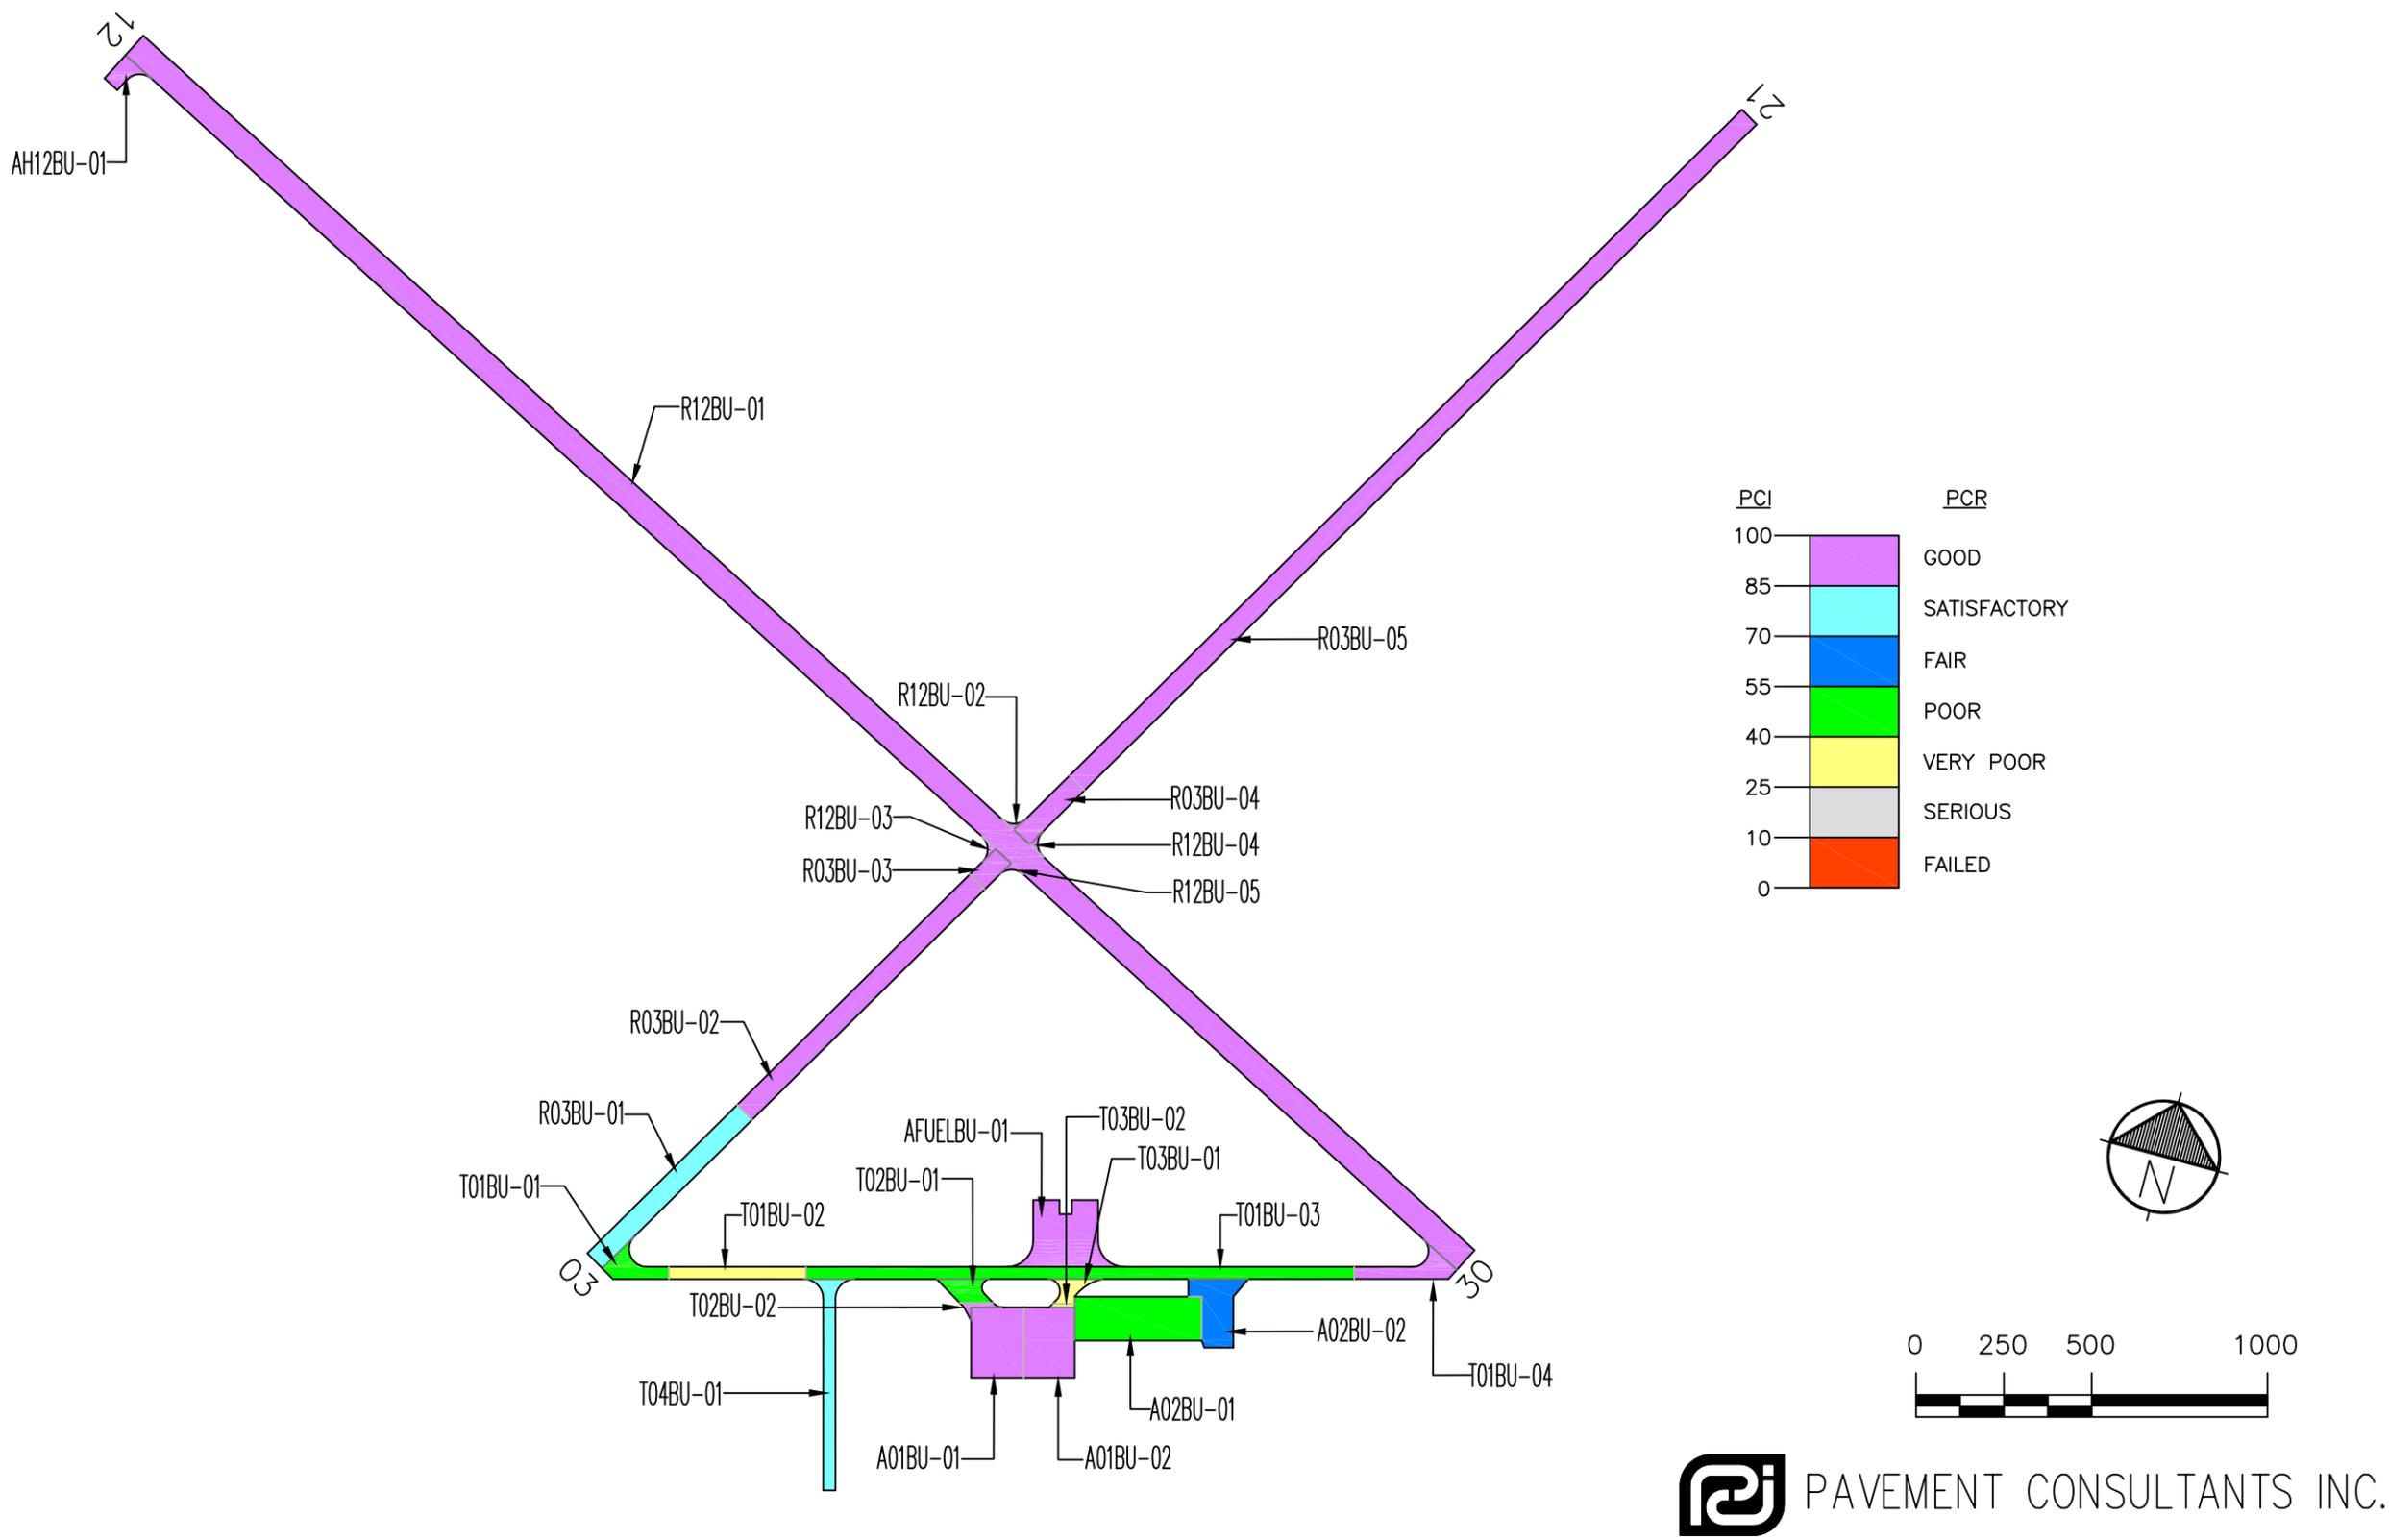
Figure BU-3. Pavement Condition in July 2014.
Burns Municipal Airport

The Branch Condition Report in Appendix 1 summarizes current pavement condition by branch while the Section Condition Report in Appendix 2 lists pavement condition by section. The current PCR is shown graphically in Figure BU-3.

Section PCIs at Burns Municipal Airport range from a low of 31 (a PCR of “Very Poor”) to a high of 100 (a PCR of “Good”). The area-weighted average PCI for all airport pavements is 86, corresponding to an overall PCR of “Good”. Figure BU-4 shows how much pavement area is associated with each Pavement Condition Rating category and also shows pavement condition distribution from the inspections conducted in 2006 and 2011.
