Eastern Oregon
Regional Airport
at Pendleton

**2014 Pavement Evaluation / Maintenance
Management Program**

**Final Report – Individual Airports
Functional Category 1, Eastern Climatic Zone**

November 2014

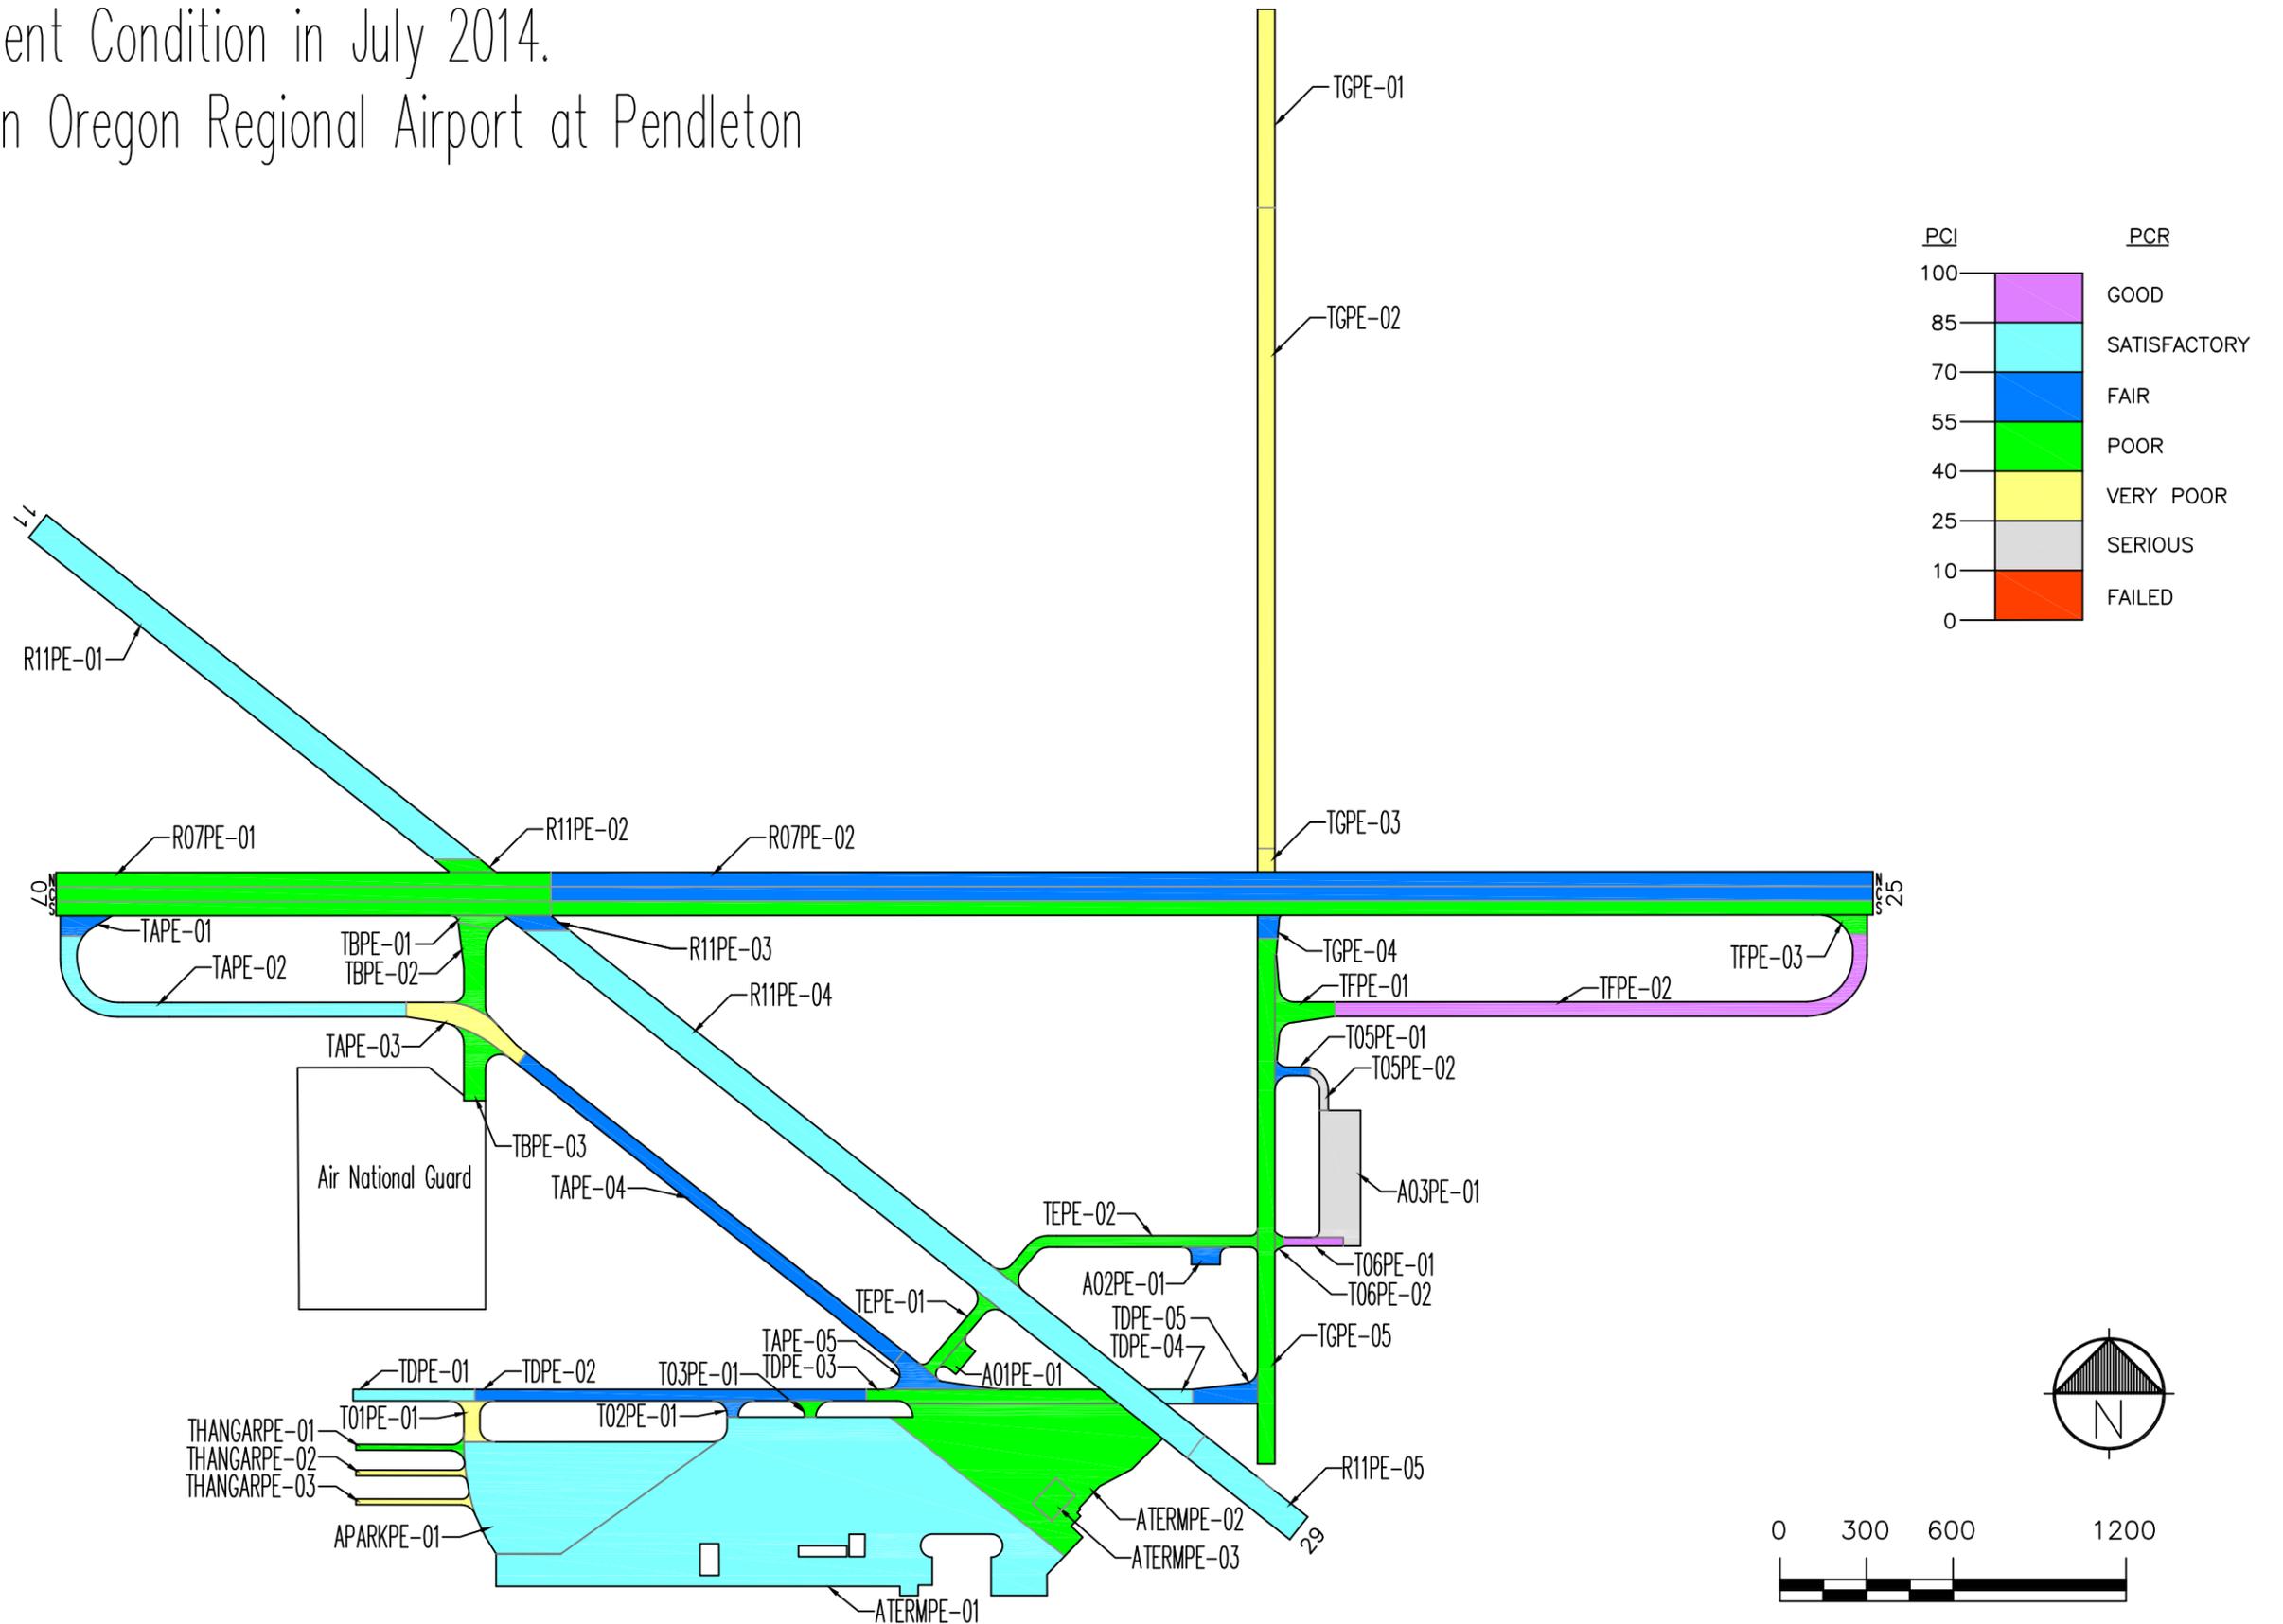
Figure PE-3. Pavement Condition in July 2014.
Eastern Oregon Regional Airport at Pendleton

Section PCIs at Eastern Oregon Regional Airport at Pendleton range from a low of 18 (a PCR of “Serious”) to a high of 84 (a PCR of “Satisfactory”). The area-weighted average PCI for all airport pavements is 64, corresponding to an overall PCR of “Fair”. Figure PE-4 shows how much pavement area is associated with each Pavement Condition Rating category.
