Pavement
Evaluation/
Maintenance
Management Program
2014

Wasco State
Airport

**2014 Pavement Evaluation / Maintenance
Management Program**

**Final Report – Individual Airports
Functional Category 4, Eastern Climatic Zone**

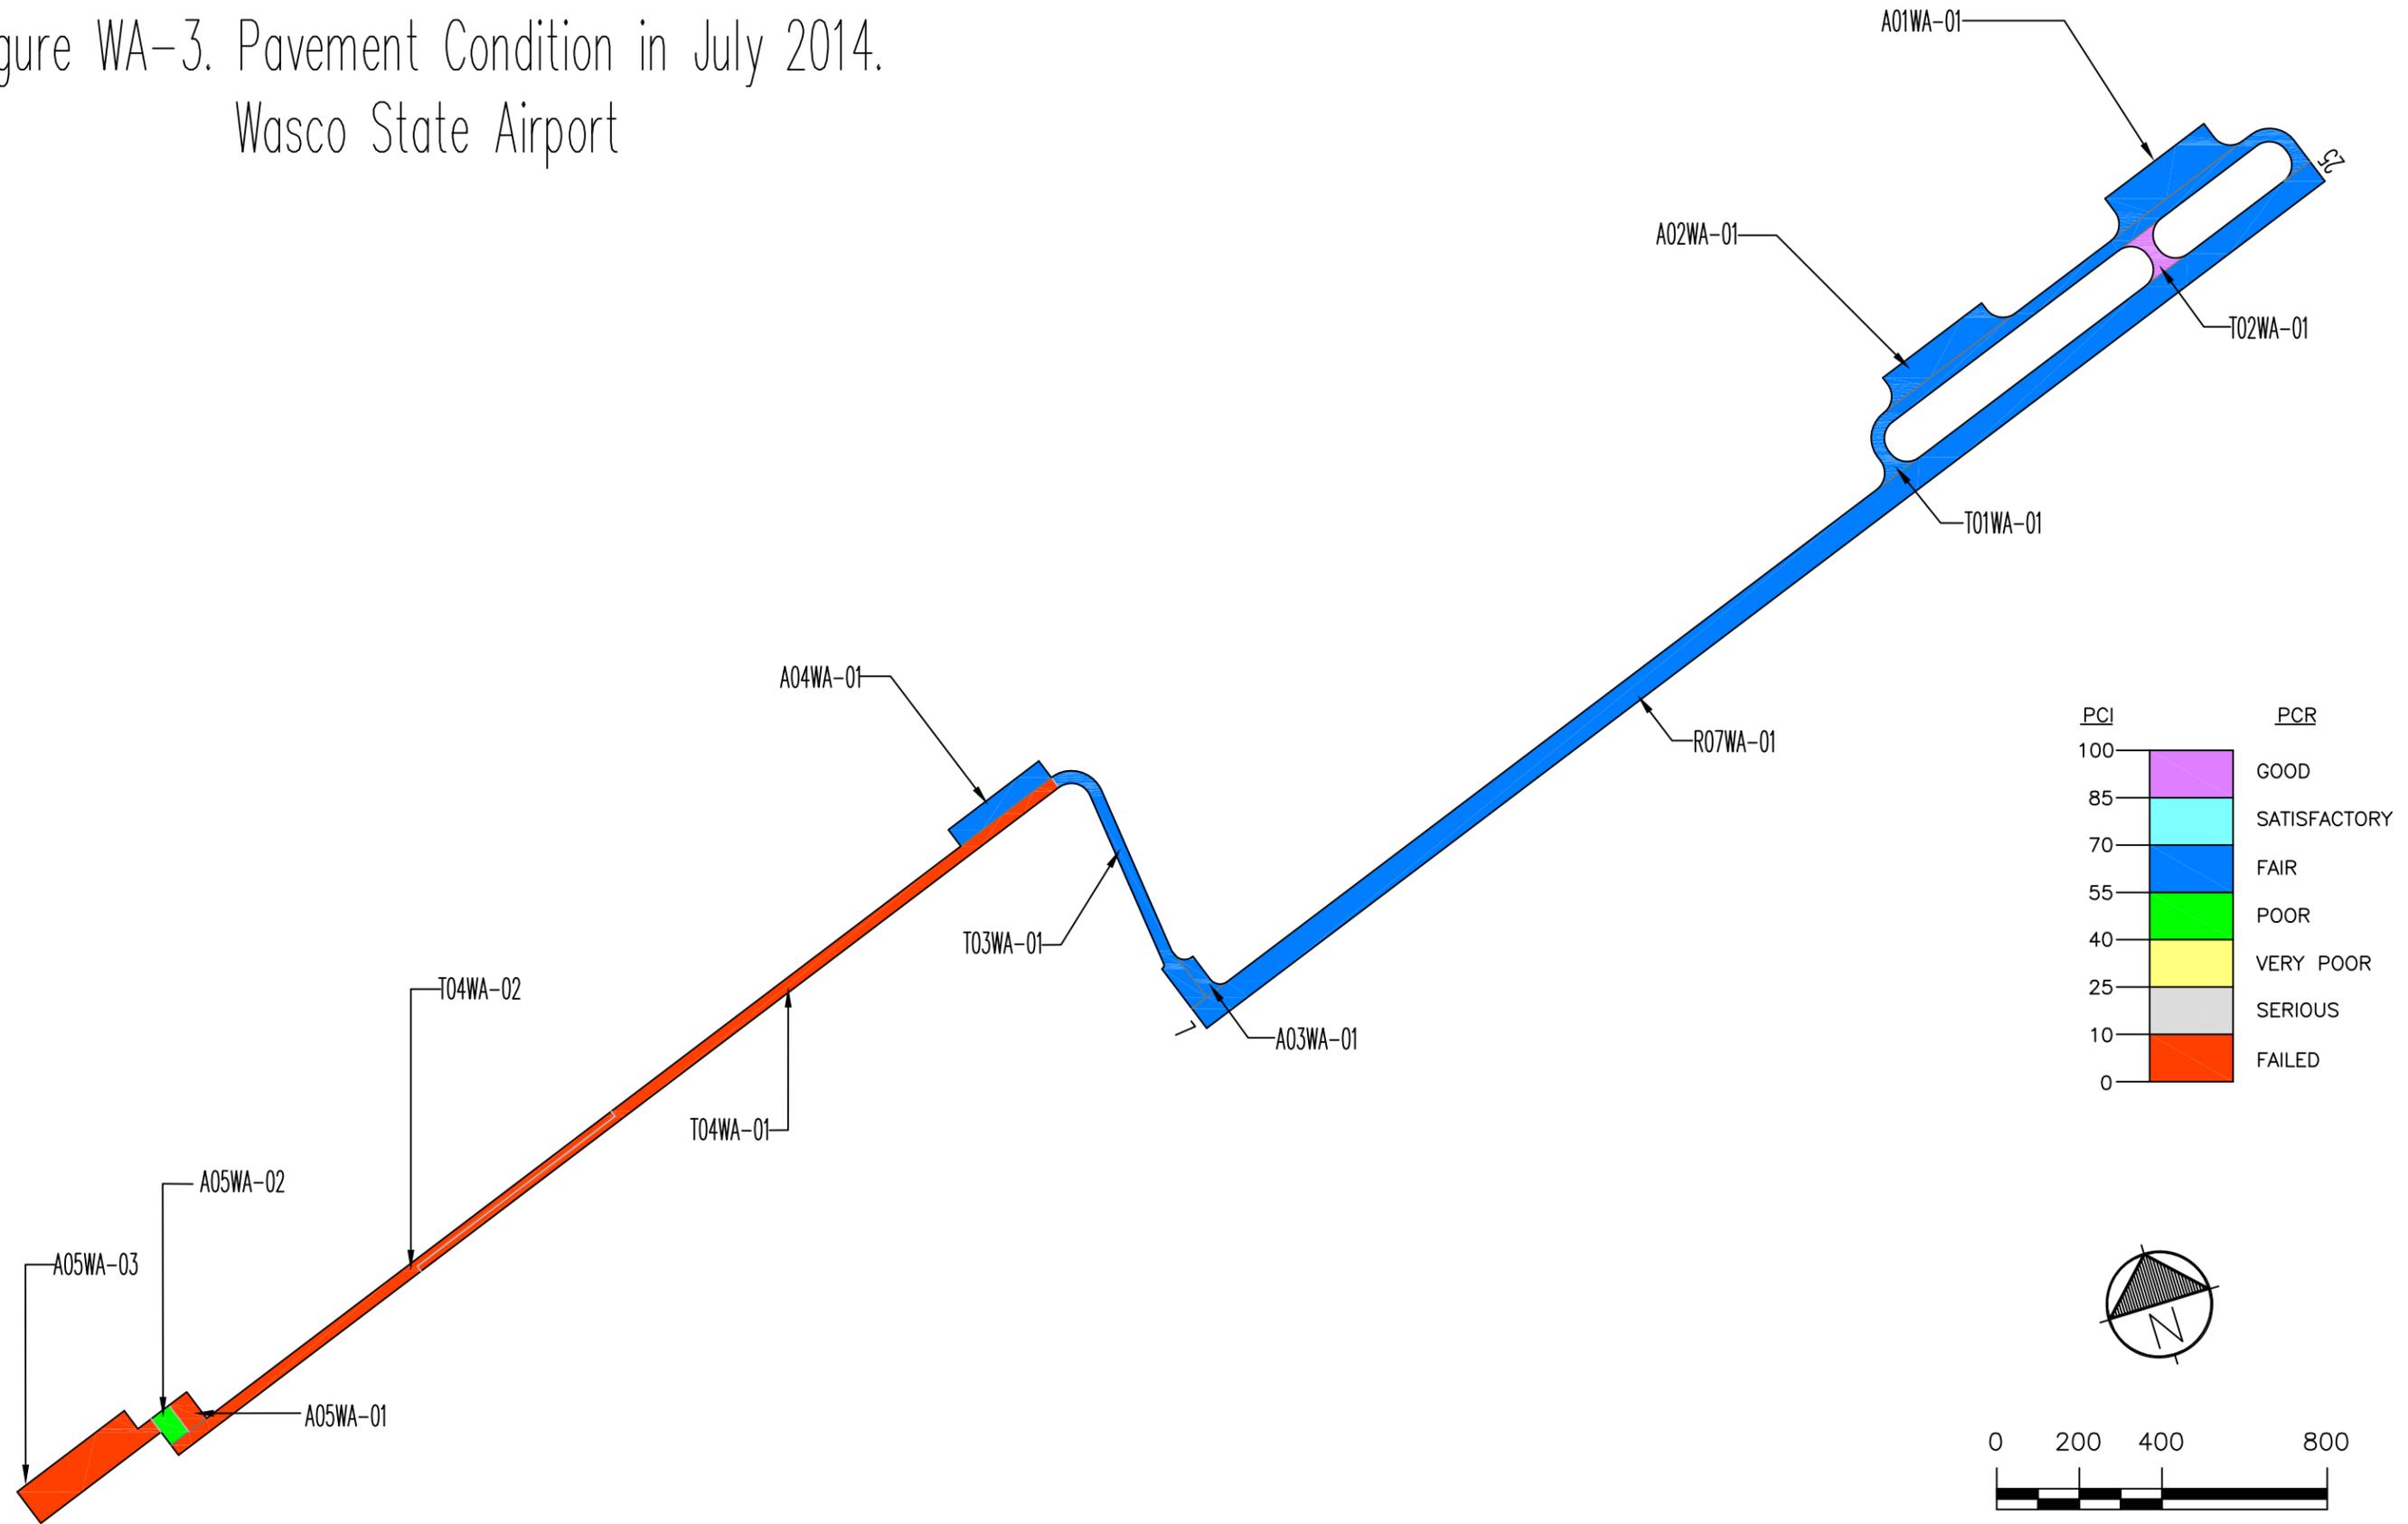
Figure WA-3. Pavement Condition in July 2014.
Wasco State Airport

The Branch Condition Report in Appendix 1 summarizes current pavement condition by branch while the Section Condition Report in Appendix 2 lists pavement condition by section. The current PCR is shown graphically in Figure WA-3.

Section PCIs at Wasco State Airport range from a low of 0 (a PCR of “Failed”) to a high of 86 (a PCR of “Good”). The area-weighted average PCI for all airport pavements is 47, corresponding to an overall PCR of “Poor”. Figure WA-4 shows how much pavement area is associated with each Pavement Condition Rating category and also shows pavement condition distribution from the inspections conducted in 2006 and 2011.

The primary distresses observed during the inspection were: weathering, block cracking, alligator cracking, longitudinal and transverse cracking, and raveling, with isolated occurrences of patching and depressions.

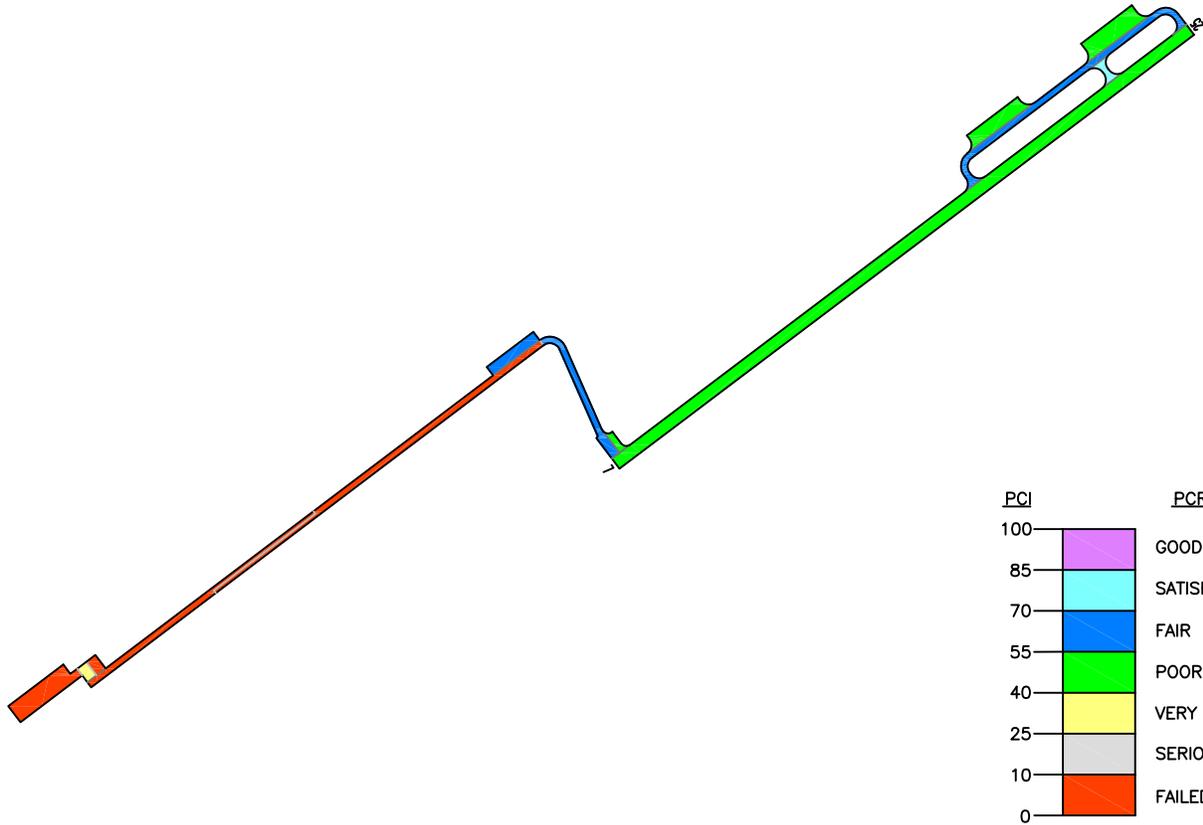
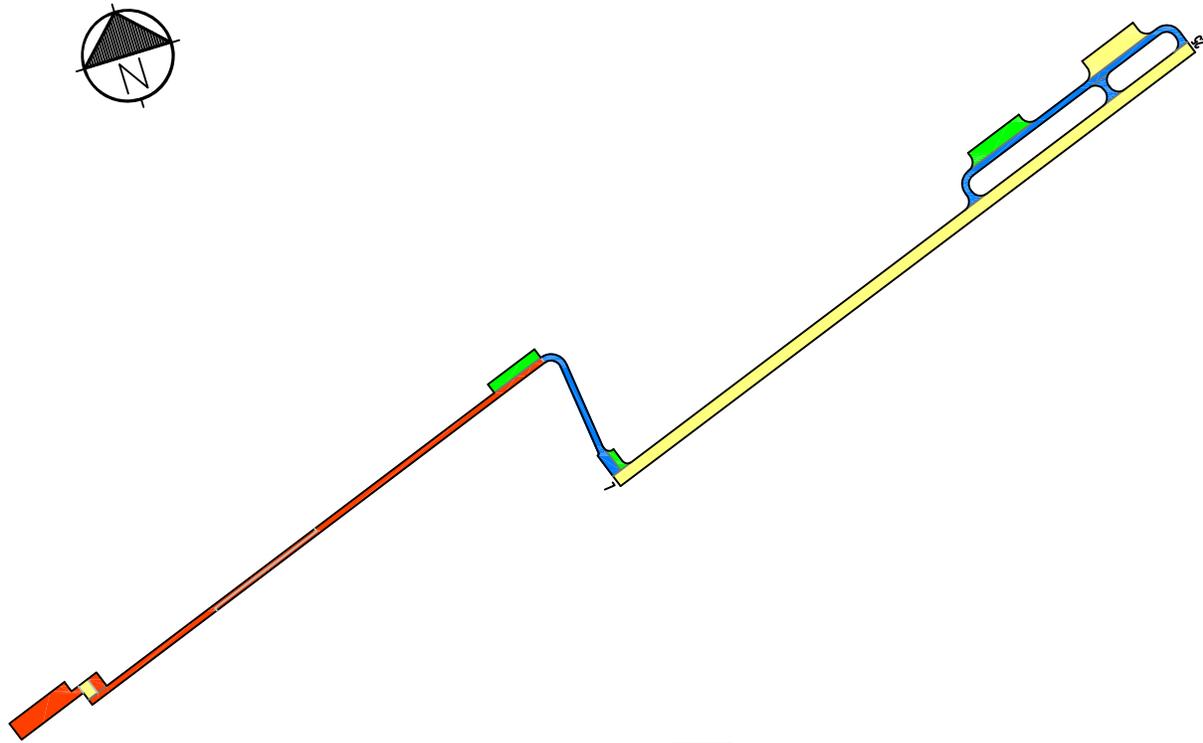
Figure WA-5. Future Pavement Condition.

A graphical representation of the projected PCIs listed in Table 1 is shown in Figure WA-5.
