Burns Municipal
Airport

**2011 Pavement Evaluation / Maintenance
Management Program**

**Final Report – Individual Airports
Functional Category 3**

July 2011

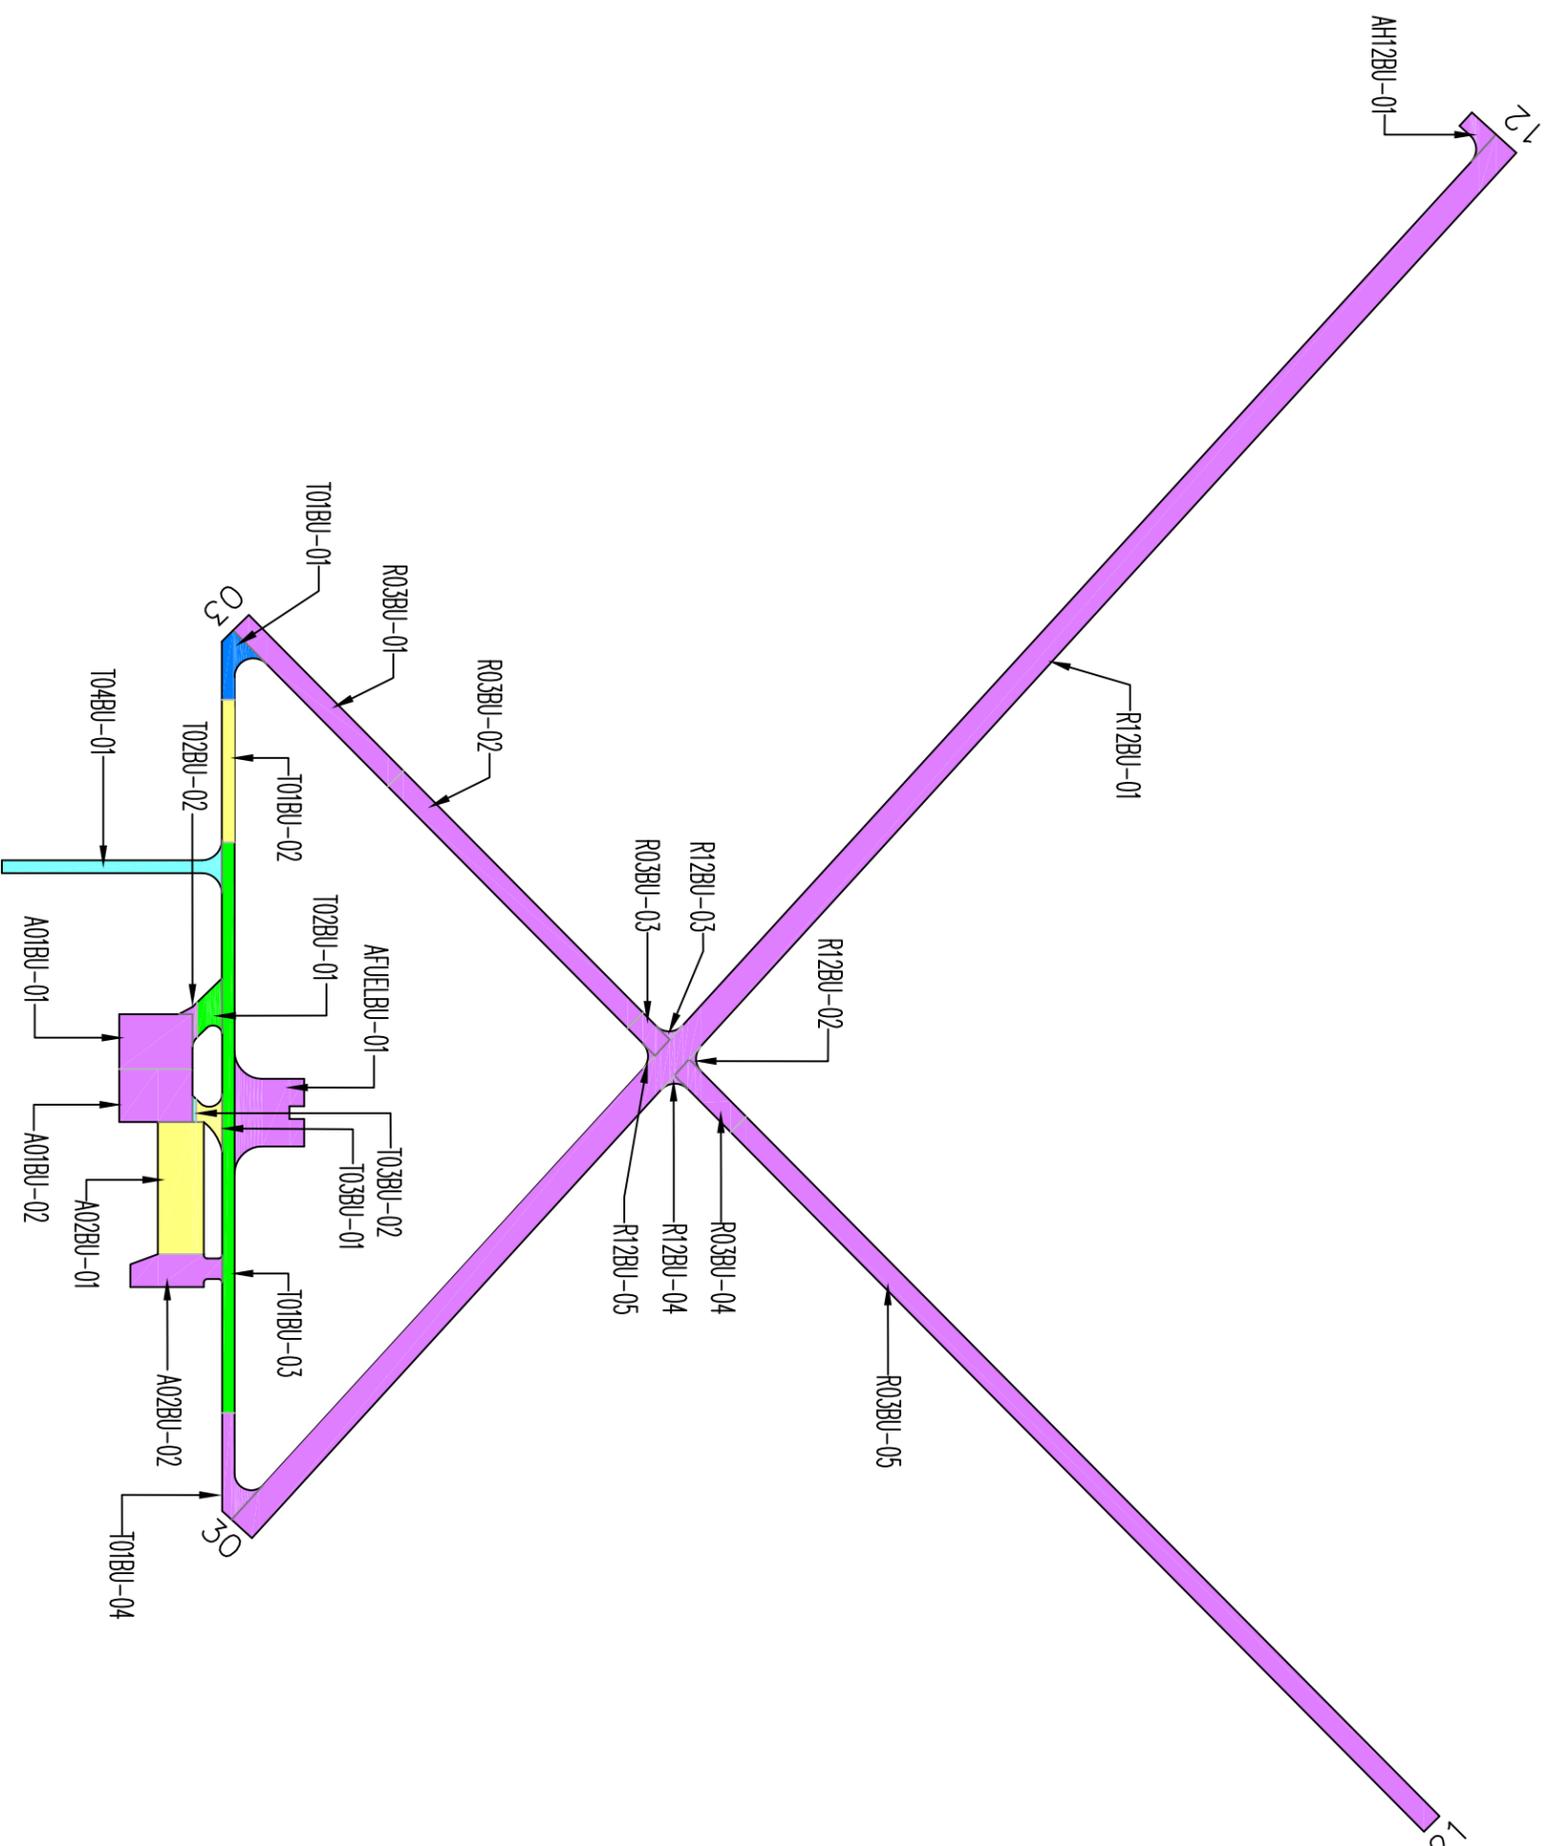
Figure BU-3. Pavement Condition in May 2011.
Burns Municipal Airport

The Branch Condition Report in Appendix 1 summarizes current pavement condition by branch while the Section Condition Report in Appendix 2 lists pavement condition by section. The current PCR is shown graphically in Figure BU-3.

Section PCIs at Burns Municipal Airport range from a low of 26 (a PCR of “Very Poor”) to a high of 100 (a PCR of “Good”). The area-weighted average PCI for all airport pavements is 87, corresponding to an overall PCR of “Good”. Figure BU-4 shows how much pavement area is associated with each Pavement Condition Rating category and also shows pavement condition distribution from the inspections conducted in 2003 and 2006.

The primary distresses observed during the inspection of asphalt concrete pavements were: raveling, weathering, block cracking, longitudinal and transverse cracking, and alligator cracking with isolated occurrences of patching and depressions. The primary distresses observed during the inspection of portland cement concrete pavements were: joint seal damage, joint spalls, small patches, corner spalls, shrinkage cracks, and large patches with isolated occurrences of scaling, linear cracks and corner breaks.

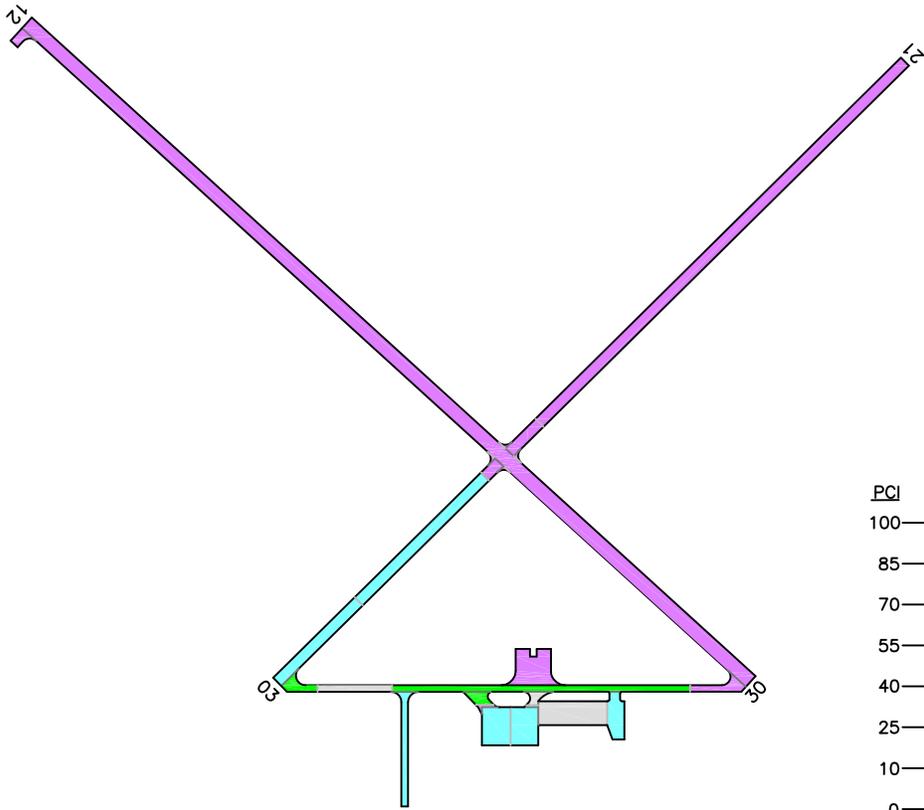
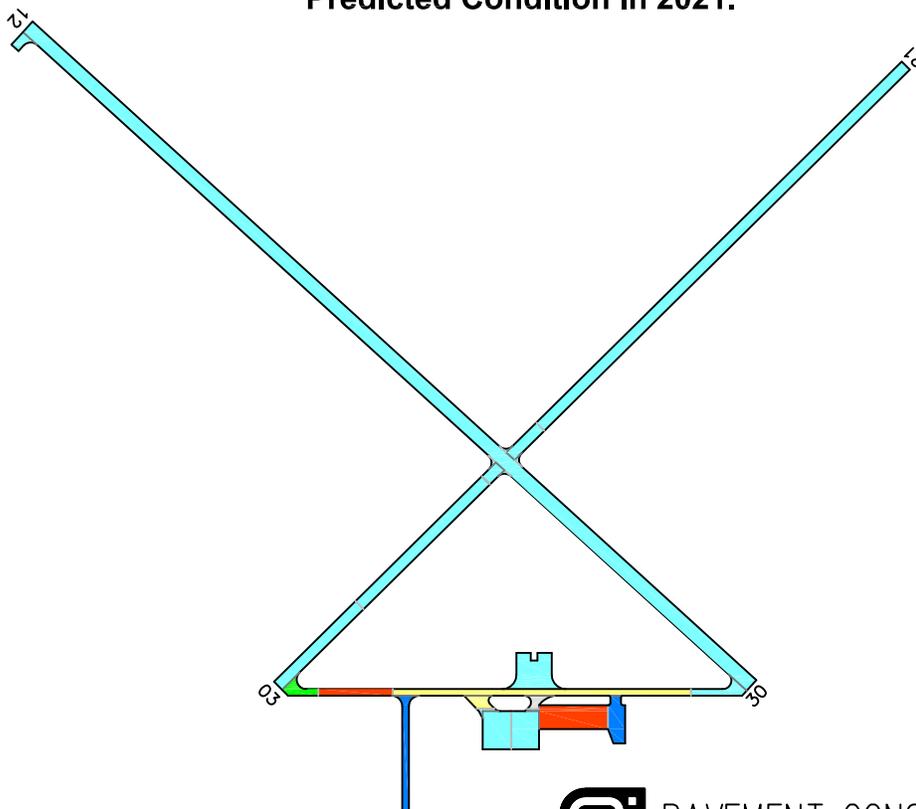
Figure BU-5. Future Pavement Condition.

A graphical representation of the projected PCIs listed in Table 1 is shown in Figure BU-5.
