**Canyon Creek Meadows  
Dam Evaluation Report  
Grant County, Oregon  
Sections 28 and 29, T15S, R33E, W.M.**

**August 2012**

**Report Date:** August 29, 2012

**Project Number:** 2923018

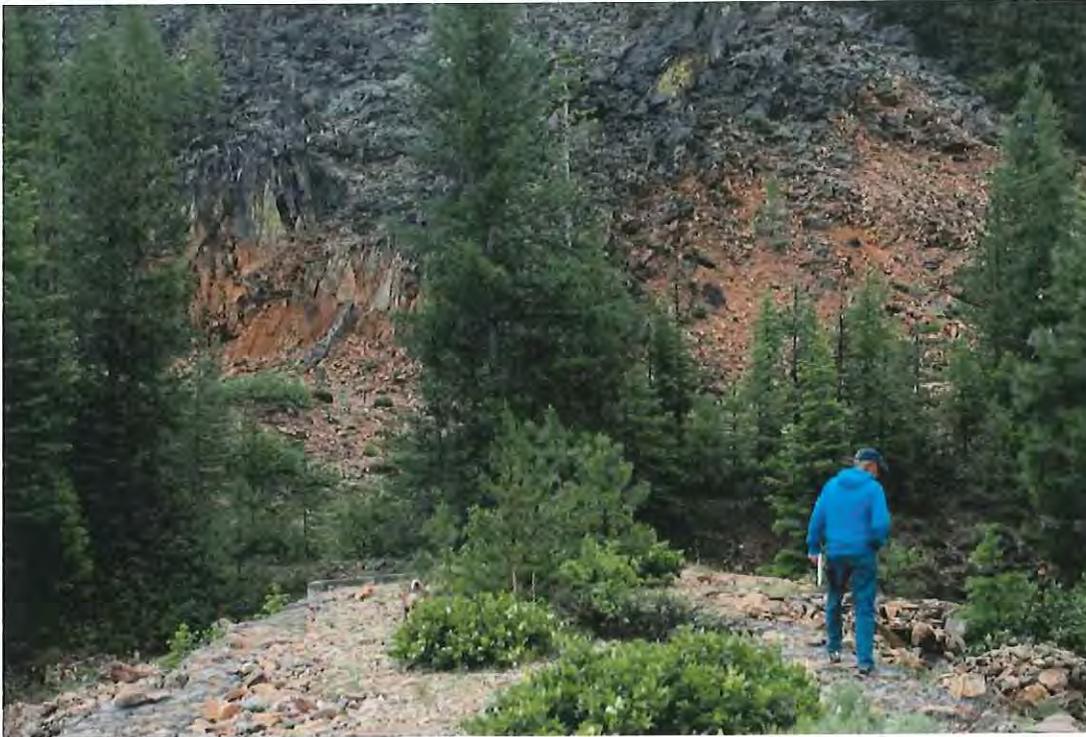
**Photograph 1:** Looking south from the top of Canyon Creek Meadows Dam at area of relatively freshly exposed rock presumed to have been the source for the construction/repair of the dam (6/19/09).

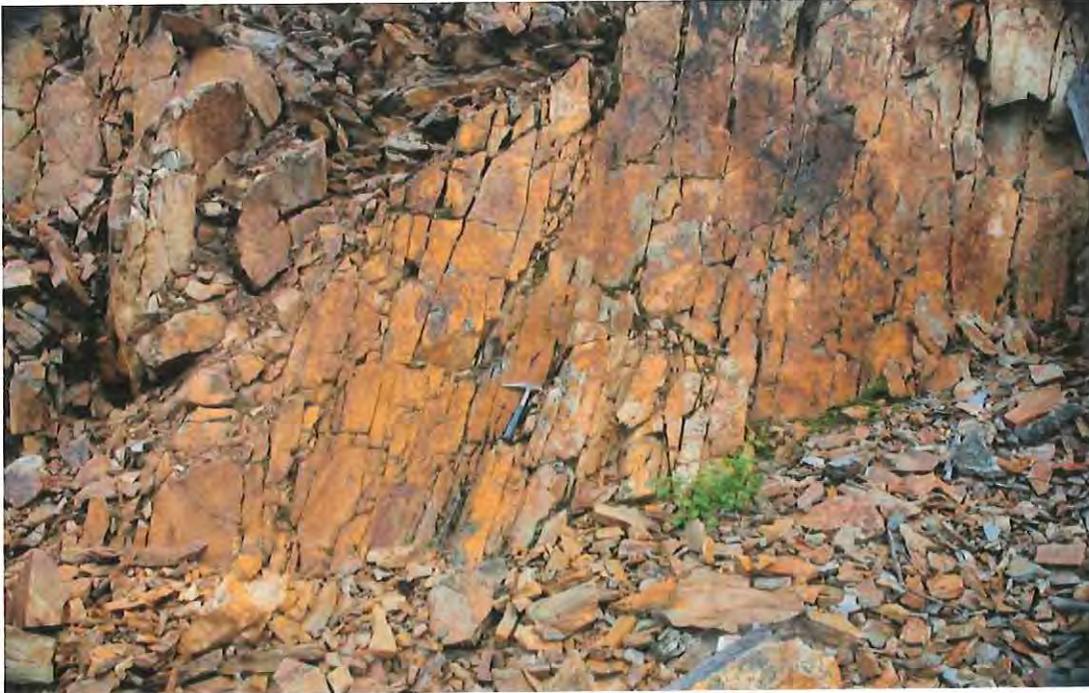
**Photograph 2:** Looking south from a point adjacent to the south abutment at relatively freshly exposed (i.e., orange color versus more weathered gray), highly fractured rhyolite similar to that found on the dam face (6/19/09).

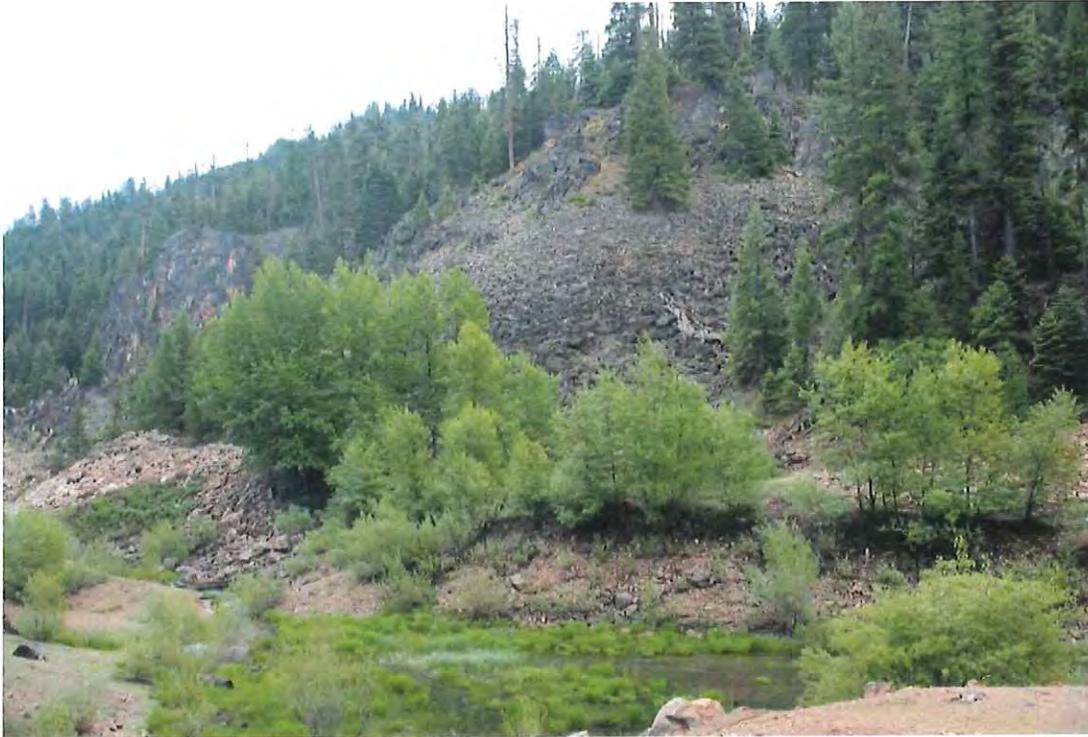
The area in the immediate vicinity of the Dam is also mapped as a landslide on the DOGAMI Statewide Landslide Inventory Data for Oregon website (DOGAMI, 2009b). A large landslide area is mapped on the south side encompassing the area both below and above the dam (Photographs 3 and 4). The landslide area is mapped as extending over 1,000 feet upstream (east) of the dam (Sheets C1 and C2). Based on a site reconnaissance, topographic maps, and previous studies, it appears that the meadow area above the dam was formed as a result of the blocking of Canyon Creek just upstream of the dam by a large landslide. The landslide is mapped as coming from the south, which consists of steep terrain in the Strawberry Volcanics. The cliff that borders the meadow to the south was also observed to have fresh rocks exposed at the base (Photograph 5), as evidenced by an orange color as opposed to the weathered gray seen elsewhere, indicating continued mass movement of the rock.

**Photograph 3:** Looking southeast from the top of the dam at loose rock in the apparent landslide area (6/19/09).

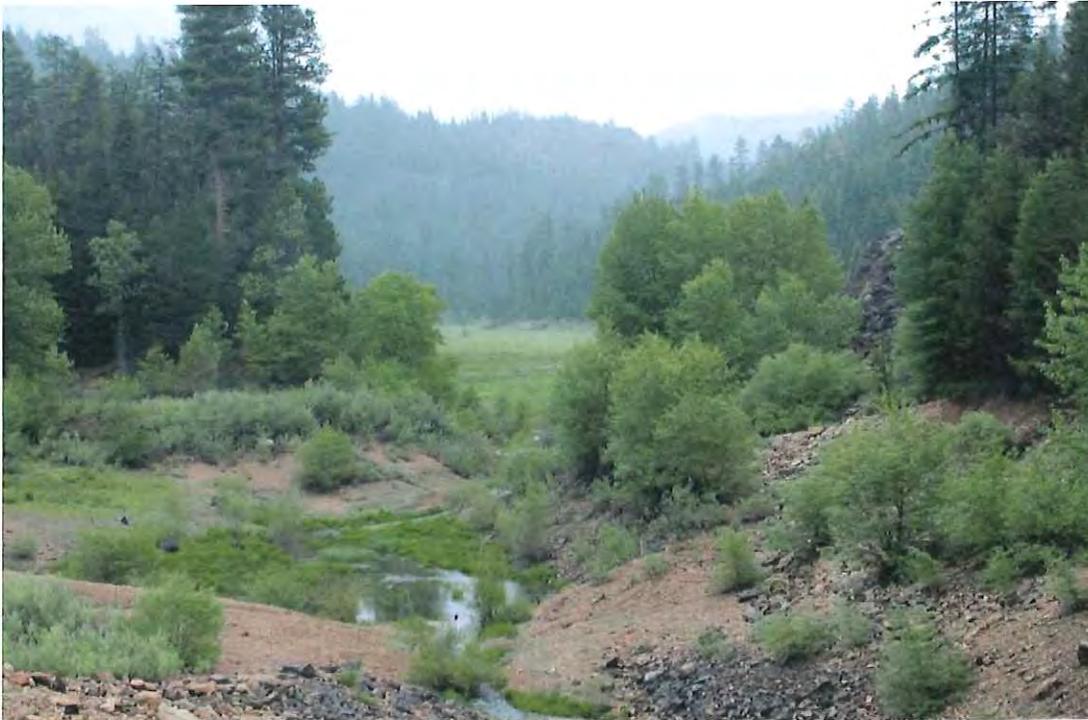
**Photograph 4:** Looking east from the top of the dam upstream; landslide area is to the right and landslide debris forms the base of the reservoir for an estimated 1000 feet upstream of the dam (6/19/09).

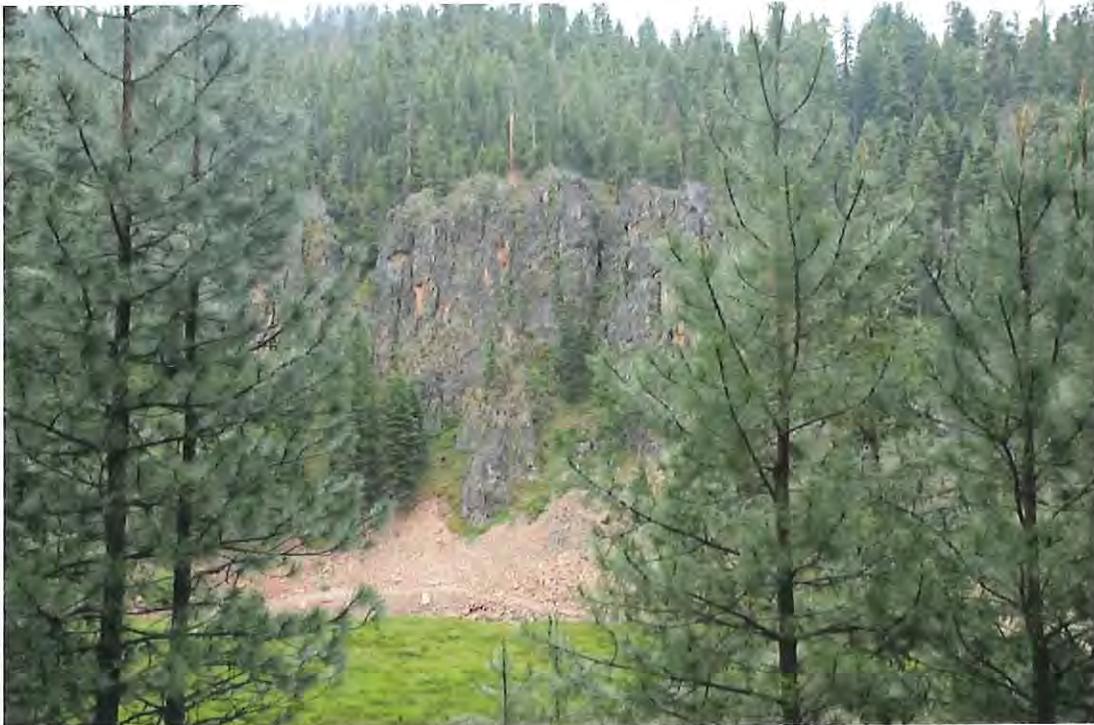
**Photograph 5:** Looking south from a campground at the cliff face east (upstream) of the dam. Note the freshly exposed rock at the base of the cliff from continued mass movement of the highly fractured rhyolitic rock (6/19/09).
