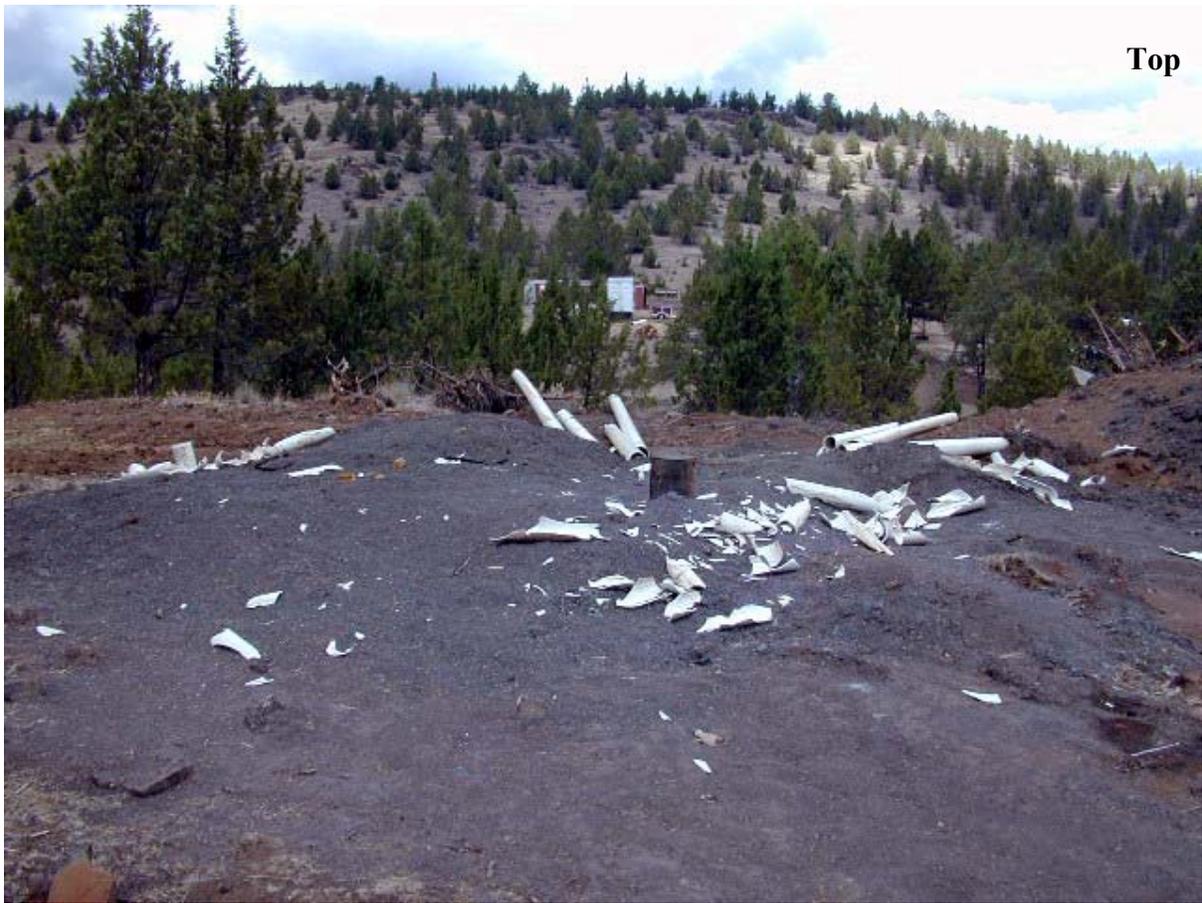
Top

Shattered PVC liner pipe scattered on the ground.

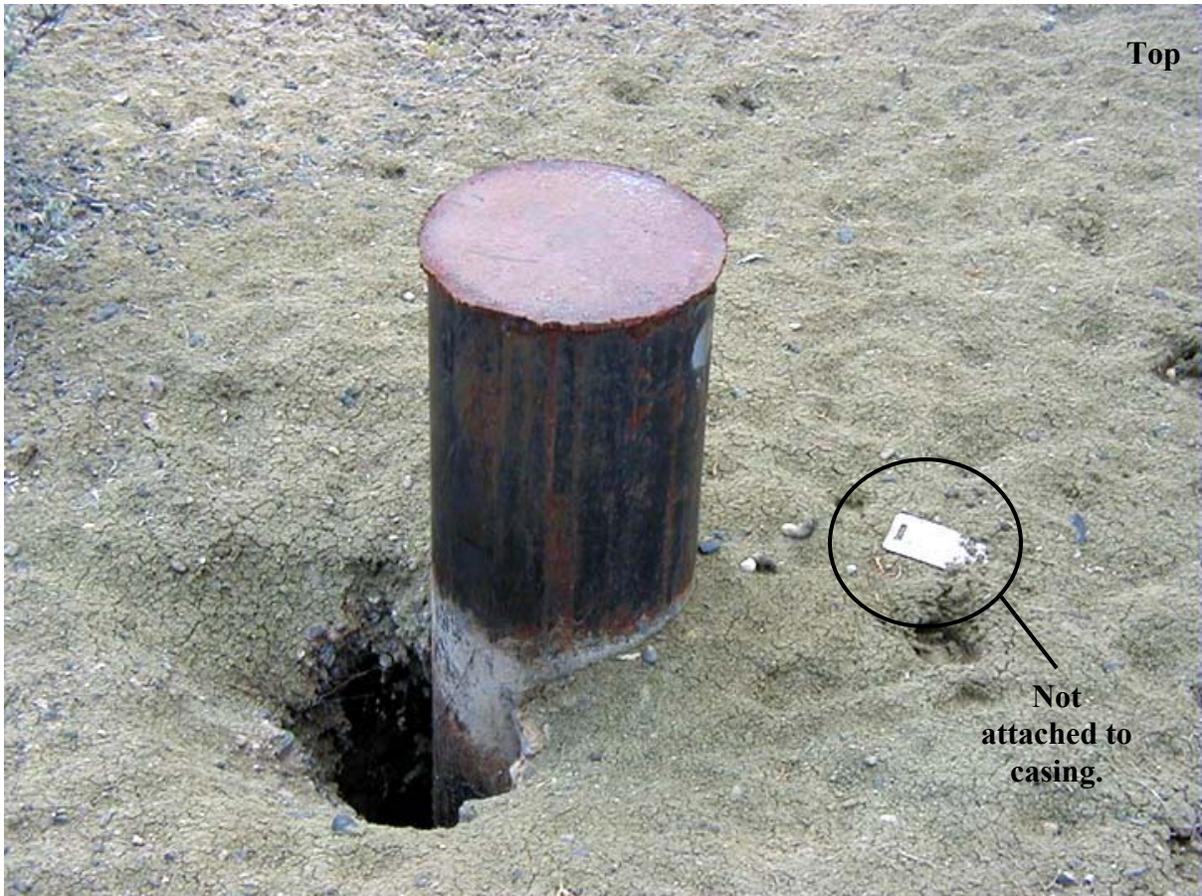
Top

Void in surface seal.

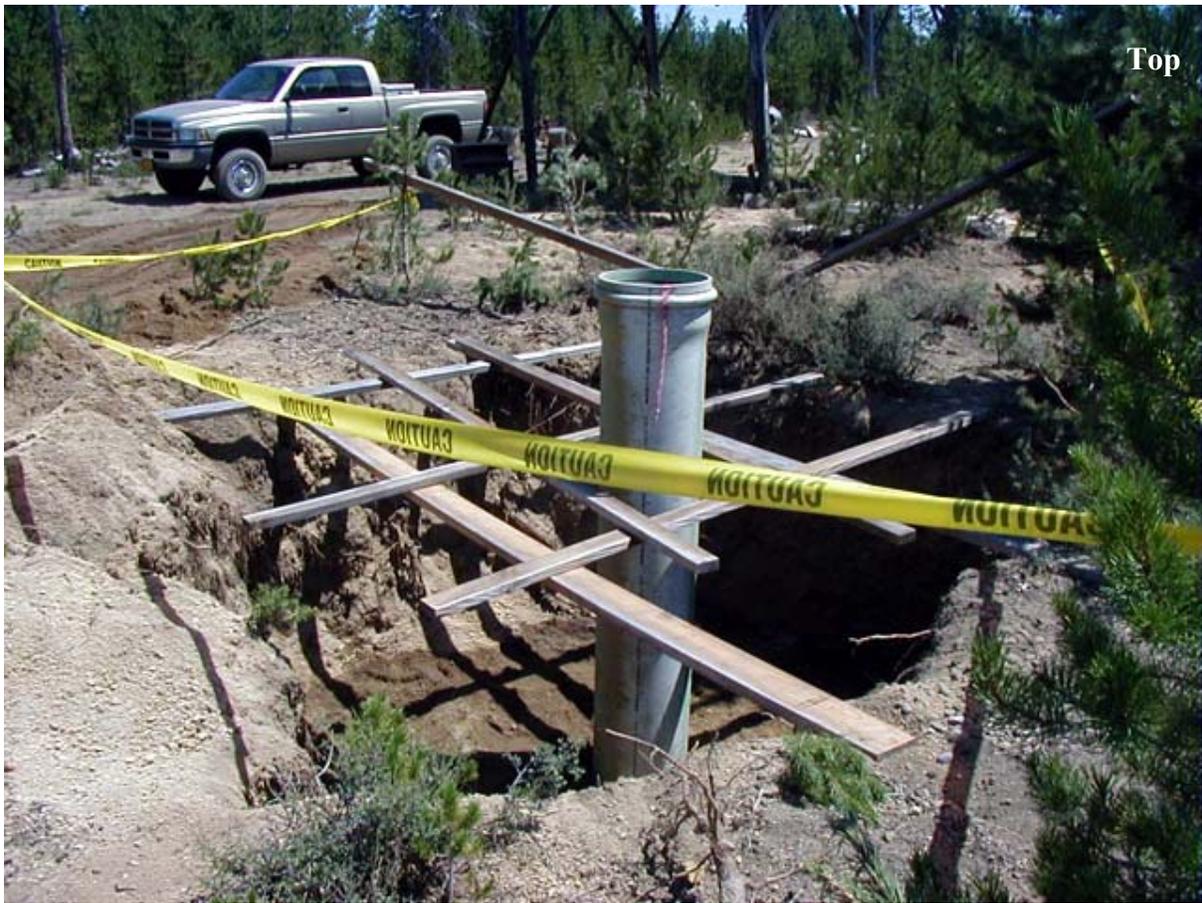
Top

Well dug with backhoe. When well was completed, driller back-filled pit without the benefit of a surface seal. Well casing did not meet standard.

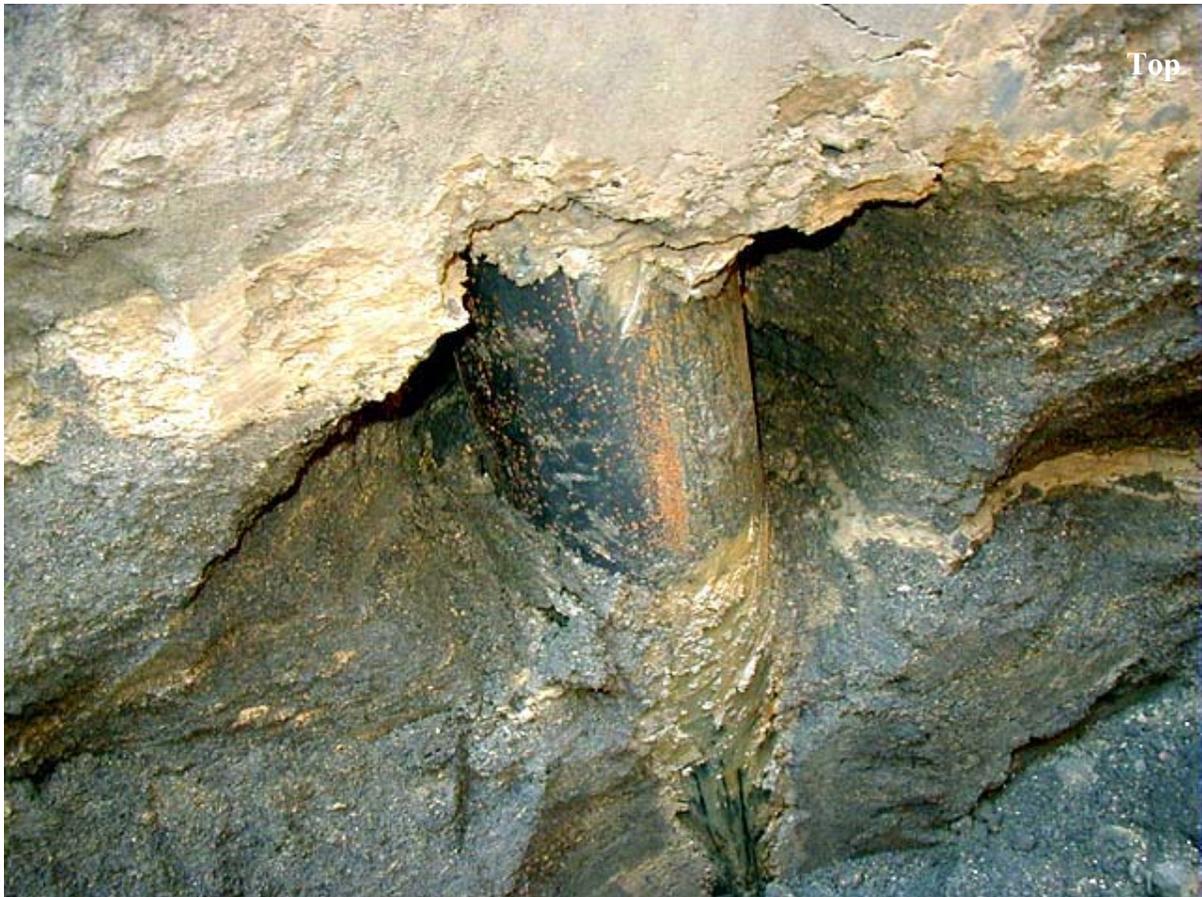
Top

Well was sealed from 0-10 feet with bentonite. No seal was found below 10 feet.

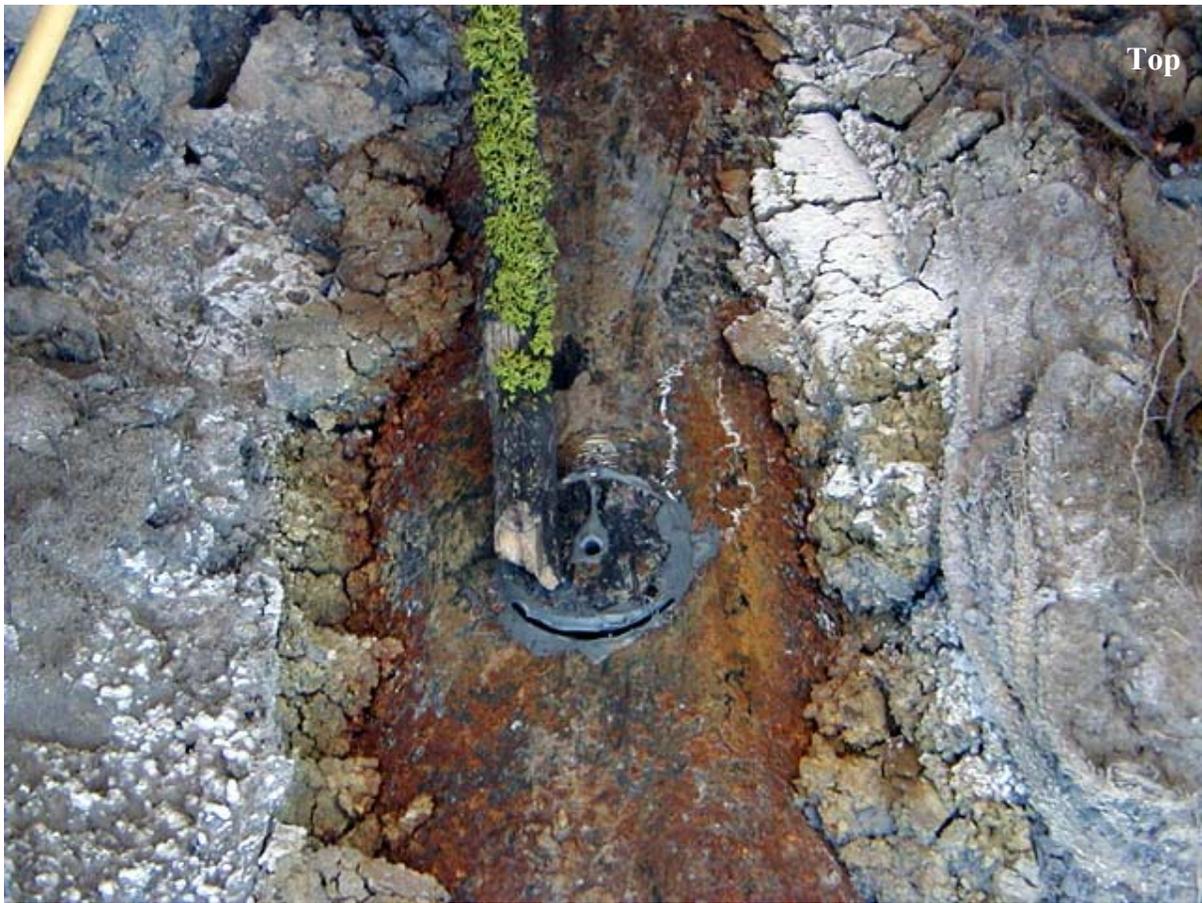
Hole was cut in casing to place pitless adaptor and then glued back together.

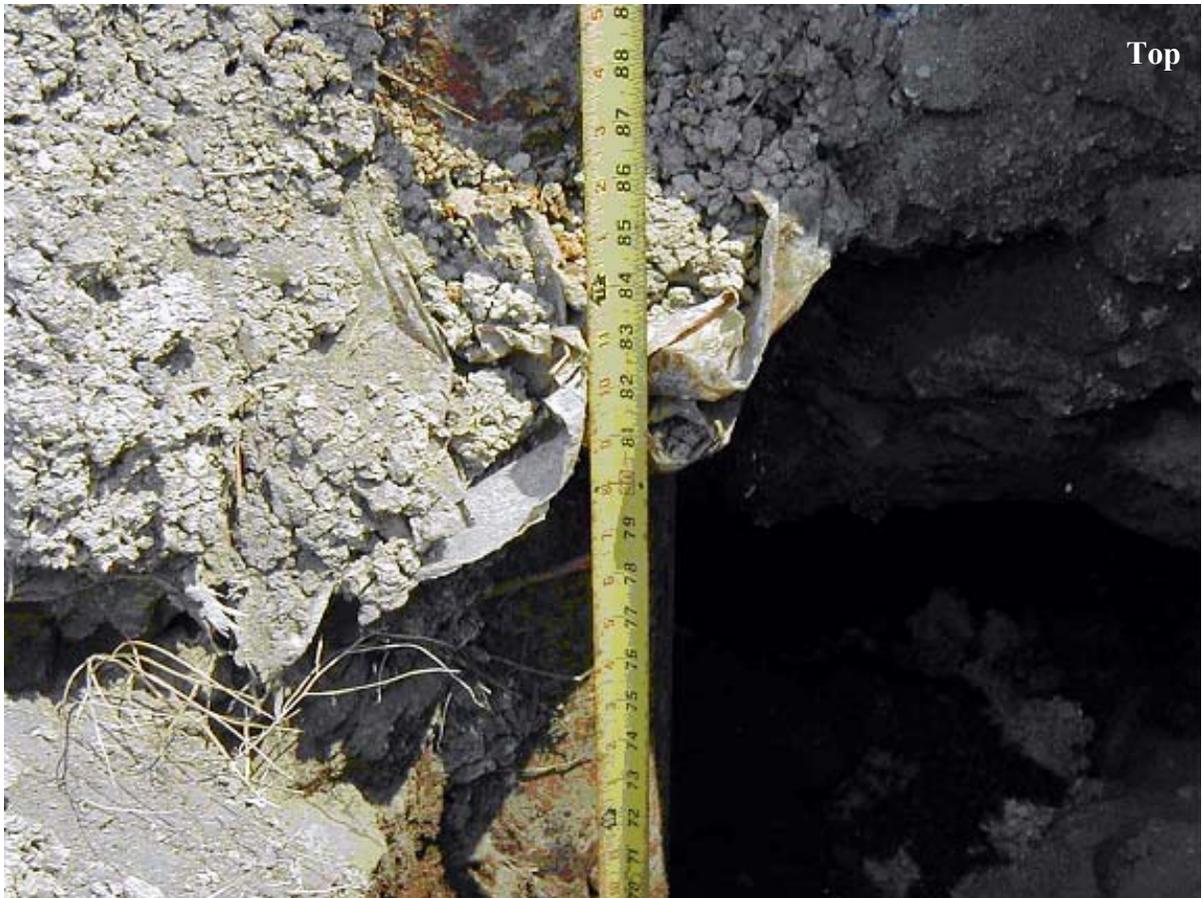
Picture taken to show depth below the plastic tarp that I was able to run my tape down along the casing in the annular space after probing along side of the casing.
