ODOT/ODFW Pilot Program

# Southwest Oregon Culverts

U.S. Highway 101 / Oregon Highway 38

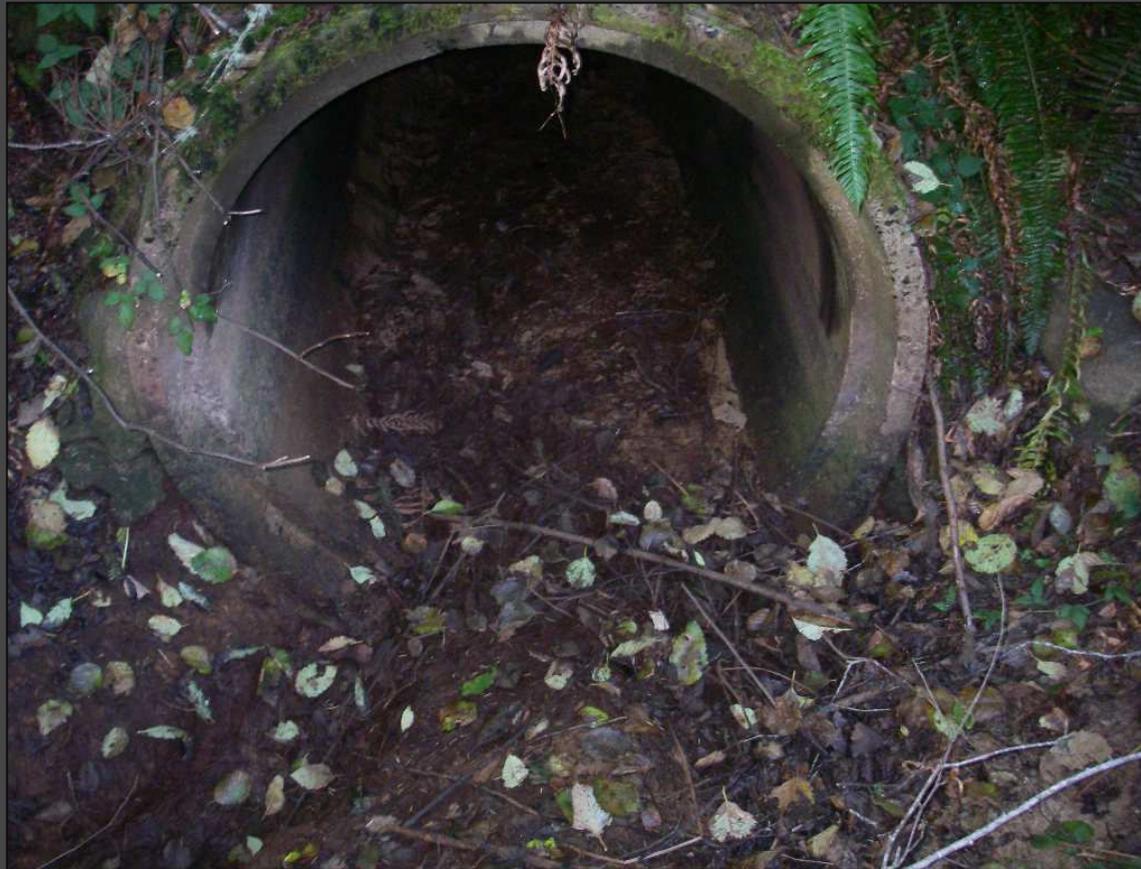
## Blocked with debris

Many small culverts along the highway fill up with leaves and other debris. These culverts are monitored and cleaned out as needed.

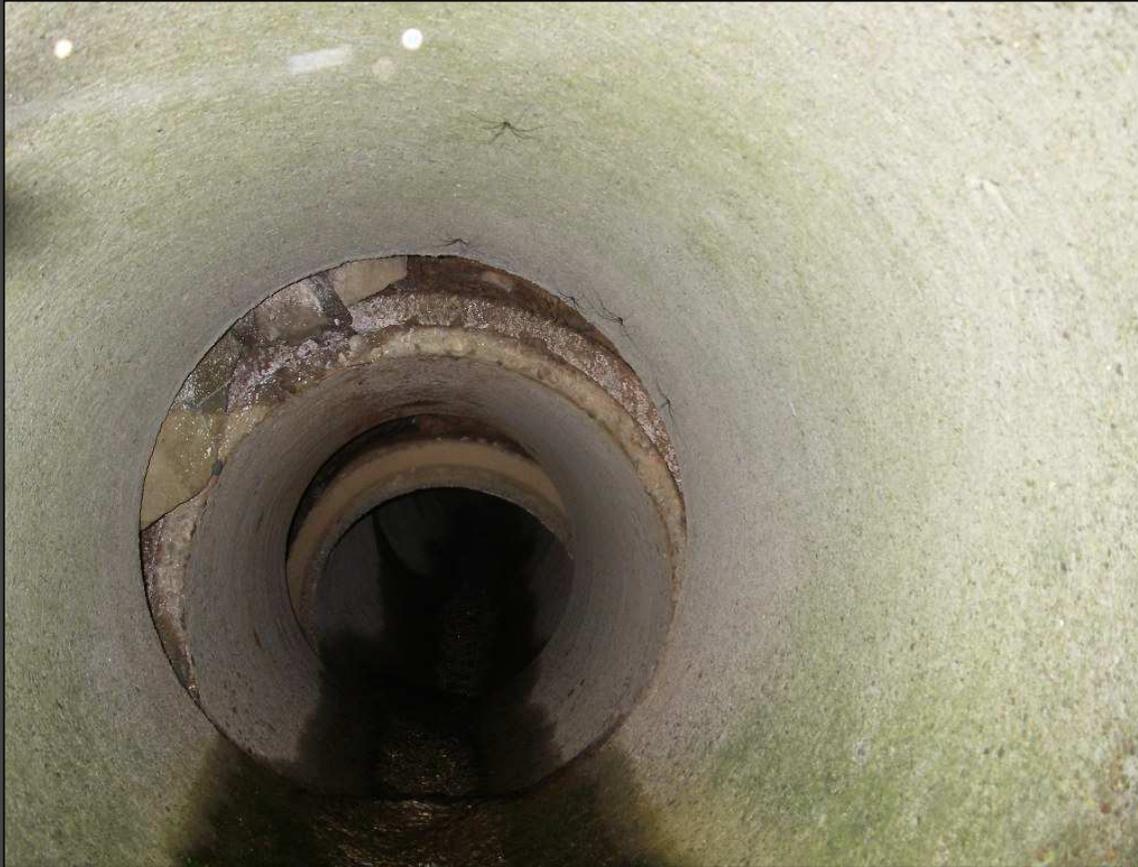
## Gaps in segments

Concrete culverts are often made up of several segments. Due to settling, these segments can move apart, creating gaps. Water leaking from the culvert can cause erosion in the surrounding areas.

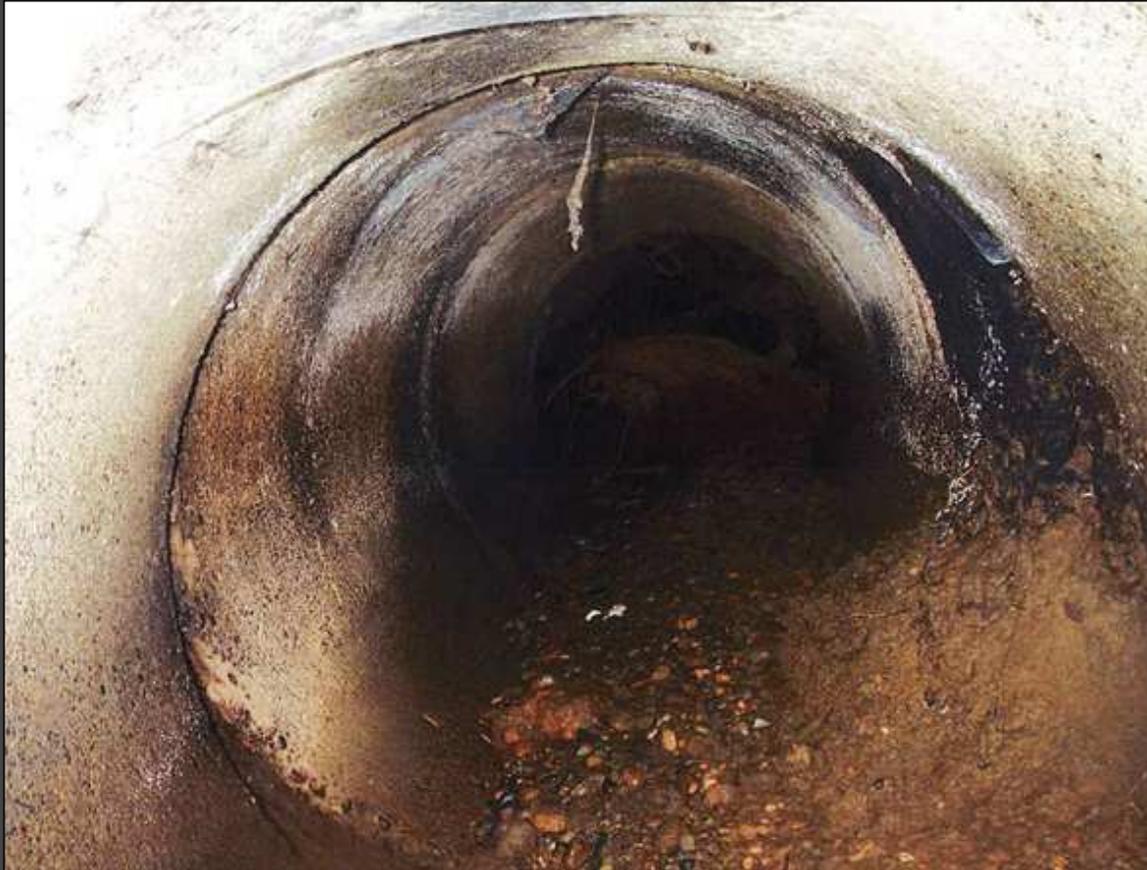
## Debris falls into culvert

Also, dirt and rocks can fall into the culvert from these segment gaps, blocking water from passing through.

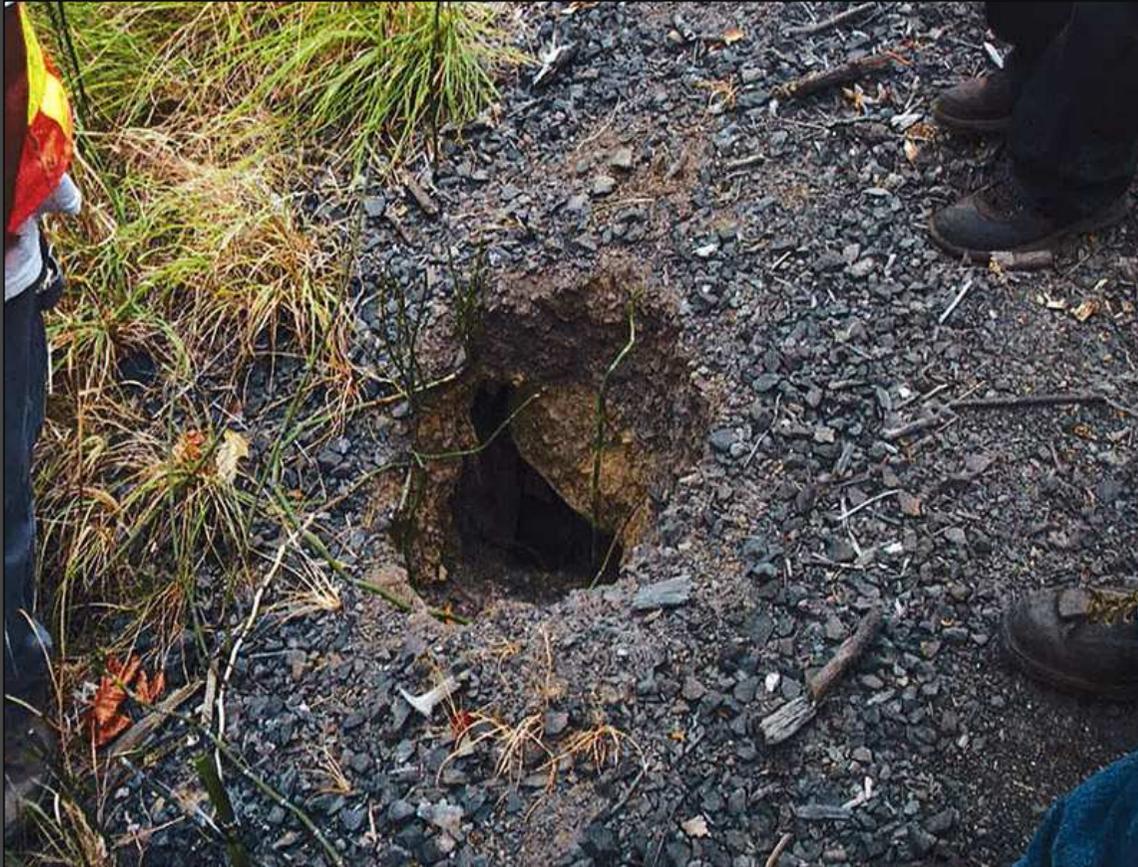
## Erosion above culverts

Small holes can be seen in the ground when sections of culverts open up and dirt filters through the gaps.

When this happens under the travel lanes, the road surface can be damaged.

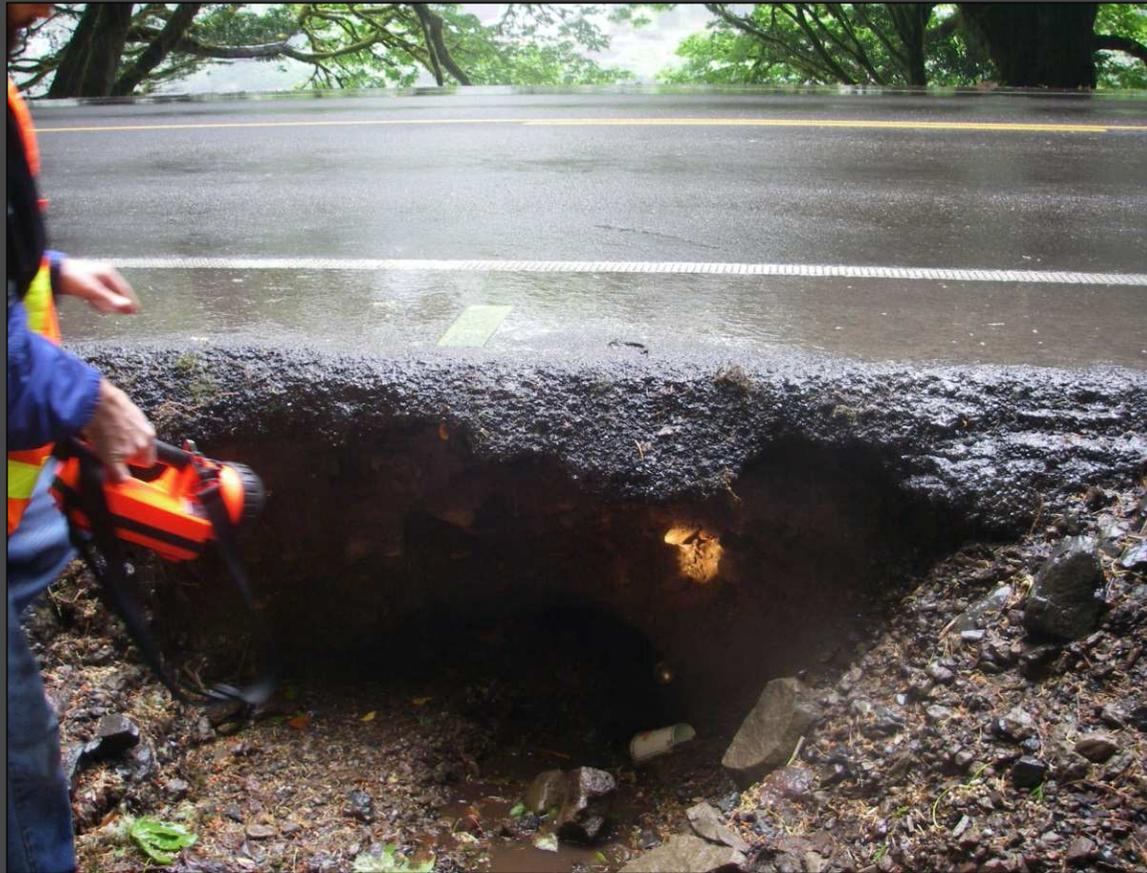
## Erosion under road

Sometimes this erosion is difficult to see from the travel lanes.

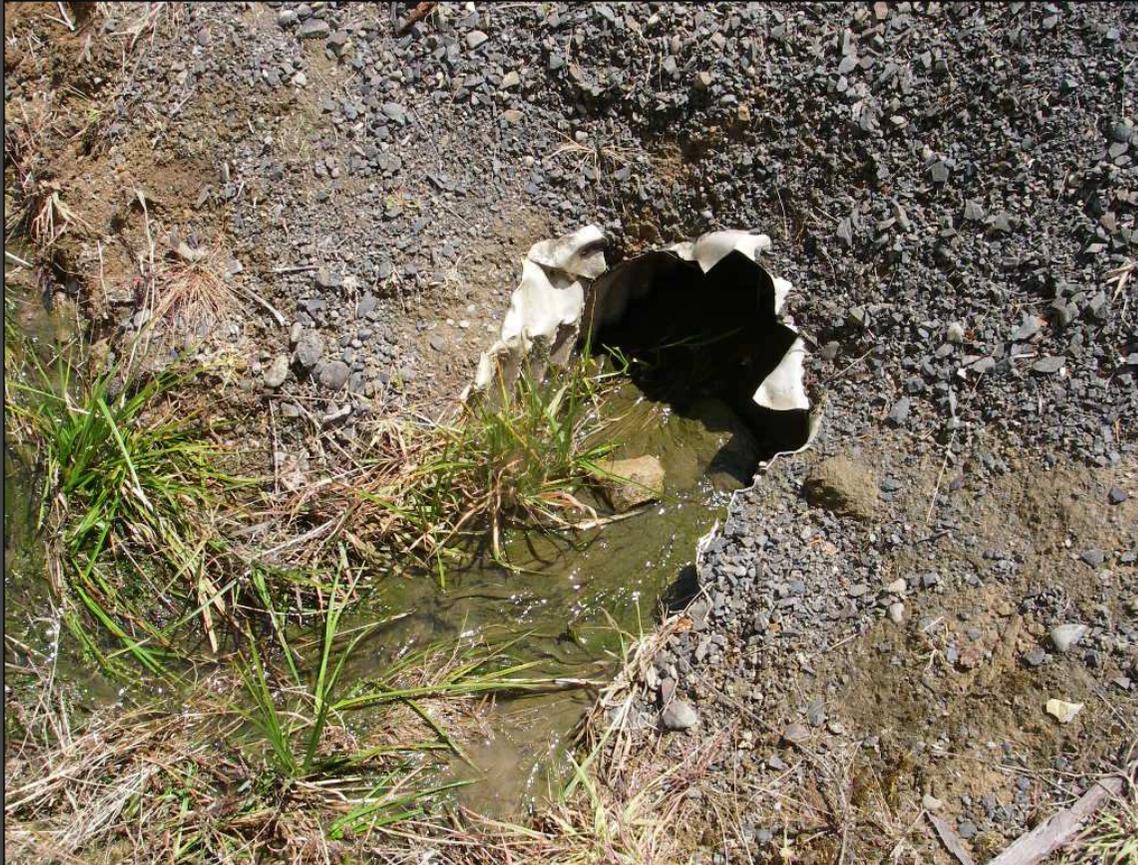
## Damaged pipe ends

The segments of steel culverts usually do not separate but they can have other problems. The damaged ends of small pipes can block the flow of water.

The culvert pilot program will repair the ends of several dozen small culverts.

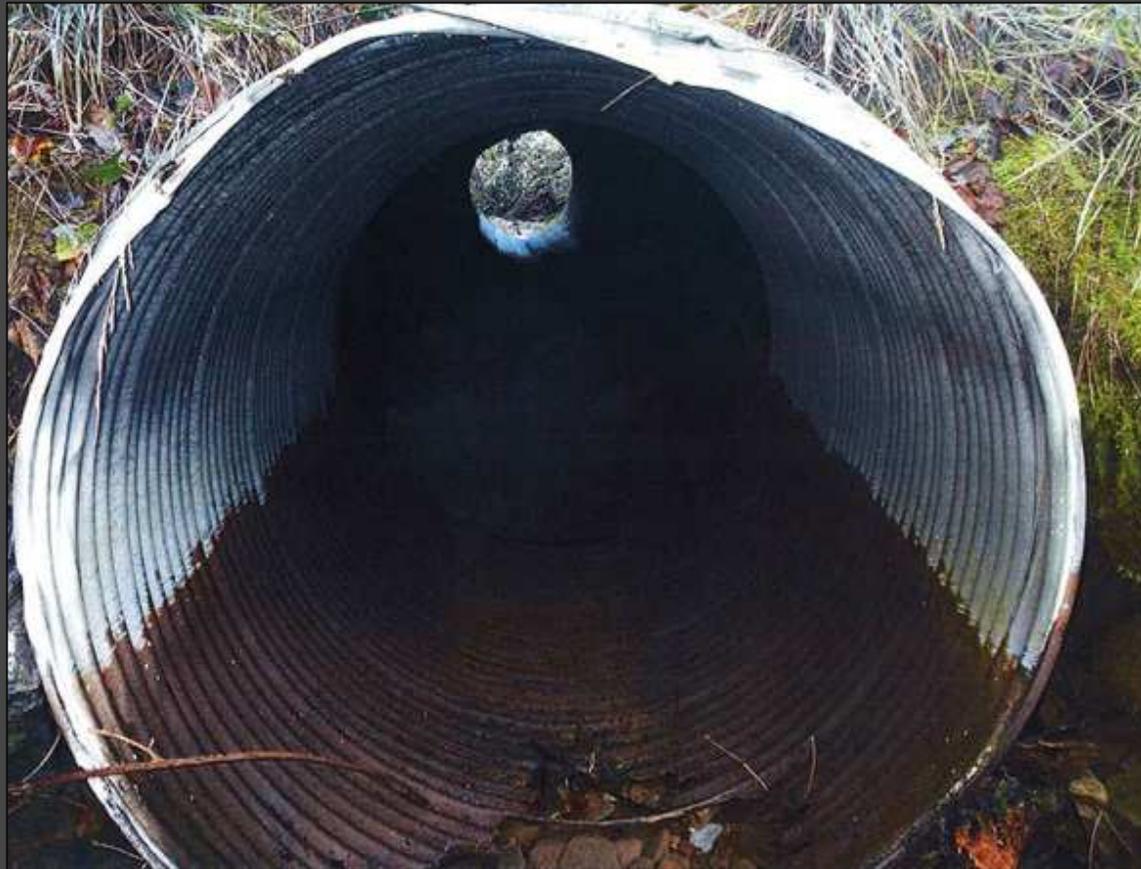
## Rusted bottoms

A more common problem with metal culverts is the bottoms can rust, which create other problems.

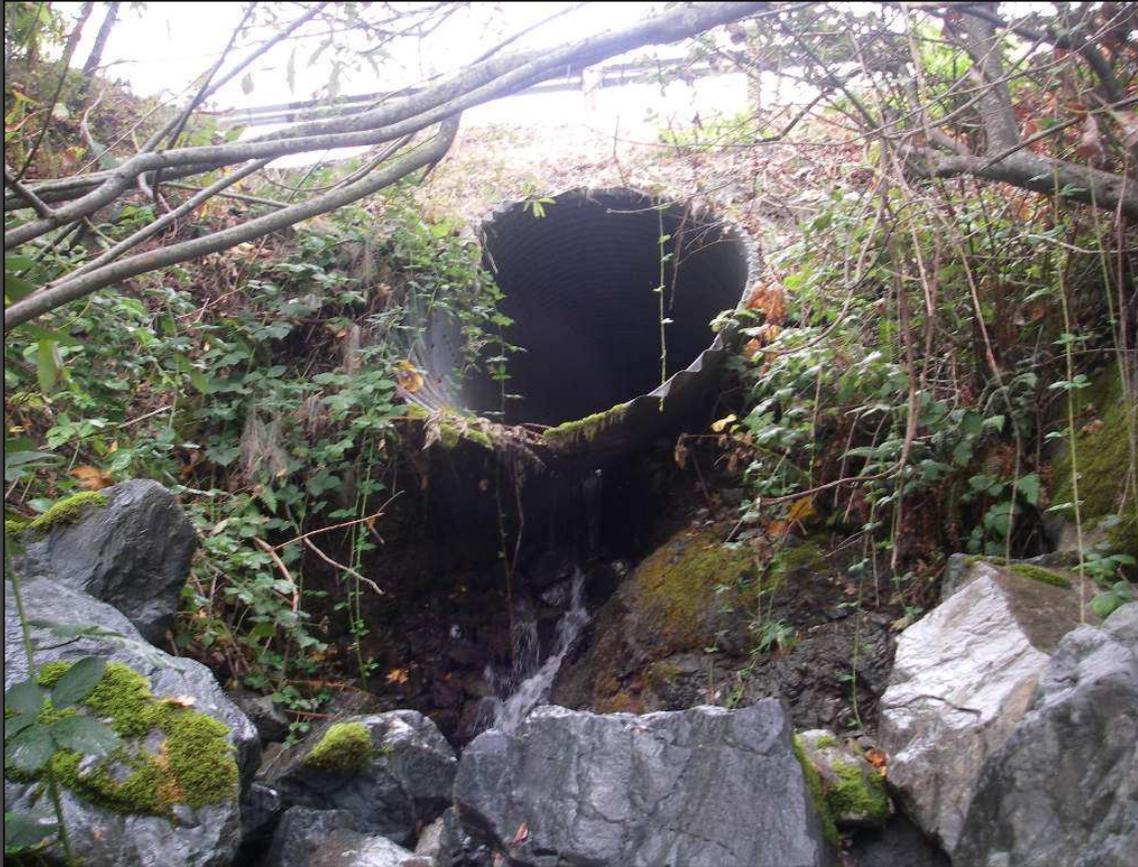
## Holes in the pipe

Water can be seen draining from a hole in a rusted out section of the culvert. This can cause erosion of the soils that support the highway at each end of the culvert.

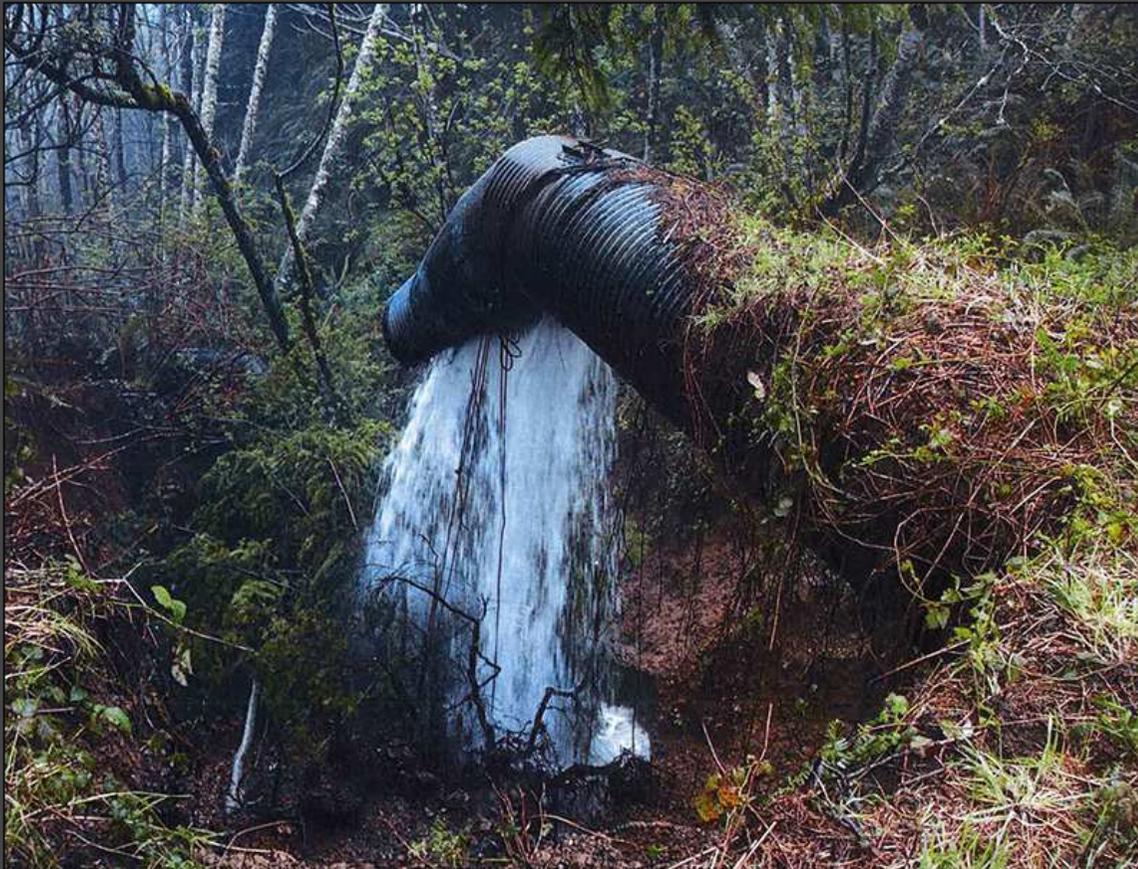
## Erosion from rusted pipes

When this culvert was installed years ago, much of the exposed pipe was underground. Rust created a hole along the bottom of the culvert, and water eventually washed away most of the surrounding dirt.

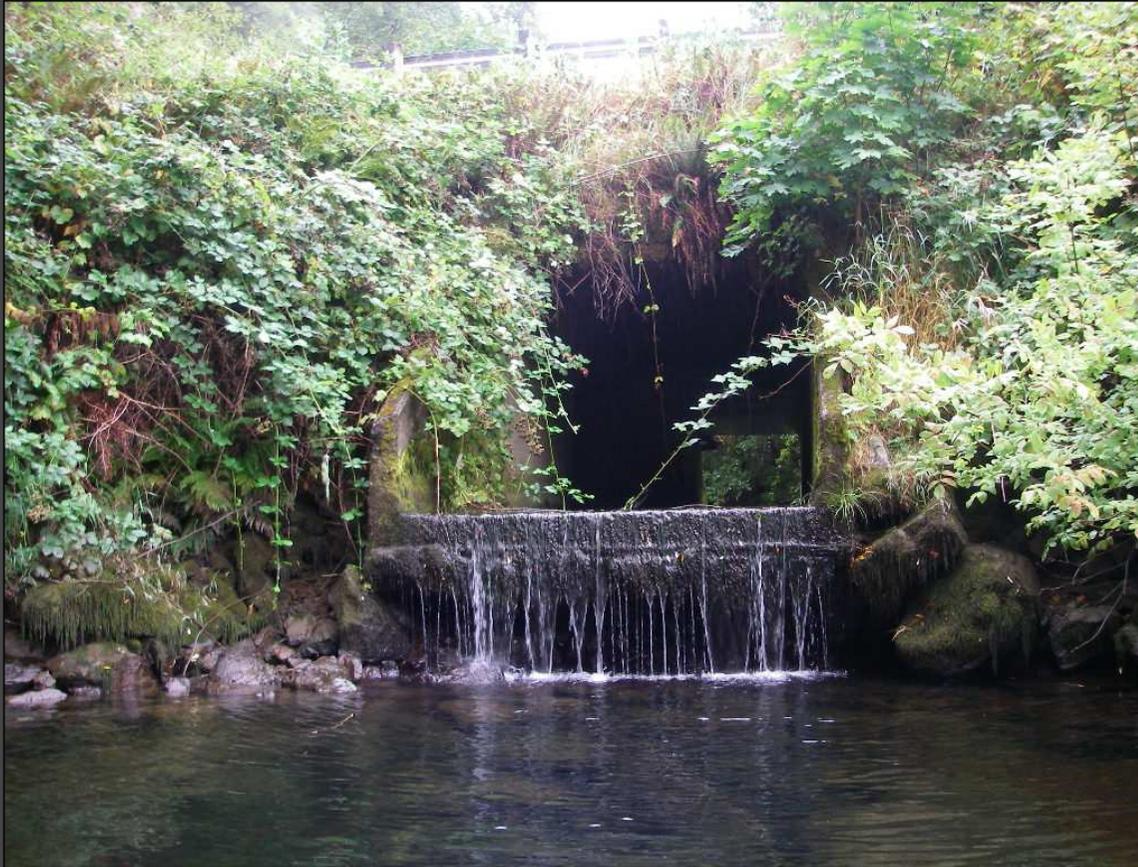
## Box culverts

Some large culverts are near the end of their design life, are damaged, and may also present a barrier to fish passage. These culverts will be replaced with larger culverts or with small bridges.

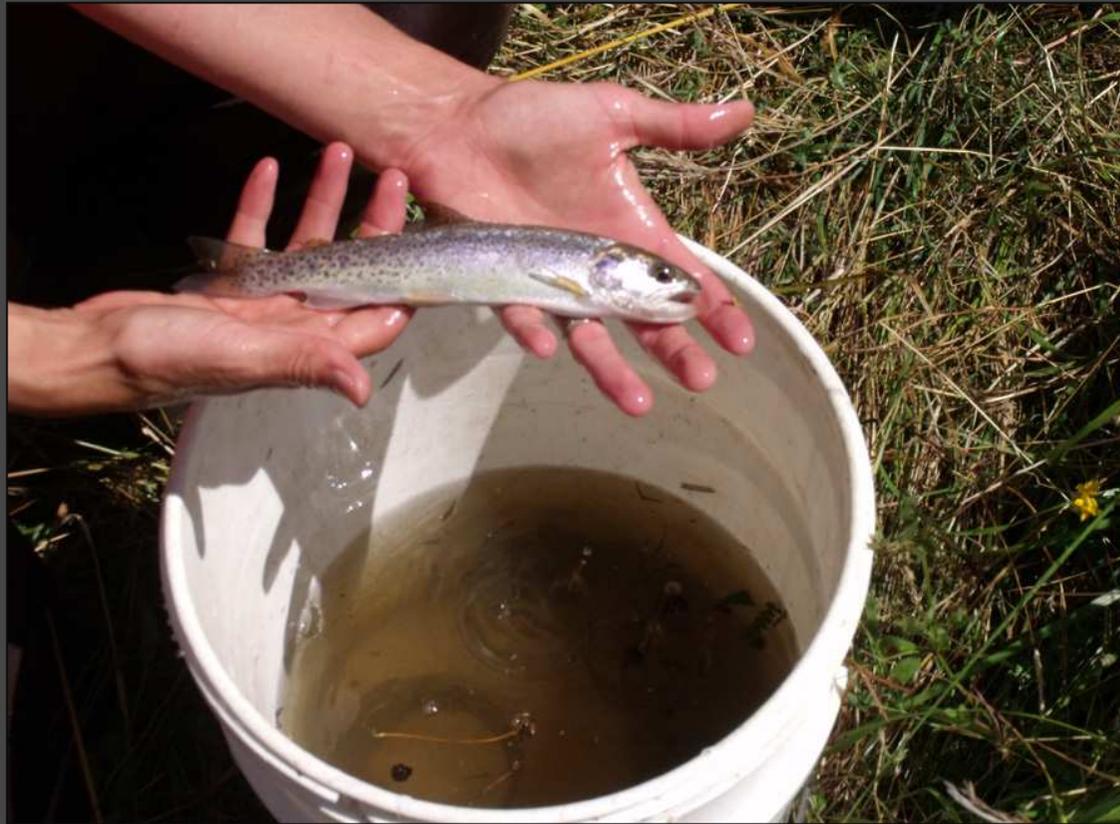
## Fish passage

Many culverts along Oregon 38 and U.S. 101 prevent fish, like this cutthroat trout, from passing upstream. As part of this project many of the culverts will be designed to improve fish passage.
