## **Historic Resources Baseline Report**

### **Sidewalk/Beautification Project**

**Rosicky Avenue, 6<sup>th</sup> Street, & Washington Avenue, Malin, Klamath County**

**Key # 17915**

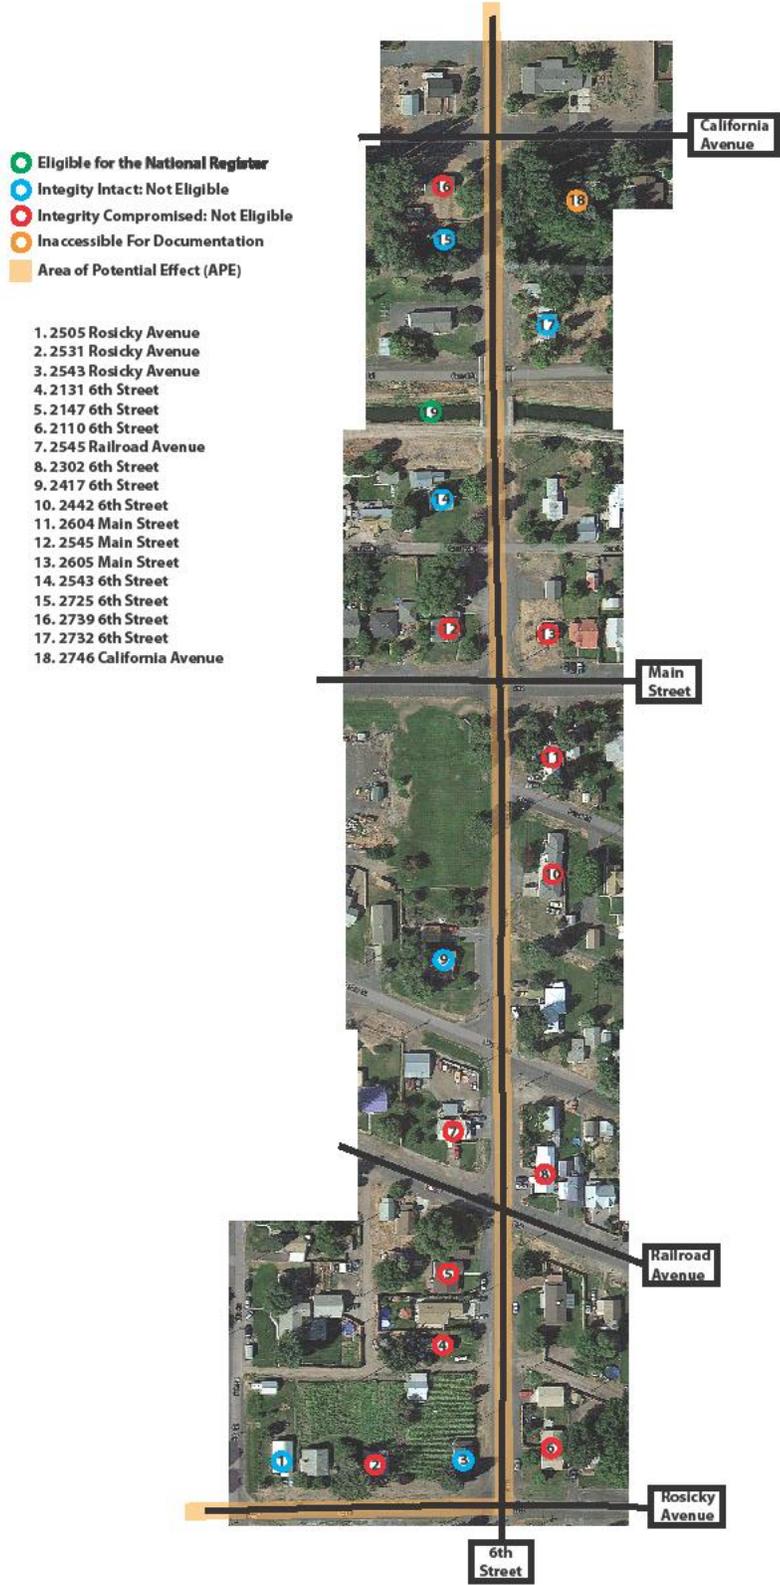
Table 1: Project Scope and Structures Identified  
 Table 2: Historic Resources Identified

For Section 106 purposes, the Area of Potential Effect (APE) is roughly defined as the Area of Potential Impact (API). This includes the existing ODOT right-of-way along Rosicky Street, 6<sup>th</sup> Street, and Washington Avenue between the project's scope. As part of ODOT's due diligence, the structures adjacent to the API were surveyed and documented for the purpose of this Historic Resources Baseline Report. See attached *Table 1: Project Scope and Structures Identified* for a map of the project API.

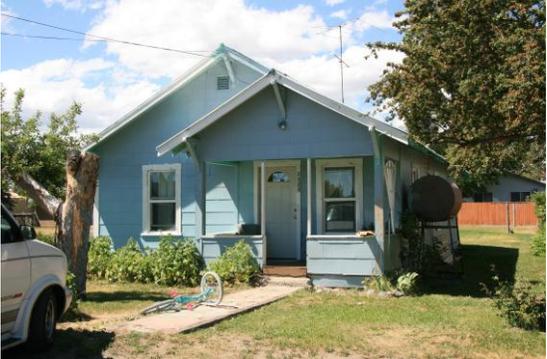
Map ID	Resource Location	Construction Date/Resource Type	National Register Status	Photograph
1	2505 Rosicky Ave.	1930 / 1-Story, Front Gable, Metal Corrugated Roof, Shingle Siding, 1/1 Vinyl Windows – Residential	Integrity Intact / Not Eligible Individually

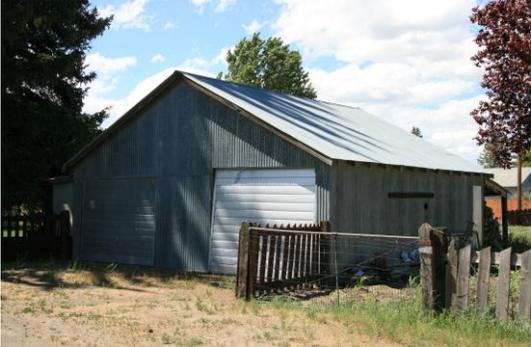
2	2531 Rosicky Ave.	1931 / 1-Story, Front Gable, Metal Corrugated Roof and Siding, 2 Car Bays	Not Eligible in Current State / Integrity Loss

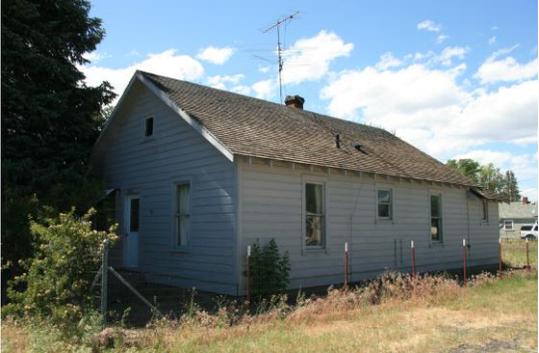
3	2543 Rosicky Ave.	1935 / 1 ½ Story, Front Gable, Wood Shingle Roof, Horizontal Drop Lap Wood Siding, 1/1 Double Hung Wood Windows, Rear Hipped Roof Addition – Residential	Integrity Intact / Not Eligible Individually

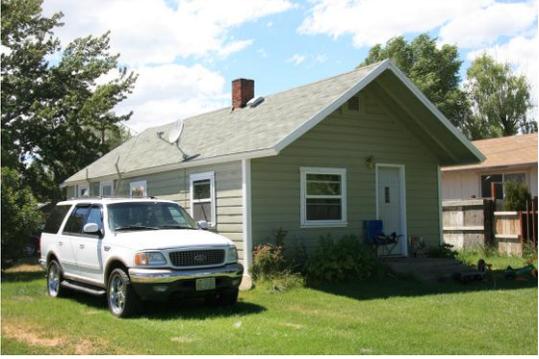
4	2131 6 <sup>th</sup> Street	1930 / 1-Story, Front Gable, Composition Roof, Horizontal Drop Lap Wood Siding, 1/1 Vinyl Windows – Residential	Not Eligible in Current State / Integrity Loss

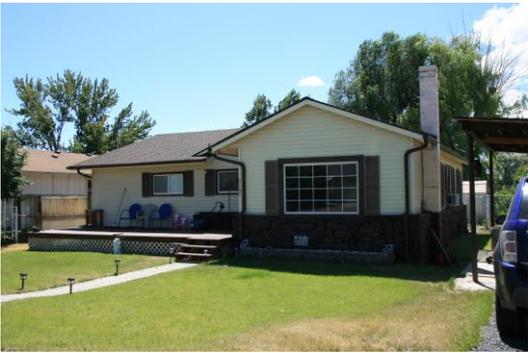
5	2147 6 <sup>th</sup> Street	1931 / 1-Story, Cross Gable, Composition Shingle Roof, Horizontal Lap Siding with Lower Half Stone Veneer, Horizontal Sliding Vinyl Windows – Residential	Not Eligible in Current State / Integrity Loss

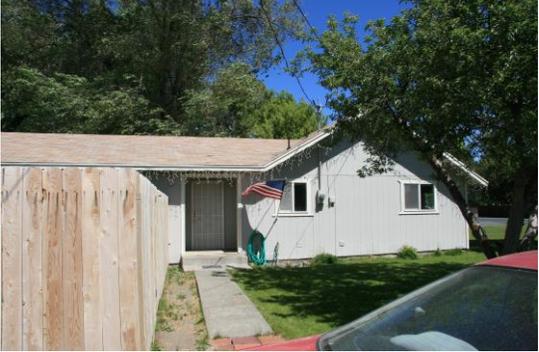
6	2110 6 <sup>th</sup> Street	1930 / 1-Story, Cross Gable, Composition Roof, Vertical Faux-Wood Board Siding, Horizontal Sliding Vinyl Windows – Residential	Not Eligible in Current State / Integrity Loss

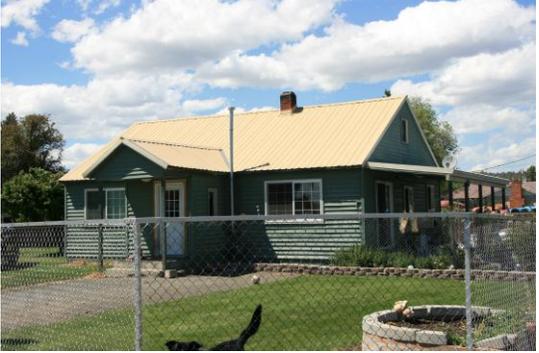
7	2545 Railroad Ave	1940 / 1 ½ Story, Side Gable, Corrugated Metal Roof, Horizontal Aluminum Lap Siding, Horizontal Sliding Windows – Residential	Not Eligible in Current State / Integrity Loss

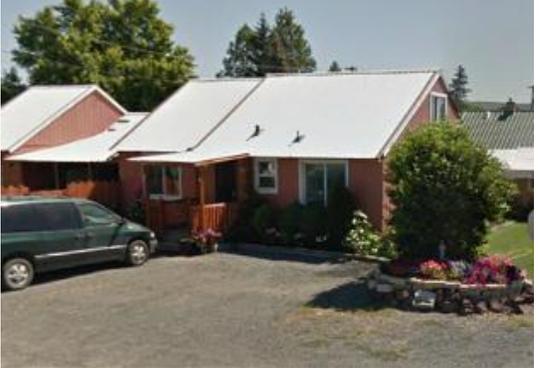
8	2302 6 <sup>th</sup> Street	1940 / 1 ½ Story, Side Gable, Corrugated Metal Roof, Veneer Vertical Wood Siding, 1/1 Vinyl Windows and Horizontal	Not Eligible in Current State / Integrity Loss

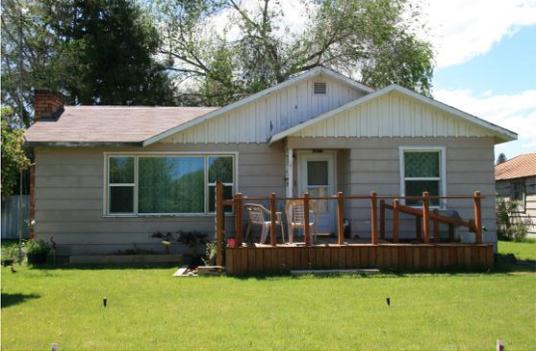
Sliding Vinyl Windows - Residential		
9	2417 6 <sup>th</sup> Street	1940 / 1-Story, Cross Gable, Composition Roof, Horizontal Faux-Wood Siding, Chicago Style Window and 1/1 Vinyl Windows, Ornamental Gable Detailing – Residential	Integrity Intact / Not Eligible Individually

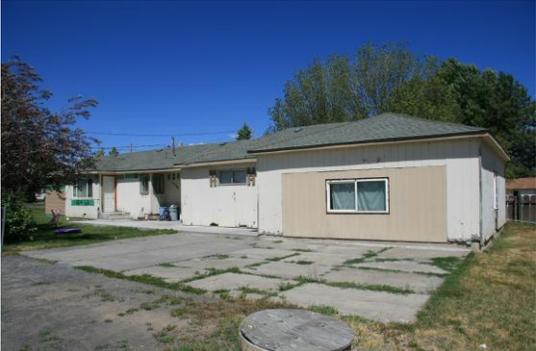
10	2442 6 <sup>th</sup> Street	1948 / 1-Story, Hipped Roof Ranch, Composition Roof, Asbestos Vertical Board Siding, Horizontal Sliding Vinyl Windows - Residential	Not Eligible in Current State / Integrity Loss

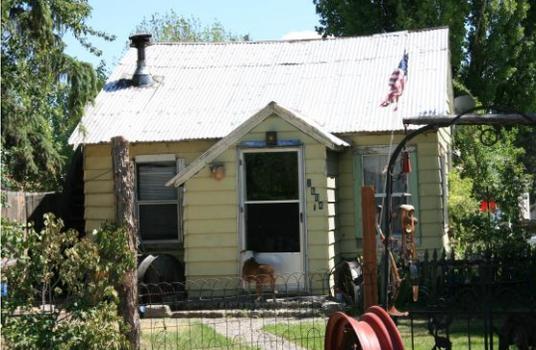
11	2604 Main Street	1934 / 1 1/2 Story, Side Gable, Corrugated Metal Roof, Metal Horizontal Siding, 1/1 Metal Windows – Residential	Not Eligible in Current State / Integrity Loss

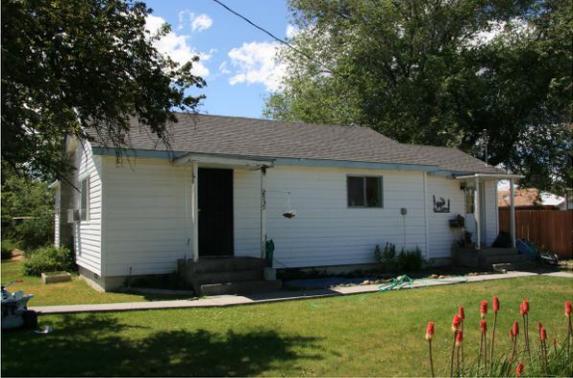
12	2545 Main Street	1945 / 1-Story, Side Gable, Composition Roof, Horizontal Aluminum Siding, Horizontal Sliding Windows – Residential	Not Eligible in Current State / Integrity Loss

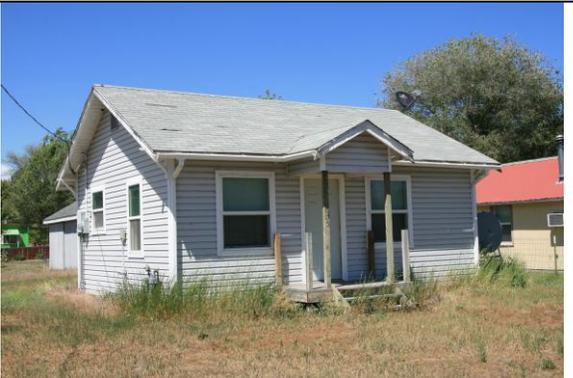
13	2605 Main Street	1930 / 1-Story, Side Gable, Composition Roof, Horizontal Aluminum Drop Lap Siding, 1/1 Vinyl Windows – Residential	Not Eligible in Current State / Integrity Loss

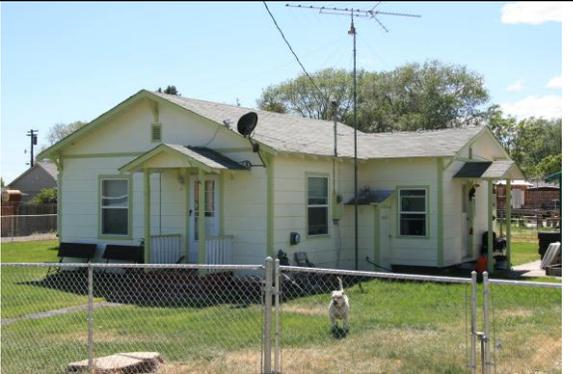
14	2543 6 <sup>th</sup> Street	1929 / 1-Story, Cross Gable, Composition Roof, Asbestos Horizontal Siding, 1/1 Vinyl Windows – Residential	Integrity Intact / Not Eligible Individually

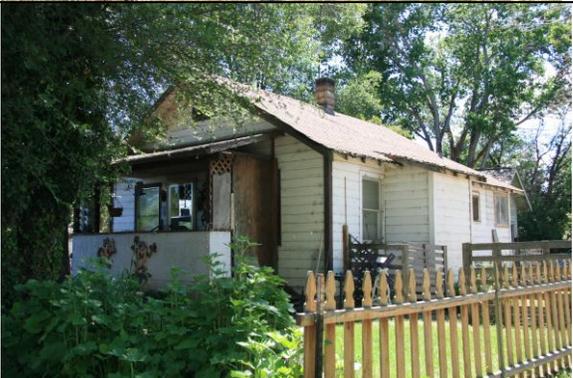
15	2725 6 <sup>th</sup> Street	1930 / 1 ½ Story, Front Gable, Composition Roof, Horizontal Wood Siding, 1/1 Wood Windows behind Metal Storm Windows – Residential	Integrity Intact / Not Eligible Individually

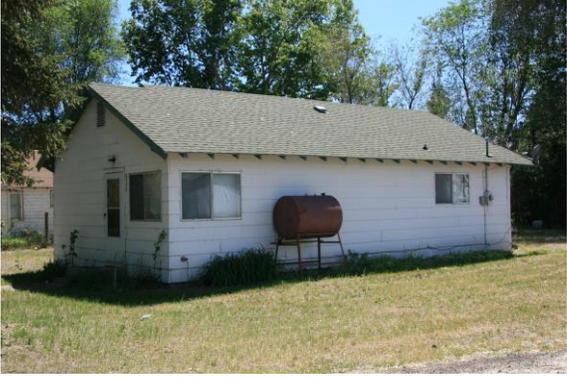
16	2739 6 <sup>th</sup> Street	1940 / 1-Story, Front Gable, Composition Shingle Roof, Horizontal Aluminum Siding, Horizontal Sliding Metal Windows – Residential	Not Eligible in Current State / Integrity Loss

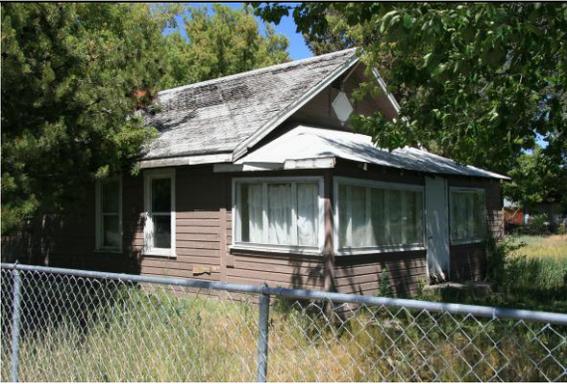
17	2732 6 <sup>th</sup> Street	1929 / 1 ½ Story, Front Gable, Asphalt Roof, Tongue and Groove Horizontal Wood Lap Siding, 1/1 Wood Windows, Hipped Roof Rear Addition – Residential	Integrity Intact / Not Eligible Individually

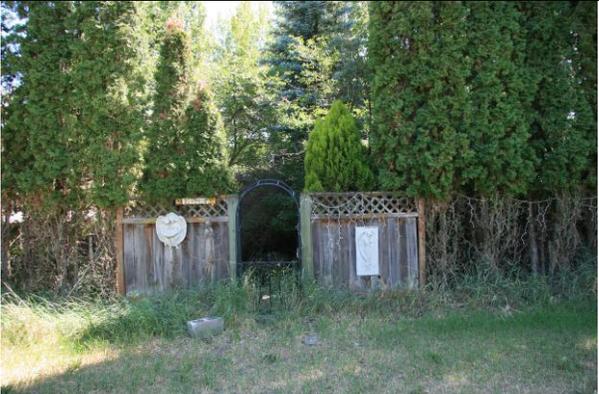
18	2746 California Ave	1930 / N/A Due to Vegetation Overgrowth	N/A

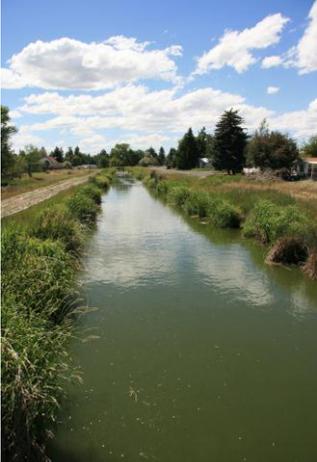
The only resources surveyed that is currently eligible for the NRHP is the irrigation canal. Newly dug in 1922-1923, the canal serves an important catalyst for the population growth and housing boom in Malin.

19	6 <sup>th</sup> Street and Canal Street	1922-1923	Potentially Eligible
