TRAILHEADS

Chapter 3

Hood River-to-Mosier – Phase 3C

Hood River-to-Mosier – Visitor Contact Station

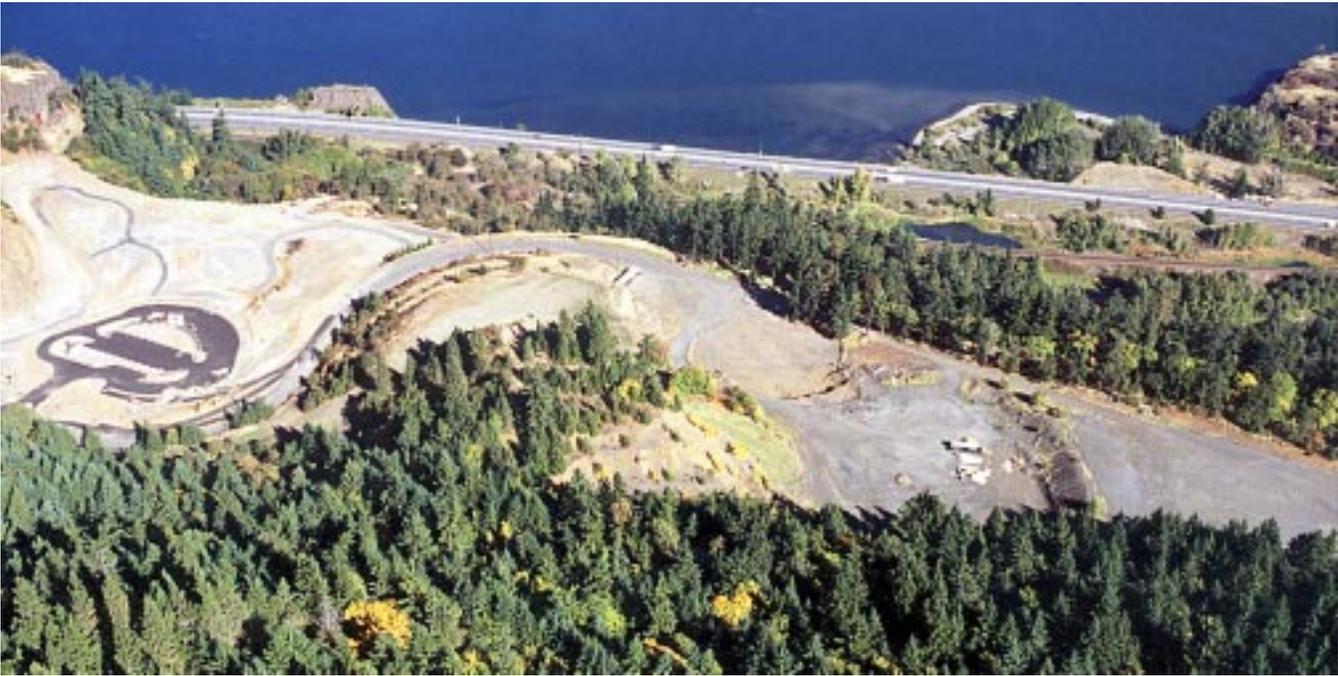
Aerial photo of the Koberg Quarry (on left) after the construction of the parking area and the Hanel Quarry (on right) before construction.

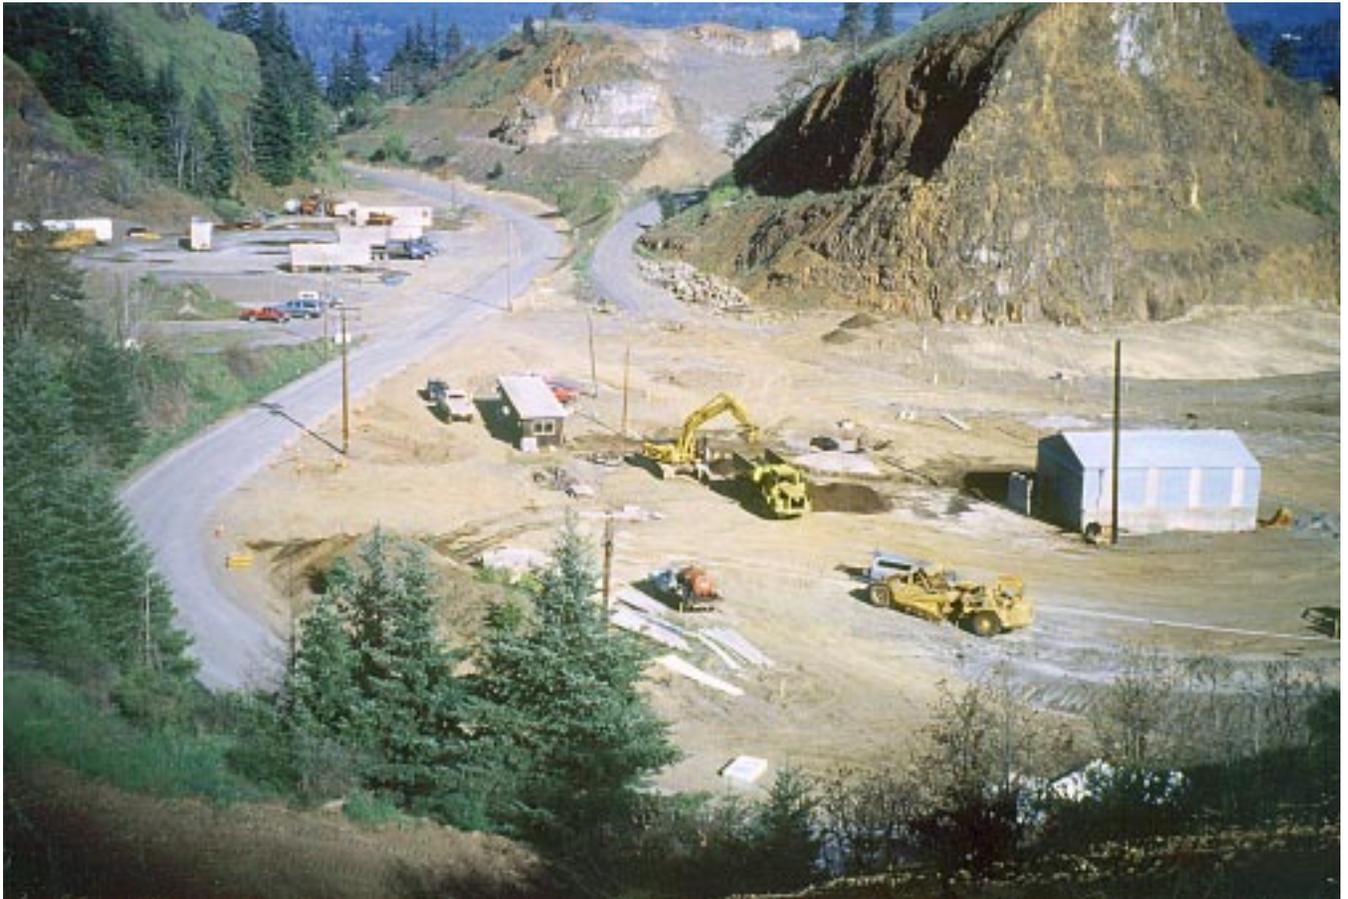
In April of 1998, JAL Construction started work in the Koberg Quarry to build the West Trailhead.

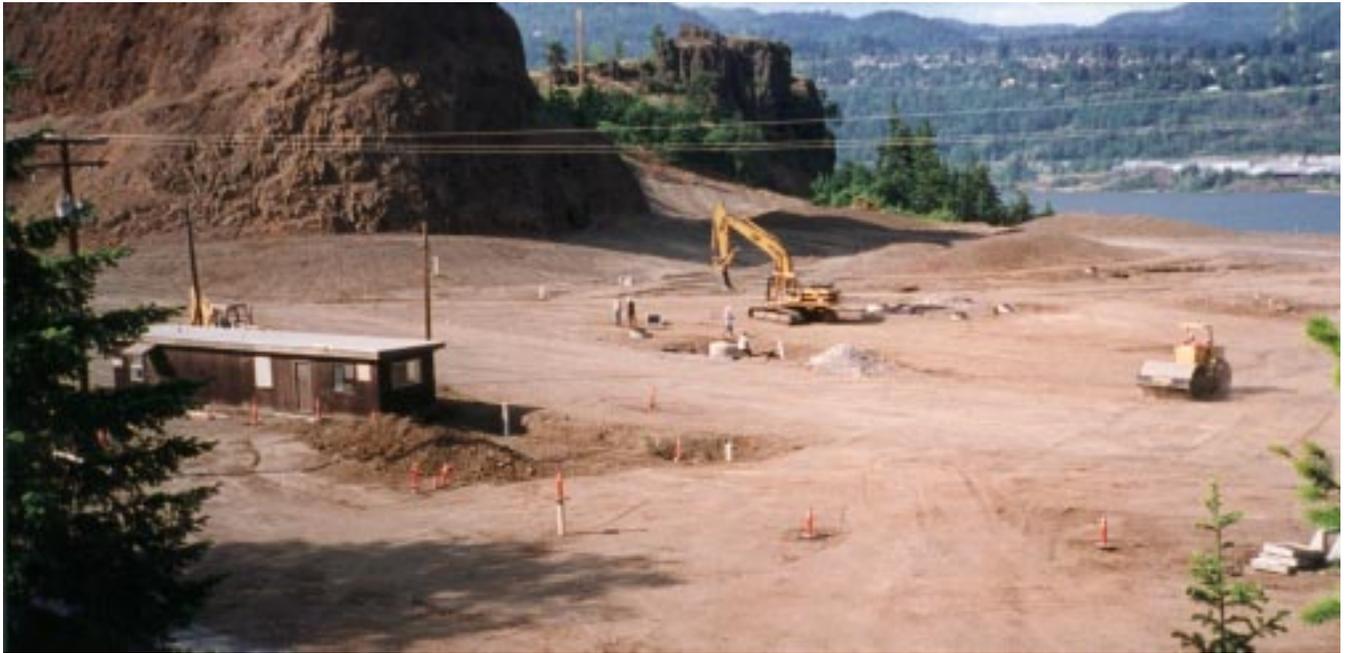
By mid-May of 1998, JAL had most of the utilities installed and had constructed the talus slopes and contoured mounds.

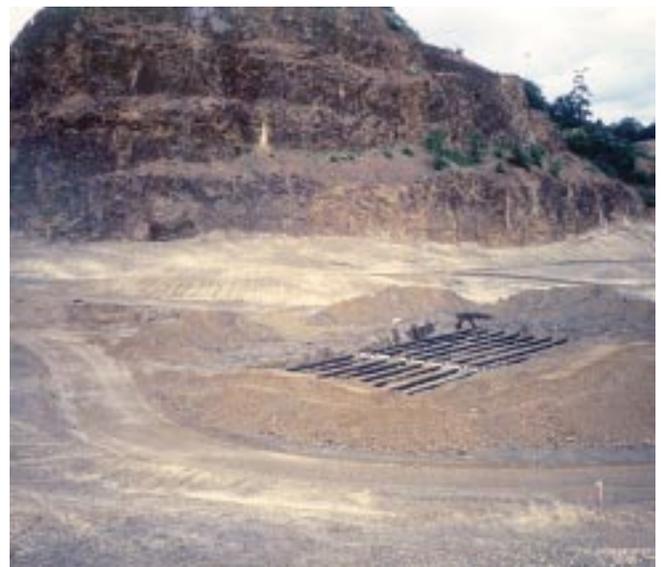
Drain field for sewer system ready for inspection without a permit.

The second major problem happened during the construction of the sewer system. According to the specifications, the contractor was supposed to contact the County Sanitary Sewer Inspector when the system had been

installed, but before it was backfilled, for an inspection. When contacted, the County official said that there had not been a permit issued on that project and that the designer had never sent him a set of plans to review after an on-site meeting. As it turned out, KPFF had met with the County official, but did not follow through with the permit process. So, with the system partially installed, the process was started to apply for a permit. After

lengthy delays and meetings, a design and system was approved, but required many additions to what had already been built. In an effort of cooperation, DEQ and the County Sanitarian approved what work had been installed, but the system had to be completed as part of the next contract. The “lesson learned” here was that, even when it is a consultant designer’s responsibility to perform some work, they need to be aggressively monitored to verify the work is being performed.

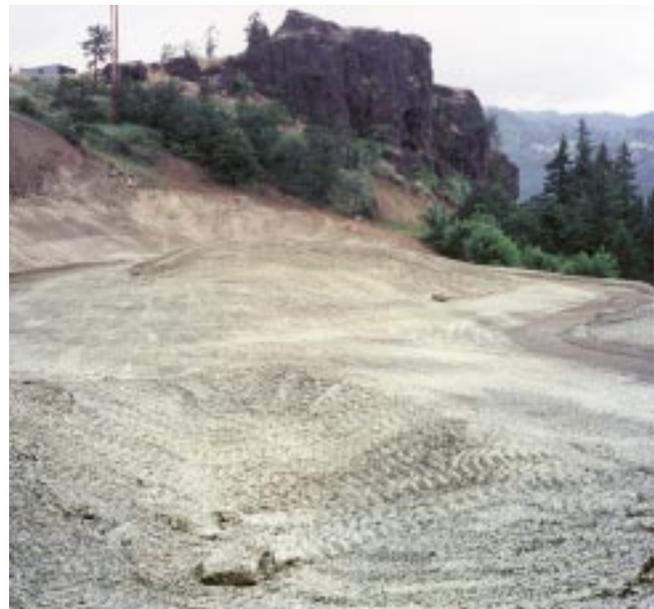
Sterile wheat grass was applied to prevent erosion and add nutrients to the soil, without germination the following year.

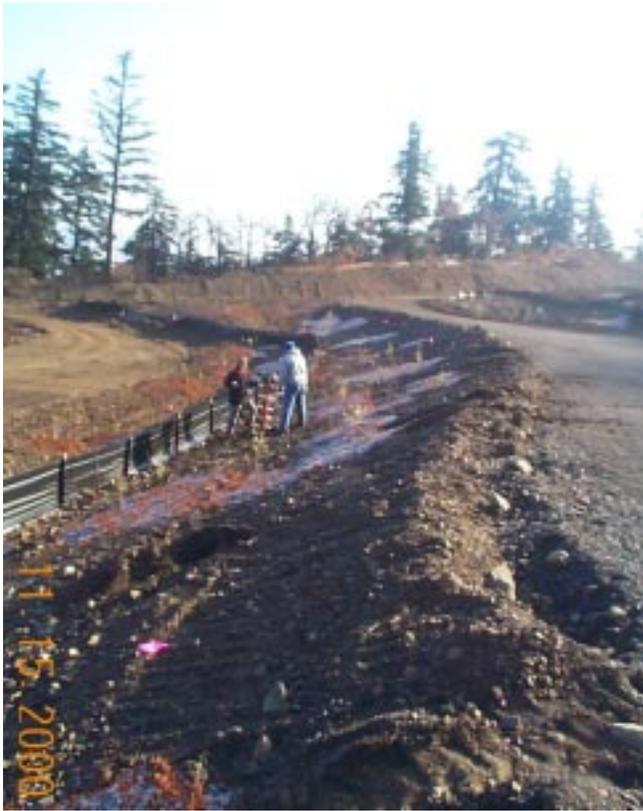
Native plants, grown within 1000 foot elevation of the project site's elevation are set in place.

During the installation of the plants on the project, a water-absorbing polymer was added into the planting hole. When it rains, this rock- salt sized crystal will absorb moisture, swelling in size so the roots of the plant can utilize the water at a later date. The “lesson learned” came after the planting a few weeks later, during the first rainstorm. The contractor’s crew who planted everything had not used the water absorbing crystal before. Instead of 1 teaspoon of crystals, they casually threw a handful into the bottom of each hole. During the rainstorm, the abundance of crystals swelled and shoved the plants out of

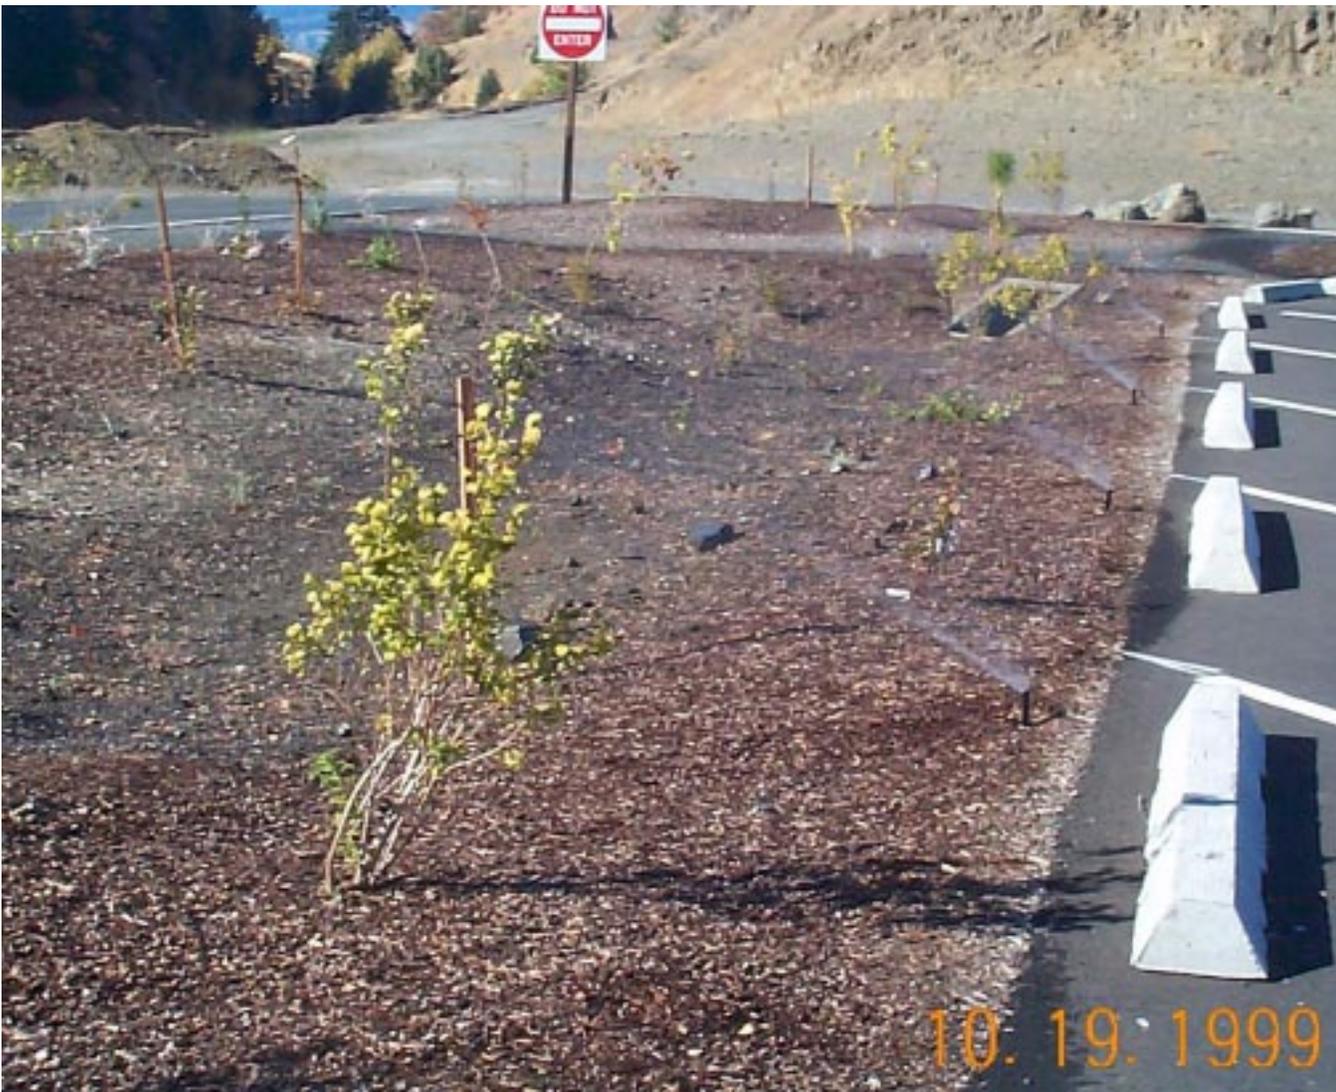
Irrigation is necessary for the plantings for two years after installation.

Another lesson learned, related to the landscaping at the West Trailhead, concerns the amount of irrigation needed after the plants are installed. Even though plants might be native to the area, they still need additional water the first two years of their life. The trick is to not over-water the planted site. While you might think you’re helping the new plant, you could also be triggering the growth of unwanted weeds.

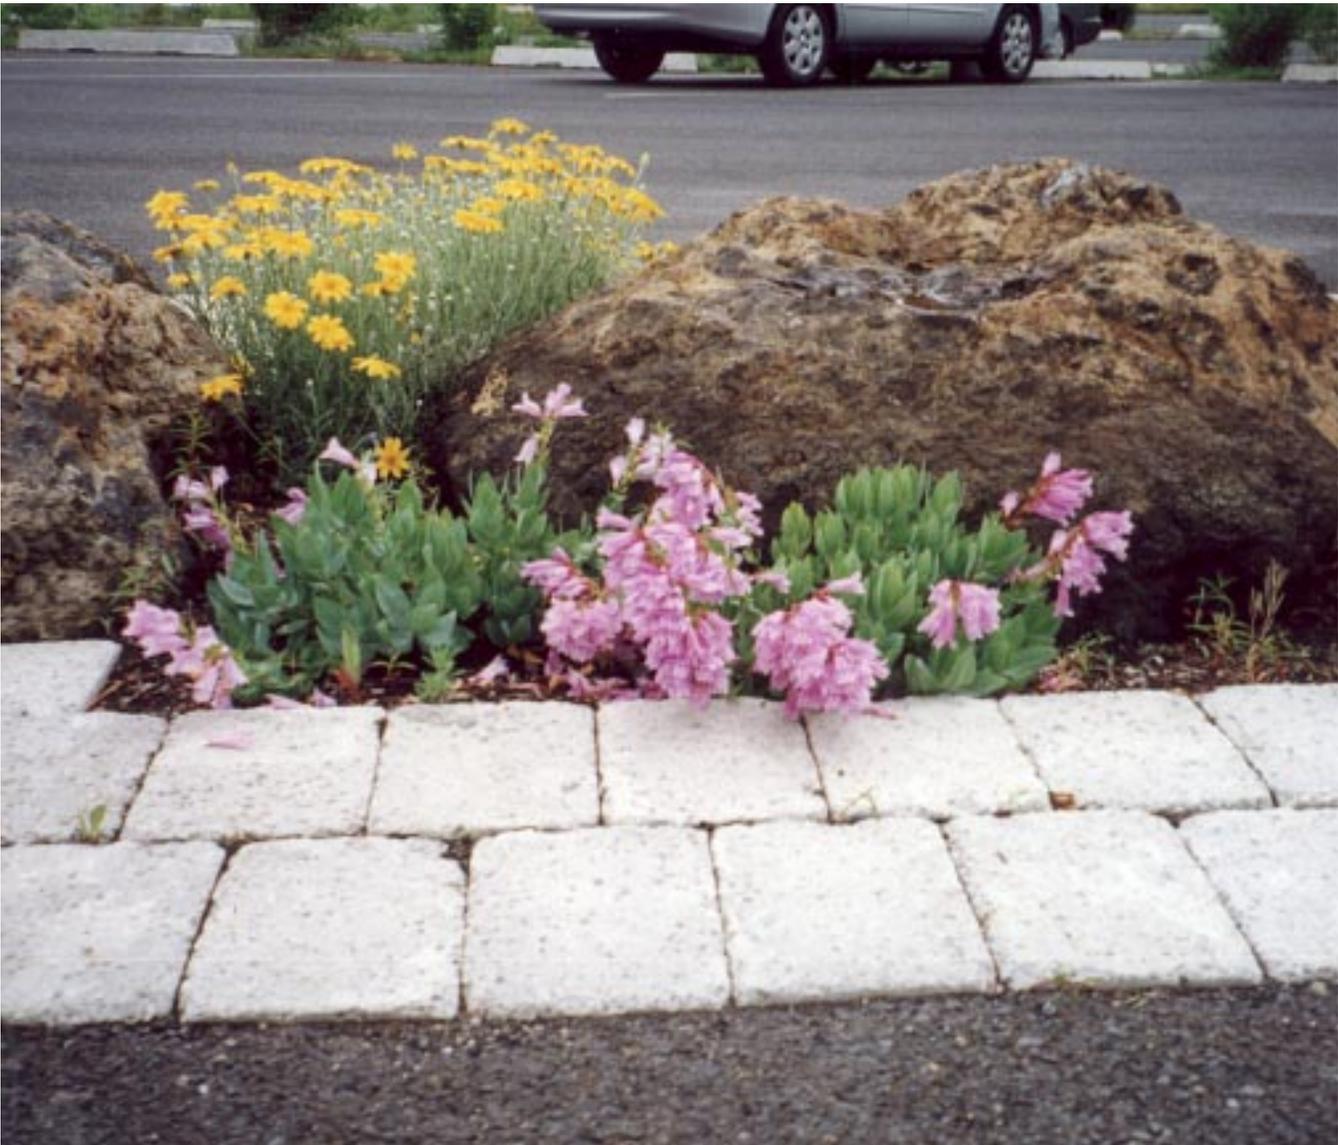
The trailhead project includes a combination of landscaping elements such as rocks, paving stones, plants and ground-surface covers which greatly enhance the visual experience of visitors to the site.

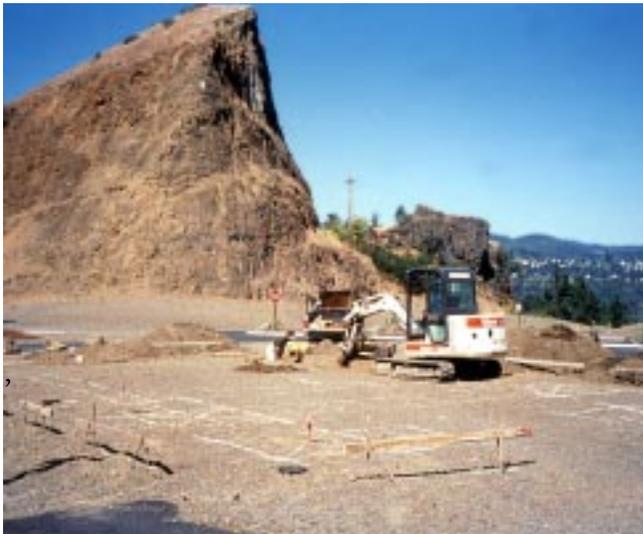
Construction of the Visitor Contact Station started in August of 1999.

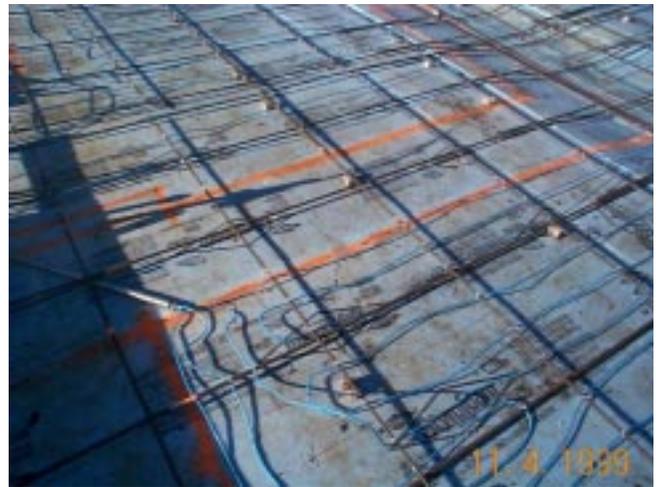
Shown here before the concrete pour are the radiant heat cables that are incorporated into the concrete floor.

There are many unique elements that are worth mentioning in the Visitor Contact Station. The concrete floor of the building contains heating cables. NEVER drill into the floor! The cables could be damaged and the heating system would no longer work. The concrete floor was also topped with a coloring agent. It was a shake-on color hardener made

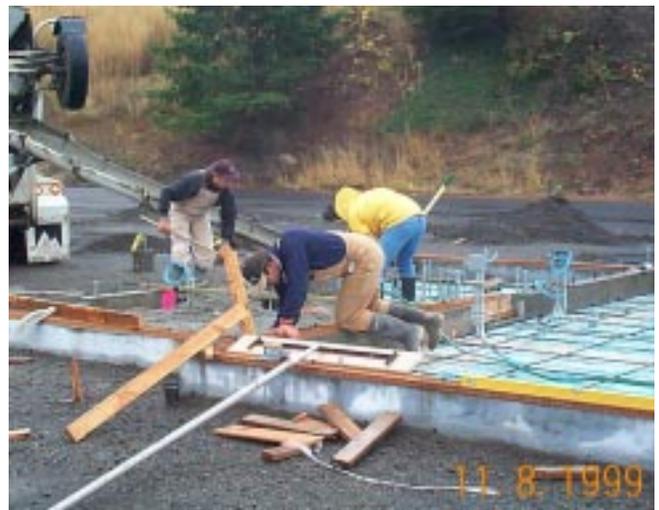
During the pouring of the concrete slab, the electrician for the project (Chris Jones of Coburn Electric in Hood River, Ore.) was on site to make sure none of the heat cables that were incorporated in the slab were damaged.

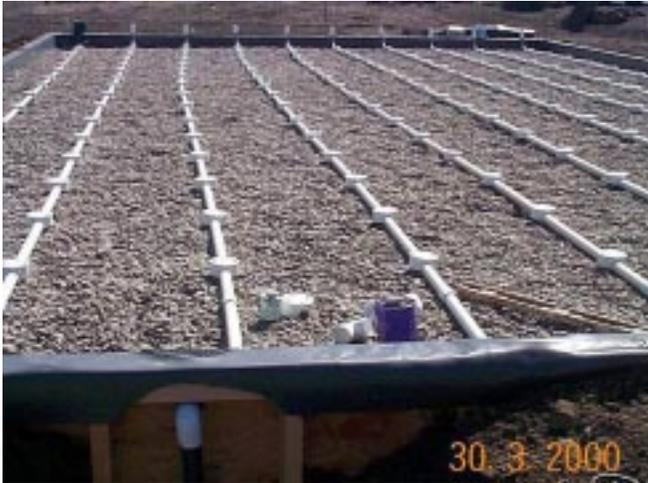
This recirculating gravel filter is part of the septic system.

The septic system, earlier started on the Phase 3C project, was completed in this project. The system is far too complicated to explain here in detail. Basically, two recirculating tanks and a gravel filter were added along with an extensive operating system. The system is so complex that OPRD has had to hire a consultant to monitor and run the system.

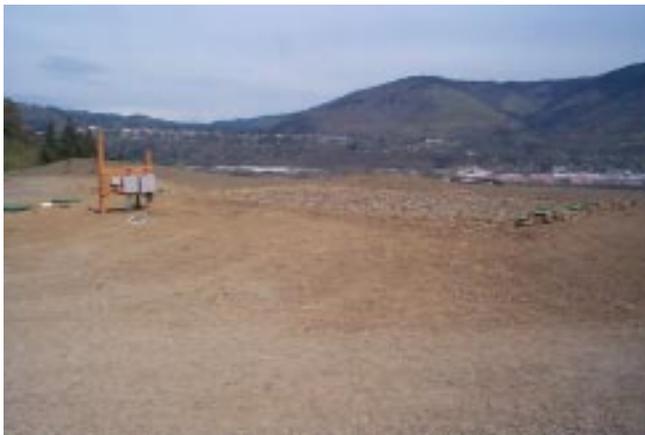
To make the septic system blend into the surrounding area, the drain gravel on top of the filter was sifted from surrounding material. After completion, a wire cage, painted black, was built by OPRD to cover the control panel on the left.

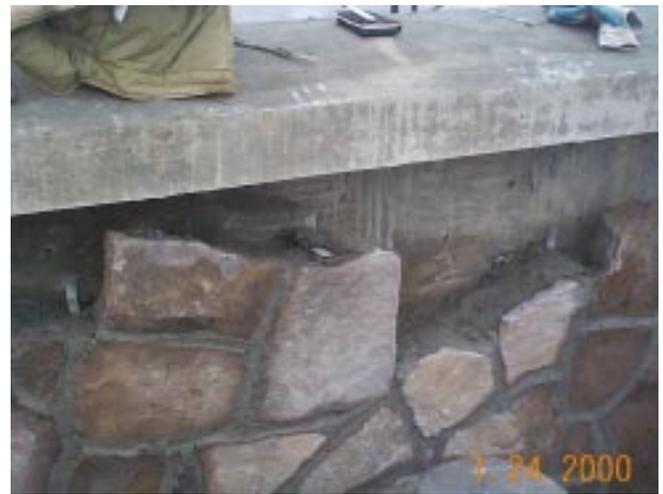
To help connect the grout and stone to the wall, OMIE used clips attached with a Hilti Gun.

on the west wall inside and outside of the building. The stone used was a basalt from Camas, Washington and is commonly known as Camas Gray Stone. Don Olmstead's crew shot on clips to the wall that Watt built with a Hilti Gun and then bent the clips into location to help adhere the grout and stone to the wall.

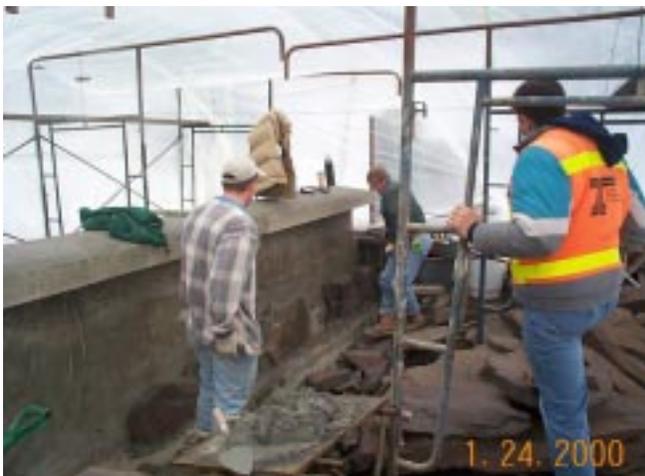
Don Olmstead (in middle) and Randy Olmstead (on left) show ODOT inspector Kevin Bracy some of the masonry work on the front wall of the building. OMIE built a large tent over the wall so the work area could be heated during the winter.

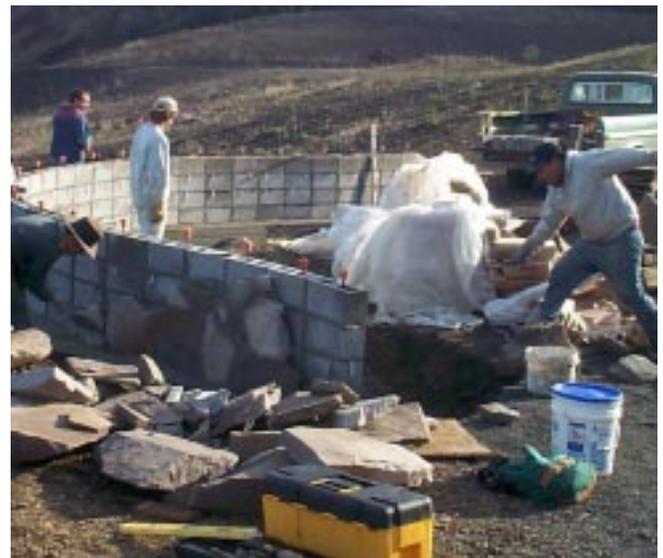
OMIE building the overlook wall.

The west wall of the building was completely built by Watt as a cast-in-place concrete wall. The overlook wall at the west side of the Trailhead is different. Watt poured the footing and had rebar extending up out of it. OMIE

then built the wall using concrete blocks and incorporated the clips into the wall. After the block was completed, they grouted on the stone. The concrete wall was more expensive, but was necessary since it was part of the building. The concrete block construction was cheaper, but still provided a high quality wall.

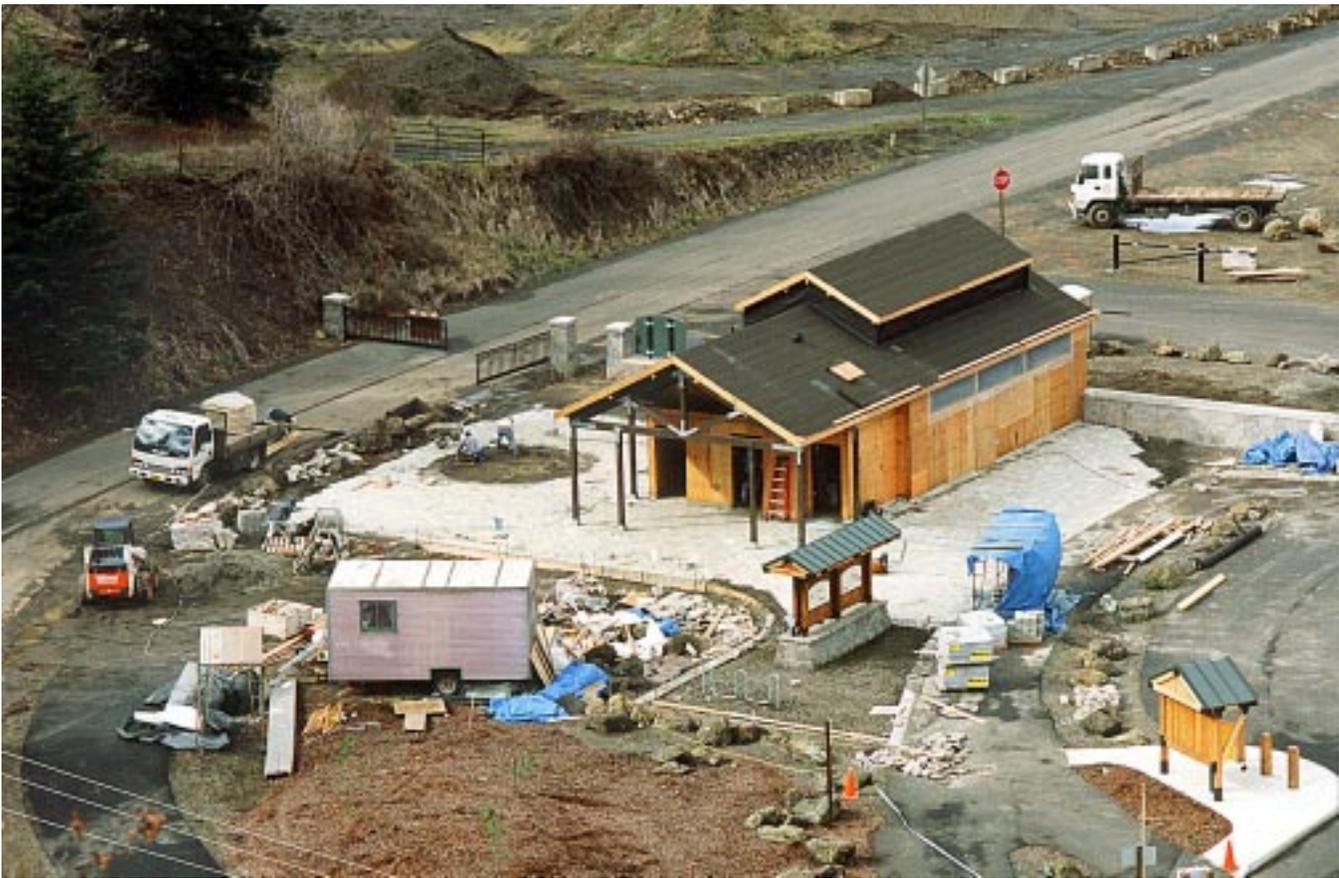
Construction of the Visitor Contact Station in March of 1999 shows work in full force.

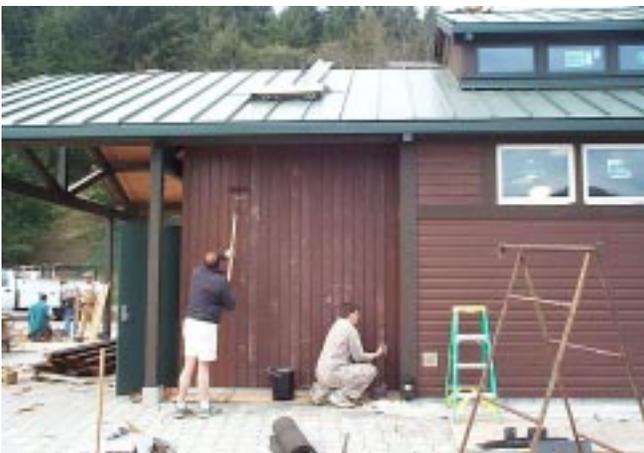
C+S Painting applying the final coat of stain to the siding on the Visitor Contact Station..

During the construction of the building, an issue arose regarding the cedar siding. In the contract, Watt was required to paint the siding after it was installed. However, in the future, when the wood siding would shrink, the surface that would become exposed would not have any paint covering it. This would not

only look bad, but would expose untreated wood to the elements. It was agreed that all of the siding should be pre-painted before installation. This was added to the contract as a \$3,000 change order. Another part of the exterior painting was to match the building to the kiosk and ticket shelter outside.

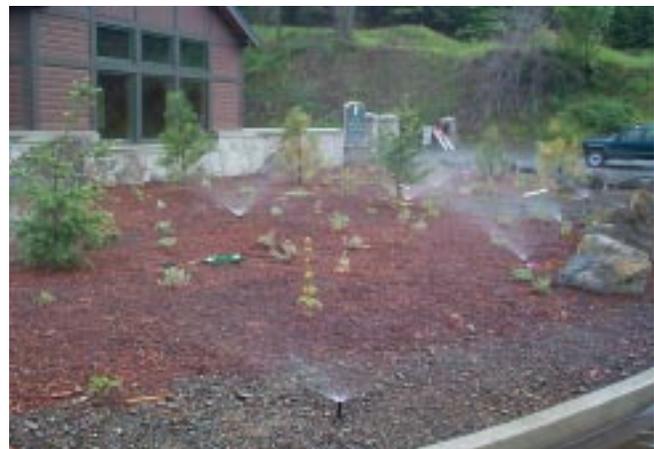
Irrigation and planting work professionally performed by Shamrock Landscaping.

The completion date of April 15, 1999 worked well for the landscape phase of the contract. Shamrock Landscaping of Hood River, Ore., owned and operated by Kevin McNevin, was hired by Watt to install the landscaping. Shamrock Landscaping purchased the plants from Milestone Nursery and the planting work was very professional and no issues occurred.

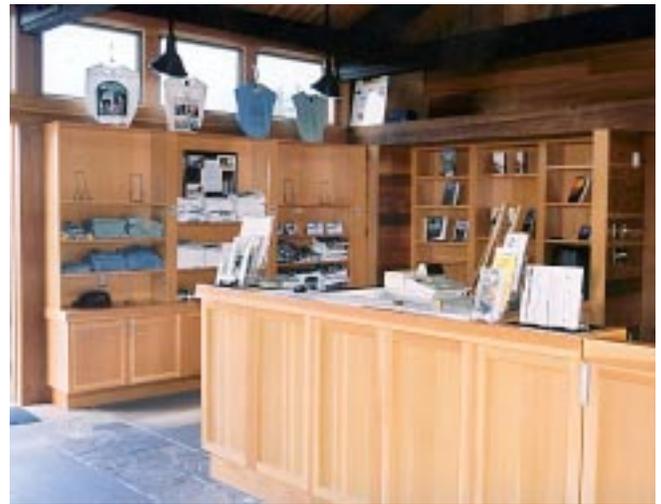
The Visitor Station contains a small office area for OPRD and the gift shop shown in picture. The building also has two restrooms, a utility room, and a visitor interpretive area.

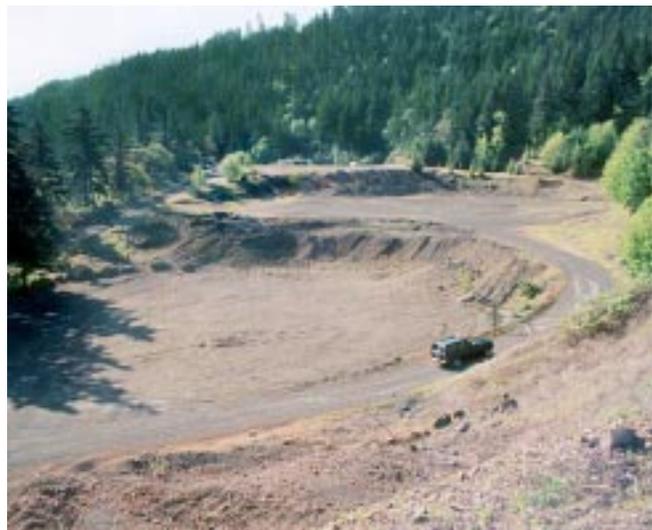
The existing site had three separate terraces that could be graded into a Trailhead parking lot without having to import or export material.

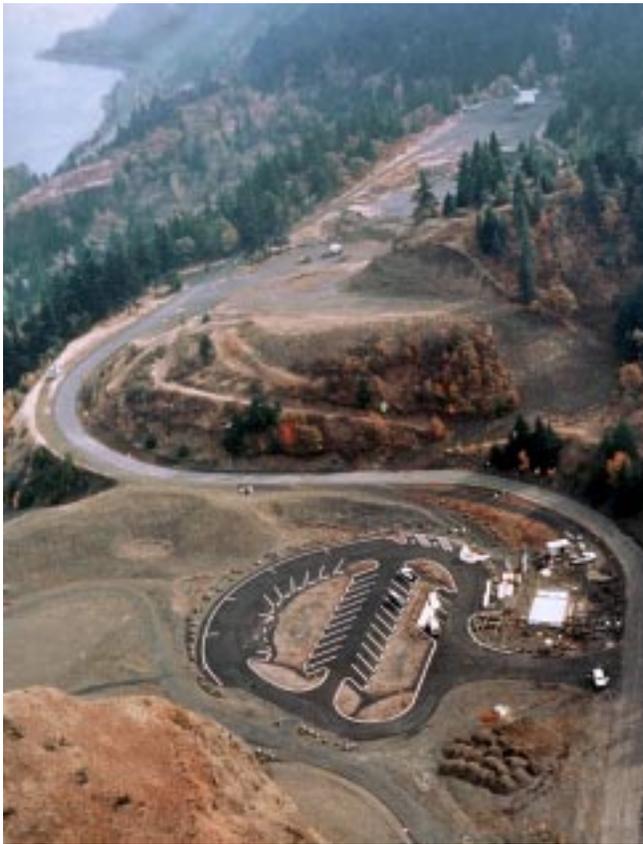
Looking east over the Hanel Quarry prior to construction in 2000.

The final phase of the West Trailhead project was the reclamation of the Hanel Quarry. Jack Bryant once used this site as the location for his asphalt plant. The site had been graded for his facility and the hill between the two quarries had been severely scarred with haul roads.

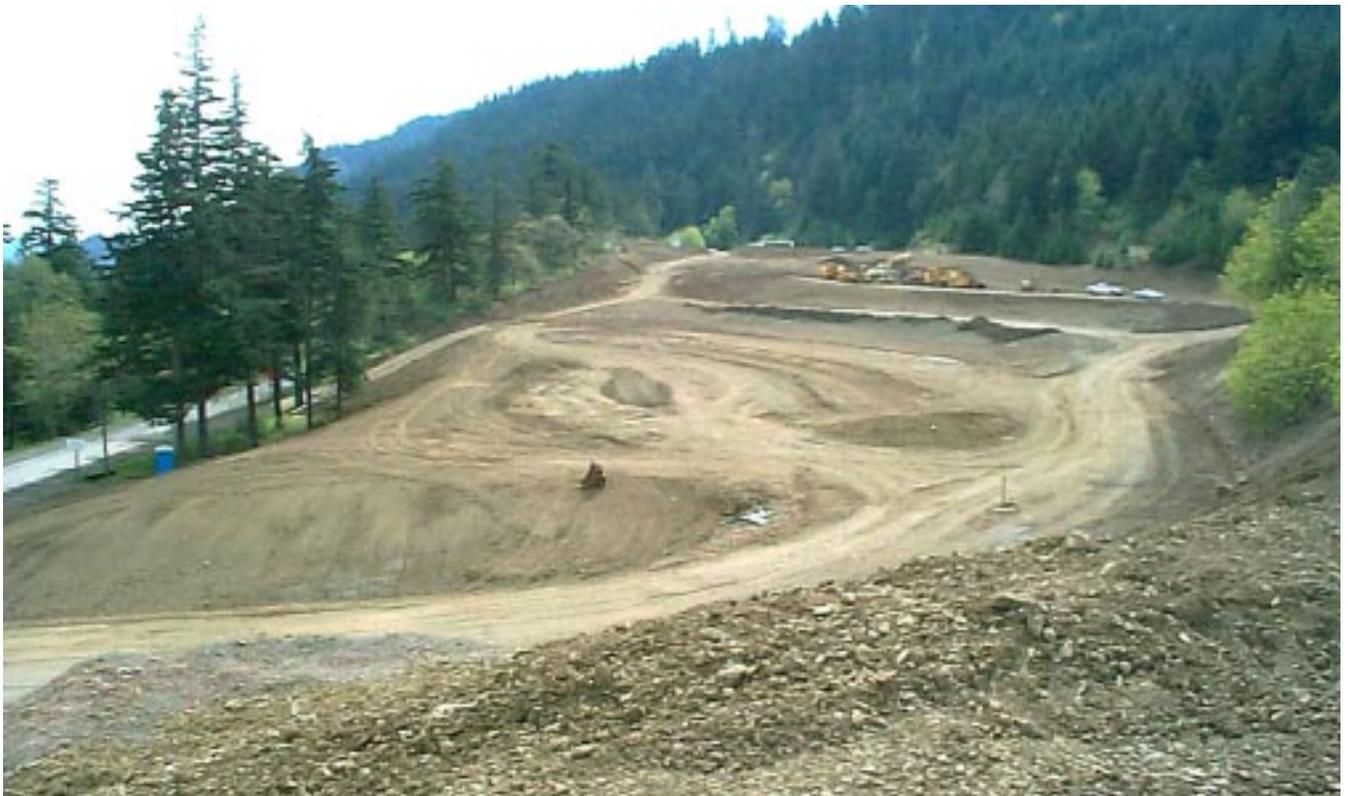
Hanel Quarry during the grading operations.

The contract work started in February of 2000. The challenge during the construction of the embankment was to not over-run the bid item quantities. Soon after JP started working, their opinion was that there was not enough material on-site to build the job. KPFF had designed the job so that 18,000 cubic meters would just have to be moved on-site. No material would have to be brought in or hauled off. As the grading work continued, ODOT performed surveys and determined that JP's hunch was correct. During construction, the design of the site was changed and the upper parking "tier" was eliminated. The final

quantity measured very close to the planned quantity. The “lesson learned” was make certain that the designers create a computerized terrain model and perform a site survey just prior to construction. You can then perform a “check” to verify quantities.

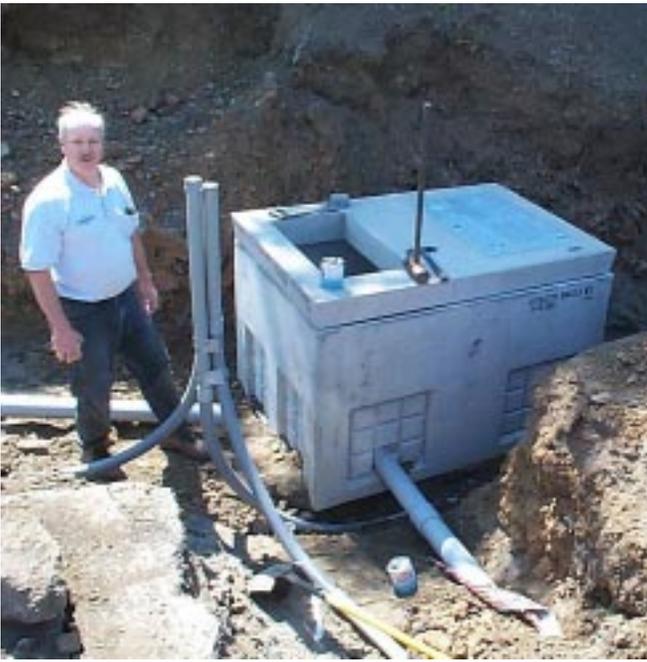
Jim Eason of Team Electric installs conduit for the electric service in the Hanel Quarry that will accommodate future development of the site.

Bringing the utilities up into the Hanel Quarry was a challenging element for JP Construction and the ODOT administration staff. The plans had not accounted for removing the last few utility poles, did not clearly show the electric contractor how to bring power into the quarry, and did not account for the cost of Pacific Power to hook up the power. While the utilities were being installed, ODOT scrambled to get a design the contractor could build. This issue cost an additional \$30,000.

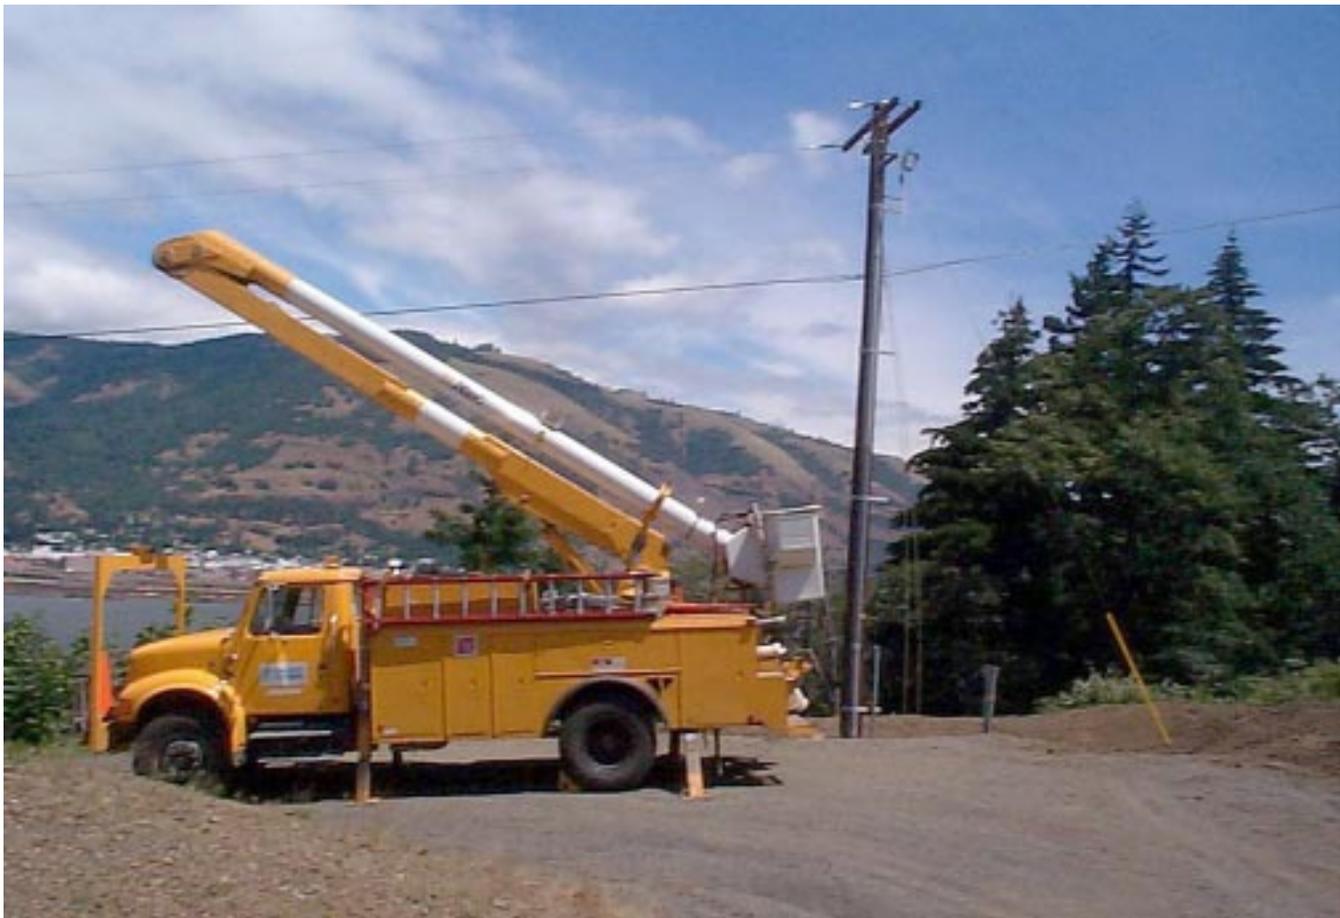
Part of the Trailhead project was to put all overhead utilities underground. Shown here is Pacific Power removing their overhead lines and poles.

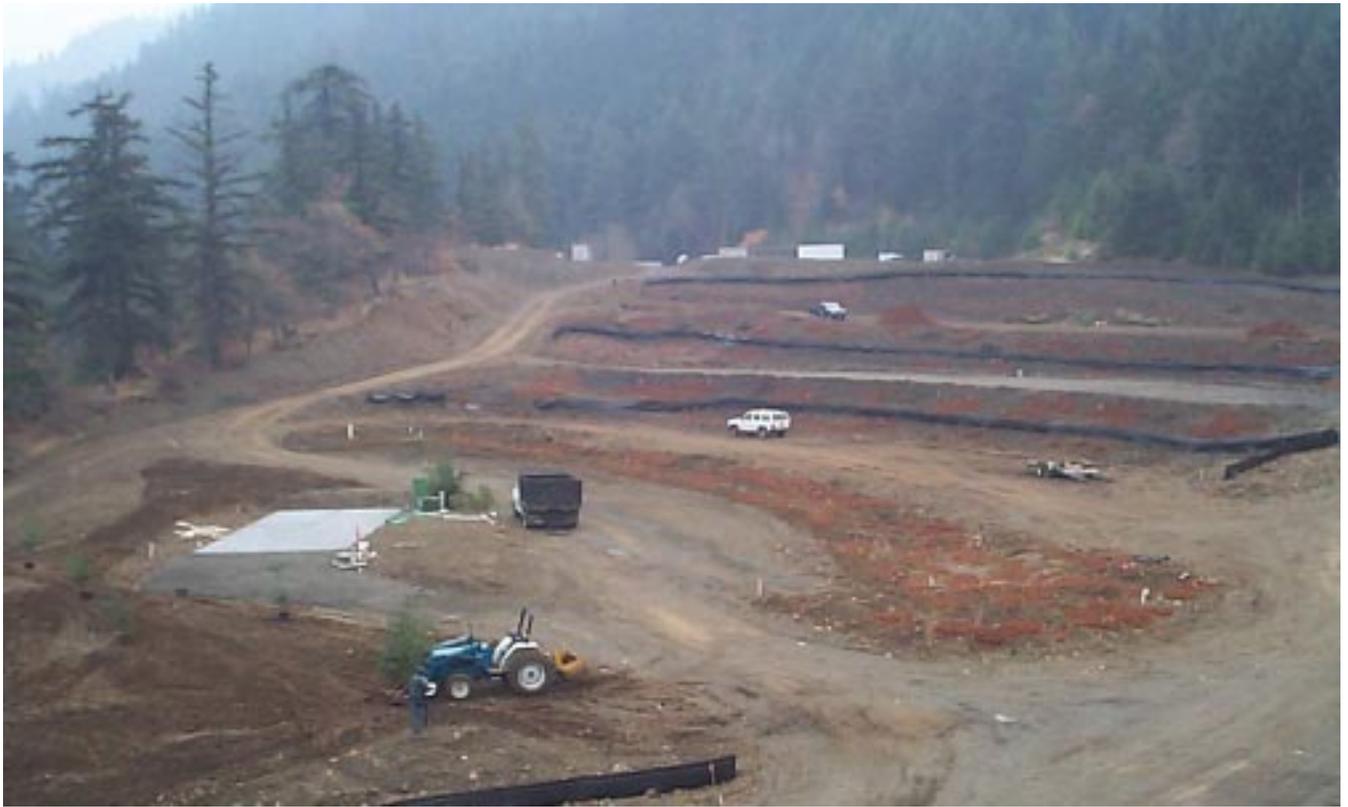
Looking east over the Hanel section of the West Trailhead during the planting of the native landscape.

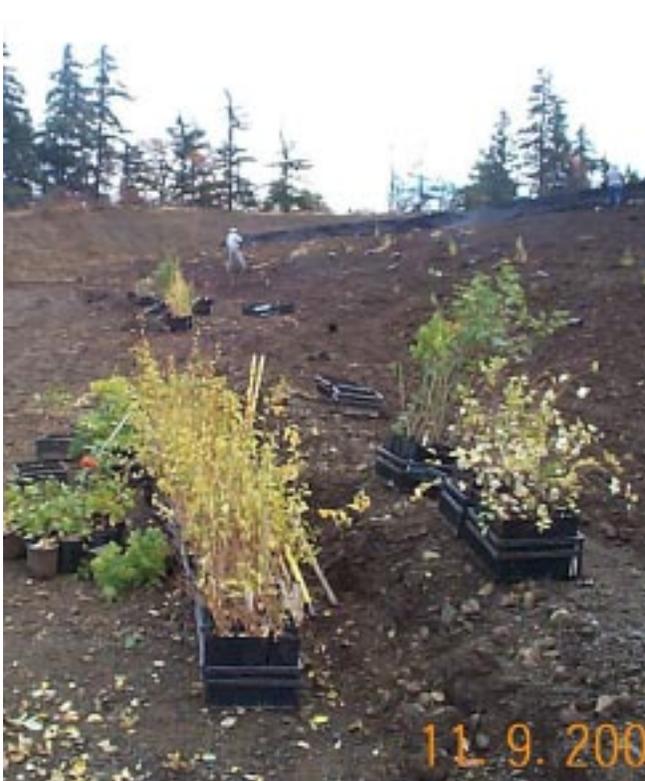
Most of the plants for the Parks project were supplied by Milestone Nursery in Lyle Washington and were planted by New Dimensions Landscape, Inc.

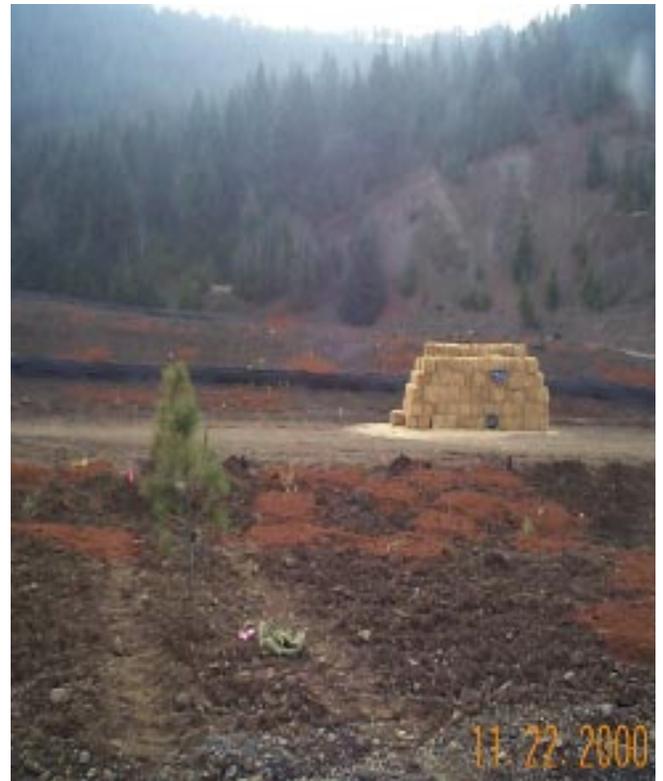
After planting was complete JP Construction placed bark mulch around many of the plants and brought straw to the site that was spread out to stabilize the slopes.

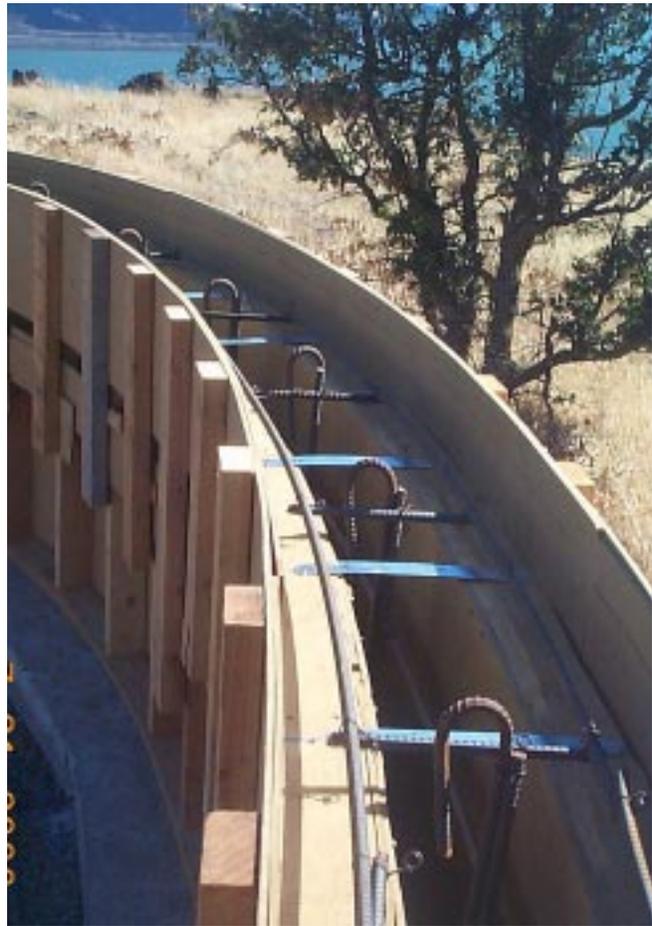
JP Construction built the formwork for the concrete core of the wall and the cap at the same time.

In the first step, JP built the core of the wall, then used the core to support the formwork for the cap. This allowed them to fine-tune the forms to make the cap a perfect ellipse. Laying out the ellipse was a challenging process. Instead of constructing the forms on site, Jeff Dodson and Brad Meadows of JP Construction opted to lay out and construct the forms on a flat slab of concrete at the West Trailhead. After the forms were constructed, they were dismantled into moveable pieces and transported to the overlook site. All of the preparatory work that JP did paid off in the end with a very high quality product.

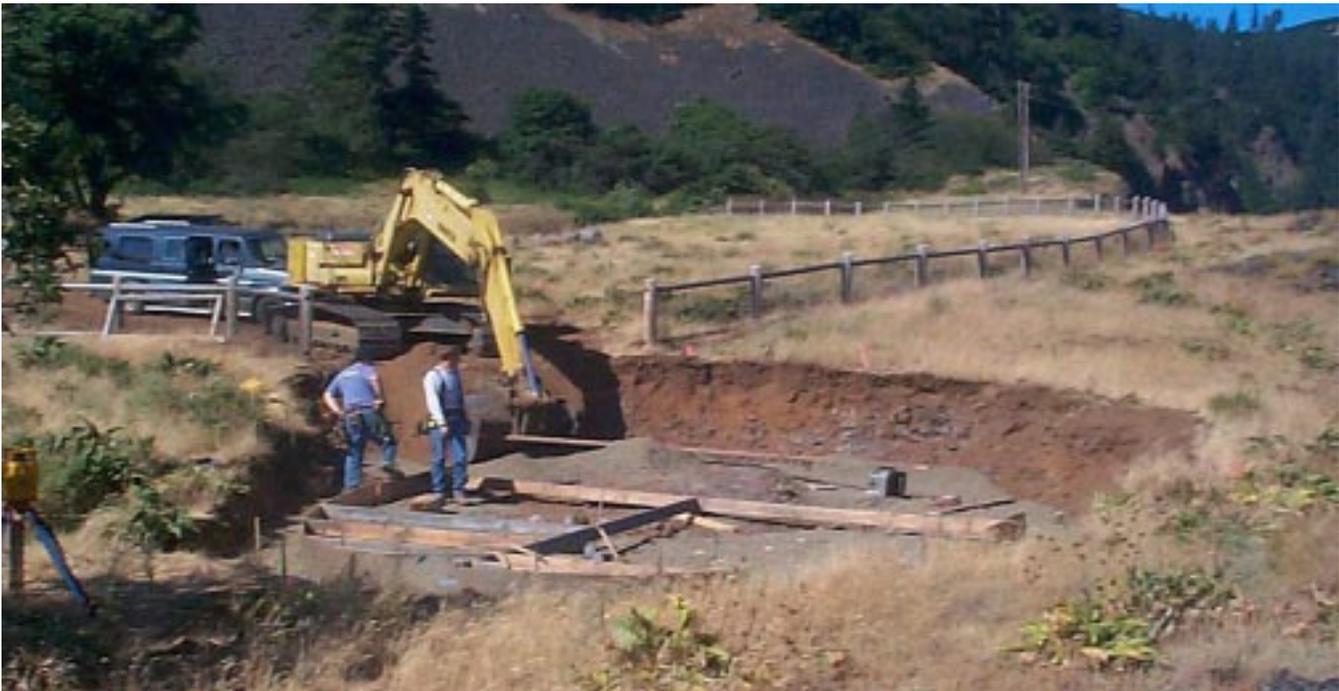
During the Parks project funding became available to construct the Mosier Overlook Wall. This feature was originally included in the Phase 3C and Visitor Contact Station projects, but was eliminated just prior to advertisement due to a shortage of funds.

The wall had two distinct elements of construction. First, JP Construction built the concrete core wall and cap. Second, OMIE Masonry constructed the rock veneer and flooring of the ellipse.

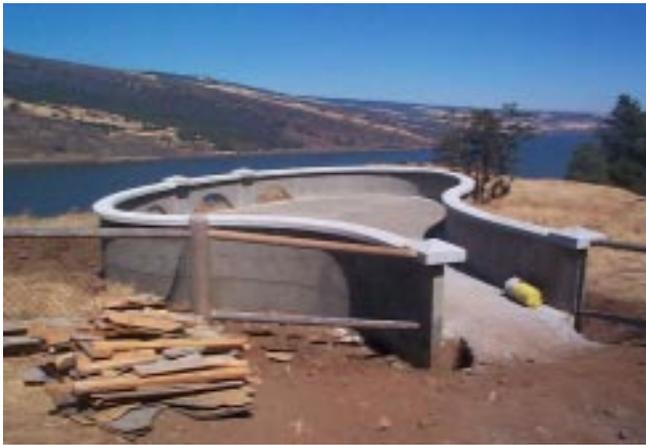
Mosier Overlook Wall prior to the placement of the rock veneer.

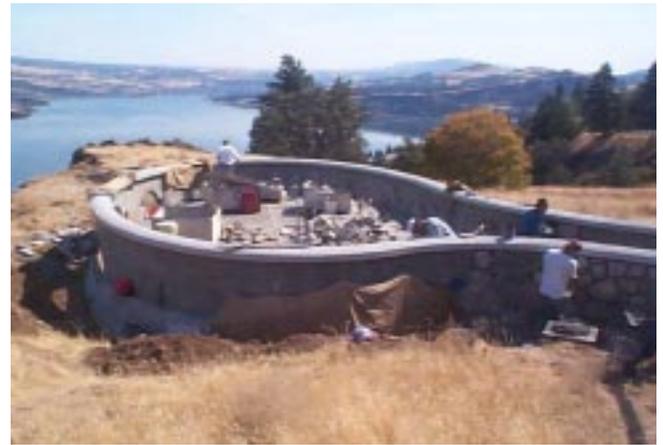
Looking east over the OMIE Masonry crew applying the stonework to the Mosier Overlook Wall.
