TRAILHEADS

Chapter 3

Hood River-to-Mosier – Phase 3C

Hood River-to-Mosier – Visitor Contact Station

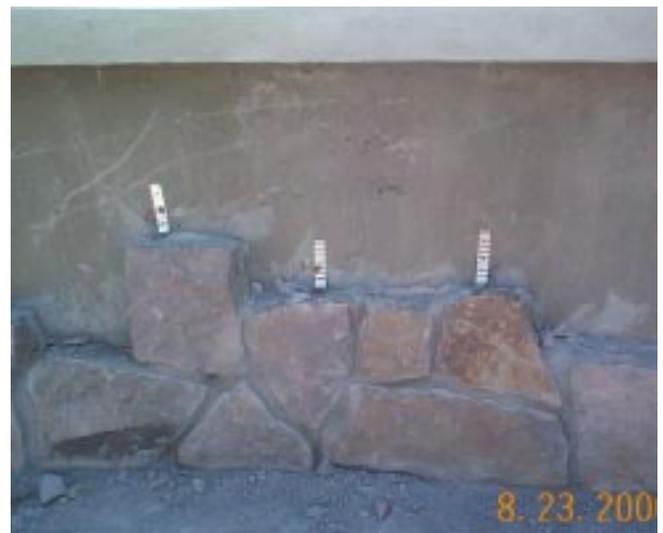
Metal straps were attached to the concrete wall with a Hilti gun and then bent into the mortar between the stones to ensure they do not come loose from the wall.

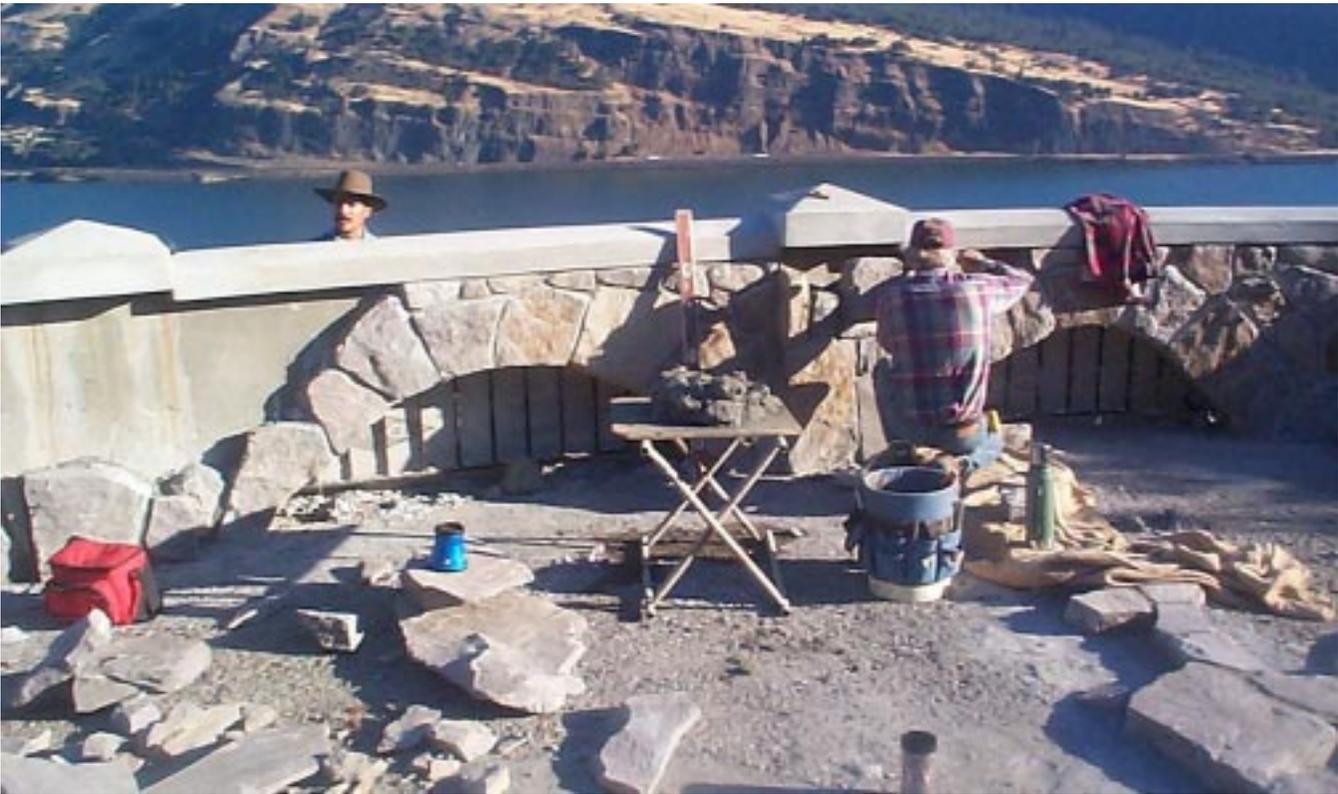
After Omie Masonry grouted the stone onto the walls, they placed the stone along the north, east, south, and west axis lines along the floor. Once the lines were completed they finished the floor and lastly they installed the center and entrance stones.

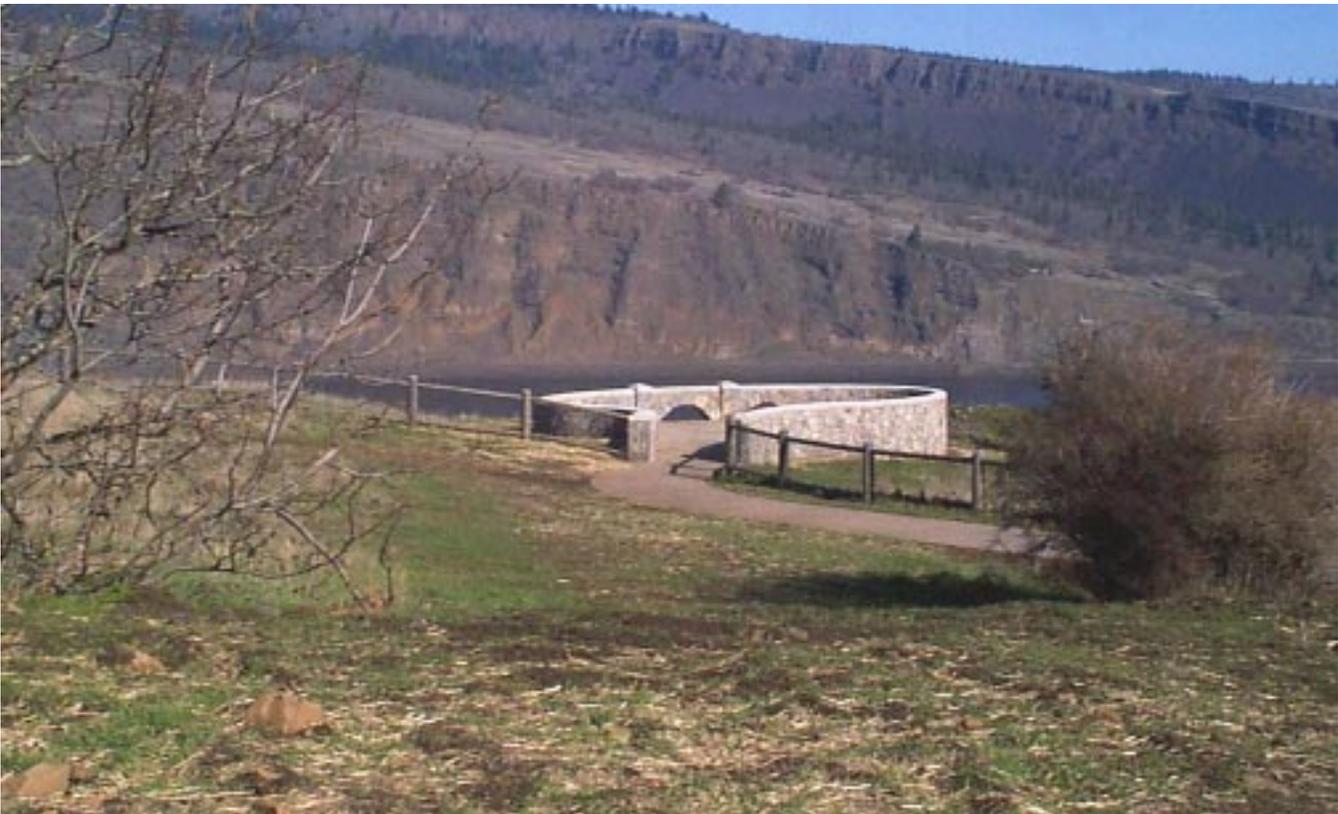
Looking north at the completed Mosier Overlook Wall
