**I-5 Exits 40 and 43 (Gold Hill)
Interchange Area Management Plans**

**Technical Memorandum #3
Study Area Inventory**

David Evans and Associates, Inc.
2100 SW River Parkway
Portland, Oregon

May 2015

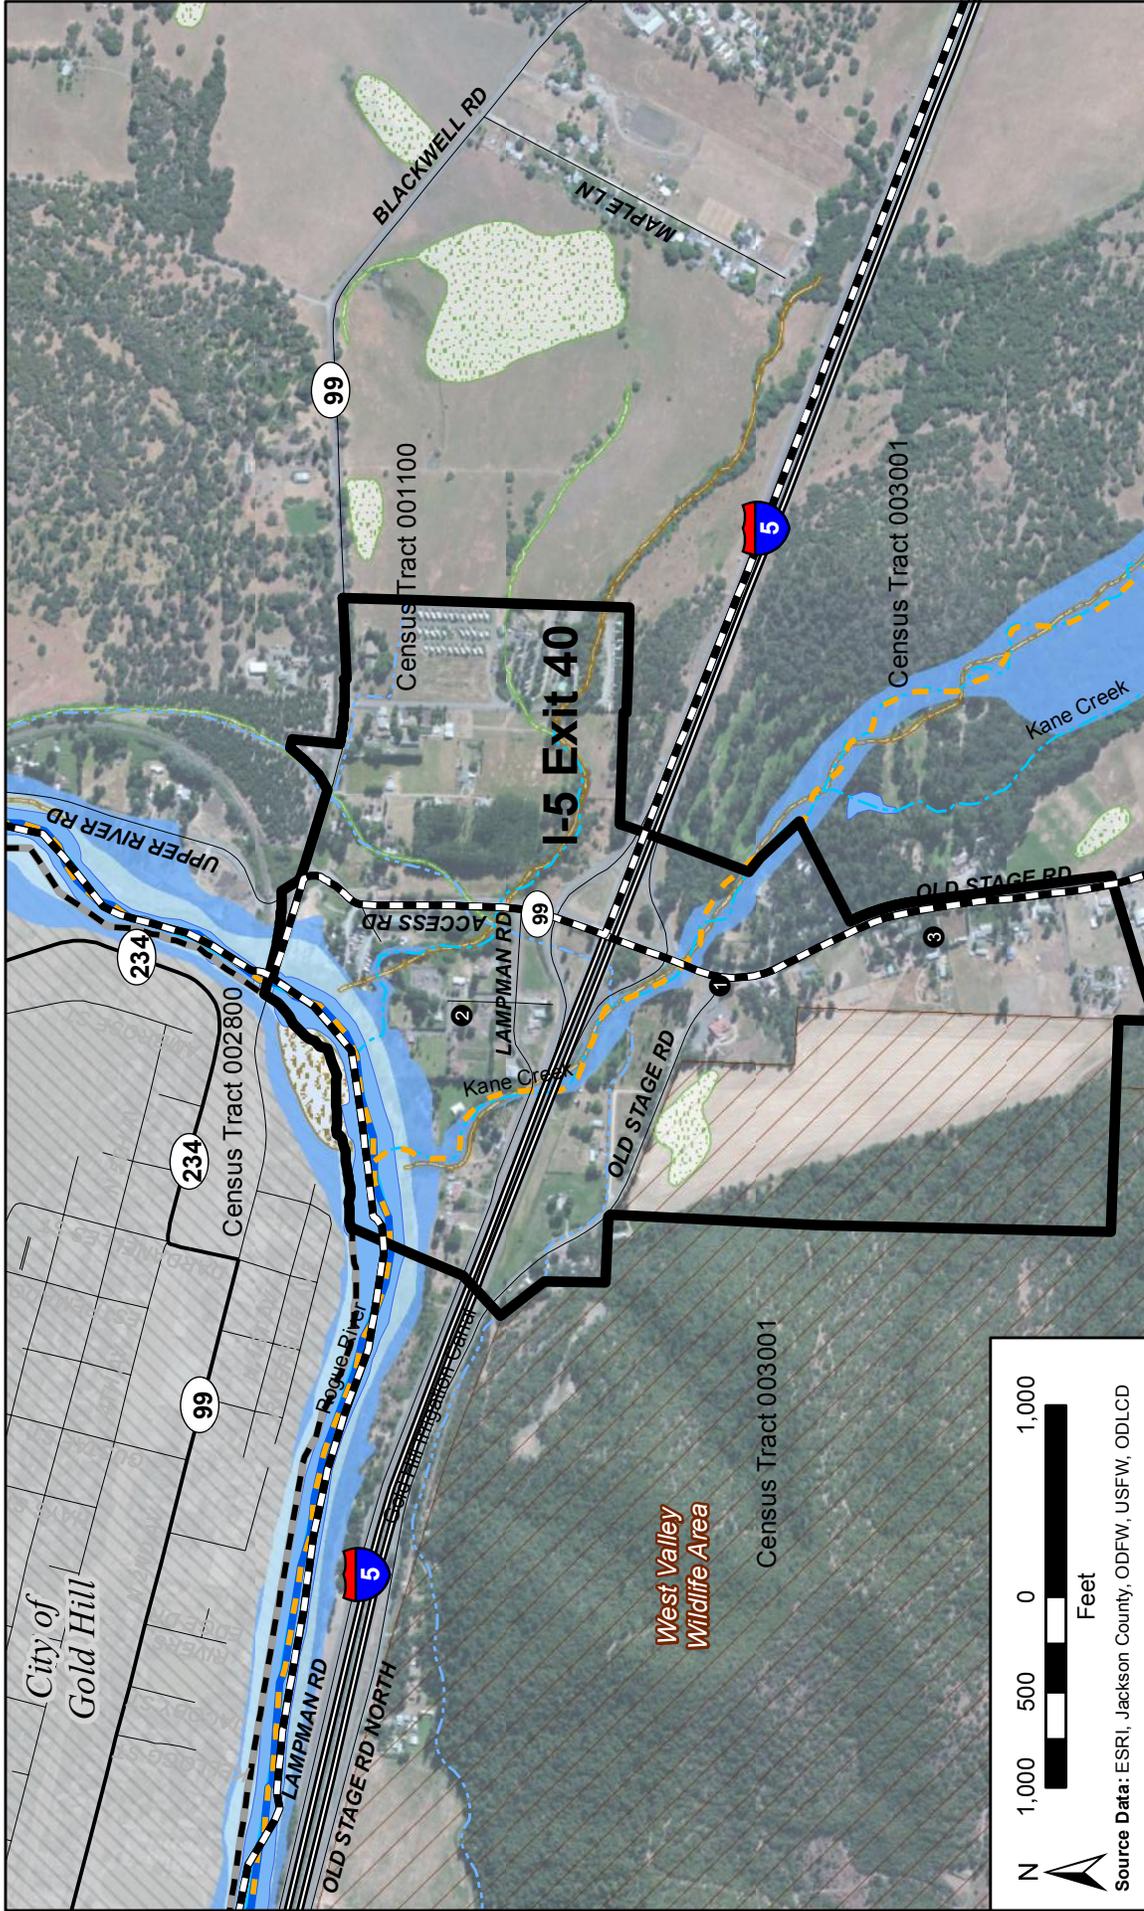
Figure 3-2a
Natural Features
I-5 Exit 40

River	Interchange Management Study Area
Creek/Stream	Urban Growth Boundary
Ditch/Irrigation Canal	City Limits
100-Year Floodplain	Interstate
Floodway	Highway
Wildlife Areas	Local Road
Census Tract Boundary

In the Exit 40 IMSA, there is a small area of Freshwater Forested/Shrub Wetlands at the river bend on the east side of the Rogue River. There is a Freshwater Emergent Wetland west of Old Stage Road. Wetland areas can be found along both Kane and Blackwell Creeks. In the Exit 43 IMSA, there is a Freshwater Emergent Wetland on the eastern and western side of the Rogue River. In addition to the mapped wetlands, there are likely unmapped wetland areas in the Exit 40 and 43 IMSAs due to the topography of the IMSAs which is a valley floor with the Rogue River and supporting streams.

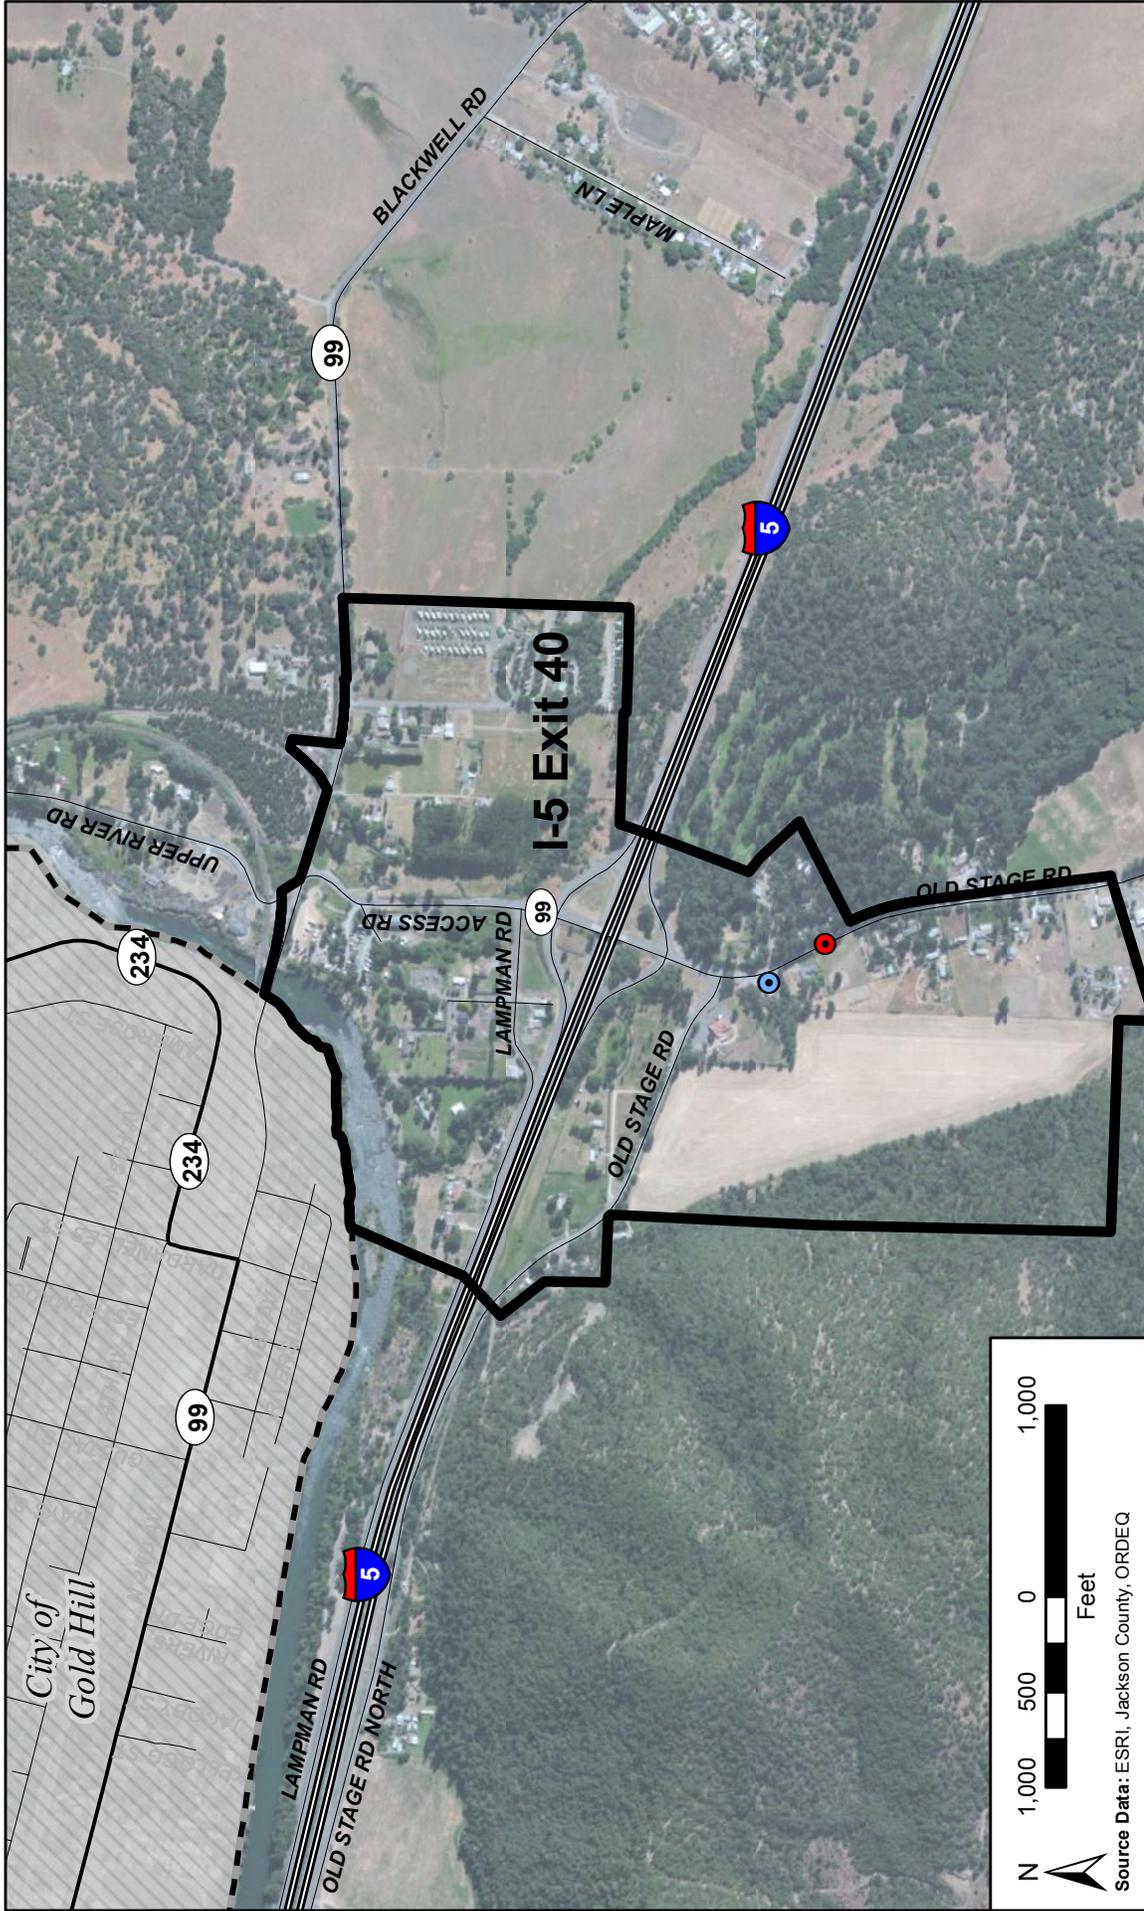
Figure 3-3a
Hazardous Sites
I-5 Exit 40

Hazardous Sites (by status and type)

Active, WQSIS
	Active, TRAACS
	Active, UST

All of the identified sites, incidents, and permitted facilities have been remediated, are being monitored, have been investigated and found not to be contaminated to the point of needing further action, or are a permitted facility. The land within the IMSAs has been previously disturbed by transportation uses that may include undocumented spills or an accumulation of many years of roadway runoff. It has been historically disturbed by agricultural uses that may include the use of chemical pesticides therefore undocumented hazardous materials may be present. Mercury vapor lamps and treated timbers may be present in the IMSAs and would require special handling if they need to be removed or replaced.

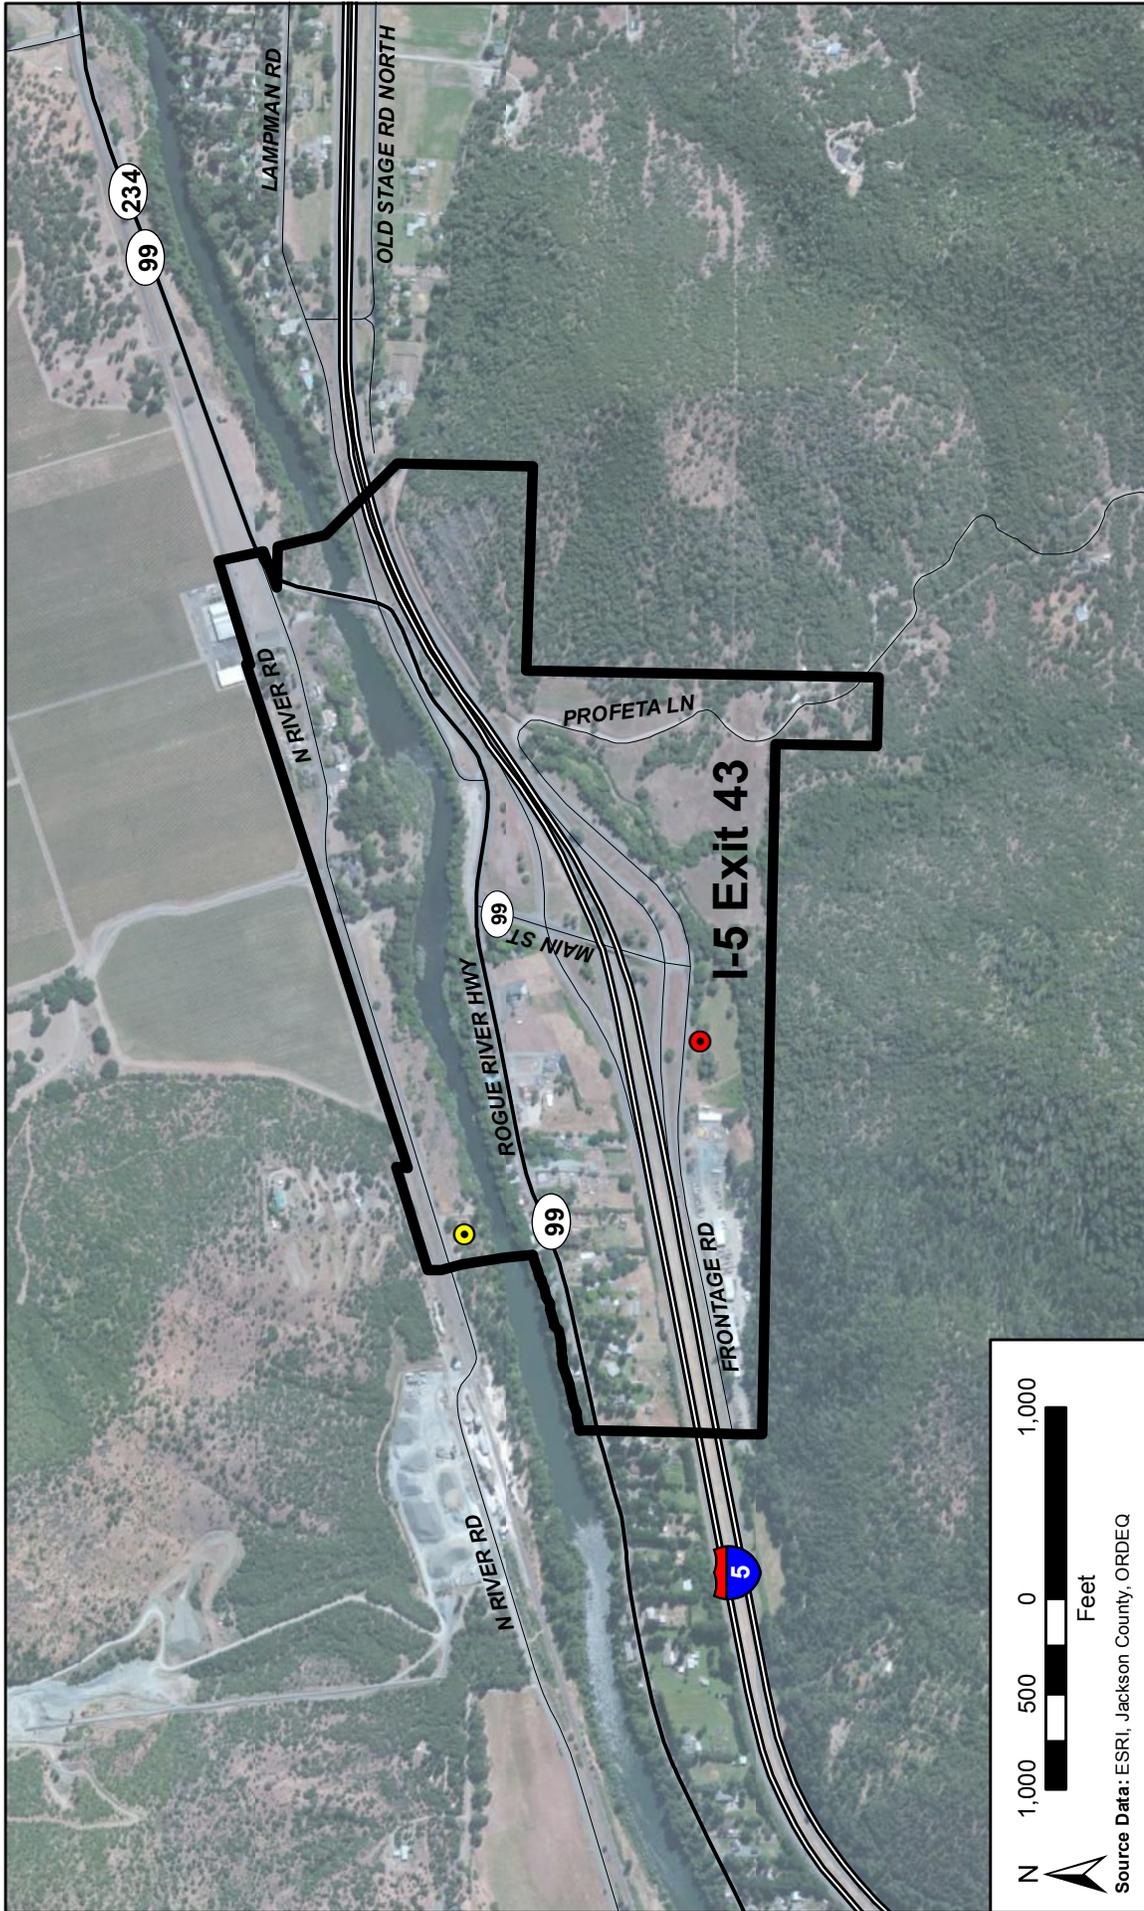
Figure 3-3b
Hazardous Sites
I-5 Exit 43

- Hazardous Sites (by status and type)
- Active, WQSIS
 - Active, TRAACS
 - Active, UST

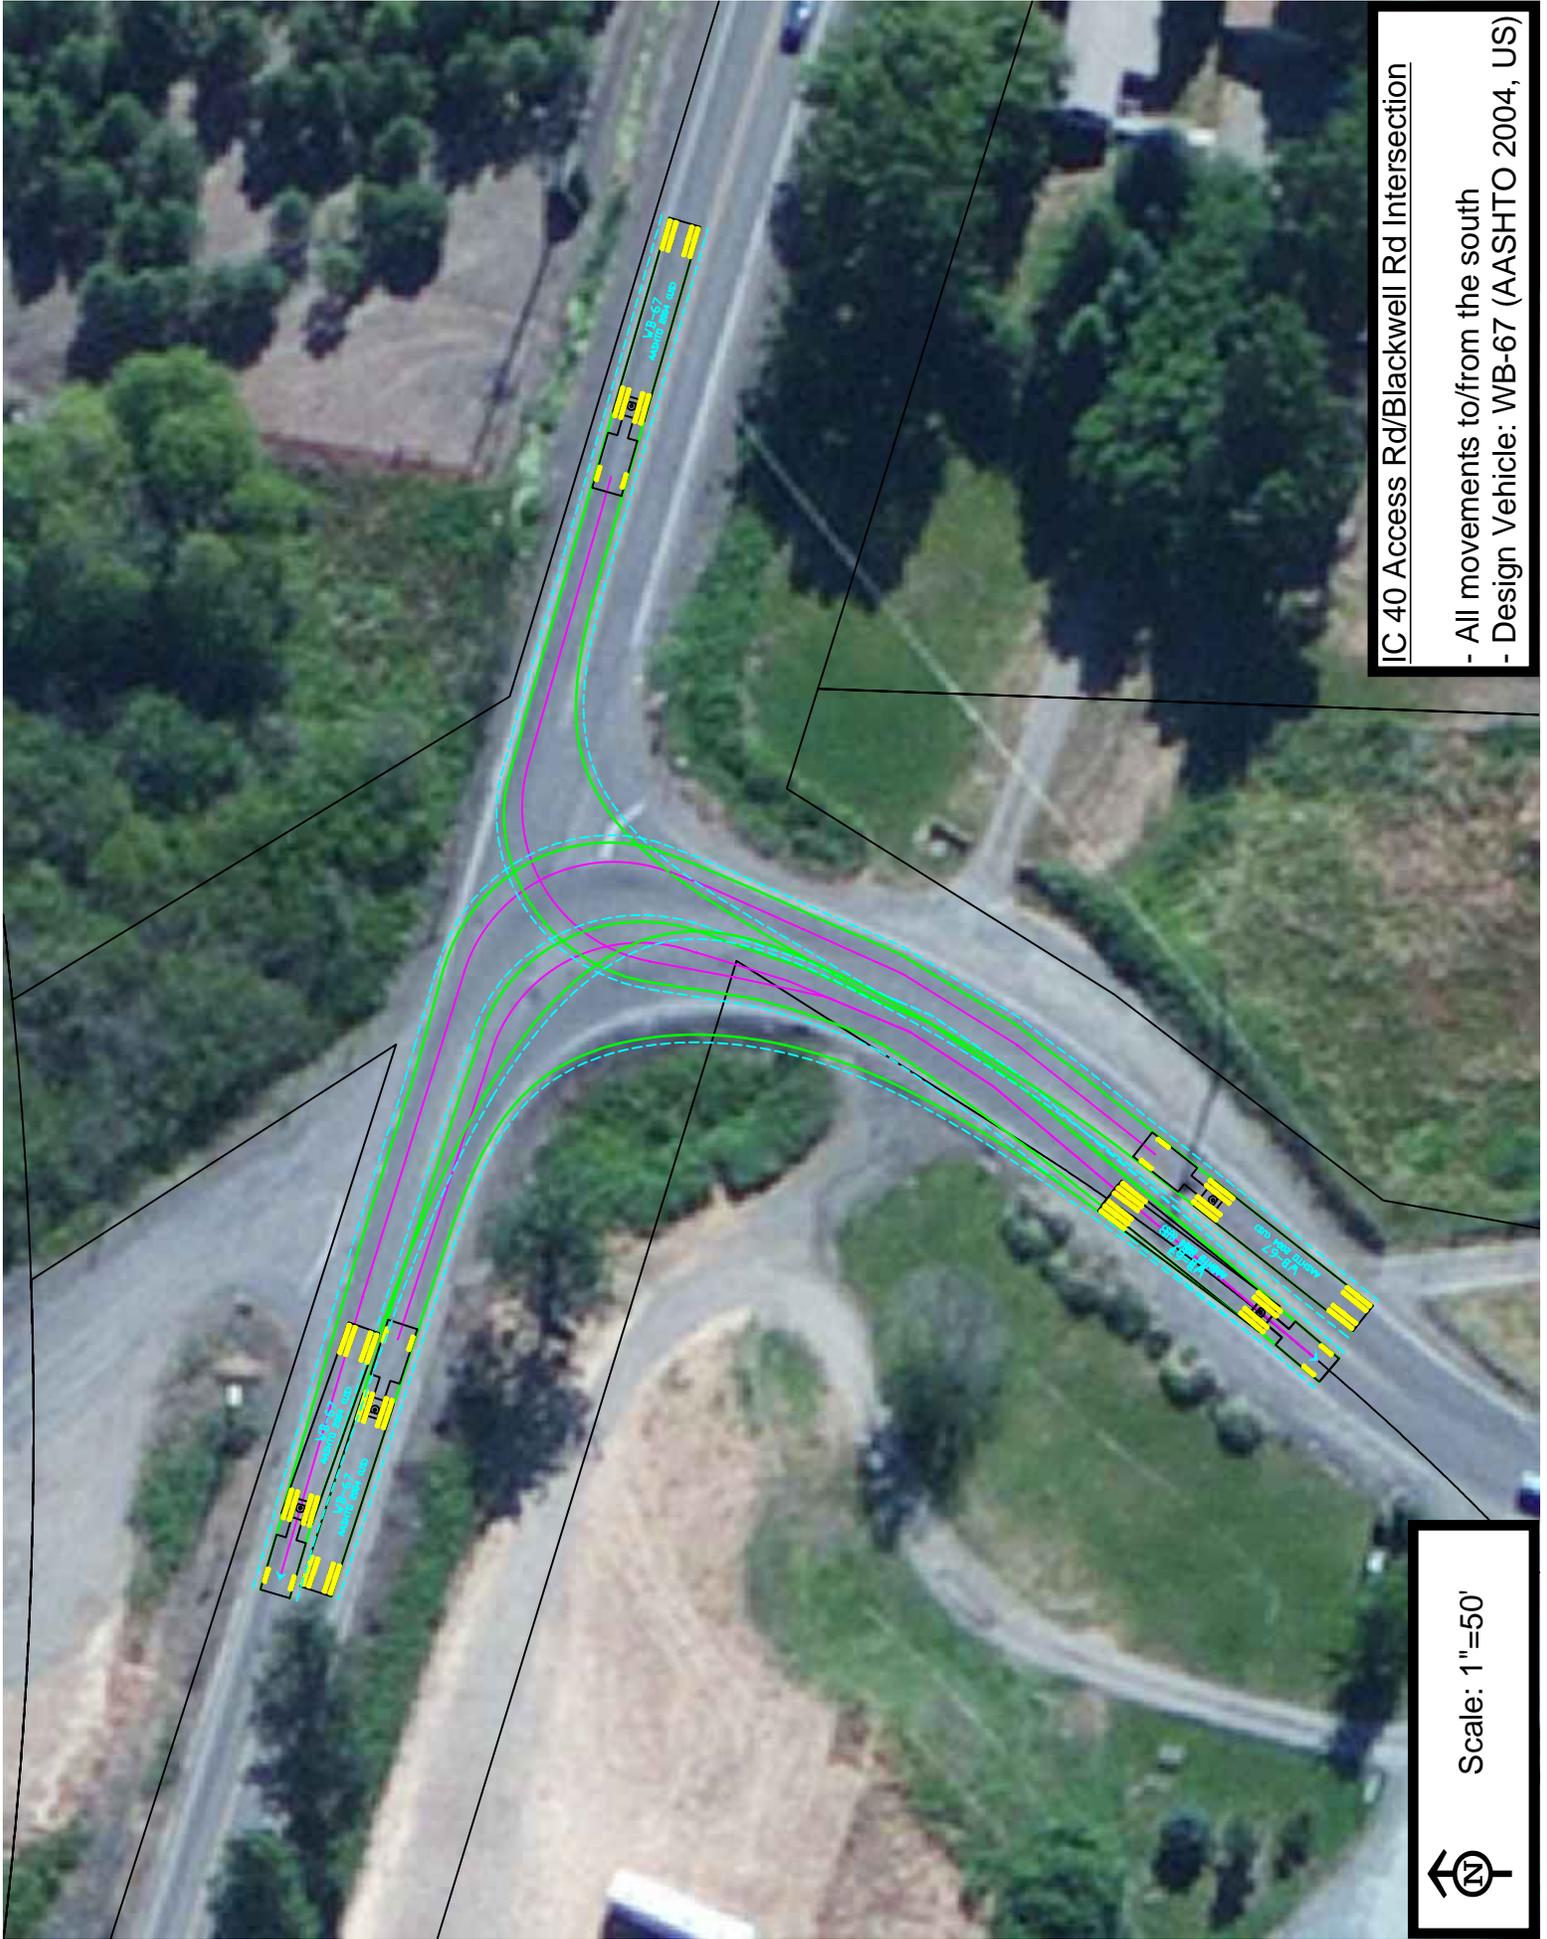
IC 40 Access Rd/Blackwell Rd Intersection
- All movements to/from the south
- Design Vehicle: WB-67 (AASHTO 2004, US)

All intersections assessed in each IMSA have at least two turning movements that will not allow a WB-67 (design vehicle) to execute a turning maneuver without crossing into oncoming traffic or tracking onto the roadway shoulder. In some cases, both are necessary when a WB-67 is making a turn. Truck turning movement diagrams can be found in Appendix B.

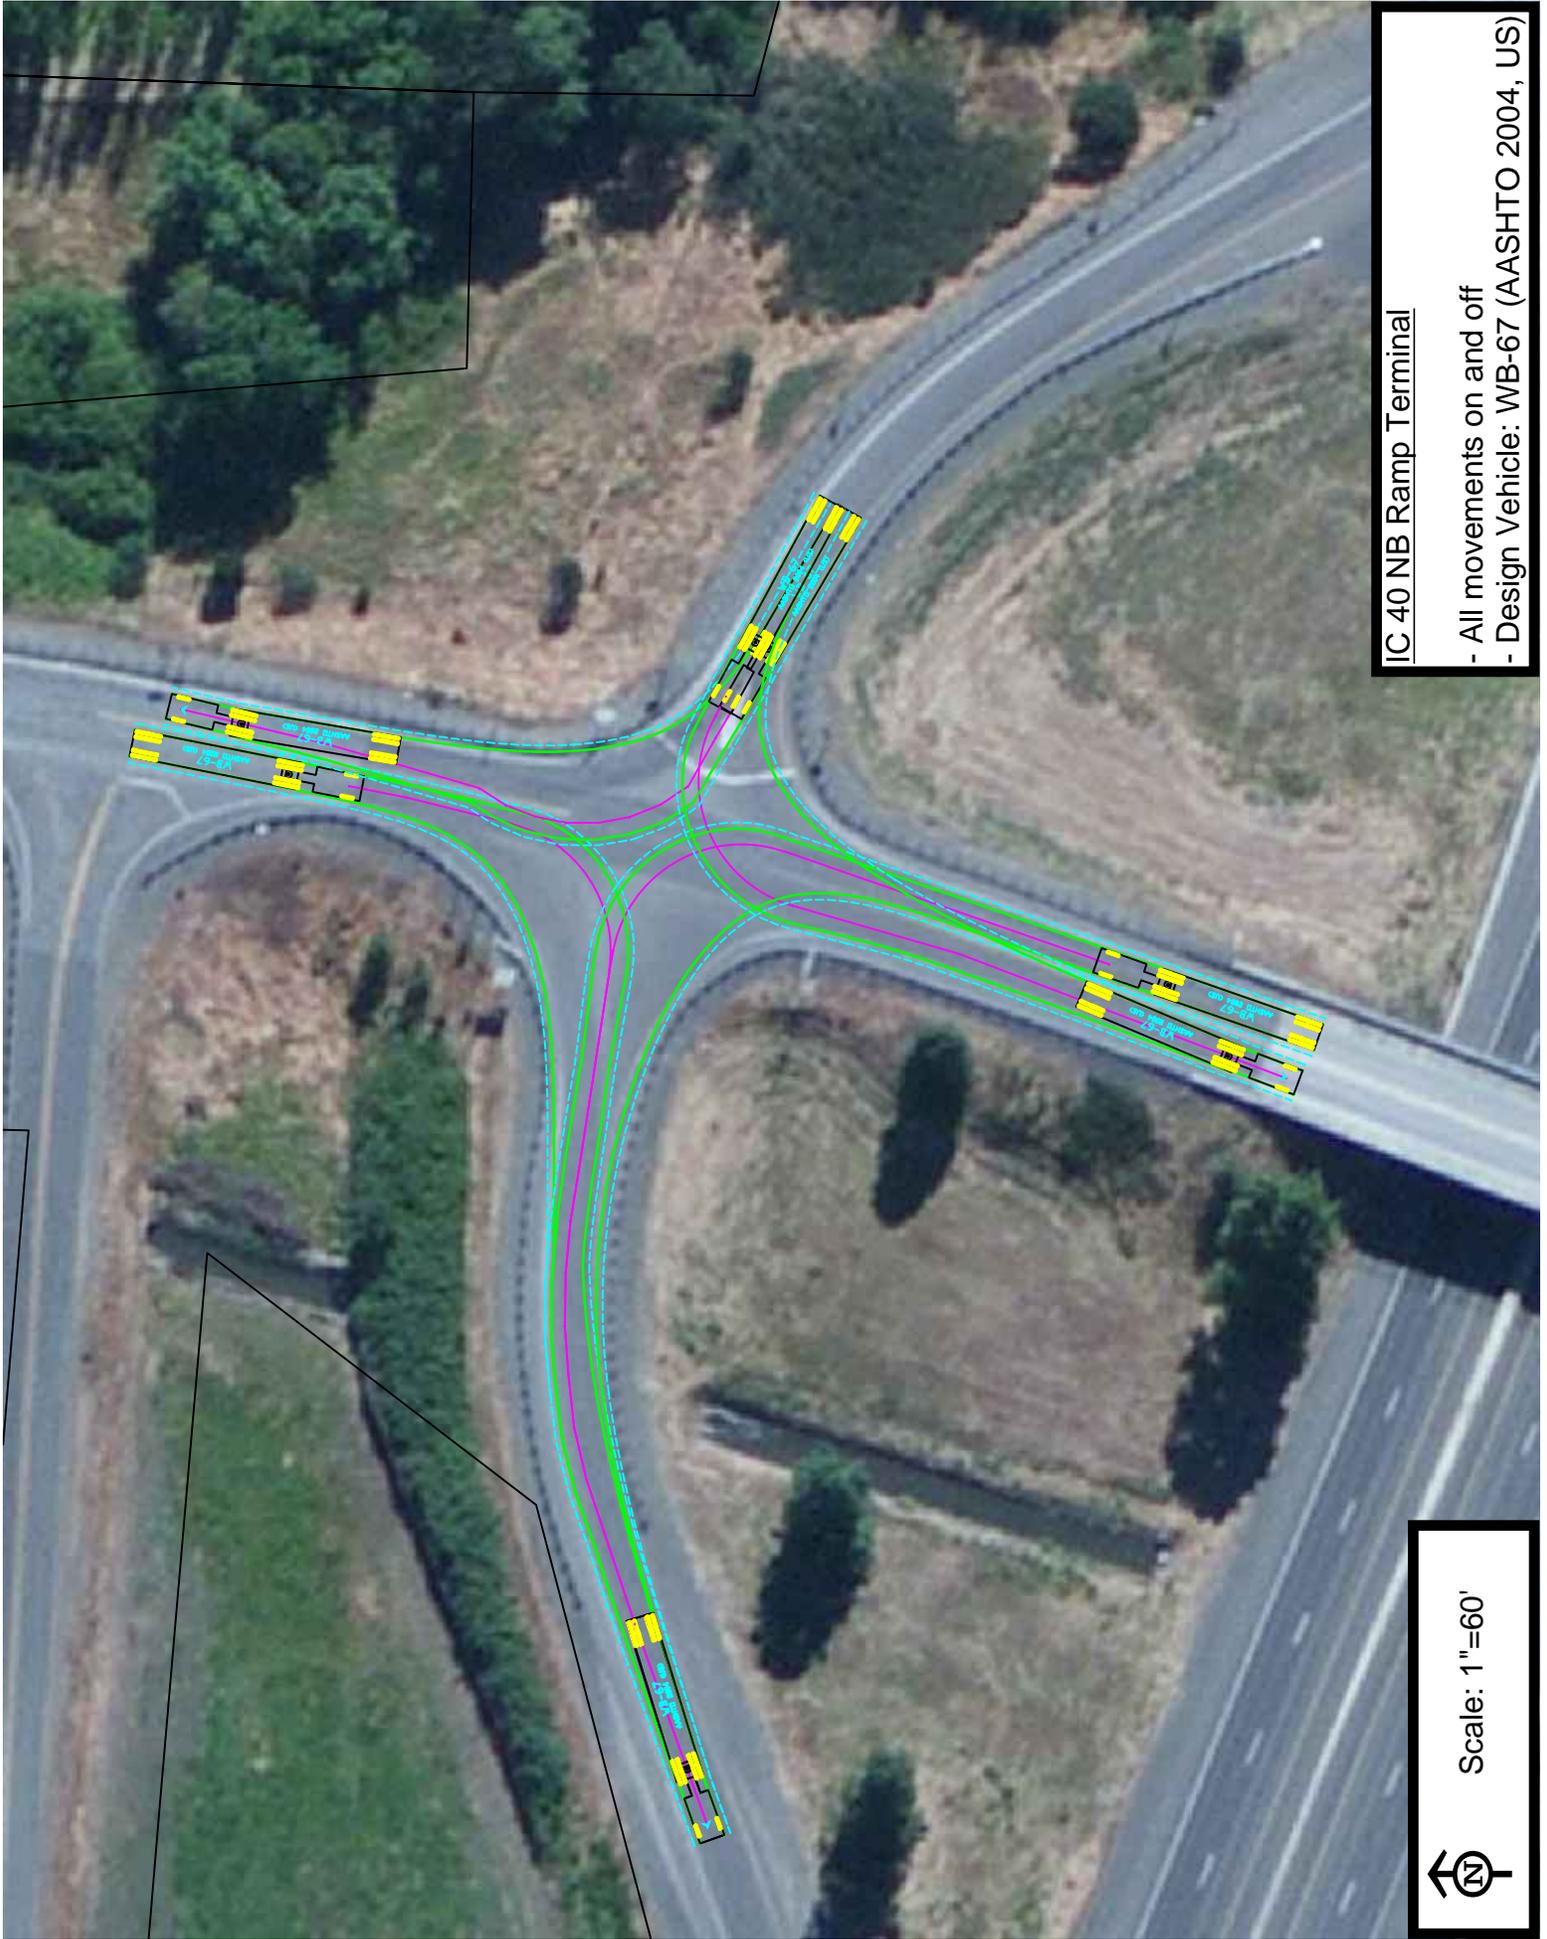
IC 40 NB Ramp Terminal

- All movements on and off
- Design Vehicle: WB-67 (AASHTO 2004, US)

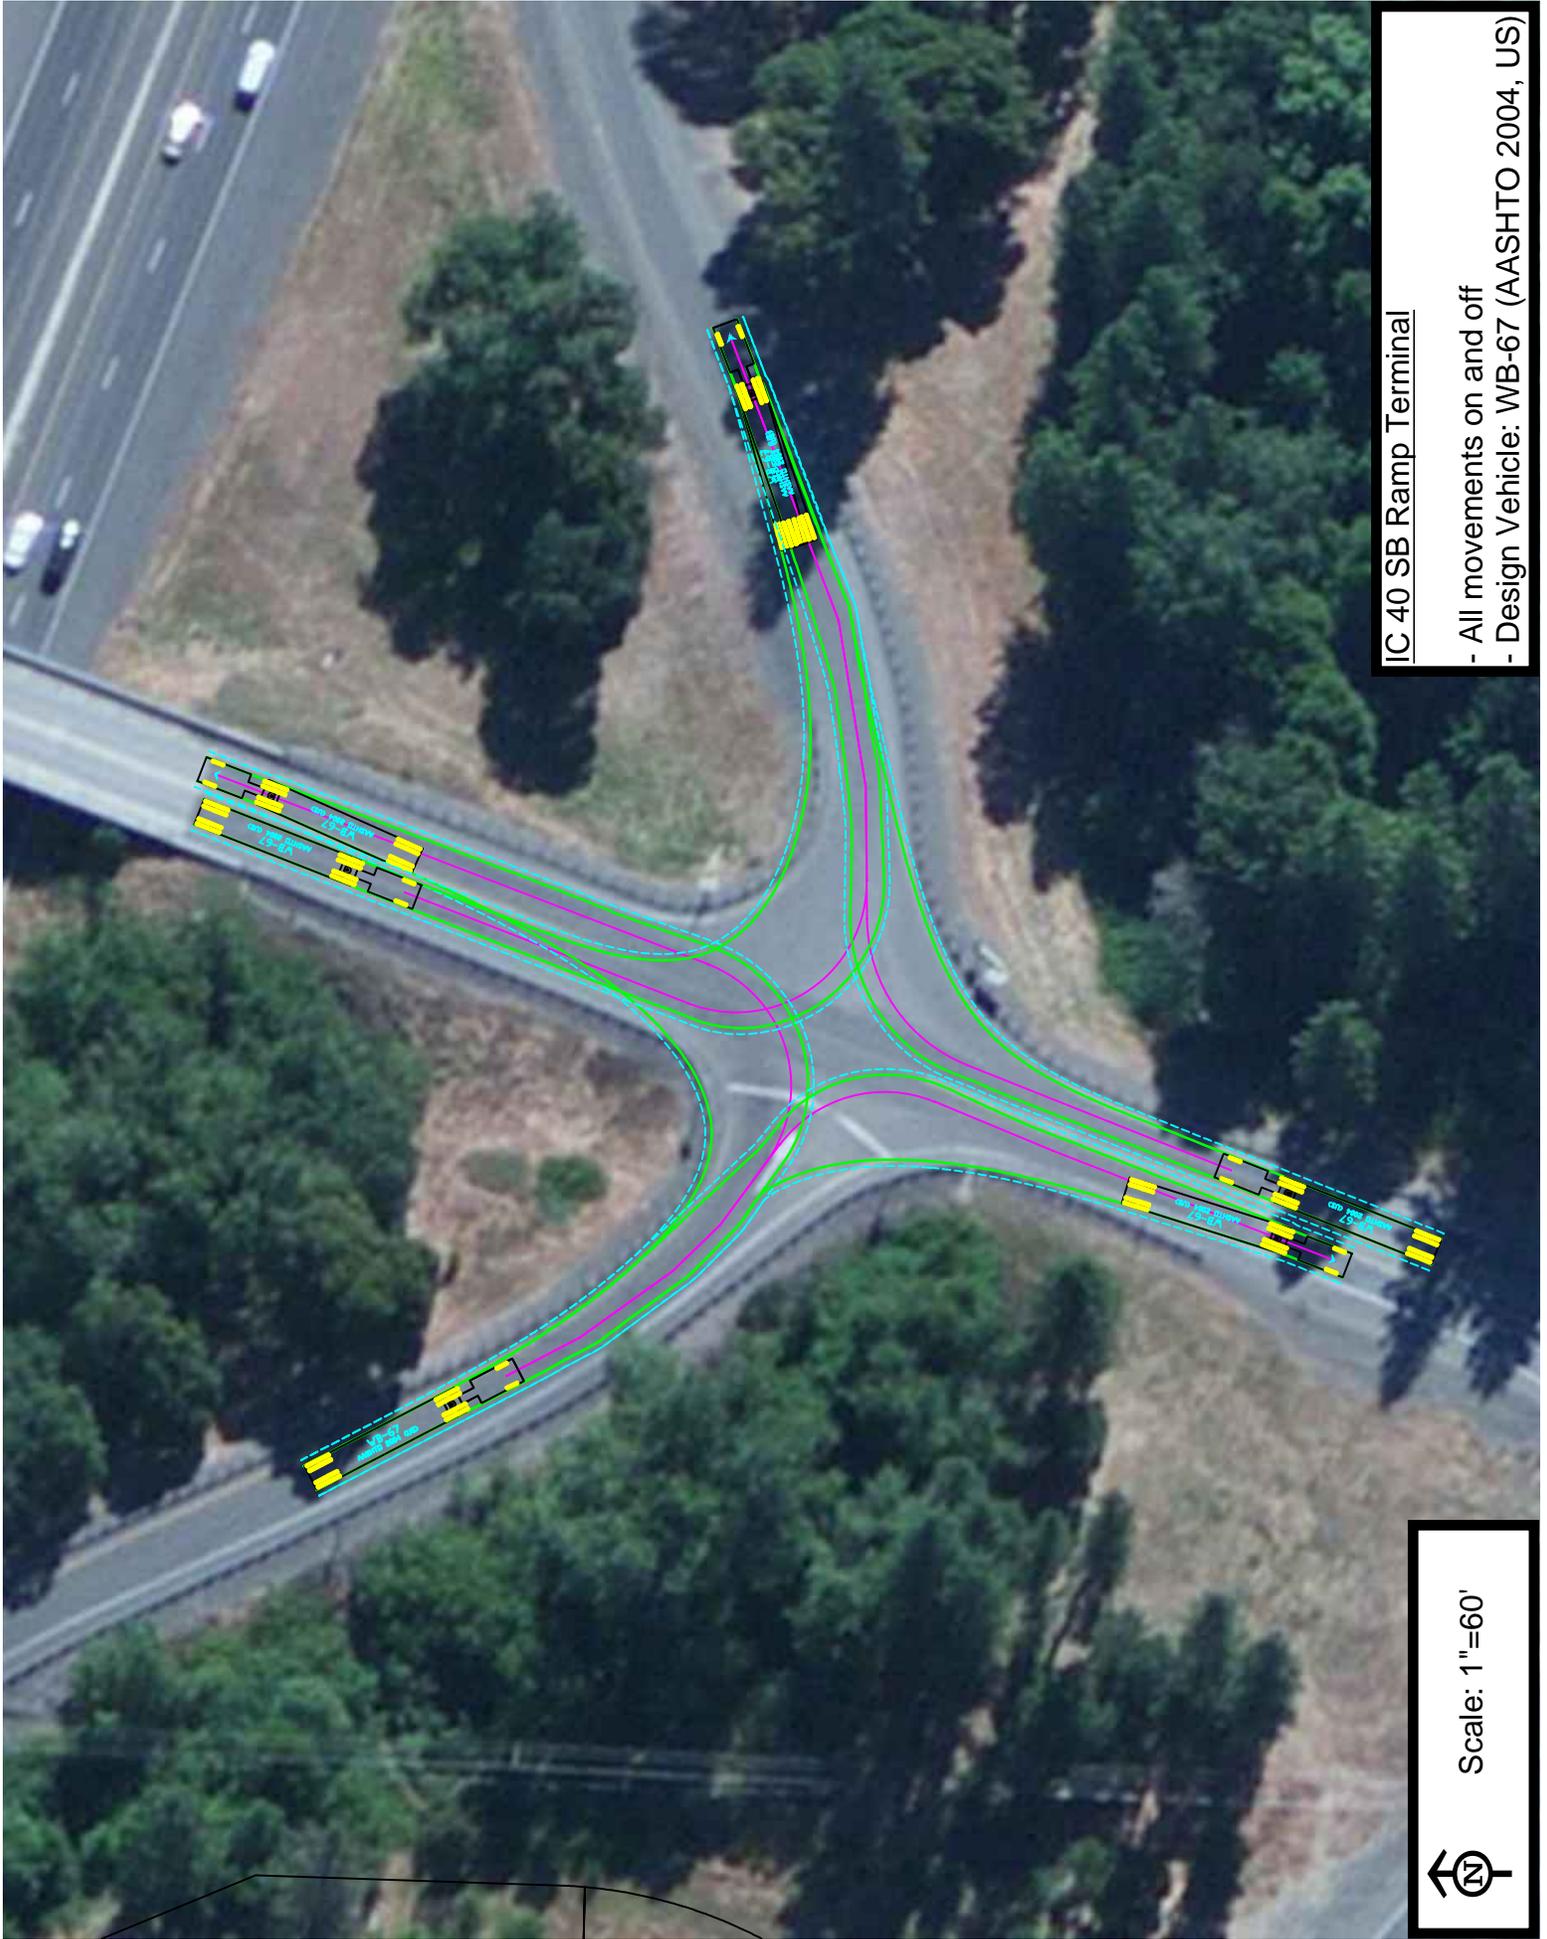
IC 40 SB Ramp Terminal

- All movements on and off
- Design Vehicle: WB-67 (AASHTO 2004, US)

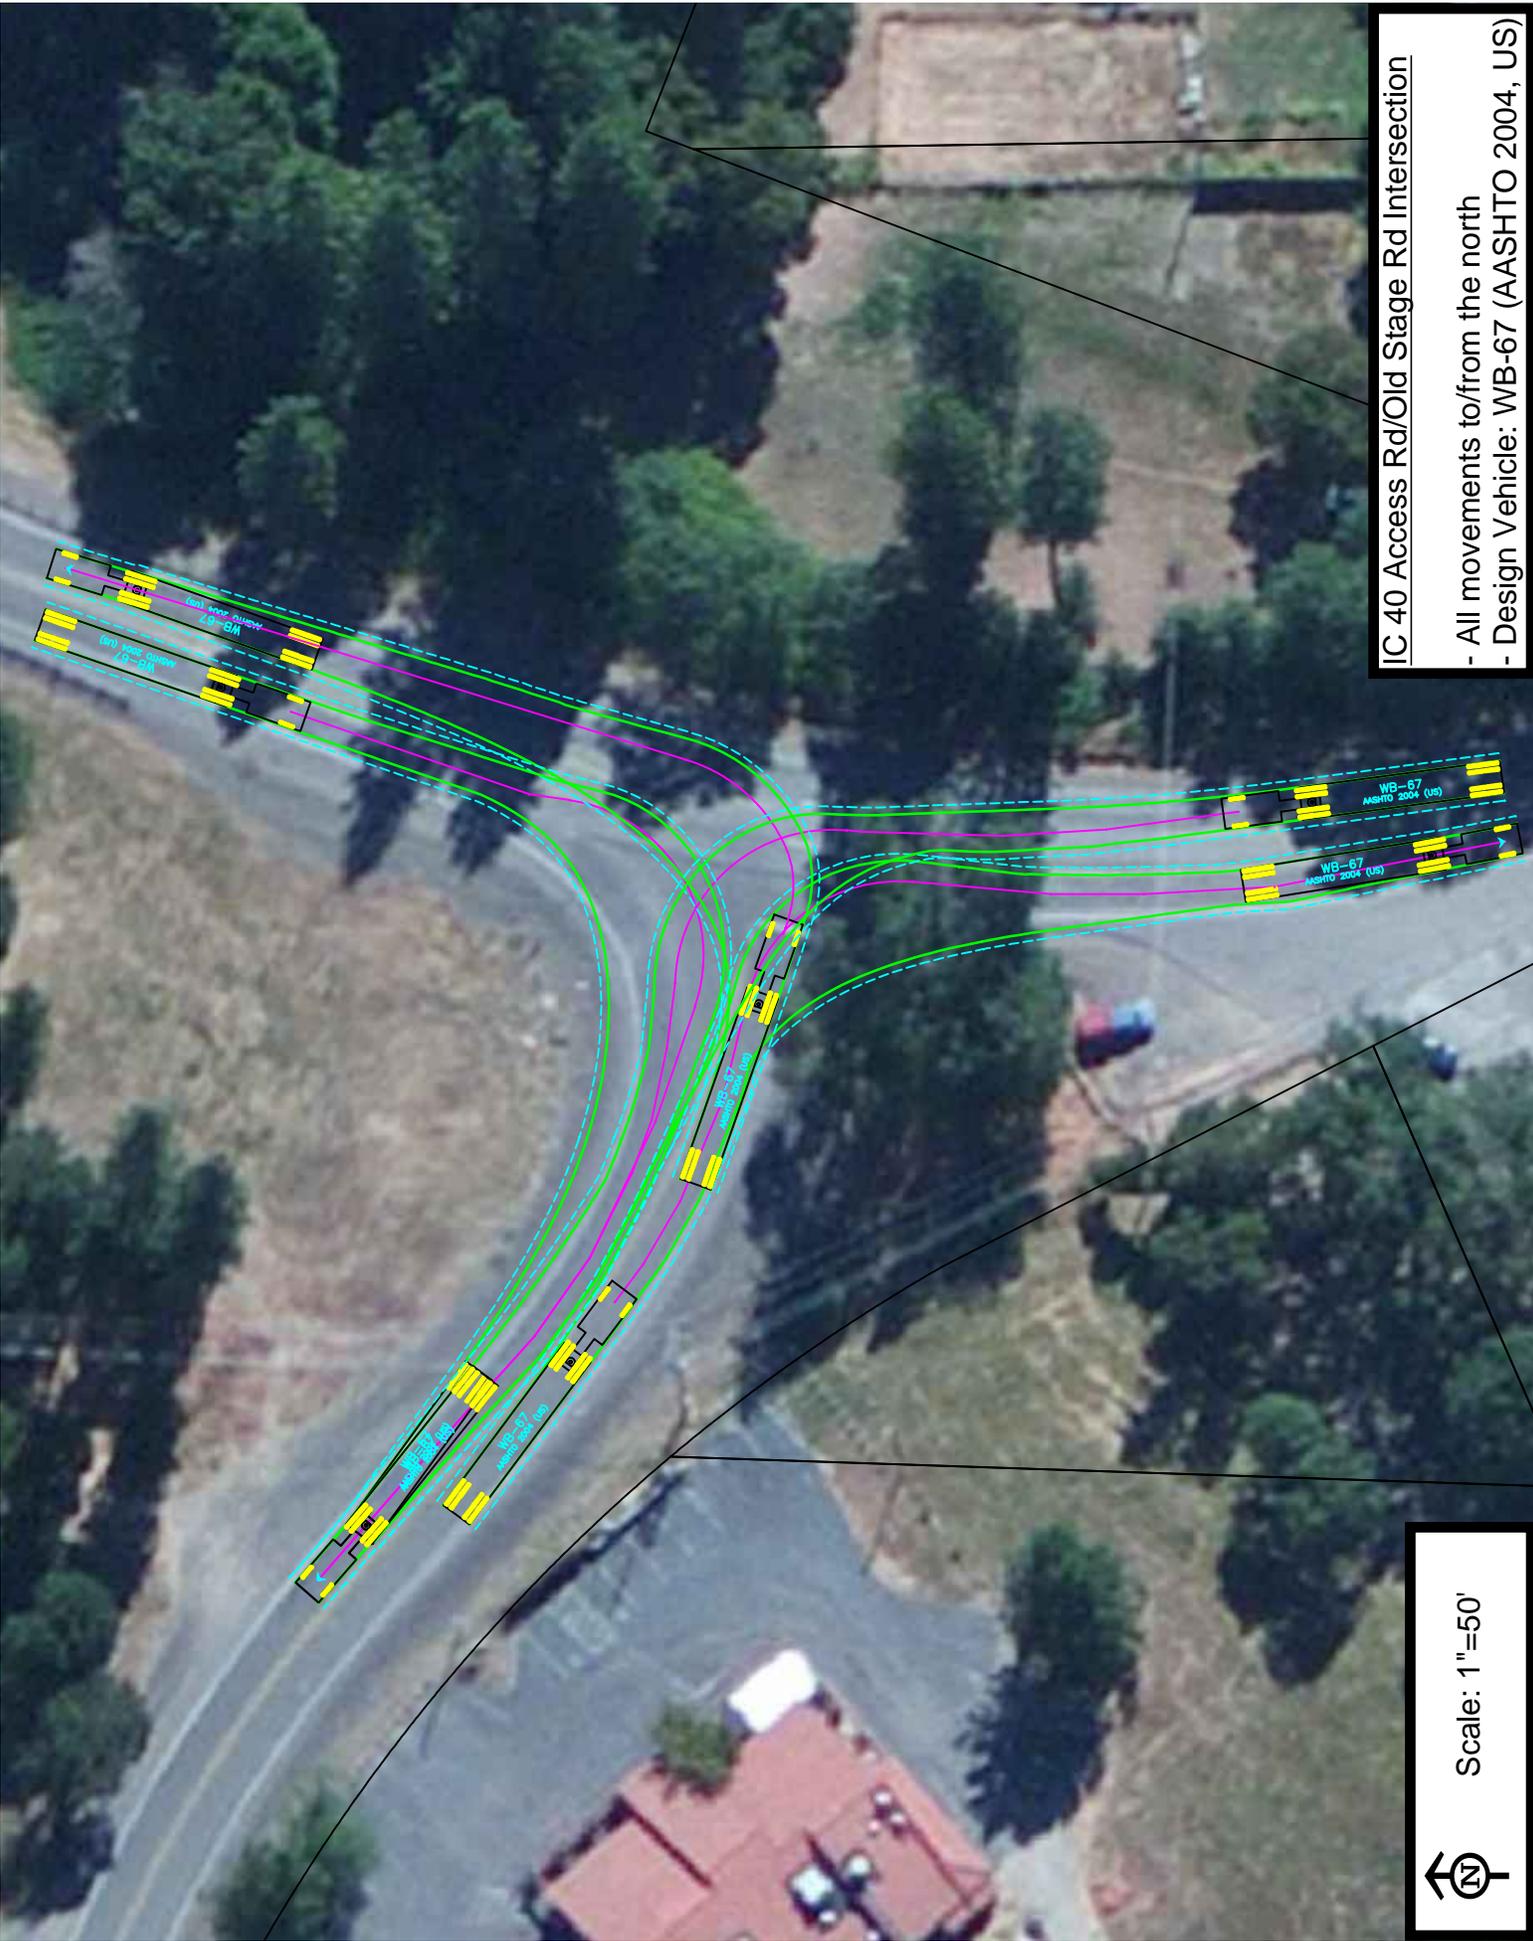
IC 40 Access Rd/Old Stage Rd Intersection

- All movements to/from the north
- Design Vehicle: WB-67 (AASHTO 2004, US)

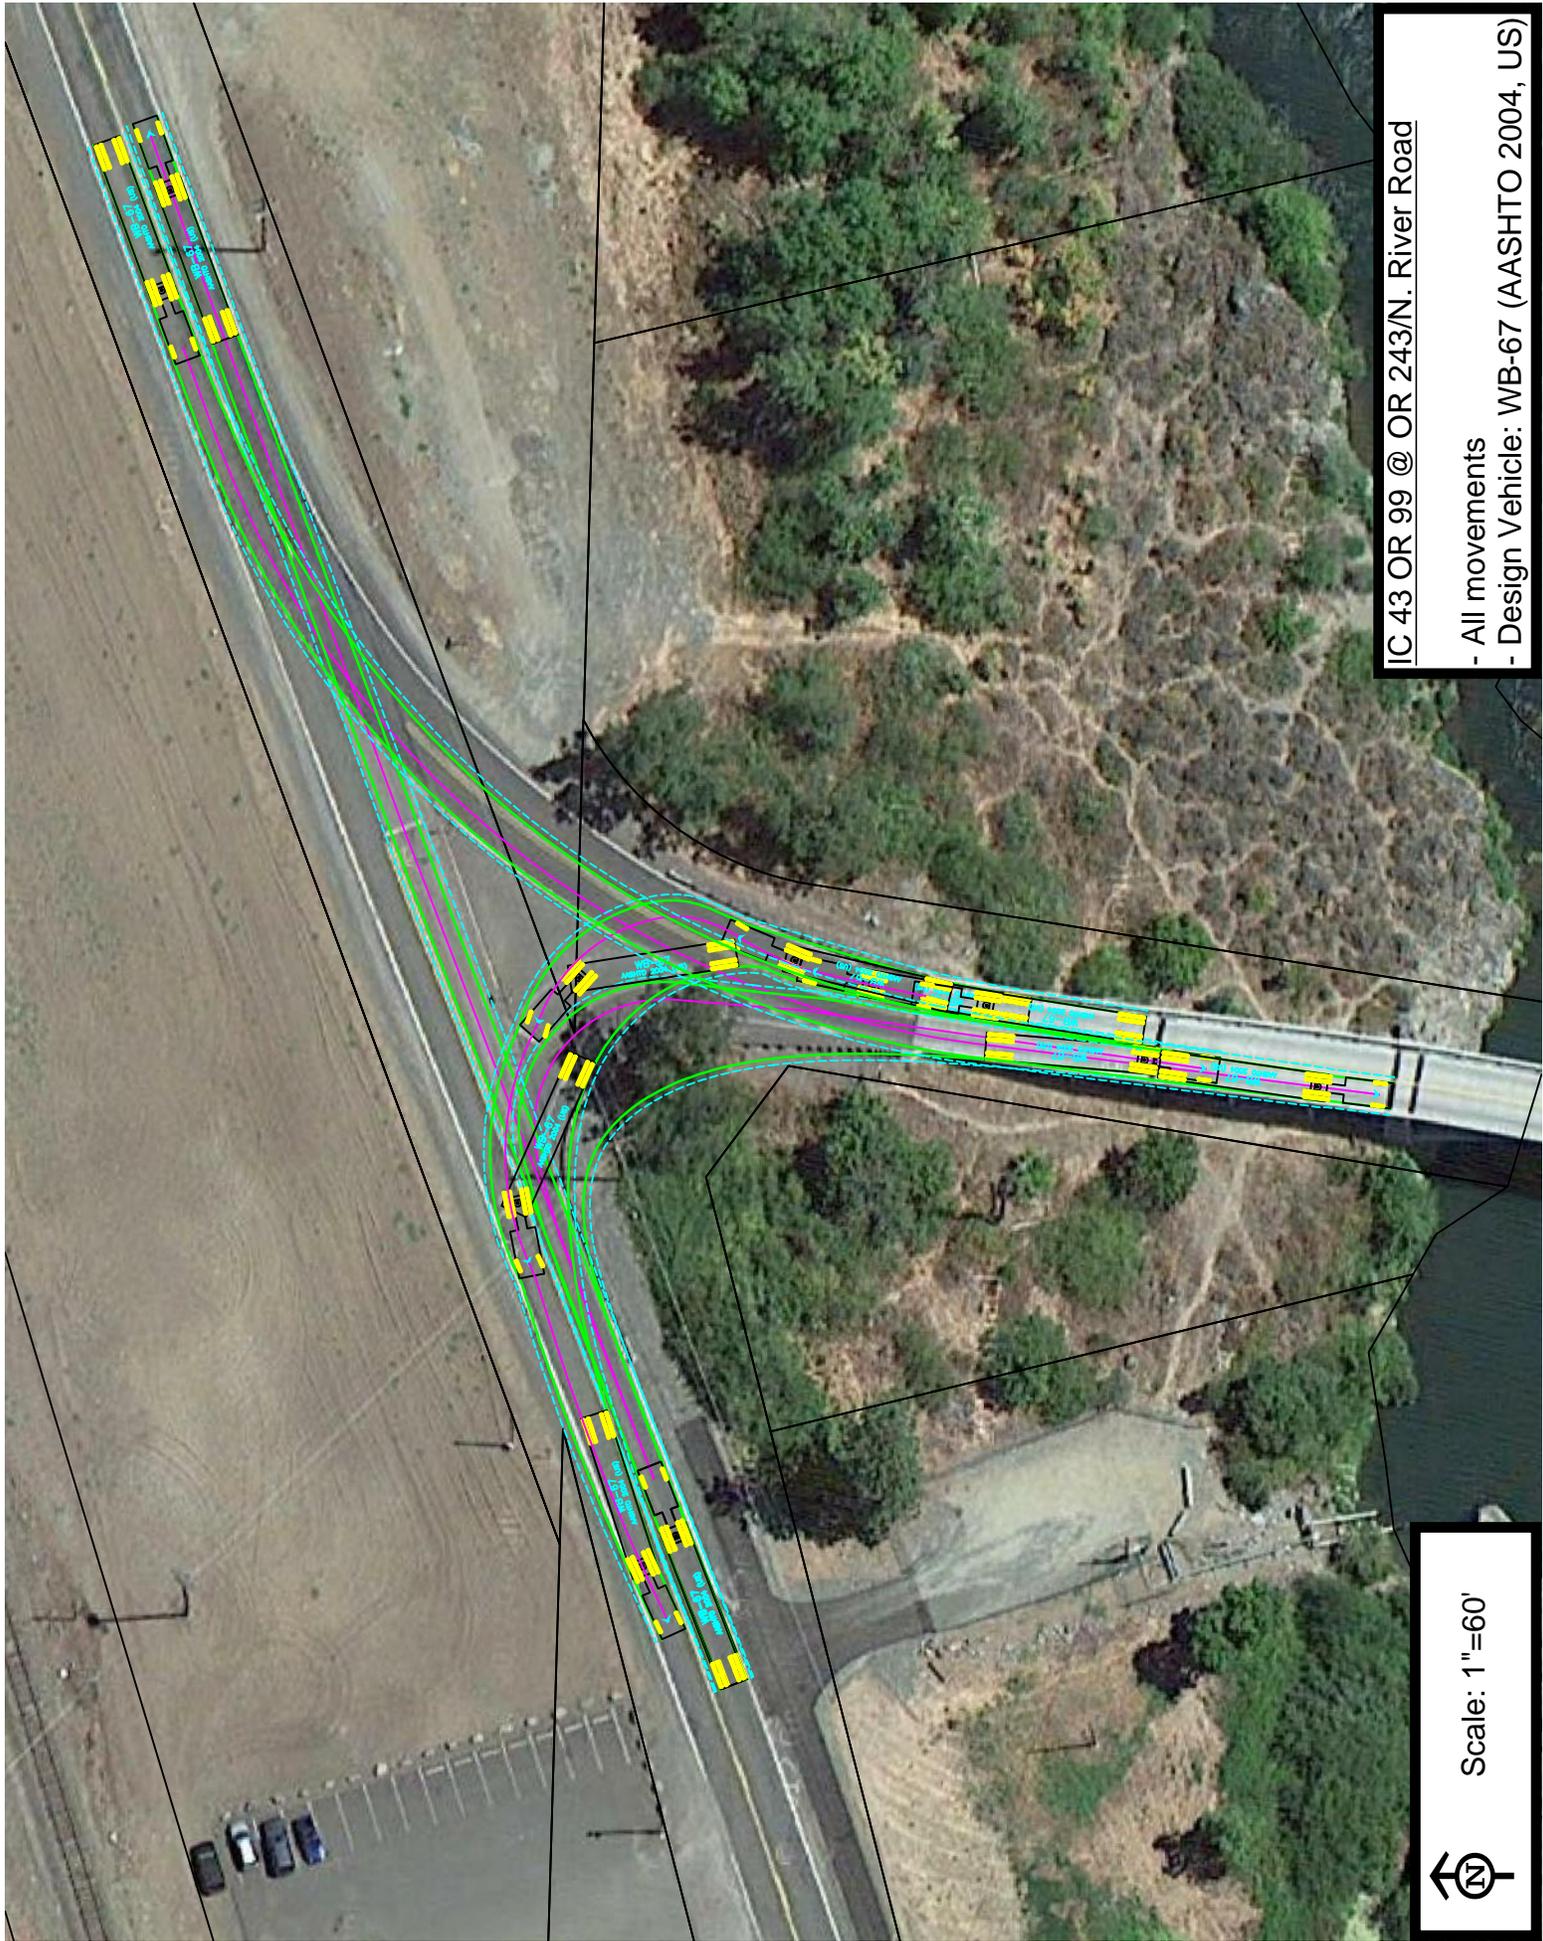
IC 43 OR 99 @ OR 243/N. River Road

- All movements
- Design Vehicle: WB-67 (AASHTO 2004, US)
