**I-5 Exits 40 and 43 (Gold Hill)
Interchange Area Management Plans**

**Technical Memorandum #3
Study Area Inventory**

David Evans and Associates, Inc.
2100 SW River Parkway
Portland, Oregon

May 2015

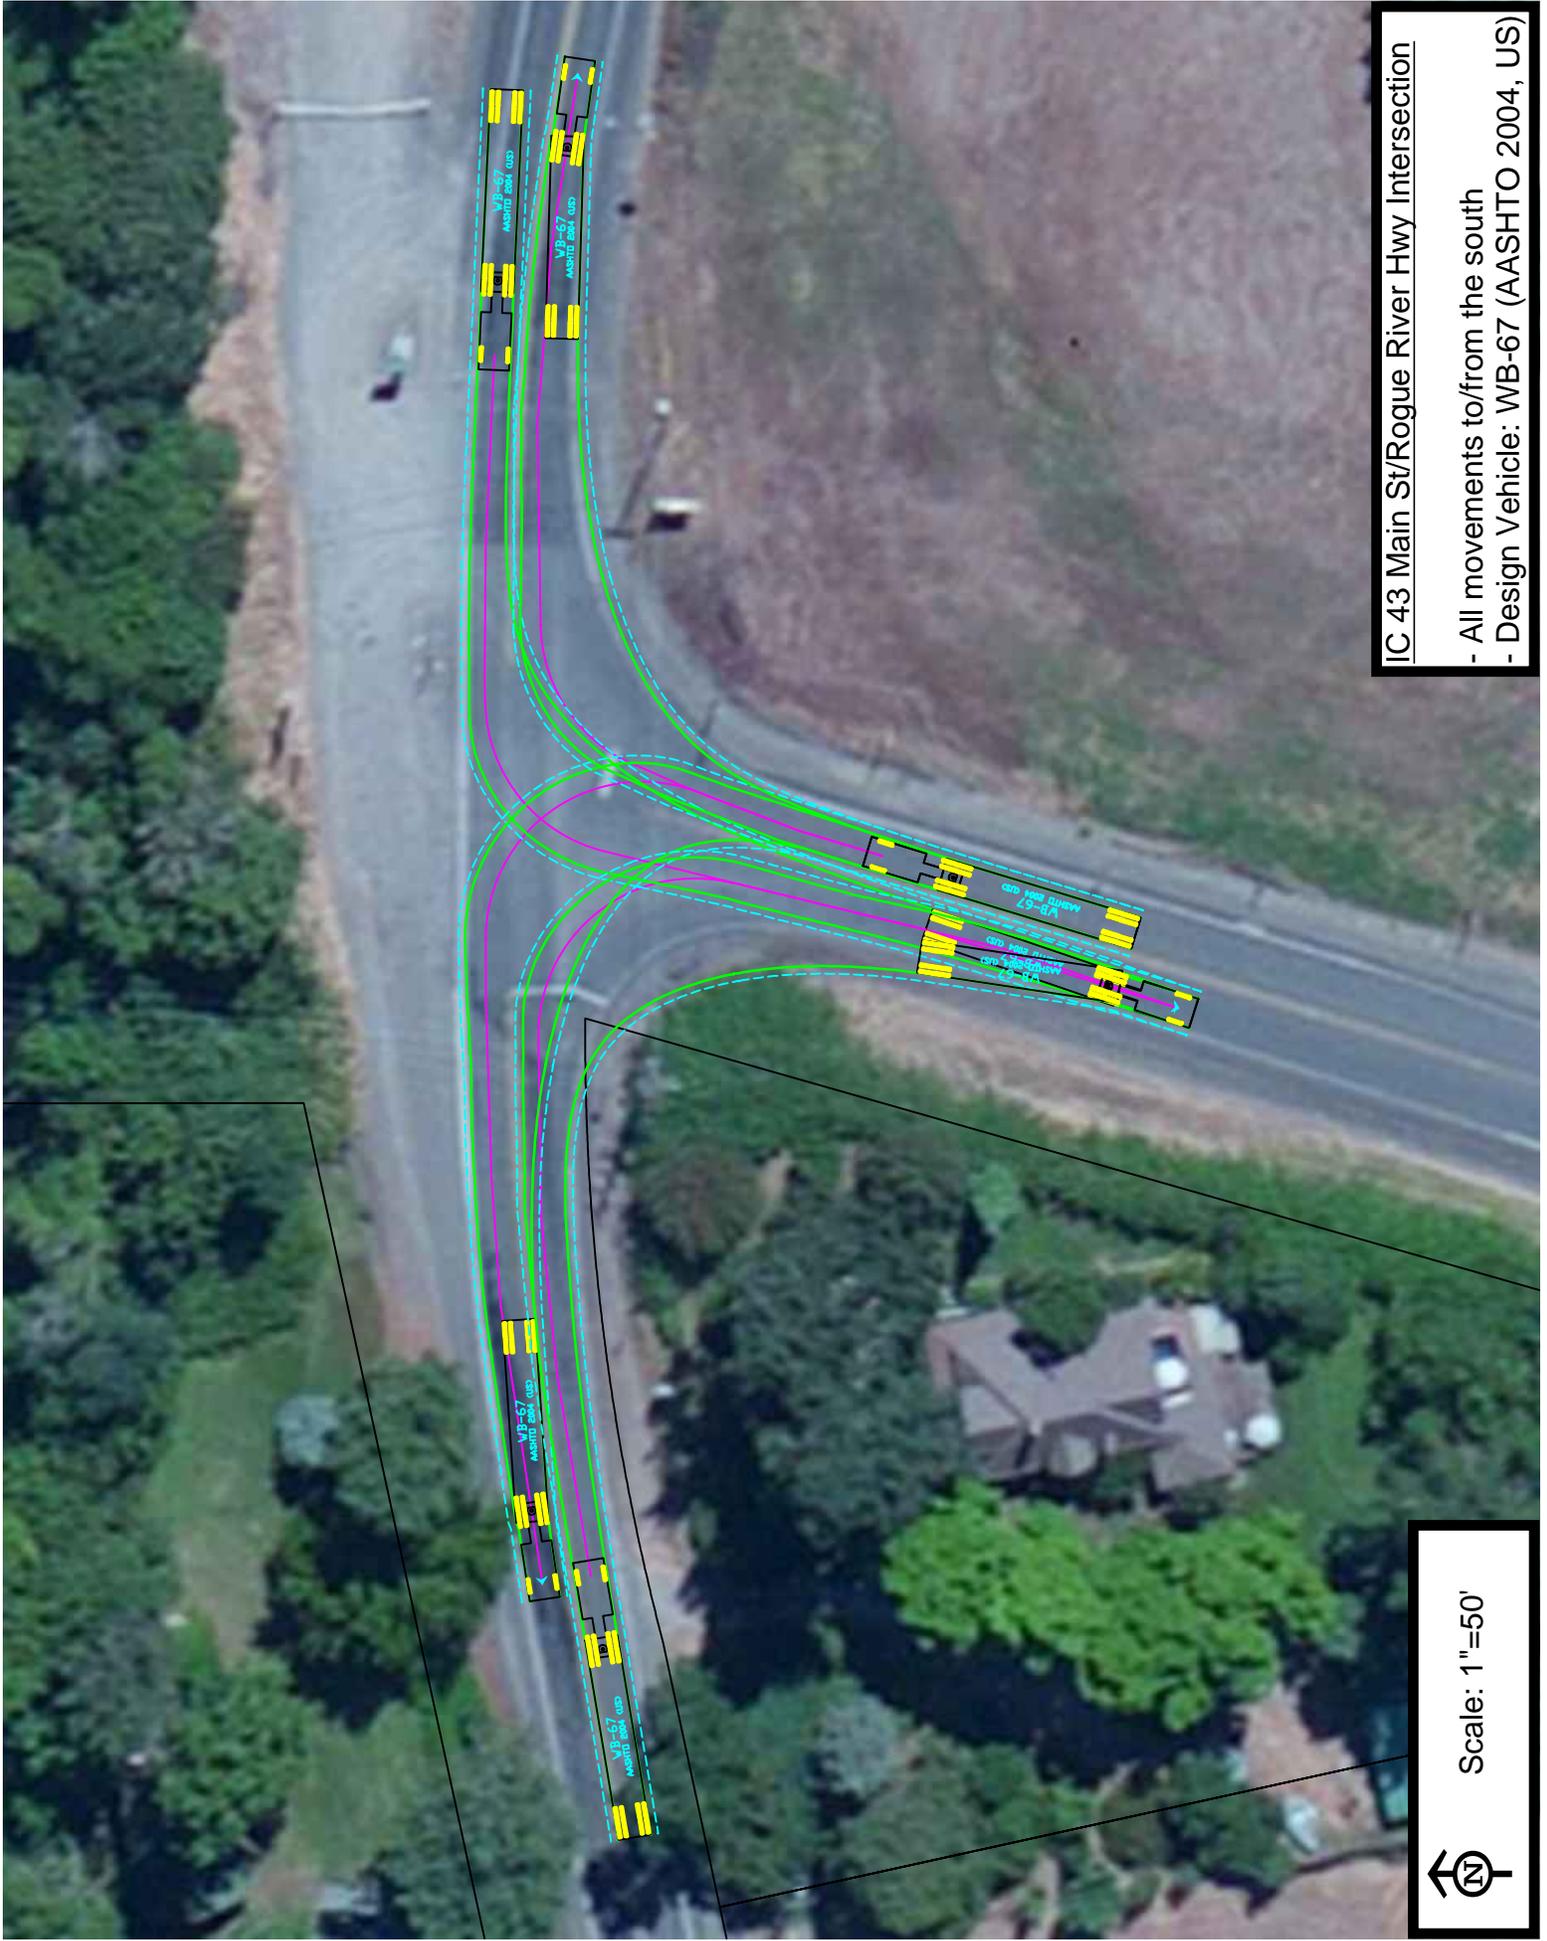
IC 43 Main St/Rogue River Hwy Intersection

- All movements to/from the south
- Design Vehicle: WB-67 (AASHTO 2004, US)

All intersections assessed in each IMSA have at least two turning movements that will not allow a WB-67 (design vehicle) to execute a turning maneuver without crossing into oncoming traffic or tracking onto the roadway shoulder. In some cases, both are necessary when a WB-67 is making a turn. Truck turning movement diagrams can be found in Appendix B.

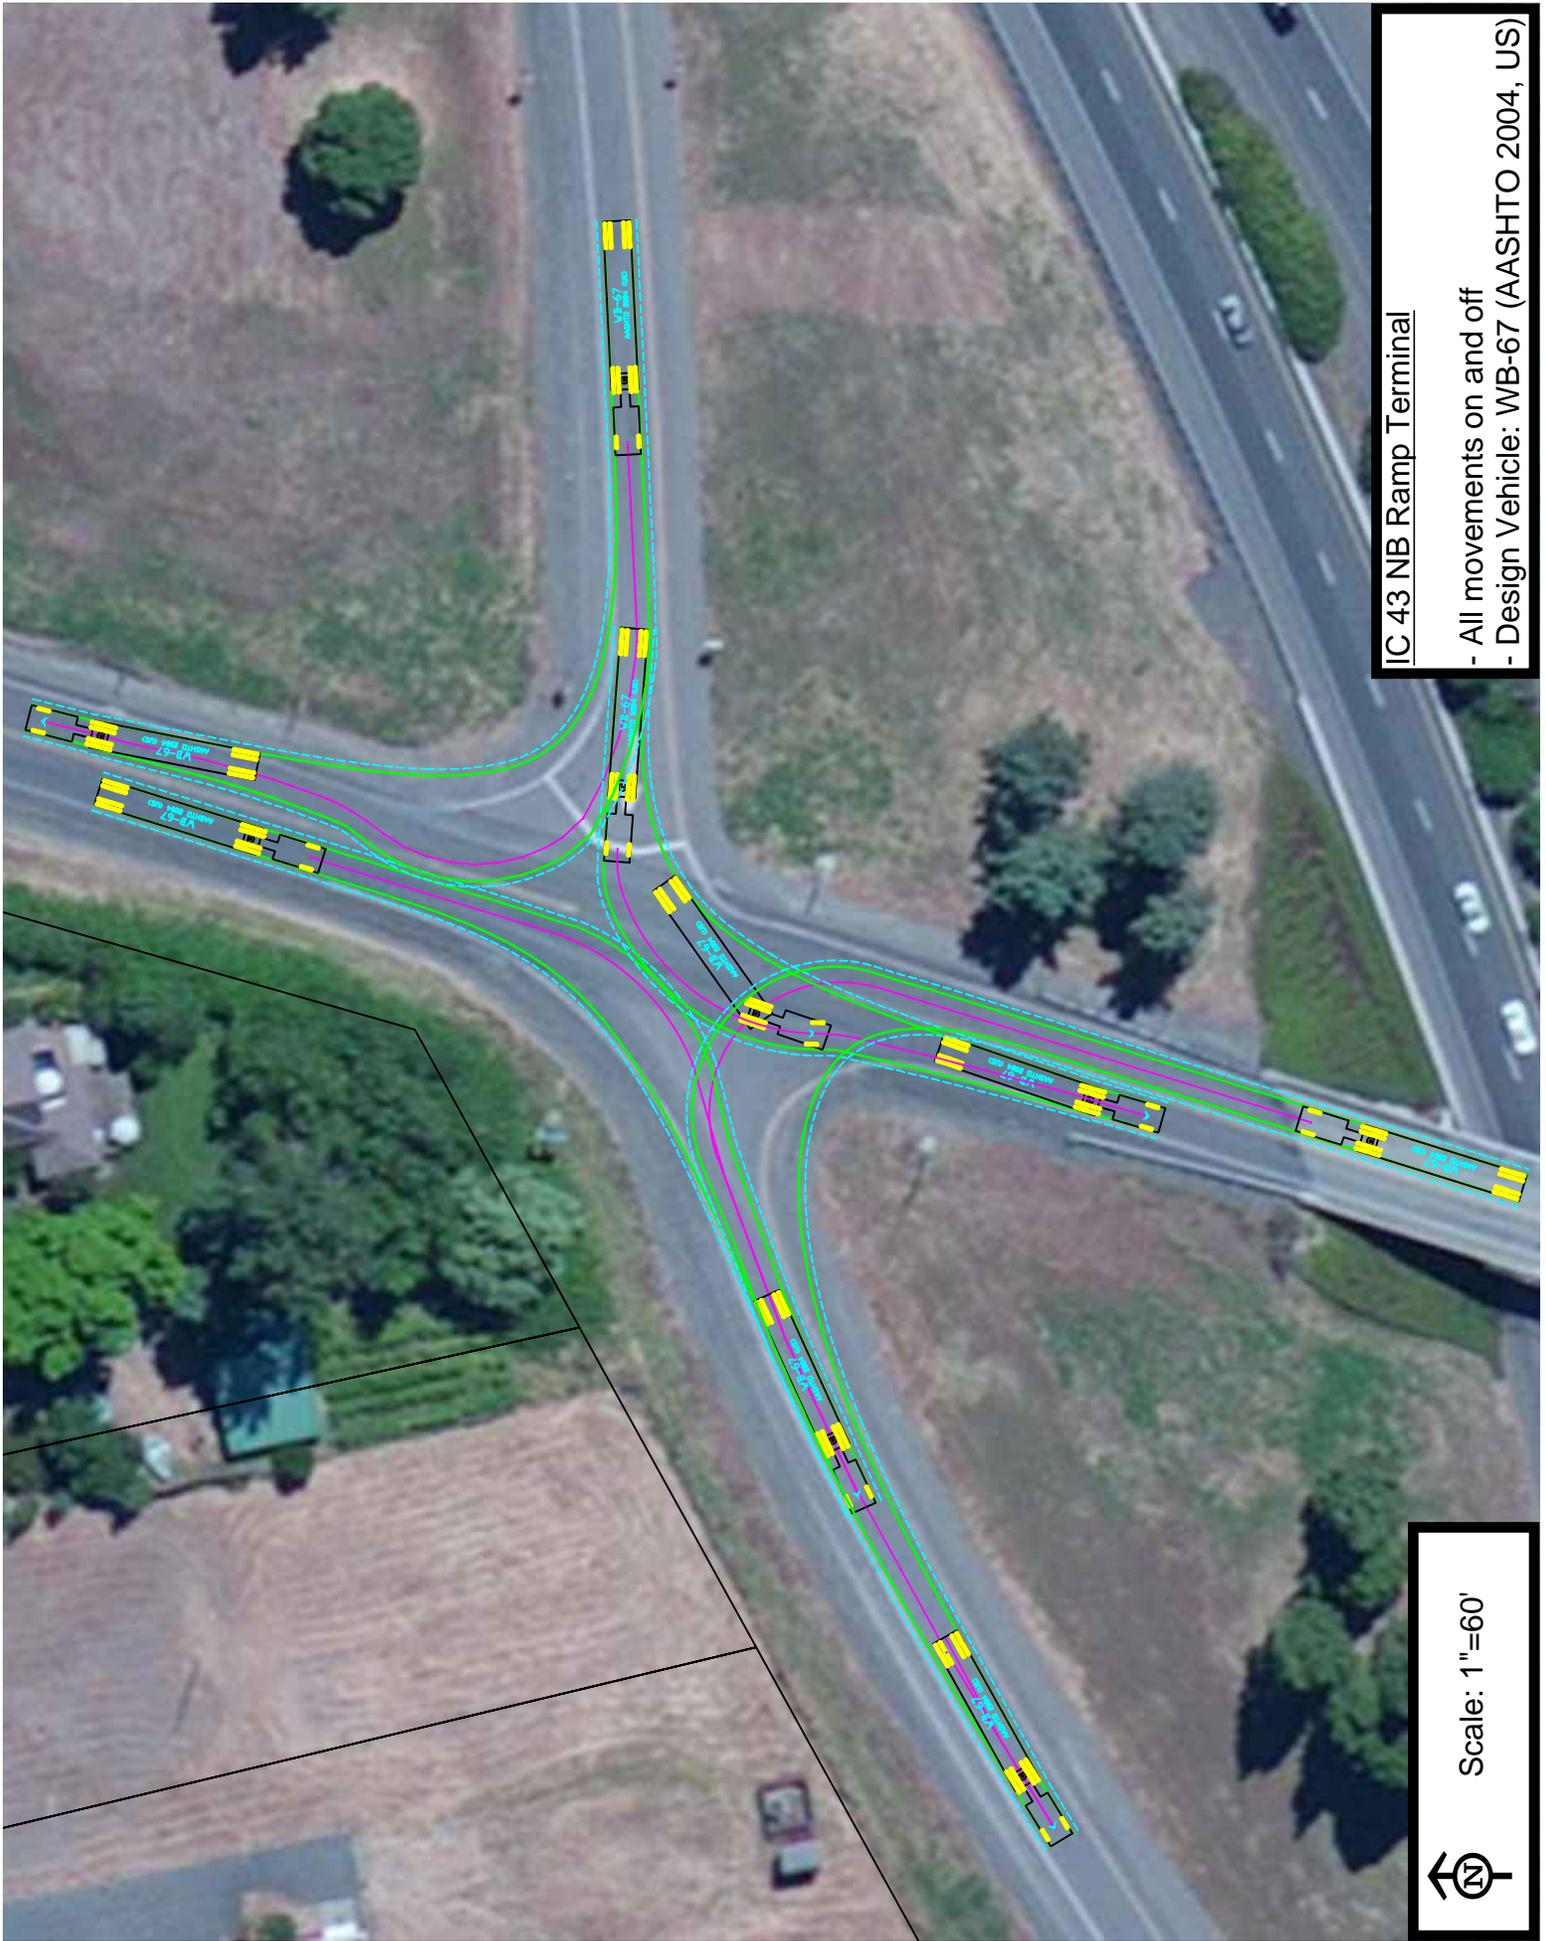
IC 43 NB Ramp Terminal

- All movements on and off
- Design Vehicle: WB-67 (AASHTO 2004, US)

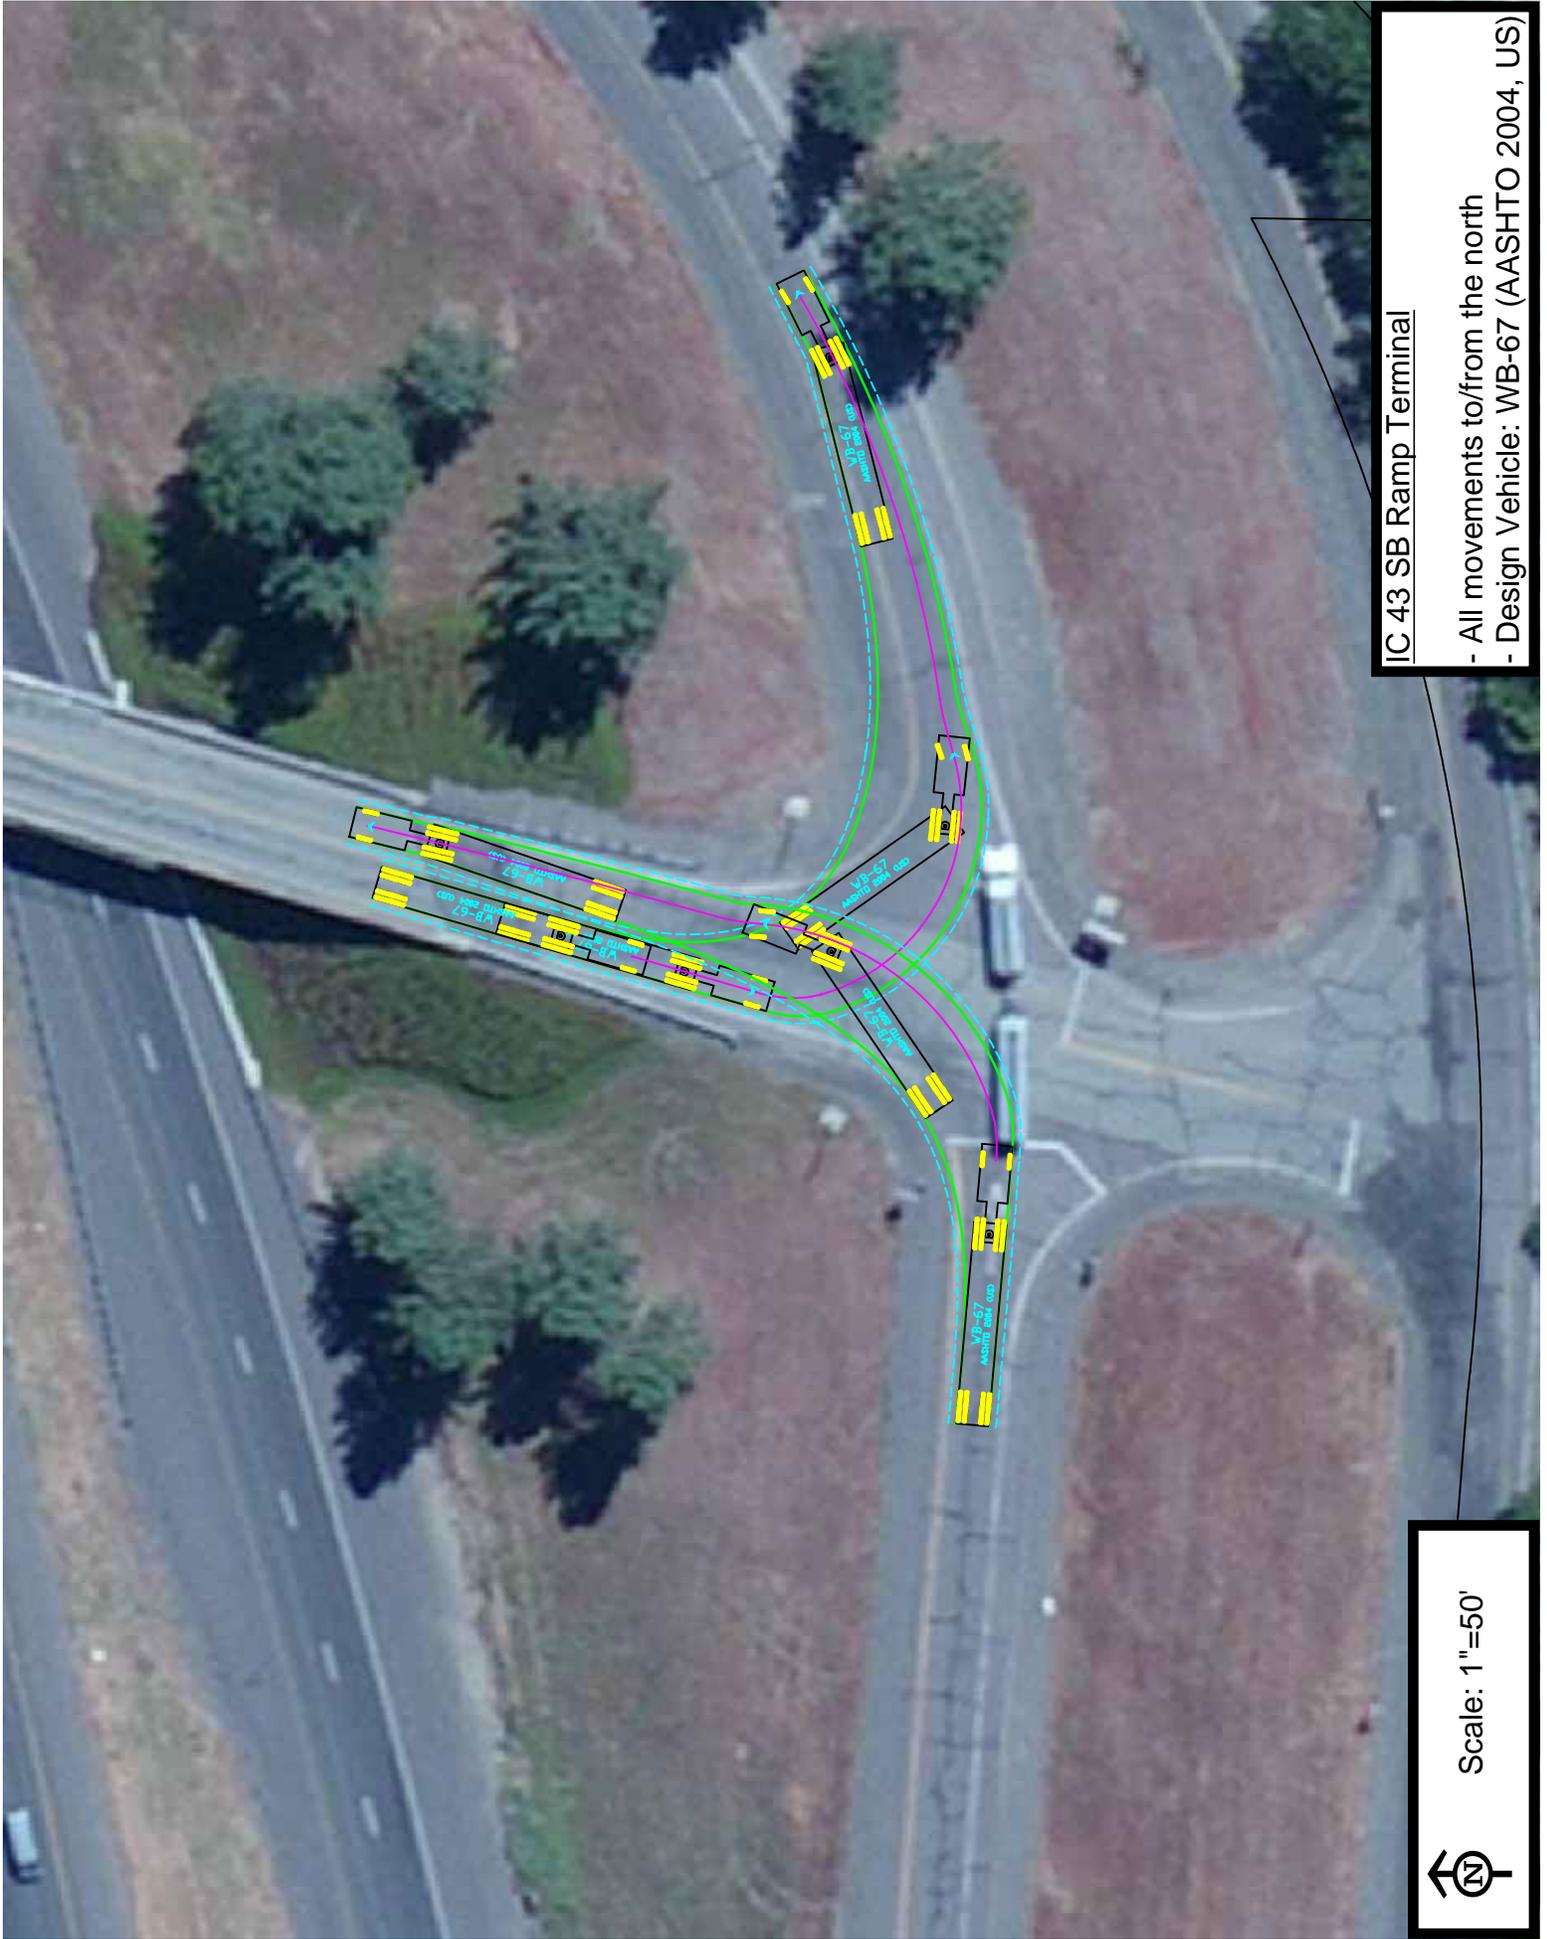
IC 43 SB Ramp Terminal

- All movements to/from the north
- Design Vehicle: WB-67 (AASHTO 2004, US)
