KEEPING BRIDGES STRONG AND HANDSOME

The historic Horsetail Falls Bridge is a 60-foot reinforced concrete bridge that consists of three 20-foot spans. The structure, built in 1914 at a cost of \$1,817, is located in the Columbia Gorge, 30 miles east of Portland. This bridge, like many others in Oregon, was not designed to carry the traffic loads that are common today.

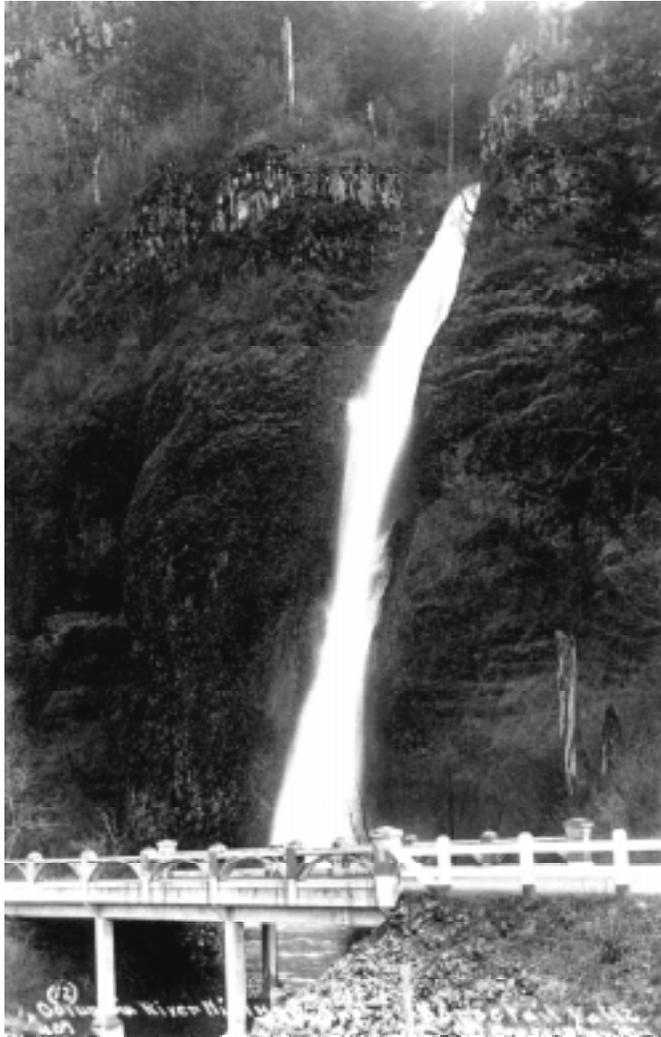
Figure 1: Horsetail Falls Bridge Circa 1914

The bridge was rated by a consultant and was found to have only 7% of needed shear capacity and approximately 50% in flexure. As a historic structure, any structural upgrade to the Horsetail Falls Bridge should not significantly alter its appearance.

Visual evaluation revealed that the bottom of the deck and beams had many hairline cracks, a few larger cracks, and some exposed, corroded reinforcing steel. However, the condition of the concrete and reinforcing steel was very good, considering the age of the bridge.

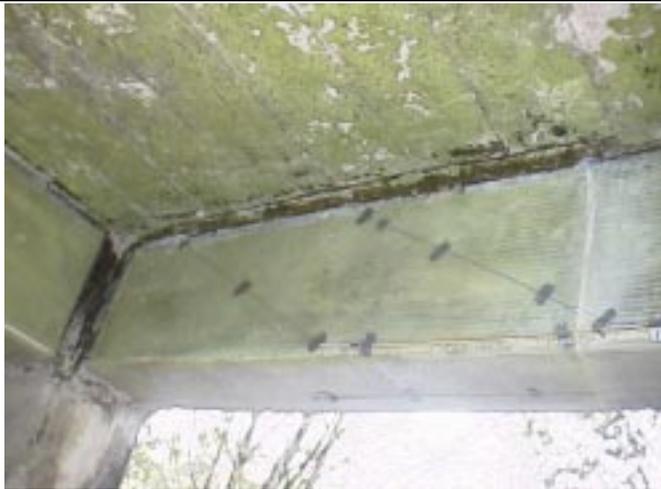
Figure 2: Shear-Strengthened Beam with Fiber Optic Sensors under the Fiber Reinforced Polymer

The composite system used for this project was developed and supplied by Fyfe Corporation of San Diego. A local contractor who was certified by Fyfe installed the composite and, working with Blue Road, installed the sensors (Figure 2)

The design and analysis for the structural upgrade was done as a joint effort between ODOT's Bridge Engineering Section and OSU. The performance and durability monitoring system was designed around fiber optic strain sensors. This phase of the work was done in a joint effort between the Research Unit and Blue Road Research in Troutdale, Oregon.

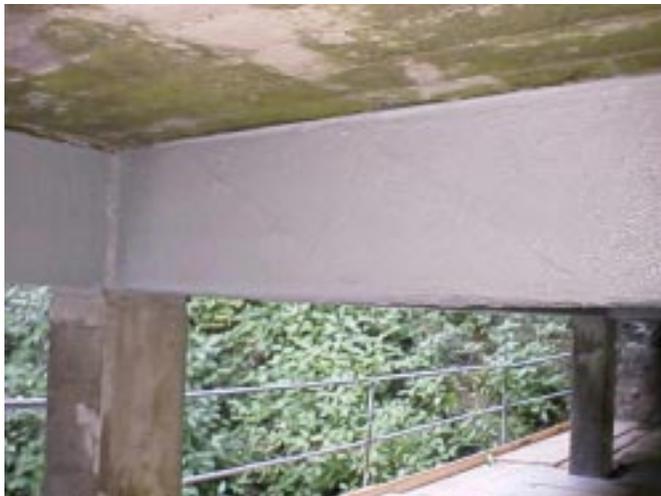
Figure 3: The Completed Beams with Cosmetic Coat

Since the Horsetail Falls Bridge is an historic structure, a special cosmetic coat (Figure 3) was placed over the FRP composite and sensors to match the appearance of the original concrete.

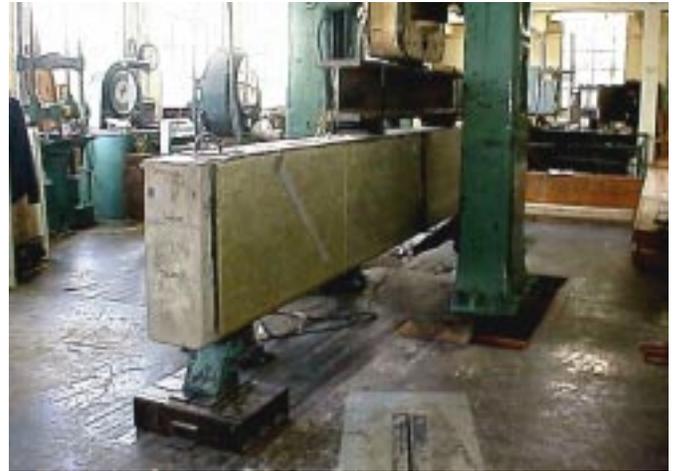
Figure 4: Testing the Full Size Beam at OSU

Concurrently, the Bridge Section and Research Unit contracted with OSU to build four full-size beams as nearly identical to the bridge's originals as possible. One beam would be used for control. The other three would be strengthened for shear, flexure and shear plus flexure respectively.

Upon completion of the construction work, the bridge was test-loaded, using a vehicle with known axle weights. Similar load testing is scheduled for the next two years. The data from the bridge is being compared to laboratory test results obtained from the full size beams that were tested at OSU.

- Tests on the full size, fully strengthened beam indicate that the beam exceeds HS20 load carrying capacity.
- Results from the bridge, when compared to the performance of the fully strengthened beam, indicate that the bridge meets or exceeds HS20 requirements.
