Tim Deboodt, OSU Crook County Extension Agent
498 SE Lynn Blvd. Prineville, OR 97754
541-447-6228
Tim.deboodt@oregonstate.edu

Increasing water availability through juniper control.

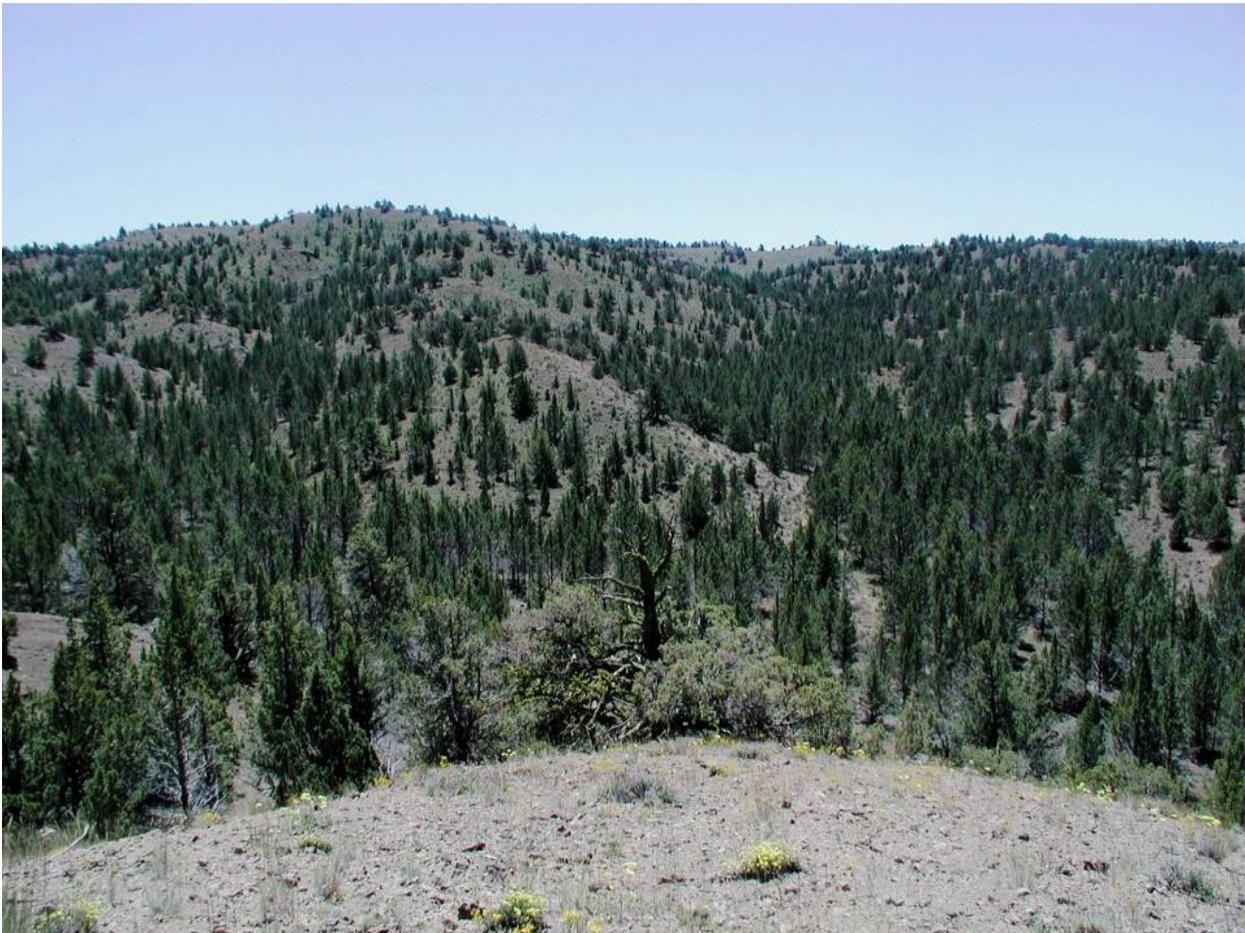
Mays Watershed: June 2005 prior to cutting. Note old growth juniper tree in the foreground.

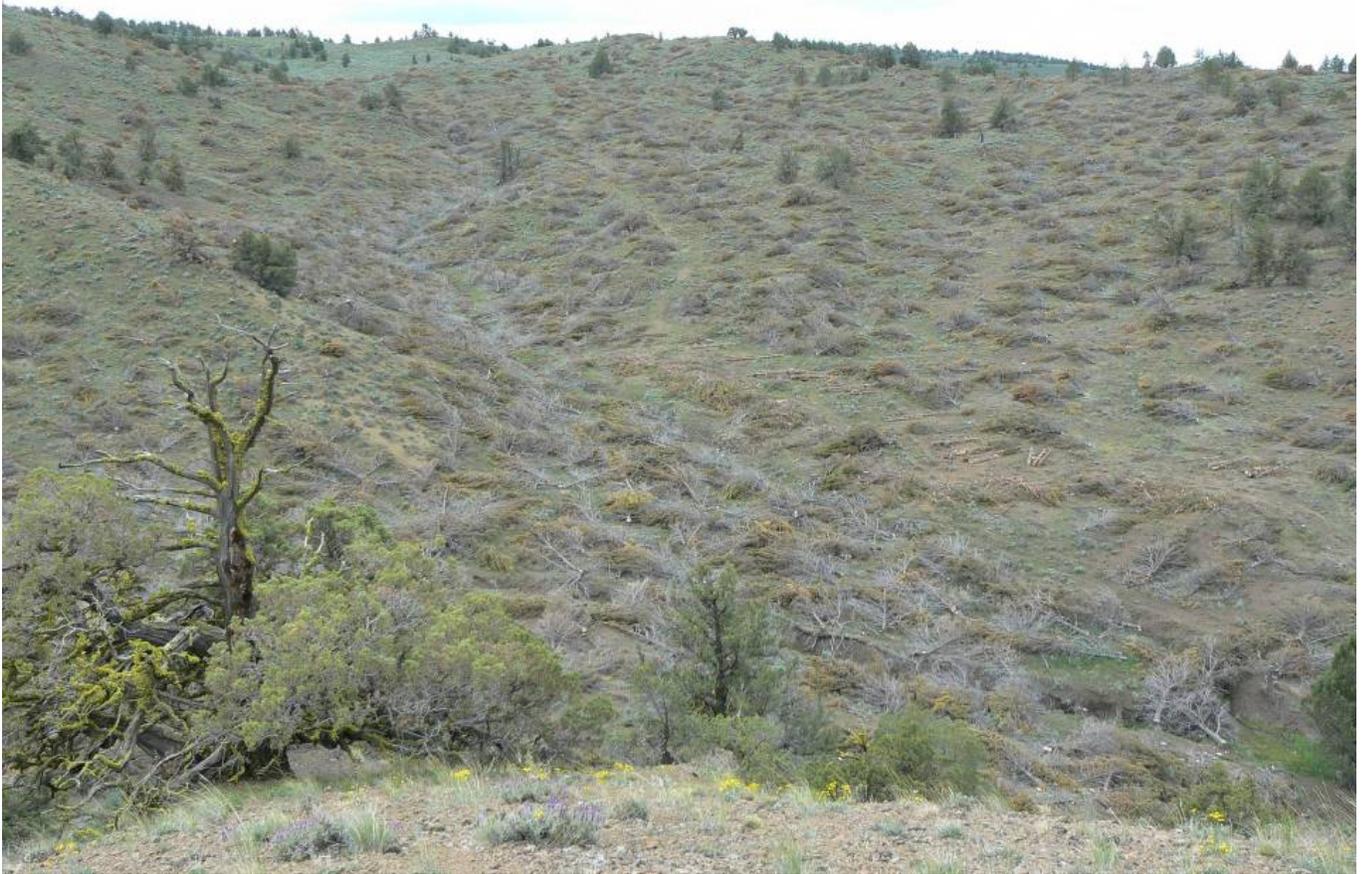
Mays Watershed: June 2006. Cutting completed. Note old growth tree in the foreground.

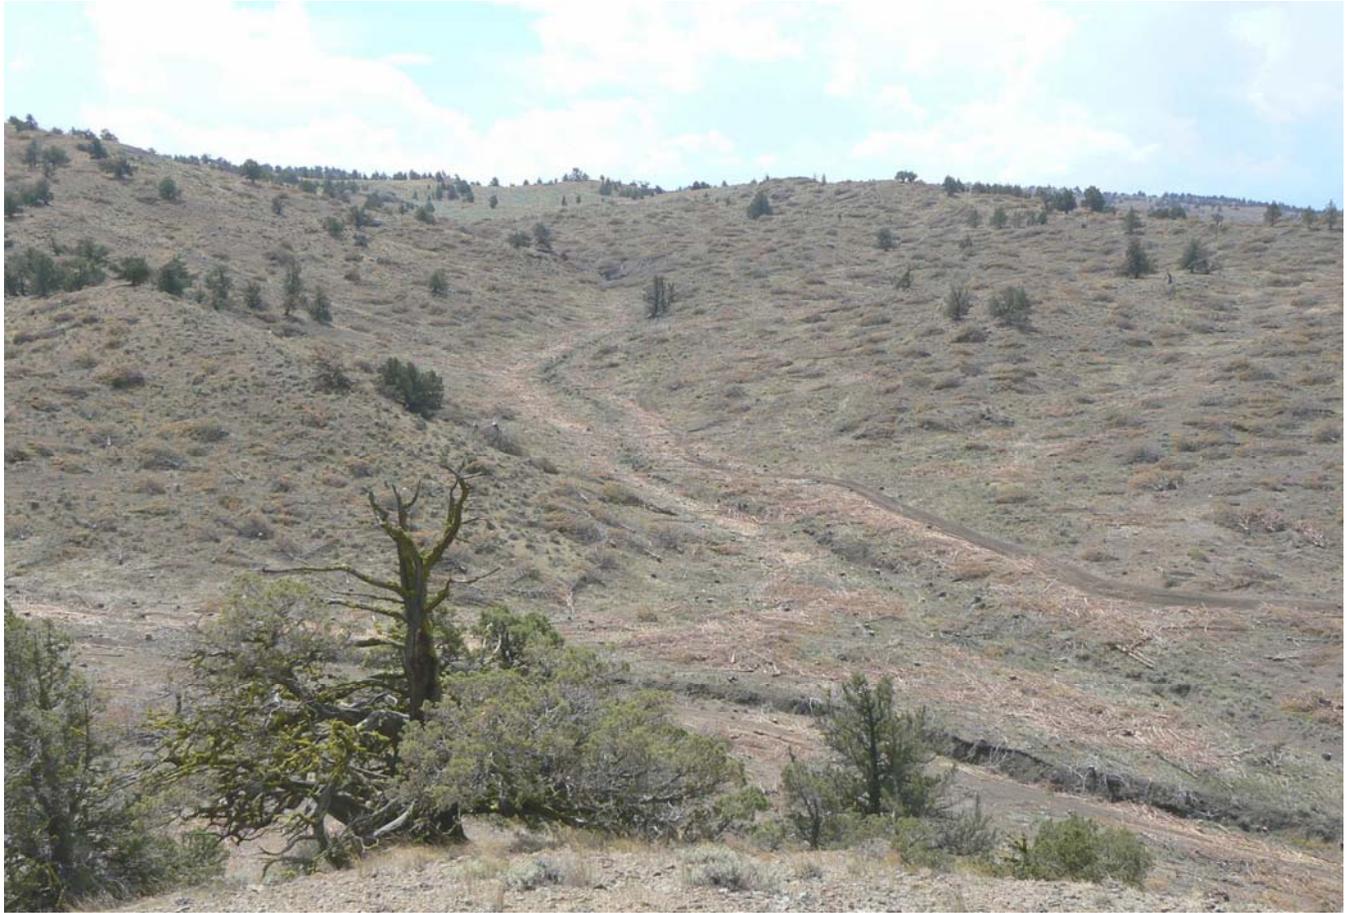
Mays Watershed: July 2006. Following removal of bole wood in valley bottom. Note old growth juniper in fore ground.

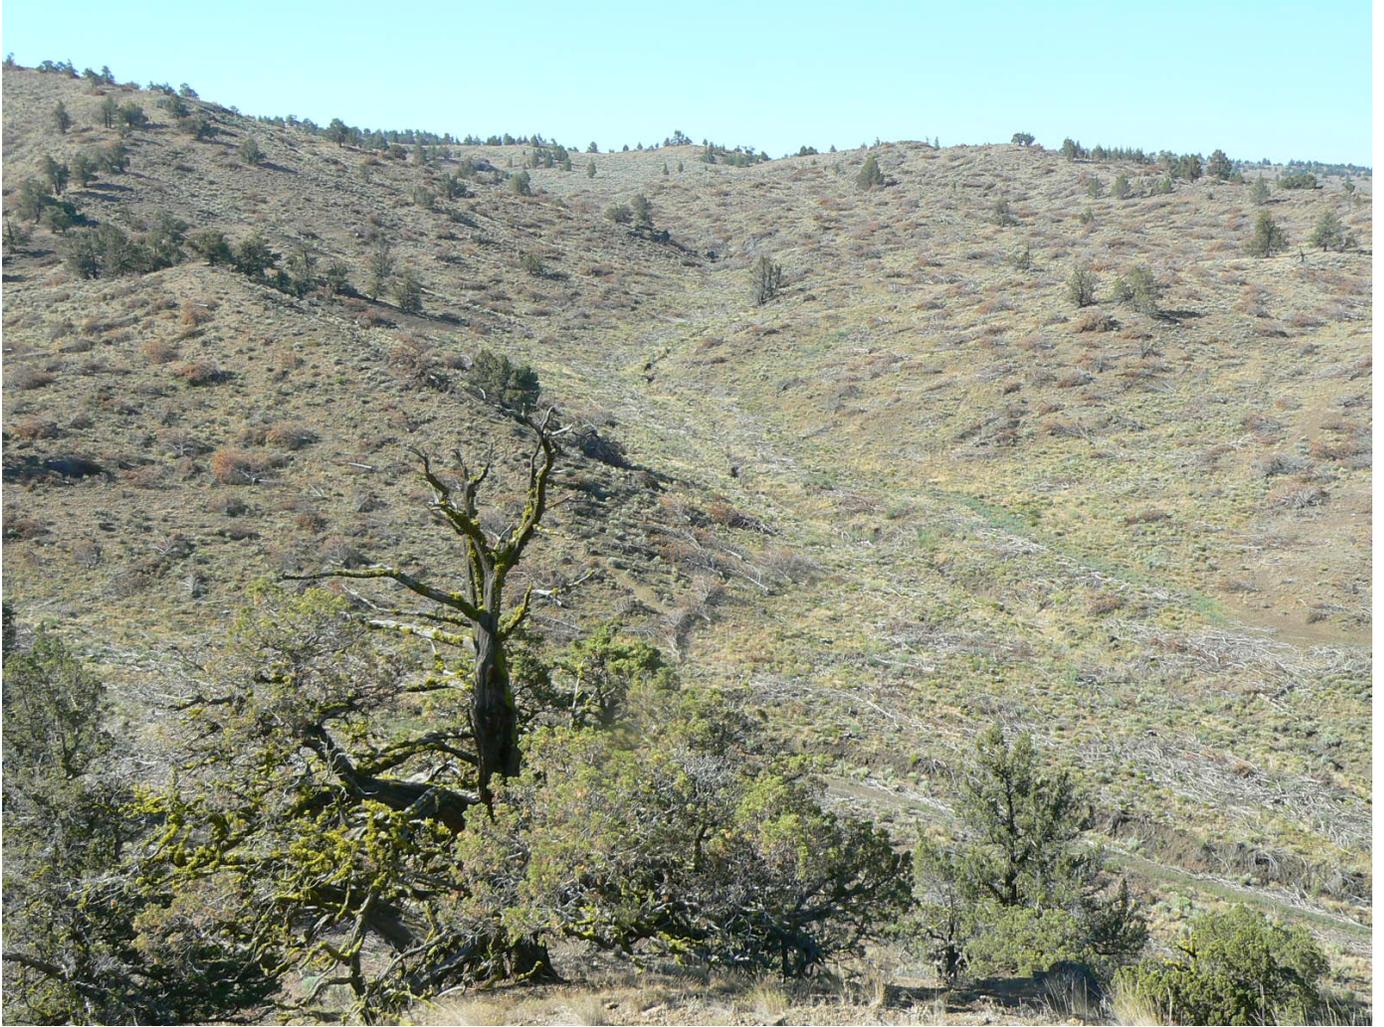
Mays Watershed: July 2007. Two years after cutting. Note old growth tree in the foreground.
