National Register of Historic Places Registration Form

historic name Hamlin, Charles Hunter, House

other names/site number Hamlin-Johnson House (preferred)

street & number 1322 SE 282nd Ave not for publication

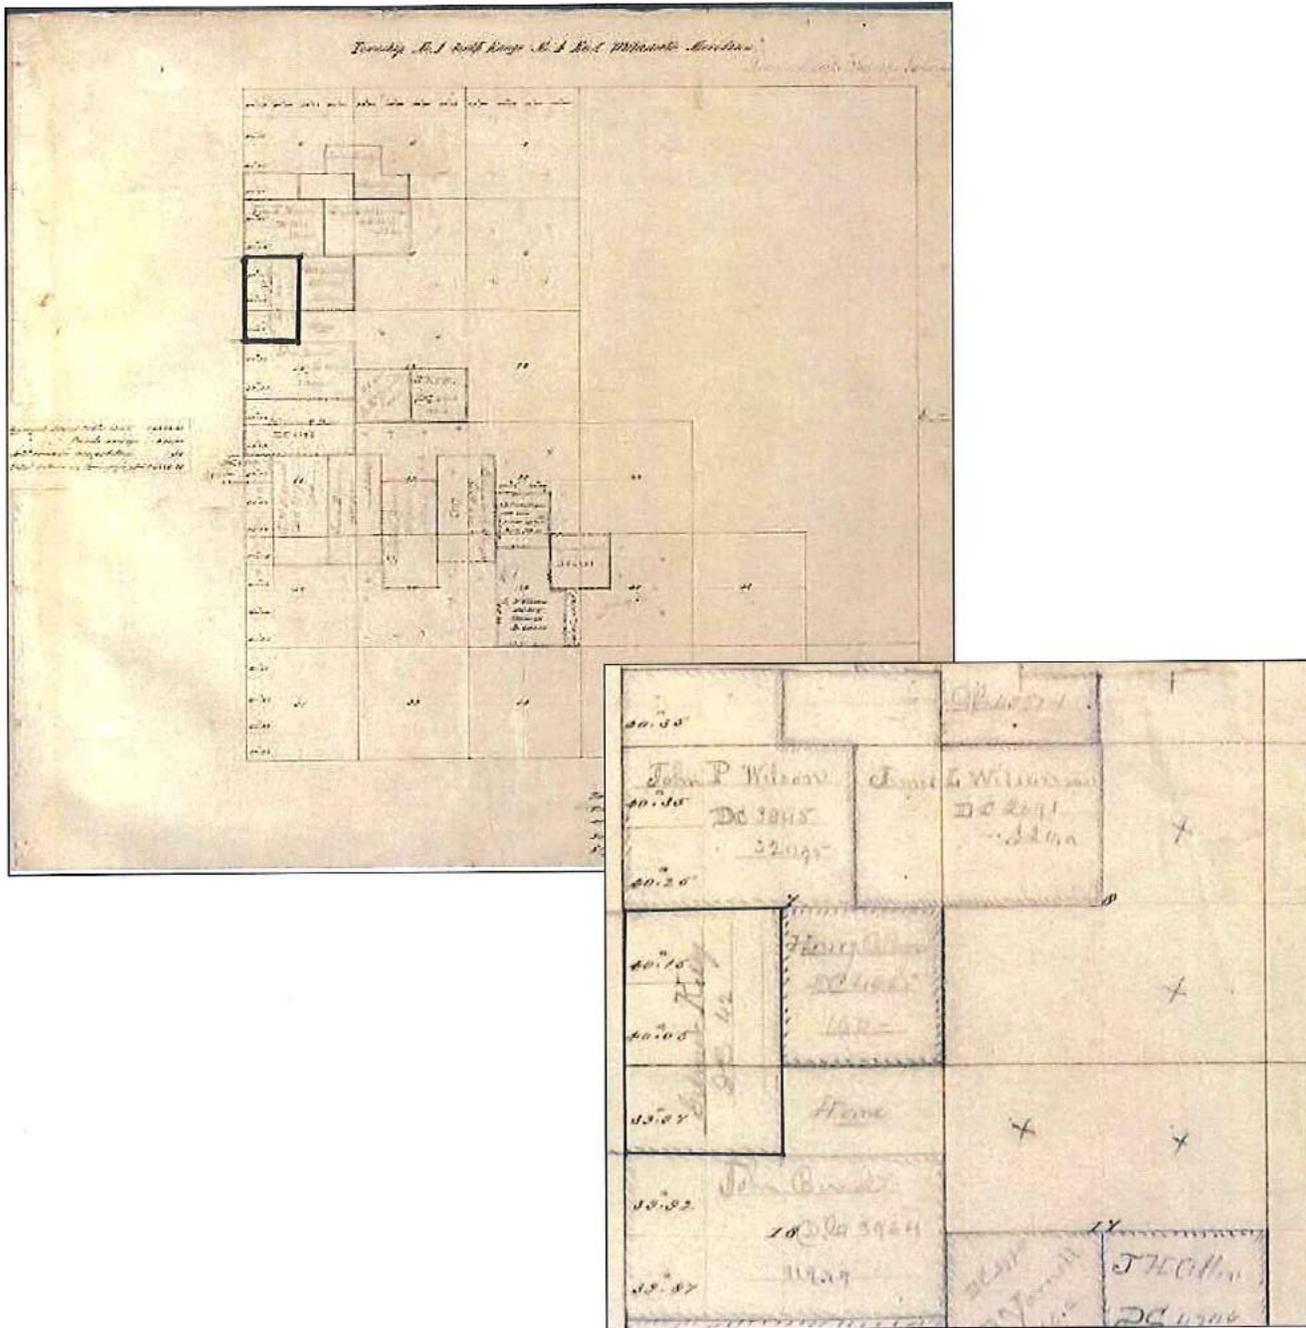
Figure 8: 1862 survey of Township 1S, Range 4E showing 120 acres of Gilmer Kelly's property

Location of
Hamlin-Johnson House

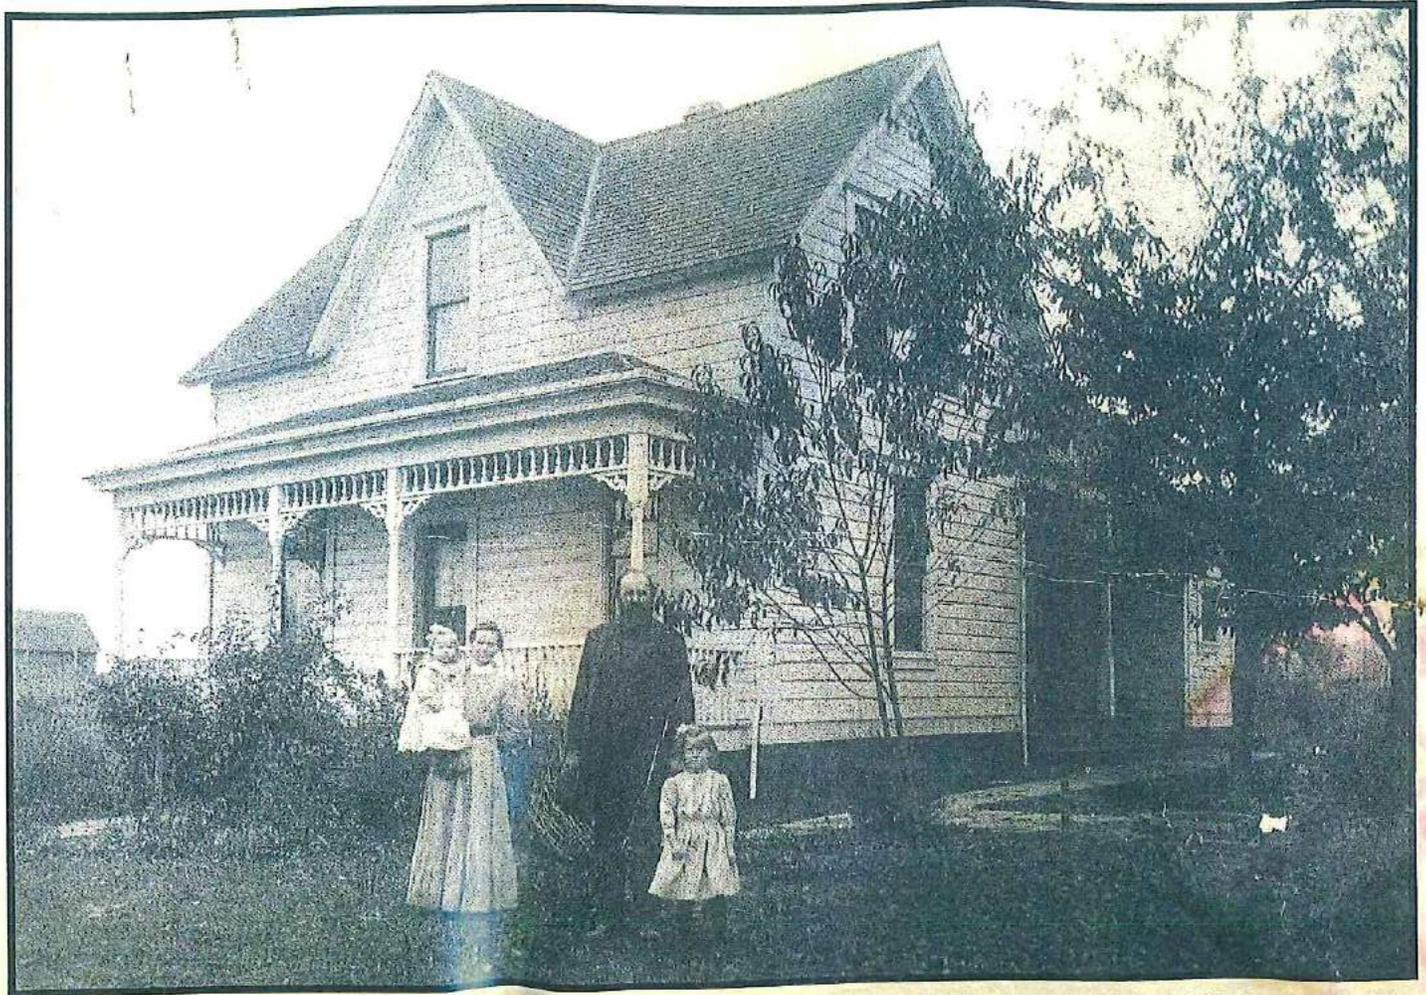
Figure 16: Photo of house with Johnson family, 1908

Former Parsonage, October, 1908, still standing across the street from present church. Rev. Jonas Johnson with his family pictured.

The front façade of the house displays excellent integrity. It appears nearly identical to the earliest photograph of the house, which dates from ca. 1908. The Queen Anne style architectural detailing on the front and side porches was likely added ca. 1903, after the tenure of a contractor who owned the house for a short time before selling it and relocating. The small chase on the right side of the porch, which was added when the second floor bathroom was added in the 1960s or 1970s, is inconspicuous.

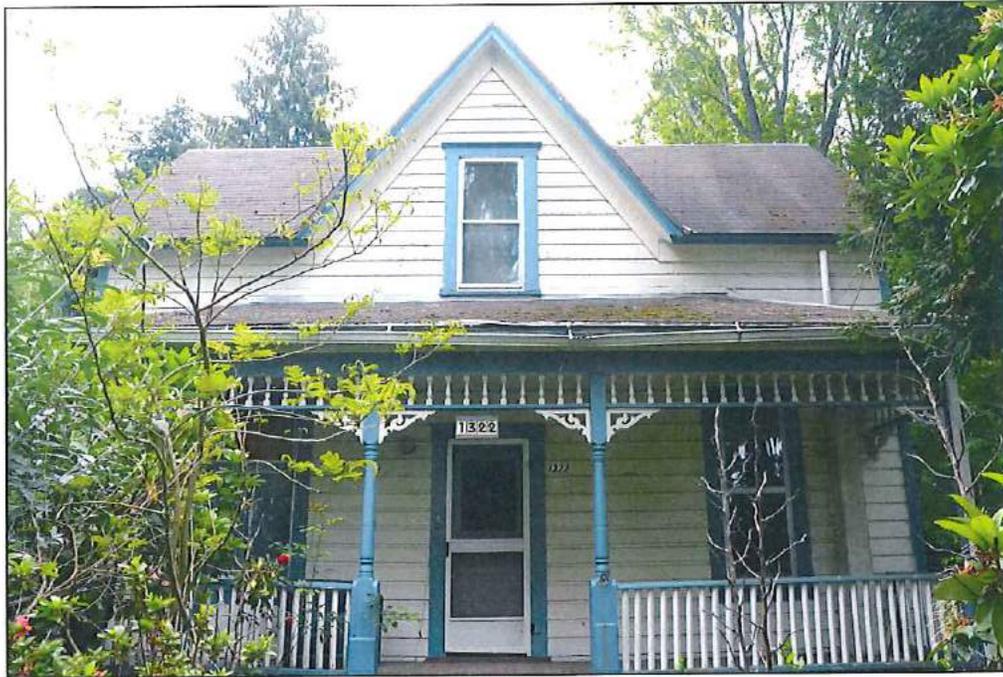
Photo 1 of 18: West side of house looking east

West (front) facade. The front facade of the Hamlin-Johnson house is symmetrical (see Photo 1). The centered front door is accessed via the hipped-roof front porch, which is in turn accessed by four enclosed wood steps. The front door is wood with four panels below a decorative window set in a molded surround. The porch stair is flanked by two turned posts with decorative brackets under the spindle-work frieze. To the right of the entry door is a one-over-one-light, double-hung window with a wood frame, plain surround and crown molding; this window is typical of the windows found throughout the house. To the left of the door is a cottage window, with a short amber-colored light over a taller light. The single, double-hung window in the front-facing gable is centered over the entry. On the right side of the porch, against the wall, is a narrow chase that encloses plumbing pipes.

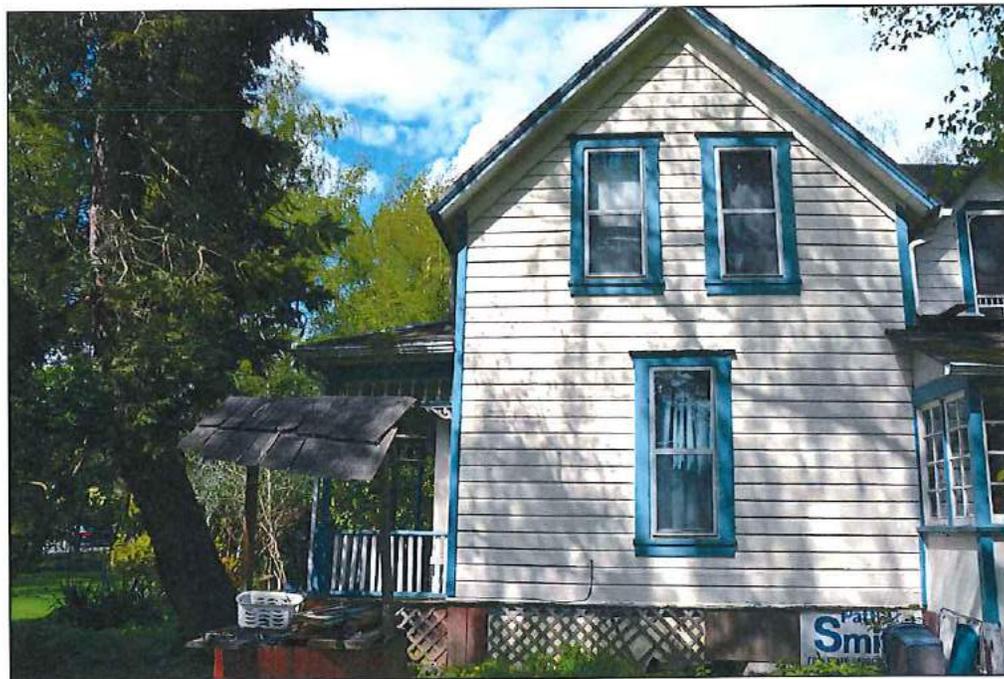
Photo 2 of 18: South side of house looking north with well in left foreground

South facade. Visible on the south side facade is the gable end of the main side gable; a gabled wall dormer above the enclosed sun porch in the center (which in turn obscures what was an exterior bay window); a hip roof addition toward the rear (east side) of this facade; and a second hip roof addition which is in the northeast corner of the building (see Photos 2-4). The gable on the west side of this facade displays a single, double-hung window centered on the lower level of this facade, and two symmetrically placed windows at the upper level. The small gable in the center of this facade has a door that opens onto a second-level open porch (the roof of the sun room). This door has three recessed panels with a single light above and a Victorian-style screen door. The projecting sun room below is enclosed with ten, eight-light windows above beadboard paneling. The roof on the sunroom is clad in corrugated metal sheeting. The hip roof addition toward the rear of this facade is partially obscured by the enclosed sunroom. The visible portion toward the rear displays a nearly square, fixed window. The addition on the northeast corner of the building has a small, one-over-one-light, double-hung window on the south facade.

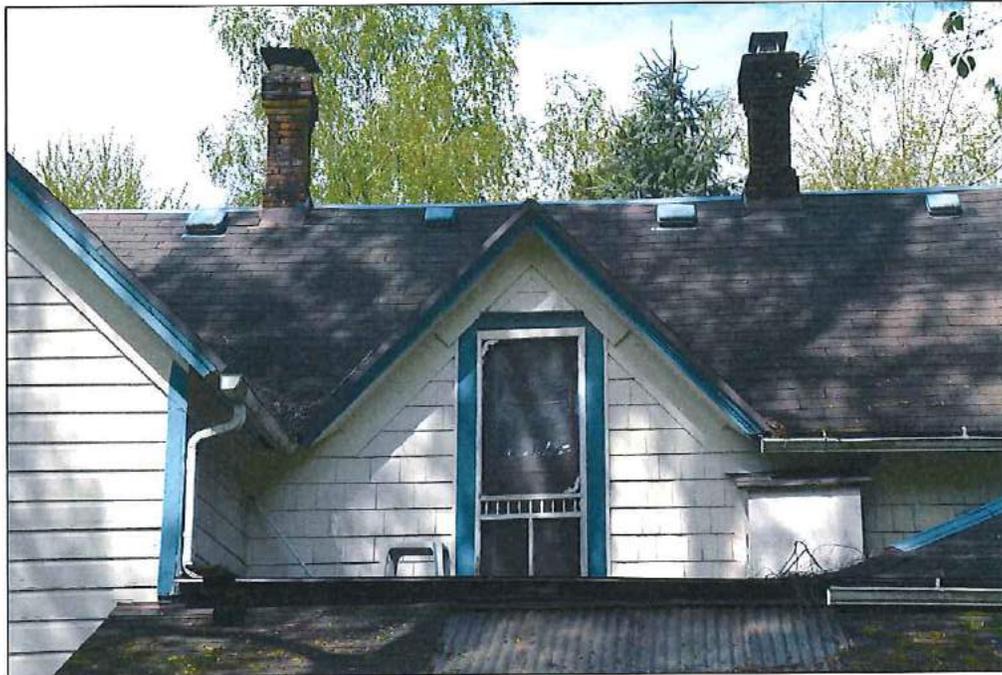
Photo 3 of 18: South side of house looking north

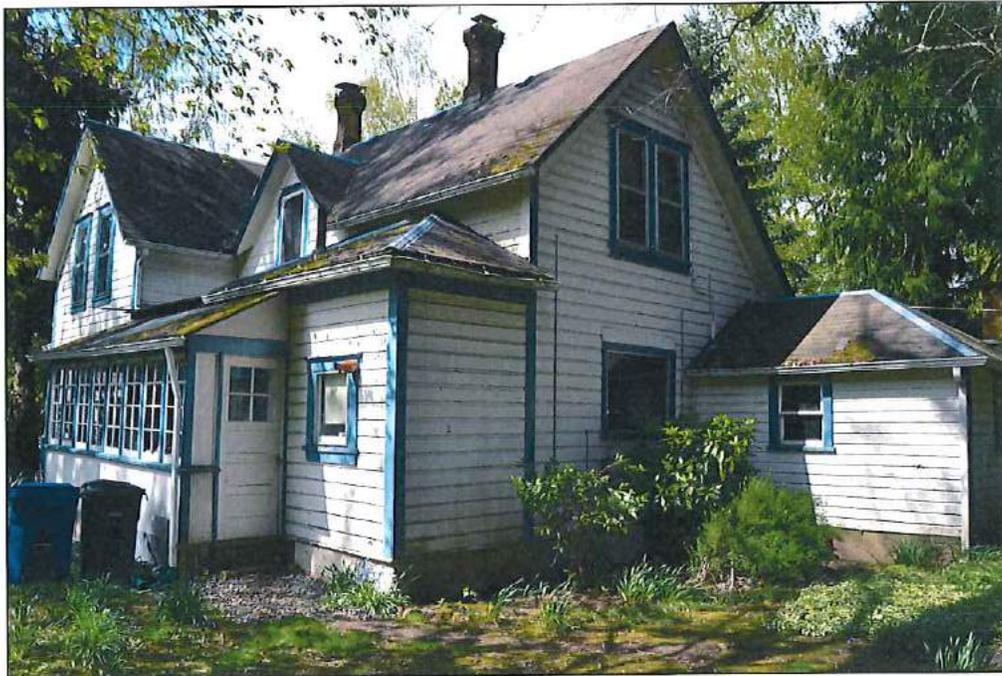
Photo 4 of 18: Southeast corner of house looking northwest

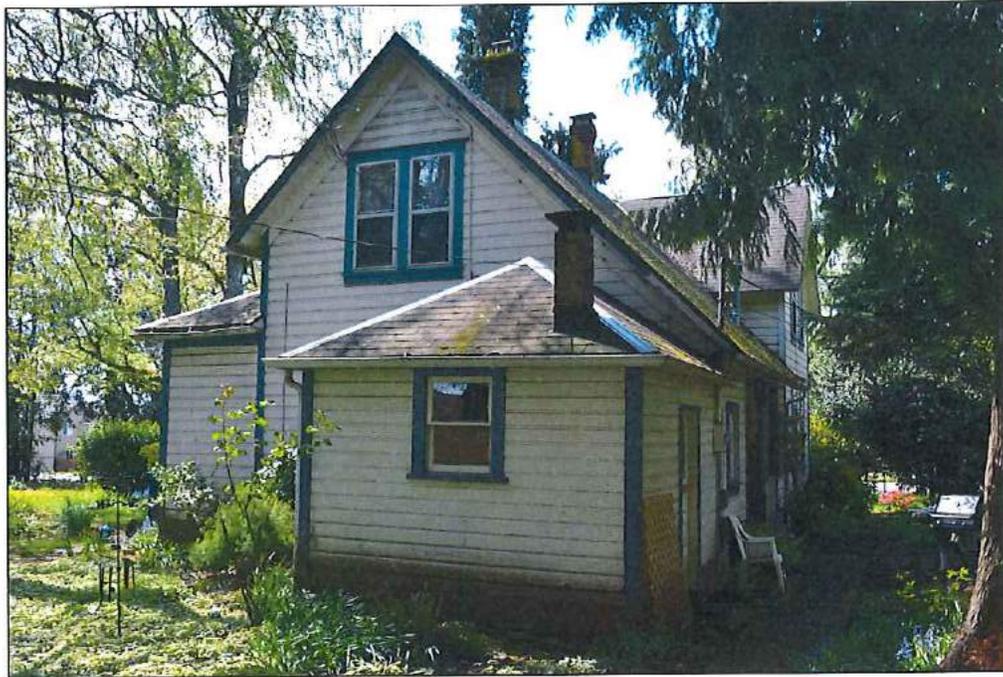
Photo 5 of 18: East side of house looking west.

East facade. The east facade includes an entry to the sun porch via one enclosed wood step, through a three-panel door topped by a four-light window (see Photo 5). In the center of the gable end is a horizontally oriented, single-light, fixed window near the center at the lower level, and a paired, double-hung window in the gable end at the second level. The gable here is asymmetrical, with the longer portion extending down toward the north side of the building. The hip roof addition here, on the north side of this facade, has a small, double-hung window on the east facade that matches the one on the south facade.

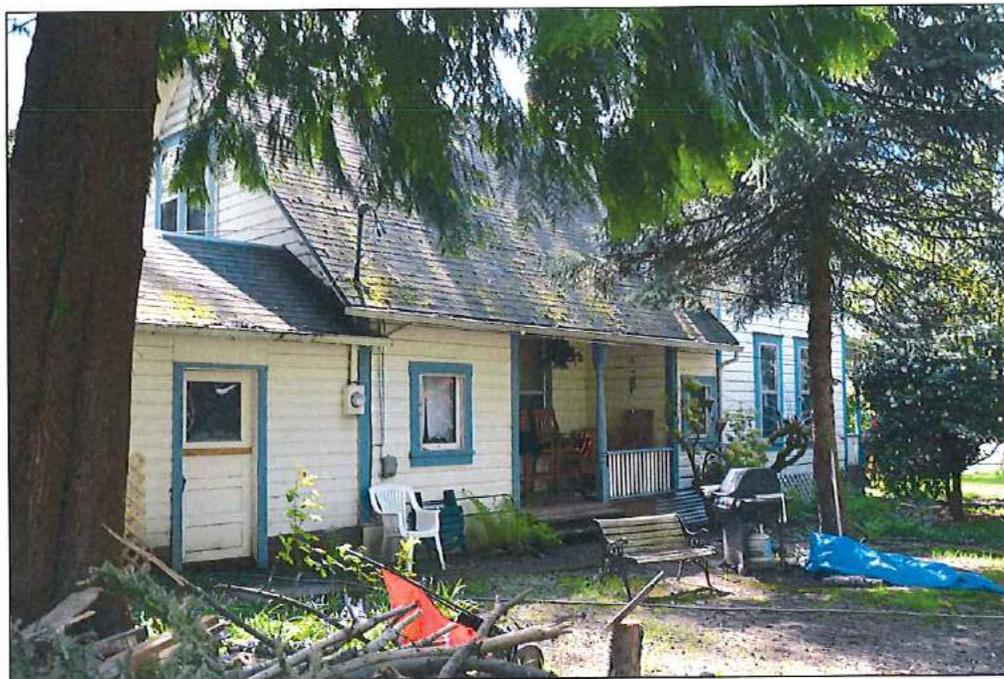
Photo 6 of 18: North side of house looking southwest

North facade. The north facade displays two double-hung windows at the lower level on the gable end, toward the west side of this facade, aligned with two double-hung windows at the second level (see

Photo 6). In the center of this façade is the second porch. This portion of the facade appears to be one story-high due to the extension of the roofline in this location. The porch is accessed via two enclosed wood steps. A plain balustrade between two turned posts is located to the right of the stairs. At the back of the porch is an entry to the kitchen, which consists of a door with a single light in the upper portion, and a double-hung window located to its right. The porch is flanked by small, single-light, fixed windows. At the east end of this façade is a door to the laundry room. It displays a small light above three wood panels.

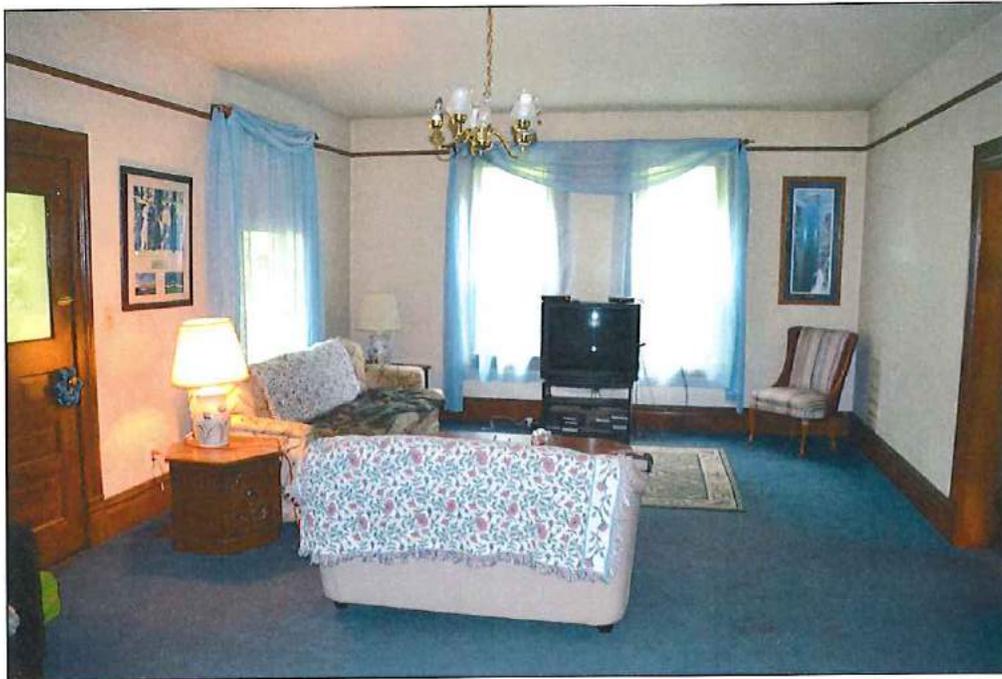
Photo 7 of 18: Living room looking south

First floor. The house is entered from the front porch through a door that opens into the center of the living room, which extends north to south across the width of the house (see Photos 7-9). The wood stairway to the second level is located in the southeast corner of this room, parallel to the long side of the room (see Photo 8-9). It is embellished with decorative detail and includes turned balusters and a turned newel post. Under the stair is a closet with a four panel, wood door. Walls are plaster, some finished with wallpaper, with tall, molded baseboards and a picture rail. Doorway surrounds are wide with molded pilaster detailing. Doors typically have two vertical panels in the upper portion and two smaller panels in the lower portion.

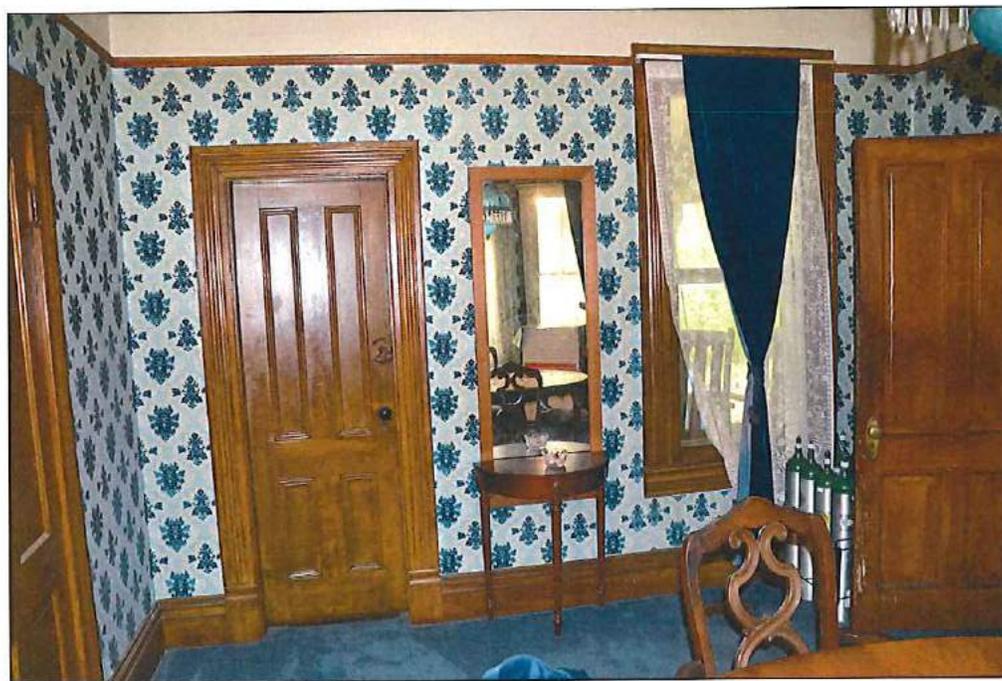
Photo 10 of 18: Dining room looking north

The middle room on this floor is the dining room (see Photo 10). It has a bay window on the south wall with a broad, central fixed window with a short light over a taller light, flanked by double-hung windows.

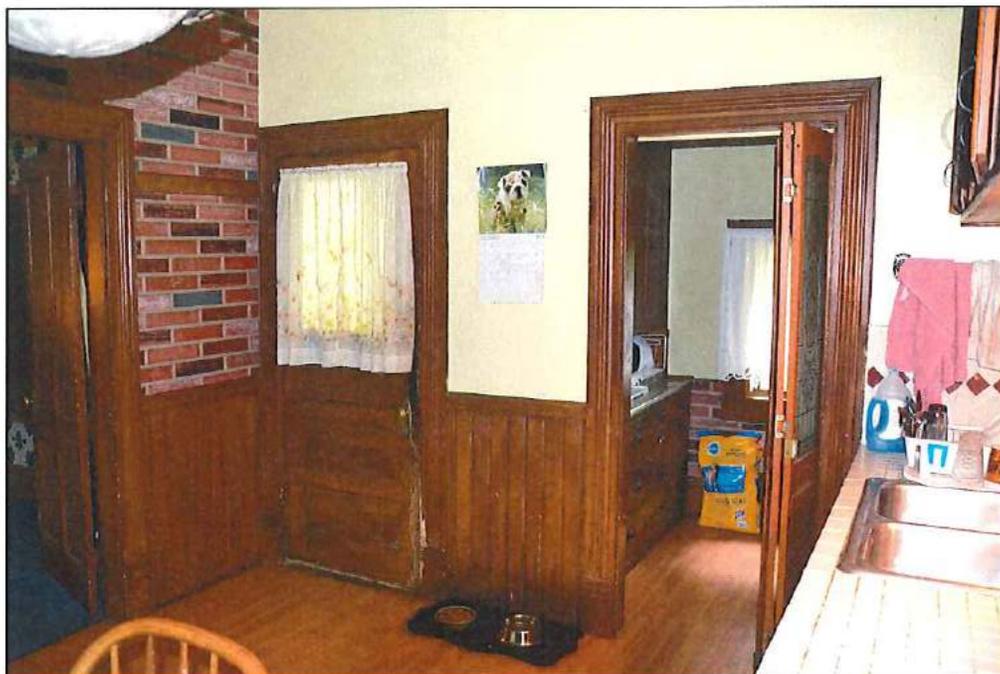
Photo 11 of 18: Kitchen looking northwest

The kitchen is the most easterly room on the main floor (see Photos 11-13). It features wood cabinetry and a wood beadboard wainscot below plaster walls and a hardwood floor. A bathroom is located off the southeast corner of this room. Adjacent to the bathroom door is the door to the sun porch. On the north side of the room is a pantry with wood bi-fold door. Northeast of the kitchen is a large laundry room that is located within the hip roof addition to the house and has only exterior access.

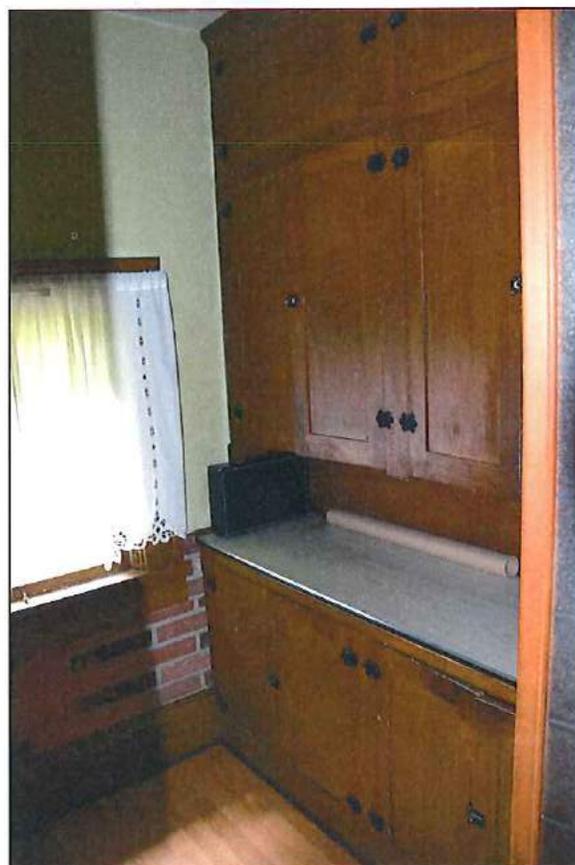
Photo 12 of 18: Pantry off kitchen looking northeast

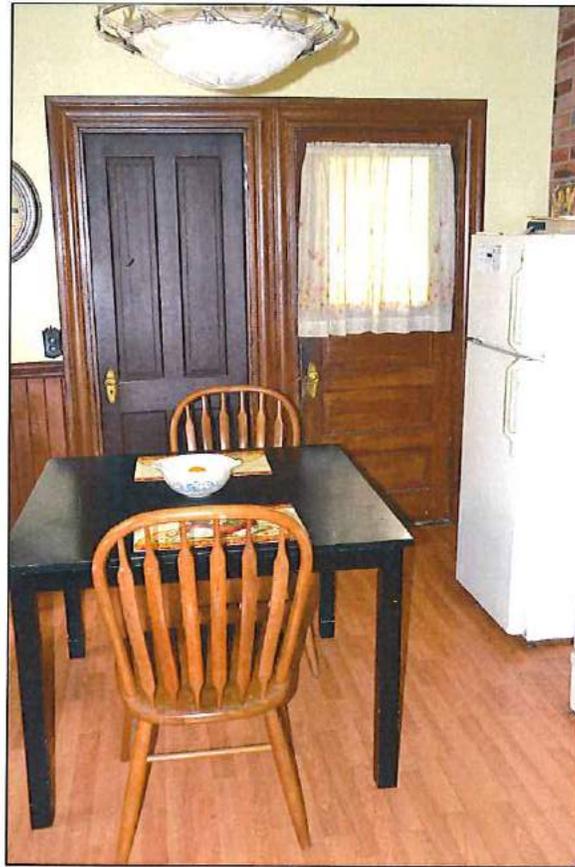
Photo 13 of 18: Kitchen looking south

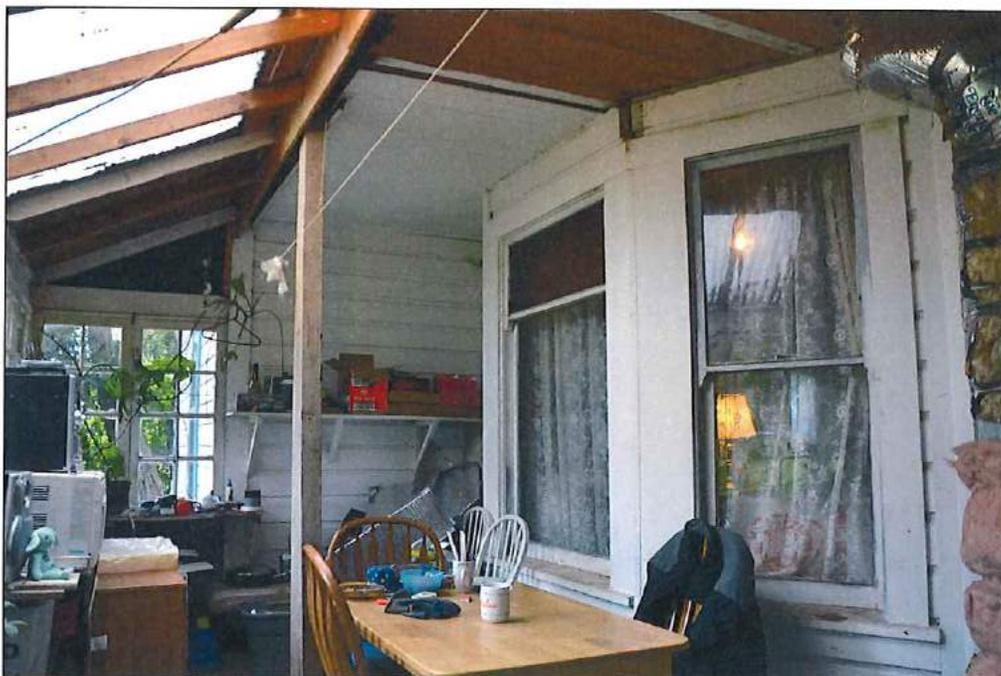
Photo 14 of 18: Sun porch off southern side of kitchen-dining room looking west

A few changes are evident on the side and rear facades of the building. The sun porch is an added feature, possibly in the 1920s, as it is not typical to have a sun porch that encloses a bay window, and the design and detailing of this feature is not commensurate with the rest of the house. The date of the addition of the southerly bay window (covered by the sun porch) is unknown, although it is known that it was added after 1908. The addition of the laundry room, with its concrete foundation and floor, is thought to have occurred ca. 1940.² The large, single-light window on the east wall of the kitchen may have been added at this time as well. The small hip roof addition at the southeast corner of the building, which contains a bathroom, is also likely a later addition, although it shows in the 1908 photo (see Figure 16). The second floor, south-facing gable is likely an addition, as again, the quality of this feature is not commensurate with the quality of the rest of the building.

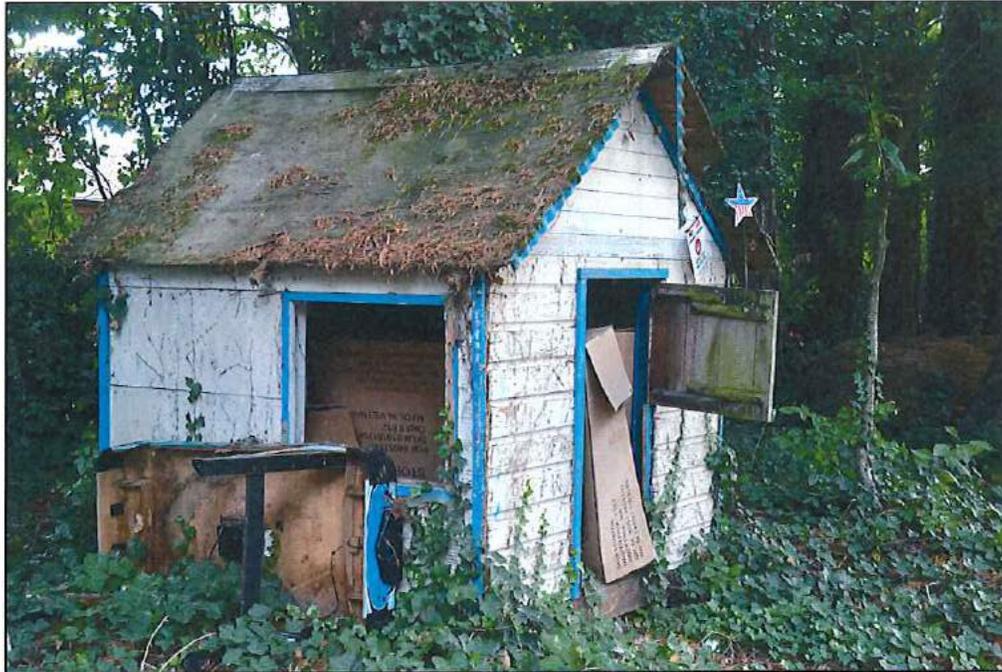
Photo 15 of 18: Playhouse looking southeast

A small building erected in 1984 as a play house is located east of the house along the back property line. It is a one-story, gable-front building clad in the same channel rustic siding as the main house. A door is located on the front, west façade. Another opening located on the north façade once had a clear plastic window.

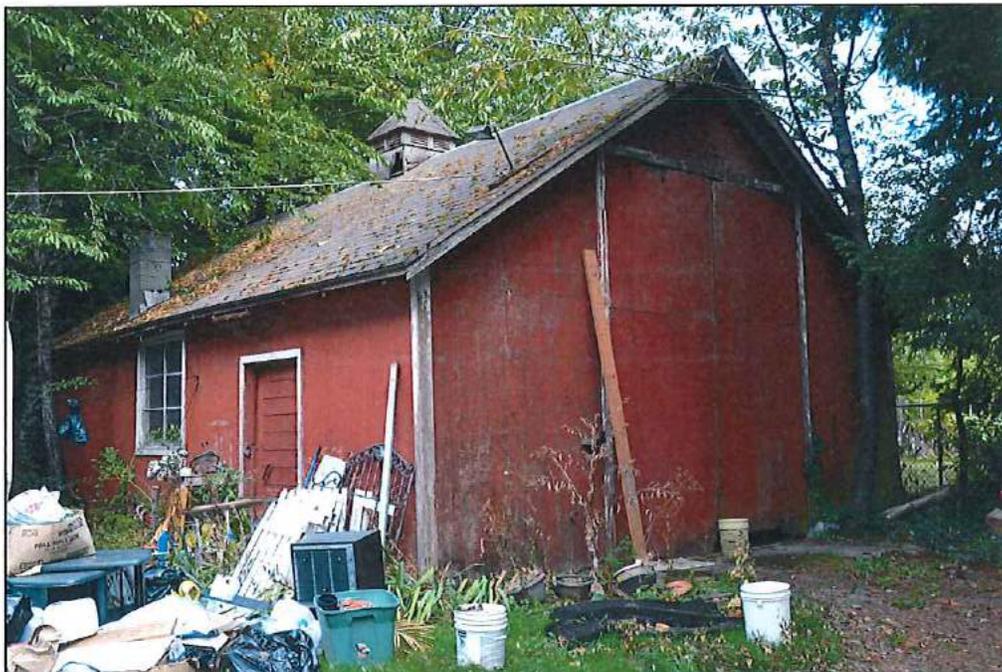
Photo 16 of 18: Barn looking northeast

The barn or workshop is located east of the house, along the rear (east) boundary of the main portion of the parcel. It is a tall, one-story building with a rectangular footprint and a steeply pitched roof with narrow eaves and exposed rafters. The ridgeline is oriented north-south. An interior concrete block chimney is located on the west side of the building and a cupola with a steeply pitched, pyramidal roof is located on the ridge. The building is wood-frame construction with horizontal siding, which has been covered by sheets of narrow, vertical board siding (T1-11) on the south and west sides, and an asphalt shingle roof. The floor is concrete, and extends beyond the threshold, forming a small concrete pad in front of the main door. The main door is tall, extending to the roof of the structure, with two sliding, vertical wood panels. A pedestrian door of horizontal wood and a six-light, fixed window are located on the west façade, facing the house.

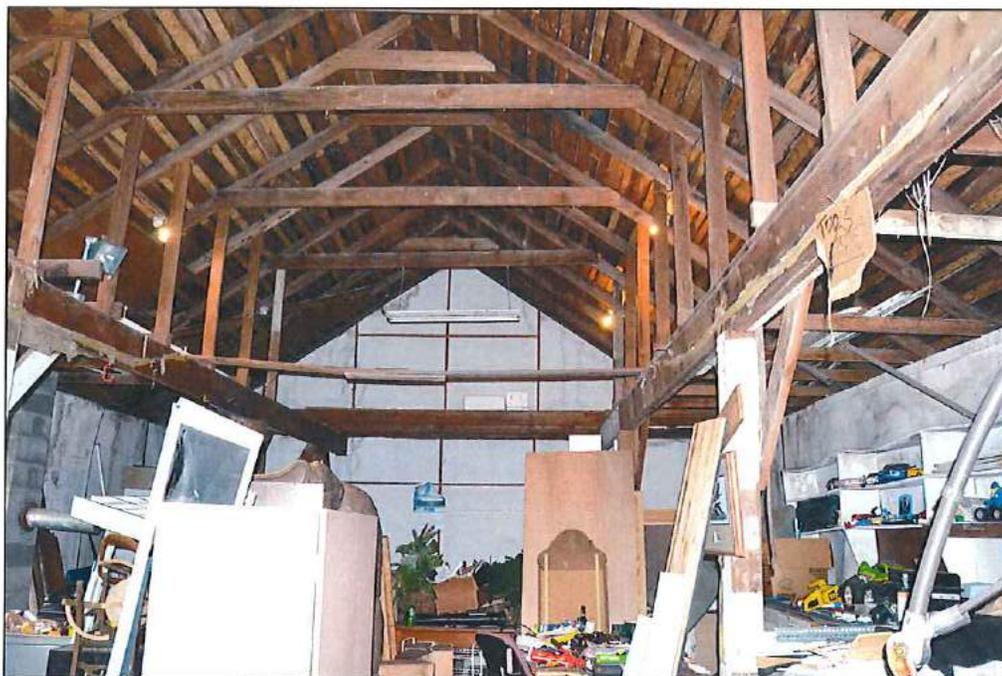
Photo 17 of 18: Barn interior looking north

The interior of the building is one large volume. A row of 8"x8" posts is located parallel to the side walls, connected by a beam that supports storage areas above. The interior is partially finished with plywood panels. The roof structure is reinforced with a bottom and top chord (horizontal boards), but displays no formal trusses.

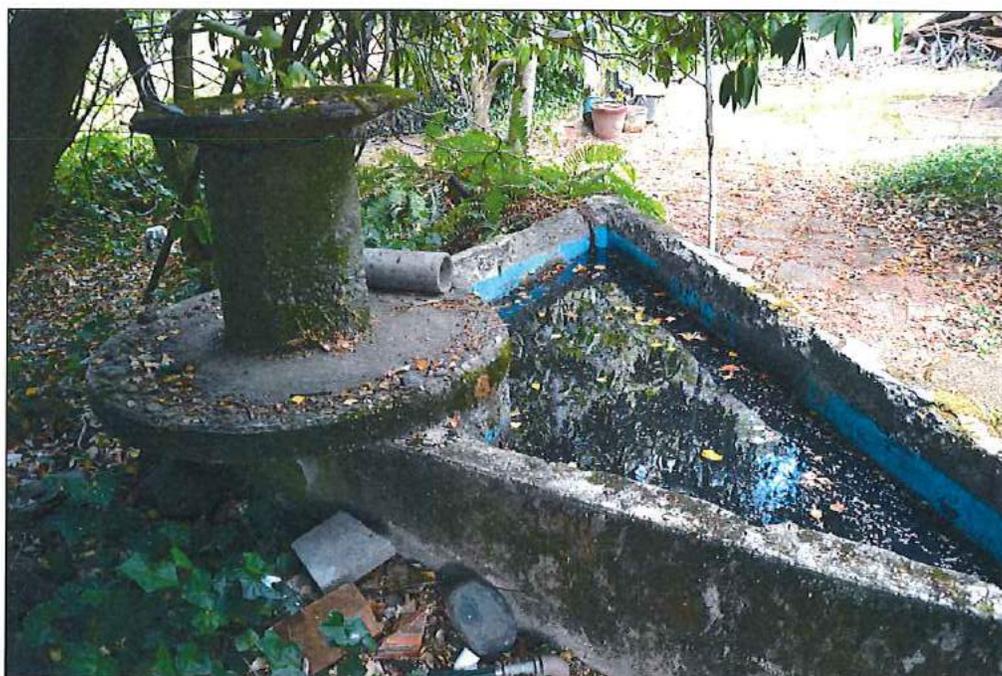
Photo 18 of 18: Pond and fountain on north side of house looking east

On the north side of the house is a concrete walk from the side porch east towards, but not reaching, the barn. There are also three stepping stones or blocks and a square section of blocks between the porch and the above-described fountain.
