**HISTORIC PROPERTY MANAGEMENT PLAN, RECREATION RESIDENCE  
TRACTS, MOUNT HOOD NATIONAL FOREST**

Prepared for the  
U.S. Forest Service  
Mt. Hood National Forest  
Sandy, Oregon

Ward Tonsfeldt, PhD  
Sally Donovan, MS

March 8, 2011

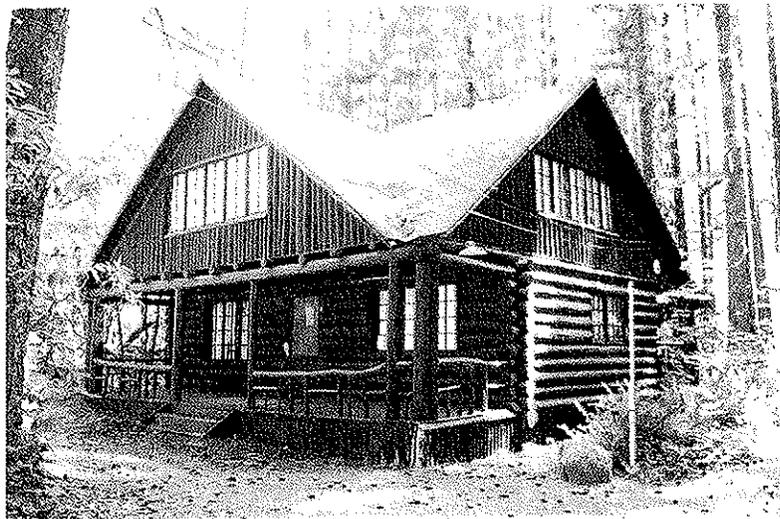
Figure 1, Still Creek Tract, Road 9, lot 17. Built by Henry Steiner, this cabin is a splendid example of vernacular design and traditional log construction

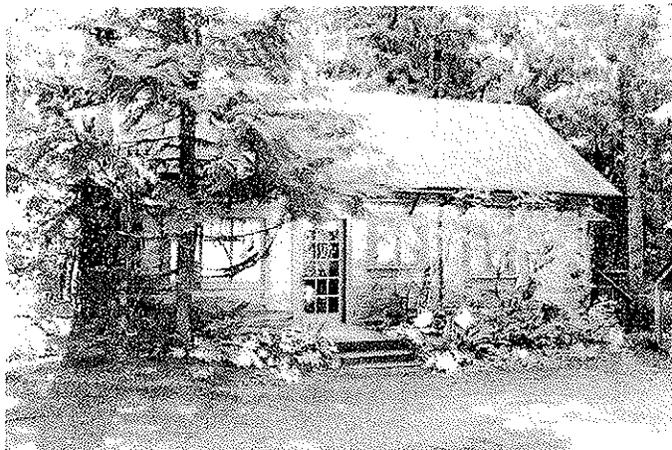
Figure 6. Mile Bridge Tract, Hwy 26, lot 16, Historic Contributing cabin

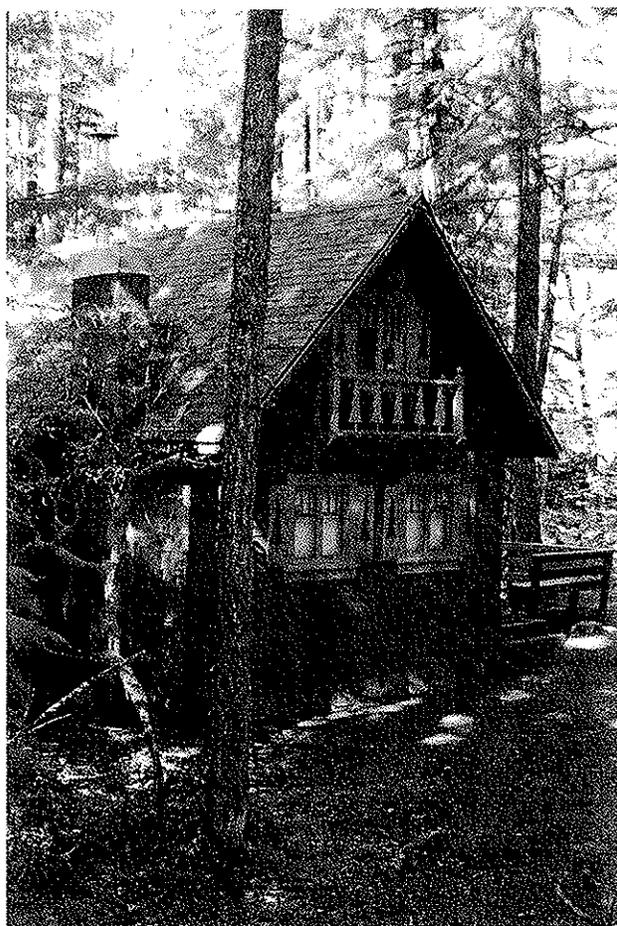
Figure 7. Mile Bridge Tract, Road 28A, lot 4, Individually eligible cabin. Note non-historic deck on entry elevation.

It is important to note that virtually all cabins show some evidence of modification. In general, period additions, replacement metal roofs, or non-historic decks are not seen as a fatal loss of integrity, provided other elements of integrity are present. Mile Bridge cabin 28A--04 (Figure 5), for example, has an expansive deck on the entry side, but other historic elements are intact.

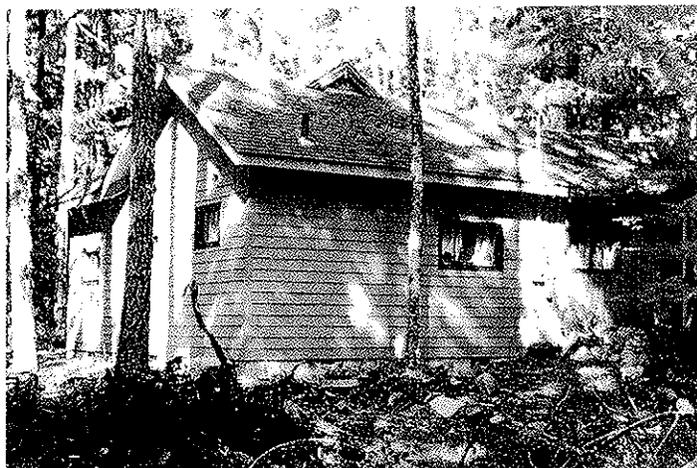
Figure 8. Mile Bridge Tract, Road 29, lot 15, Non-contributing cabin. Note multiple additions to original structure on the right

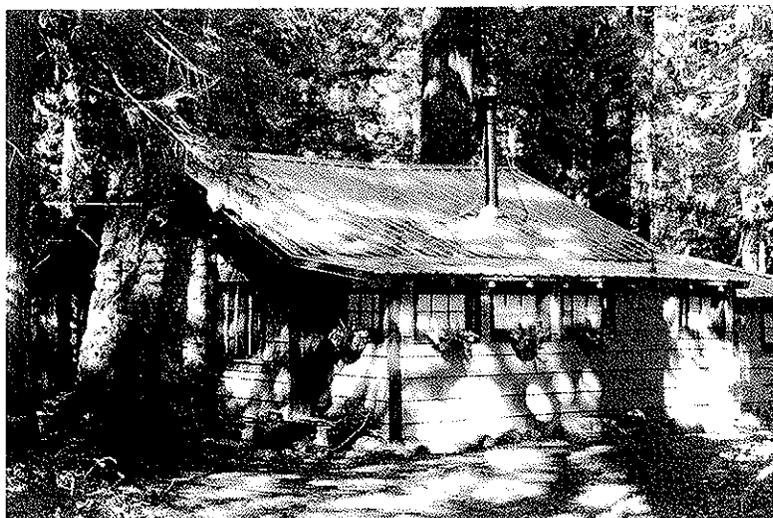
Figure 9. Mile Bridge Tract, Road 36A, lot 2 was classified as Contributing although it has a metal roof

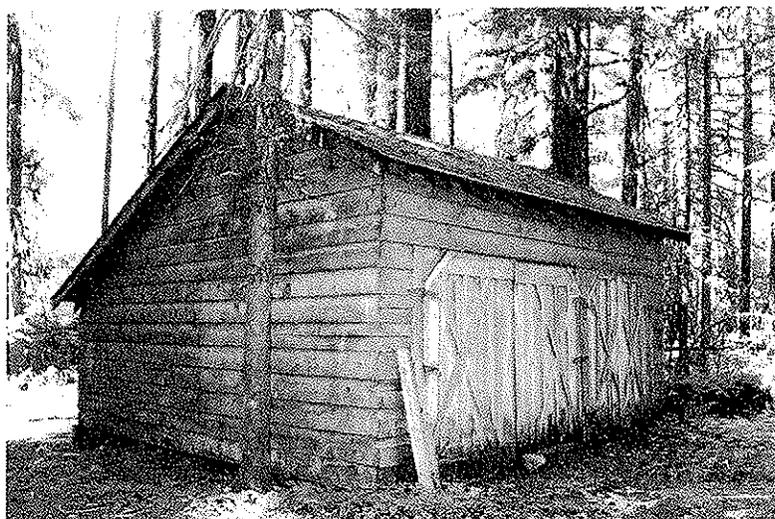
Figure 10. Contributing garage in Still Creek Tract, Road 14, lot 10. This outbuilding has the same method of construction as the cabin and dates from the same period.

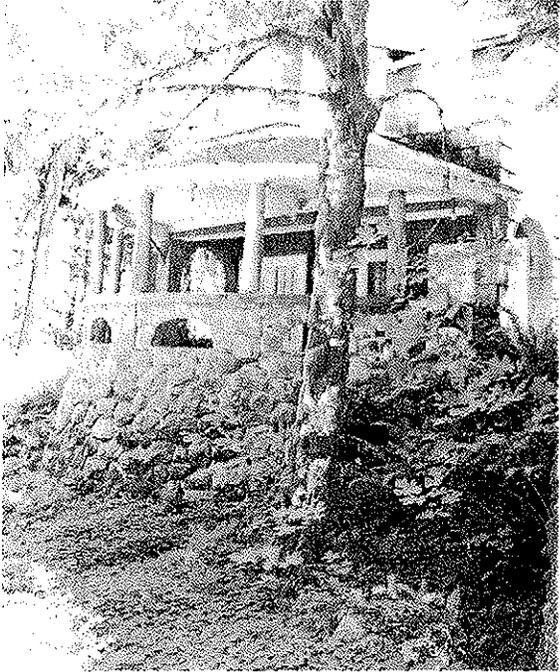
Figure 12. Formal stone foundation, entry portico, Still Creek Tract, Road 13, lot 9

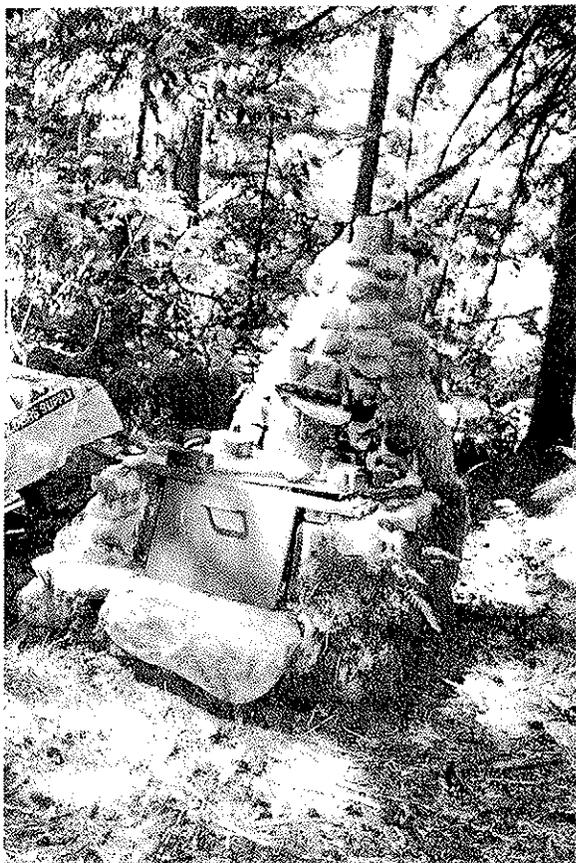
Figure 13. Outdoor stove, Zigzag Ski Club Tract, Road 27, lot 26. Outdoor stoves are currently allowed to remain if they are in good condition.

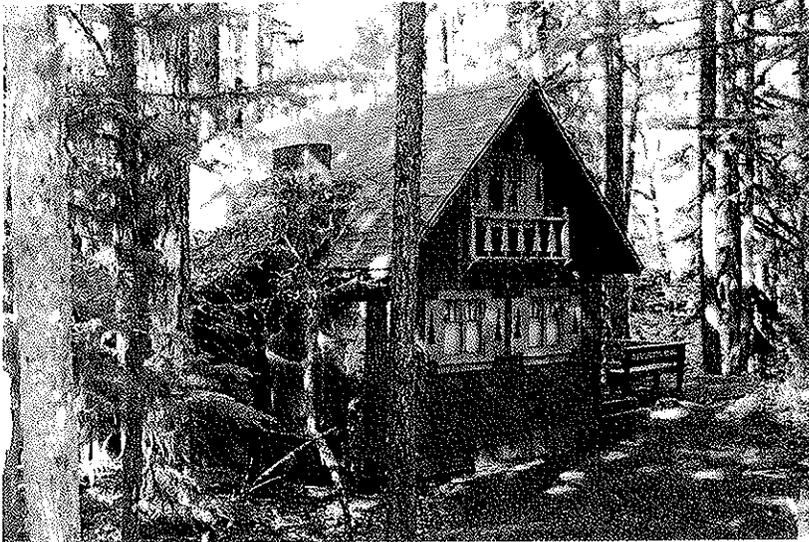
Figure 16 Mile Bridge Tract Road 28A, lot 4 with traditional wooden skirt

Many cabins have been fitted with skirting to fill in the area under the sill timbers. These are cabins built on post and pier foundations, without perimeter foundations of concrete or stone. Skirting keeps animals out from under the floor and can provide some insulation. The traditional material is 1" lumber, either horizontal or vertical. Suitable materials for skirting include 1" lumber, painted plywood faced with dry-stacked rock, vertical/horizontal lath lattice. Textured oriented strand board (OSB), T-111 plywood, sheet metal, cultured stone veneer, diagonal lath lattice, and corrugated plastic are not suitable. Wooden lath lattices are often used for skirting, although they do not exclude animals or provide any insulation. Lattice that is vertical and horizontal is preferred to diagonal lattice.

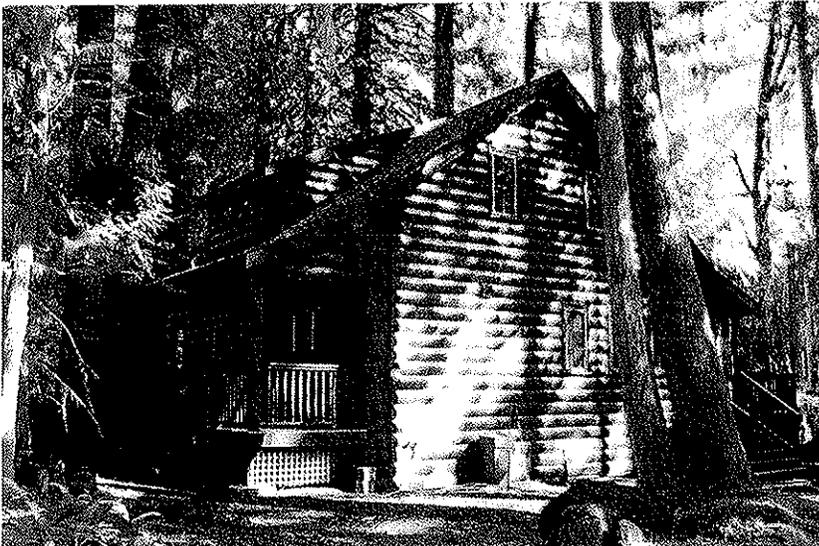
Figure 17 Mile Bridge Tract, Road 35A, lot 14 with traditional vertical/horizontal lattice skirting

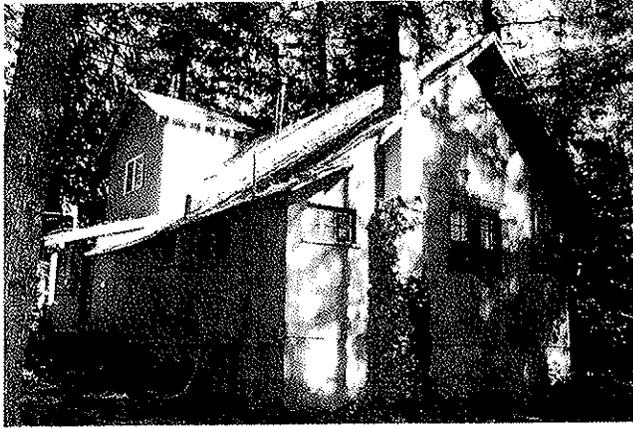
Figure 18 Mile Bridge Tract, Road 35A, lot 78 with T-111 skirting (not appropriate)

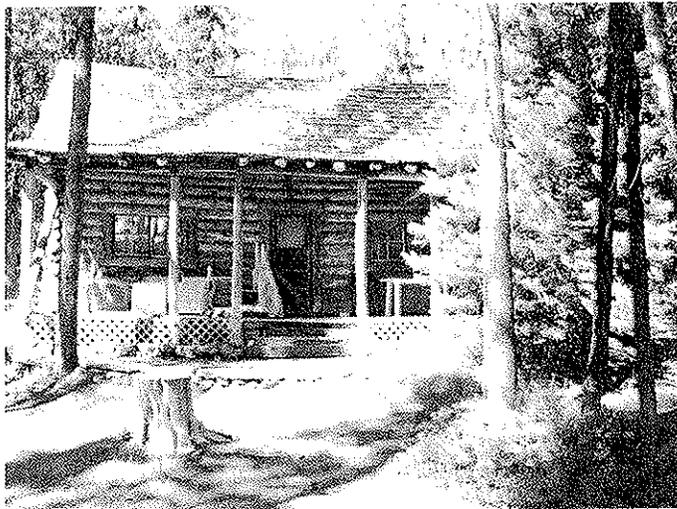
Figure 19 Cabin with inappropriate diagonal lattice skirting.

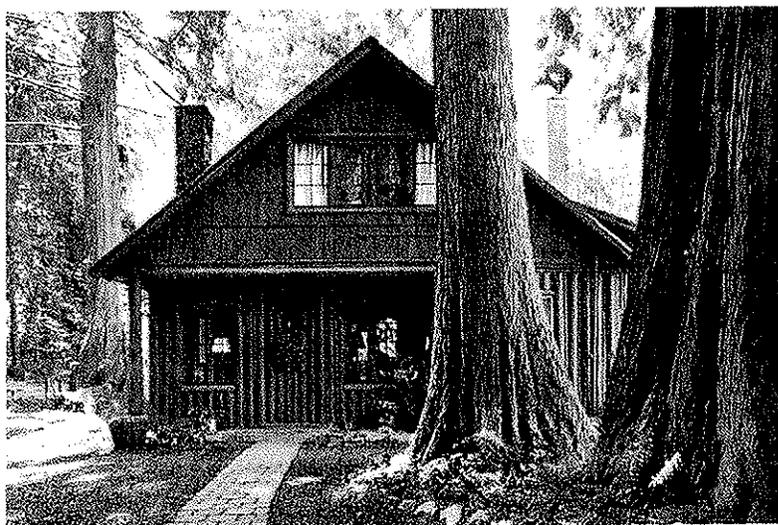
Steiner cabin on private property, Rhododendron. Photo from [http://www.loghome.com/historic\\_log\\_cabin\\_photos/articles/2988](http://www.loghome.com/historic_log_cabin_photos/articles/2988)

Distinctive Steiner elements in his hand-crafted cabins and summer homes include hand-peeled logs, saddle-notch exterior walls often chinked with quarter-round molding, river rock or basalt chimneys, multi-light windows, wood shakes roofs, and handcrafted architectural features including doorknobs fashioned from tree roots, porches supported by peeled, forked trees, latches crafted from bent wood, and sun rays decorating the gable ends. Interiors were beautifully crafted including central stone fireplaces, peeled log rafters, half-log stair treads, curving half-log staircases and handrails, and hand-made furniture. Reflecting the natural forested setting, Steiner cabin designs grew out of the natural qualities of the logs or limbs he selected.

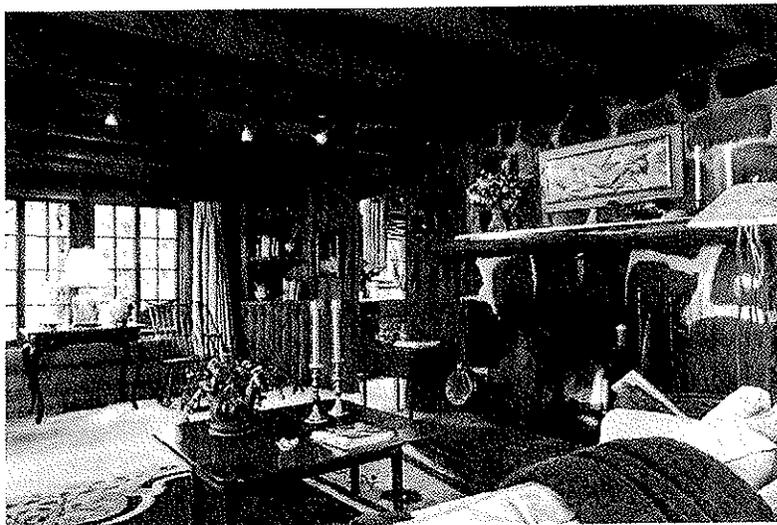
Interior details of Steiner cabin on private property, Rhododendron. Fireplace was built from basaltic ashlar by John Steiner. Photo from [http://www.loghome.com/historic\\_log\\_cabin\\_photos/articles/2988](http://www.loghome.com/historic_log_cabin_photos/articles/2988)
