BRIDAL VEIL
MULTNOMAH COUNTY, OREGON

HISTORICAL AND ARCHITECTURAL EVALUATION

August 20, 1992

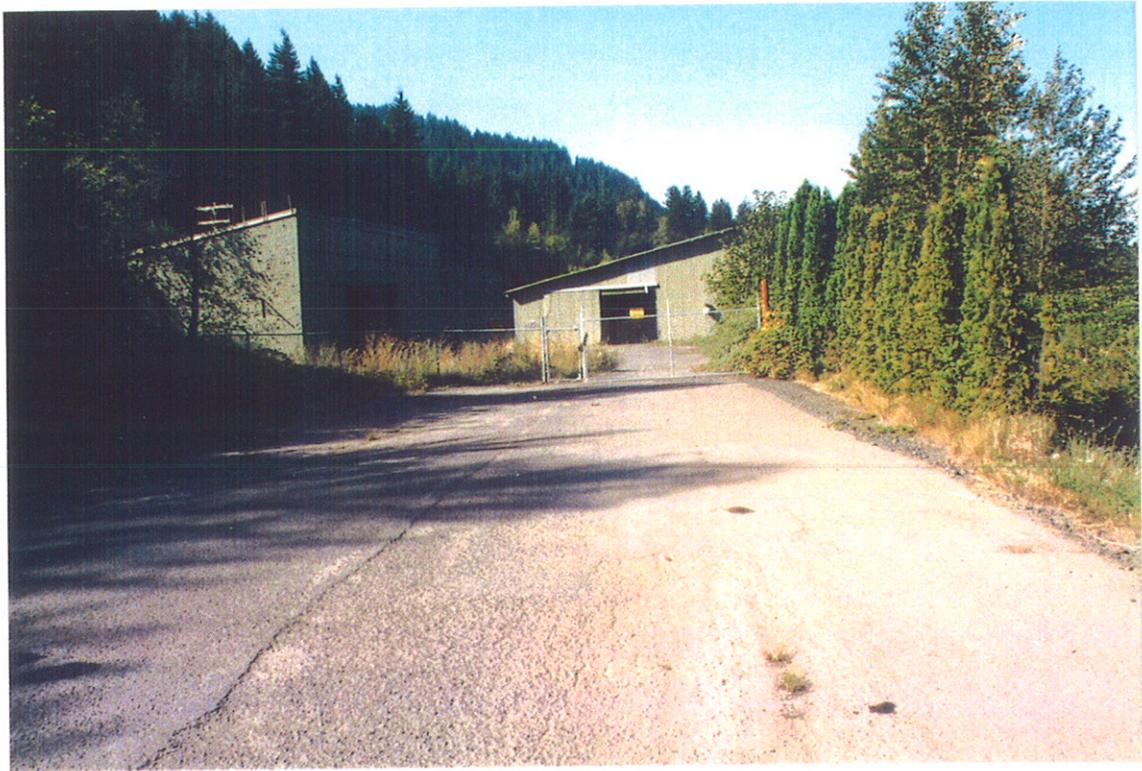
The mill site is the industrial area west of the Post Office. While historically the center of the lumber sawing activity, today the only buildings remaining are the maintenance shop, the resaw building and the warehouse. The maintenance building was likely built in the 1920's and then doubled in size in the 1960's. The resaw building and warehouse likely date to the 1920's. The buildings are exceedingly simple in design, essentially four walls and a roof, without any special accommodation reflecting their use in the lumber industry. They are all in poor to fair condition. They all have been remodelled to a point where today they have little historical integrity or interest.

No documentation exists for the original mill site, individual buildings or ancillary systems, such as the flume. Any attempts at reconstruction would be speculative.

Mill Site Looking West (above)
Mill Site Looking East (below)

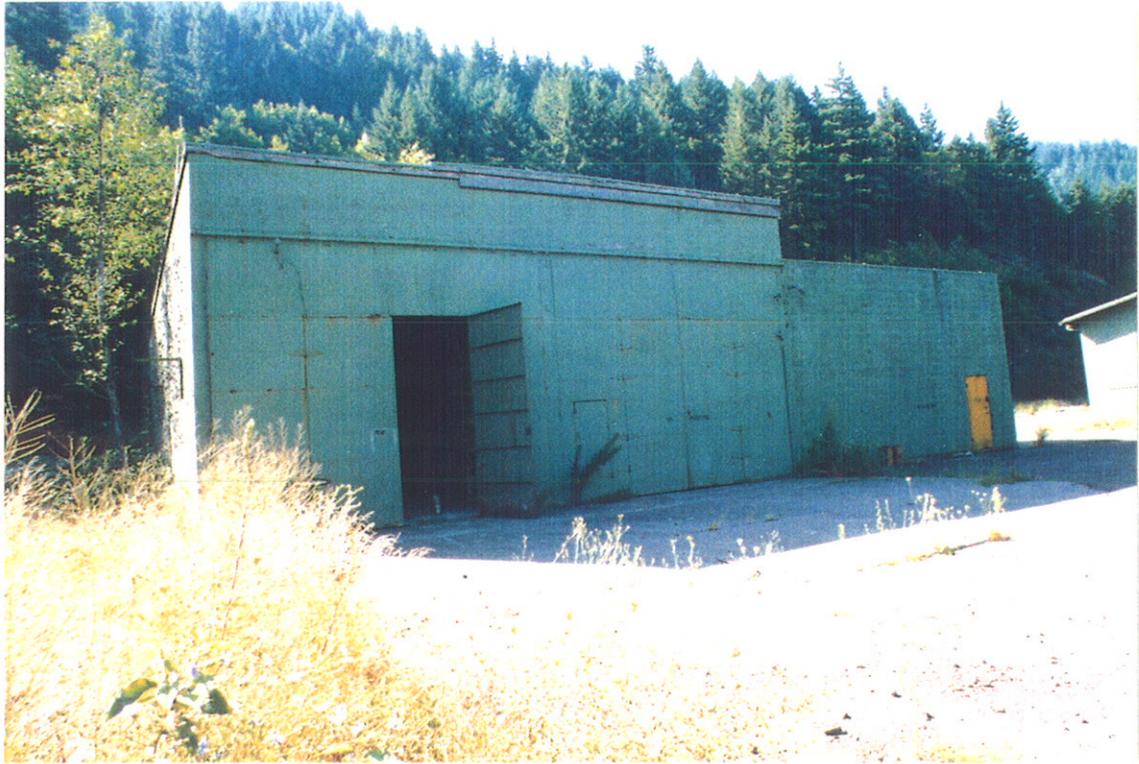
The second section is attached to the west facade of the first building. It is approximately 14 feet high and 30 x 45 feet. It is made of concrete block and features three bays with modern overhead metal doors. The building is in fair to poor condition. The older section dates to the 1920's, while the newer section dates to the 1960's.

Like the warehouse, the shop was built as a functional building and has been treated accordingly. The basic structures are intact, but not in the best of shape. Because of its simplicity, the structure has a certain amount of integrity but very little historical significance. The concrete block addition damages what significance there is.

Maintenance Shop - North Facade (above)
Maintenance Shop - East Facade (below)

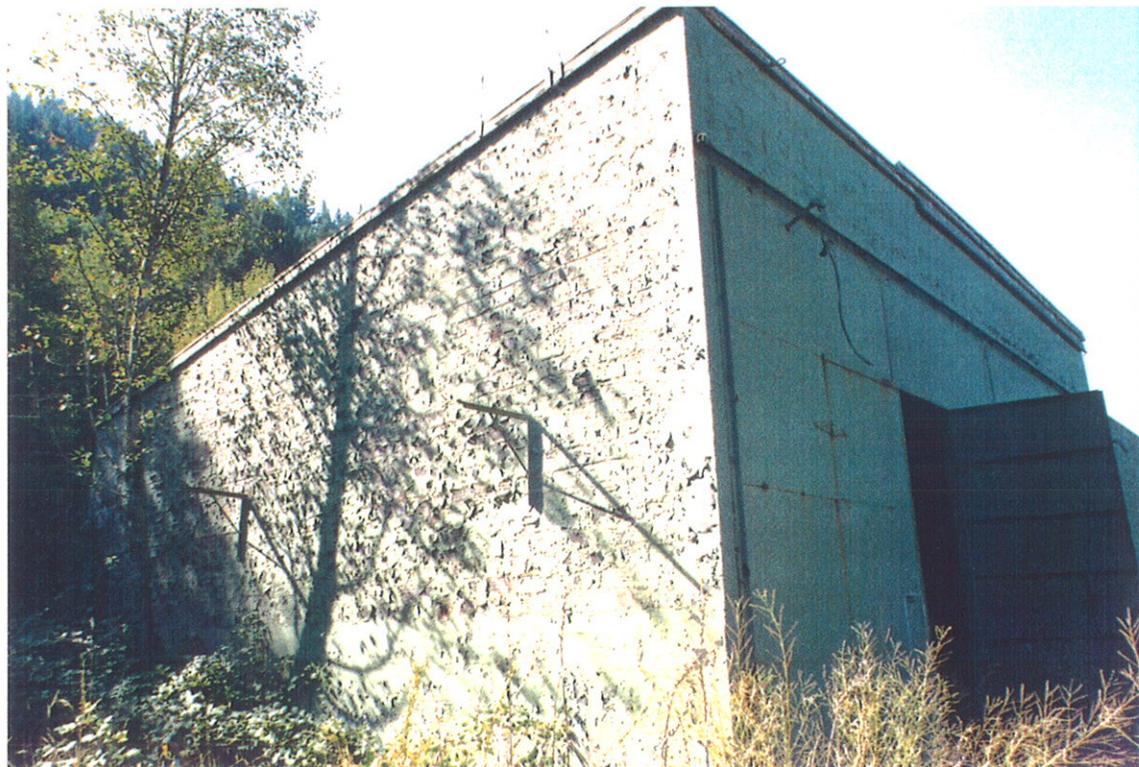
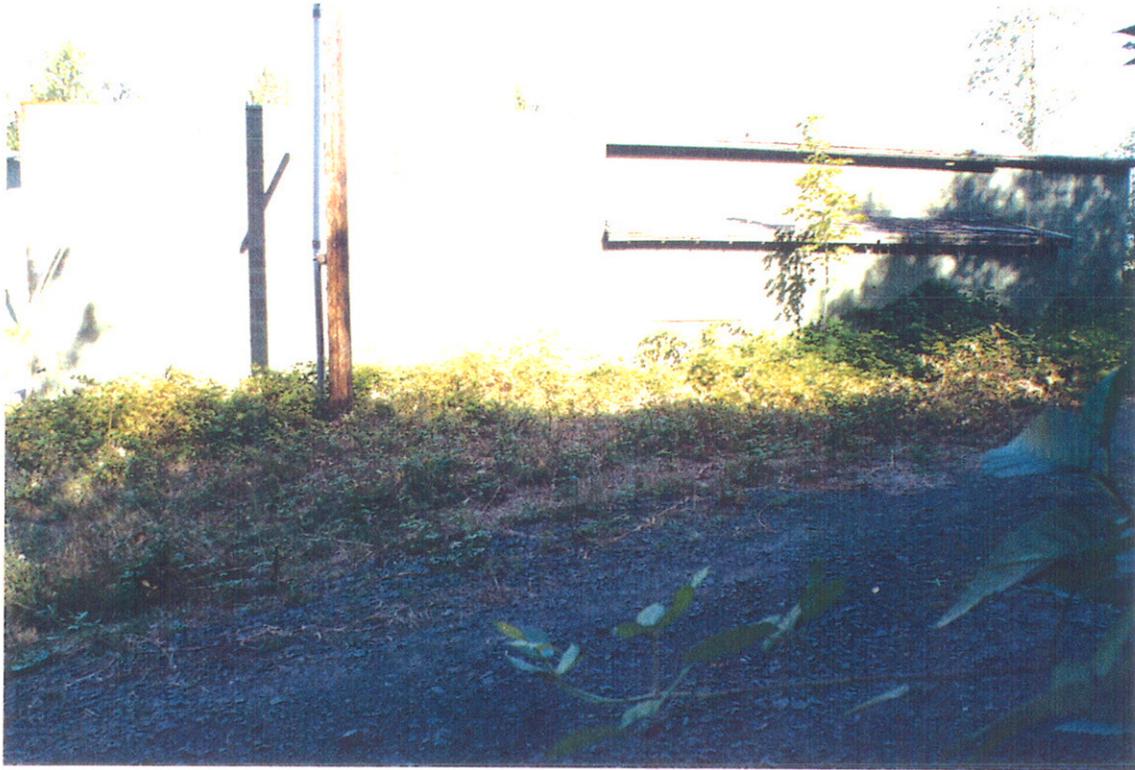
Maintenance Shop - South Facade (above)
Maintenance Shop - West Facade (below)

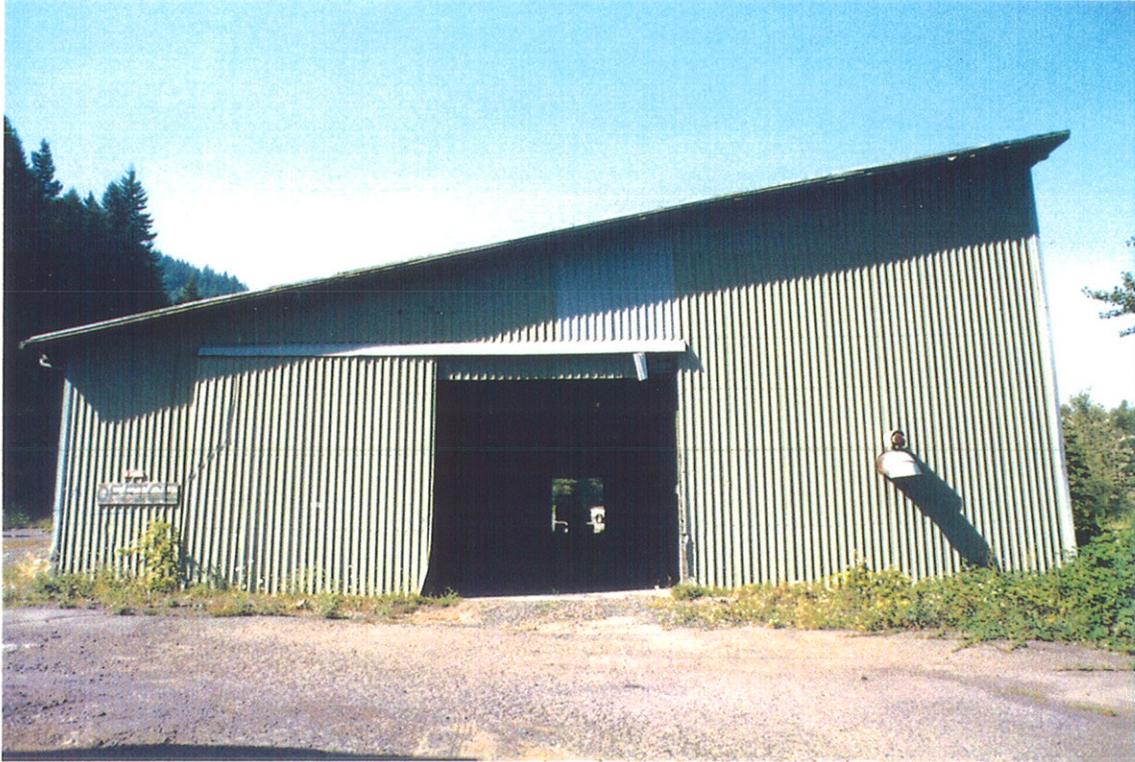
The warehouse is 60 x 169 feet with 13 bays. It has corrugated steel over lap siding. It is frame construction on cement foundation. It has a flat slant roof, approximately 17 feet on the south sloping up to 25 feet on the north. At both east and west elevations, there is a 15 x 12 foot doorway. The north facade is along a rail siding and cement loading dock. It features a 15 x 12 foot doorway approximately 40 feet from the northwest corner. The facade has several sizable holes in the fabric. It was built approximately in the 1920's and is in fair to poor condition.

The warehouse was built as a functional building and has been treated accordingly. The basic structure is intact, but not in the best of shape. Because of its simplicity, the structure has a certain amount of integrity but little historical interest. The corrugated metal covering and the damage to the north facade limit that little interest further.

Warehouse - East Facade (above)
Warehouse - South Facade (below)

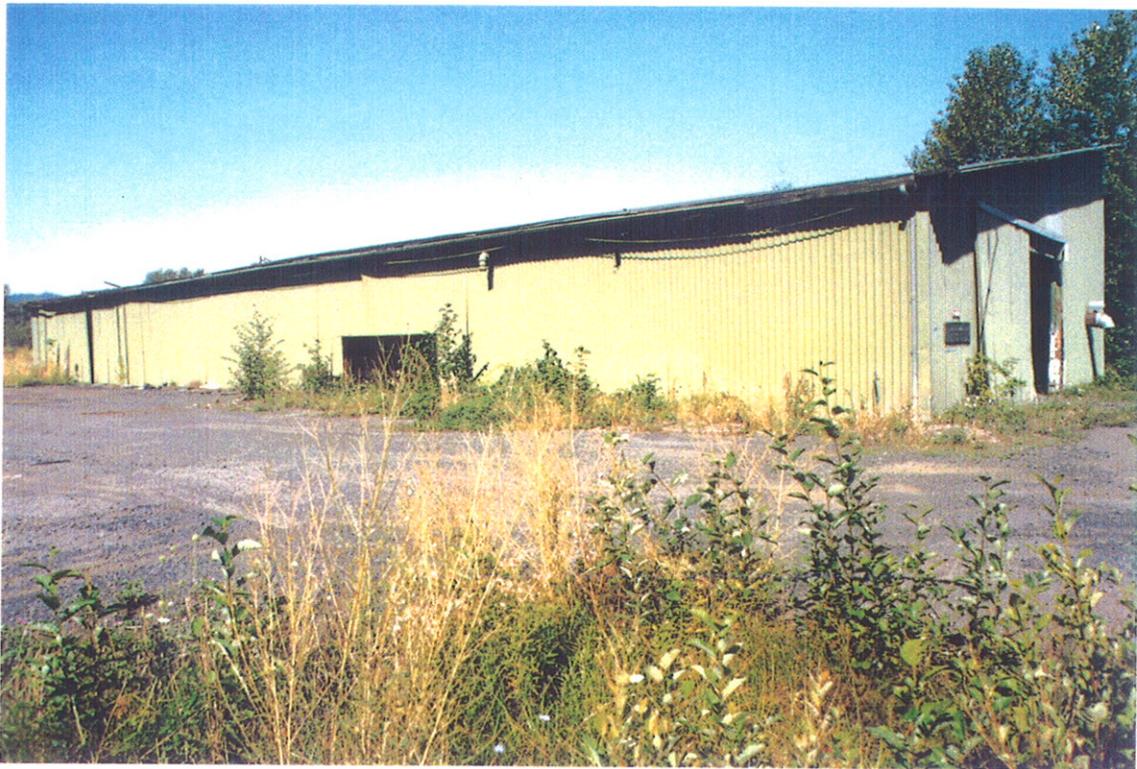
Warehouse - West Facade (above)
Warehouse - North Facade (below)

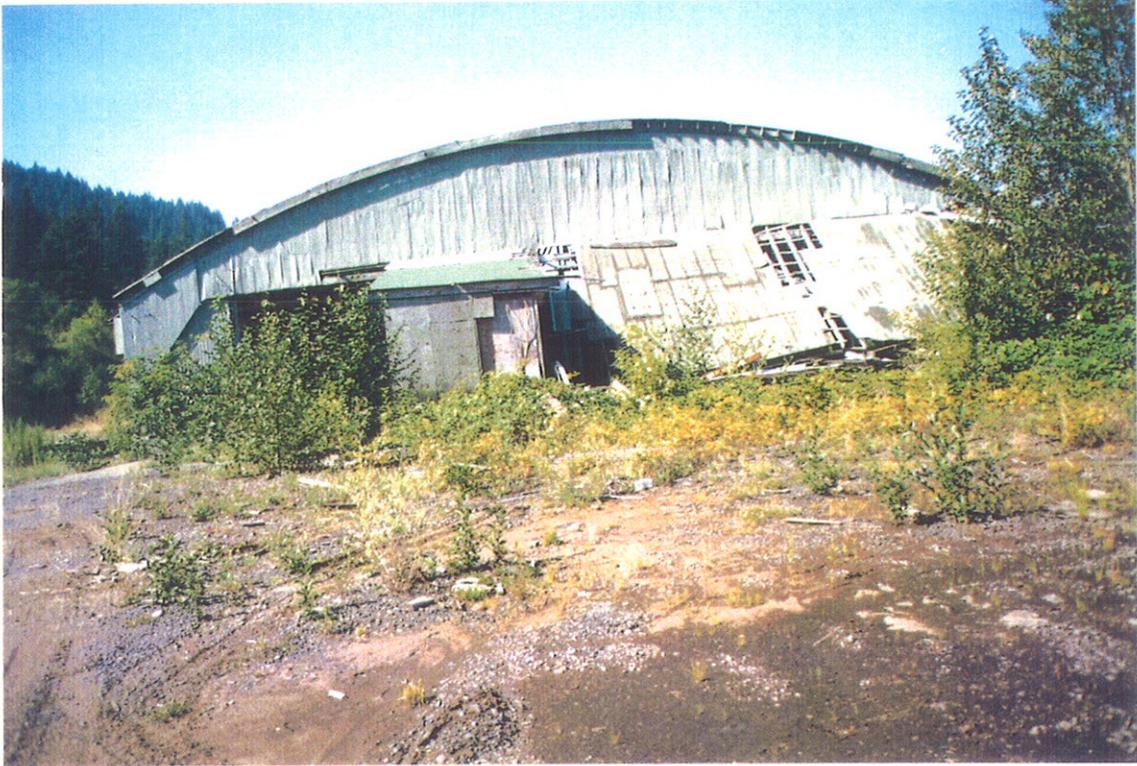
An older frame building, circa 1938, the resaw building was once 114 x 150 feet, enclosed on three sides. It has a corrugated metal skin covering a wood frame and bow truss roof construction. On the south, it featured a rail siding. At the east facade, it included a 15 x 7 foot office of wood construction. The west half of the building has collapsed.

Given the condition of the building and its simple design, it has very little historical integrity remaining. Given its simple design, it has even less significance.

Resaw Building - East Facade (above)
Resaw Building - South Facade (below)

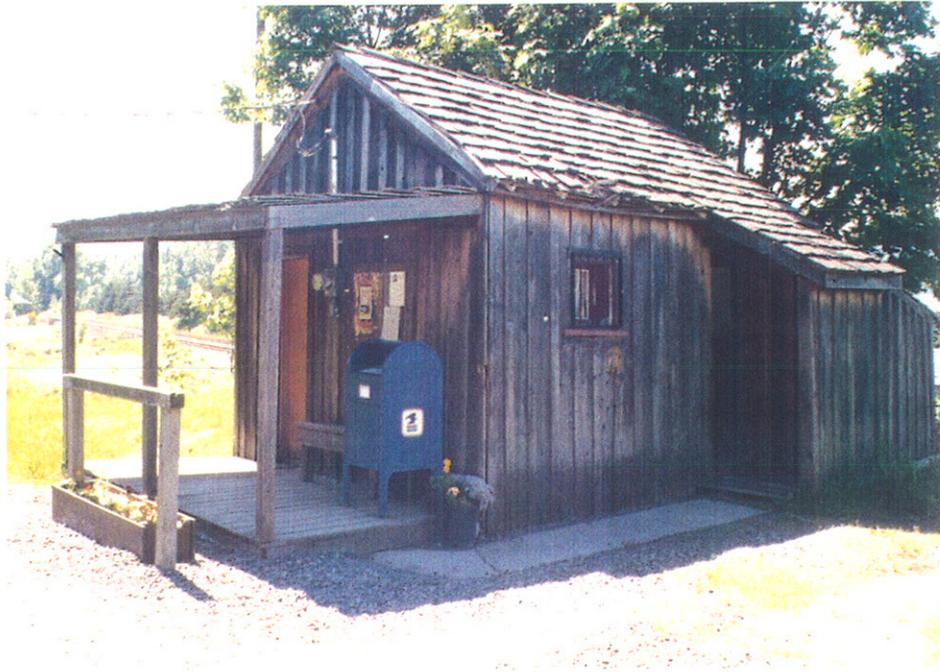
This building measures 10 x 12 feet in size, with a gabled roof. At the front is a 6 x 10 porch with a shed roof. The siding is vertical boards and battens, with some 6 inch drop-siding visible. The roof is wood shake and in poor condition.

Upon investigation, the building appears to date from the 1940's and is non-historic. In general, it has a romantic rustic appearance that is out of character for the area, the era and the use. Due to the change in use and the rustic remodelling, the building has no historical integrity.

Post Office - Southeast Corner (above)
Post Office - Southwest Corner (below)

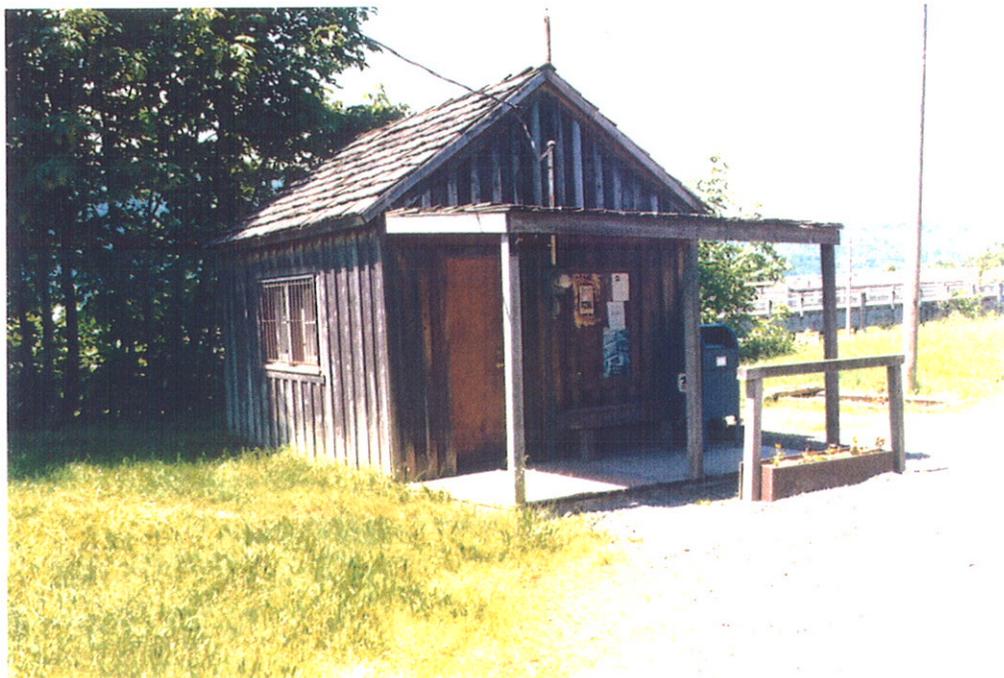
The building is in good condition and in use as a post office.

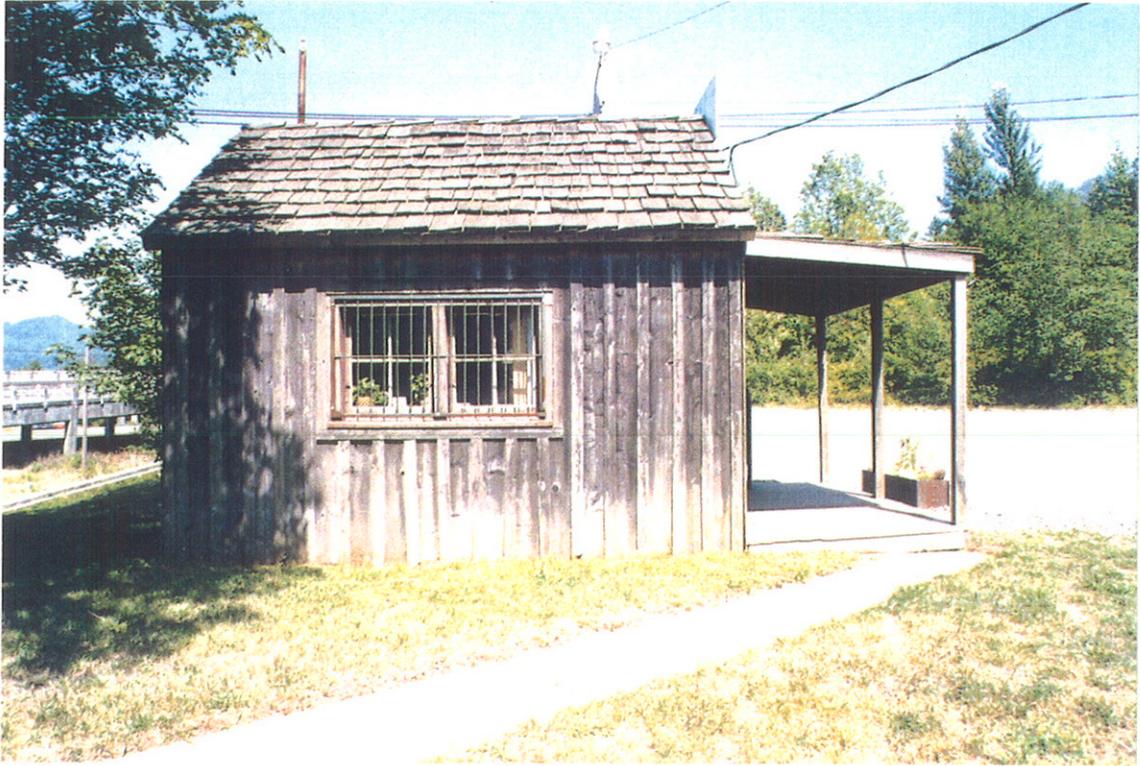
Post Office - West Facade (above)
Post Office - Northeast Corner (below)

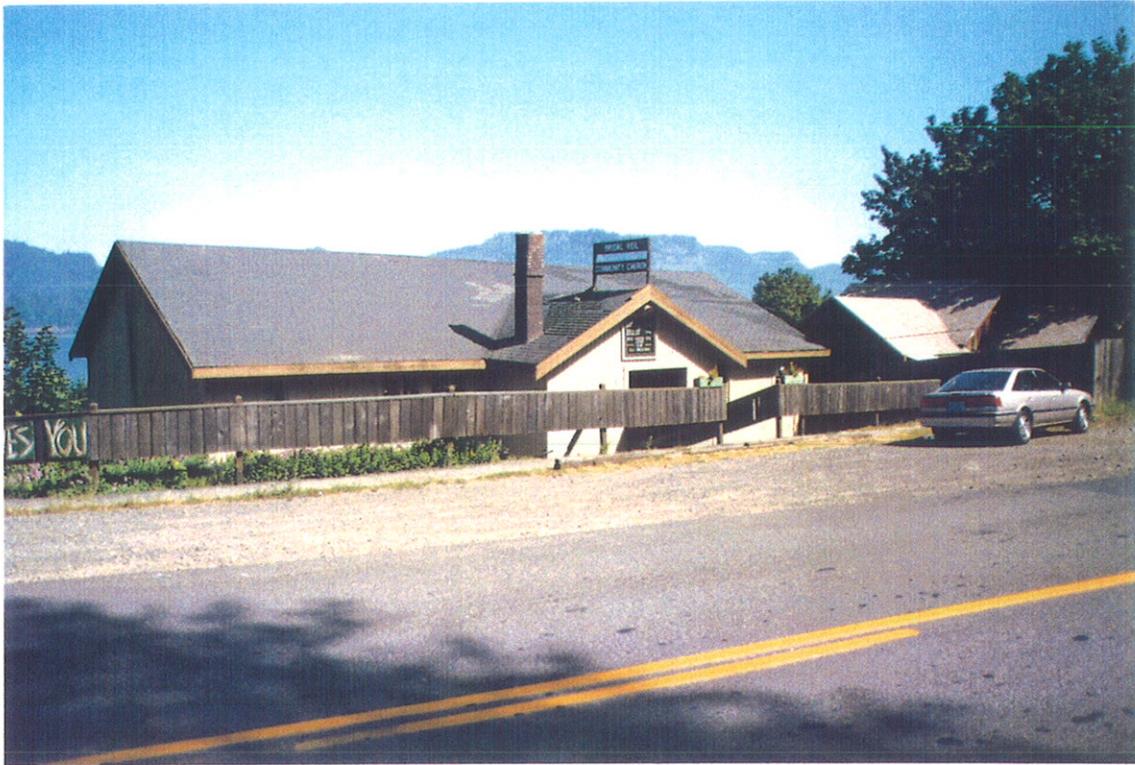
Structurally the building seems to be in fair condition. According to an appraisal report on the structure, the electrical system is in poor condition. The roof needs attention.

Church - South Facade

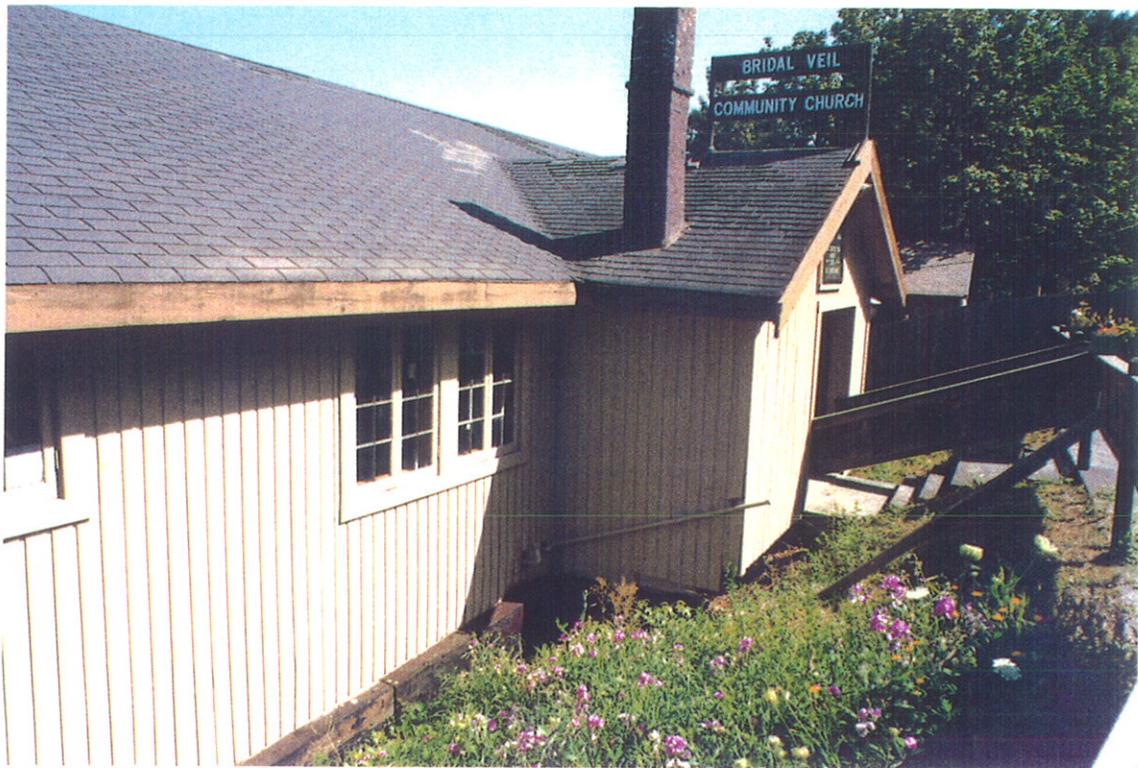
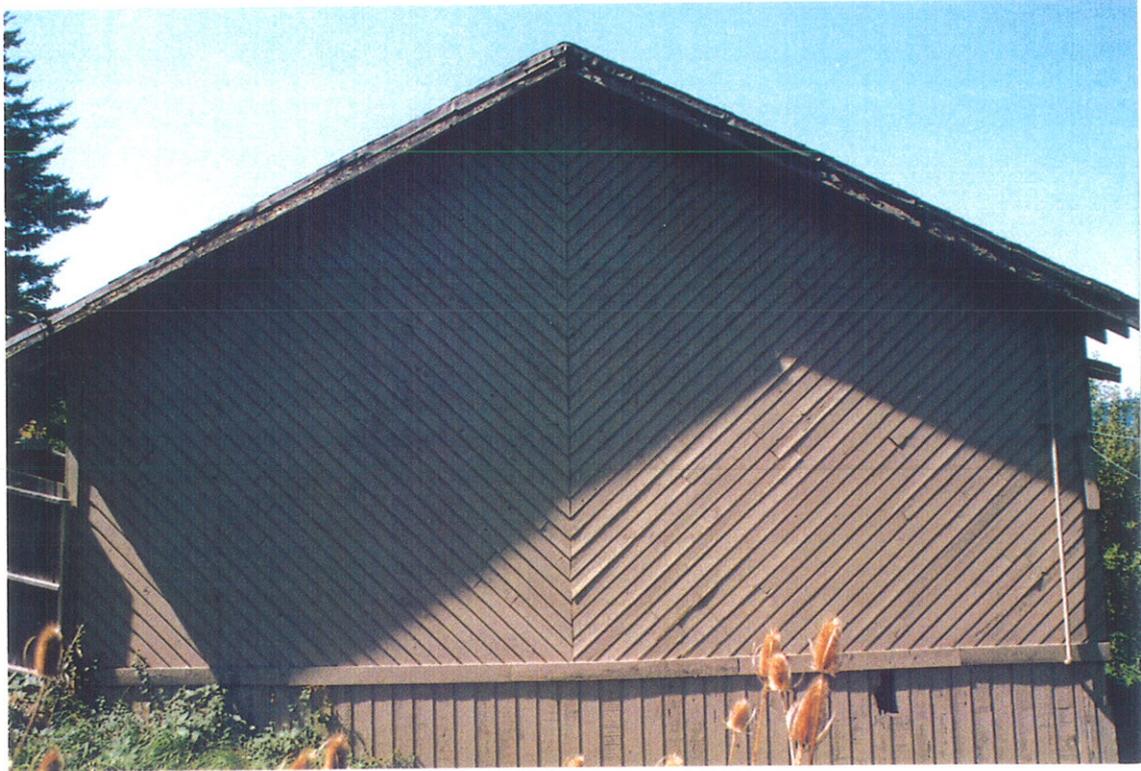
Church - West Facade (above)
Church - Southeast Corner (below)

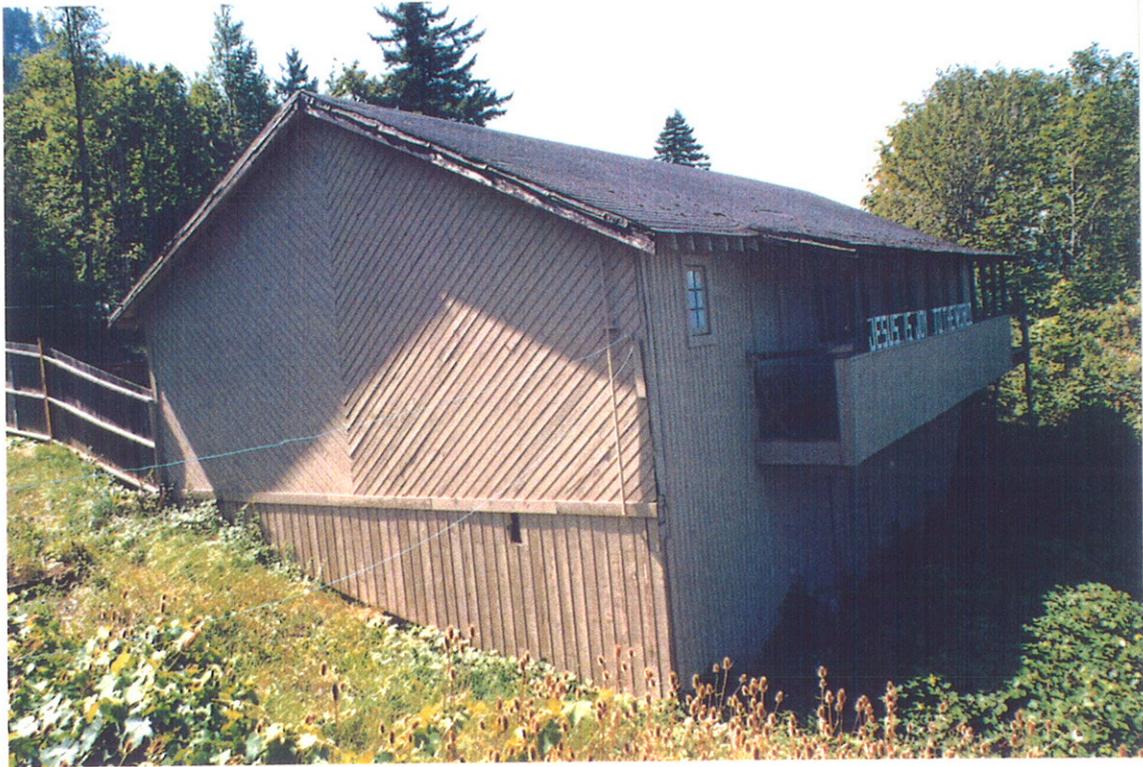
The building, on a steeply sloping site, has a post-pier foundation. The walls are vertical siding, except that at the ends the siding is diagonal. The roof is gabled, and surfaced with composition shingles.

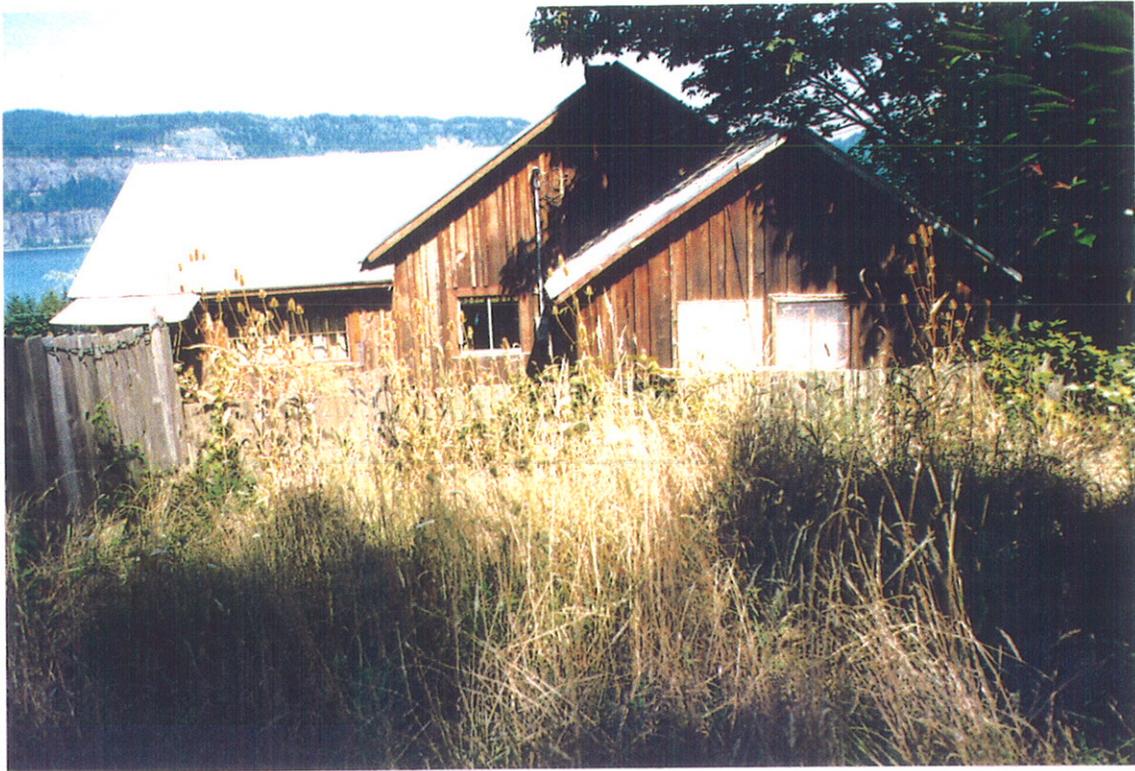
Structurally the building appears to be in fair to poor condition. The building has been altered well beyond its original appearance. Due to the additions, loss of original fabric and existing condition, the building totally lacks any historic integrity.

House #2 - South Facade (above)
House #2 - Southwest Corner (below)

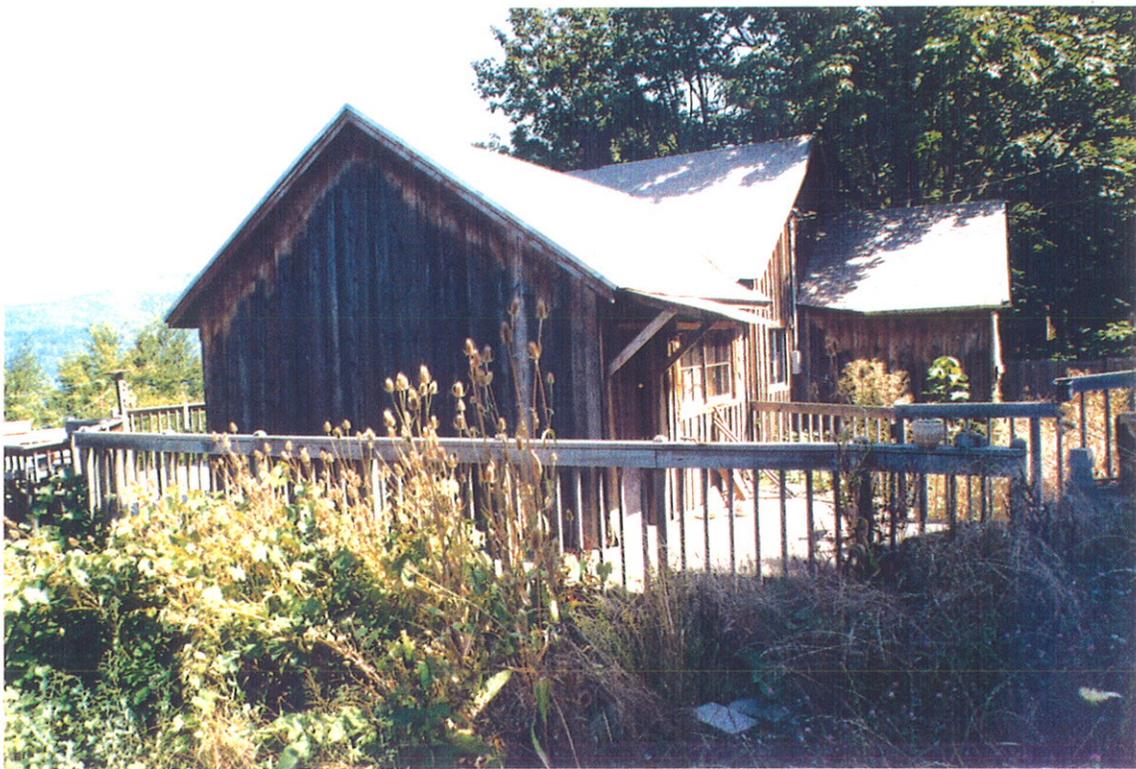
House #2 - Northwest Corner (above)
House #2 - East Facade (below)

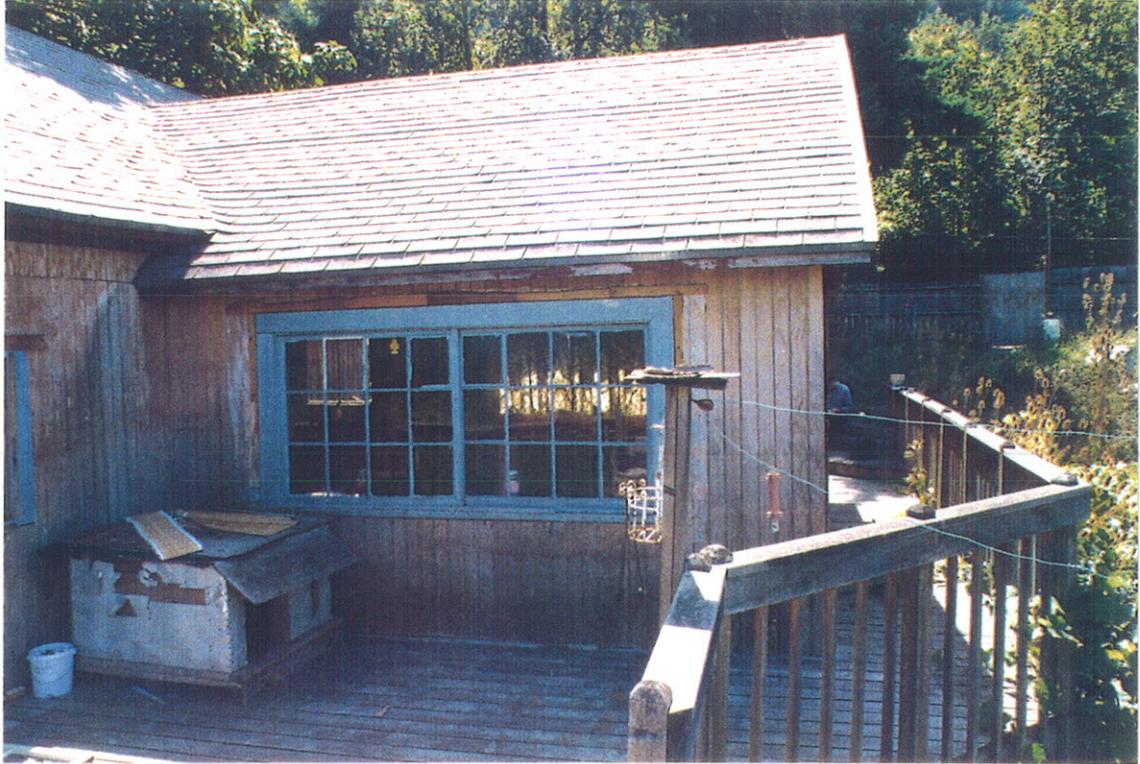
The core of the house is in the standard worker's 24 x 24 foot shell. It has two additions: The first is a 6 x 9 foot addition at the southeast corner. The second is a 15 x 18 foot ell at the southwest corner. The original front porch is gone, replaced with a broader wrap-around deck, porch. The original front door and several original windows have been covered over. New windows and doors have been cut into all facades. The house has new board and batten siding, stained, and new aluminum and wood windows. The roof is composition shingles. The foundation is post-pier. Modern fencing borders the property on the east and south. The original brick chimney still exists, and some of the original drop-siding is still evident.

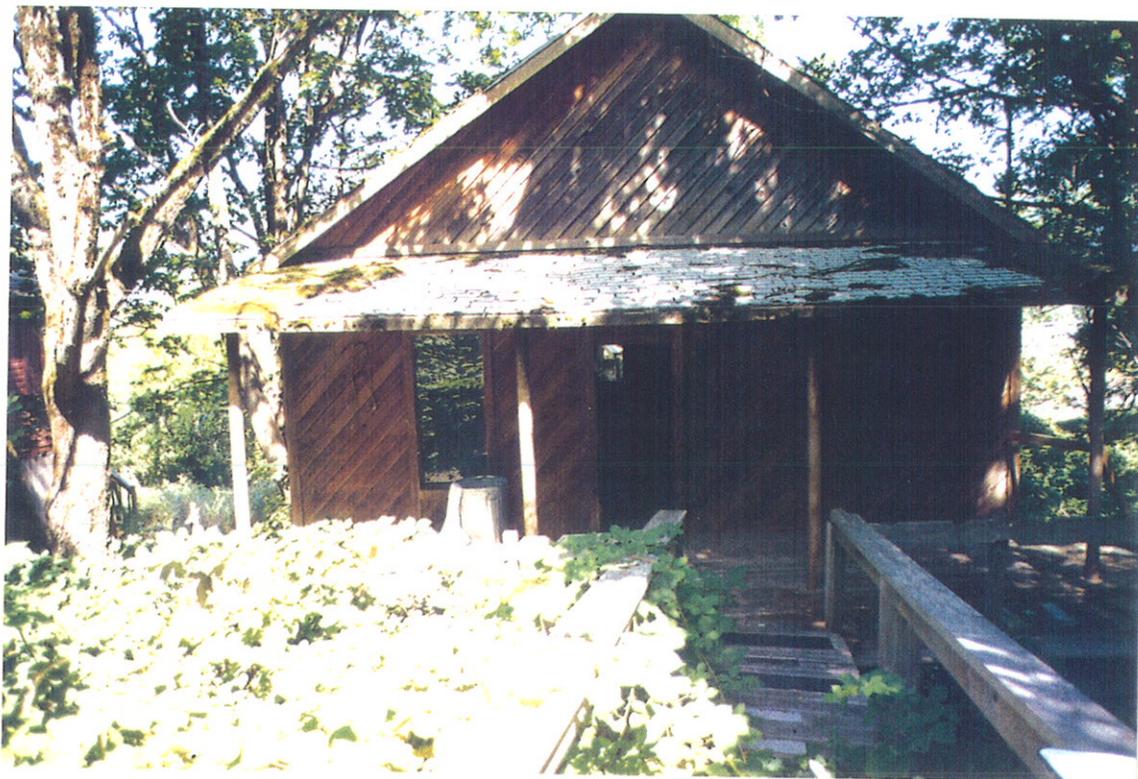
Structurally, the building appears to be in fair to poor condition. The chimney is in extremely poor repair and the roof needs replacement. Although in its original exterior configuration, the changes to its exterior, particularly on the north facade, have greatly compromised its historical integrity.

House #3 - South Facade (above)
House #3 - West Facade (below)

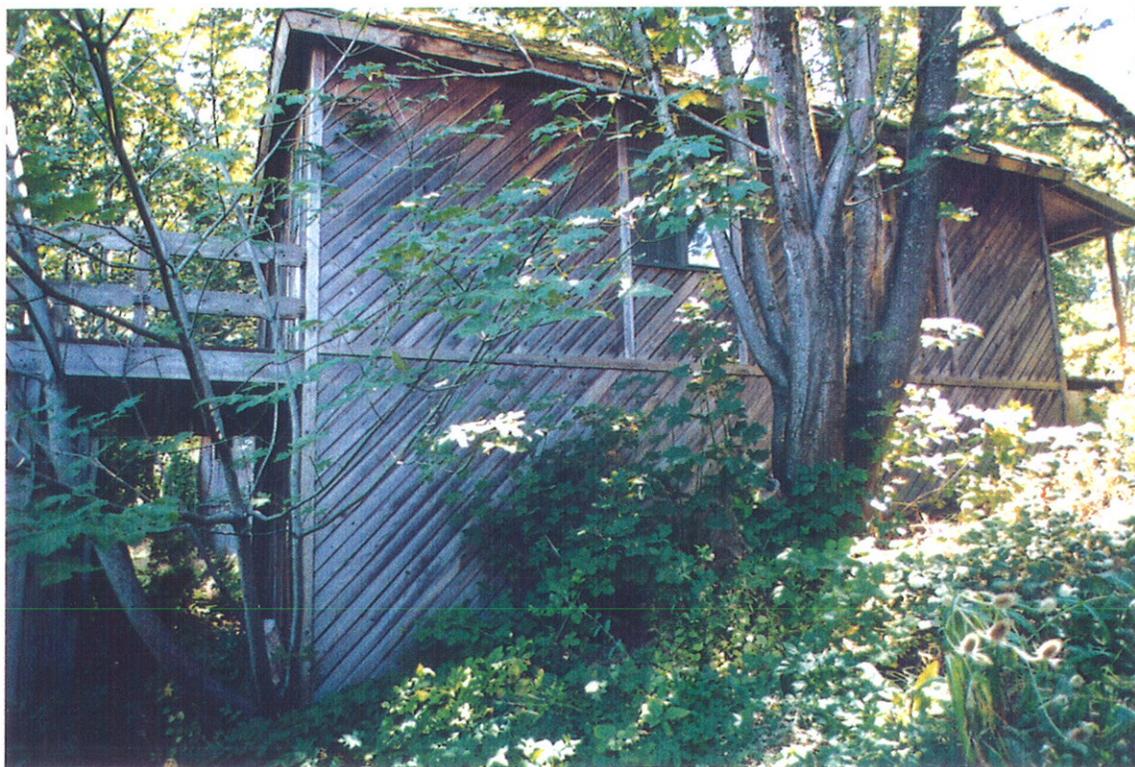
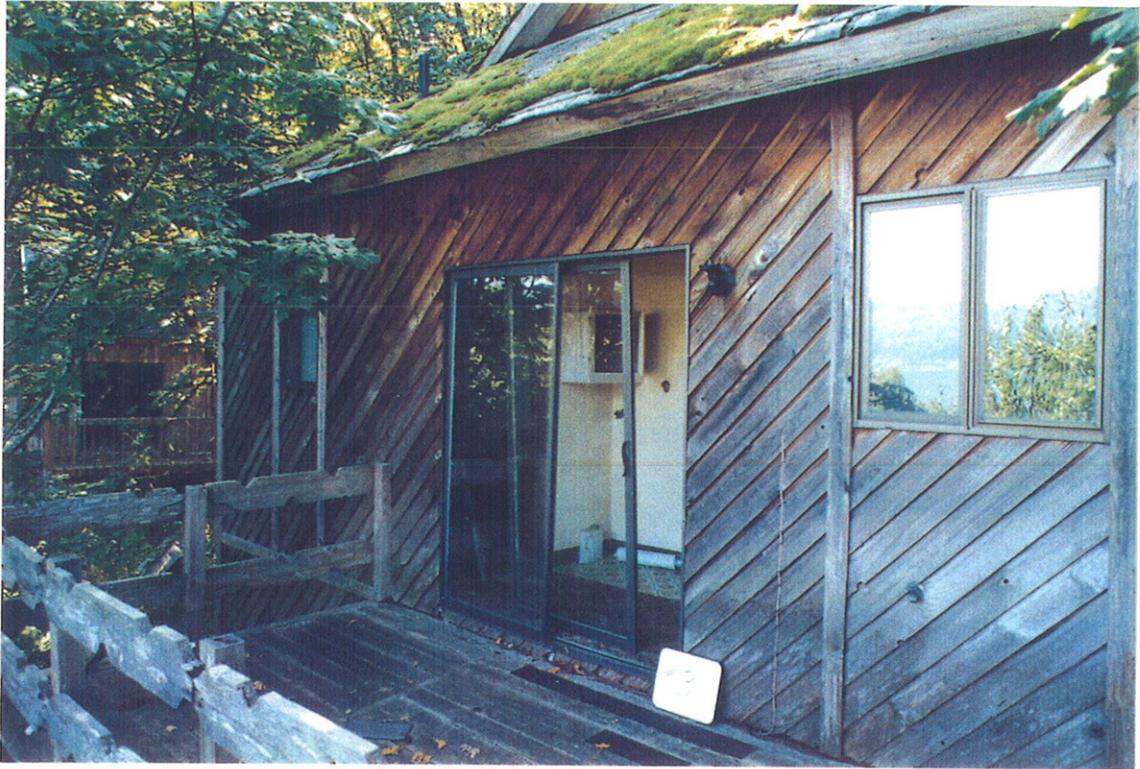
This house is in original configuration with the old rear addition. The house has new siding, stained, and the windows have been replaced with plate glass in the front, aluminum and wood sash elsewhere. A new deck has been placed on the west side and rear, with a sliding glass door cut in at the rear. The roof is composition shingles. The foundation is post-pier. The original chimney is in place, but a new metal patent chimney has been installed.

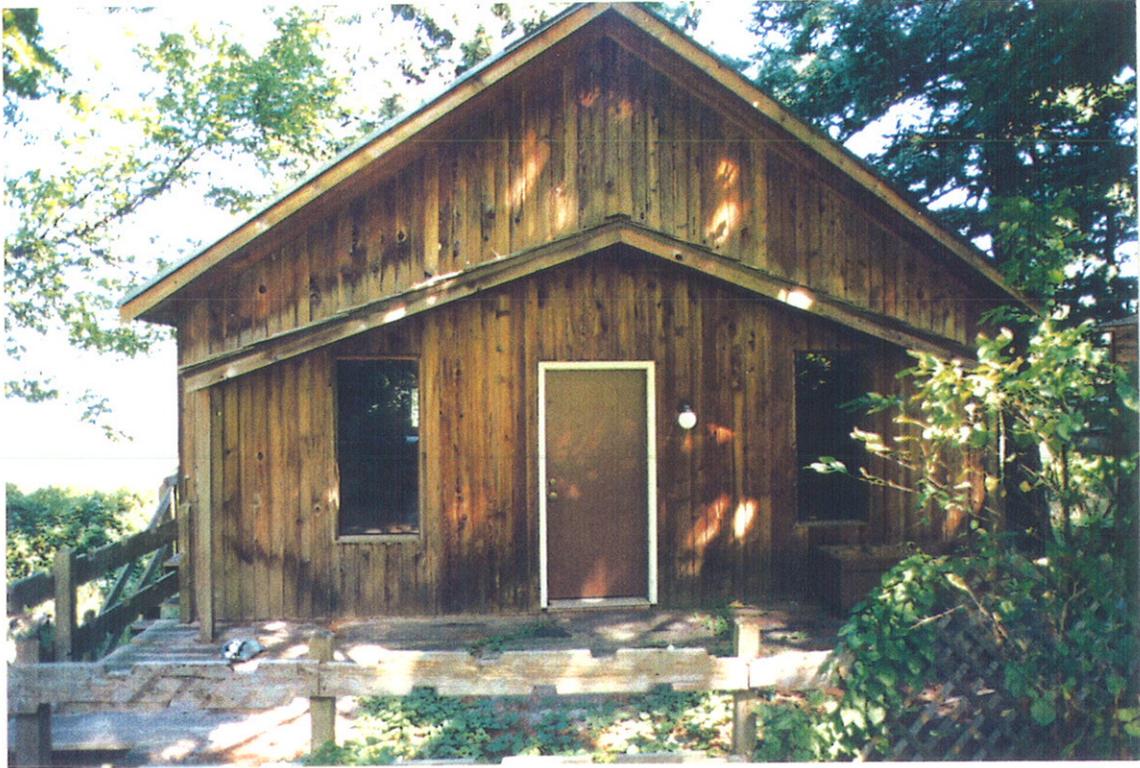
The building appears to be in fair structural condition. While maintaining its original configuration, the historical integrity of the building has been greatly compromised with the addition of vertical siding, the changes to the west facade, the replacement of the windows and replacement of the original chimney.

House #4 - South Facade (above)
House #4 - West Facade (below)

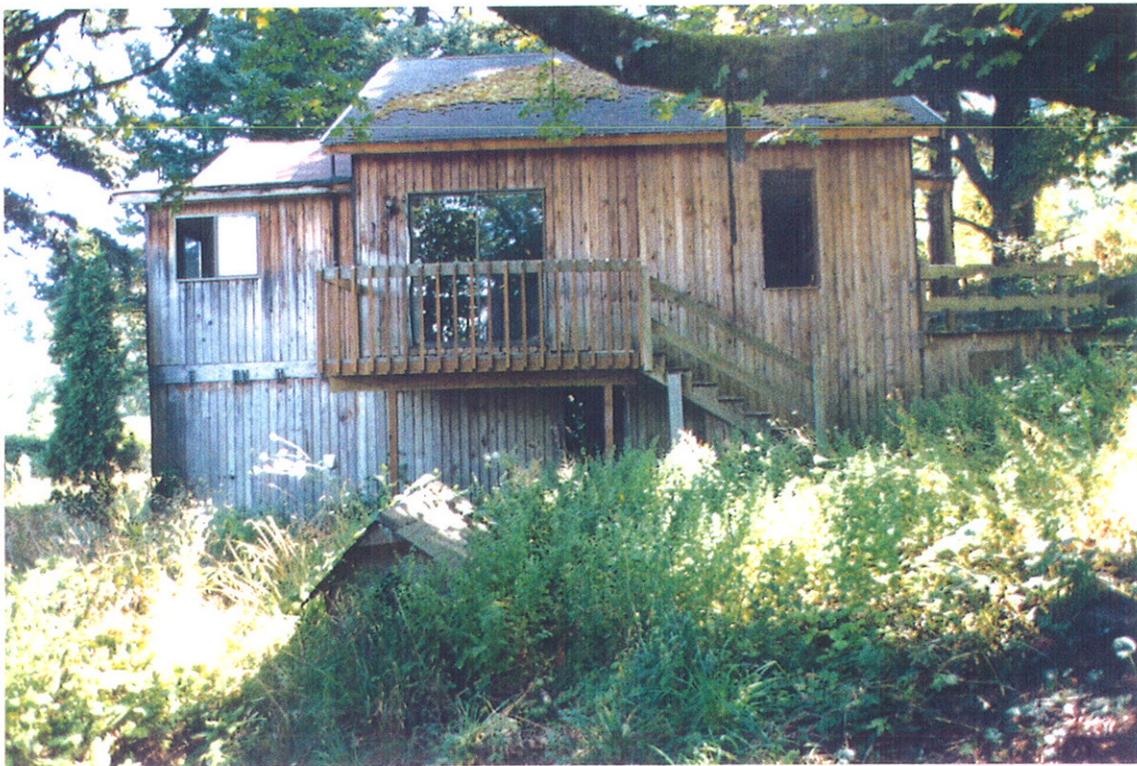
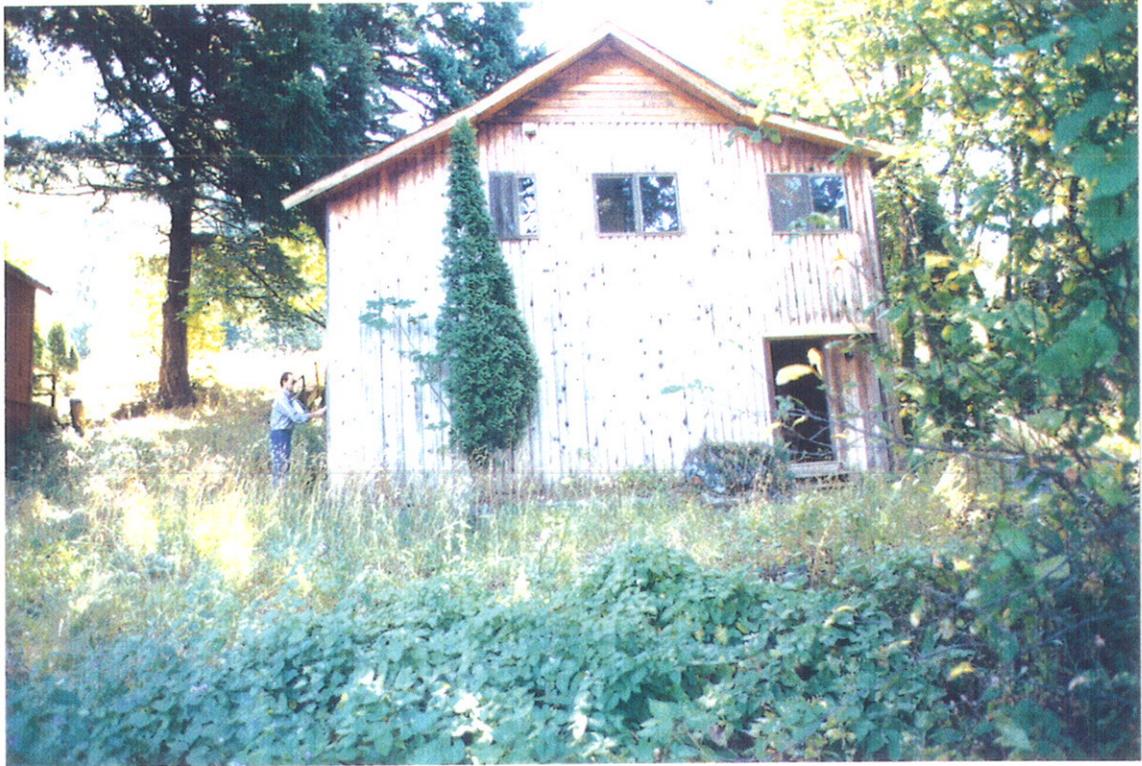
This house is in its original configuration with the old rear addition. The house has new vertical siding, stained, and has some of the original drop-siding showing. Windows are plate glass and aluminum sash replacements. The roof is wood shake. The original chimney has been replaced with a metal patent chimney. The foundation is post-pier. The original porch has been removed and a decorative porch treatment, 18" deep, has been built at the front with a lower gabled roof over it mirroring the roof line. A modern deck wraps around the front and west side, leading to a sliding glass door entryway off the kitchen.

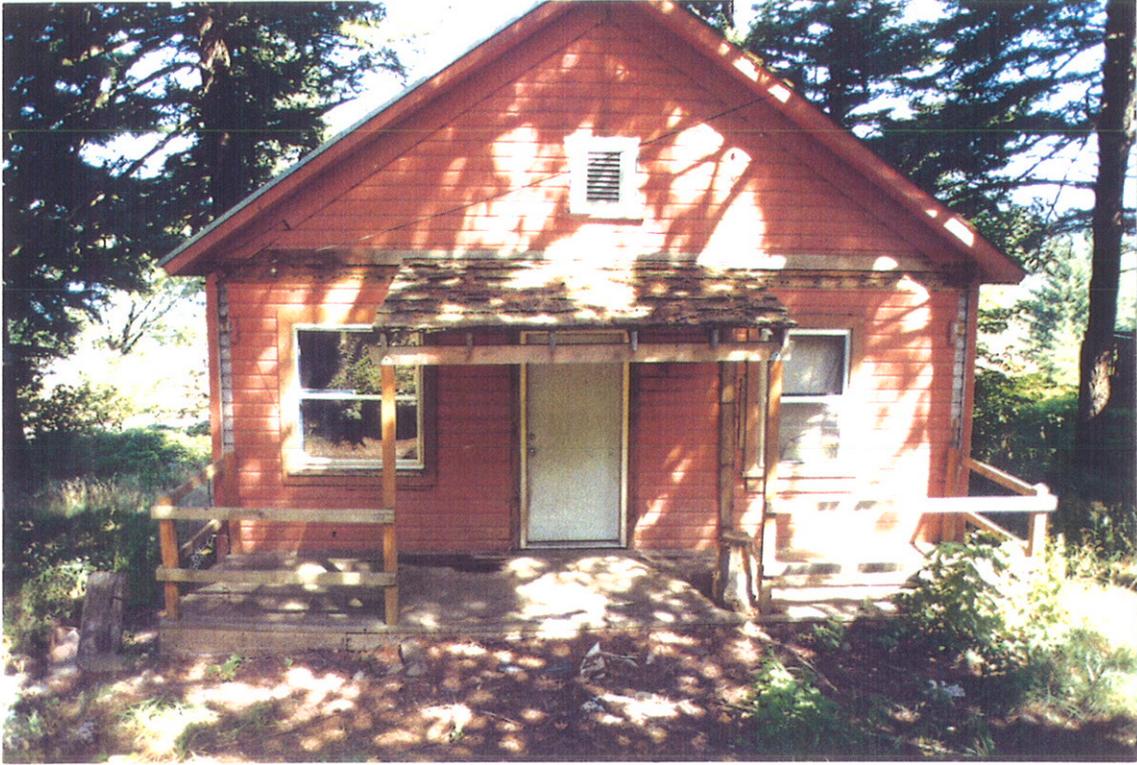
The building appears to be in fair to poor structural condition. The building is in considerable disrepair. This structure contains more of the original features of the standard home than any other in Bridal Veil. However, the new window treatments significantly compromises the historic integrity of the building.

House #5 - South Facade (above)
House #5 - West Facade (below)
