BRIDAL VEIL
MULTNOMAH COUNTY, OREGON

HISTORICAL AND ARCHITECTURAL EVALUATION

August 20, 1992

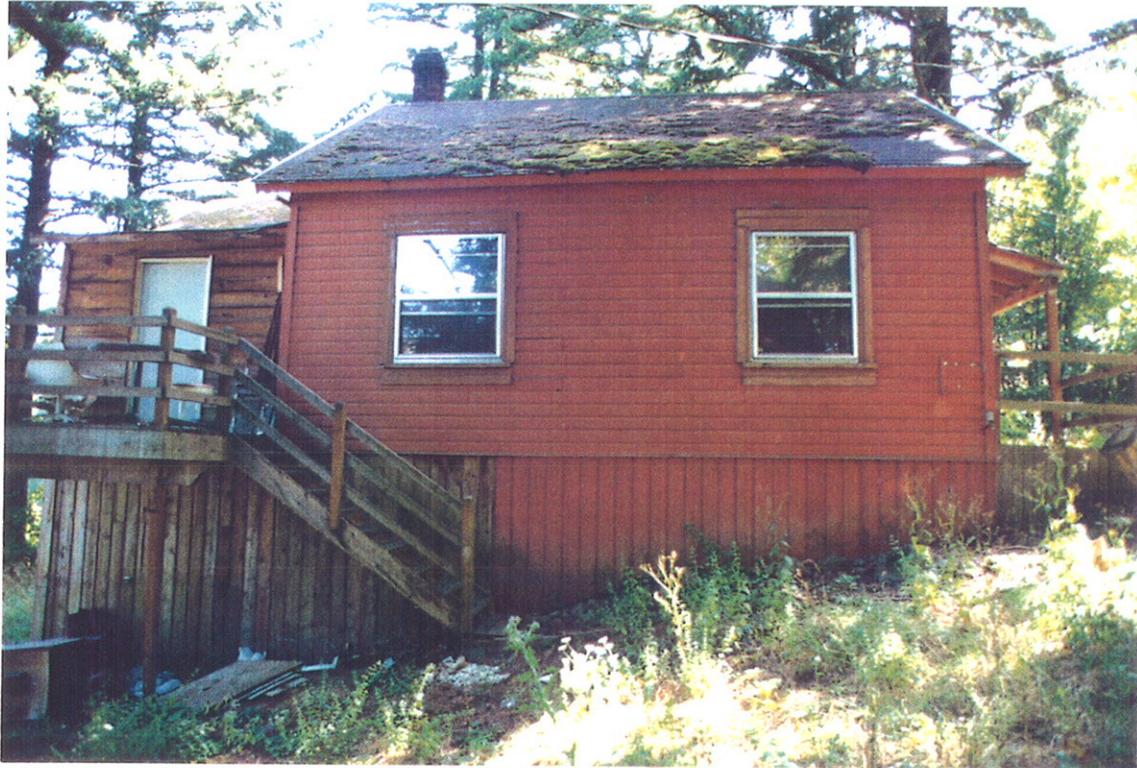
House #5 - South Facade (above)
House #5 - West Facade (below)

This house is close to the original configuration with the old rear addition. Siding is original six inch drop-siding, but the windows have been replaced with aluminum sash. While most windows are of similar size, the front aluminum replacements are larger than the original wood sash. In addition, new windows have been cut into the rear addition. An original roof vent window has been covered over and a new vent installed. The roof is composition shingles. The foundation is post-pier. The original brick chimney is in place.

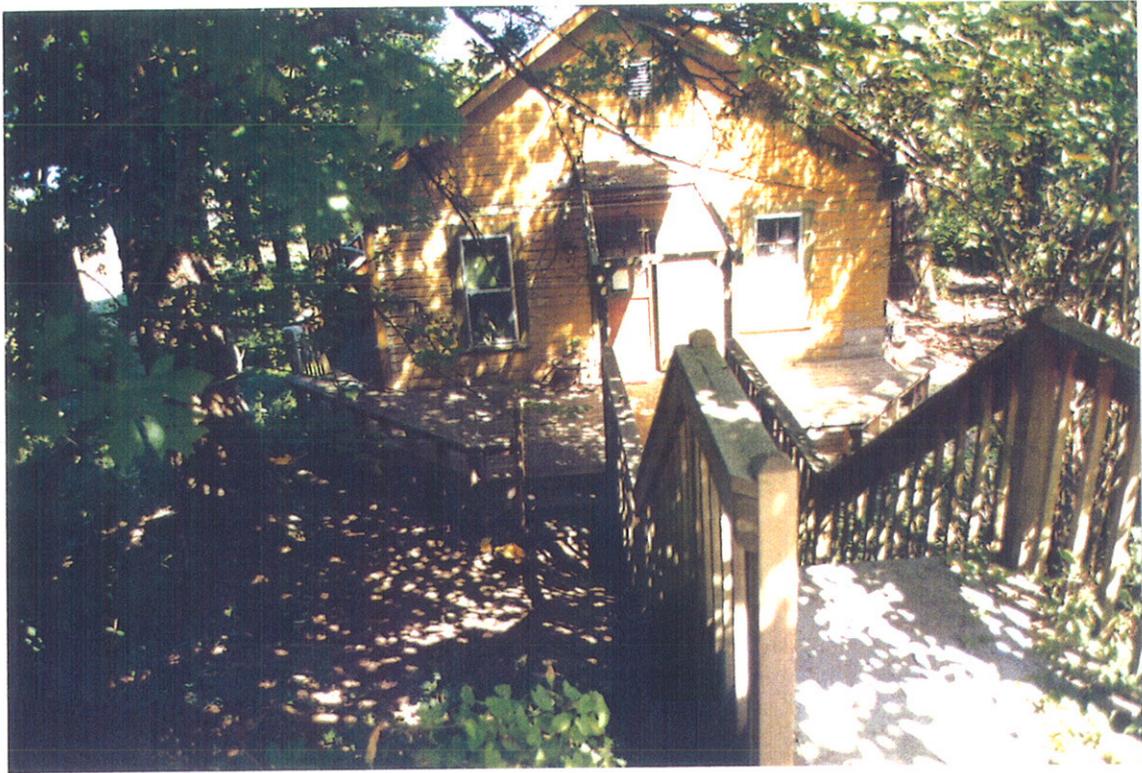
The structural condition of both buildings is poor. Replacement of the original porch comprises the historic integrity of the building.

House #6 - South Facade (above)
House #6 - West Facade (below)

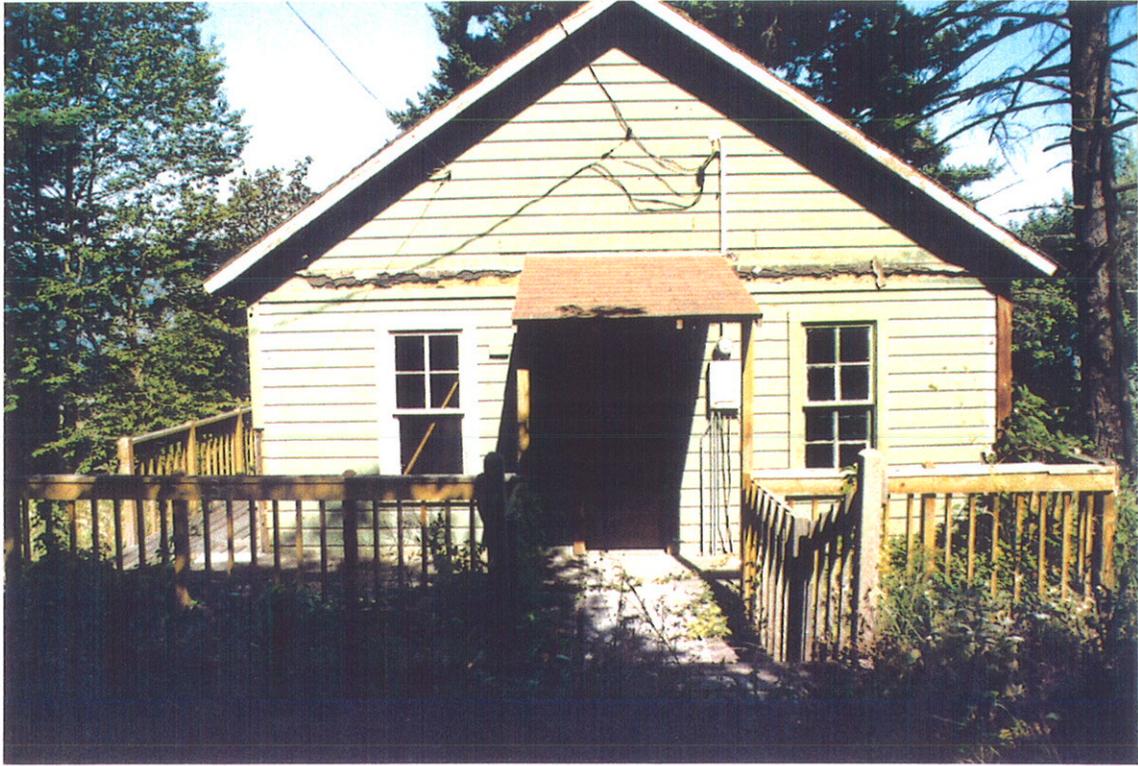
Despite being in near original condition, the structural condition of the house is extremely poor. The removed original porch and the window changes also compromise the historic integrity of the building.

House #7 - South Facade (above)
House #7 - West Facade (below)

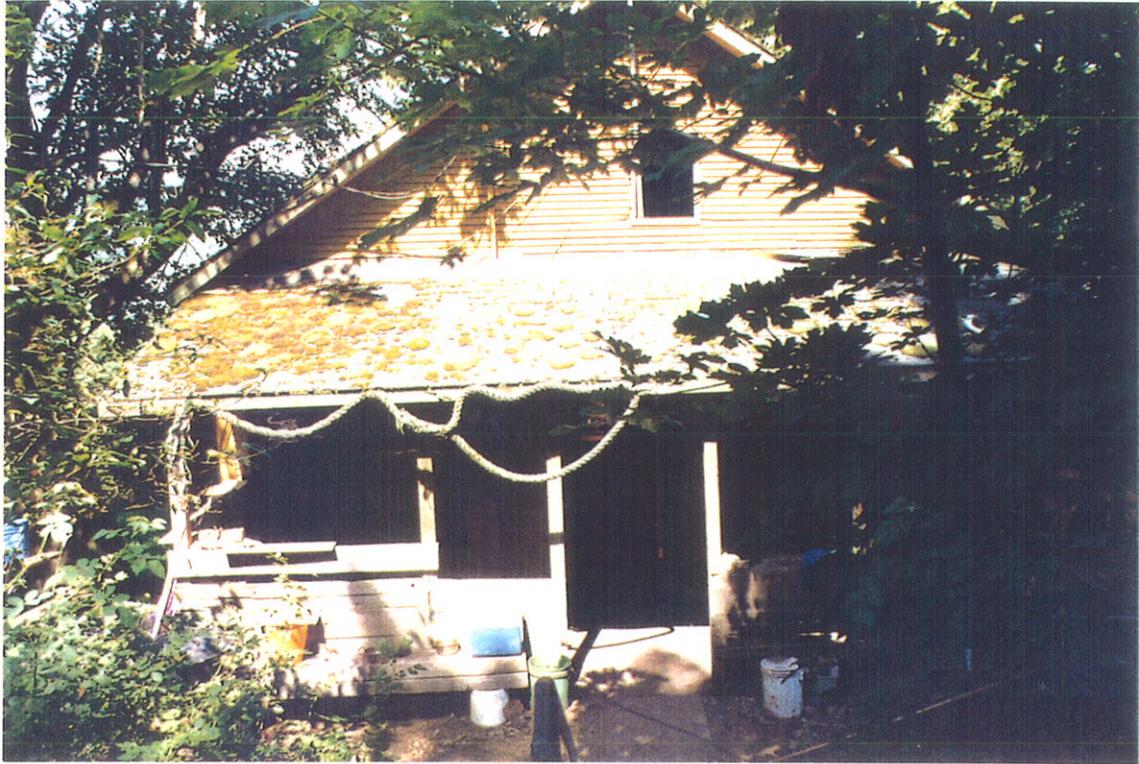
The building appears to be in fair to poor structural condition. The building is in considerable disrepair.

House #12 - South Facade (above)
House #12 - West Facade (below)

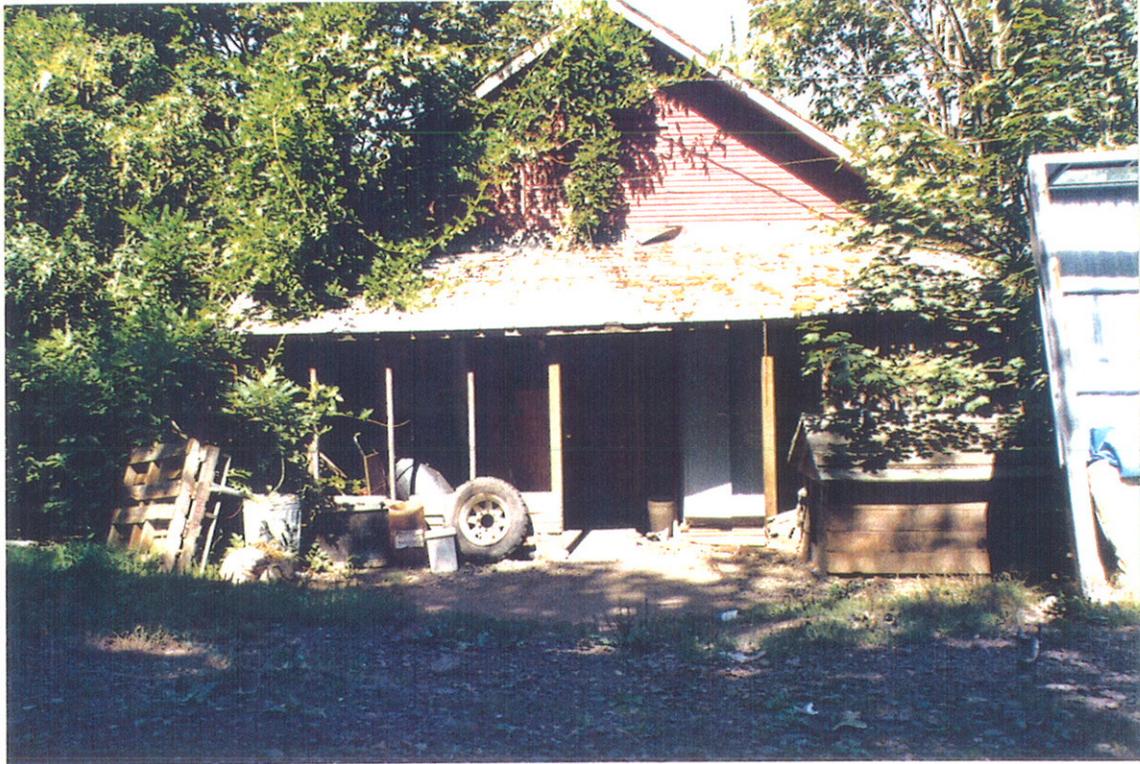
The building appears to be in fair to poor structural condition. The building is in considerable disrepair.

House #13 - South Facade (above)
House #13 - West Facade (below)

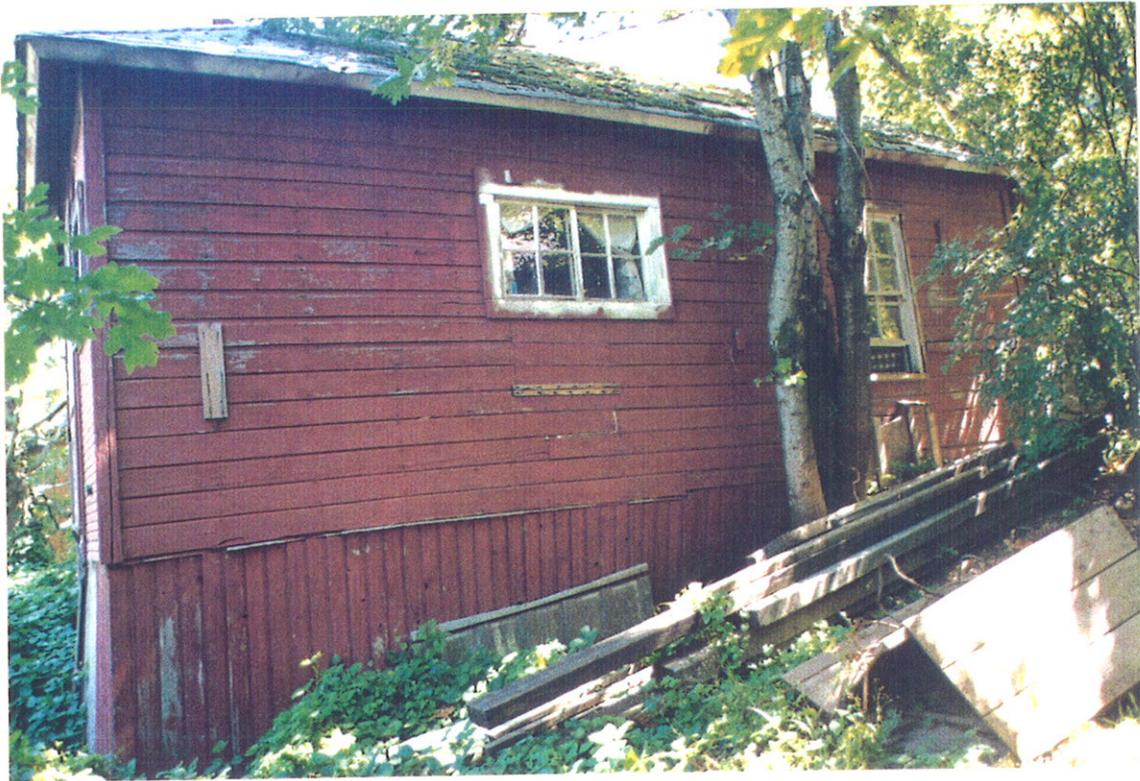
This house is the same as No. 12, except that the siding is V-joint rustic, with two v-joints per board. The second story vent window has been covered over.

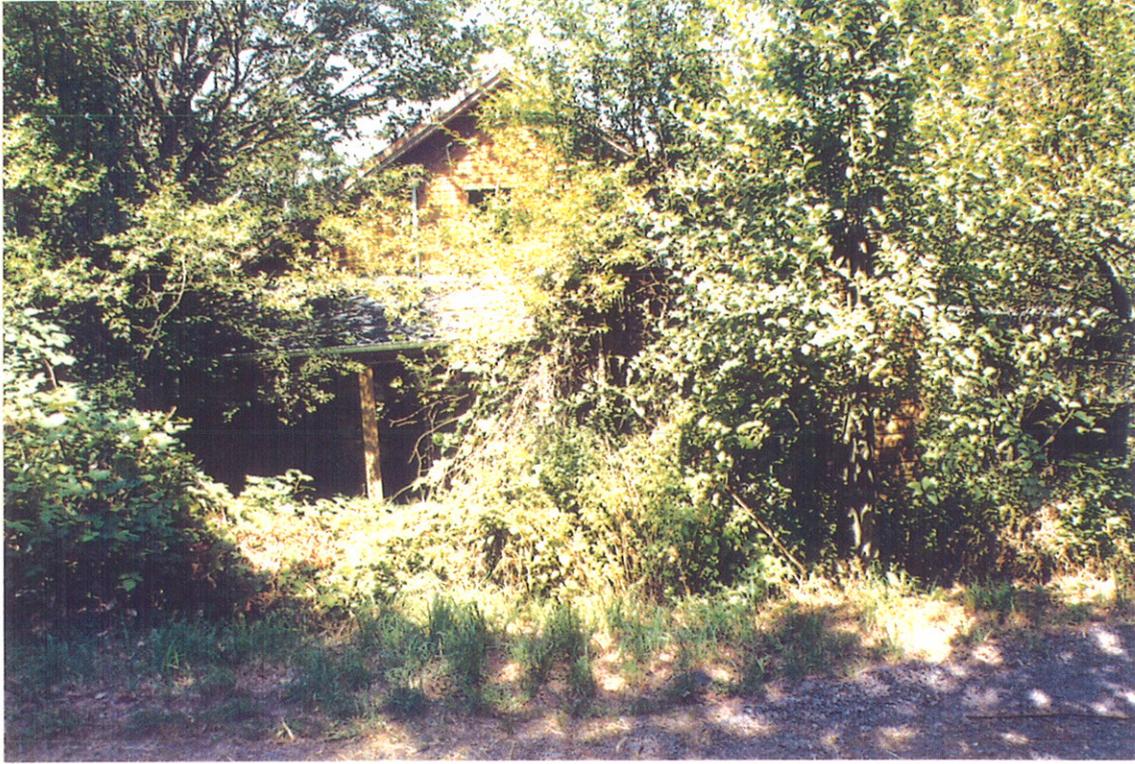
The building appears to be in fair to poor structural condition. The building is in considerable disrepair. The new doorway, window treatments and orientation greatly compromises the historic integrity of the building.

House #14 - South Facade (above)
House #14 - Northeast Corner (below)

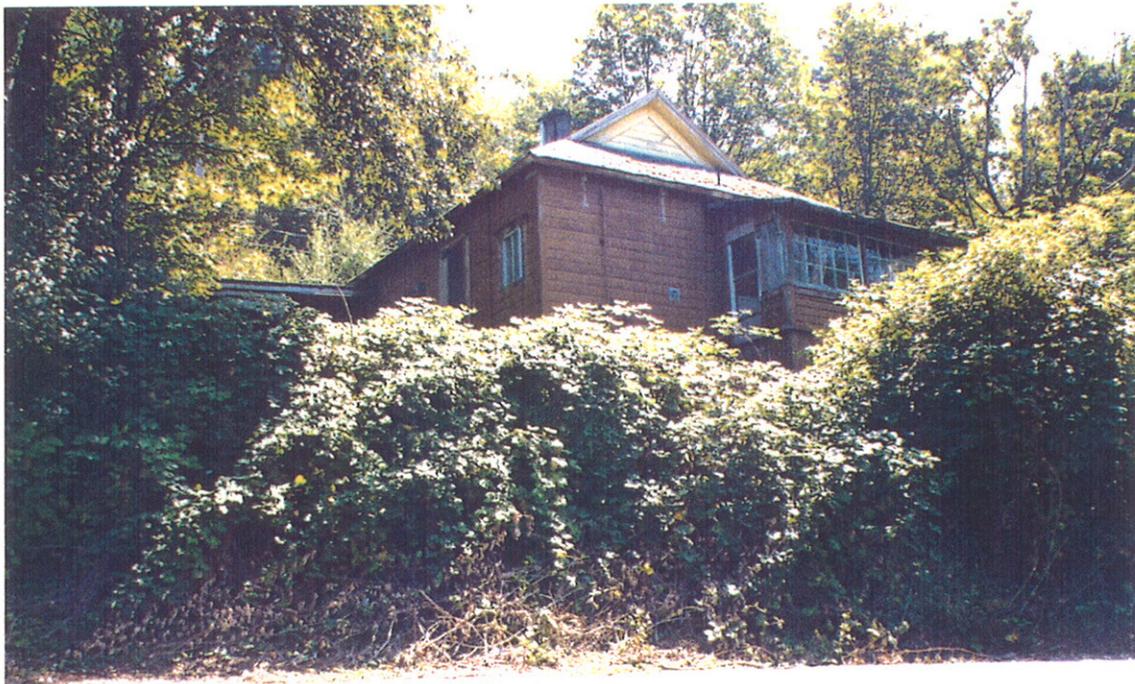
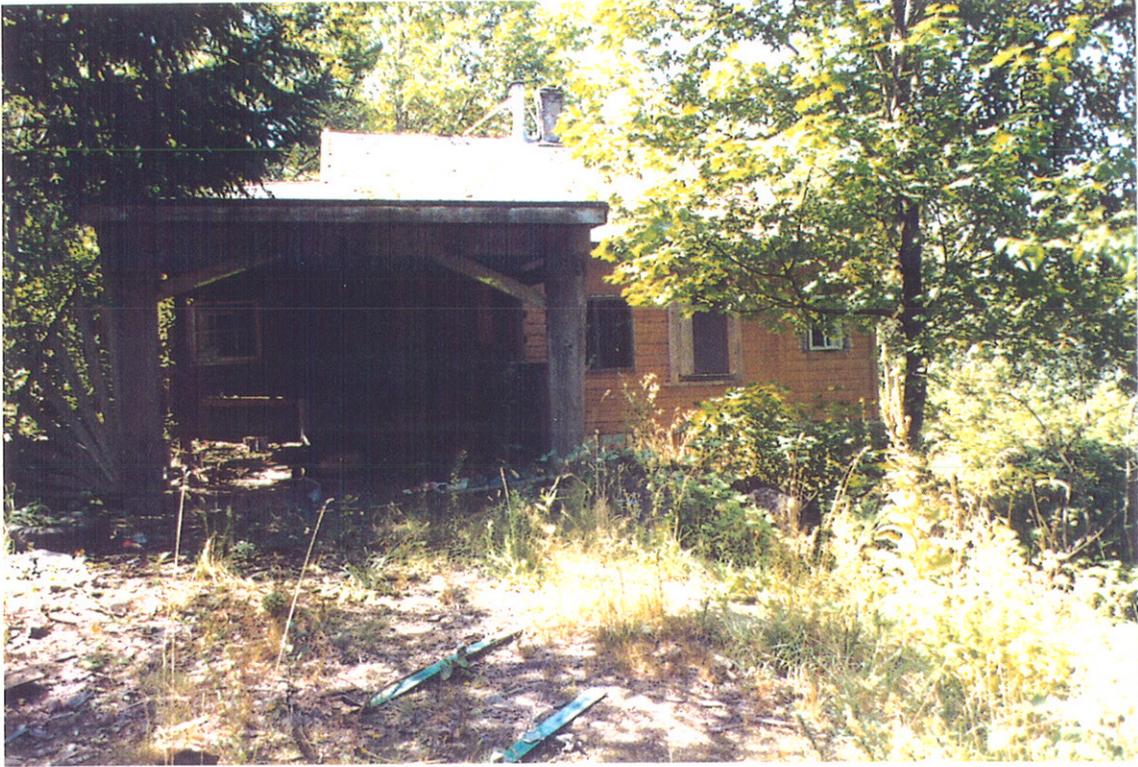
This house is in its original configurations with the old rear addition. It also has a gabled roof addition at the front, and a 12 x 21 foot flat roofed shed/carport addition at the east facade. It has several types of siding, including six inch v-joint rustic. The windows are both aluminum and wood sash, with several original windows on the east covered over and new windows cut in. A new doorway has been cut in for access from the carport which reorients the house 90 degrees to the east. The porch on the front also appears to be new.

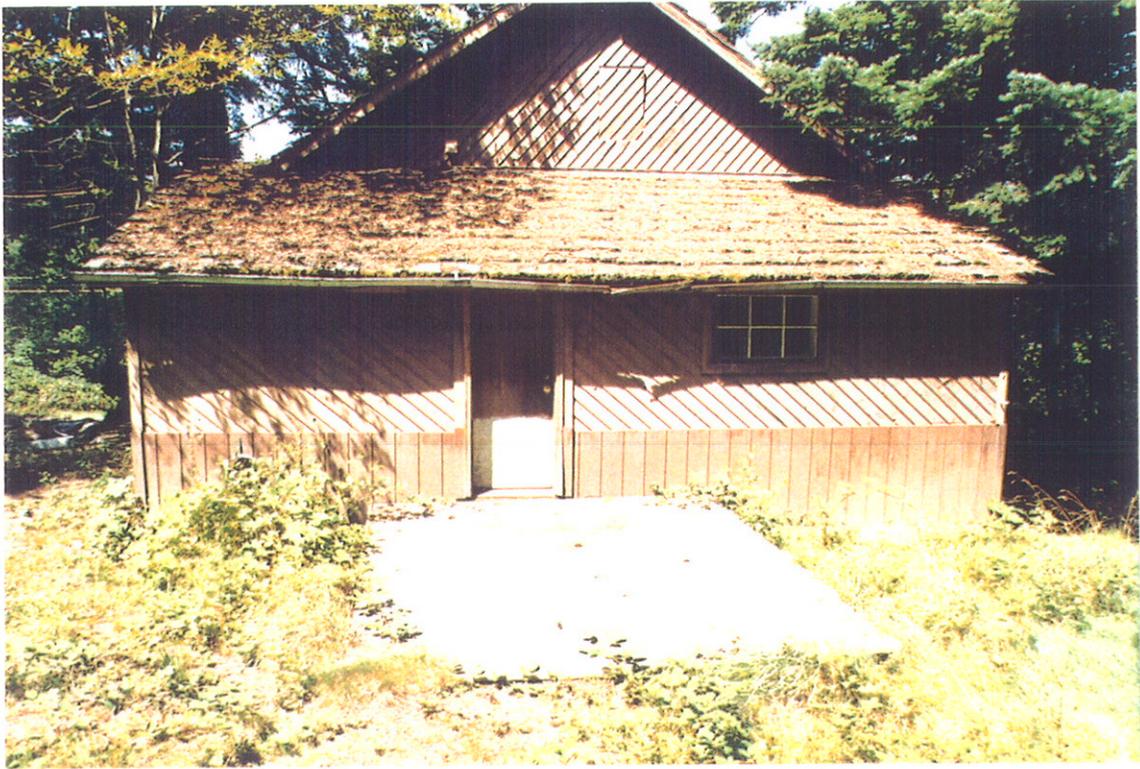
The building appears to be in fair structural condition. The building is in considerable disrepair. Because of the reorientation and extensive remodeling, the house has little historical integrity.

House #15 - South Facade (above)
House #15 - West Facade (below)

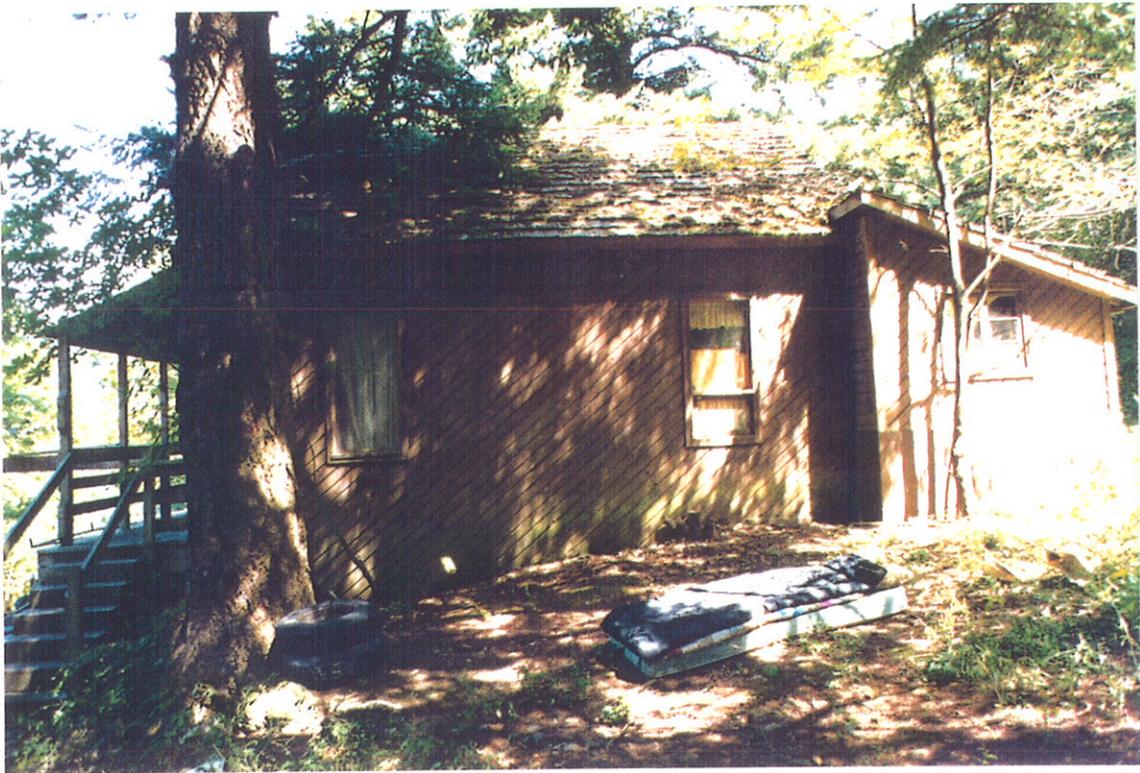
This house has the original configuration with the old rear addition. However, its orientation has been reversed, with the primary entryway from the north, not south as originally built. The original south porch has been covered over and enclosed for living space. A new porch and deck have been built on the north, along with a new doorway and new windows. The original windows have been replaced with aluminum sash. The siding is new diagonal boards, stained. The foundation is post-pier. The chimney is a new metal patent chimney. The roof is wood shake.

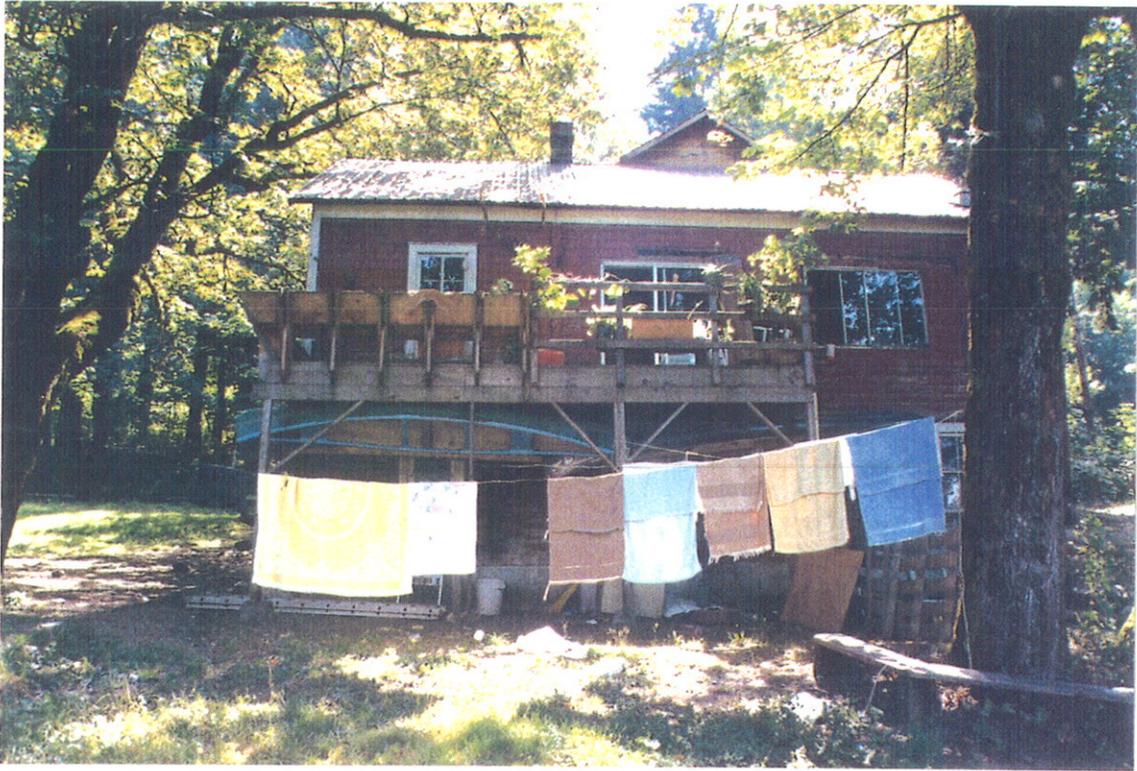
In very poor condition, the extensive changes to the structure over time seriously undermine any historical integrity.

House #17 - South Facade (above)
House #17 - West Facade (below)

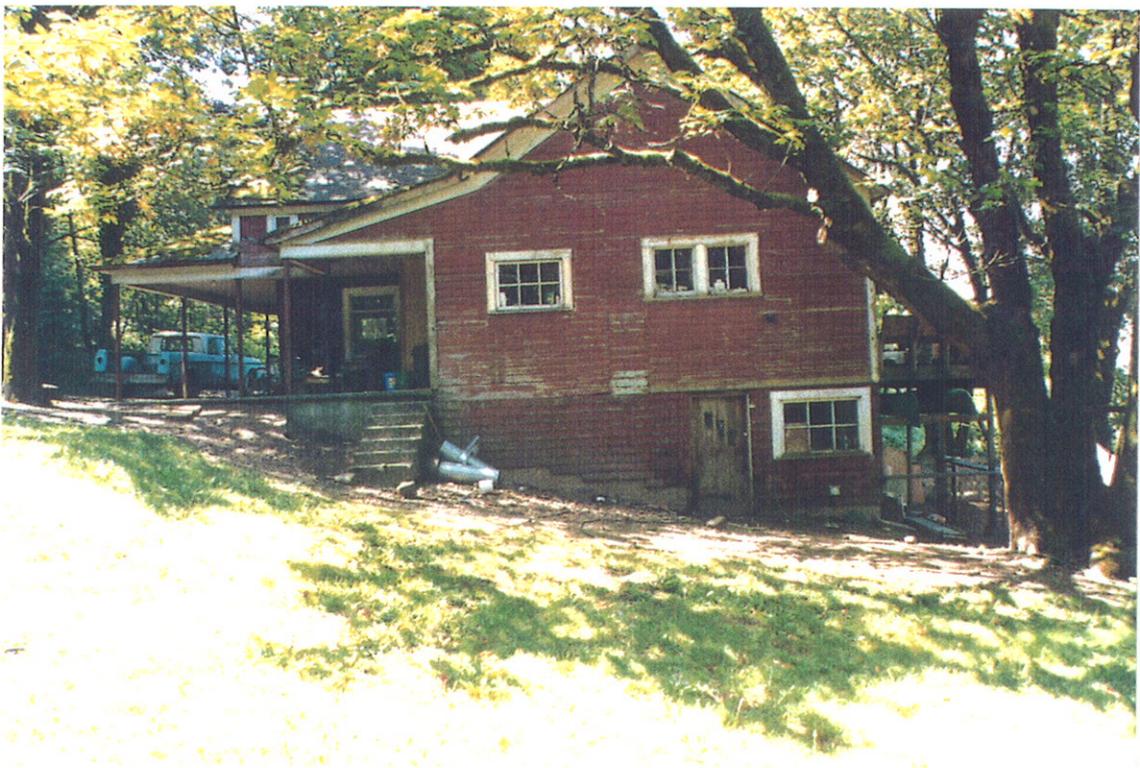
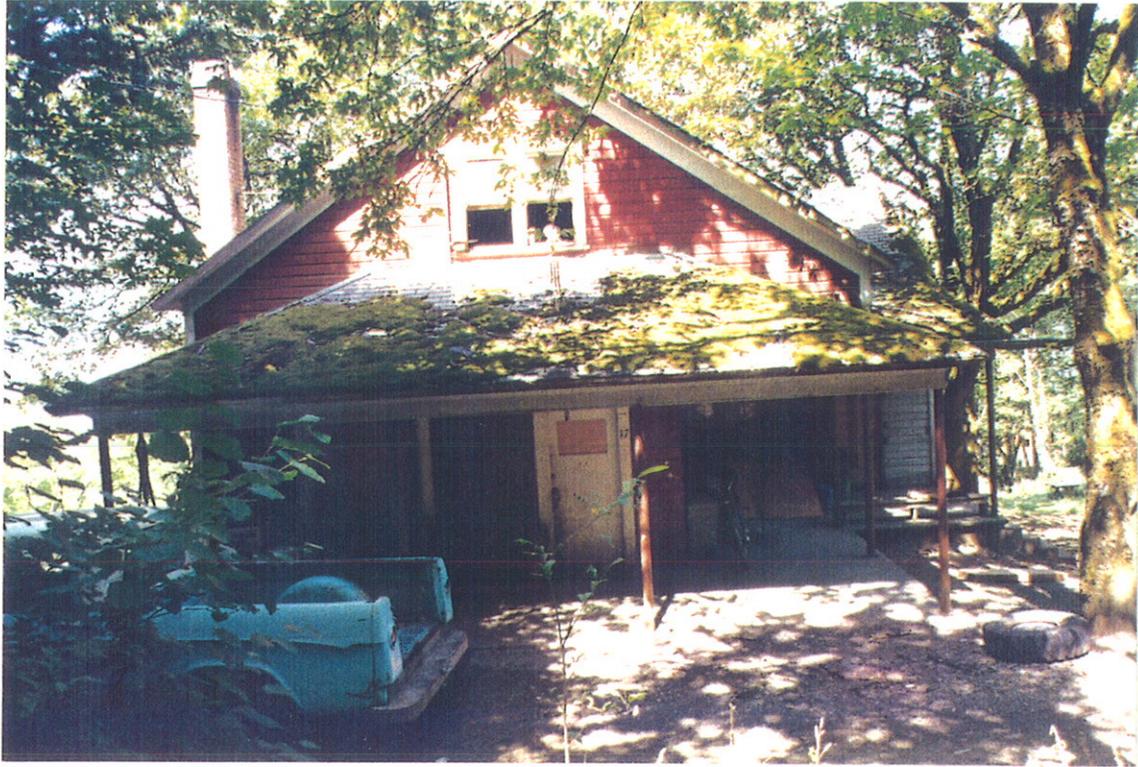
The windows on the front have been replaced by larger one over one double hung sash windows and new aluminum sash windows have been cut into the west elevation. On the north, most of the original windows have been covered over and new ones with aluminum sash cut in. A sliding glass door also has been cut in with a new deck on the second rear level. The first floor interior spaces have apparently been rearranged several times. The roof is surfaced with composition shingles on the south, east and west; corrugated metal on the north.

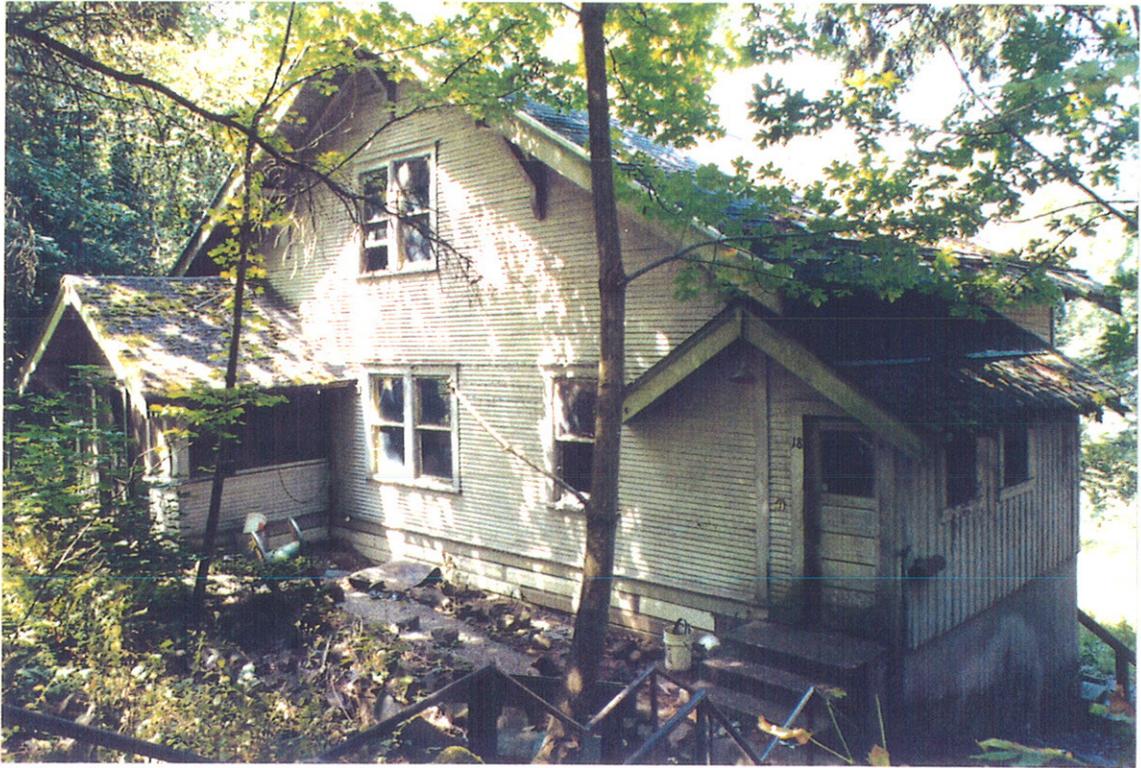
Noteworthy as the largest and finest house in the community, building number 18 is not a singularly noteworthy example of architectural design on its own merits. It is noteworthy in Bridal Veil for its size and its decorative detail simply because the other buildings are smaller and lack any decorative detail. Further, its generally poor condition undermine its historical integrity.

House #18 - South Facade (above)
House #18 - Northwest Corner (below)

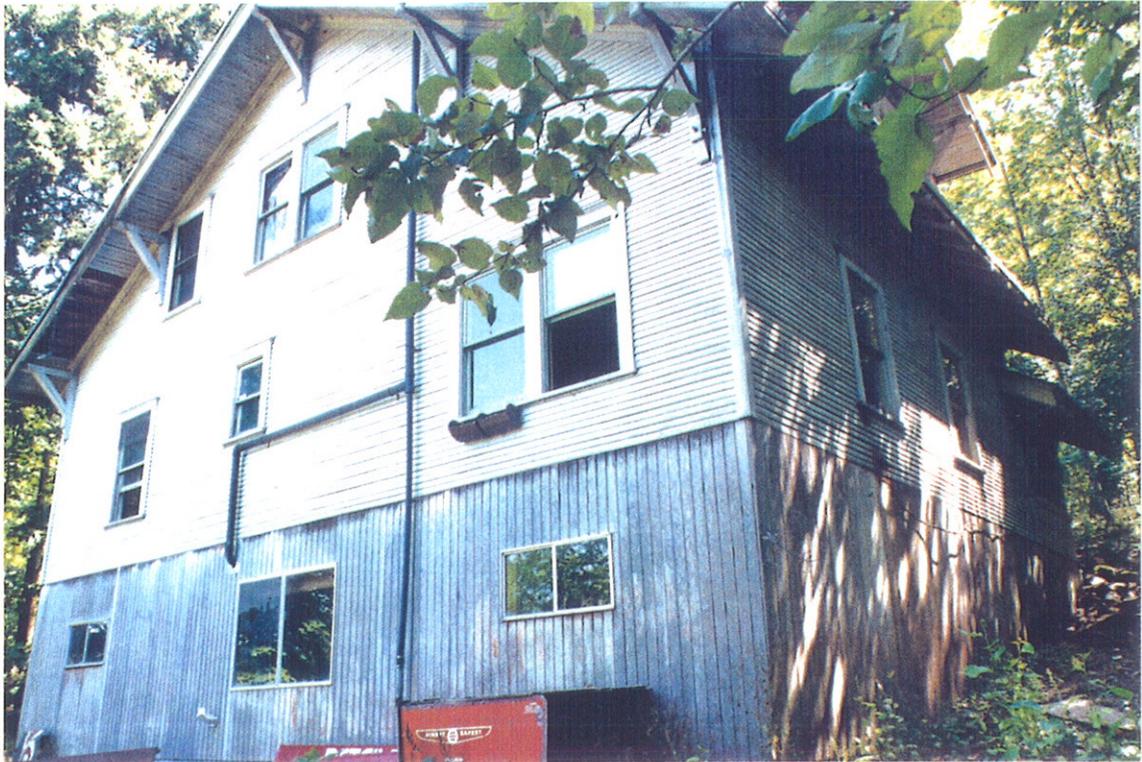
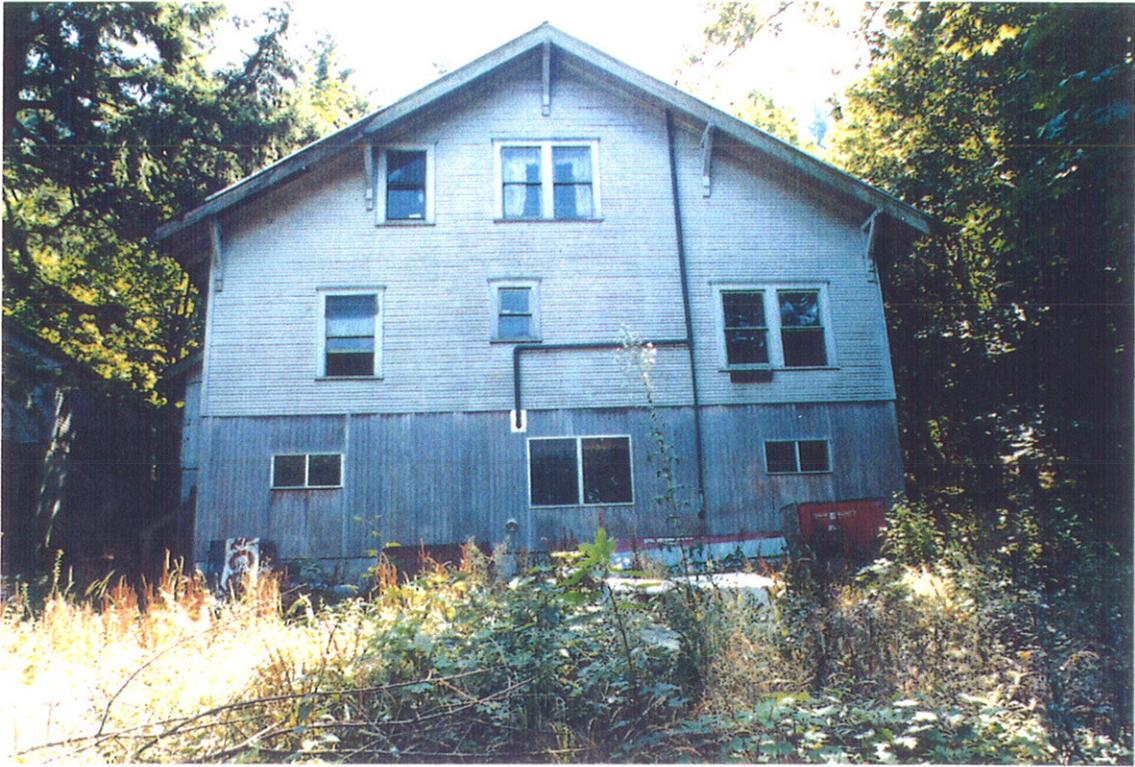
The siding is a combination of wood shingle, V-joint rustic and bevelled lap siding. Windows are one over one double hung wood sash, original and mostly paired. The roof is composition shingles.

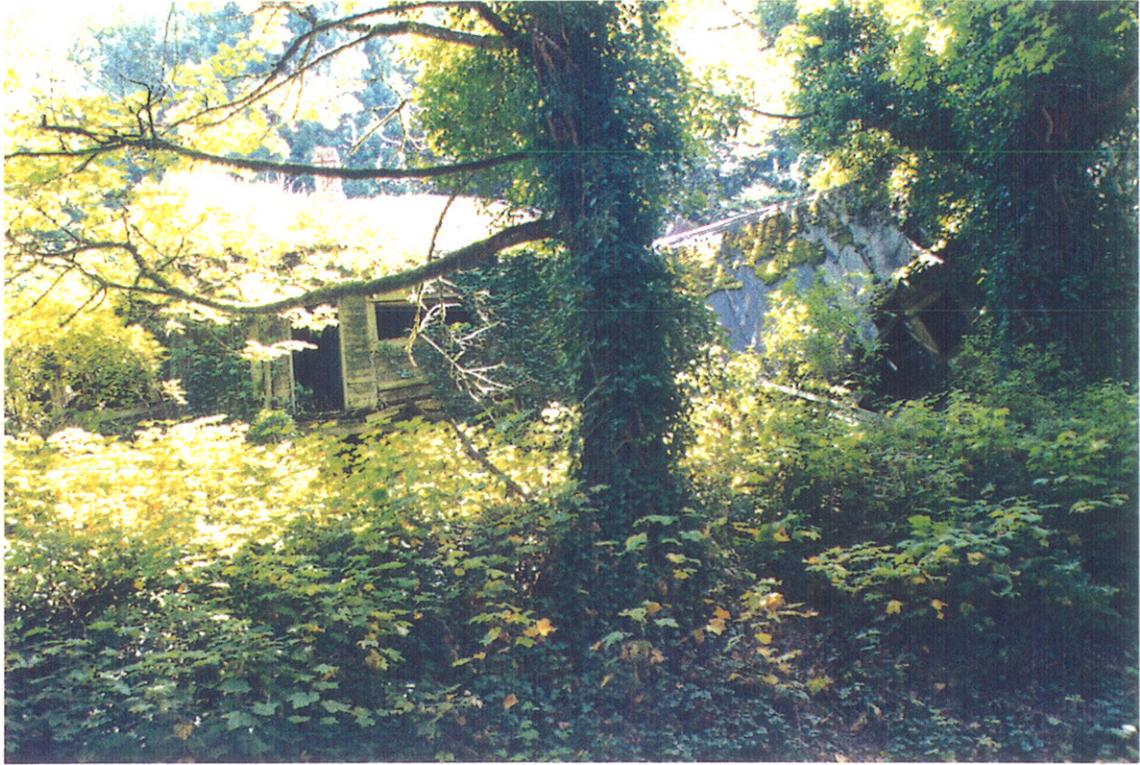
This house was apparently in original configuration with the old rear addition, drop siding, gabled roof and post pier foundation. However, at some point, it suffered from a serious fire. Today, it is totally collapsed and beyond repair. It is without any historical integrity.

House #19 - South Facade (above)
House #19 - West Facade (below)

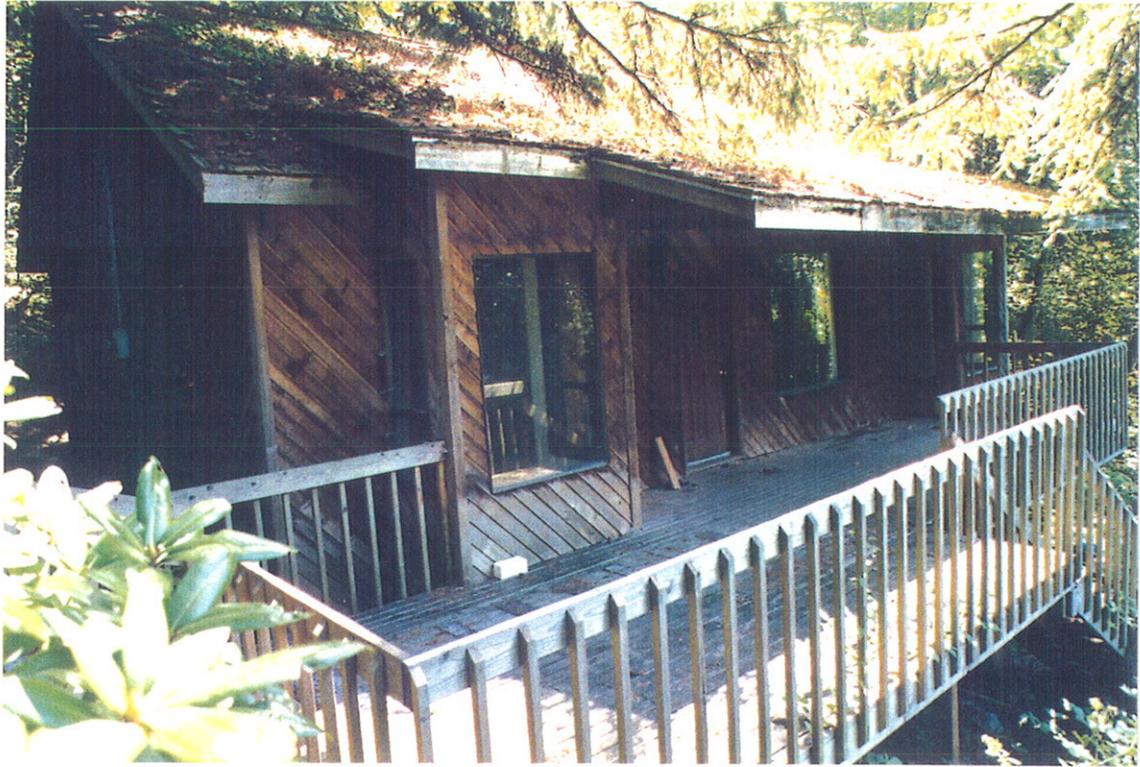
The house appears to be in fair to good condition. The extensive additions and remodeling however have totally compromised the historical integrity of the house.

House #20 - North Facade (above)
House #20 - East Facade (below)

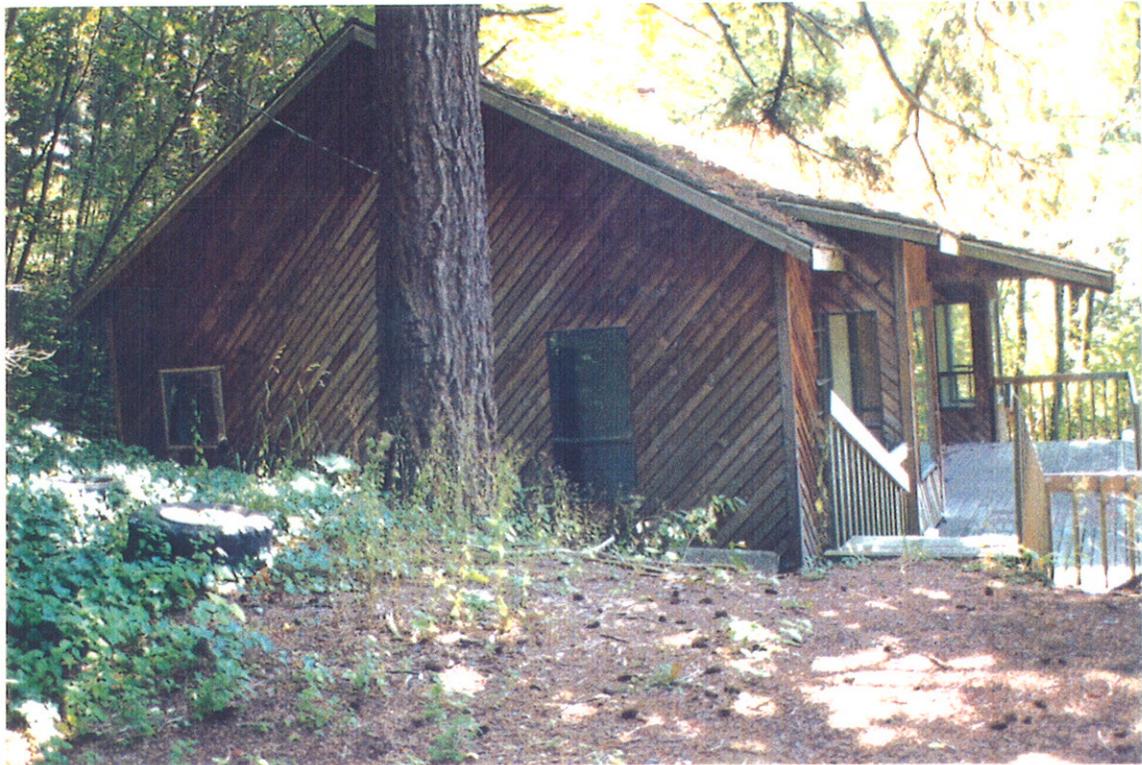
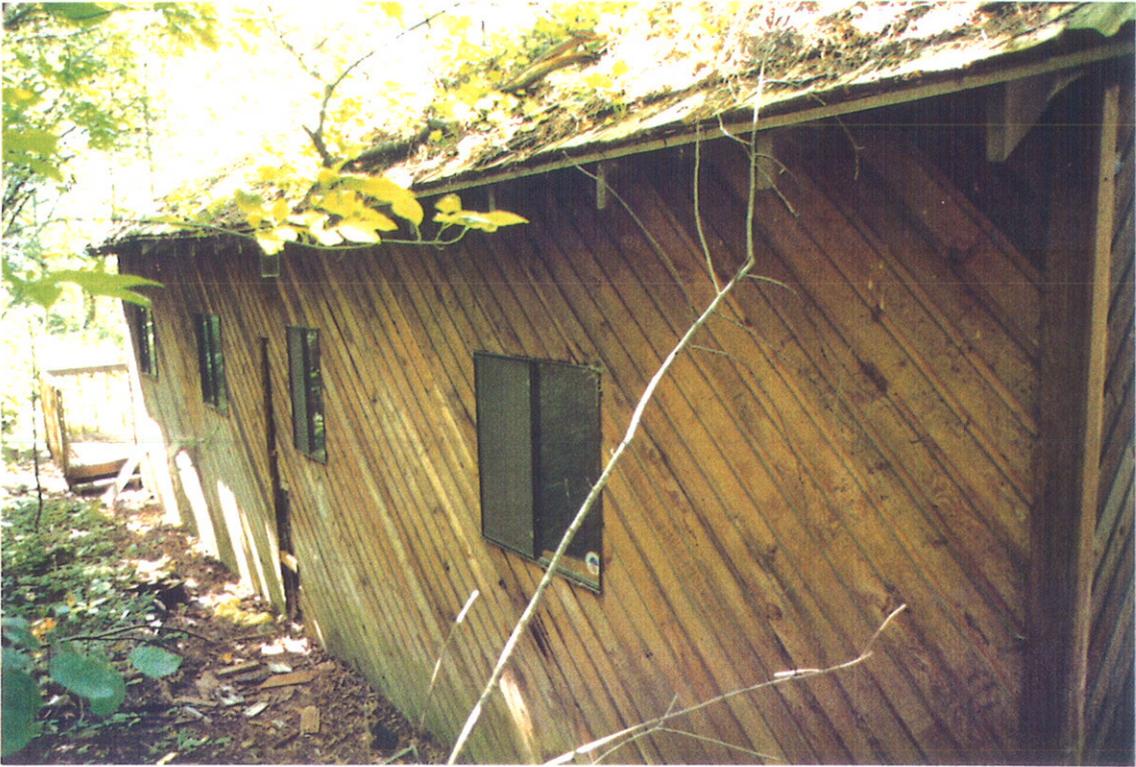
This house does not have the rear addition and has undergone complete remodeling. It's orientation has been changed from east to north. It has a modern porch and roof addition on the north with two square bay windows flanking the main entryway. The siding is diagonal, stained. The roof is wood shake. A new metal patent chimney has replaced the original brick chimney. The windows are plate or aluminum sash, with the original windows covered and new windows cut in. A sliding glass door on the west facade leads to a new deck. While this is the only house in the townsite in which the remodeling reflects any sense of design, the extent of the remodeling makes it unrecognizable as a early 20th century house.

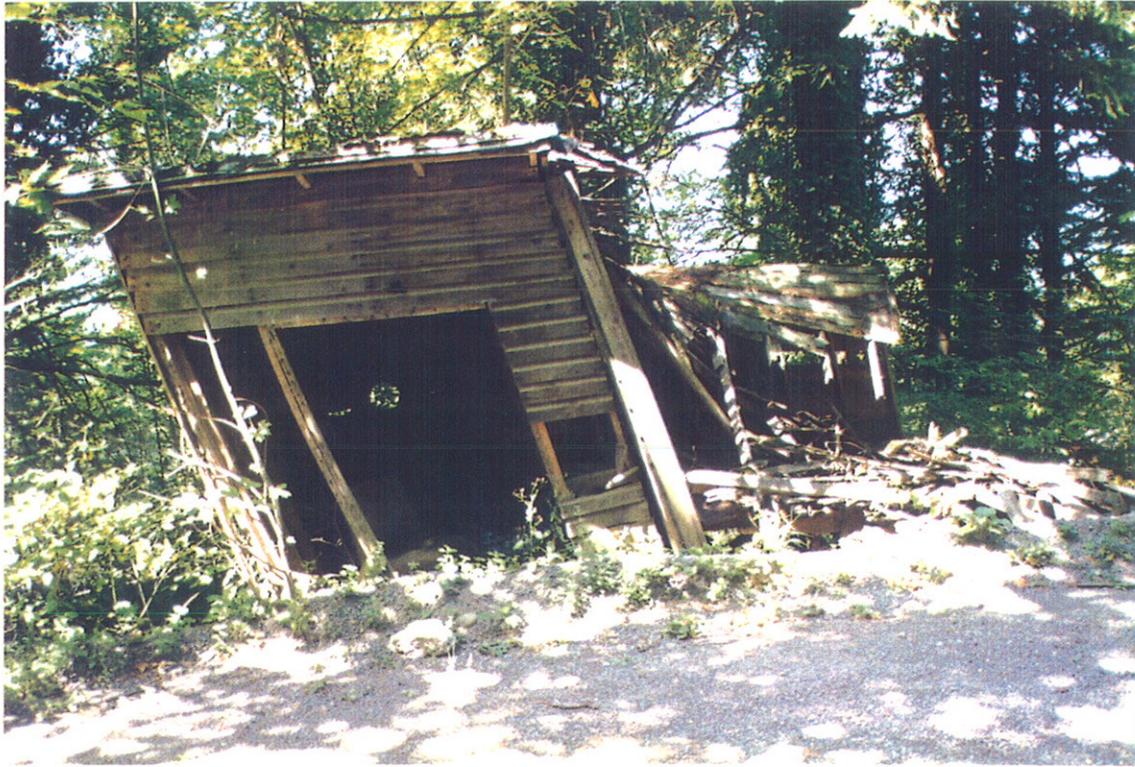
Regardless, today, the building is totally collapsed, beyond repair, and largely unrecognizable. It is without any historical integrity.

House #21 - South Facade (above)
House #21 - Southeast Corner (below)

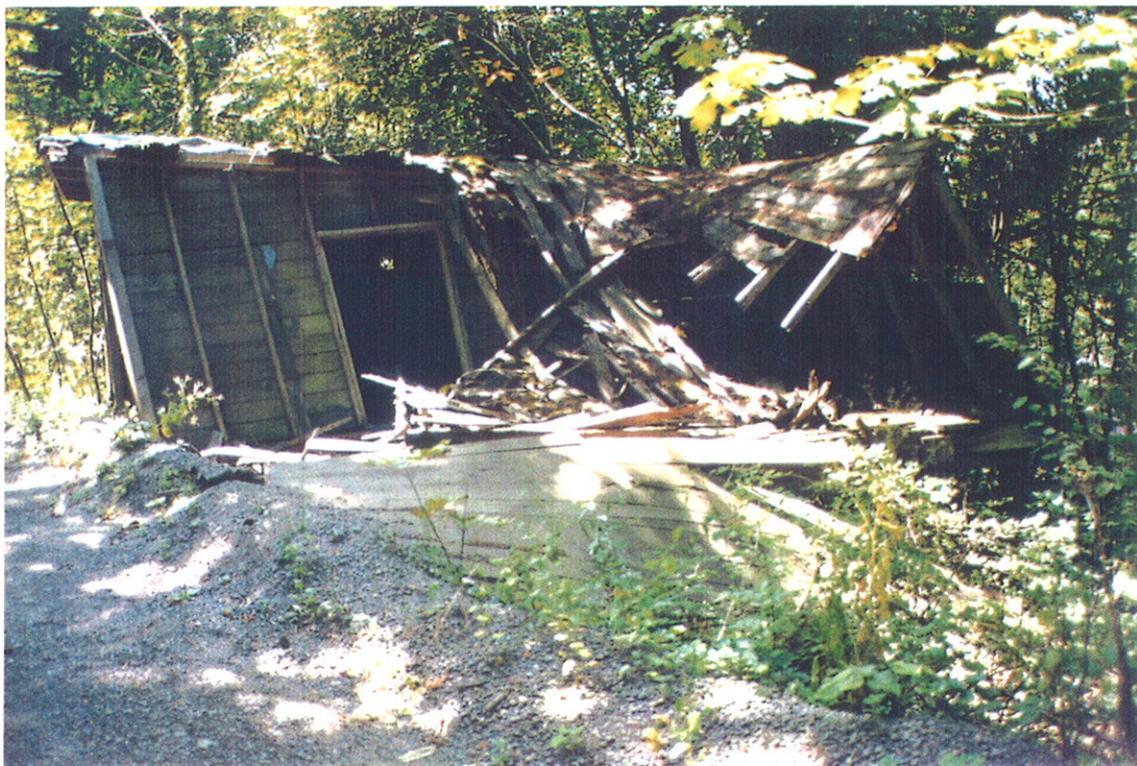
This structure was either built as a garage or more likely adapted for use as one. Given its size, it may have been one of the original 24 x 24 foot worker's homes without the addition. It is considerably larger than the other garage in Bridal Veil. The building features drop siding and post pier foundation. The roof apparently was flat.

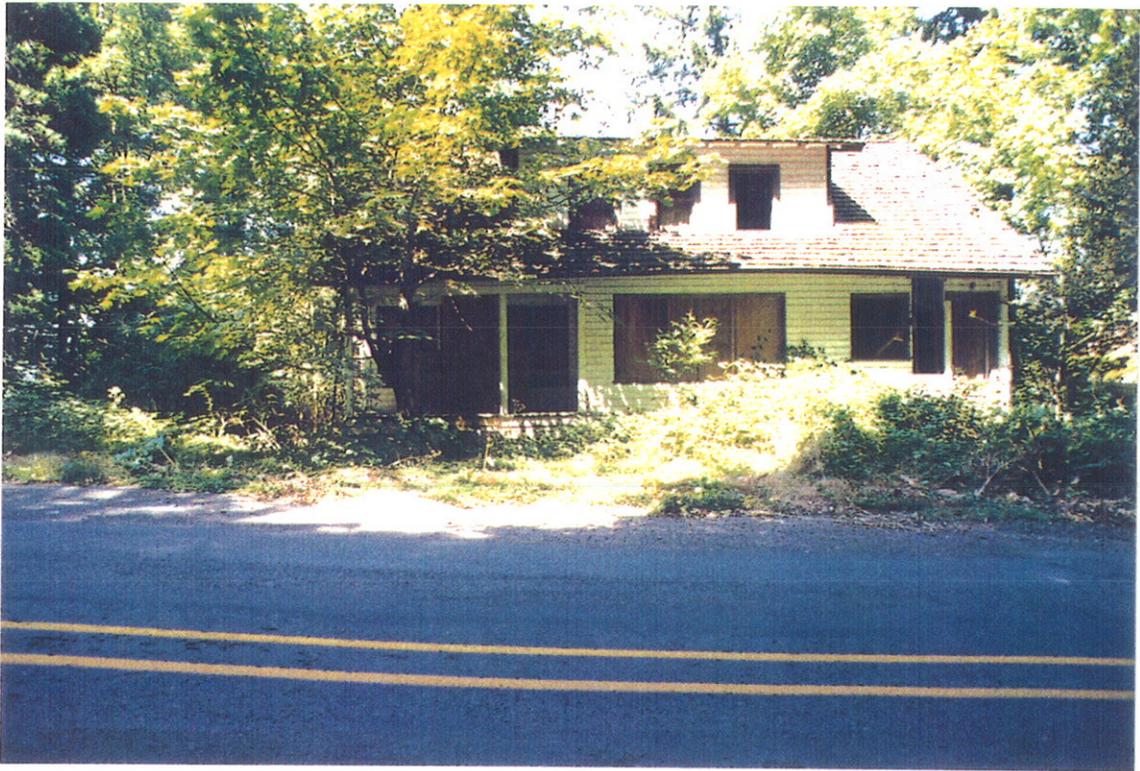
The house is unoccupied and appears to be in poor condition. It is in considerable disrepair. Because it has been stripped so totally, the structure is but a shell and without any historical integrity.

House #22 - South Facade (above)
House #22 - West Facade (below)
