BRIDAL VEIL
MULTNOMAH COUNTY, OREGON

HISTORICAL AND ARCHITECTURAL EVALUATION

August 20, 1992

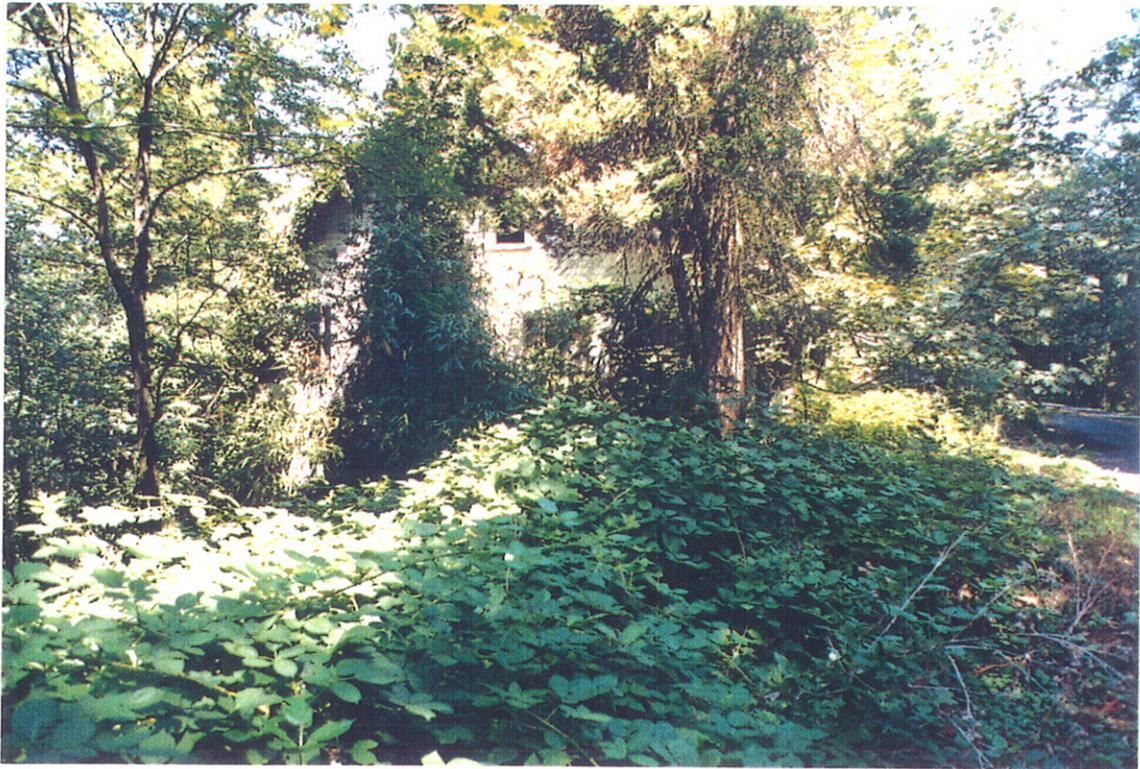
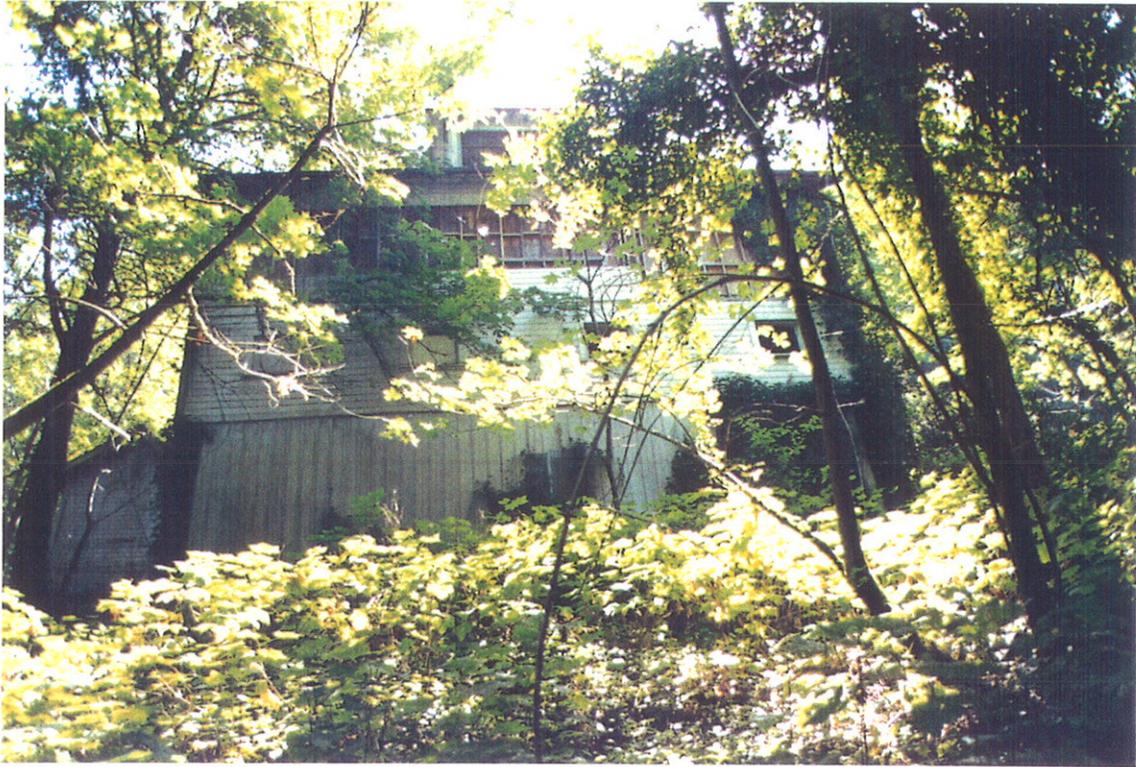
House #22 - South Facade (above)
House #22 - West Facade (below)

With 1,500 square feet on each of its three floors, this house is larger than most of the worker houses. Yet, it does not feature the detail of the manager homes. Located on a steep hillside, it has one full floor below street level and two above. Below the lower floor is unexcavated space surrounded by wood skirting boards having a V-joint pattern and applied vertically. The foundation is post-pier, except that at the street level a concrete block foundation has been added along the front.

The house is unoccupied and appears to be in poor condition. It is in considerable disrepair. Because it has been stripped so totally, the structure is but a shell and without any historical integrity.
