HISTORIC FIRE LOOKOUTS  
ON THE  
DESCHUTES NATIONAL FOREST

A Determination of Eligibility  
to the  
National Register of Historic Places

USDA Forest Service  
Pacific Northwest Region  
Deschutes National Forest

August 17, 1991

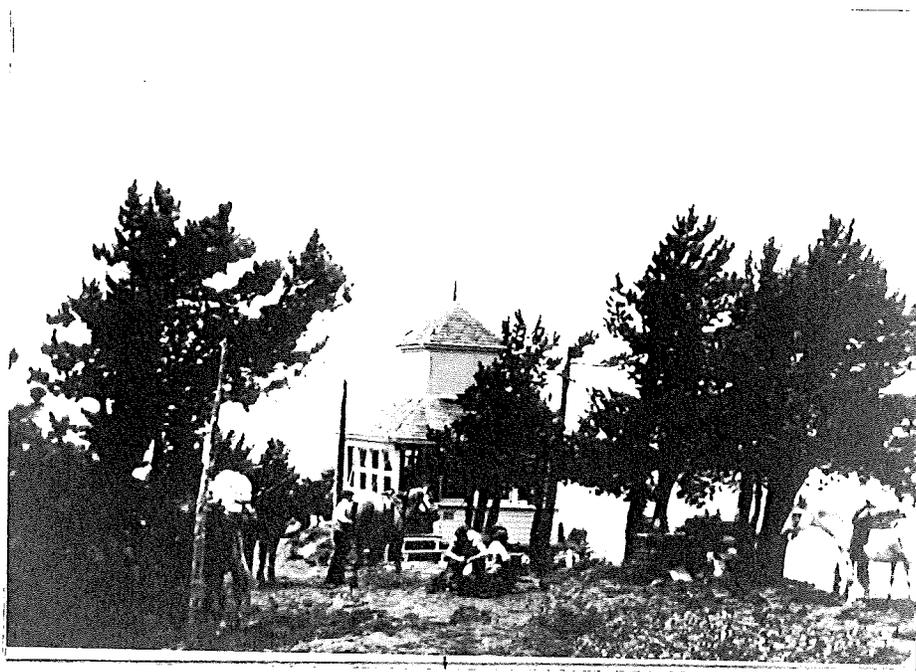
Photo (5): Black Butte Cupola sometime after 1934 when it was used as a ground house in conjunction with the Black Butte Tower. Sisters Ranger District CRM Photo Files.

The D-6 was innovative because it was the first standardized lookout structure in the Region combining both fire detection and living facilities in one building. This further collapsed the separation of work from living space which had begun with the establishment of rag camps in place of patrolling. The completion of this collapse reoccurred in both the "Supervisor Hall Special" and the L-4. The D-6 was effective on high promontories where the view from the cupola was adequate without the added height that a lookout tree or open platform could provide. According to Kresek (1984), eventually 200 lookouts of this style were placed on high points in Idaho, Montana, Oregon and Washington, including the Black Butte cupola on the Sisters District of the Deschutes. Approximately 13 survive.

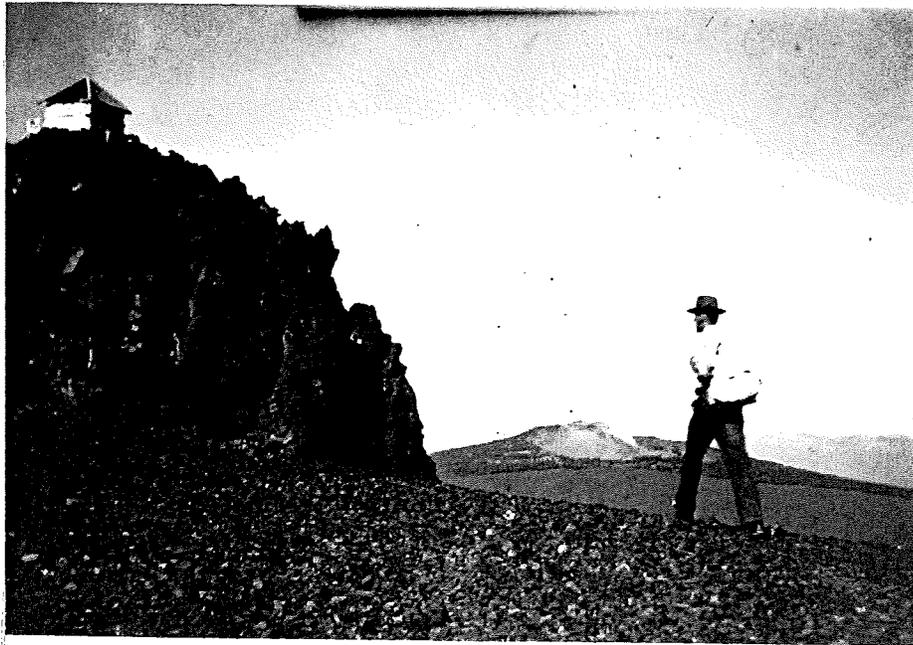
Photo (6): Forest Ranger Slim Hein on Black Crater, September, 1938. One of the earliest lookouts on the Deschutes, Black Crater was later abandoned because of limited visibility due to fog and the steepness of the territory. The Deschutes and other National Forsets found that the higher peaks of the Cascades were not necessarily the best lookout points. This lookout house is an example of a "Supervisor Hall Special." Deschutes National Forest Supervisor's Office Photo Files.

According to Cox, this style was a modification of the 4A style developed in Region 5. Lookouts similar to this style also appear in Region 3's 1989 publication, Lookouts in the Southwestern Region. These were 14-foot square, hip-roofed structures whose roof was steeper and taller than the later L-4's in Region 6. The windows were single paned, five to a side except on one side where a door took the place of the center window. Built in the twenties, three of this style were built on the neighboring Willamette National Forest. At least one was built on the Deschutes at Black Crater; none of these survive.

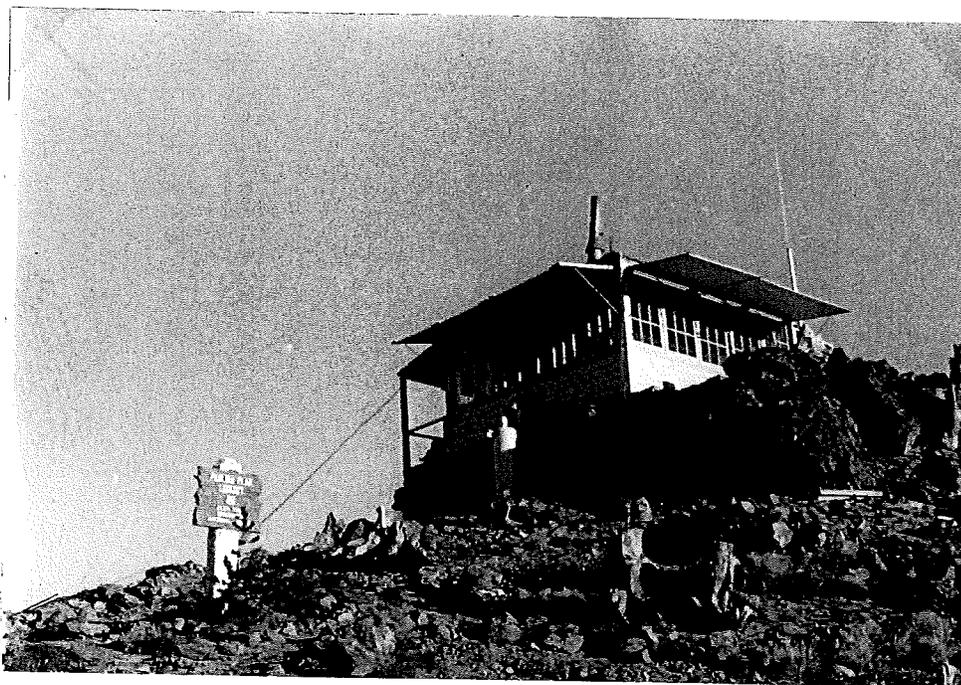
In 1929 the Forest Service introduced the L-4 or Aladdin style. Coinciding with a period in which the agency was busy installing its fire control system as well as one in which increased funds became available through the implementation of the New Deal Works Projects Administration, and the CCC, over 1000 were built in Region 6. Designed to be a living as well as a work space, the L-4 measured 14' by 14'. A band of windows extended all around the cab, five to each side except where the door replaced the fifth on one corner. Shutters, designed to swing up, shaded the windows when in use and covered and protected them in the off season.

Photo (7): Former Paulina Peak Lookout: An example of a nine pane L-4 on the Deschutes. Presently all existing L-4 lookouts on the forest are the either the gable roof or the four pane hip roof versions. Deschutes National Forest Supervisor's Office Photo Files.

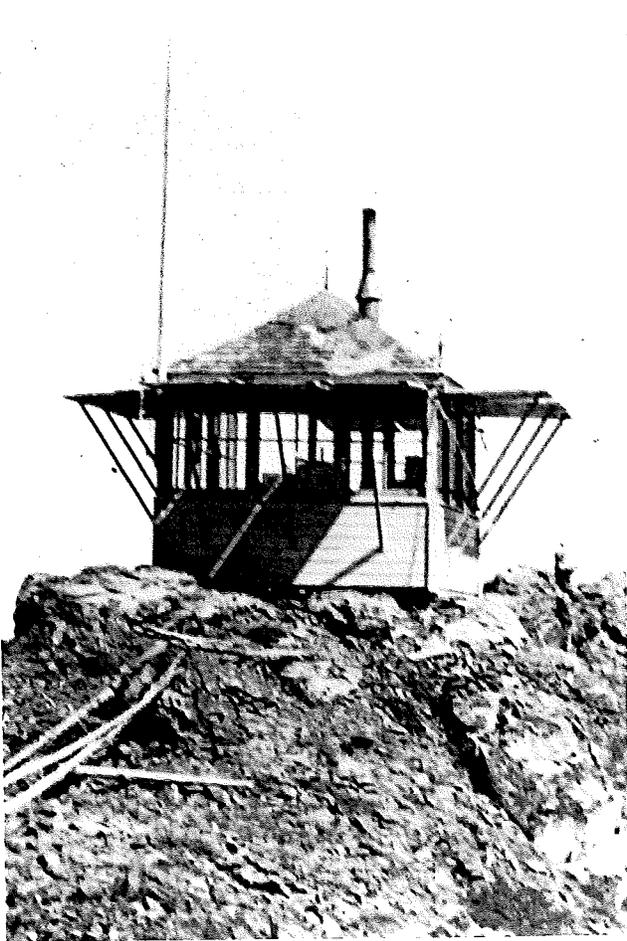
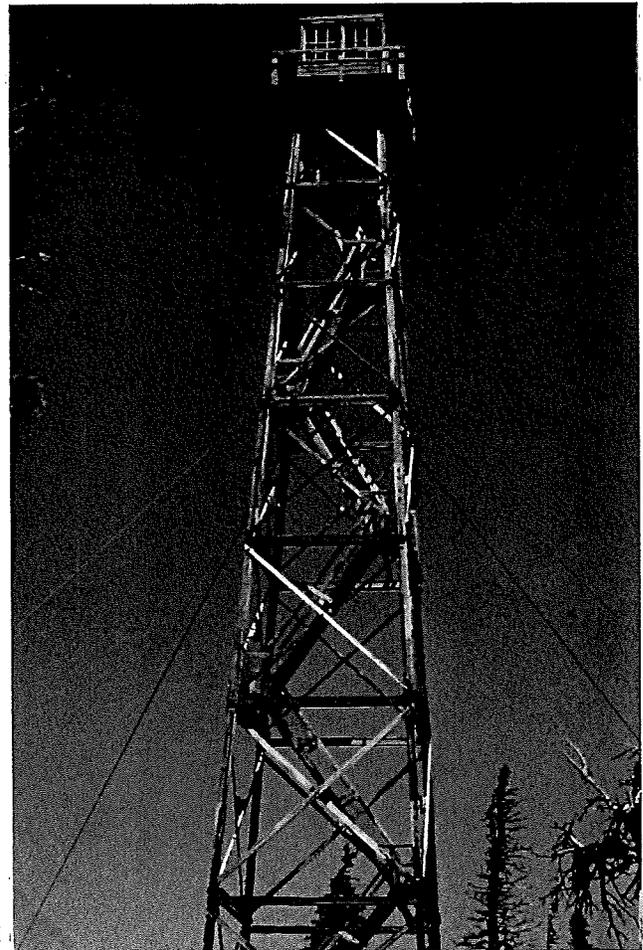
Photos (8) and (9): L-5 and L-6 lookout towers. (8) The Deschutes National Forest built four L-5's. Today none remain in the Region. Deschutes National Forest Fire Photo Files. (9) The 83 foot lookout tower on Black Butte is an L-6. Deschutes National Forest Cultural Resource Management Photo files.

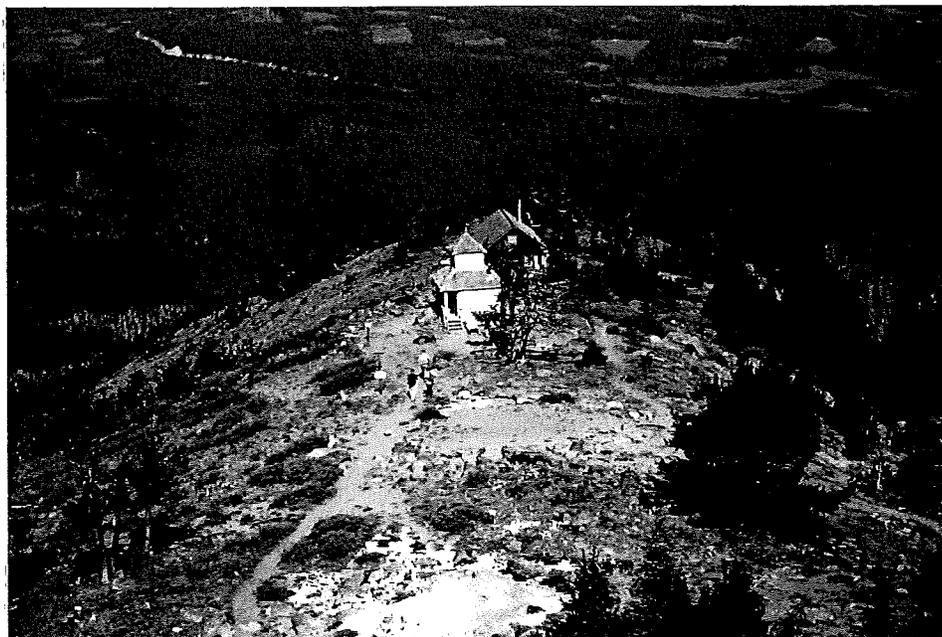
Photo (11): Black Butte Lookout Site: The 1922 Cupola and adjacent YACC built ground house from the Black Butte Tower. With the tower decommissioned, presently staff are working from the cupola second story. Sisters Ranger District CRM Photo Files.

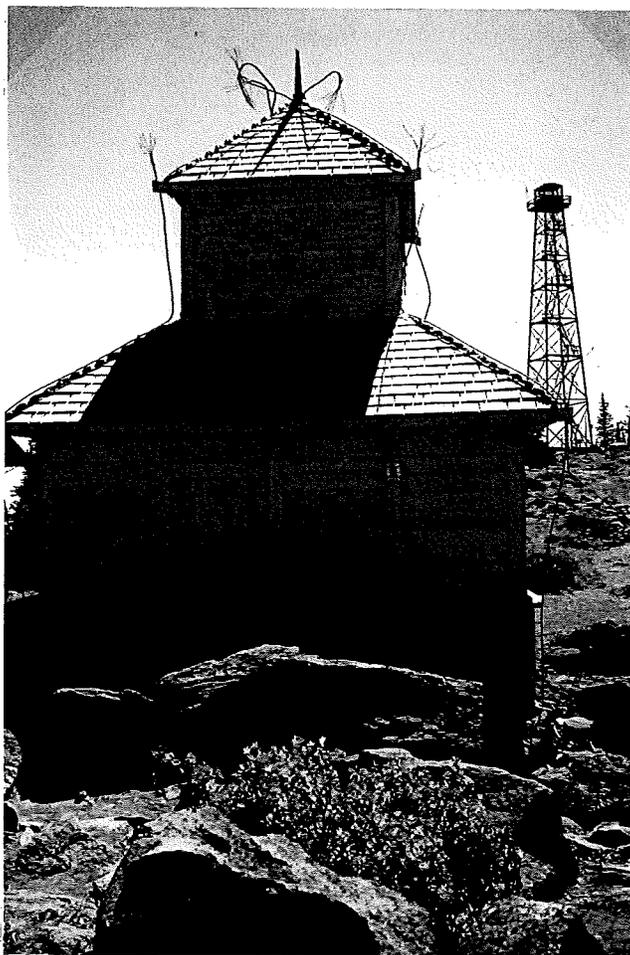
The three historic buildings, the cupola, the lookout tower, and the CCC era outhouse, are all either unaltered or altered slightly. All three buildings possess integrity of location, design, setting, materials, workmanship, feeling, and association and are recommended for eligibility to the National Register.

Photo (13): Black Butte Cupola with tower in background. The Black Butte Site is unique not only for its historical buildings but because of the site is an illustration of historic continuity: The D-6 Cupola was a Region 6 design. The tower was built by the CCC. Deschutes National Forest CRM Photo Files.

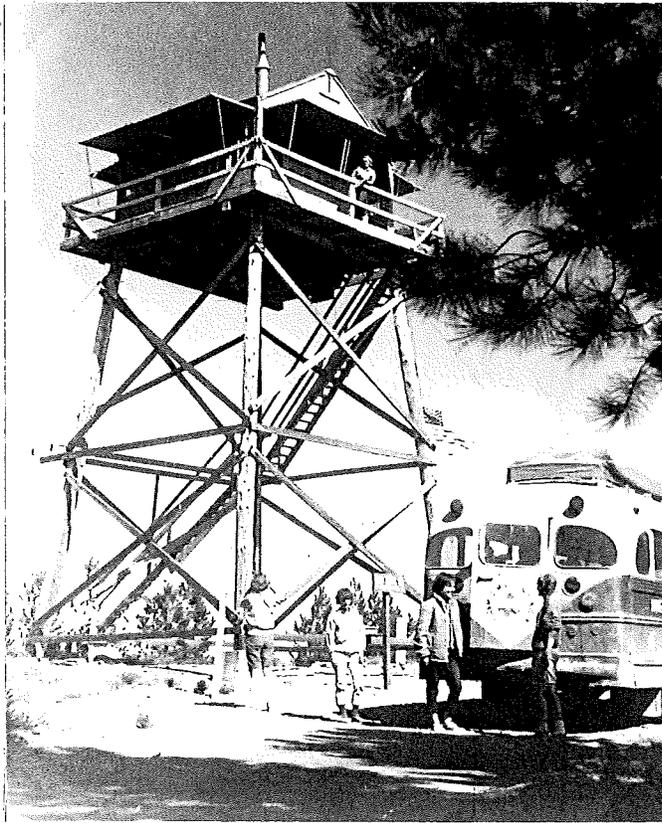
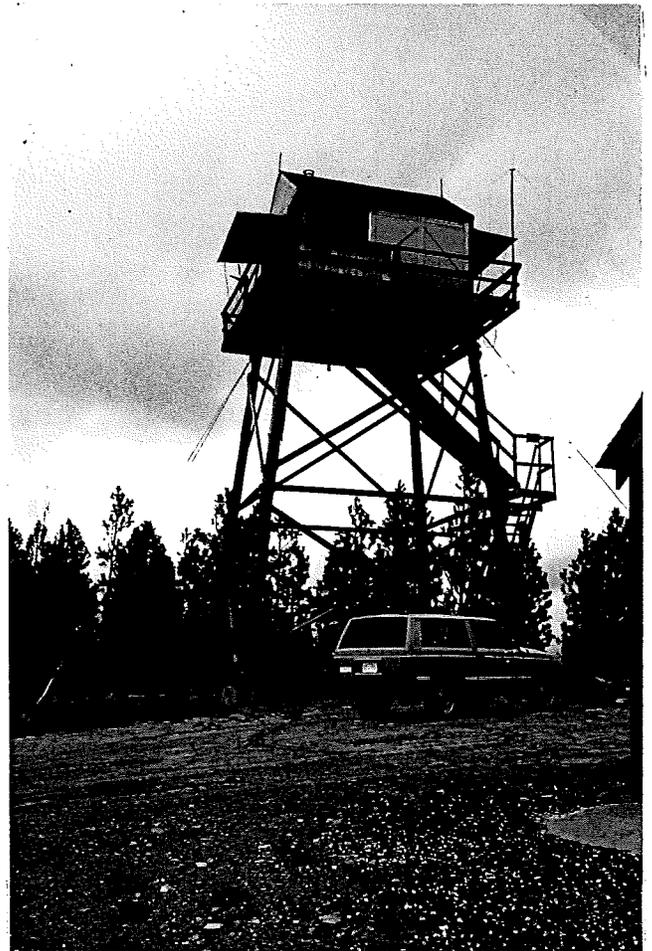
Several elements of the East Butte Tower have been altered. The former tongue and groove exterior siding was covered in 1960 with T111 plywood. The shutters have also been replaced, as well as the windows and door. The interior siding, however, as well as the floor, ceiling, roof, sheathing, deck and basic shape and structure of the lookout are intact: the original siding exists under the T111 and the tower is recognizable as an early 1930's L-4.

There are only four known gable roofed L-4's of the 47 standing L-4's in Oregon, one of which is a complete reconstruction. The garage has had its door replaced but is largely unaltered. Without testing it is difficult to establish the date of the garbage pit. Since the East Butte Lookout tower and

Photos (14) and (15): East Butte Lookout in the late 1950's/early 1960's and in 1991. East Butte is one of two gable roofed L-4 lookout structures on the forest and the only gable roofed L-4 in its original location.

garage possess integrity of location, design, setting, materials, workmanship, feeling and association, they are recommended for eligibility to the National Register. The eligibility of the garbage pit cannot be established without testing.

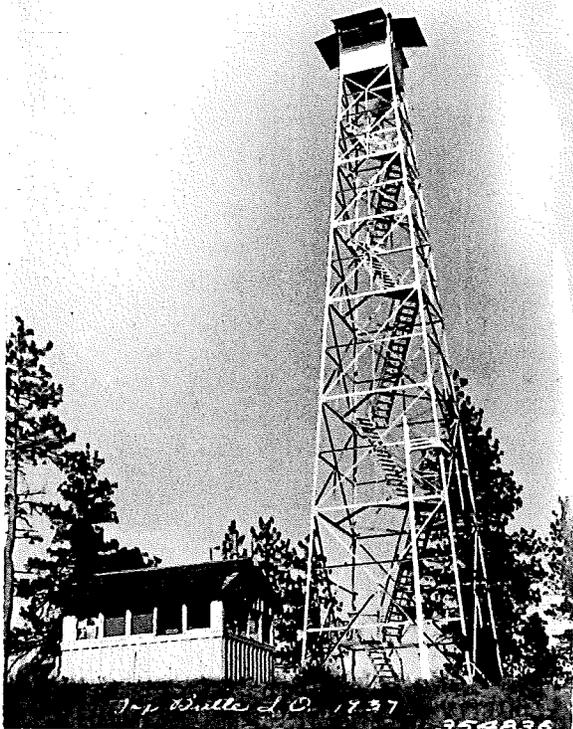
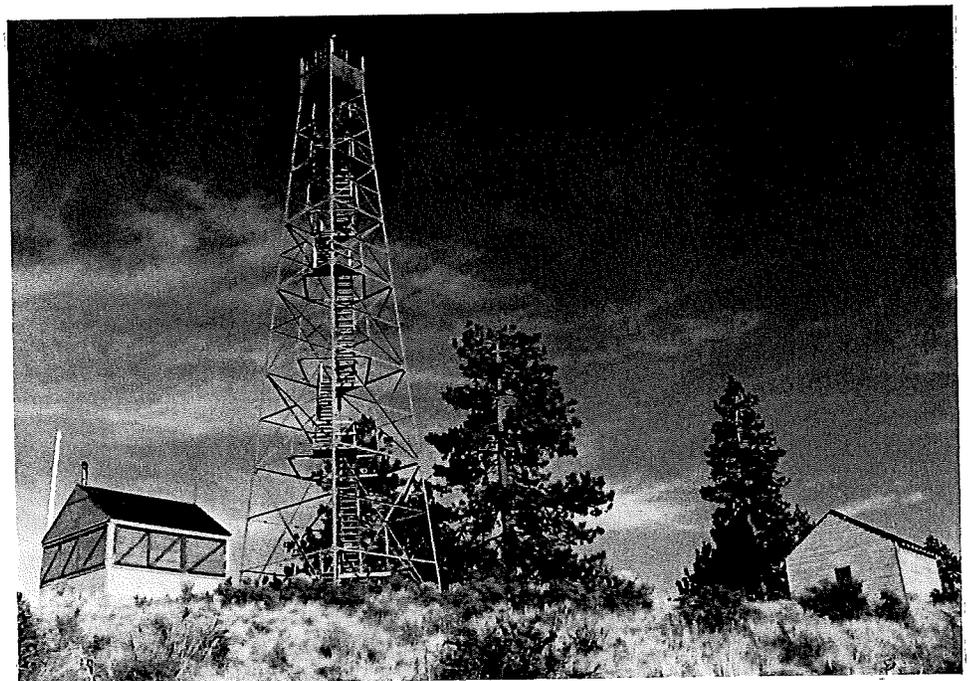
The Fox Butte ground house is a gable roofed L-4 lookout building which formerly served as a lookout on nearby Sixteen Butte. According to Kresek (1985), the building was built in 1931 making it the oldest known standing L-4 in Oregon (Mark Swift, personal communication). It was moved to Fox Butte in 1948, presumably when Fox Butte's original ground house was destroyed. Though covered with T111 plywood, the original exterior siding is intact, as well as the original windows, ceiling, floor, interior siding and lightning protection. An old F. S. Lang Company wood cook stove sits in a corner.

Photos (16) and (17): Fox Butte Lookout Site in 1937 and 1991. The present ground house was moved from nearby Sixteen Butte to Fox Butte in 1948.

Although the Fox Butte ground house has been moved less than 50 years ago, it possesses integrity of design, materials, workmanship, feeling, and association. Its setting and location are comparable to its original one: it is still located on a Butte in the High Lava Plateau and is still associated with fire detection on the Fort Rock District of the Deschutes National Forest. Furthermore, this report argues that the ground house is integral to the site because a tower this size necessitates the use of a ground house for habitation. The Fox Butte ground house is a moved building of lesser significance than the tower which is the crucial and dominating building of the complex. Though it has been moved, it still has an orientation, setting, and general environment comparable to its historic one. It is still associated with fire detection activities and fire lookouts and still provides housing for lookout staff. Dismantling or movement of the ground house would affect the overall quality of the site, which would lack an historic building to house lookout staff. Furthermore, as the oldest standing L-4 in Oregon, its loss would be significant. Therefore, the Fox Butte Ground House is recommended for eligibility to the National Register.

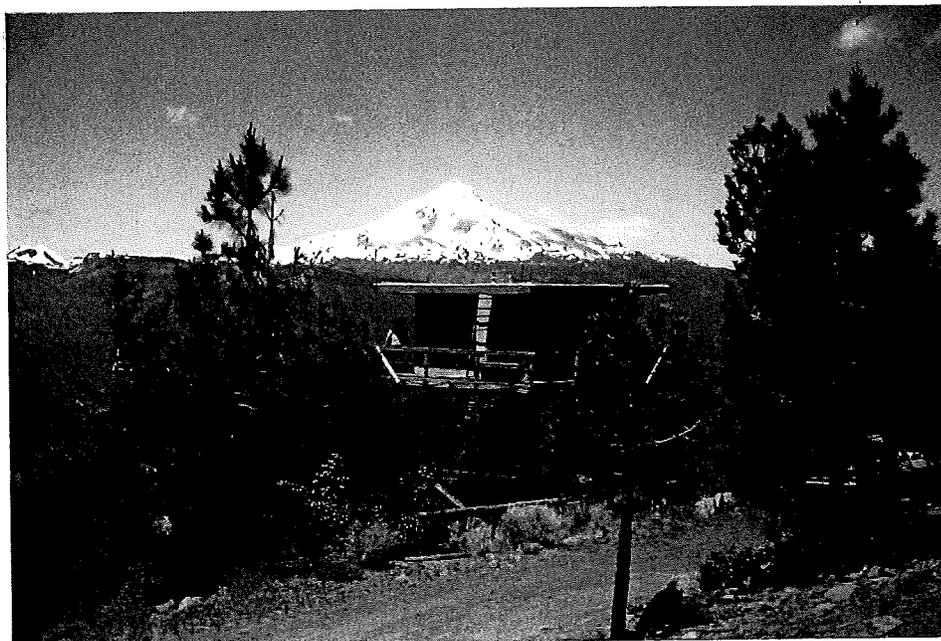
Photo (18): Green Ridge Lookout, 1991, an R-6 Flat Top on a treated tower. Deschutes National Forest Photo Files.

Presently, Green Ridge is a secondary lookout on the Deschutes. Built in 1961, it is a R-6 Flat Top cab on a 20 foot treated timber tower. An earlier lookout was built on Green Ridge in 1933, 500 feet below the site of the present tower. This was an L-5 according to Kresek, though no pictures of it exist. The earliest records indicate that Green Ridge was used as a lookout point as early as 1931 and that it has been a secondary lookout throughout its history. Because the present structure is less than 50 years old, it is not recommended for eligibility to the National Register of Historic Places.

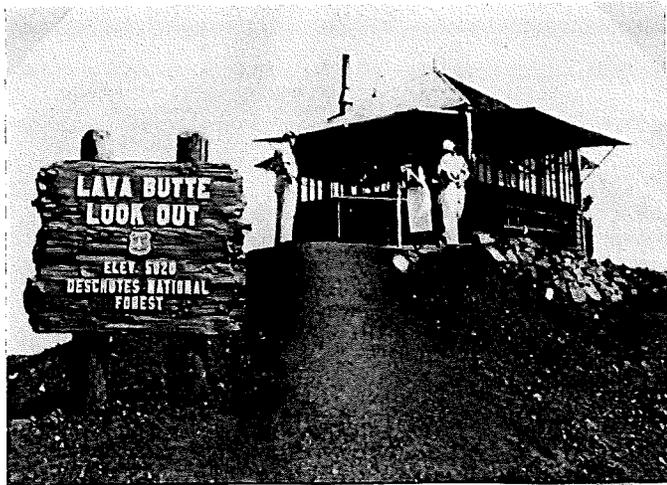
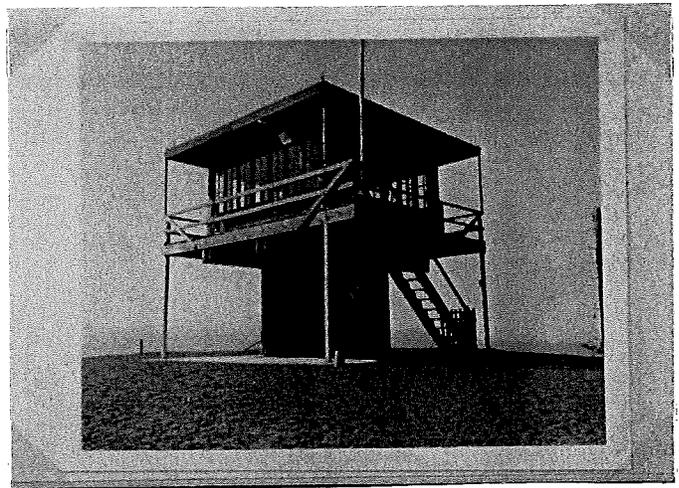
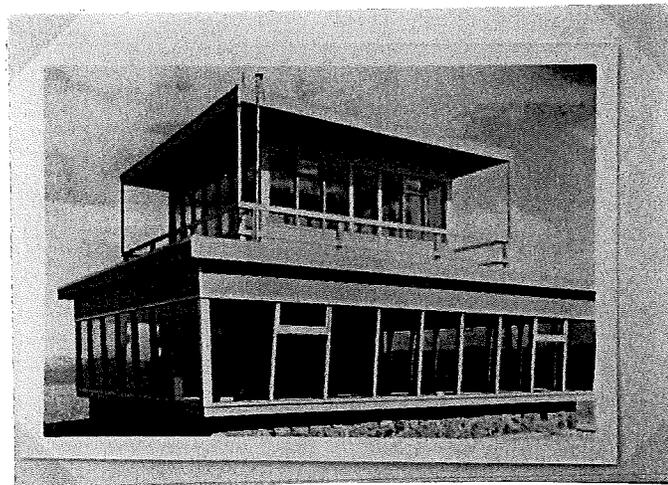
Later, after the Butte became property of the Forest, a nine paned window, hip roofed L-4 was built in 1932. A ground house, this structure occupied the same site as the present lookout and was replaced in 1957 by a 15' x 15' R-6 structure. In 1962, the bottom of the new lookout was enclosed with stone and glass and became the first Lava Butte Information Center. The Forest Service later built a new information center at the foot of the butte in the 1970's.

Lava Butte historically turns in the most forest fires on the Deschutes. It is also a well visited lookout with over 80,000 visitors per year. A pizza was once delivered here in 1989 when lookout Joe Perrin had a craving. Quoted in an 1989, Bend Bulletin article, Perrin described the delivery by John Dough's Pizza owner Rick Shain, "With courage, determination-- no fear-- he came up that hill dauntlessly and delivered that pizza...It was a moment. What can I say?" Perrin called the other lookouts on the radio, "You could hear jubilation ring across the forest." Despite this, because Lava Butte is less than 50 years old, it is not recommended for eligibility to the National Register.

Photos (18), (19) and (20): The Evolution of Lookout Styles at Lava Butte: (clockwise) (18) the original hip-roofed L-4, (19) its 1957 R-6 replacement which was walled in 1962 to create a visitor center. Deschutes National Forest Photo Files.

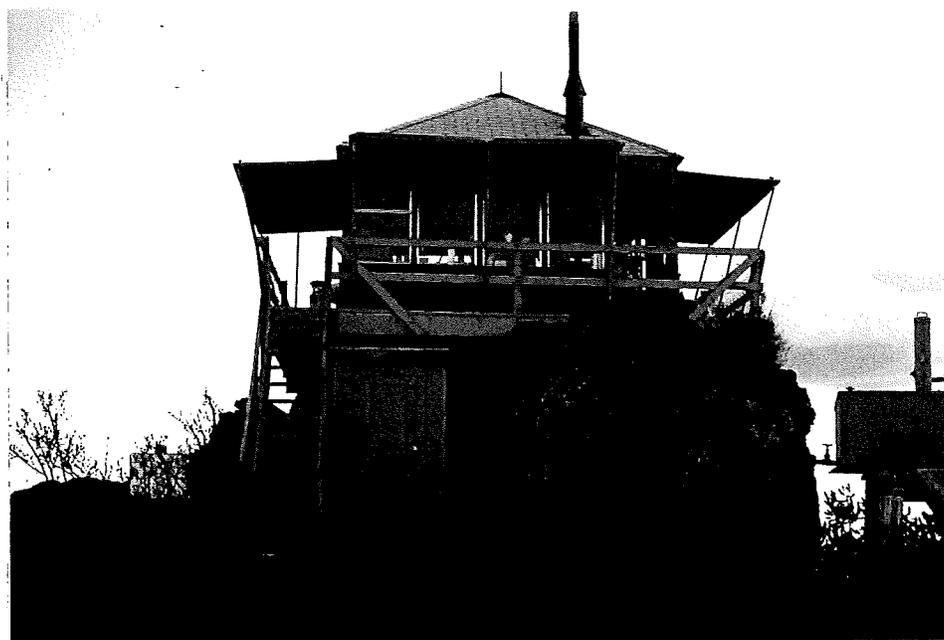
Round Mountain Lookout has been altered in many ways. The original windows have been replaced as well as all of the log bracing, 1/3 of the deck, and the catwalk. The original roof has been replaced several times including most recently with asphalt rather than cedar shingles. The original floors and exterior siding have been covered. Shutters as well as cabinets are not the originals. The lookout building is extensively modified and therefore lacks integrity of design, materials, and workmanship. It is not recommended for eligibility to the National Register of Historic Places.

Photo (23): Round Mountain Lookout, 1991. Round Mountain is a well-maintained L-4. Unfortunately, alterations have resulted in loss of its historical integrity. Deschutes National Forest Photo Files.

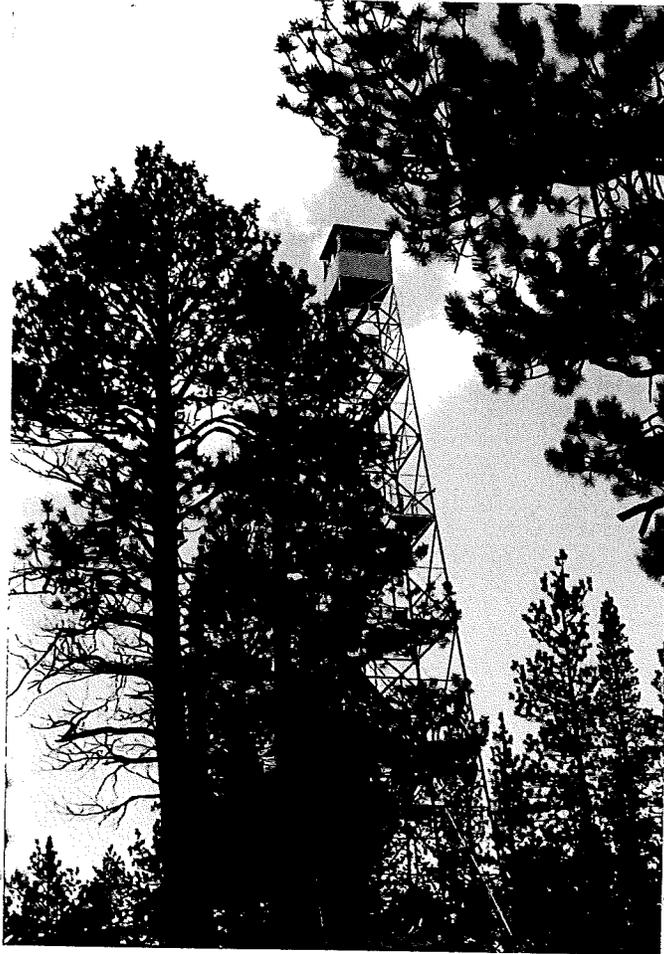
Photo (25): Trout Creek Butte Lookout in 1991. Vandalism is a problem in the management of these historic structures due to their remote locations. Deschutes National Forest Photo Files.

Aermotor MC-39 tower with 7' x 7' steel cab is still intact, though the window panes and the cab have been shot through. At one time the Forest had plans to move the Trout Creek tower and cab to replace the deteriorating Black Butte Tower. In 1976, footings were actually poured on Black Butte to receive the tower which was to be transported by helicopter to the site. These plans were later abandoned. Trout Creek has not been used as a lookout on the Forest since before 1976.

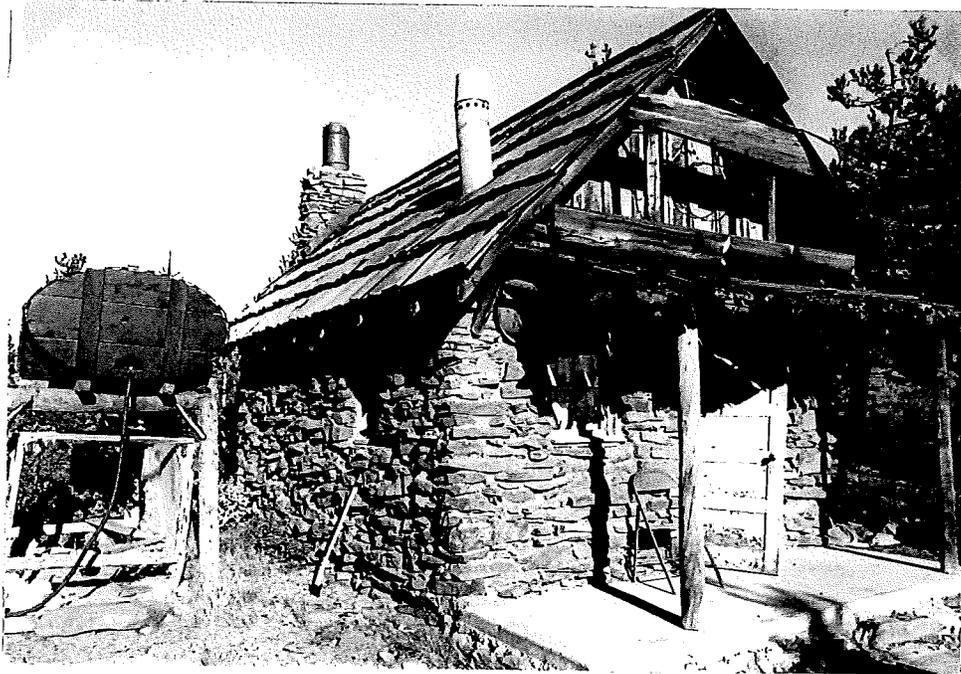
Photo (26): Walker Mountain Cabin sometime between 1964 and 1983. Since this picture was taken, the cistern has fallen over and the door has been replaced. (See Site Form in Addendum for recent photos) Deschutes National Forest Photo Files.

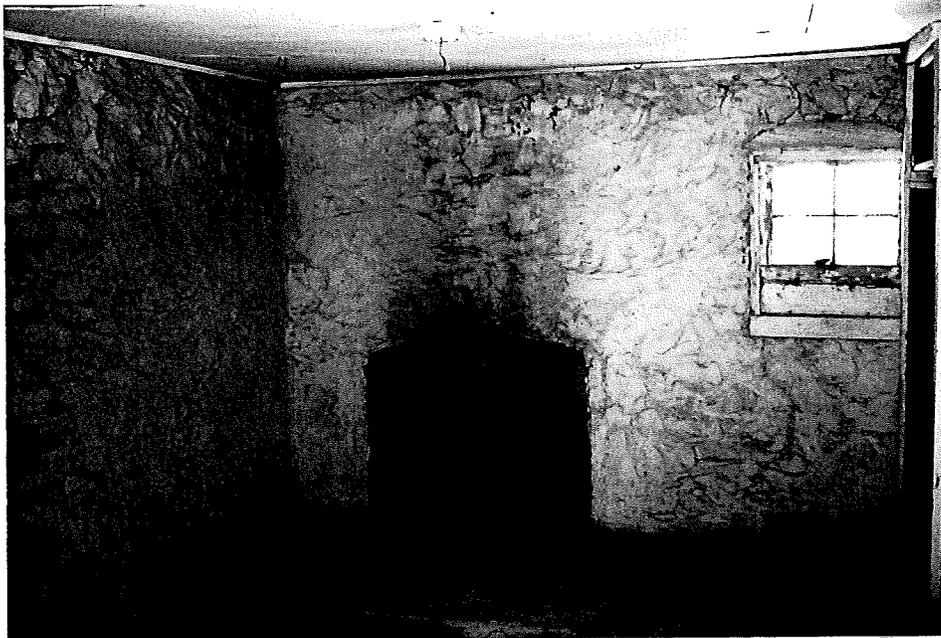
Photo (27): Walker Mountain Cabin, 1991, interior looking west. Deschutes National Forest CRM Photo Files.

Forest property records date the construction of this cabin to 1917. Although the daylight can be seen through the roof, the cabin is in good shape considering very little maintenance seems to have been done on it. It is made of native stone with a stone chimney along its west (back) side. The window and door frames, gable, cabin roof, and the porch roof and braces are made of timbers. Some of these timbers are unmilled, such as the rafters above the porch which show ax marks. Modifications include electricity, a plywood ceiling, and emplacement of concrete over the floor of the cabin and porch in 1964. While stone can be seen under the concrete of the porch, it is not known what the original materials of the cabin floor were made of.

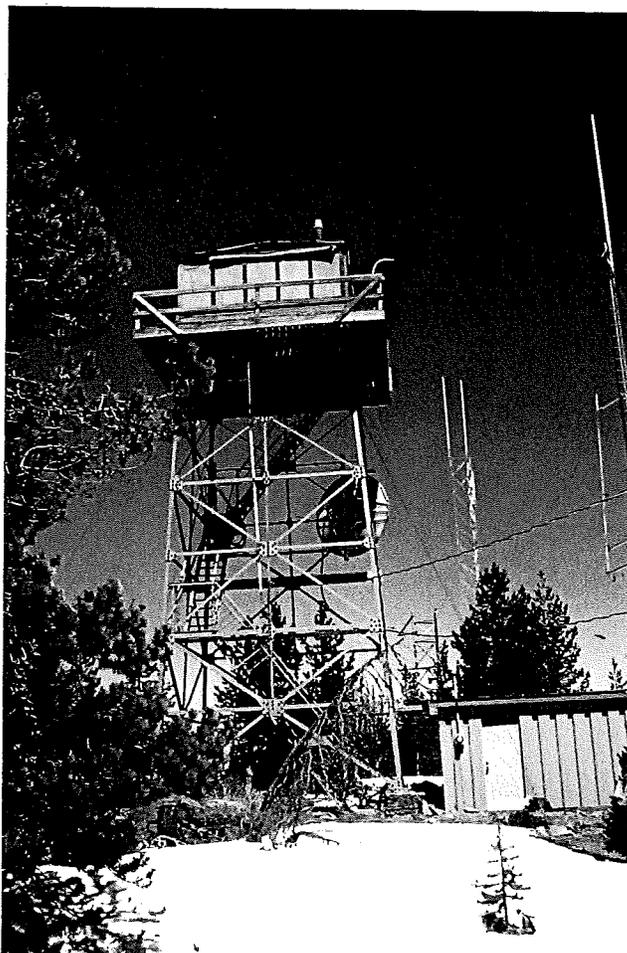
The Walker Mountain Lookout Tower is a 35-foot galvanized steel tower with a hip roofed L-4 on top. At one time there was a tree lookout on the site, northeast of the present tower. The tower was built in 1932 or 1933. According to Hal Pierce, head of Walker Range, Shorty Gufstenson hauled the pieces of the lookout up the road by team and wagon. While a fourteen foot cab atop a metal tower is very common in the Southwest Region, according to Kresek (1985), Walker Mountain may be the only example of an L-4 on a metal tower in Oregon.

Photo (28): The Walker Mountain Tower, 1991. Because its tower-cab combination is the tower is recommended for eligibility to the National Register. Deschutes National Forest CRM Photo Files.

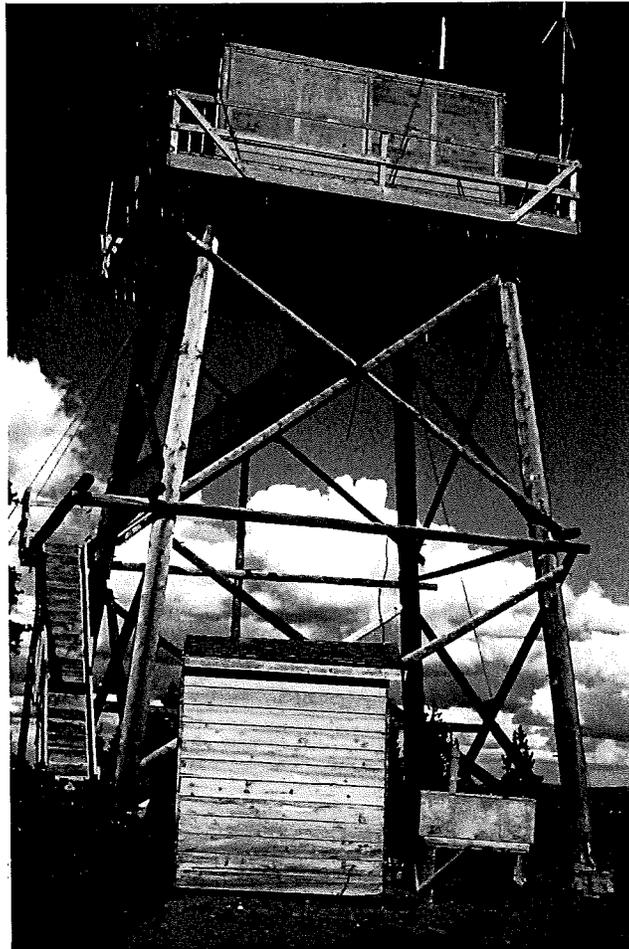
The Wanoga Butte tower is largely intact. While the legs have been replaced, they have largely been in character with the original design of the tower. Shutters have been replaced with plywood, but swing up and are propped in largely the same manner as is in character with the original design. Wanoga Butte lookout tower possesses integrity of location, design, setting, materials, workmanship, feeling, and association. It is recommended for eligibility to the National Register.

Photo (29): Wanoga Butte Lookout, 1991. Its Garage was moved and converted to a cabin at Sparks Lake. Deschutes National Forest CRM Photo Files.

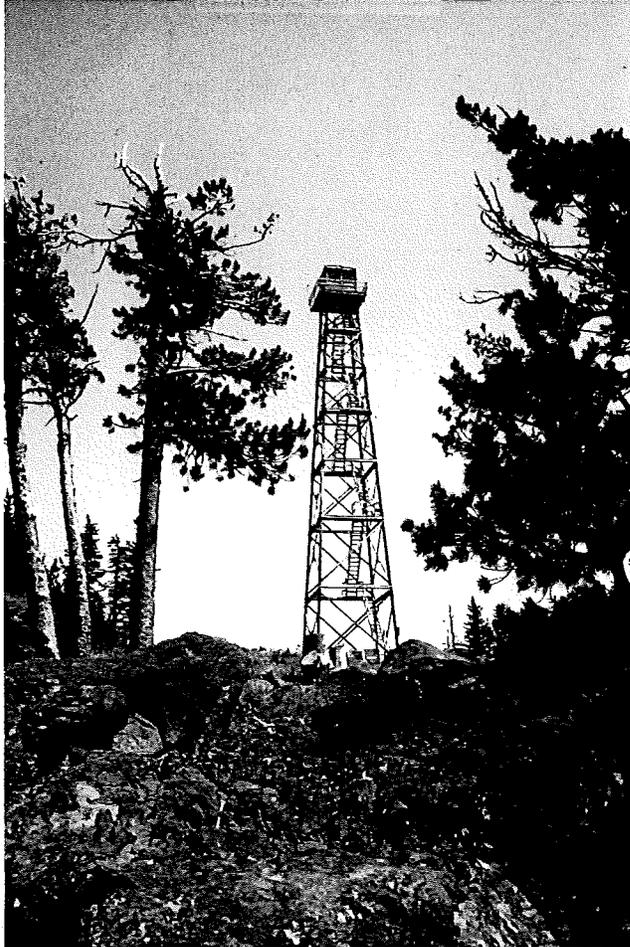
The Black Butte Tower is one of six L-6's left in the region, one of two which have a trapdoor in the floor of the cab versus through the catwalk and no exterior cab door, and the only L-6 on an 83 foot CT-1 tower. The tower has been condemned due to dry rot and instability. The other L-6 with a hatch through the floor is Frazier Peak, on the Malheur National Forest, which is also in bad shape due to woodpecker damage. The Black Butte Tower is a major cultural resource management challenge at this time (see site form).

Photo (30): Black Butte Lookout Tower, 1991. Its management is one of the Forest's biggest challenges concerning lookouts. Deschutes National Forest CRM Photo Files.
