HISTORIC FIRE LOOKOUTS
ON THE
WILLAMETTE NATIONAL FOREST

A Determination Of Eligibility
to the
National Register of Historic Places

USDA - Forest Service
Pacific Northwest Region
Willamette National Forest

James B. Cox
Archaeologist

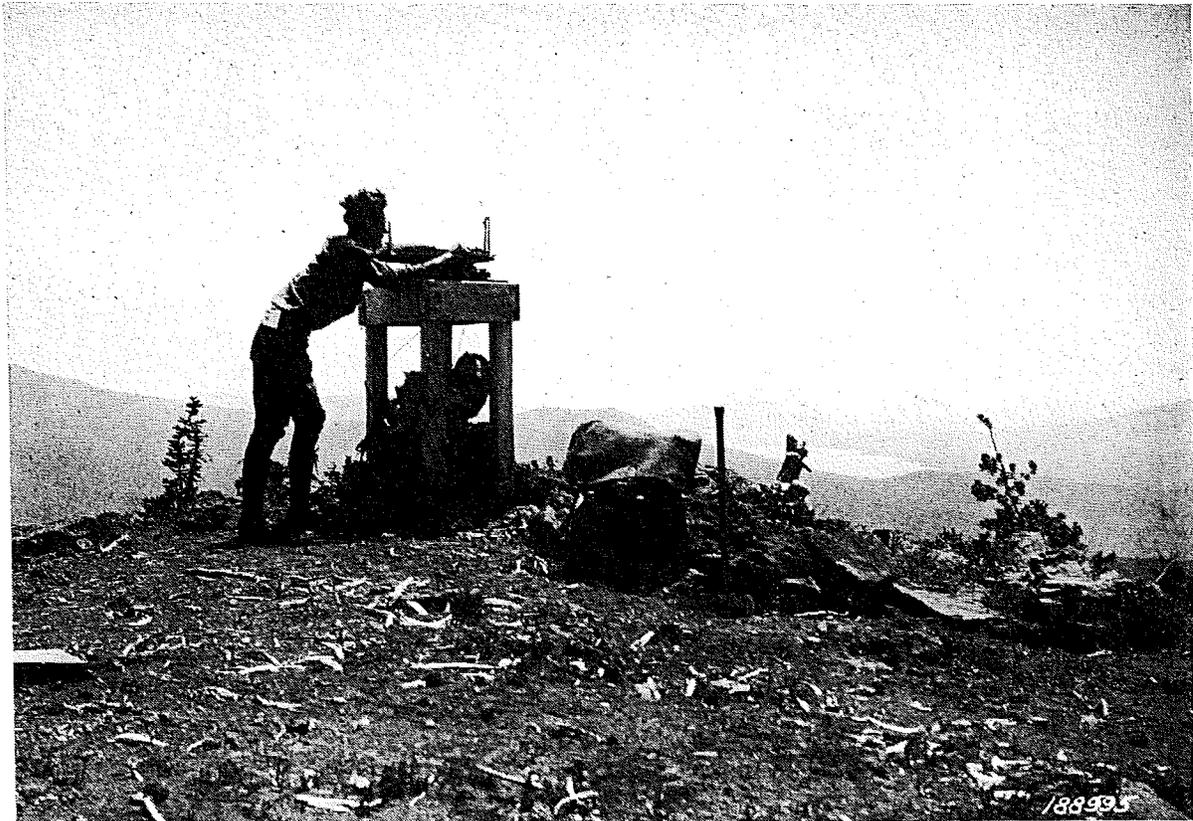
Figure 1. Alidade on Fuji Mountain, 1924
By D. C. Ingram. Willamette NF Historic Photograph Files

The first fire lookouts were simply high points with a good view of the surrounding area. A patrolman would visit the site, check for smokes, and depart. By 1907, some peaks on the Willamette had been equipped with alidades, a survey instrument used to assist in the location of fires (Figure 1). Most alidades were placed on simple supports and exposed to the elements although some were covered by open pole structures. While such lookouts were used on the Willamette National Forest until the 1970's, their period of most extensive use was between about 1915 and 1935.

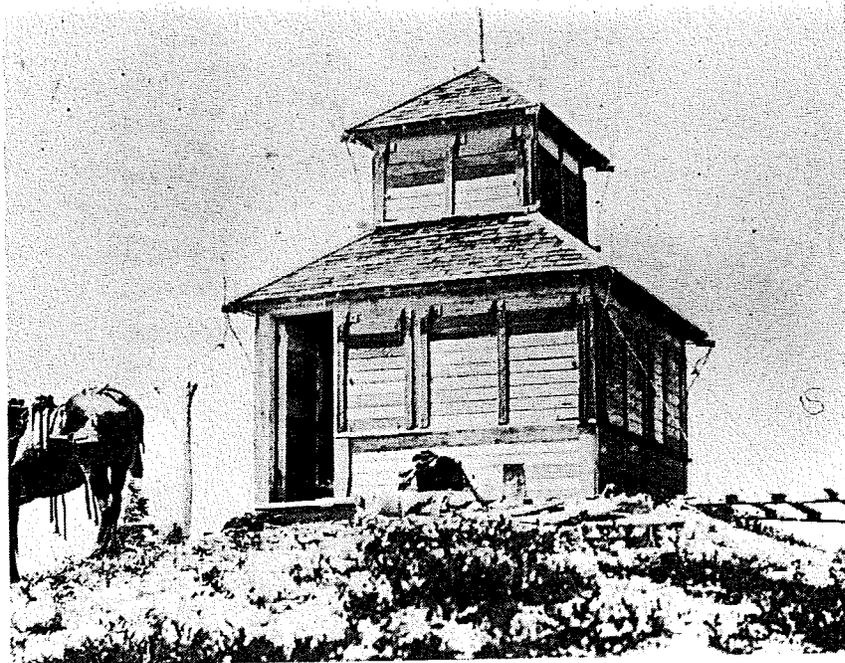
Figure 2. D-6 Cupola Style Lookout. Huckleberry Mt. 1930's
Photographer Unknown. Provided by Lillian Williams and Ron Johnson

The earliest standard lookout house design used by the Forest Service in the Northwest Region was the D-6 plan (Figure 2). The plan was originally developed by Lige Coalman in 1915 to be placed on the 11,245 foot summit of Mt. Hood. The lower floor of the 12 x 12 foot frame house had a band of windows around the upper half of all four elevations. This was the living area for the lookout. The second floor consisted of a cupola which was also surrounded by windows and contained the fire finder. This cupola provides the common name for this style of lookout house. All of the windows were furnished with shutters which were closed when the lookout was not in service. Approximately 14 of the cupola style lookouts were constructed on the Willamette, mostly between 1918 and 1929. The only lookout house of this style built on the Forest outside of this period is located on Warner Ridge, Rigdon Ranger District. This is a replica built on a low tower in 1985 and is still in use. None of the earlier cupola style lookouts have survived.

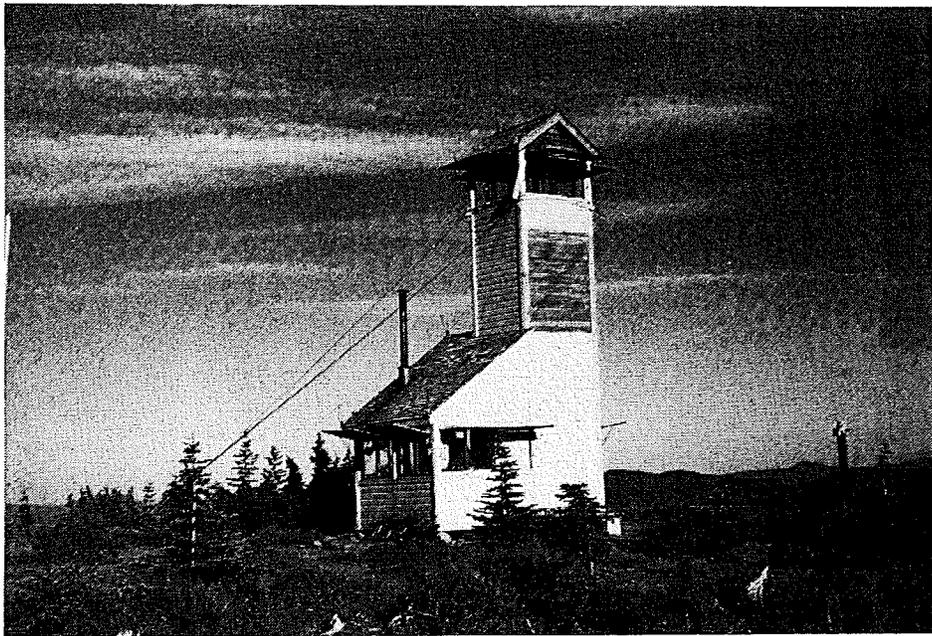
Figure 3. Cathedral Style Lookout. Indian Ridge, 1955
Photographer Unknown. Provided by Ed Anderson and Ron Johnson

In the late 1920's the Cathedral style lookout was developed (Figure 3). This was a square or rectangular frame house with an enclosed tower on one end which served as an observation point. According to Kresek (1985), only seven of these were built and all differed slightly. Two of the Cathedral style lookouts were built on the Willamette at Indian Ridge (1928) and Scott Mountain (1929). Neither has survived.

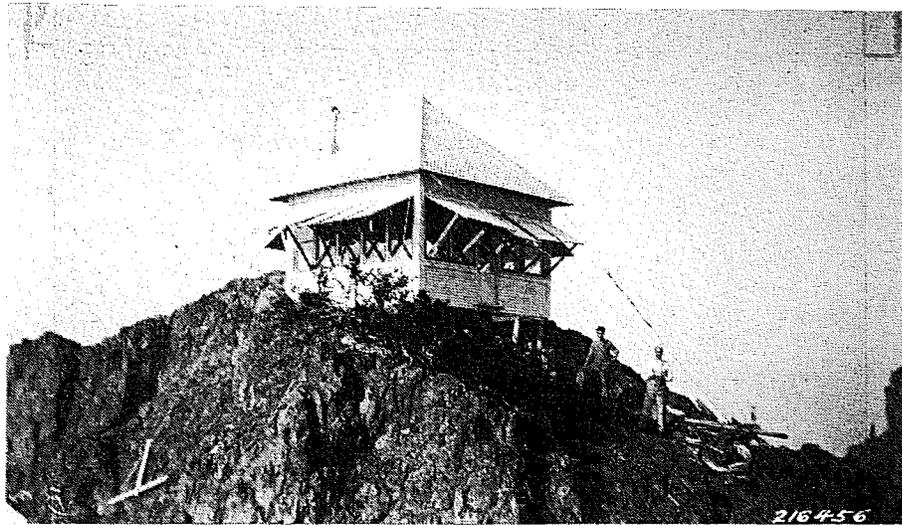
Figure 4. Supervisor Hall Special. Tidbits Mountain, No Date.
Photographer Unknown. Willamette NF Historic Photograph Files.

Another early style of lookout house built on the Willamette was known locally as the "Supervisor Hall Special" (Figure 4). The style was named for Charles C. Hall who was the Forest Supervisor on the Santiam National Forest from 1916 until 1933 when the Santiam was combined with the Cascade National Forest to create the Willamette (Rakestraw, N.D. p. 187). The style appears to be a modification of the 4A style developed in Region 5 (California) in 1917 by Coert duBois (Thornton, 1986 p. 27). Three of this style lookout were constructed on the Willamette at Tidbits Mountain (1925), Scar Mountain (1926), and Dome Rock (1928). None survive.

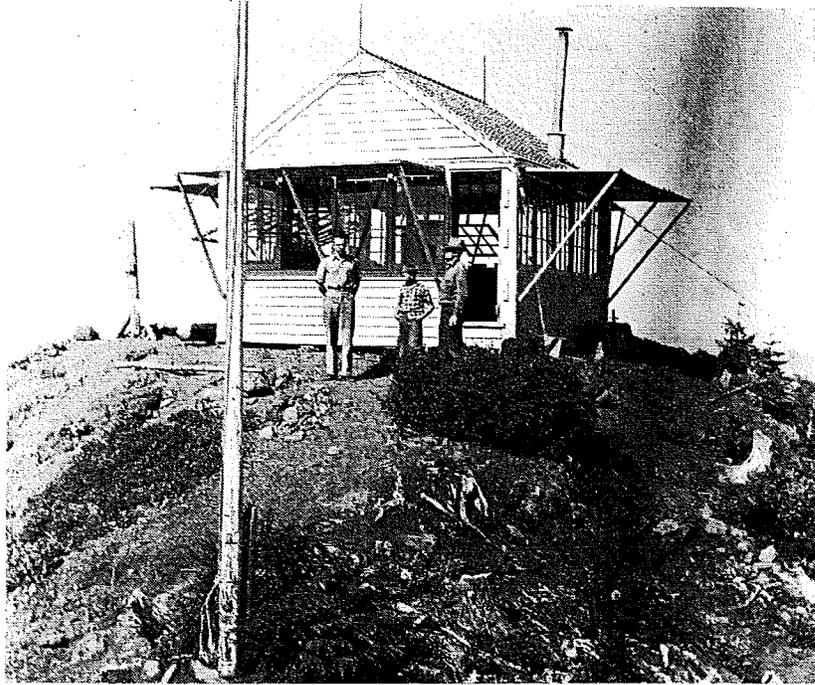
Figure 5. L-4 Lookout, Gable Roof Version. Twin Buttes, 1939
Photographer Unknown. Willamette NF Historic Photograph Files

In 1929 the L-4 style lookout house was designed and became the most widely used style on the Willamette as well as throughout the Pacific Northwest with over 1000 built throughout the Region (Kresek, 1985 p. 11). The L-4 is a 14 X 14 foot wood frame house dominated by windows in all four elevations. The windows have either four or nine lights and are both fixed and hinged. A single door with windows is offset in the main elevation. Shutters over all windows and the door serve to secure the building when not in use and are swung up to provide shade when the lookout is in service. Original roofing material is shake and siding in 1 X 6 inch ship lap. The L-4 was constructed as both a ground house and on towers.

The L-4 style evolved over time. The original plan had a gable roof (Figure 5). By 1932 the plan was revised and provided for a hip roof which gave greater structural stability (Figure 13). The plan was further revised in 1936. In this revision the ceiling joists were extended beyond the eaves approximately two feet creating ridged supports for the raised shutters. This version of the L-4 is also referred to as the "Standard 1936" (Figure 6).

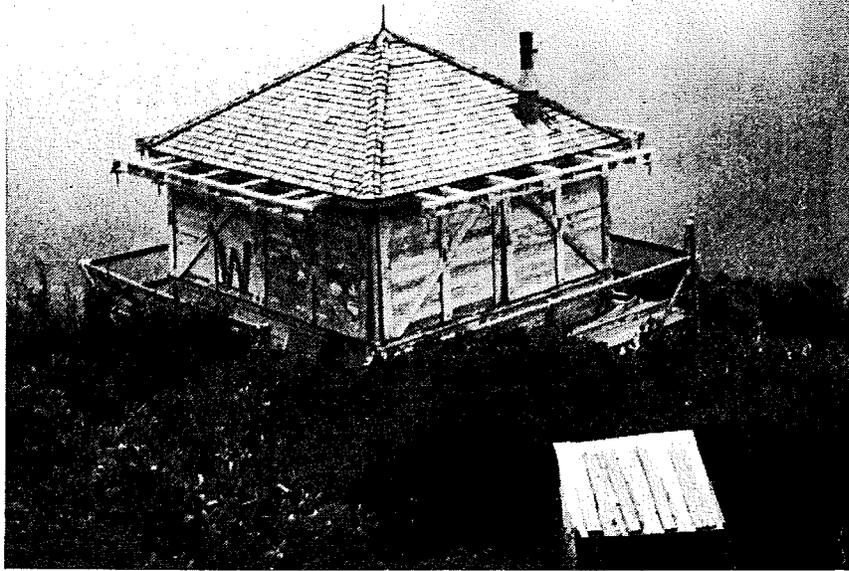
Figure 6. L-4 Lookout, "Standard 1936" Version. Rebel Rock, No Date
Photograph by Richard Miller

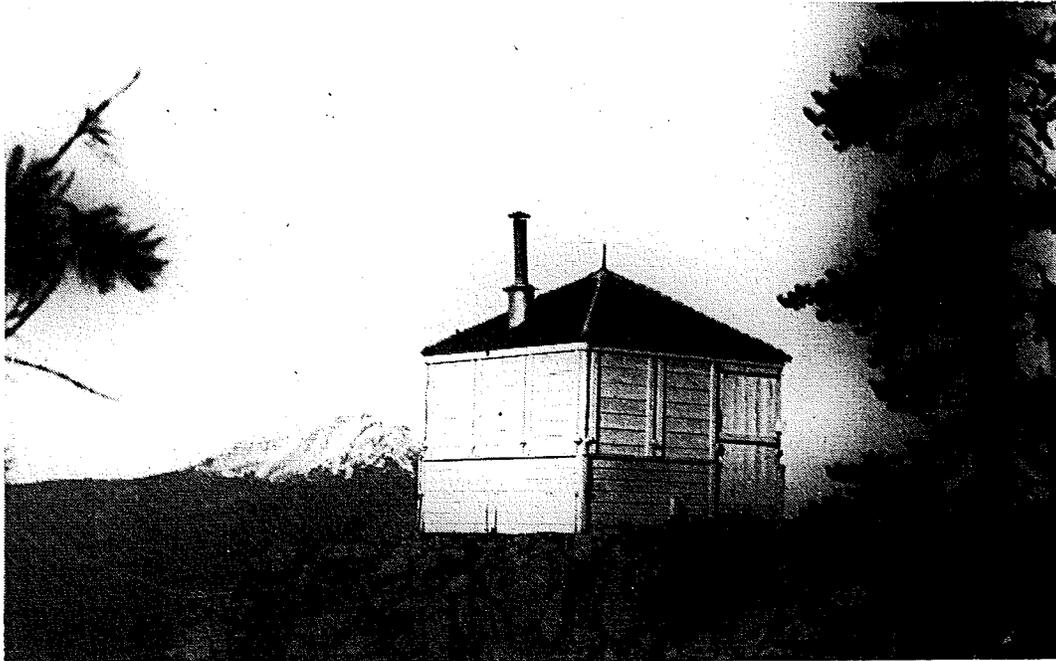
Figure 7. L-5 Lookout. Hills Peak, 1946
Photographer Unknown. Willamette NF Historic Photograph Files

Two other styles used during this period were the L-5 (Figure 7) and L-6. These were smaller (10 X 10 foot and 8 X 8 foot) versions of the L-4. According to Kresek (1985), the L-5 was primarily used at secondary patrol points and was rarely lived. On the Willamette, the smaller L-6 was used both as a ground cabin and on a tower. Fifteen of the L-5 and three of the L-6 styles were built on the Willamette between 1933 and 1935. No lookouts of either style have survived.

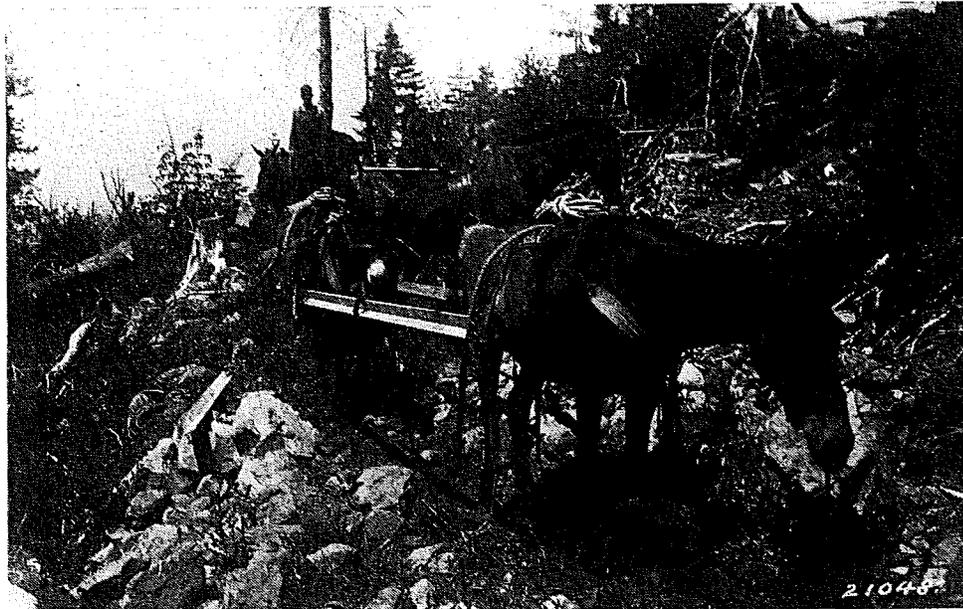
Figure 8. Packing Materials For Saddleblanket Lookout, 1926
By Nelson McDuff. Willamette NF Historic Photograph Files

Saddleblanket Mountain Lookout was constructed in 1926 for the Forest Service by Tom May and Harolds Engles, a Forest Service employee. Mules were used to pack the steel components nine miles from the trail head to the 4969 foot peak. The tower replaced a lookout tree that had been used at the site since 1922.

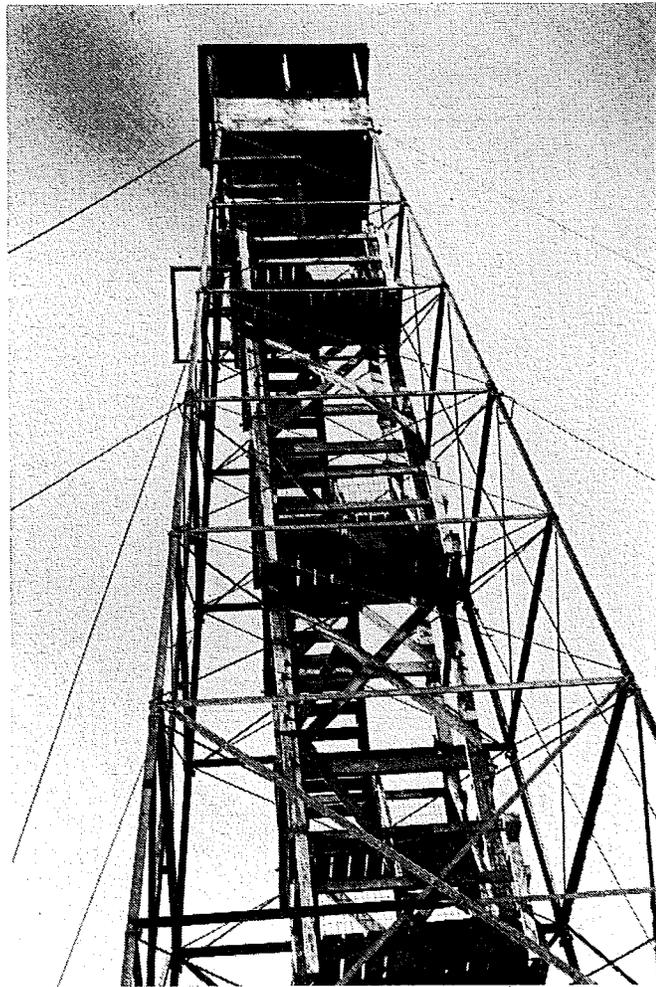
Figure 9. Saddleblanket Lookout
By Dave Nordenson. Willamette NF Engineering Files

Saddleblanket Mountain Lookout is a 7 X 7 foot sheet metal cabin with a low hip roof atop a 70 foot steel tower. The upper portion of the cabin is surrounded with windows. The lookout was manufactured by Aermotor, a company from the Chicago area that primarily built windmills. The lookout appears to be a model LX-24 (Richard Miller, personal communication, Jan. 1991). Originally, access was by an exposed ladder up the outside of the tower to a landing just below the cabin from which another ladder led to a trap door in the cabin floor. In 1939 an internal wooden stairway, designed in the Regional Office in Portland, was added. The lookout was closed in 1968.

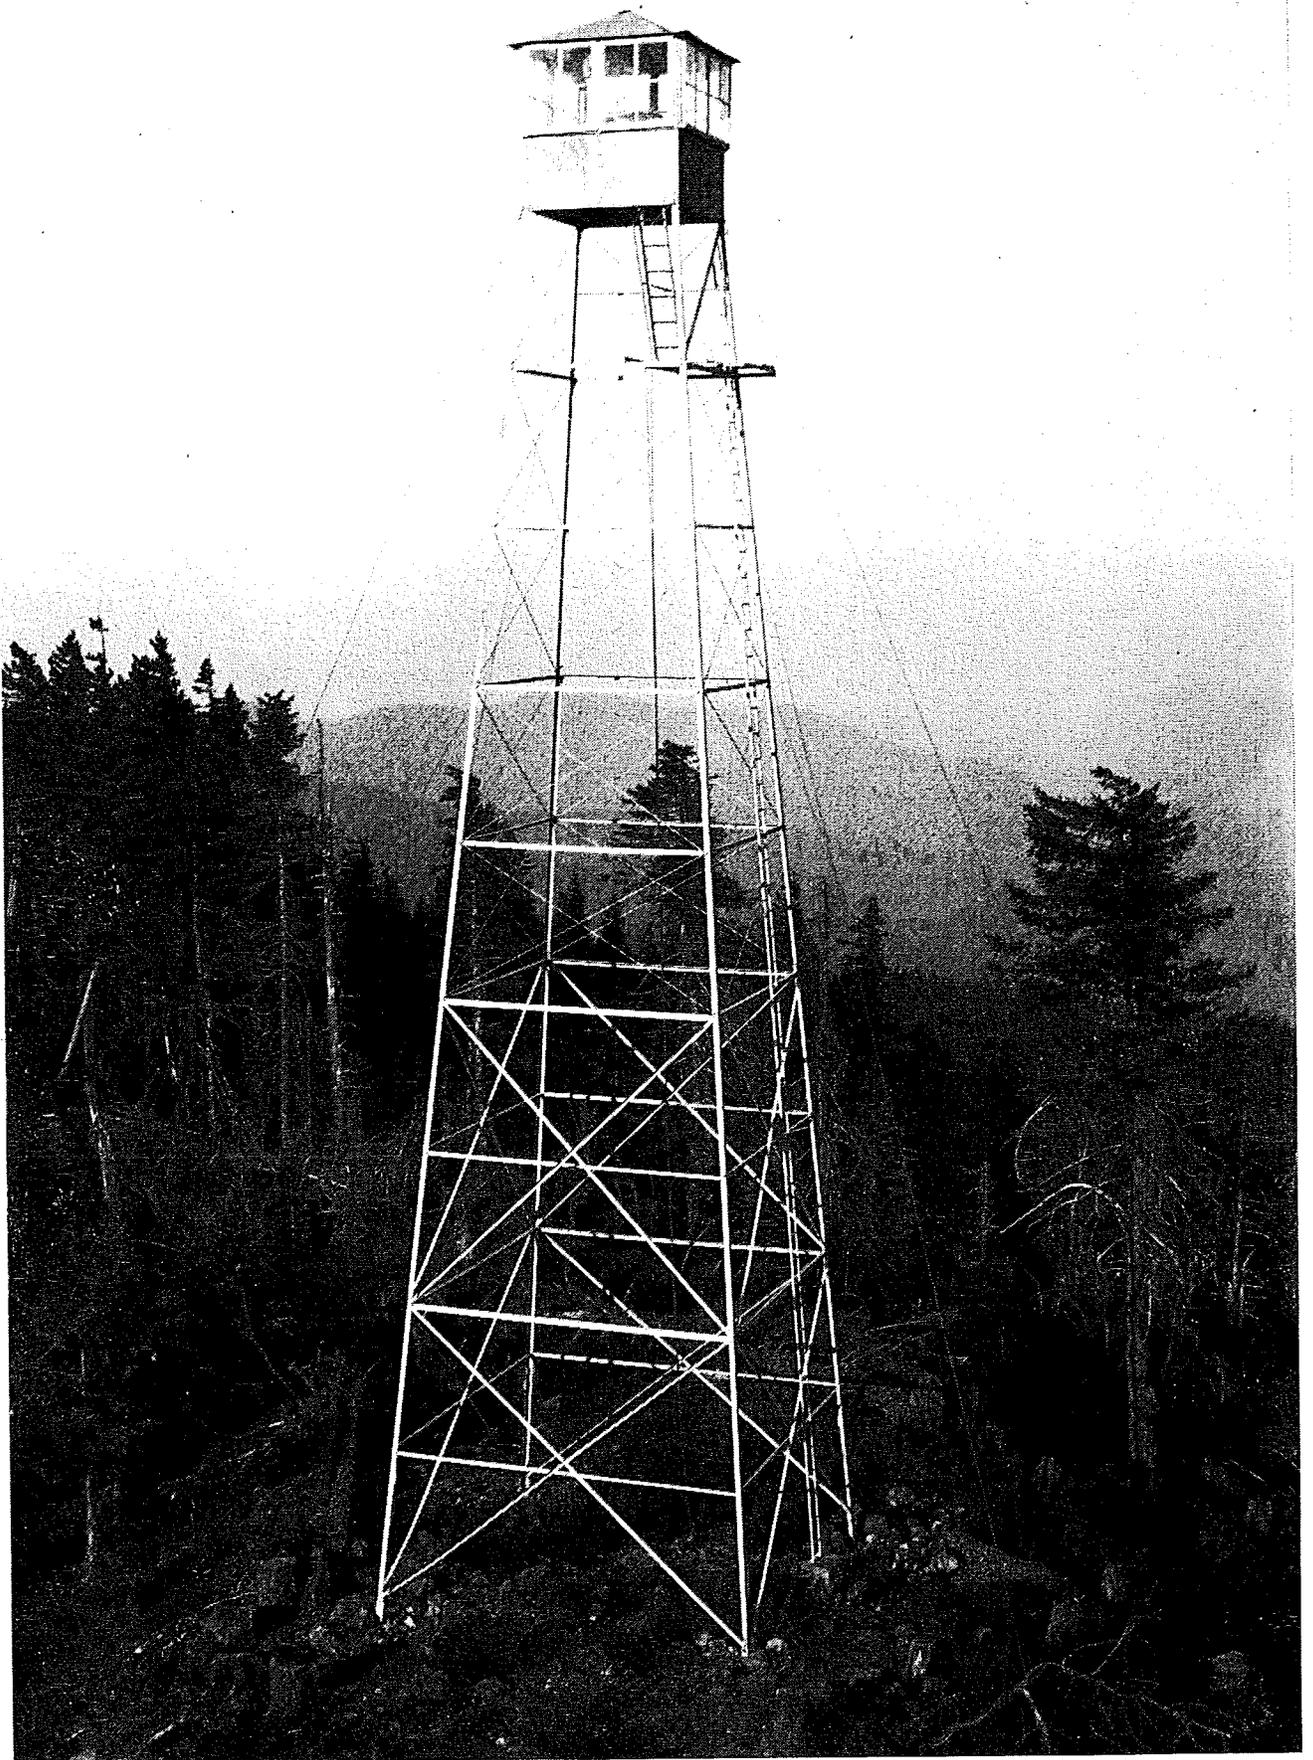
Figure 10. Saddleblanket Lookout, 1927
Photographer Unknown. Willamette NF Historic Photograph Files

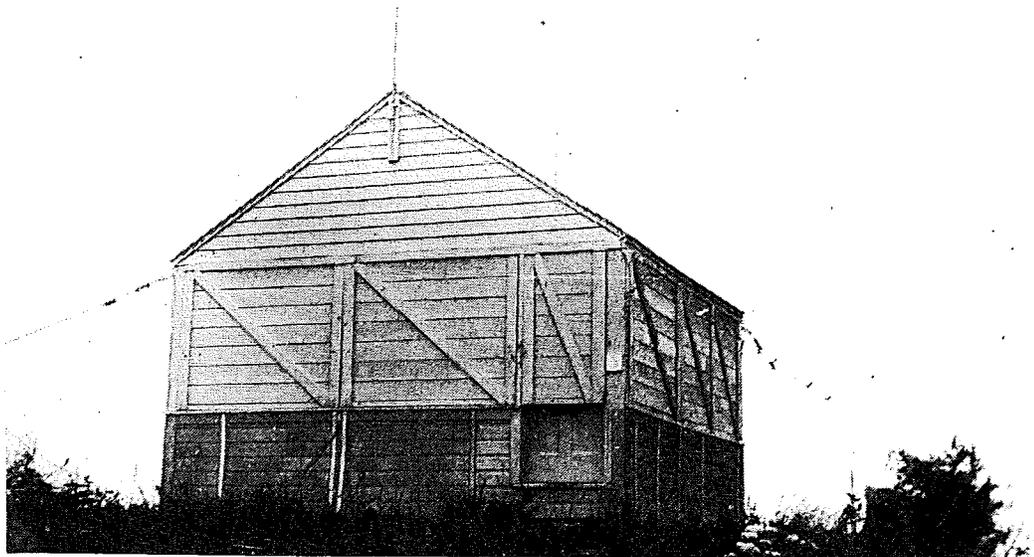
Figure 11. Olallie Mountain Lookout, No Date
Photographer Unknown. Willamette NF Historic Photograph Files

The Olallie Mountain Lookout was built in 1932 and replaced an alidade which had been used at the site since 1922. The lookout is located within the Three Sisters Wilderness atop 5700 foot Olallie Mountain. It is approximately 3 miles by trail from the nearest road. The lookout is a gabled roof version of the L-4 style. It is the only surviving example of this version of the L-4 on the Willamette.

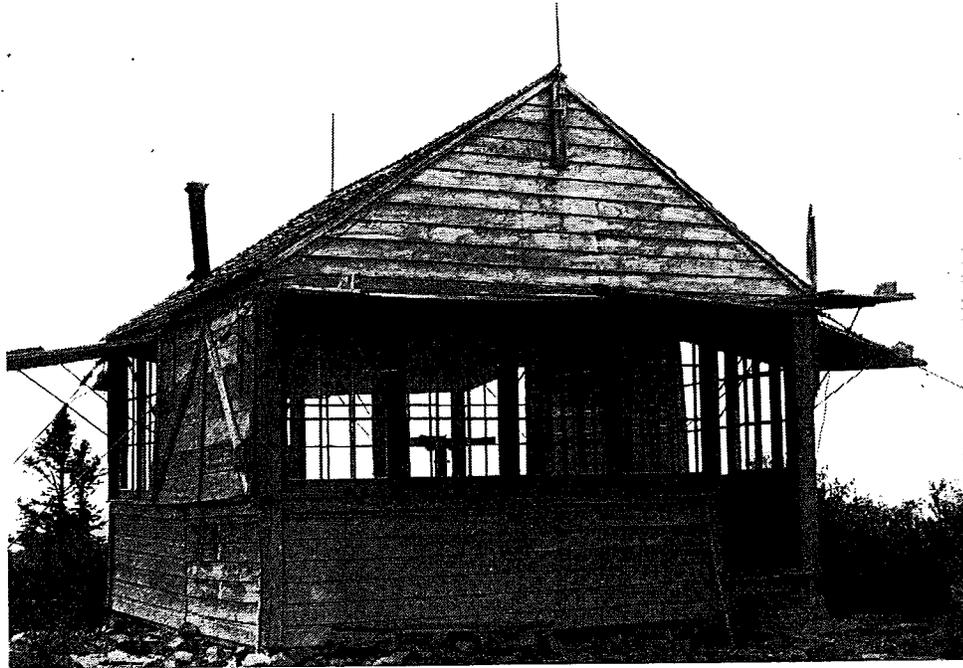
Figure 12. Olallie Mountain Lookout, Prior to Shutter Replacement
By Jim Cox. Willamette NF Cultural Resource Photograph Files

The Olallie Mountain Lookout retains the best integrity of all of the historic lookouts on the Forest. This is probably the result of the distance from road access which has discouraged both vandalism and planned alterations. Noted alterations are limited to replacement of the shutters with shutters of similar materials and design. This has had a modest effect on the integrity of design and materials of the lookout.

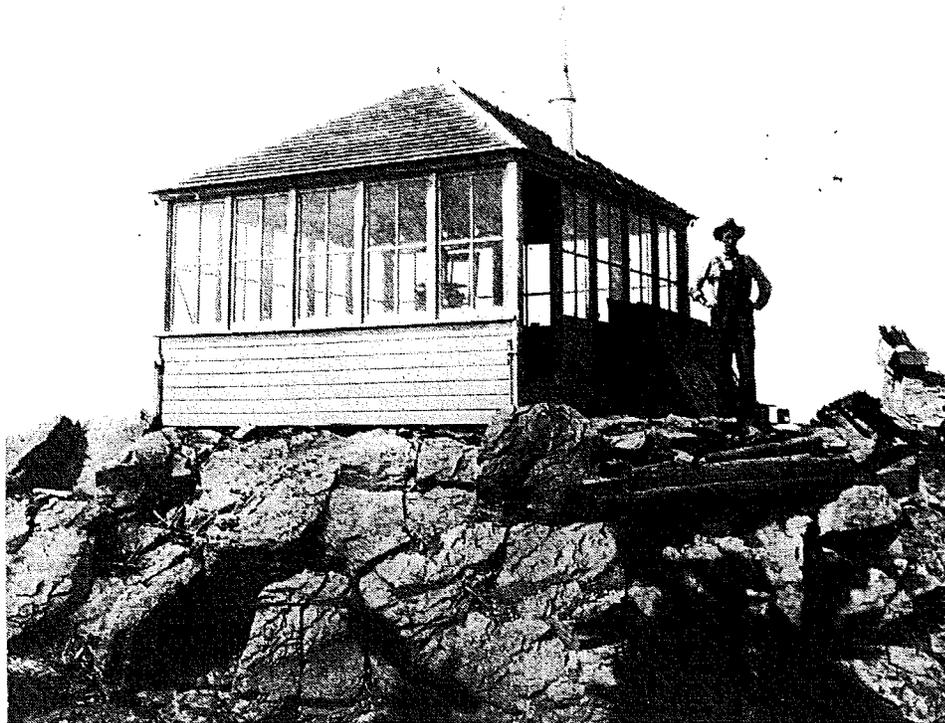
Figure 13. Carpenter Mountain Lookout Under Construction, 1935
By Gordon Short. Willamette NF Historic Photograph Files

The current lookout is an L-4 design with a hip roof. It occupies virtually the entire top of the 60 foot high basalt plug that forms the 5349 foot summit of Carpenter Mountain. A lumber and wire mesh fence enclose a narrow walkway on the east, south, and west sides of the lookout.

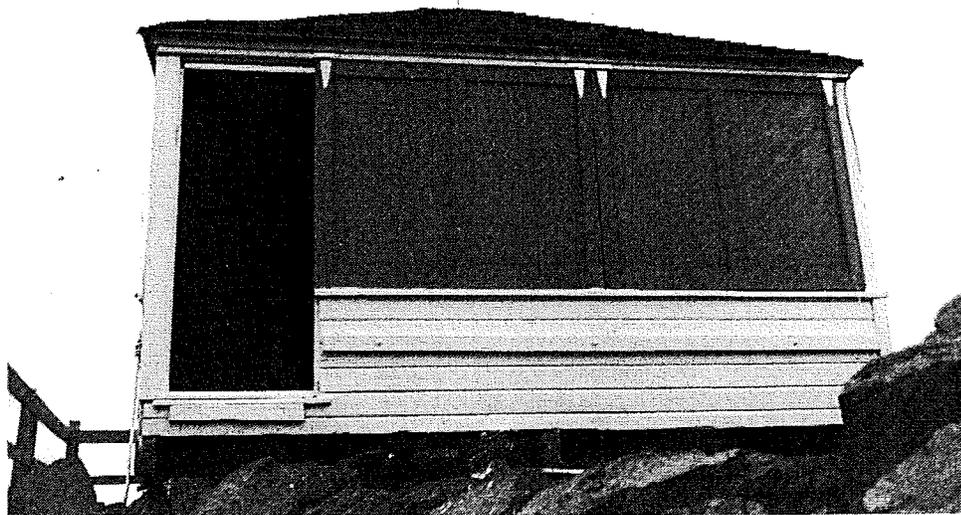
Figure 14. Carpenter Mountain Lookout
By Jim Cox. Willamette NF Cultural Resource Photograph Files

The Carpenter Mountain Lookout is one of two surviving examples of the hip roof version of the L-4 style lookout house. The integrity of the lookout is good. Alterations appear to be limited to the replacement of the original door with a plywood door and the replacement of the original board shutters with plywood shutters. While these alterations have had some affect on integrity of design and materials, they are relatively minor.

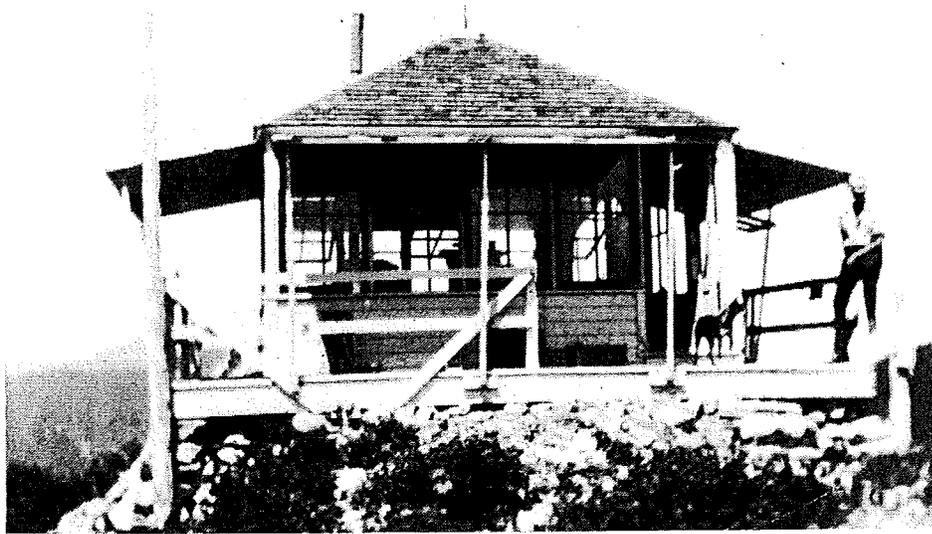
Figure 15. Gold Butte Lookout, 1936
Photographer Unknown. Provided by Willis Grafe and Ron Jonhson

Gold Butte is a 4618 foot peak located northeast of the town of Detroit. The Gold Butte Lookout was constructed by the CCC in 1934. The lookout is a hip roof version of the L-4 style and is surrounded by a three foot wide 2 x 6 cat walk with railings.

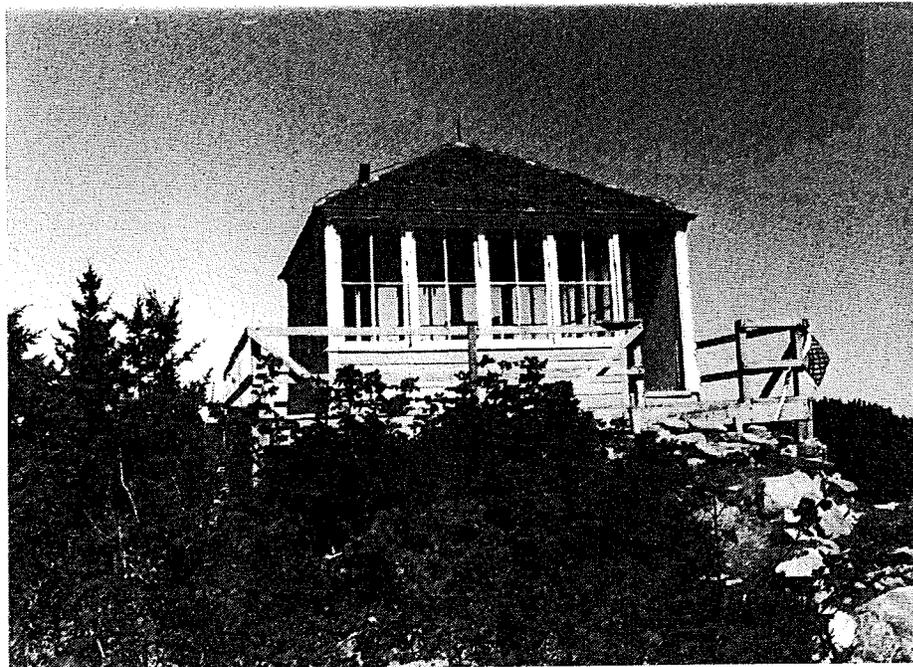
Figure 16. Gold Butte Lookout
By James Cox

Gold Butte Lookout is the only surviving CCC built hip roofed version of the L-4 style lookout house on the Willamette National Forest. The only other surviving CCC built lookout, Huckleberry Mountain Lookout, has been determined to be not eligible for listing on the National Register. Noted alterations to Gold Butte are the replacement of the door and the removal of the shutters. While these alterations do affect integrity of design and materials, the building retains sufficient integrity to convey its historic character.
