HISTORIC TRAIL SHELTERS
OF THE
WILLAMETTE NATIONAL FOREST
An Inventory and Determination of Eligibility

Addendum to
Historic Trail Shelters
Of the
Willamette National Forest

A Determination of Eligibility
To the
National Register of Historic Places
For
Ash Swale Shelter

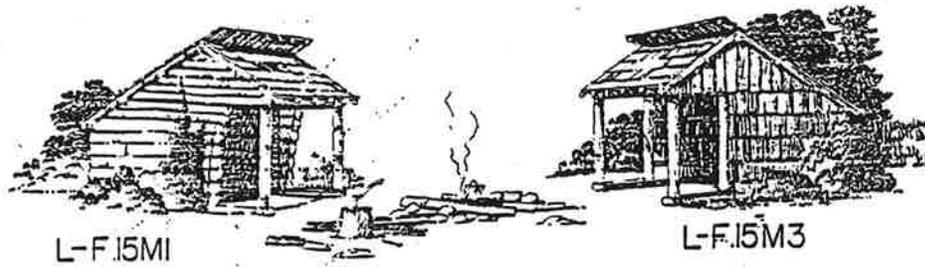
TYPICAL END FRAMING
 For 12'-0" x 14'-0" Shelter

Sills should be of cedar 10" to 12" dia.
 Posts and beams should be 6" to 10" dia.
 Bracing is better if made of 6" dia. and using
 one end of timber for each brace.
 Shims may be as small as 1 1/2" to 1"
 and may be round, square or some other of cedar.
 All posts to be round, straight and sound.
NOTE: Care must be taken to construct stone foundations
 which will relieve need of permanent
 concrete retaining walls. Framing suitable
 Recreational Shelters, Hikers, etc.

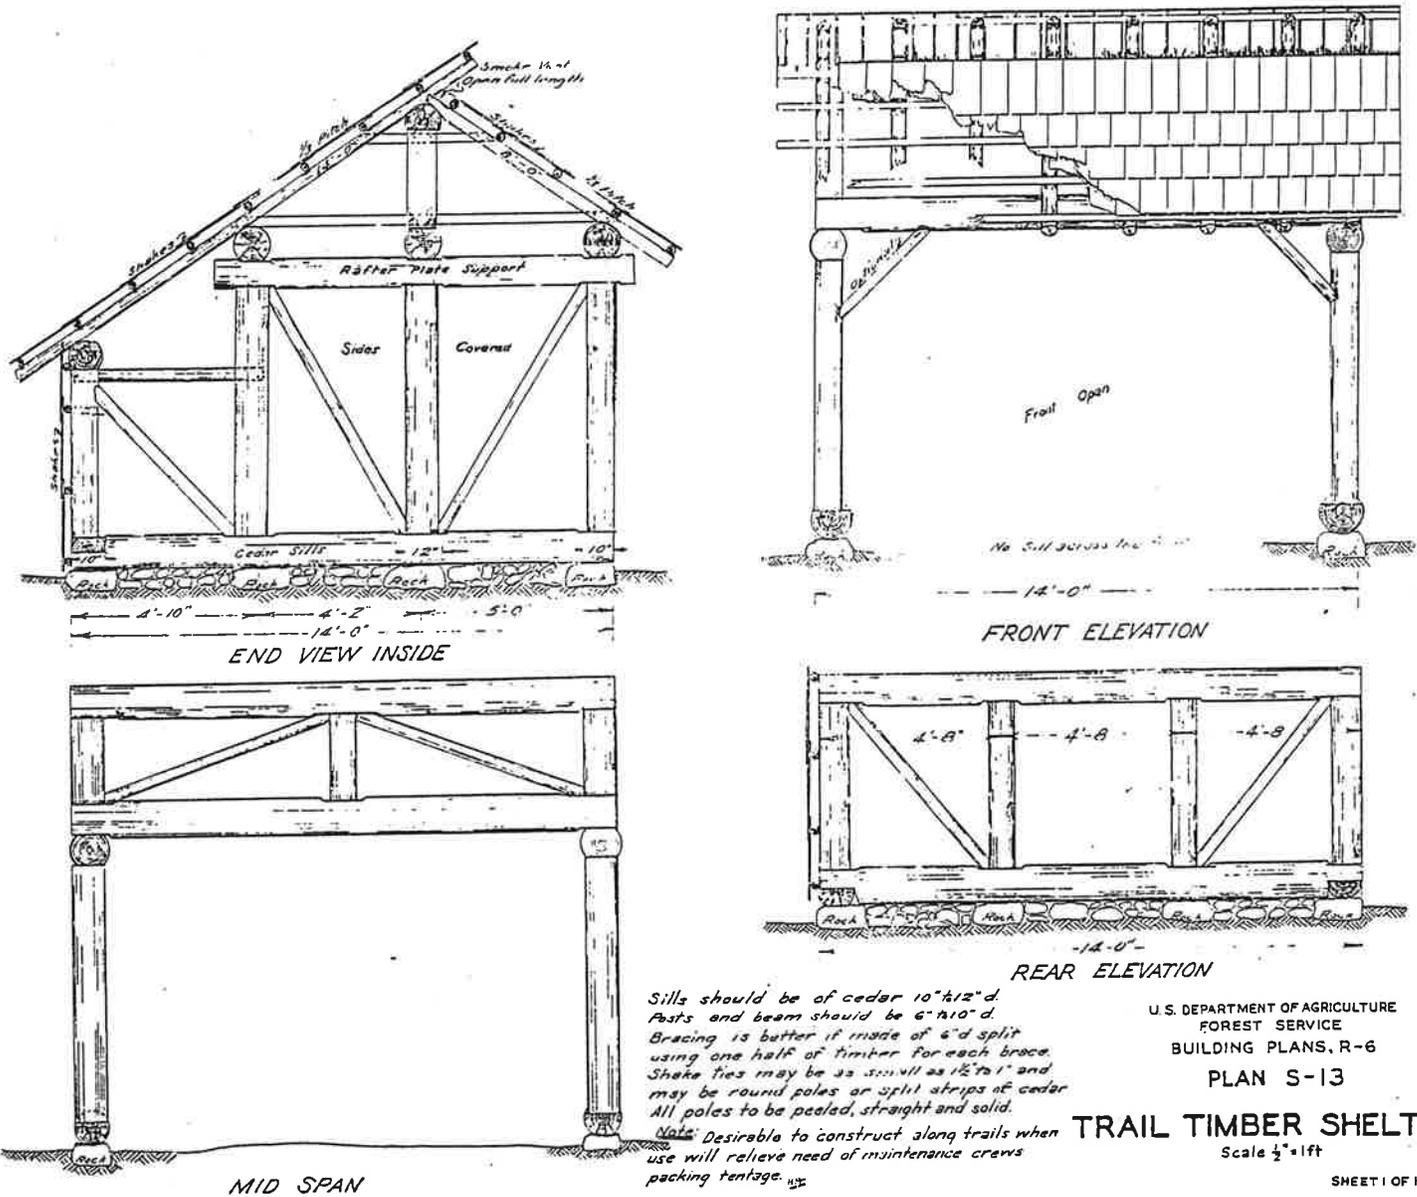
Figure 1

On the Willamette National Forest, trail shelters retained the basic design of the original Adirondack shelter. However, several modifications were made to accommodate local conditions and needs (Figure 1). Rather than being made solely of logs, most shelters were framed with peeled logs and poles, then covered with a variety of materials, especially split cedar shakes. Logs and hand split boards were also used for siding. Native rock was utilized for construction of portions of the walls at some shelters. All of the shelters were built of native materials obtained near the shelter locations.

Roofs were modified in two ways. First, the pitch was increased in response to the heavy snows common in the mountainous areas where most were located. The rear slope was also extended beyond the ridge line approximately one foot forming a comb which created a smoke vent the full length of the ridge.

Plan used for trail shelters constructed on the Willamette National Forest.

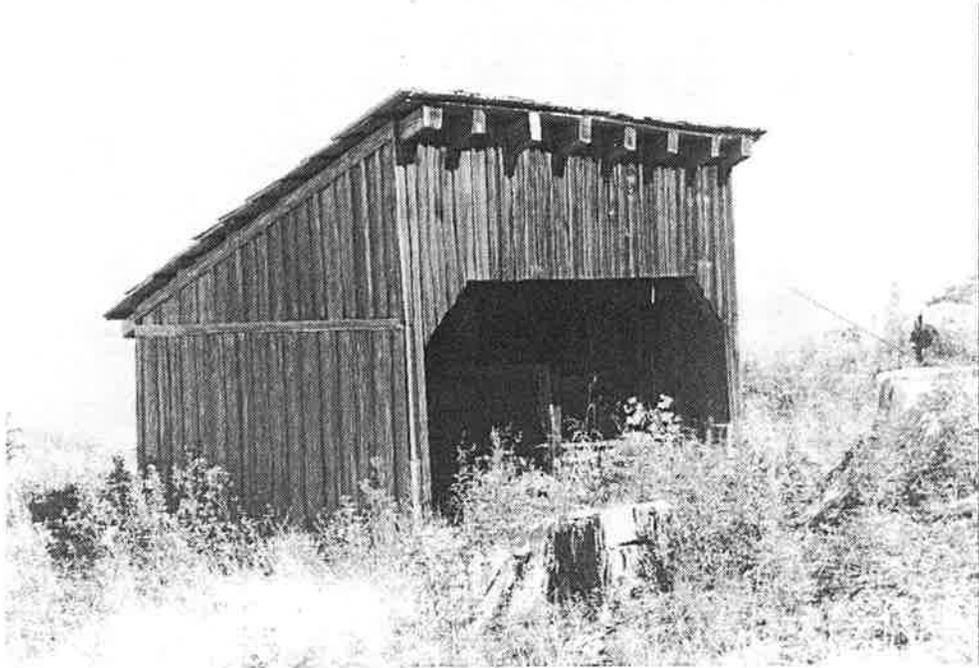
The shelter currently is in good condition. The framing siding and roofing are sound. The shelter was blown over in the mid-1970's but was rebuilt using the original materials. Since then, the roof was replaced in kind. The surrounding timber was harvested several years ago and the shelter now stands in a clear cut.

Coffin Burn Trail Shelter
Looking North

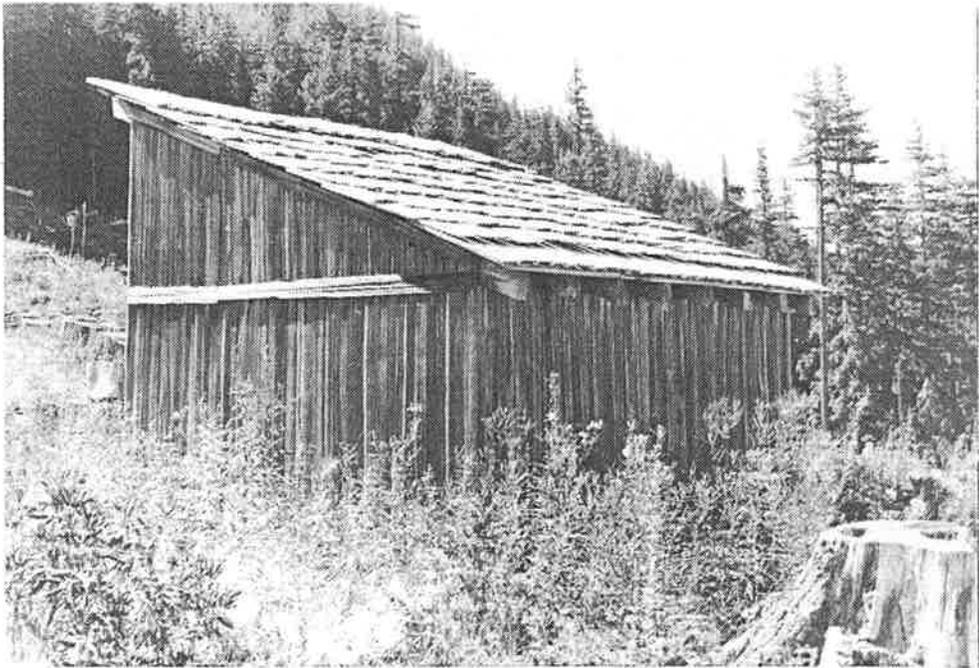
Coffin Burn Trail Shelter
Looking South

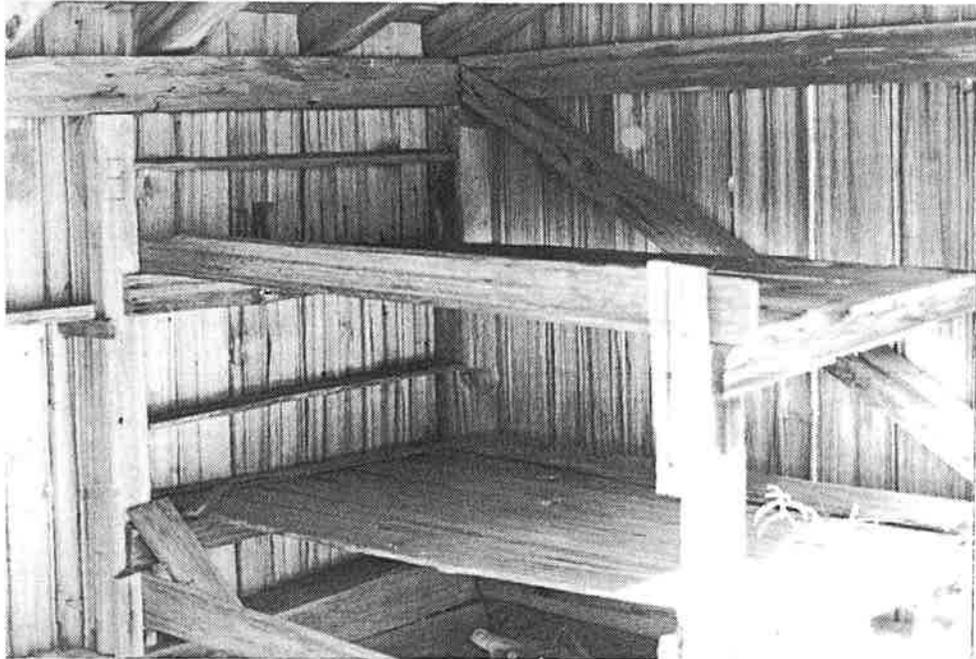
The Coffin Burn Trail Shelter is one of two shelters on the Willamette National Forest which was not based on a modification of the Adirondack style. It is rectangular (10 X 14.5 feet) with one open side facing southeast toward the hillside. It has a shed roof sloping toward the rear of the shelter. The shelter is framed with split cedar beams. The sill logs rest on native rock piers except for the eastern sill which rests on a pressure treated 4 X 4. Siding is split cedar boards and battens. The roof is shake. A 5 X 7 foot bunk bed with split cedar board decking is attached to the eastern wall. A table of split cedar boards is attached to the western wall near the rear of the shelter. The table is hinged and can be swung up against the wall when not in use.

Coffin Burn Trail Shelter
Interior View Showing Bunk Beds

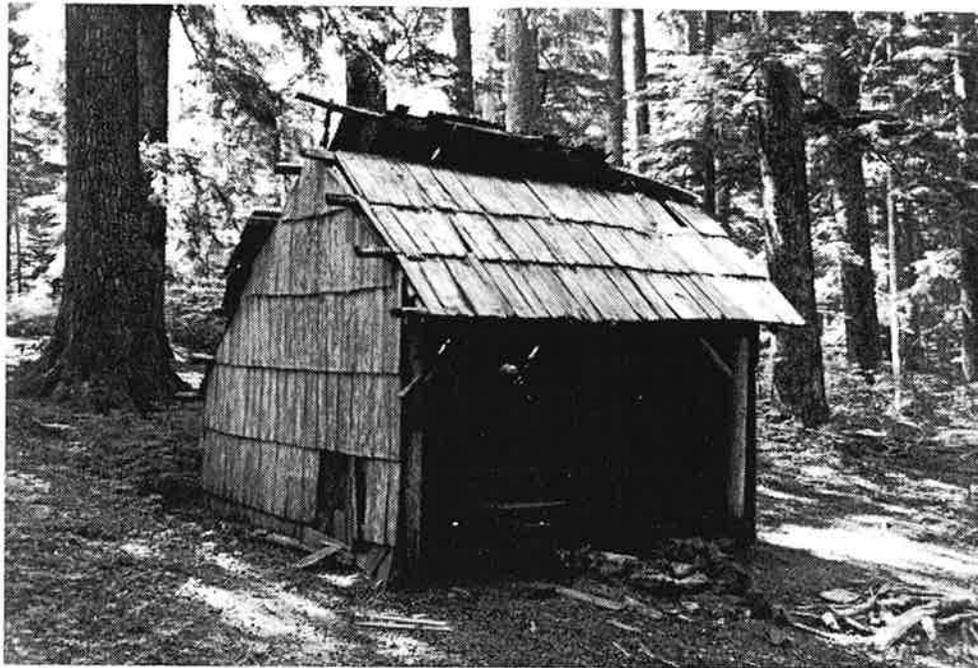
The current condition of the shelter is fair. Shakes are missing from the walls and roof and those still in place show signs of decay. The framing is in good condition with the exception of the badly decayed sill log located on the east wall. The ends of the rafters and the nailer which form the comb are also deteriorated, especially on the west end where it has collapsed.

McQuade Creek Trail Shelter
East and North Elevations

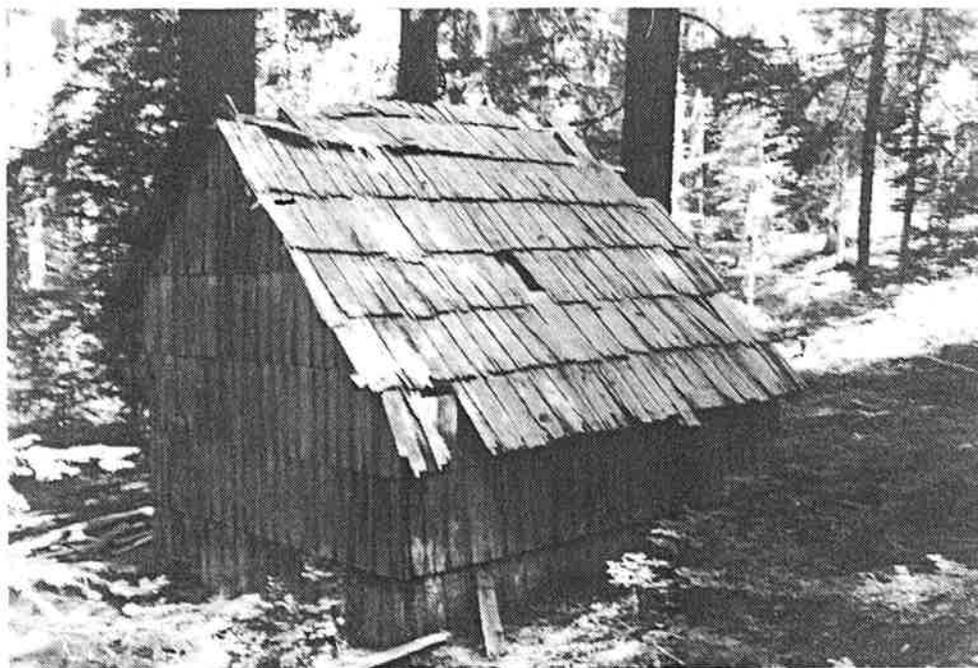
McQuade Creek Trail Shelter
South and West Elevations

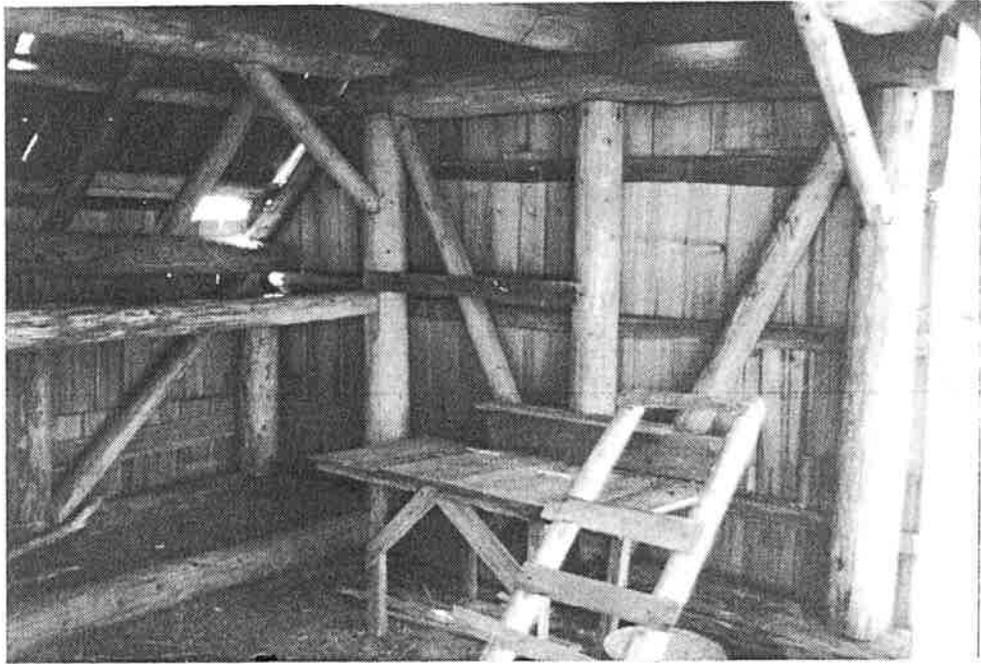
McQuade Creek Trail Shelter
Interior View Showing Bunks and Table in Southwest Corner

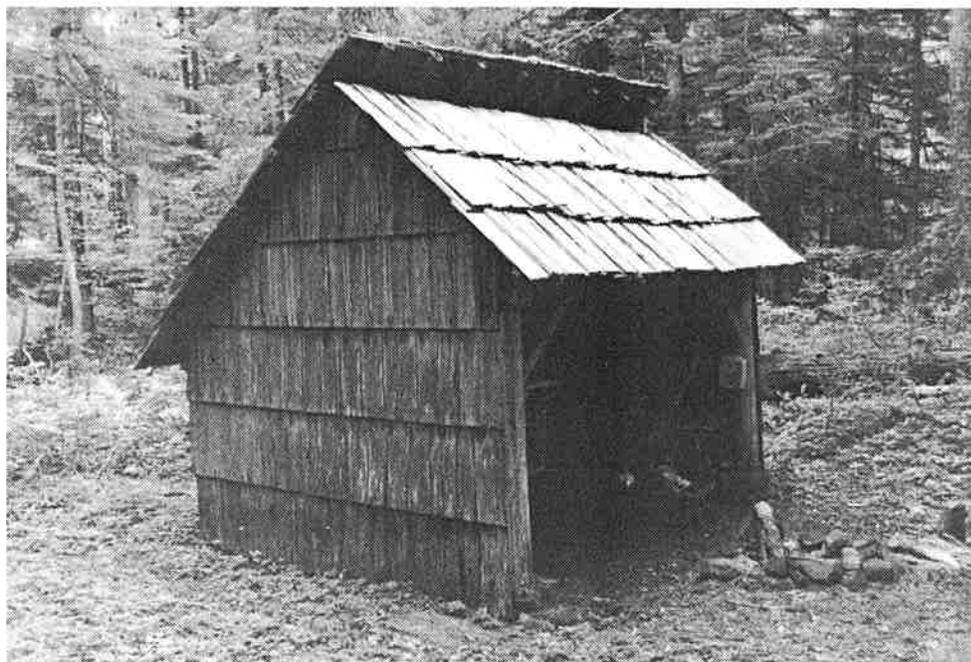
The shelter is currently in excellent condition. The framing is sound with the only decay noted in the sill logs at the extreme ends near the open side. The replacement of the original shakes was well executed and the roof and walls are in good condition. The removal of shakes, presumably for fire wood, which is common at many of the shelters, is not apparent here.

Middle Santiam Trail Shelter
South and East Elevations

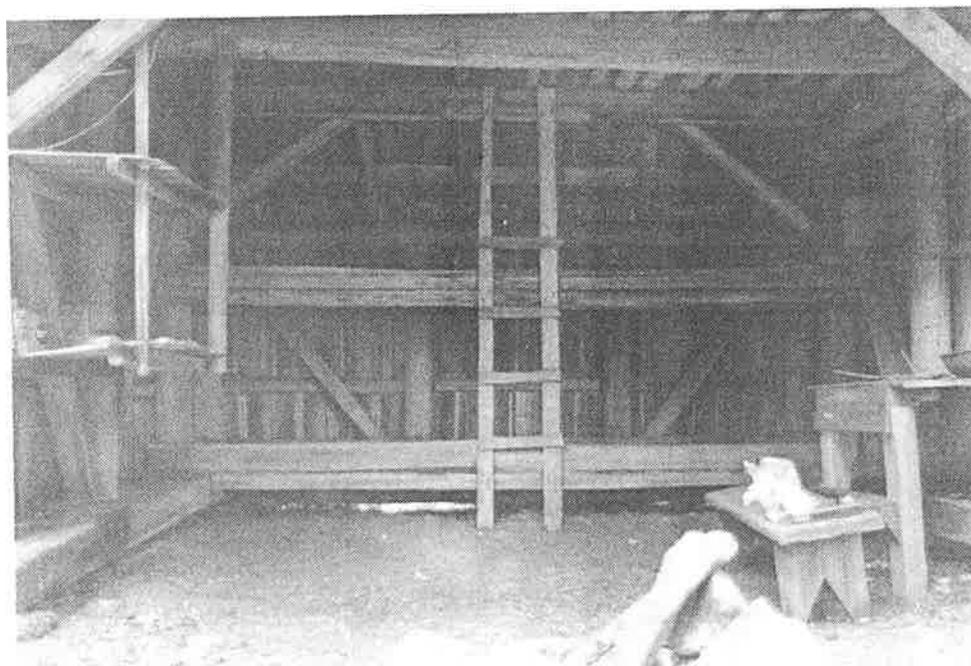
Middle Santiam Trail Shelter
Interior

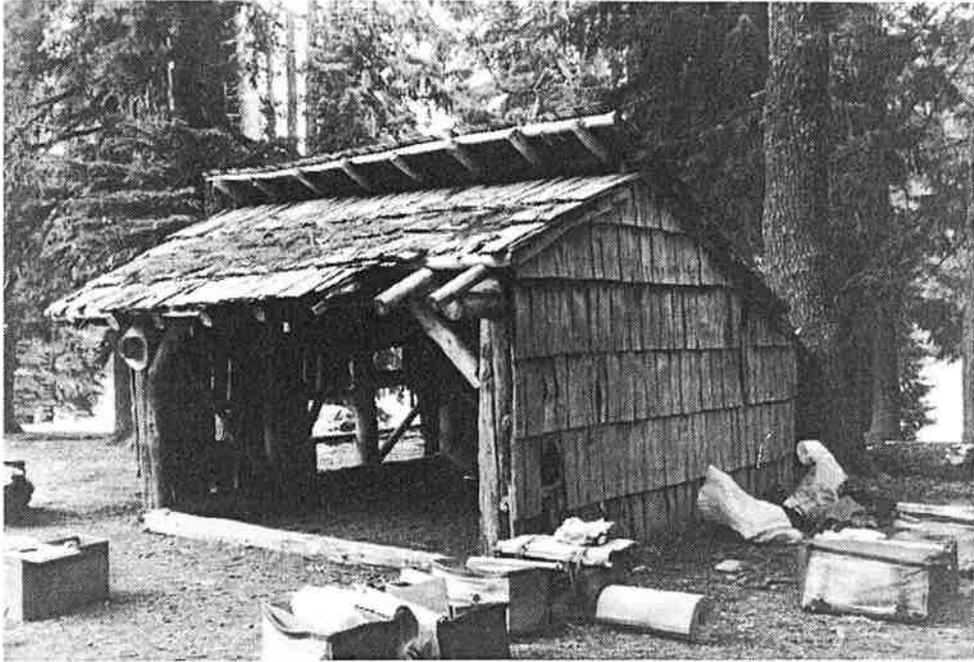
The shelter is structurally sound. With the exception of decay in two rafter ends which have been exposed due to the removal of roof shakes, the framing is in good condition. A substantial number of shakes are missing, especially on the south elevation. Those shakes still in place show signs of decay. The shelter is unstable, probably due to the missing shakes and the poor condition of those present.

Buck Meadows Trail Shelter
East and North Elevations

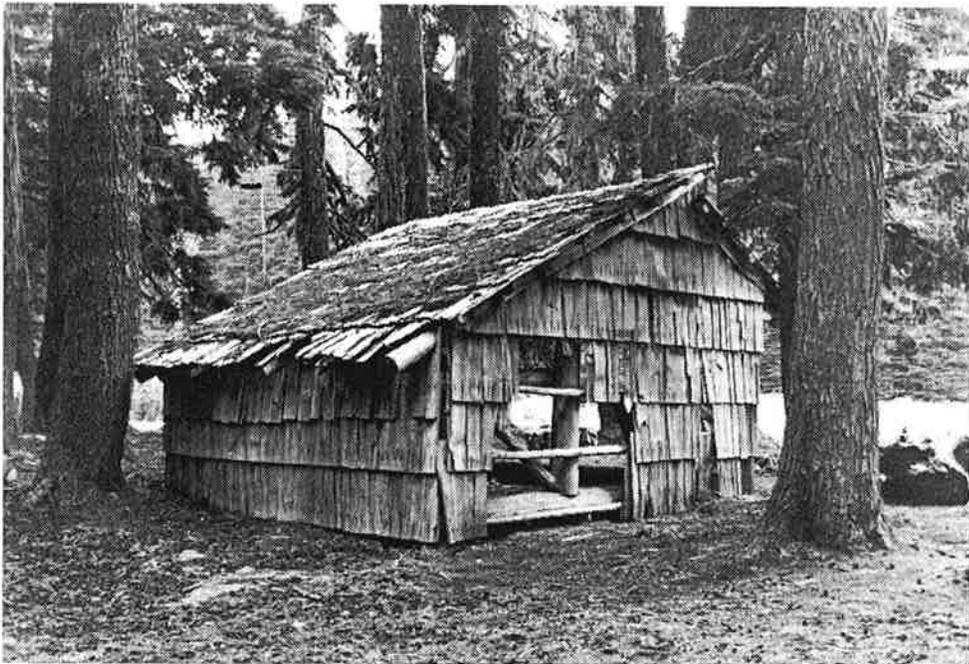
Buck Meadows Trail Shelter
South and West Elevations

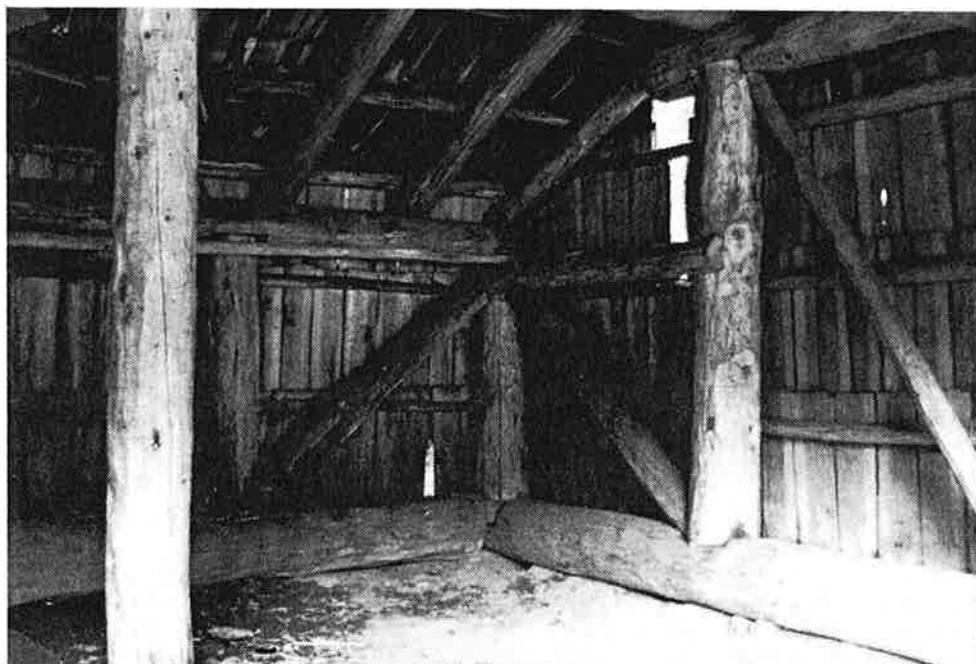
Buck Meadows Trail Shelter
Interior View Showing Framing in Northwest Corner

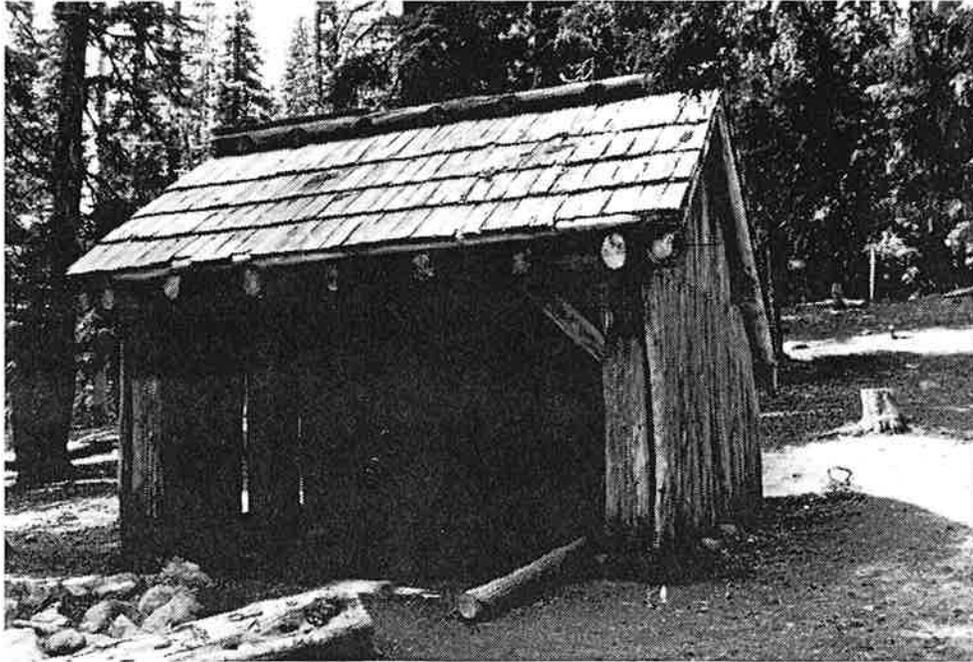
The shelter is in good condition, is structurally solid, and the roof is sound. The lower 8-12 inches of the wall logs exhibit moderate to severe decay. Some decay is also noticeable in the the sill logs, especially near the open front.

James Creek Trail Shelter
East and North Elevations

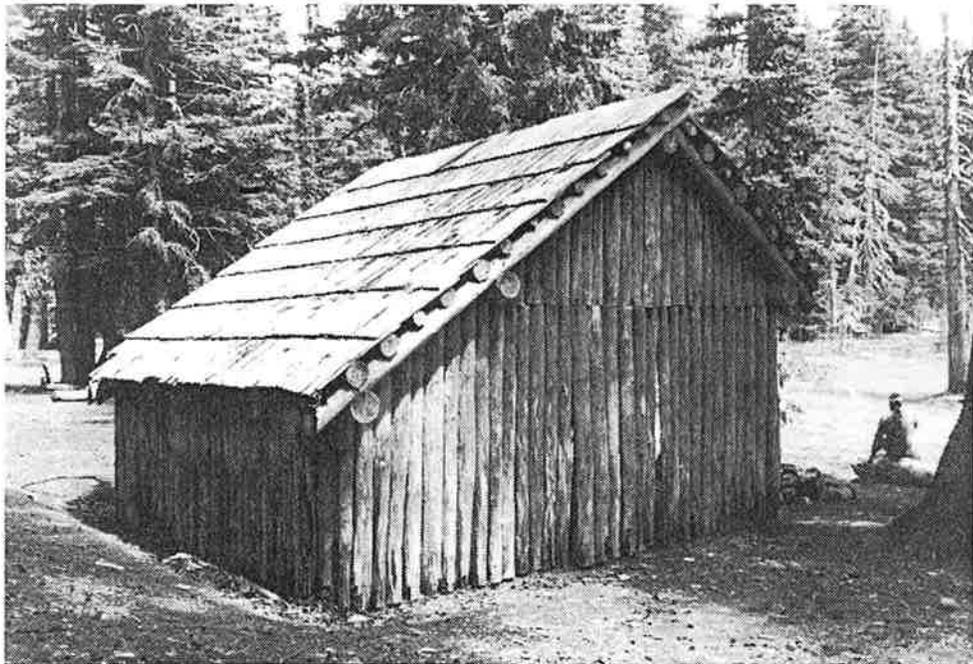
James Creek Trail Shelter
West and South Elevations

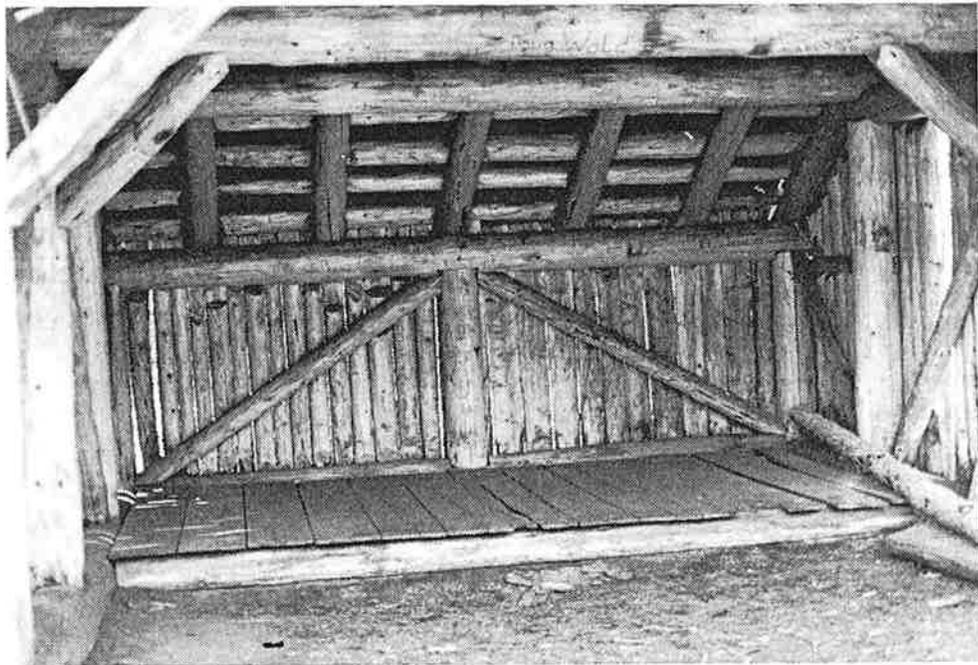
James Creek Trail Shelter
Interior View Showing Sleeping Platform

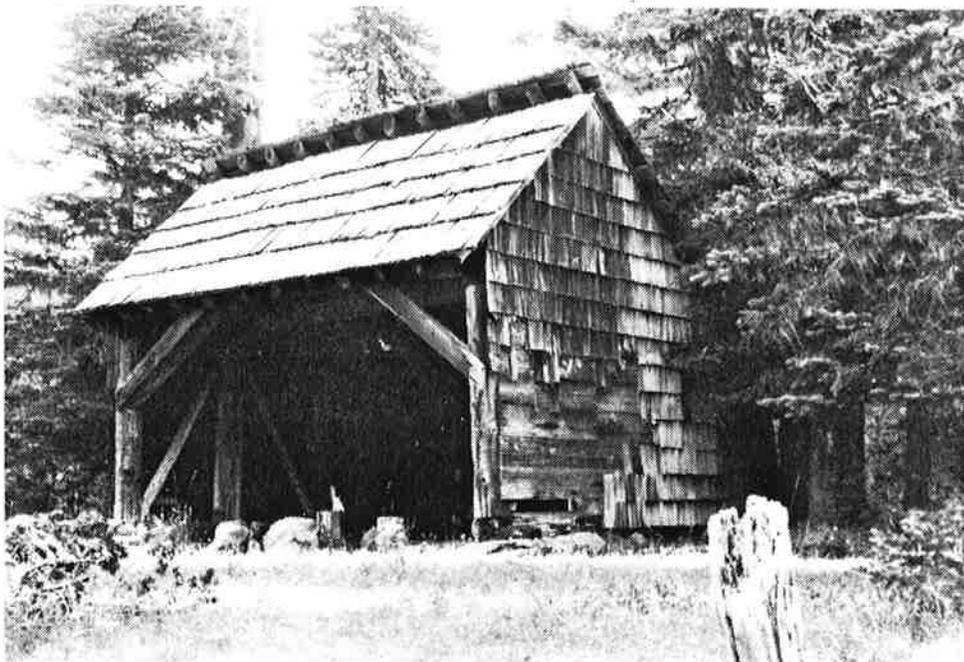
The shelter currently is in good condition. The log/pole framing and board sheathing is sound. The rock piers supporting the sill logs continue to keep the shelter well above grade, preventing any significant deterioration. A substantial number of wall shakes have been removed and there is a small hole in the roof at the north corner. Neither have affected the structural integrity of the shelter.

Hand Lake Shelter
South and West Elevations

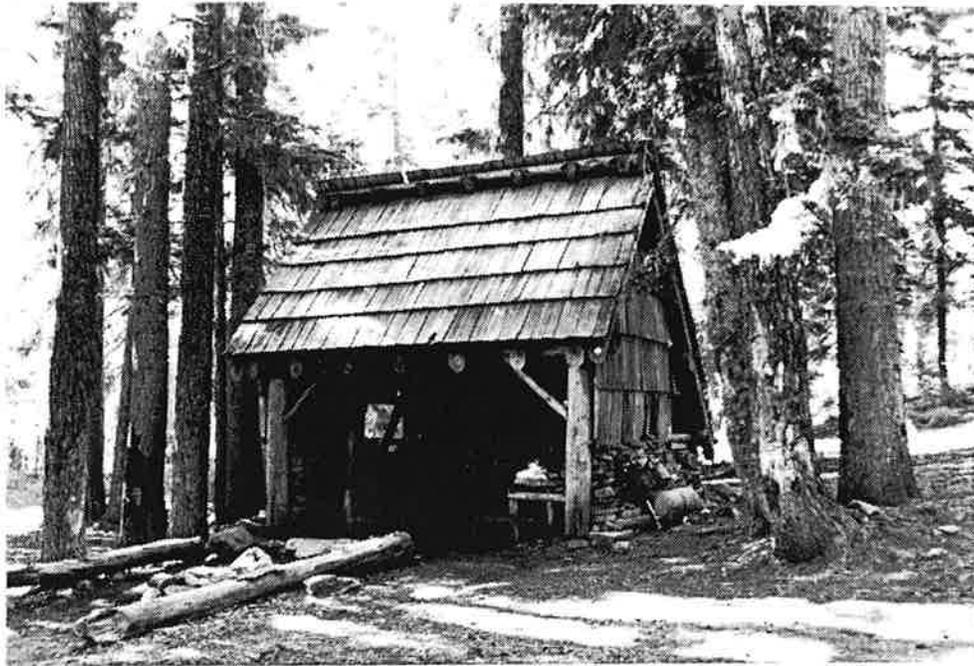
The shelter is in very good condition. The only apparent decay is in the east sill log near the open front. The remainder of the framing is sound. The rock

work forming the lower portion of the walls is intact and stable. The roof is sound. Shakes have been removed from the bottom course on both sides, probably for use as fire wood.

Cliff Lake Trail Shelter
South and East Elevations

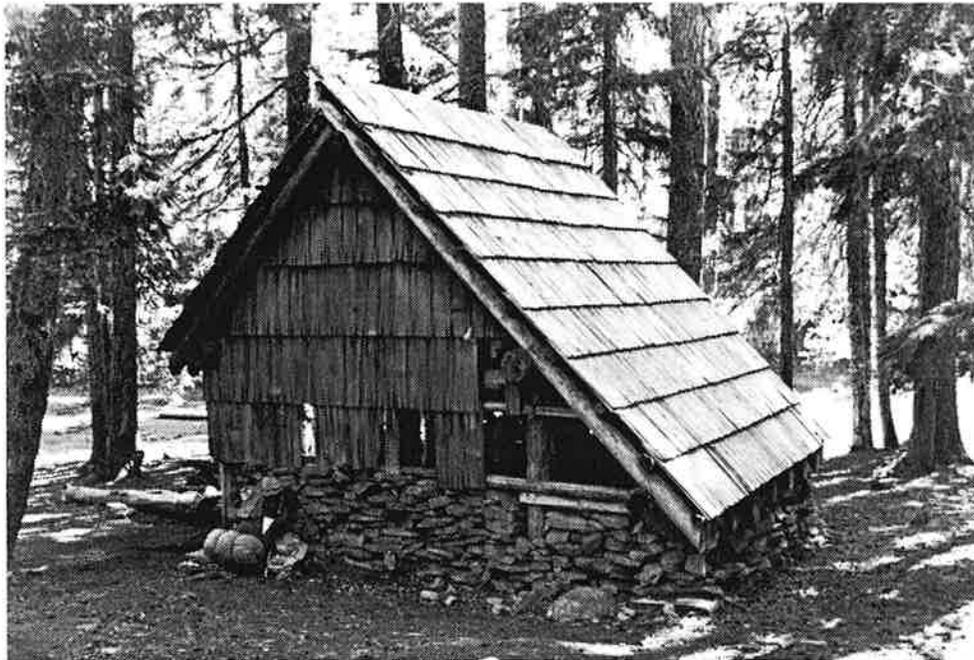
Cliff Lake Trail Shelter
East and North Elevations

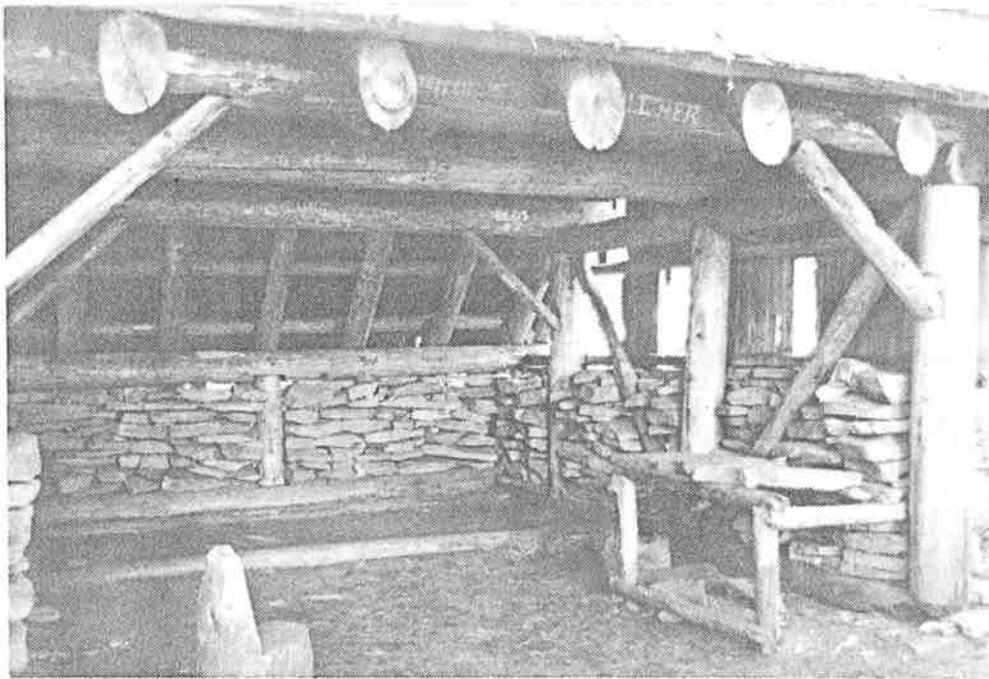
Cliff Lake Trail Shelter
Interior View

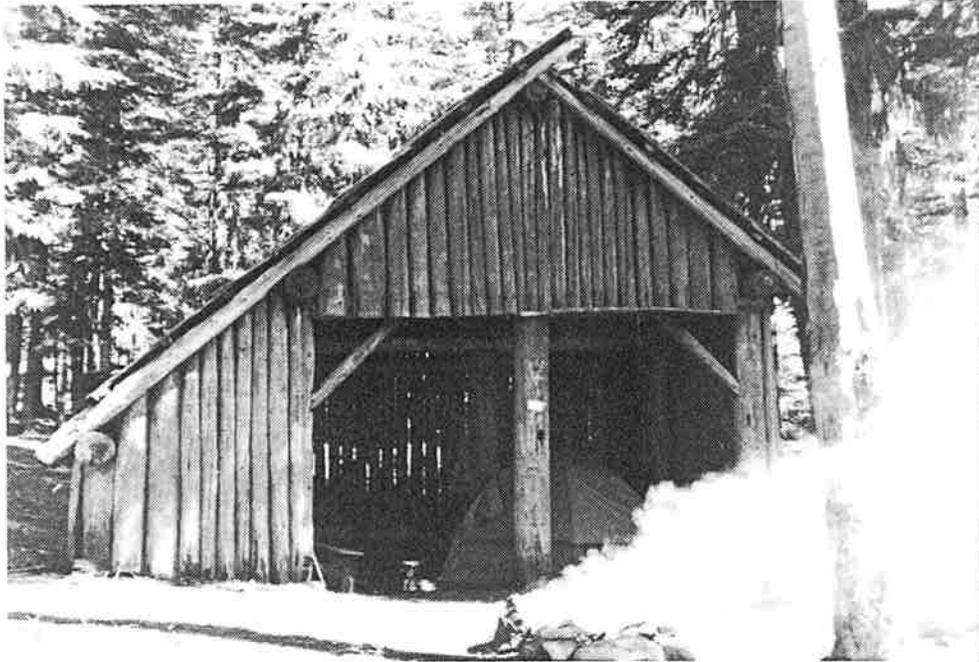
The overall condition of the shelter is good. While some deterioration has occurred, the structural elements are sound. An exception is the central post supporting the king truss which is sound but no longer bears any weight. There is significant decay in the ends of 3 rafters at the northwest corner of the shelter where roof shakes have been removed. The lower foot of the log siding has moderate to severe decay, the result of a buildup of soil and organic debris. A number of roof shakes have been removed from the northwest corner. The remaining shakes are in an advanced stage of decay.

Mink Lake Trail Shelter
South Elevation

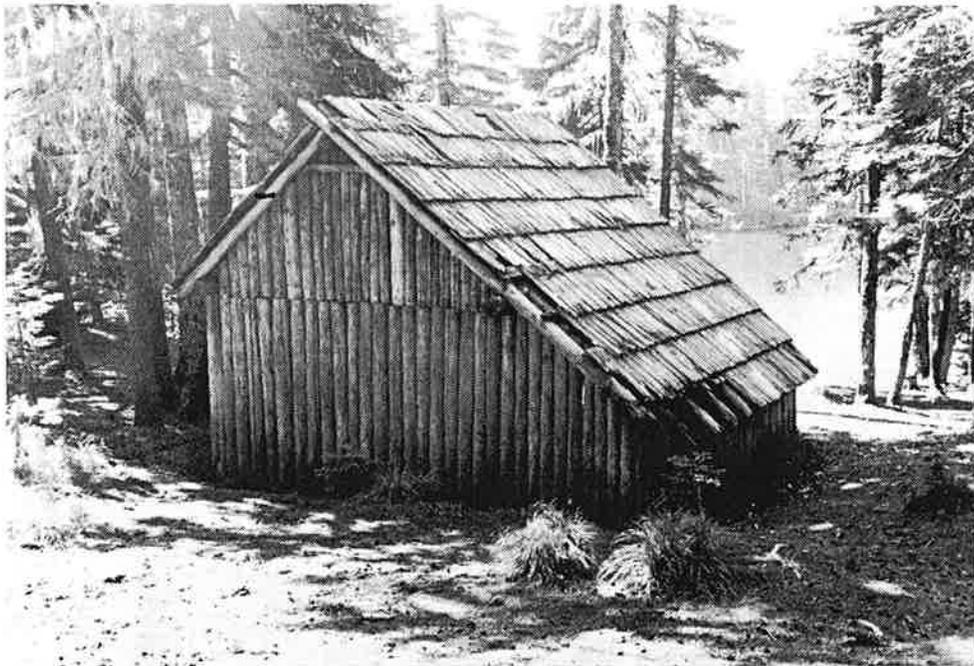
shakes. The bottom rows of shakes above the west elevation have been carved with dates and the names of visitors to the shelter. The rustic table, toilet, and garbage pit which were part of the original development at the shelter site (USDA-FS, 1935a:14) are no longer present.

Mink Lake Trail Shelter
North and West Elevations

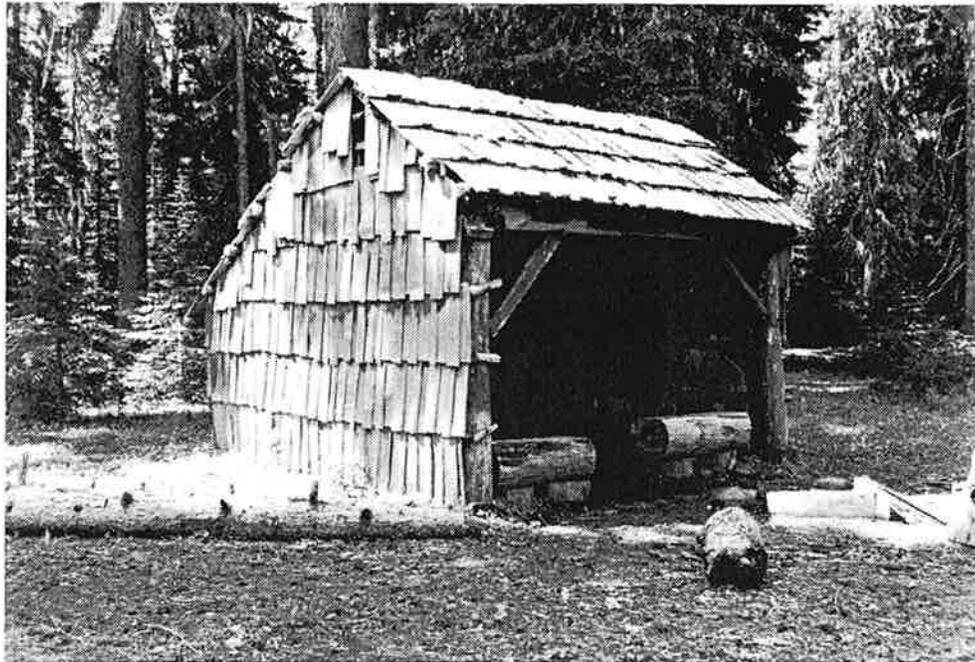
The shelter is in good condition. The only deterioration noted is in the sill logs and post in the southeast corner. The walls and roof have been reshaked using 24" shakes which are split on one side and sawn on the other. They were applied with the split side exposed. Additional dimension lumber nailers have

This is the only Adirondack style shelter on the Forest that does not have the roof comb shown in all of the trail shelter designs approved by the Regional Office. However, it is likely that this shelter also had a comb and that it was removed when it was reshaked.

South Waldo Trail Shelter
East and North Elevations

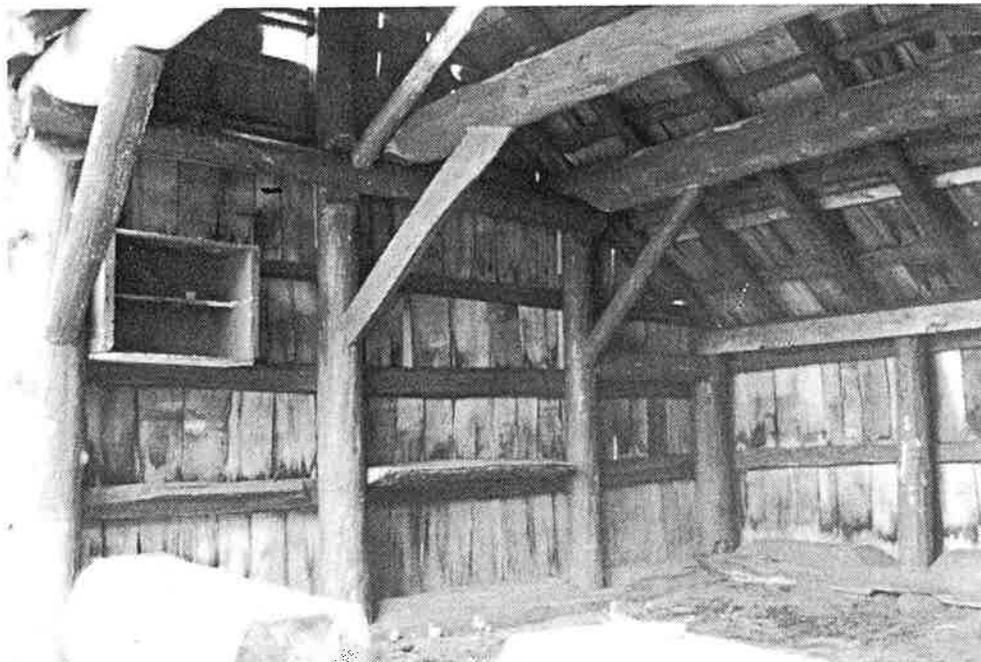
South Waldo Trail Shelter
Interior Showing East Wall Framing

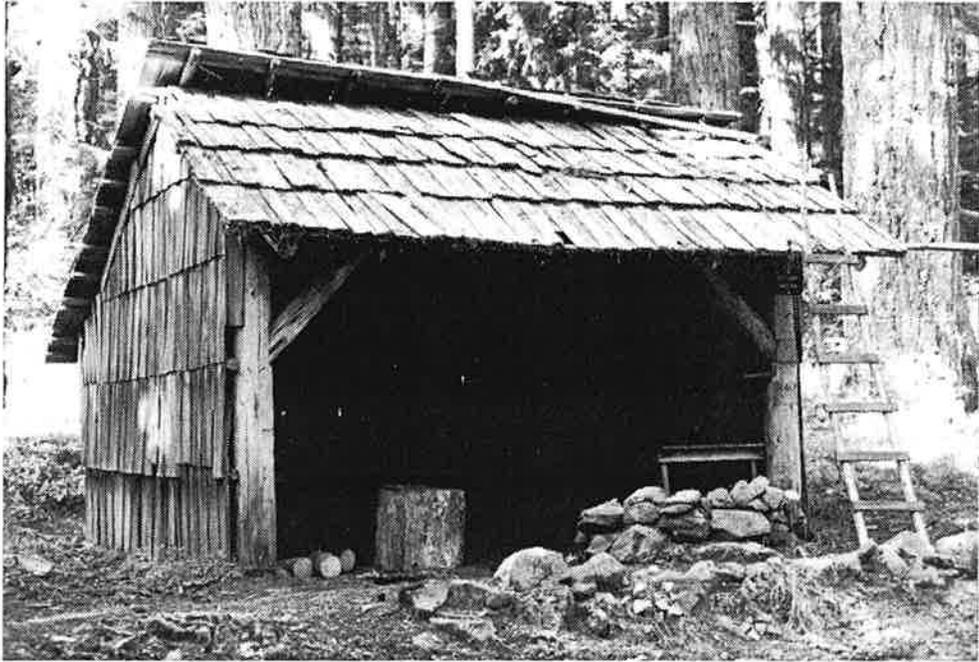
The shelter is in good condition. The framing elements are generally sound as are the wall and roof shakes. Noticeable decay is present in the rafter ends at the north end of the comb. The roof was reshakes in-kind about 15 years ago (Helen Smith, personal communication, 4-29-88).

Elk Camp Trail Shelter
East and South Elevations

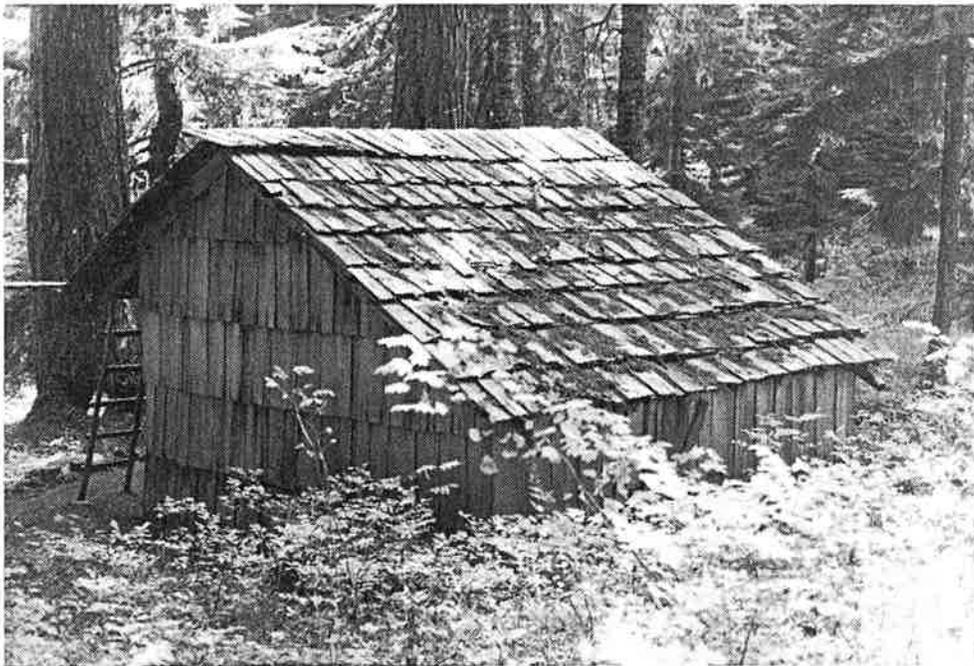
Elk Camp Trail Shelter
North and West Elevations

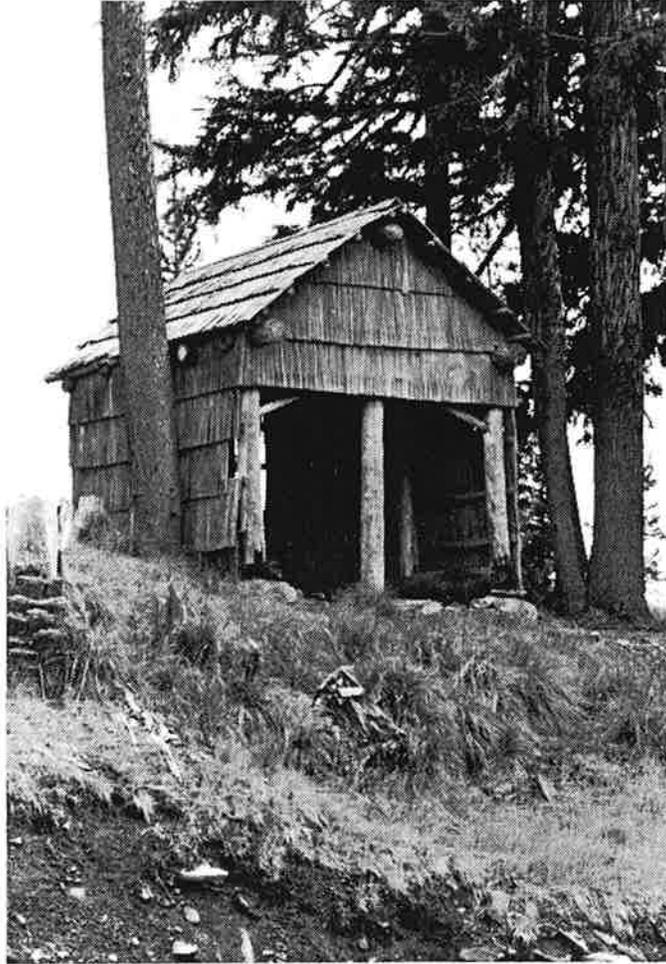
The shelter is currently in excellent condition. The log frame is sound, primarily due to the rock piers which keep it out of contact with the ground. There are two areas on the rear wall where shakes are missing although these may have been left open intentionally to serve as windows.

Mule Mountain Barn
West and North Elevations

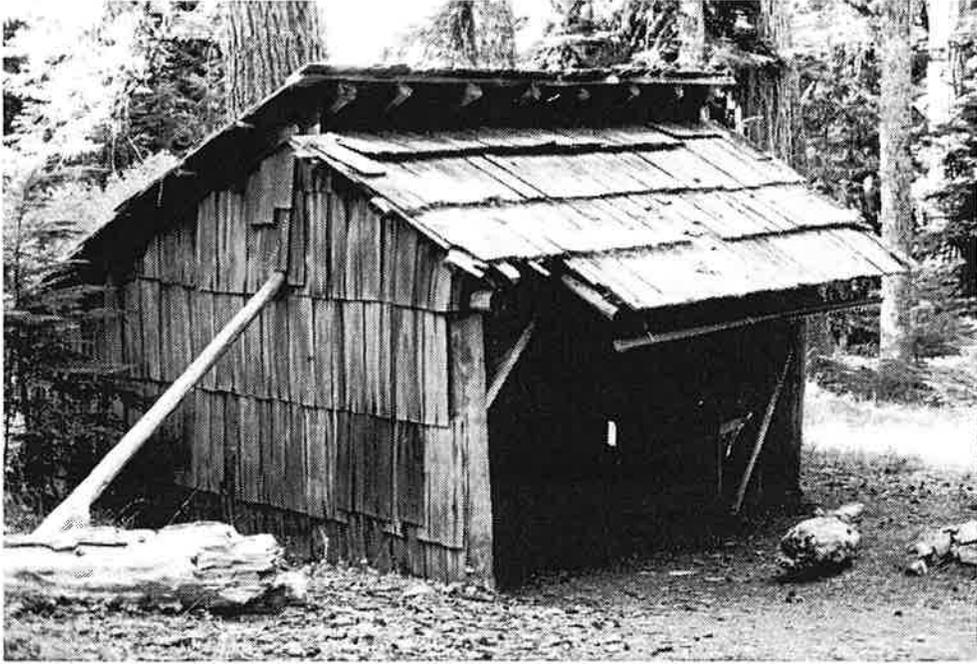
The shelter is in fair condition. The sill logs, especially near the open front, are decaying. A pole four inches in diameter, one end set in the ground and the other against the rafter plate support, has been added as support. Another similar brace has been added to support the corner post at the west

front of the shelter. The lower end of the rafter at the eastern front of the shelter is gone. Some of the shakes on the side walls have been replaced with shorter shakes in an uneven manner. A section of plastic rain gutter is suspended by wire under the eave overhanging the open front.

Little Blanket Trail Shelter
East and North Elevations

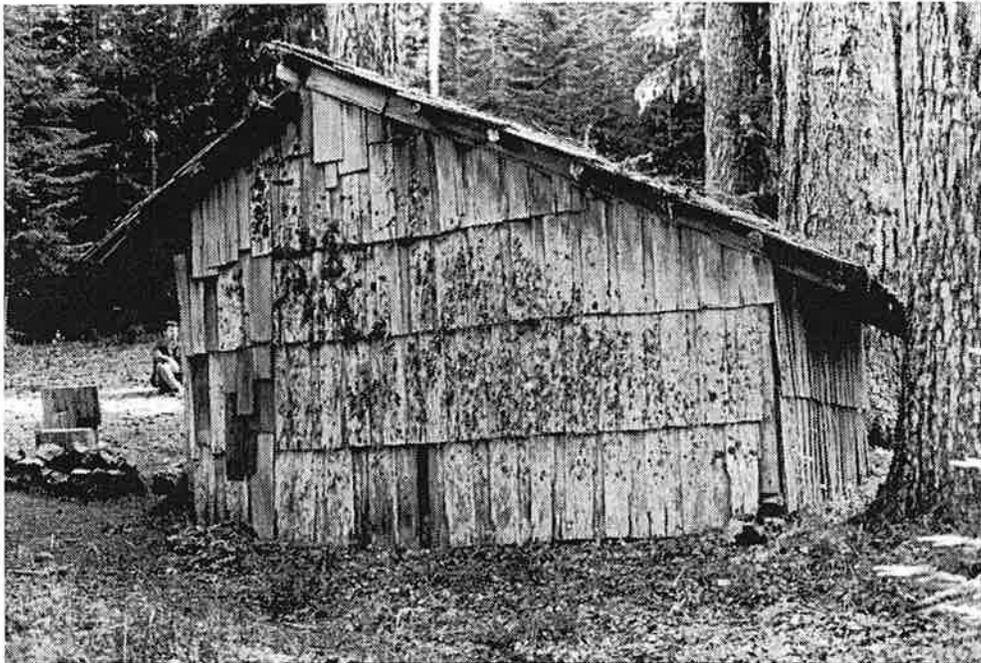
Little Blanket Trail Shelter
West and South Elevations

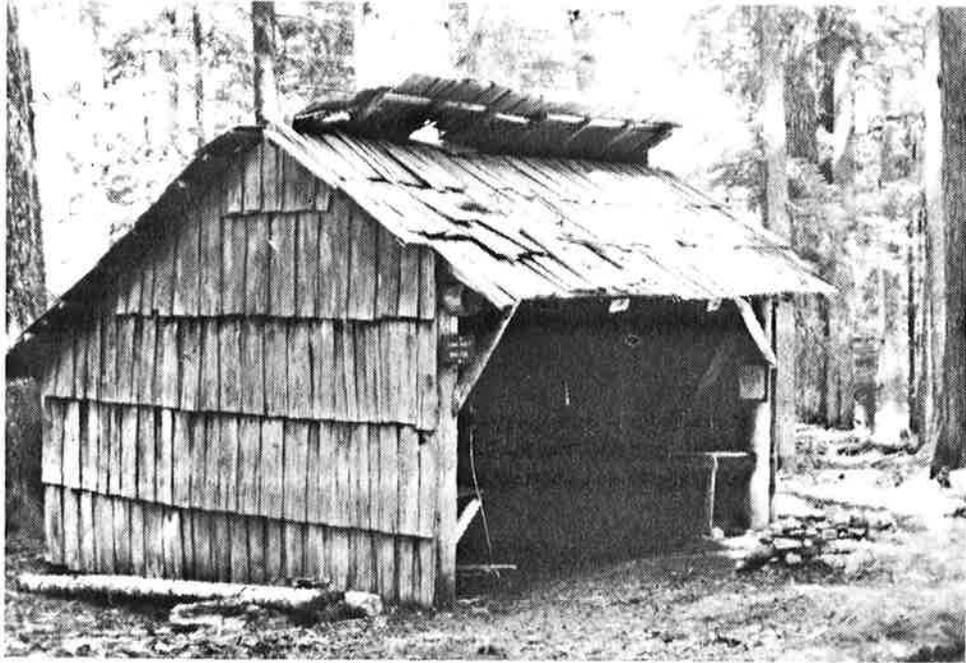
The shelter is currently in good condition. The only decay noted was in the rafter ends and a slight amount in the sill logs. The shakes on the rear slope have been replaced in-kind (Helen Smith, personal communication, 4-29-88).

Lone Wolf Trail Shelter
South and West Elevations
