HISTORIC TRAIL SHELTERS
OF THE
WILLAMETTE NATIONAL FOREST
An Inventory and Determination of Eligibility

Addendum to
Historic Trail Shelters
Of the
Willamette National Forest

A Determination of Eligibility
To the
National Register of Historic Places
For
Ash Swale Shelter

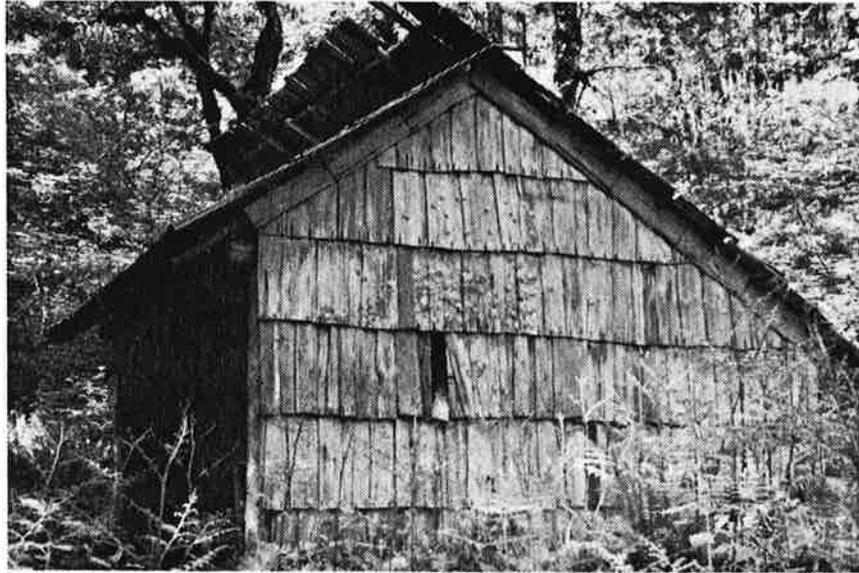
The shelter is in fair condition. A significant amount of decay has occurred. Eight feet of the sill log on the western side near the front is completely gone and the remainder is badly decayed. The lower 12-18" of the posts which were originally supported by this sill are also decayed and the two nearest the front of the shelter rest on the ground. The rear sill log is badly decayed along its western half. The bottom half of the eastern sill log is completely decayed.

The shakes on the front slope of the roof have been replaced. The replacements are the same length as the original shakes but have split faces and sawn backs. Other shakes have been replaced on all elevations using shakes similar to those on the roof.

Ash Swale Trail Shelter
East Elevation
