Mapleton Ranger Station

Mitigation Documentation
prepared for the
USDA Forest Service, Siuslaw National Forest

April 2012

Site and Architectural Description

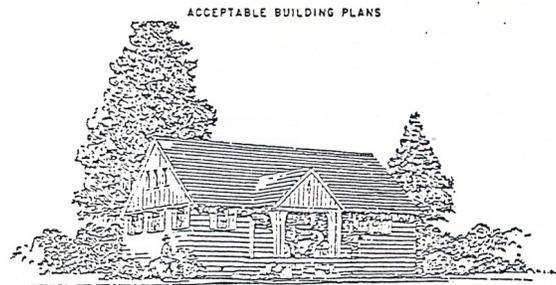
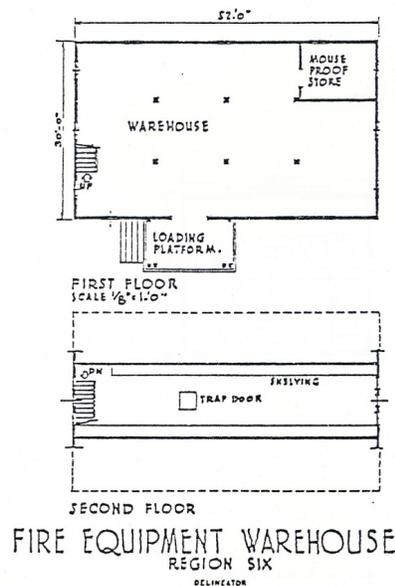
PLAN NO 623.

Plan Number 623 for a Fire Equipment Warehouse from United States Forest Service
Acceptable Plans Forest Service Administrative Buildings, 1938.

Beyond overall site planning, the Forest Service also had specifications for design of individual buildings. In 1938 they issued a manual entitled *Acceptable Plans Forest Service Administrative Buildings* that gave guidelines for construction of all building types, including residences, offices and gas and oil houses. These standard plans were based on functionality, circulation, ventilation and lighting, and most had a rectangular, "T," "L," "U," or "H," plan. Consistency and cohesion were achieved through uniform roof shapes, repetition of materials, subtle decoration and integrated covered entrances.⁴² These features characterized many buildings throughout Region 6 such as Zigzag Ranger Station on the Mt. Hood National Forest. While the Mapleton Ranger Station was constructed prior to the publication of this document, it was no doubt influenced by these same principles.⁴³ The Fire-Cache Warehouse is a close representation of the Fire Equipment Warehouse illustration from this manual.

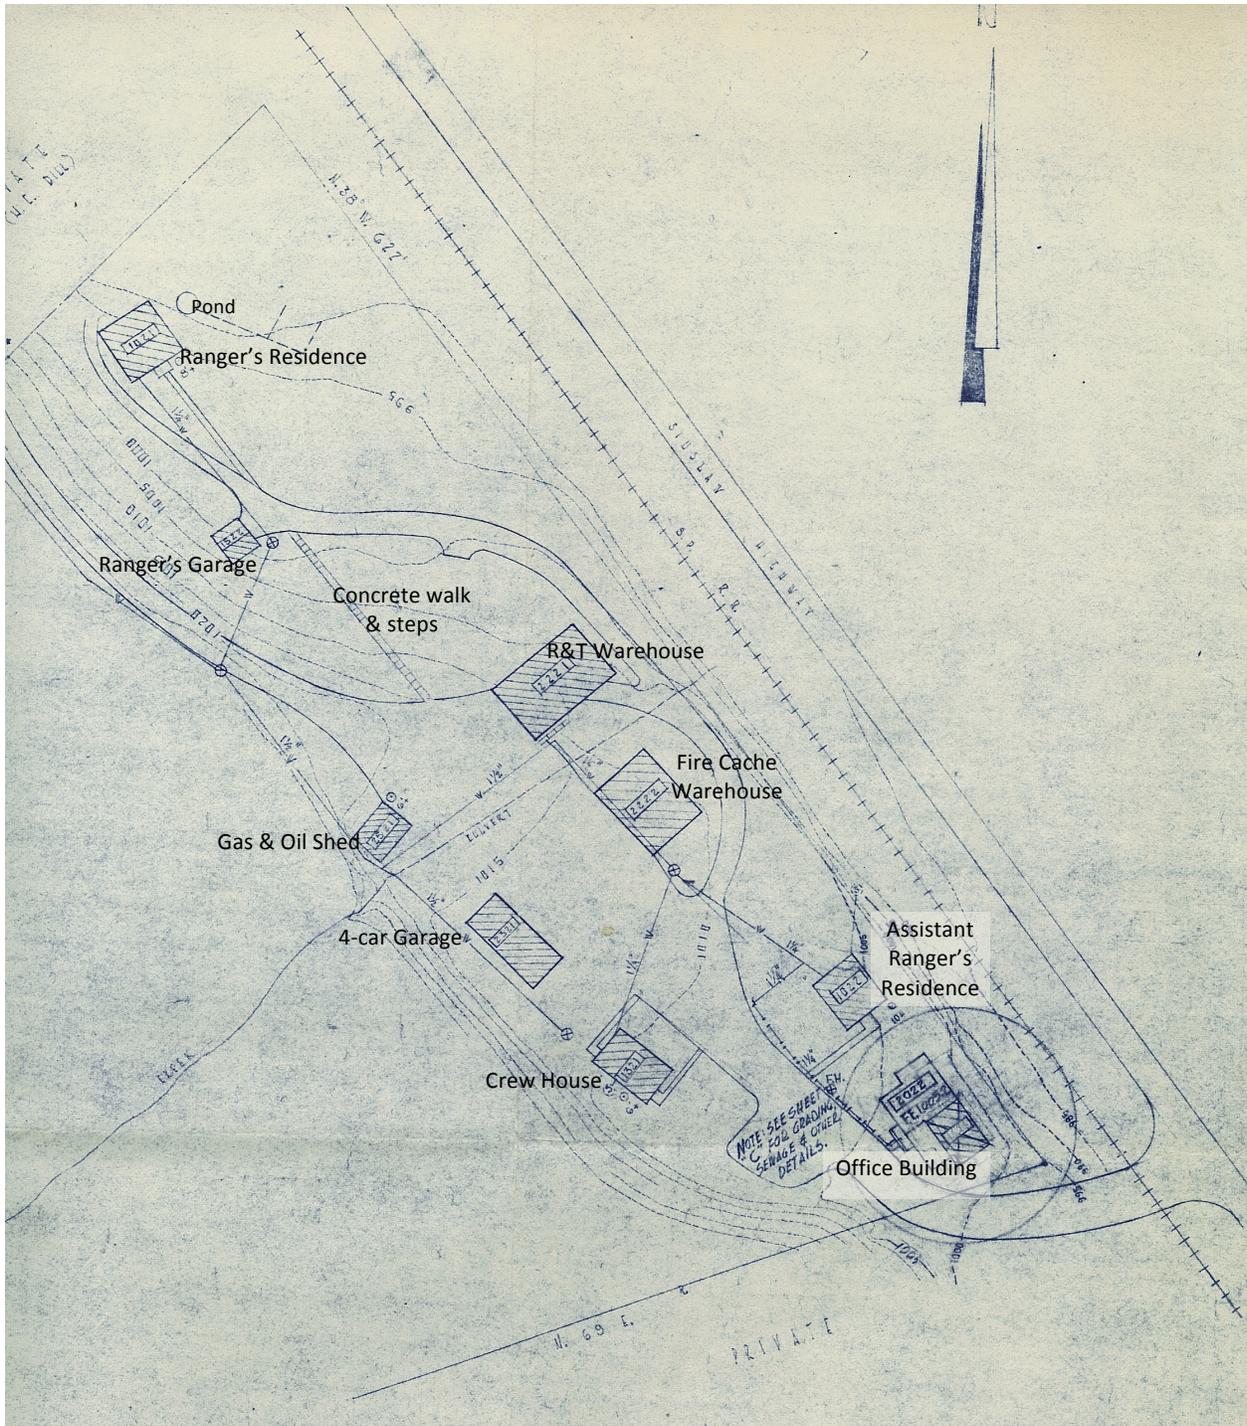
Figure 3. Site plan of Mapleton Ranger Station, 1958.

Near the house to the southwest is the raised poured concrete foundation that is all that remains of the wood framed garage. Adjacent to the concrete path leading to the house from the compound is a stone bench built by the Civilian Conservation Corps crew. (Fig. 11) The surrounding yard today consists of some terracing planted with grass and shrubs; historically the yard to the east of the house included a designed garden with a pond and fountain that was fed by a ditch that apparently channeled water from the steep wooded hillside to the west. (Figs. 3, 10)

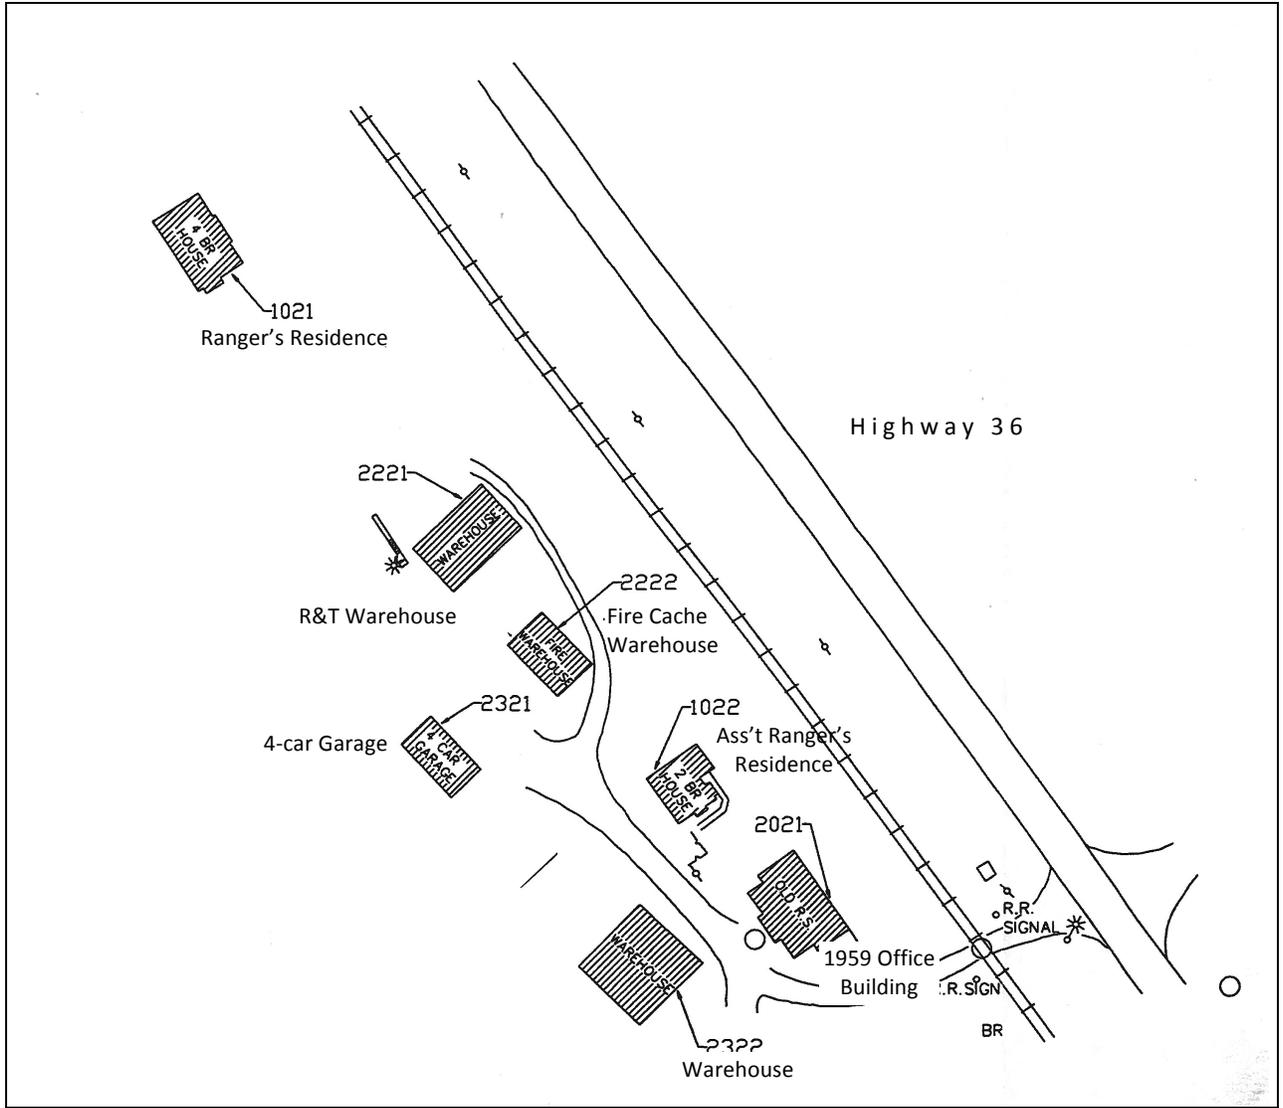
Figure 4. Site plan of Mapleton Ranger Station, 1989 updated 2012.

The buildings are organized in a linear pattern on either side of a paved central drive that runs parallel to Highway 36 in a southeasterly to northwesterly direction for about 200 feet. (Figs. 4-7) A secondary gravel drive loops down slope from the main drive to provide access to the rear (east) of the Recreation & Trails (R&T) Warehouse building (#2221), and extends north to the Ranger's Residence.

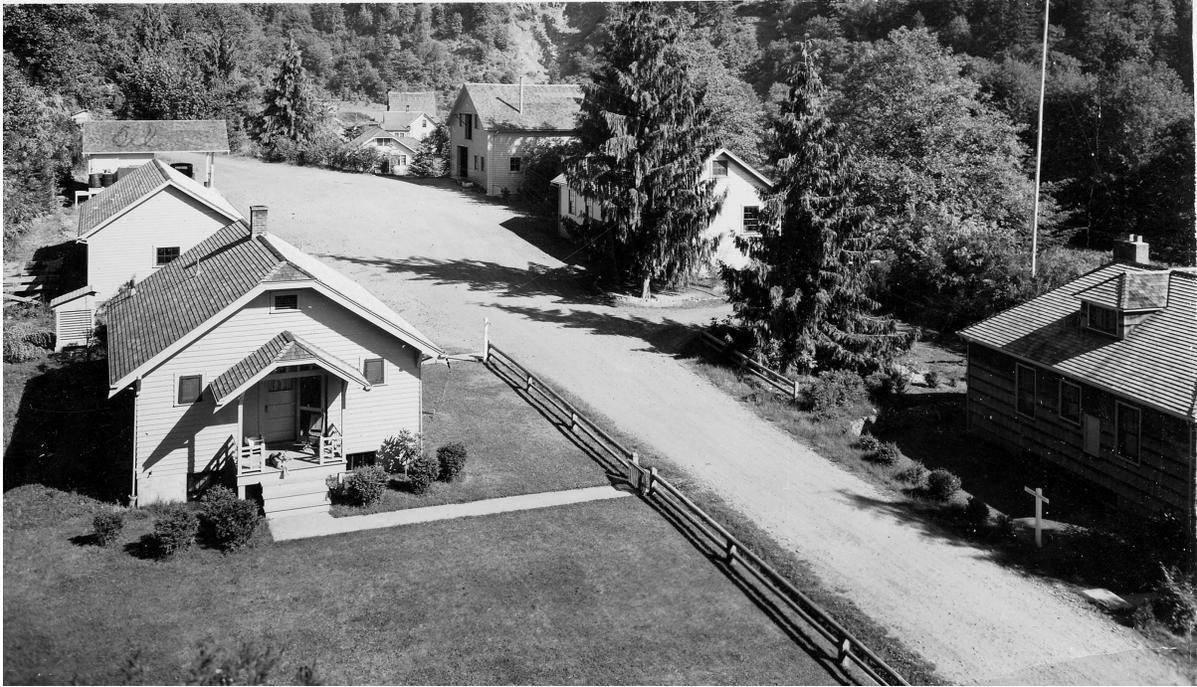
Figure 5. Historic view of Ranger Station Complex looking north, no date.
Buildings to left of drive, front to back: Bunkhouse, Garage, Gas/Oil House.
Buildings to right of drive, front to back: Assistant Ranger's Residence, Fire Cache Warehouse, R&T Warehouse.
Far background: Ranger's Residence.

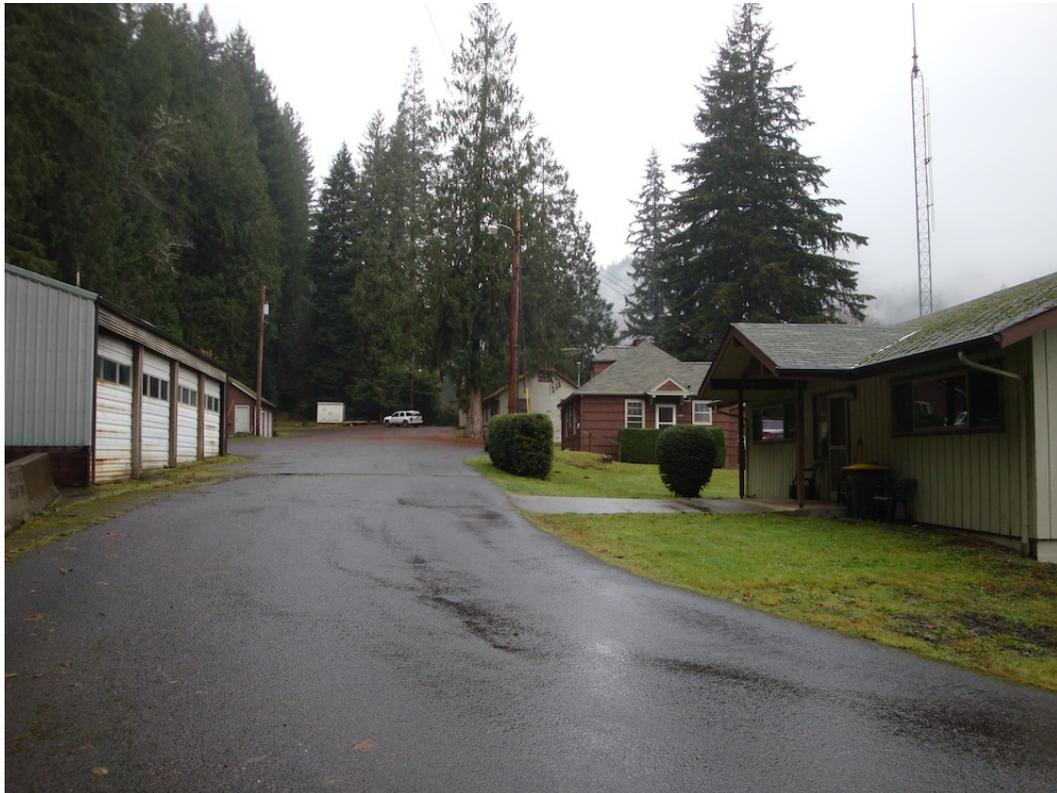
Figure 6. View looking north/northwest from entrance drive and Office Building (on right).

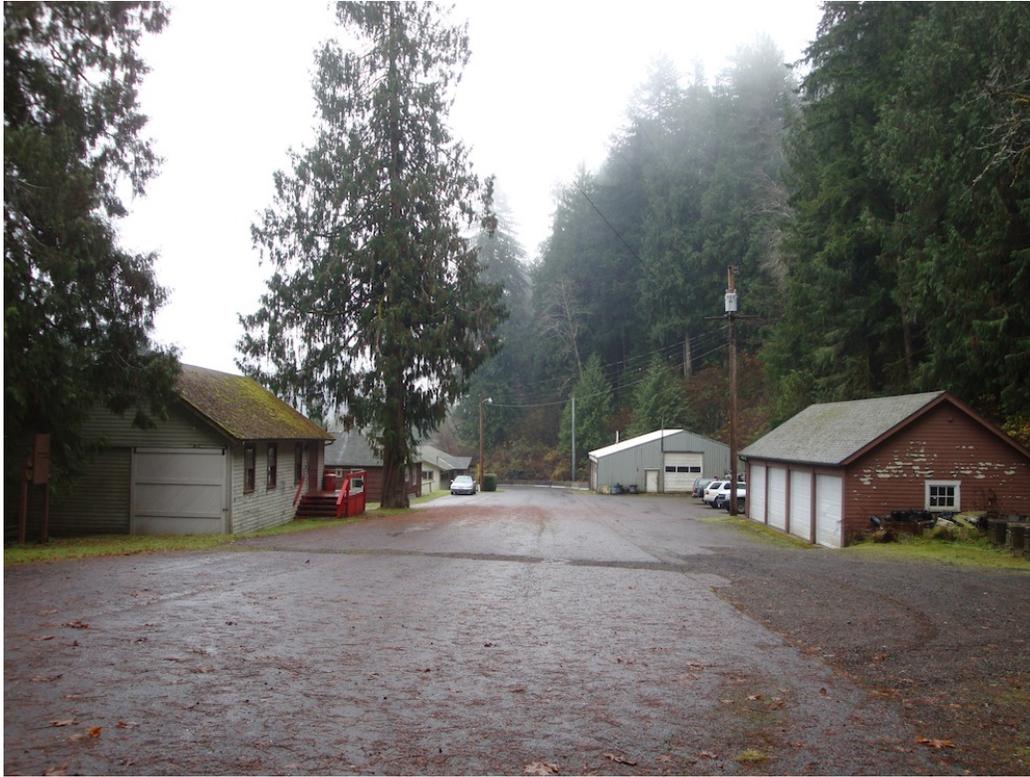
Figure 7. View looking south from R & T Warehouse.

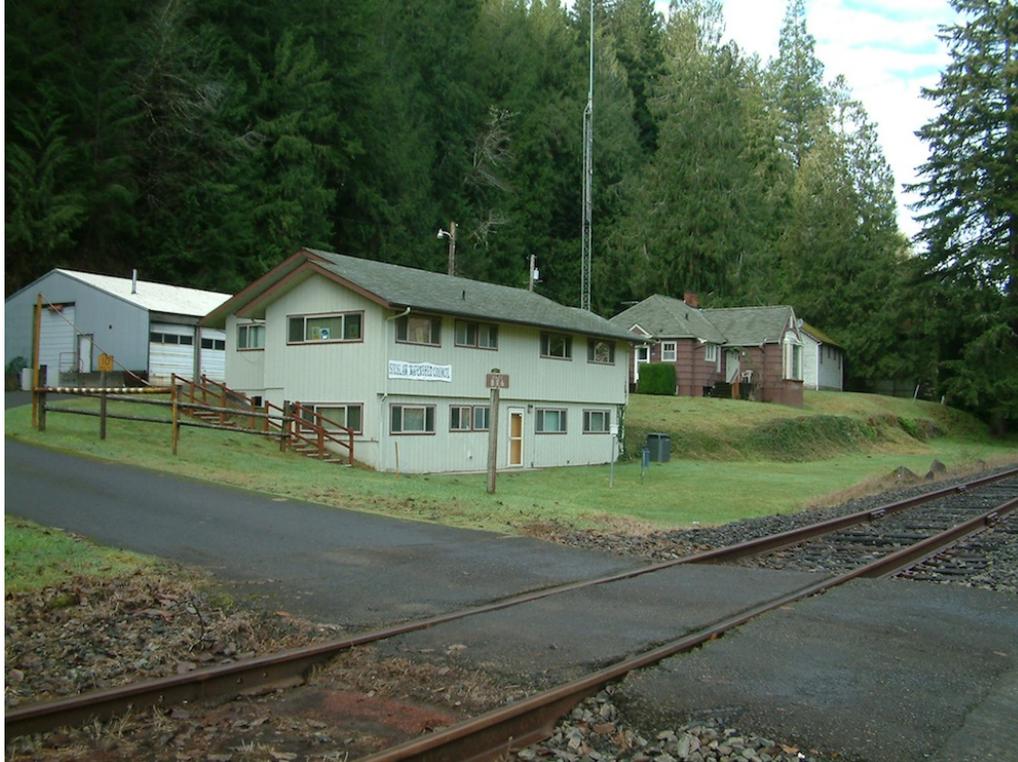
Figure 8. View looking north/northwest from driveway entrance at railroad right-of-way.

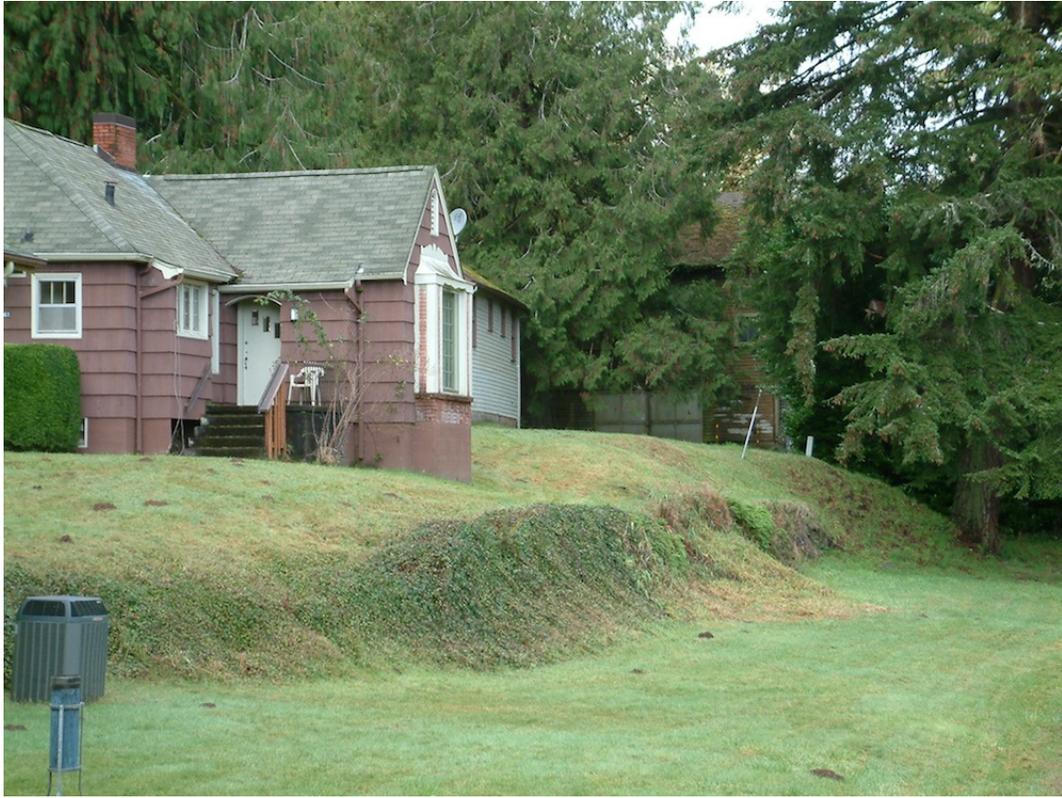
Figure 9. View looking north/northwest at overgrown stone retaining wall system.

The grouping is situated on what appears to be a man-made terrace with steep forested slopes to the west; slopes in the immediate vicinity vary from 5-40 percent.¹ Overgrown, variable-height, rubble stone retaining walls built by the Civilian Conservation Corps are extant along the eastern alignment of the property, between the railroad line and the eastern side of the tract of buildings. (Figs.1-4) Although surrounded by forest, the compound itself originally had a landscape plan, of which a number of features remain visible. In addition to the stone retaining walls, a stone bench in front of the Ranger's Residence, introduced plantings (maples, conifers and shrubbery) and much of the circulation system (roads and sidewalks) are extant.

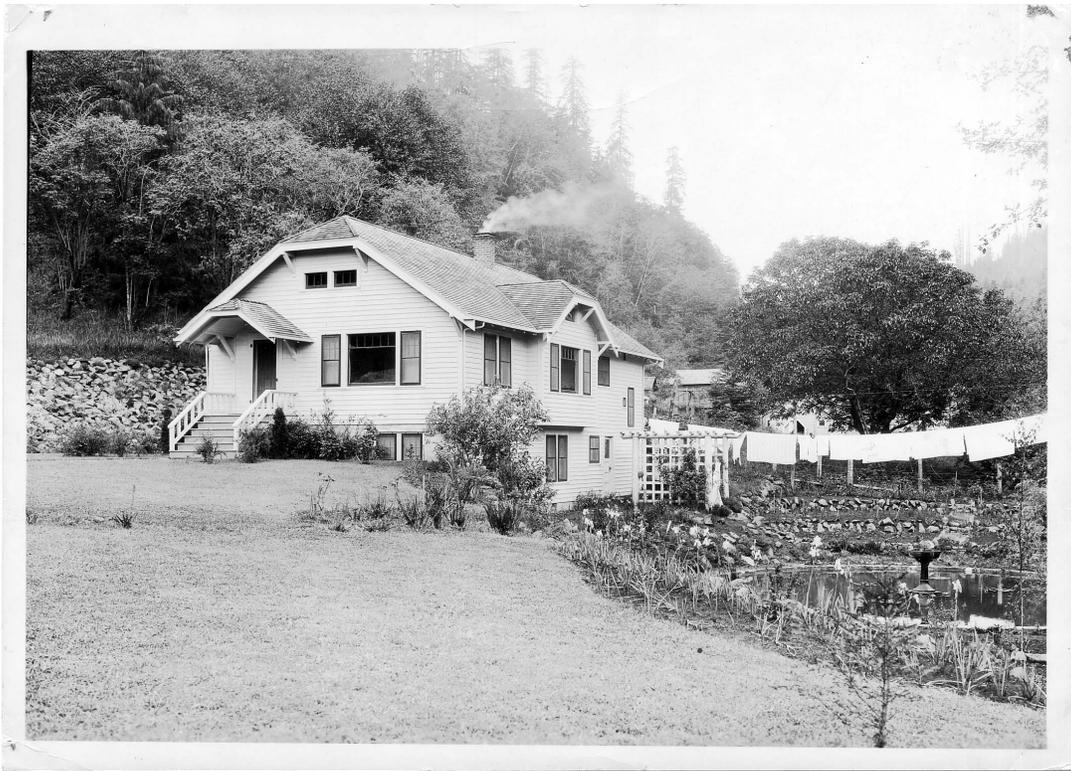
Figure 10. View looking north/northwest at designed landscape and yard of Ranger's Residence, 1936.

The original pond and fountain located to the east of the Ranger's Residence (Fig. 10), a grand landscape feature that appeared somewhat out of place in a Pacific Northwest forest setting, has been removed and filled in, leaving little to remind observers of its existence.

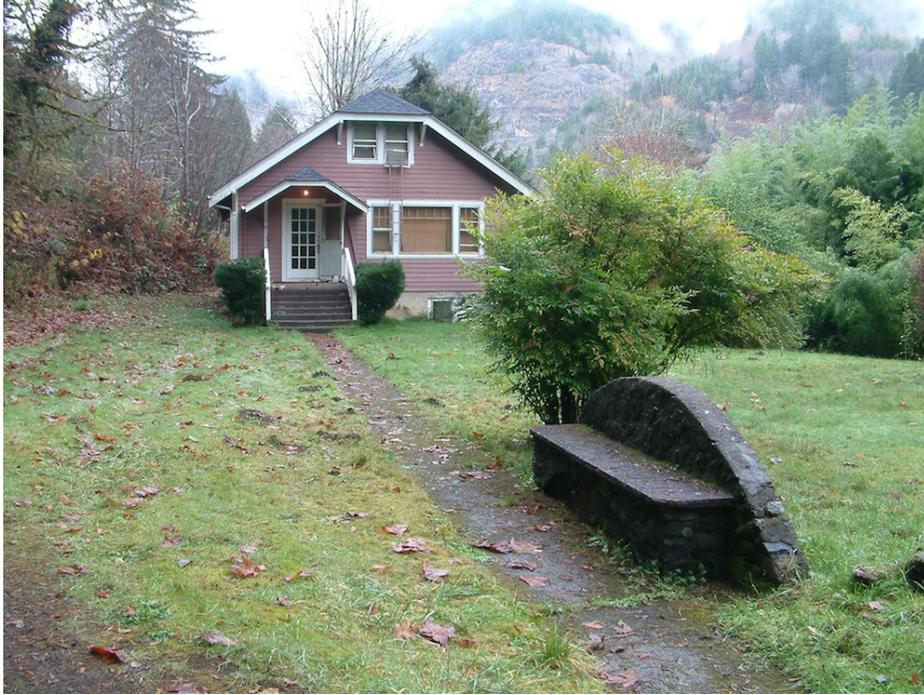
Figure 11. View looking north/northwest at Ranger's Residence yard and stone bench, 2012.

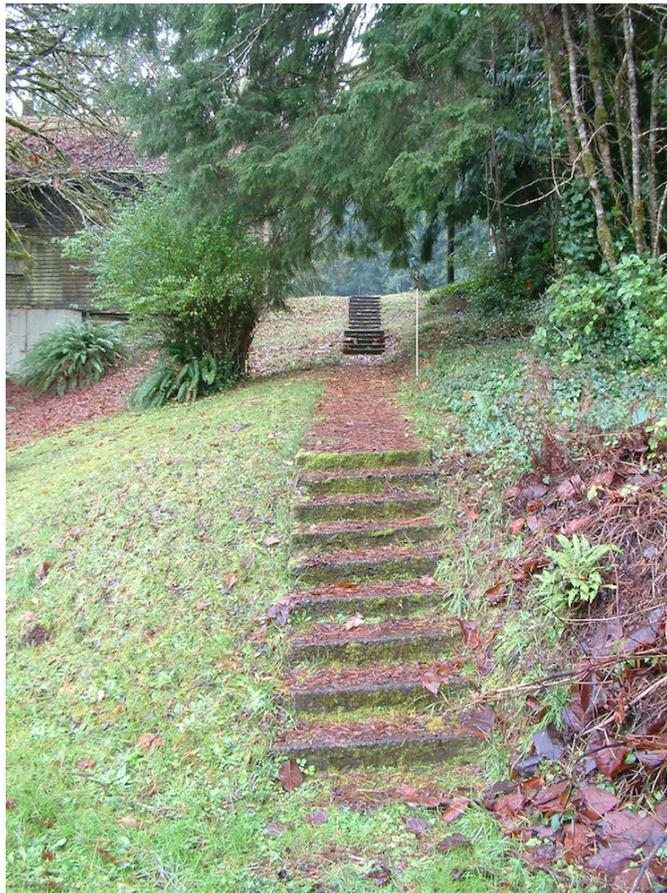
Figure 12. View looking southward at concrete steps and walk from Ranger's Residence to rest of compound

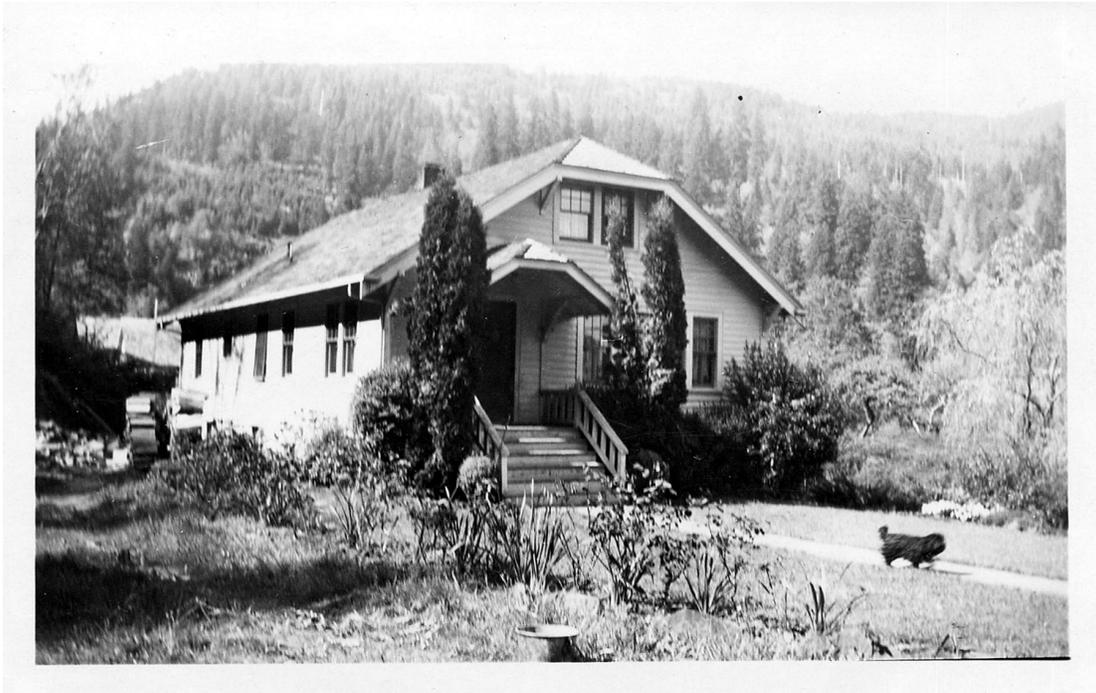
Figure 13. Ranger's Residence, circa 1936.

This one-and-a-half story, gable-front house is rectangular in plan, resting on an elevated continuous poured concrete foundation. Since the site is sloped, the basement is fully day-lit on the east (down slope) side, and displays wood sash basement windows on the west (upslope) side. The wood stud wall construction is clad in clapboard siding from foundation to eaves. The primary window type is six-over-six double hung wood sash of various sizes, arranged in singles and pairs in an irregular fenestration pattern. Two large picture windows consisting of a large multi-paned central window flanked by six-

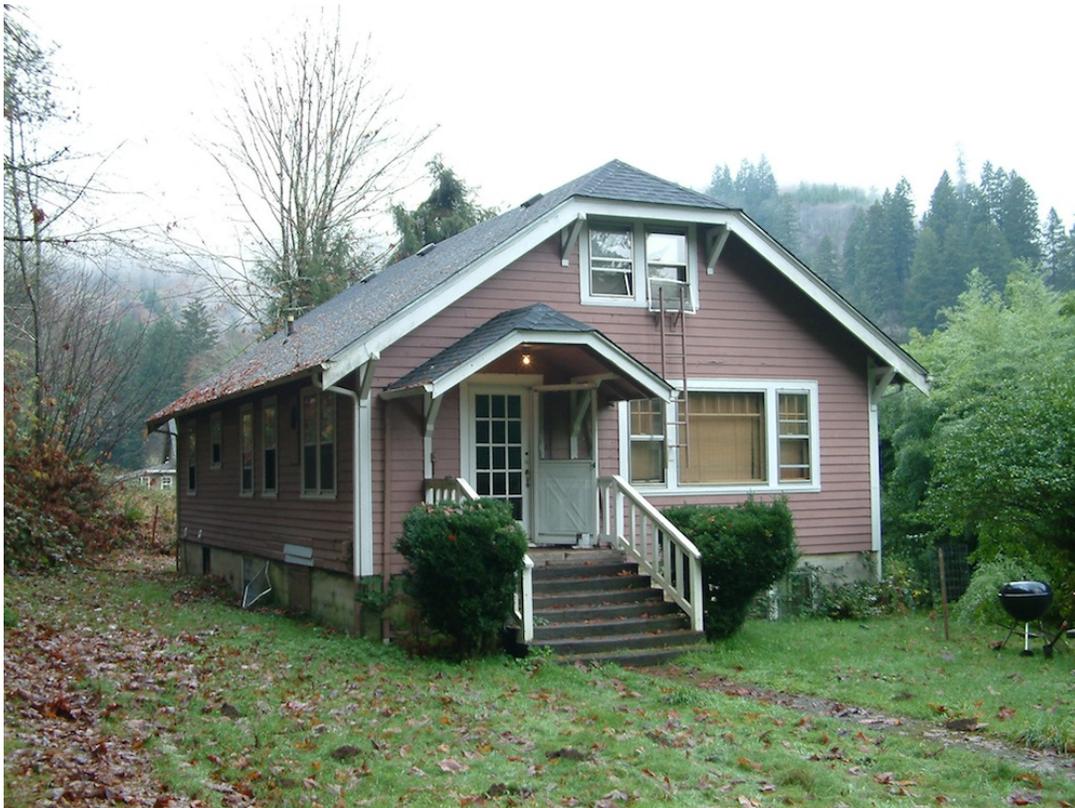
Figure 14. Ranger's Residence, front (south) elevation, 2012.

over-six double hung sash are located on the south (front) and east (side) elevations. The jerkinhead roof has broad overhanging open eaves with knee-brackets typical of the bungalow/ Craftsman tradition, as well as a simple vergeboard with cornice moulding.

The front door, placed on the western side of the south elevation, is elevated above grade approximately three feet, and is marked by a 15-light wood front door, a stoop porch and a wide stairway approach. The porch roof displays the same jerkinhead roof and bracket details as the main volume of the house. On the east side elevation an oriel window (in the dining room) projects approximately 18" from the main wall, and also has an intersecting jerkinhead roof, broad eaves and decorative brackets as found on the main volume of the building. The only other projection from the main rectangular volume is a small back stoop, which provides access to the basement and the kitchen from the north (rear) elevation of the residence.

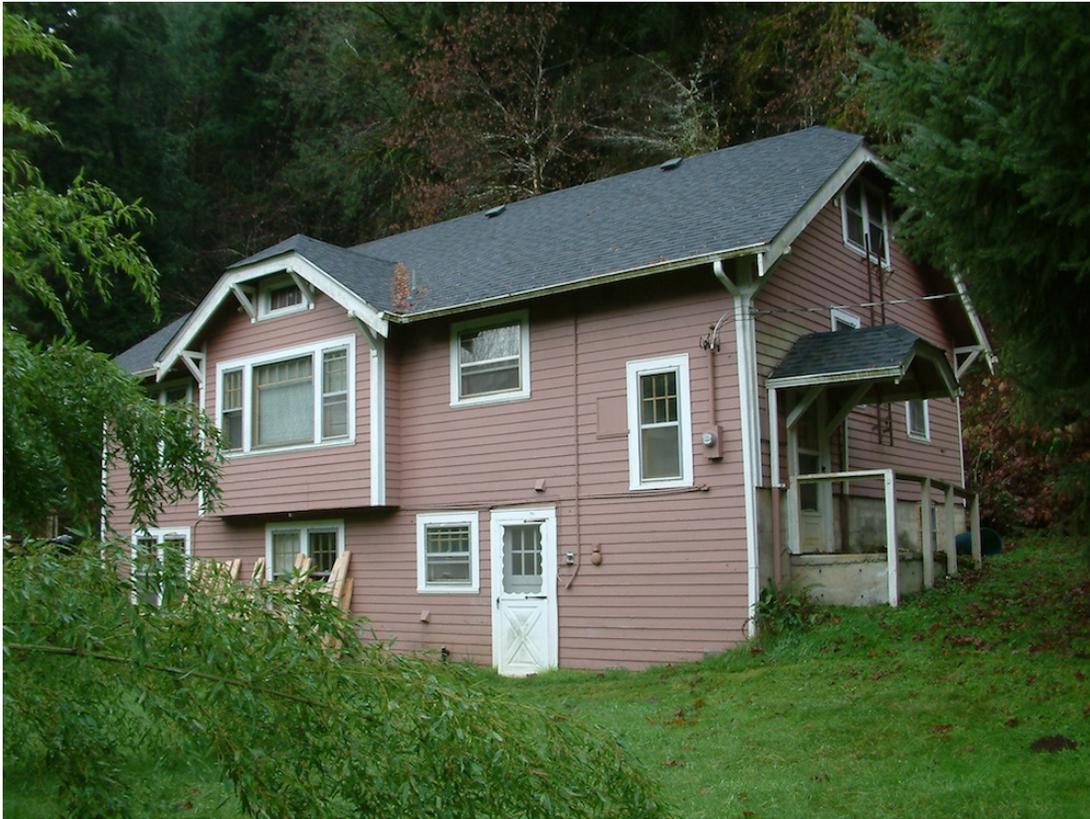
Figure 15. Ranger's Residence, east (side) and north (rear) elevations, 2012.

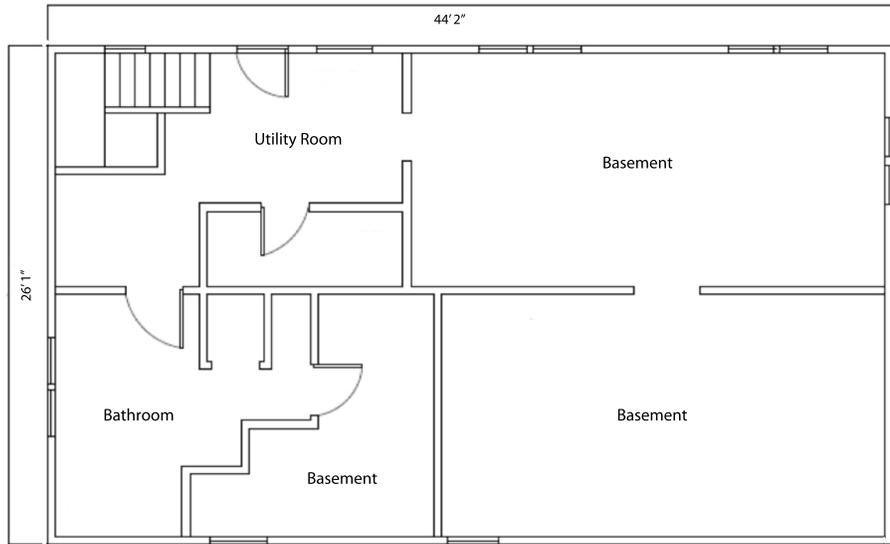
Mapleton Ranger Station, Siuslaw National Forest
 Mapleton, Lane County, Oregon
 Ranger's House
 Basement Floor

Figure 18. Ranger's Residence, basement plan.

The main level plan contains the living room, dining room, kitchen, and two bedrooms separated by a bathroom. A centrally-located stair provides access to the finished attic, comprised of a stair and hallway, with a bedroom at either end (north and south). The basement is large, roughly divided longitudinally (with a main north-south wall) and includes a large crew shower room and two large, open undefined spaces. (Figs.18-20)

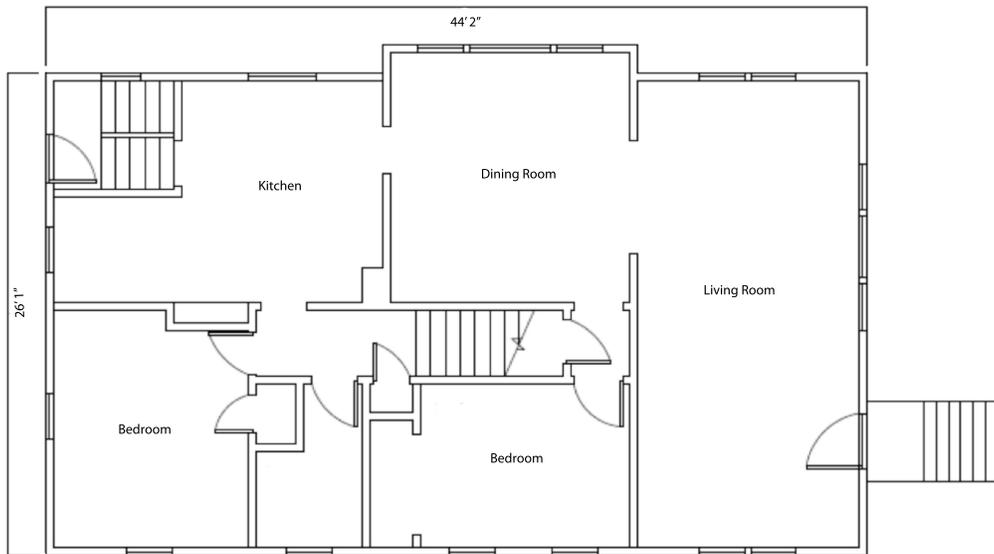
Mapleton Ranger Station, Siuslaw National Forest
 Mapleton, Lane County, Oregon
 Ranger's House
 Main Floor

Figure 19. Ranger's Residence, main floor plan.

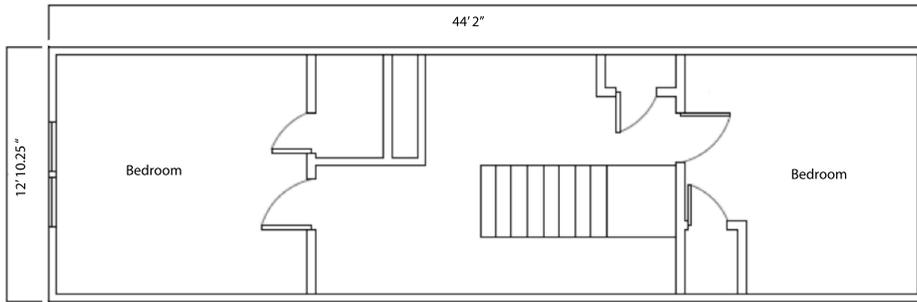
Mapleton Ranger Station, Siuslaw National Forest
Mapleton, Lane County, Oregon
Ranger's House
Second Floor

Figure 20. Ranger's Residence, attic plan.

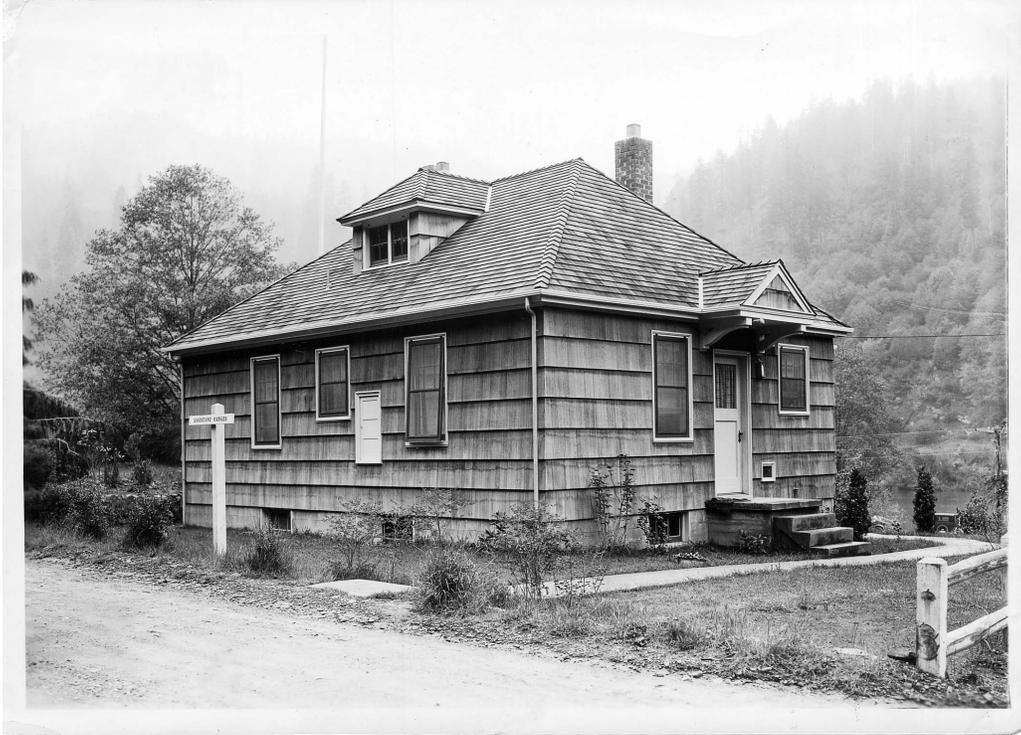
Figure 21. Assistant Ranger's Residence, 1936.

The 1935 Assistant Ranger's Residence is located south of the Fire Warehouse Building on the east side of the central drive, fronting south. (Figs. 21-25) The two-bedroom, cottage-style residence has an L-shaped plan with a continuous poured concrete foundation and full basement. Constructed with a wood stud wall system, the house has raked cedar shingle siding from foundation to eaves. The hip and gable roof has shallow closed eaves and one hipped dormer (on the west roof slope), all covered in asphalt composition shingles. A red brick chimney rises from the juncture of the hip and gable rooflines, near the center of the building. Fenestration is irregular and window types vary, including three-, six- and eight-over-one double hung wood sash and multi-paned casement wood sash with moulded board trim.

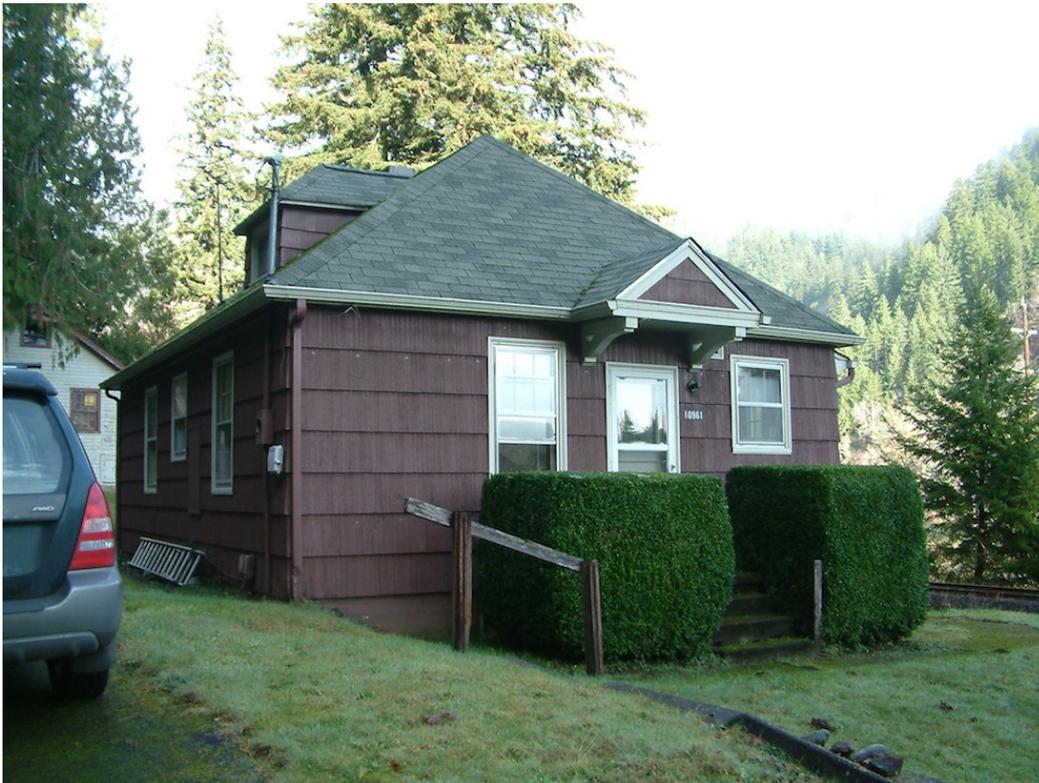
Figure 22. Assistant Ranger's Residence, 2012.

Alterations to the building are minimal, and appear to be limited to the installation of aluminum storm windows and replacement wooden porch railings. The Assistant Ranger's Residence has a high degree of integrity and is in good condition.

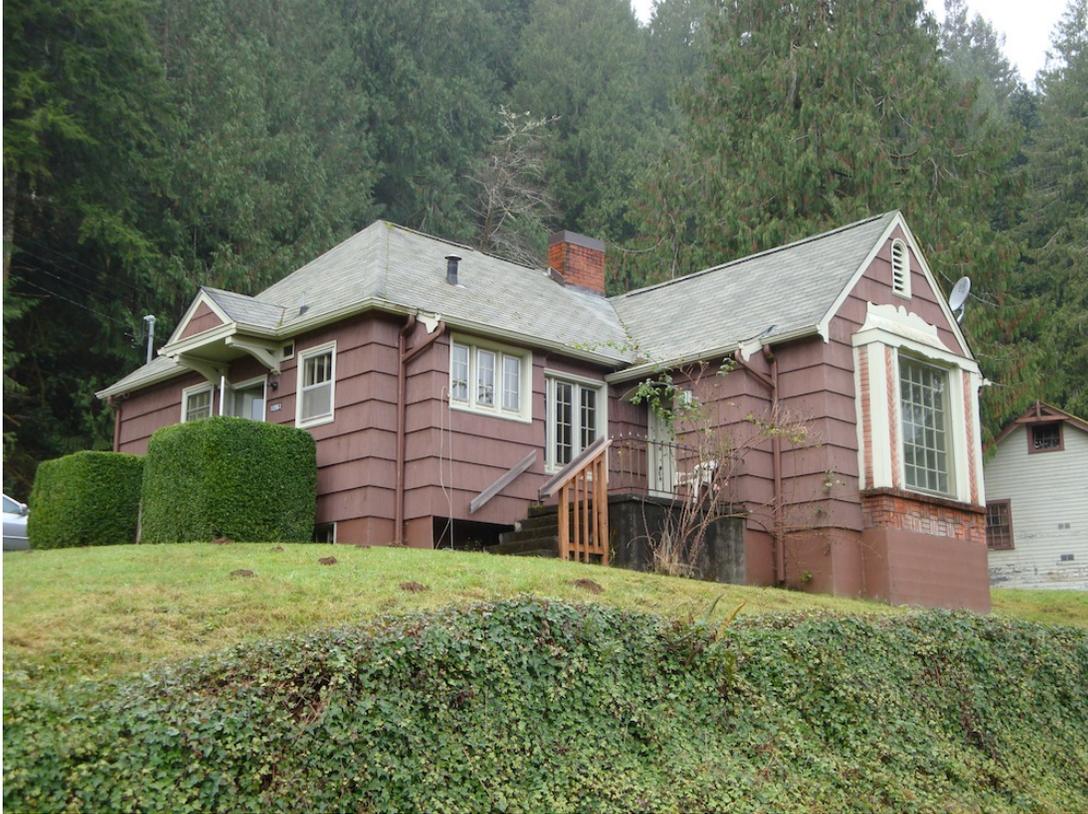
Figure 23. Assistant Ranger's Residence, south and east elevations, 2012.

The building has subtly applied architectural detailing, evident in the articulation around the two entrance doors on the south elevation, a simple oriel window and a shallow bay window on the east elevation. The main front door is slightly recessed into the crook of the L-shaped plan, facing south. A secondary "back" door, which is actually more prominently placed on the south elevation than the main entrance, provides access to the basement and the kitchen. This doorway is marked by a small

projecting gable stoop with curved support brackets. On the east elevation, a shallow projecting square bay indicates the kitchen. A slightly larger bay window in the living room is accented with red brick applied in herringbone and patchwork patterns, and has a large fixed, multi-paned wood picture window topped with a metal roof trimmed with scalloped wood boards.

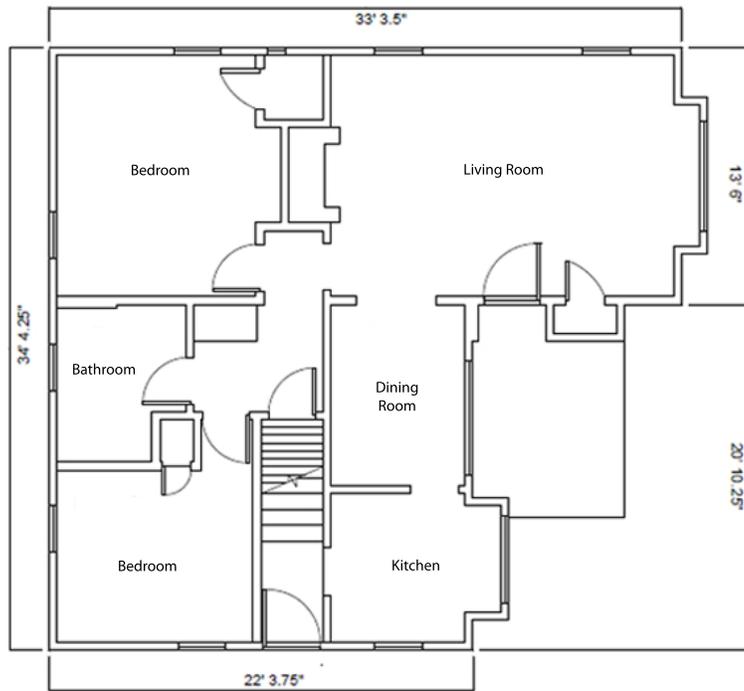
Mapleton Ranger Station, Siuslaw National Forest
 Mapleton, Lane County, Oregon
 Assistant Ranger's House
 Second Floor

Figure 26. Assistant Ranger's Residence, first floor plan.

The main floor interior encompasses a kitchen, dining area, living room with brick fireplace, two bedrooms and a bathroom. The attic is accessible via a staircase, but is unfinished. The full basement has a concrete slab floor, and houses the furnace. (Figs. 26, 27)

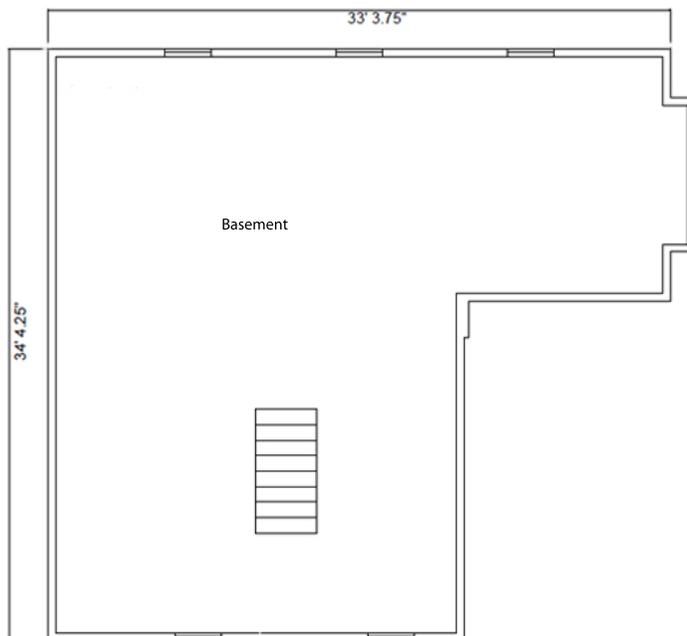
Mapleton Ranger Station, Siuslaw National Forest
 Mapleton, Lane County, Oregon
 Assistant Ranger's House
 Basement Floor

Figure 27. Assistant Ranger's Residence, basement plan.

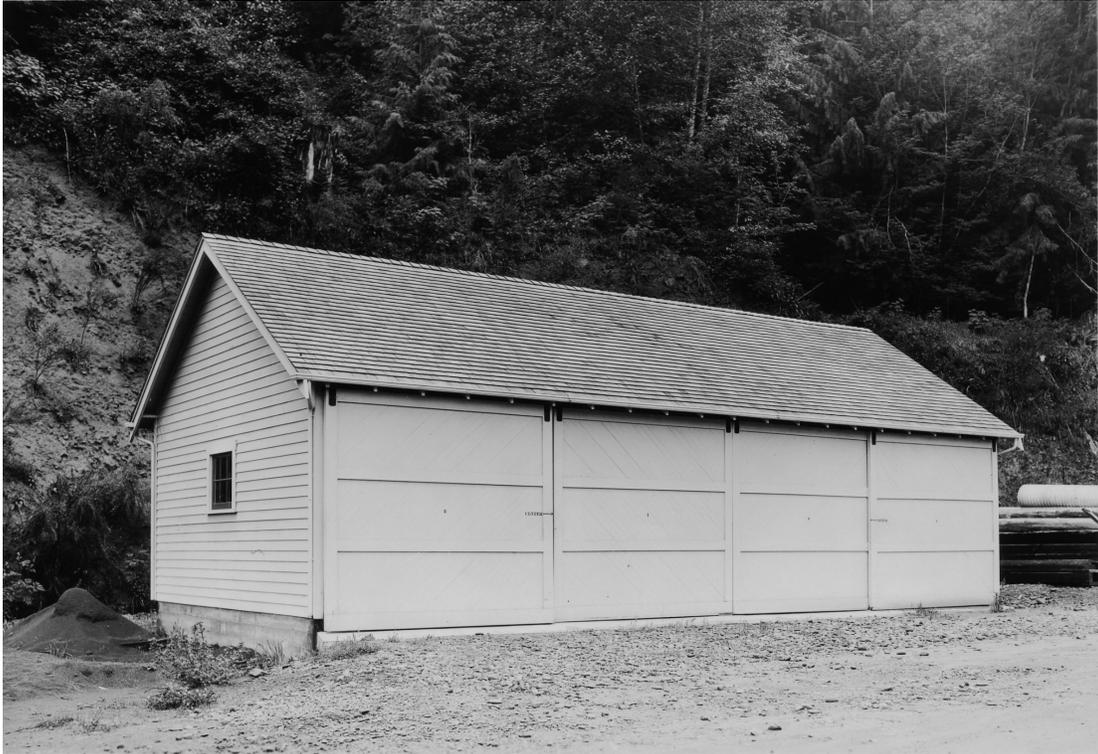
Figure 28. Equipment Storage Building/Four-car Garage, 1936.

The Equipment Storage Shed, built in 1934, is located on the west side of the central drive. (Figs. 28-29) The building has a concrete foundation, wood stud wall construction clad in horizontal lap siding, and a side gable roof with asphalt composition roofing. Four vehicle bays with newer overhead doors dominate the east (front) elevation. In each gable end (north and south elevations) is a single six-pane wood sash window, with a single door that provides access into the building from the south end. The west (rear) elevation has four regularly-spaced six-pane windows, all original to the building.

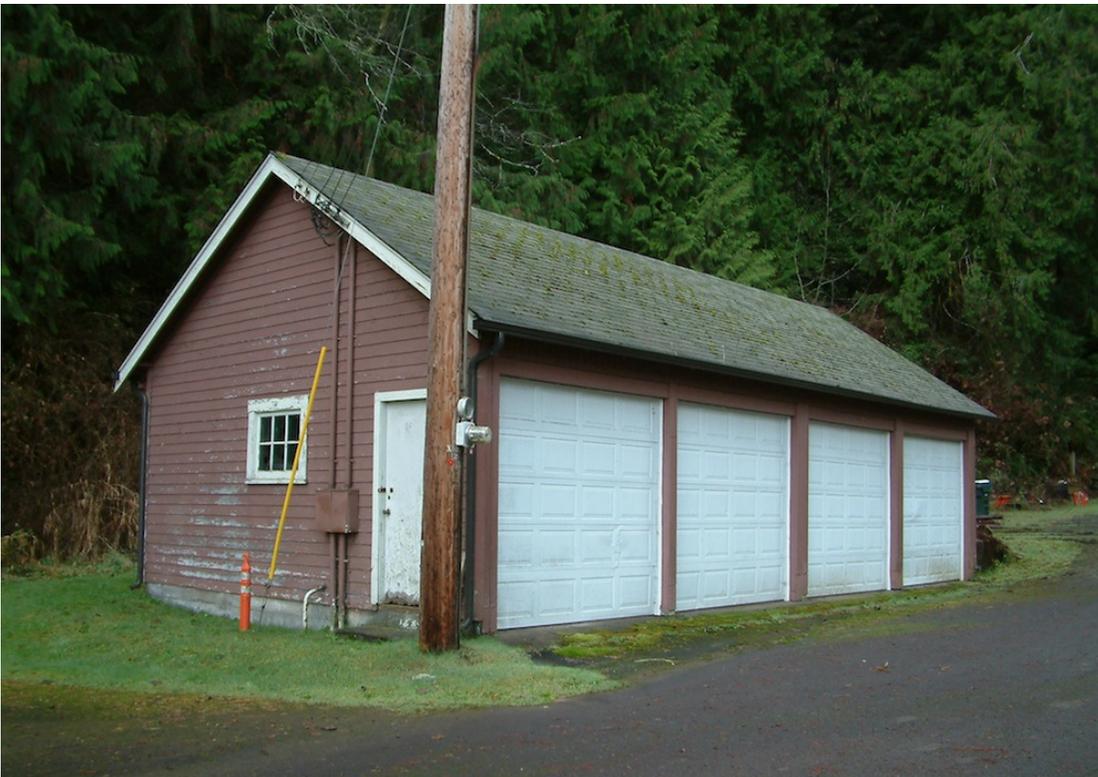
Figure 29. Equipment Storage Building/Four-car Garage, 2012.

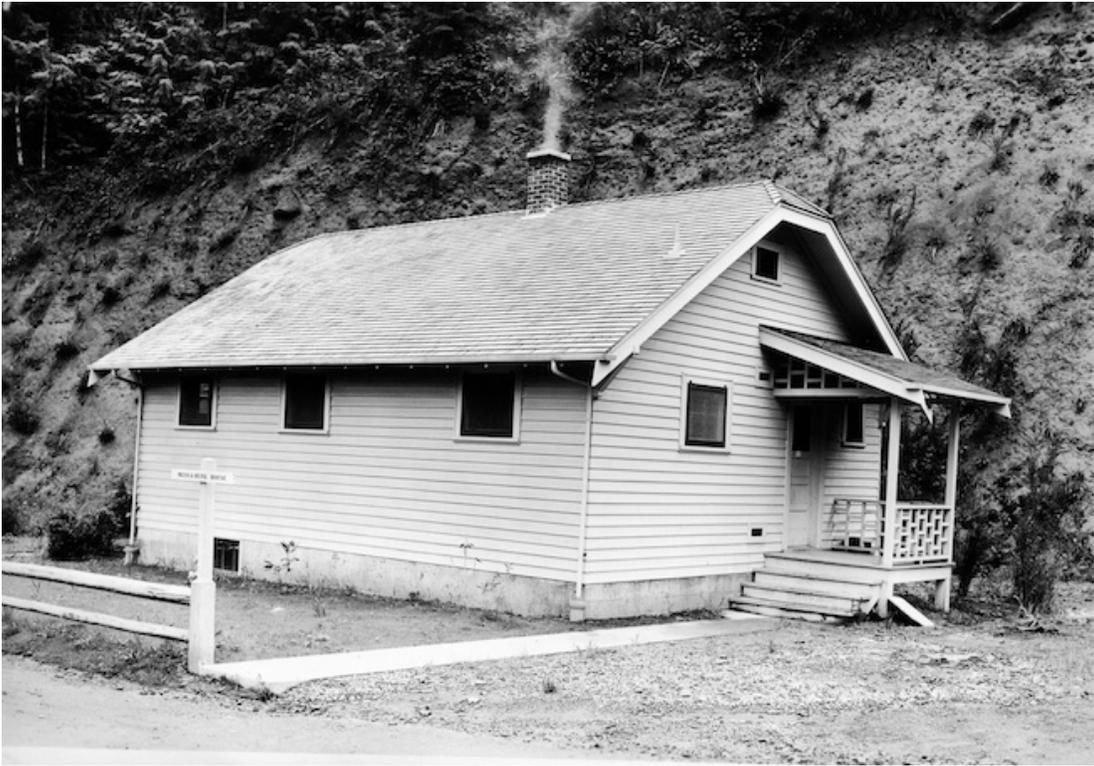
Figure 30. 1936 view of Crew House, demolished circa 1978.

Several other changes have occurred on the property since the initial construction period in the 1930s. The original Office and Hose Shelter were removed sometime before 1978 and it was at this time that the Crew House was demolished and replaced with the metal warehouse that remains on that site.⁵² A new office building still on the site today was constructed in 1959 to accommodate increasing numbers of employees. The old office building was put up for sale, but when no offers were received, the Forest Service donated it to the local Lions Club who moved it to another site in Mapleton.⁵³ The Ranger's Residence was formerly extensively landscaped as evidenced in a photograph from 1936. (*Fig. 10*) On the east side of the building was a garden with a pergola, pond and fountain framed by retaining wall on the south side that remains to this day.
