Mapleton Ranger Station

Mitigation Documentation
prepared for the
USDA Forest Service, Siuslaw National Forest

April 2012

Site and Architectural Description

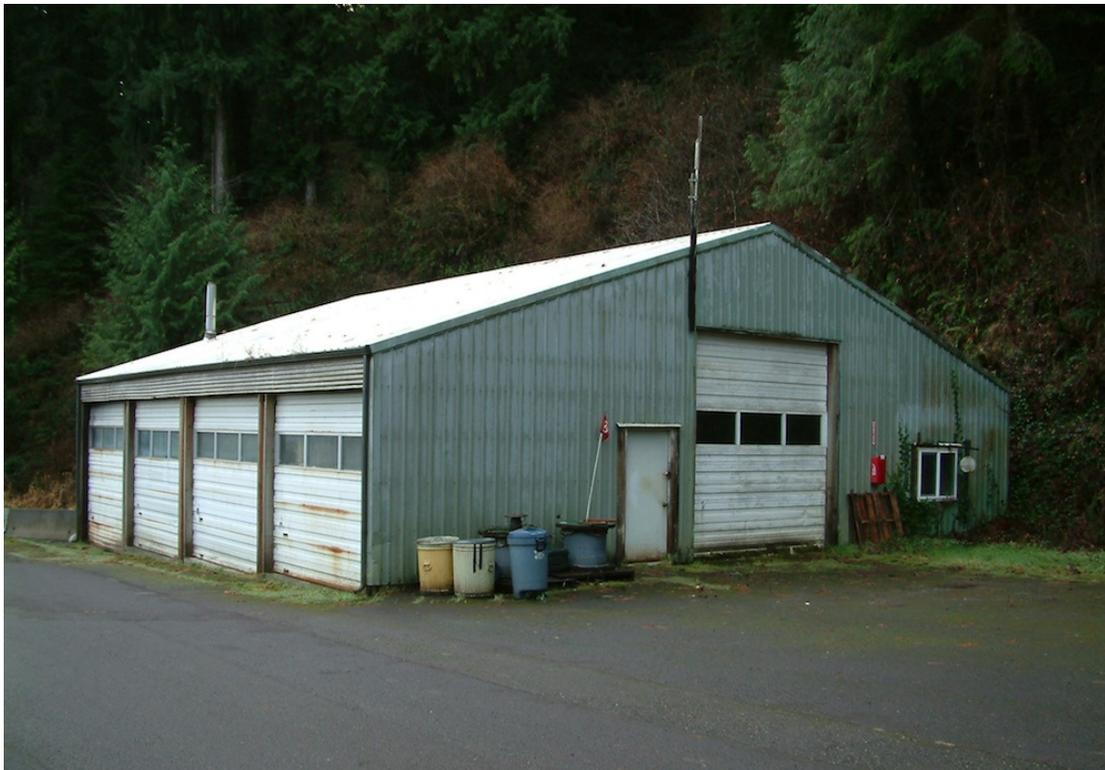
Fig. 31. Storage Building, current on site of original Crew House.

The metal-clad Warehouse building (#2322) located at the southern end of the compound was constructed in 1978 on the former site of the 1930s Crew House (Bunkhouse). (Figs. 30-31) Rectangular in plan, this wood frame structure is clad in corrugated metal, and has a low-pitched gable roof also clad in corrugated metal. The east elevation is dominated by four large garage bays with overhead doors. The north and south gable end elevations each display large garage bays with overhead doors, in addition to smaller access doors and a single small vinyl sash window.

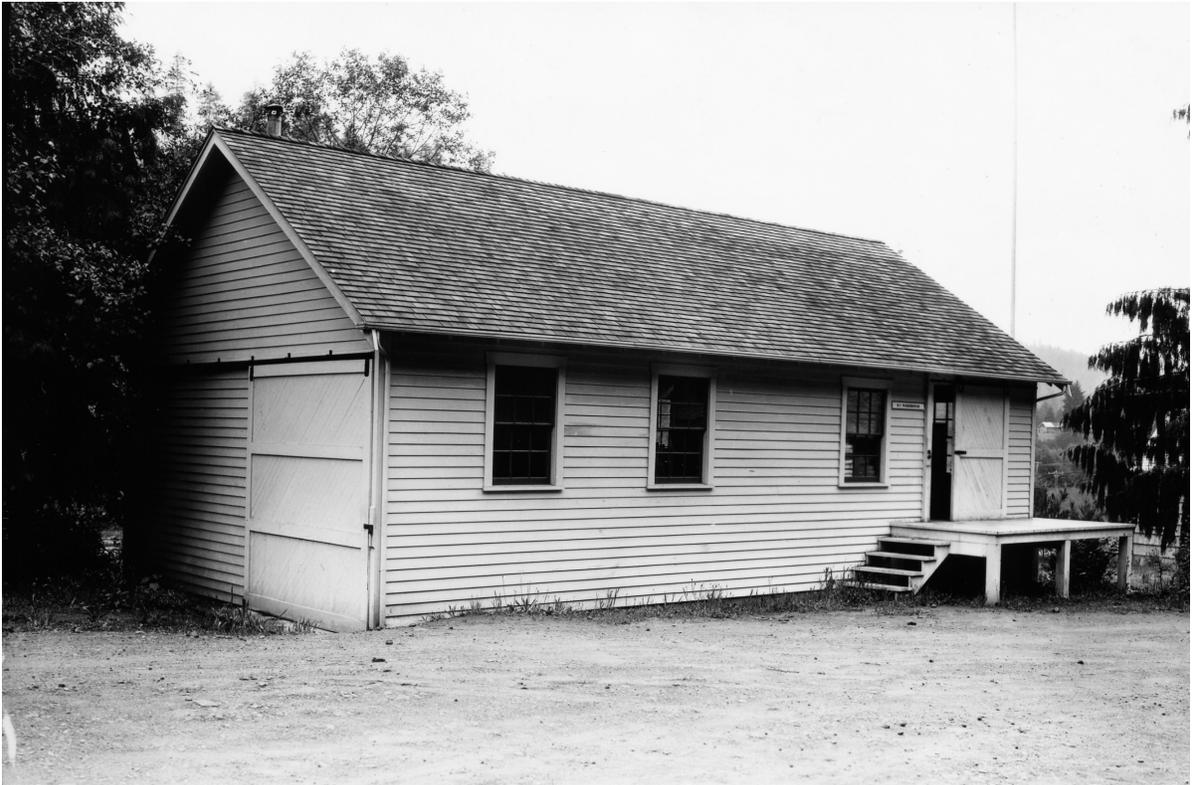
Figure 32. Fire Cache Warehouse Building in 1936.

The 1934 Fire Cache Warehouse Building (#2222) is located on the east side of the central drive. (Figs. 32-33) This building has a continuous poured concrete foundation, wood stud wall structure clad in narrow horizontal lap siding, and a side gable roof with asphalt composition shingles. Windows are six-over-six double hung wood sash with simple casings; there are single six-pane sash located on the east elevation and in the gable ends. The building retains its original wood sliding doors on the west and north elevation. The open interior space appears to be largely intact, with some slight alterations to accommodate changing equipment storage needs. Overall the Fire Cache Warehouse retains a high degree of historical integrity and is in good condition.

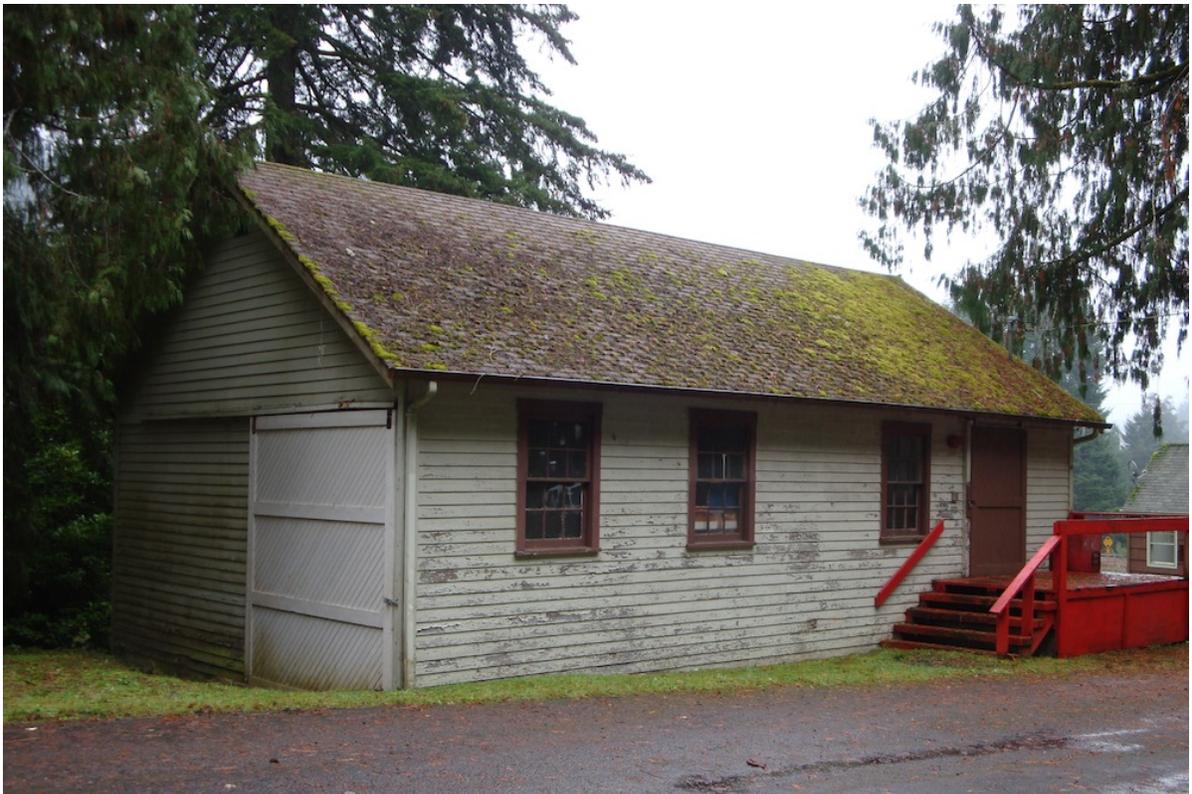
Figure 33. Fire Cache Warehouse Building in 2012.

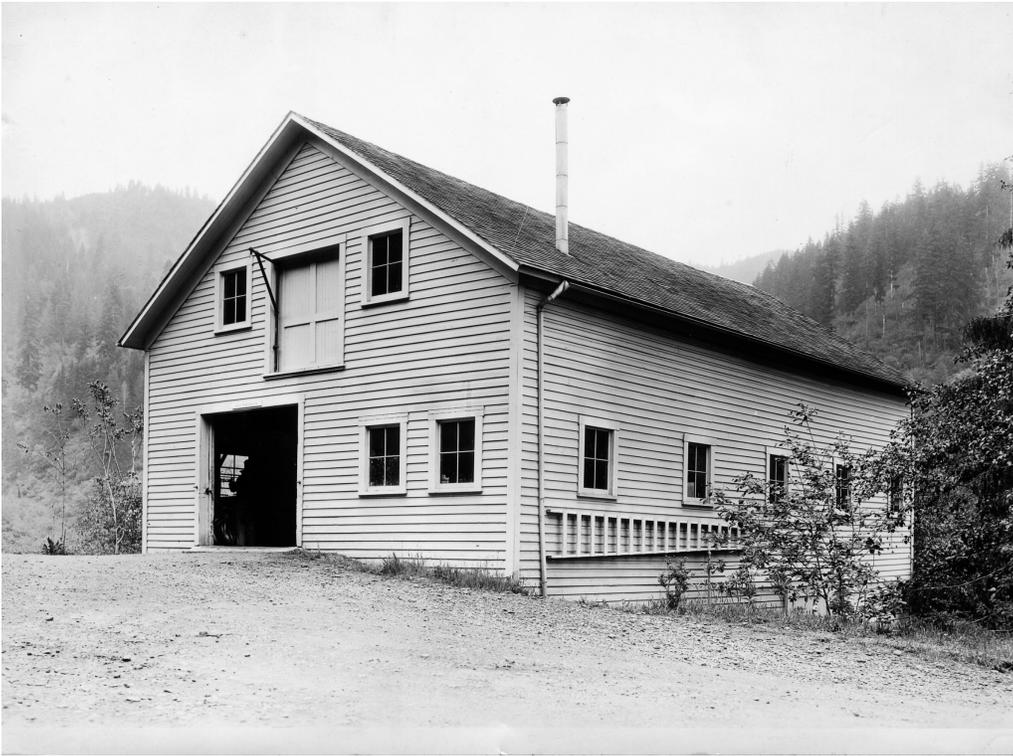
Figure 34. Recreation and Trails (R&T) Warehouse Building in 1936.

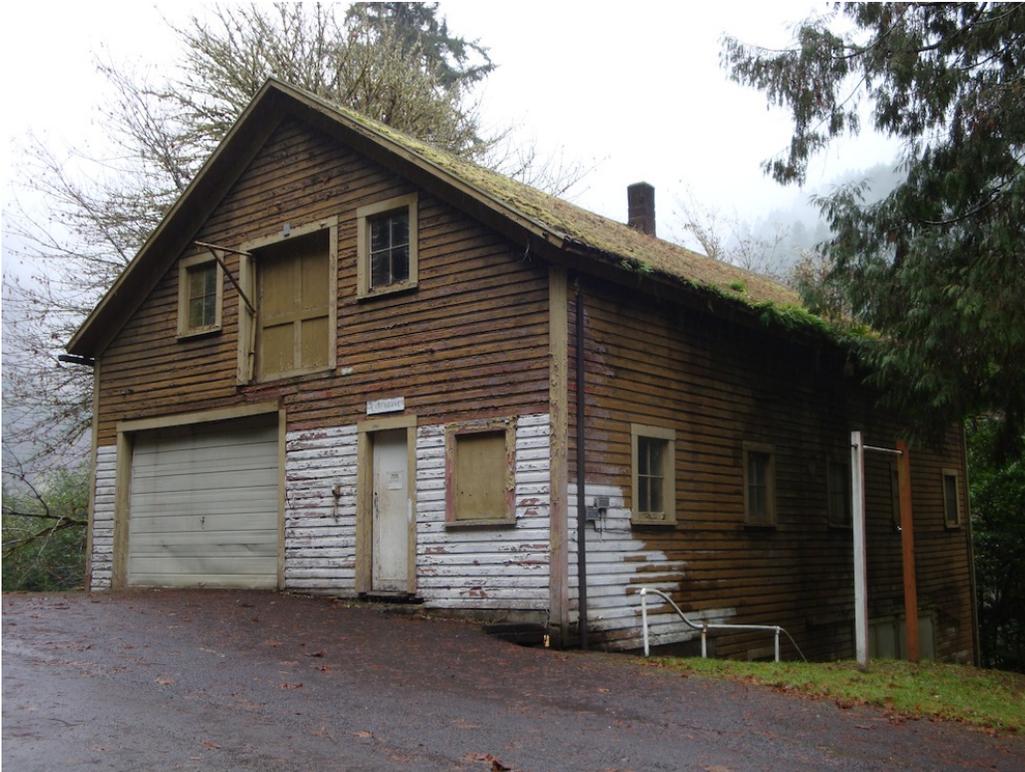
Figure 35. Recreation and Trails (R&T) Warehouse Building in 2012.

The circa 1907 R&T Warehouse building is built into a slope, located on the west side of the central drive, north of the Fire Warehouse Building. This substantial 1½ story wood framed building is rectangular in plan, and has a continuous poured concrete foundation. (Figs. 34-35) This foundation replaces or reinforces the original open braced post-and-pier system. The Warehouse measures thirty feet by fifty; the height is estimated at more than thirty feet, and the basement and first floor are each about nine feet in height. The support system is a braced frame construction utilizing heavy sawn timbers for the posts and girts, with 2"x6" stud walls and 2"x10" floor joists. All structural members are sawn.

The exterior is clad in what appears to be original wood shiplap with cornerboards. The front (west) elevation displays an irregular arrangement of large and small doors and four-pane windows. The first floor exhibits a large metal overhead door on the north half, and a small doorway and four-paned window opening (now boarded up) on the south half. The upper floor presents a central wooden "hay door" flanked by four-pane windows.³

On the north and south side elevations, a number of four- and six-pane wood windows (appearing to be fixed sash) are placed at regular intervals, along with large doors at the basement/ground level of each elevation. The double wood sliding doors on the south side appear to be original. The pair of north side hinged leaf doors have been replaced or re-surfaced with plywood. Fenestration on the rear (east) elevation is irregular, consisting of four-pane wood sash.

Alterations are limited to the replacement of the large front (west) door with a metal overhead door, replacement or reinforcement of the foundation with poured concrete, and the boarding of several windows (with no change to the openings). The R&T Warehouse appears to retain a high degree of historical integrity from the 1934 Forest Service period, but is in poor condition due to deterioration.

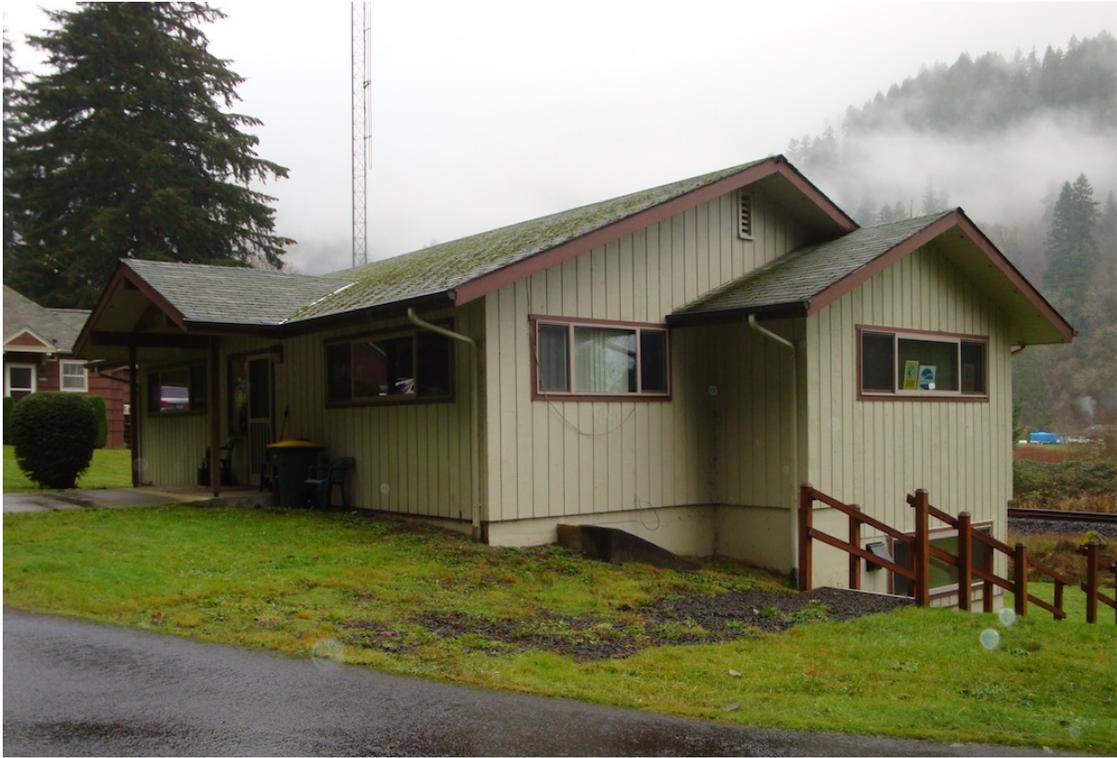
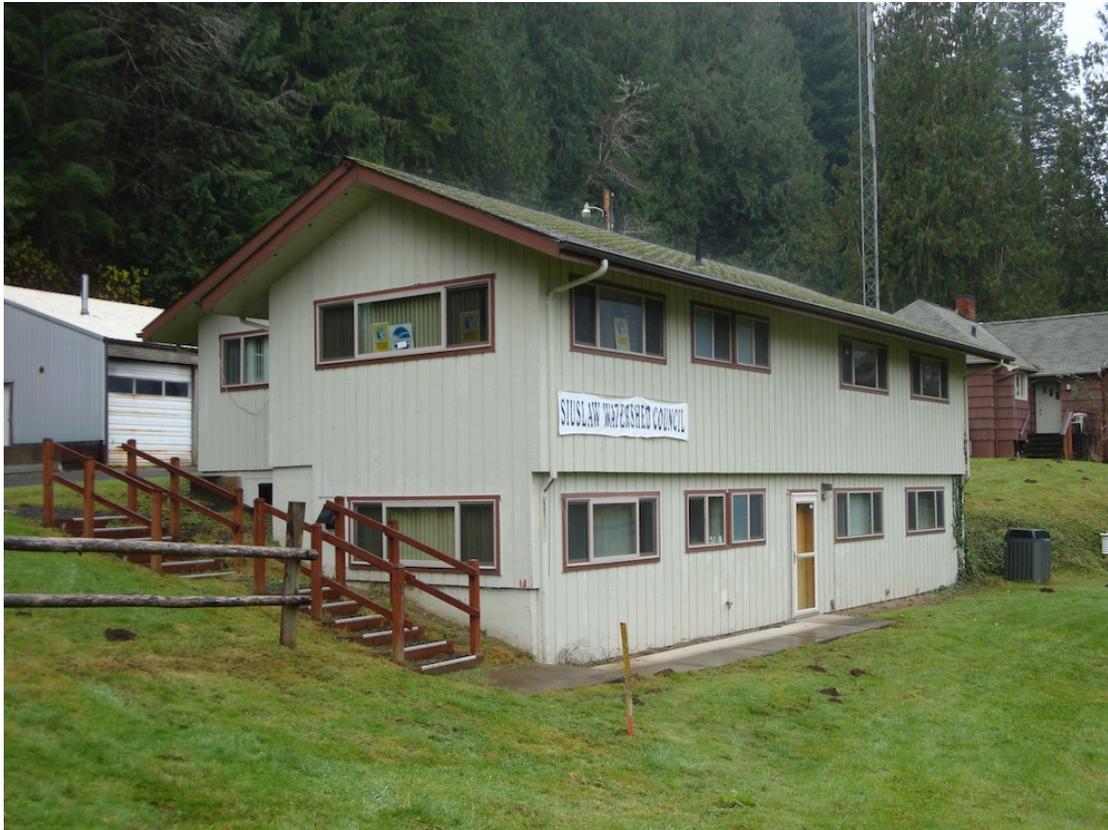
Figure 36. West (front) and south side facades of Office Building.

Figure 37. South side and east (rear) facades of Office Building.

The Office Building, constructed in 1959, replaced the earlier 1930s Office Building on the site that was relocated off-site just prior to construction of the new building. This modern Ranch-style-like building fronts west, and is built into the slope on a continuous poured concrete foundation. (Figs. 36-39) It is irregular in plan, with wood stud wall construction clad in wide-patterned vertical T-111 siding typical of the post-war period. Fenestration is regular, with vinyl sliding sash windows that probably replaced

aluminum sliding sash of similar configuration. The low-pitched side-gable roof has broad overhanging eaves, and is intersected by a small projecting gabled porch roof at the central entrance.

The building is in good condition. Integrity has been slightly compromised by the replacement of the original windows, and possibly by some of the T-111 siding which nonetheless is compatible with the type and materials being used in the mid-twentieth century.
