# Thompsons Mills State Heritage Site Cultural Landscape Plan

Oregon Parks and Recreation Department  
February 2010

## Cultural Landscape Plan 2010

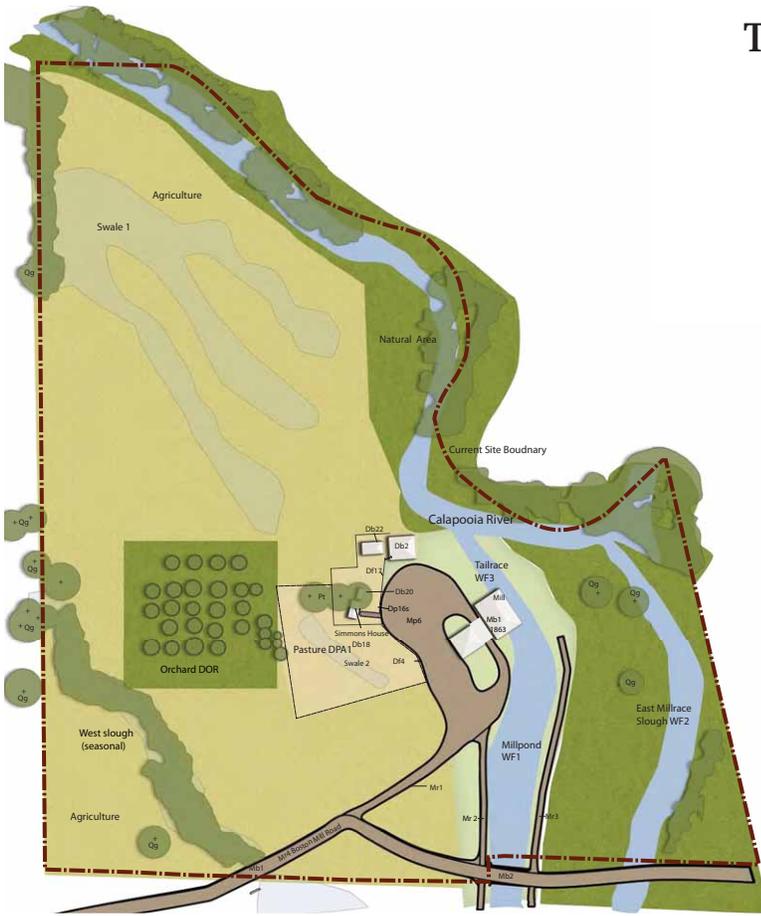
# Thompson's Mills Period Plan: 1898

- Land Use Areas**
- Agricultural Use
  - Mill Grounds/Mowed Area
  - Natural Area
  - Boston Town/Domestic Use

- Physical features**
- Picket fence
  - Post and board fence
  - Gate
  - Dirt road or path

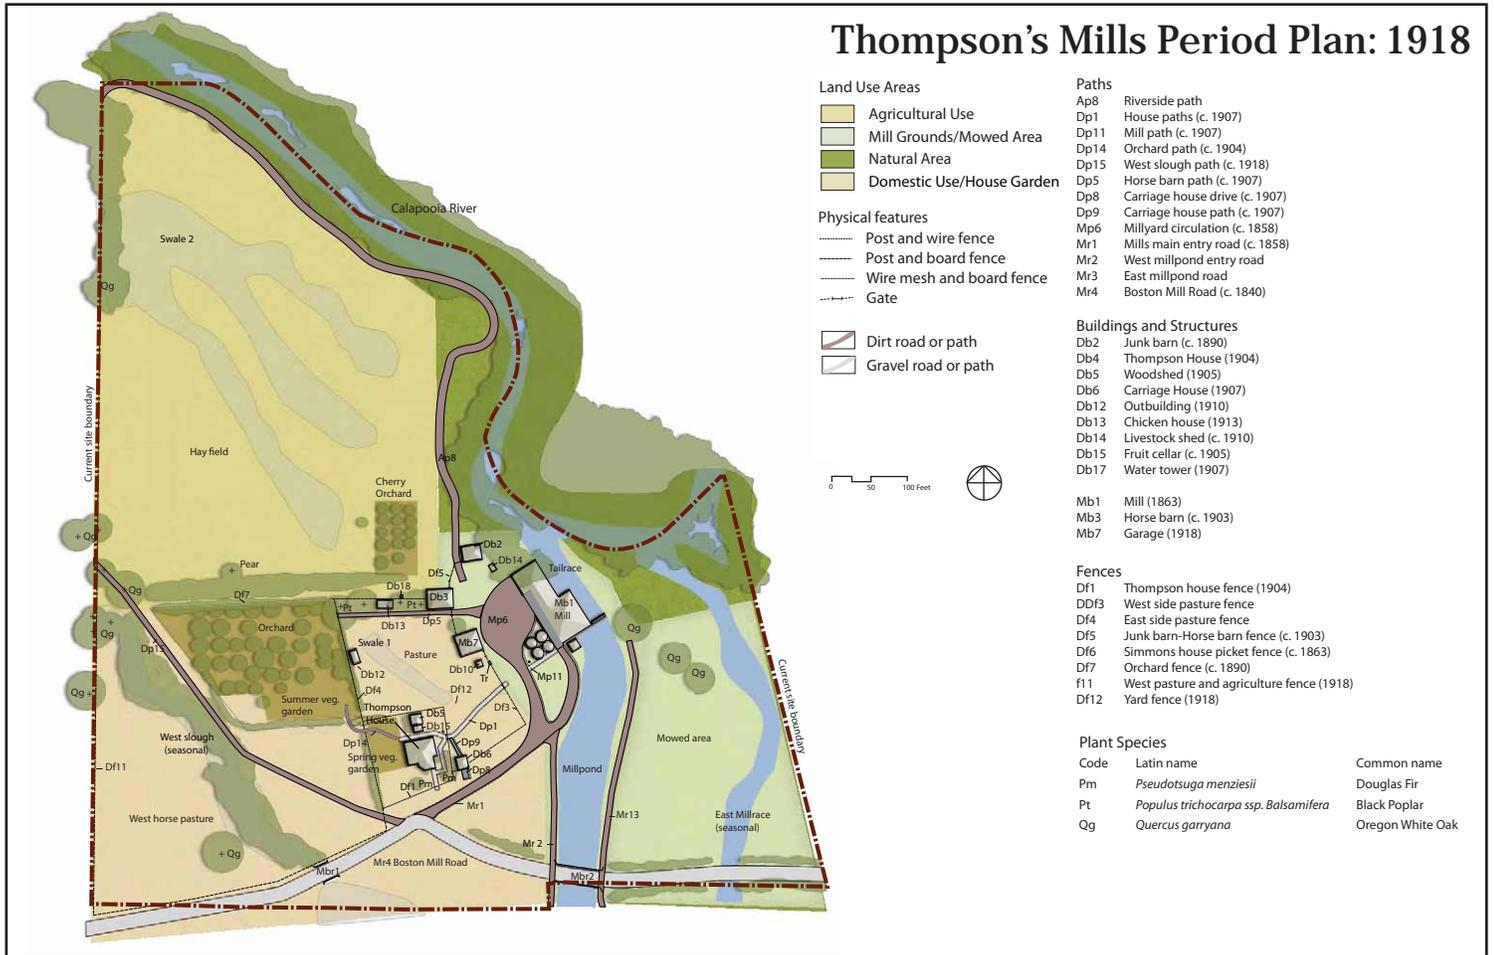
# Thompson's Mills Period Plan: 1918

## Land Use Areas

- Agricultural Use
- Mill Grounds/Mowed Area
- Natural Area
- Domestic Use/House Garden

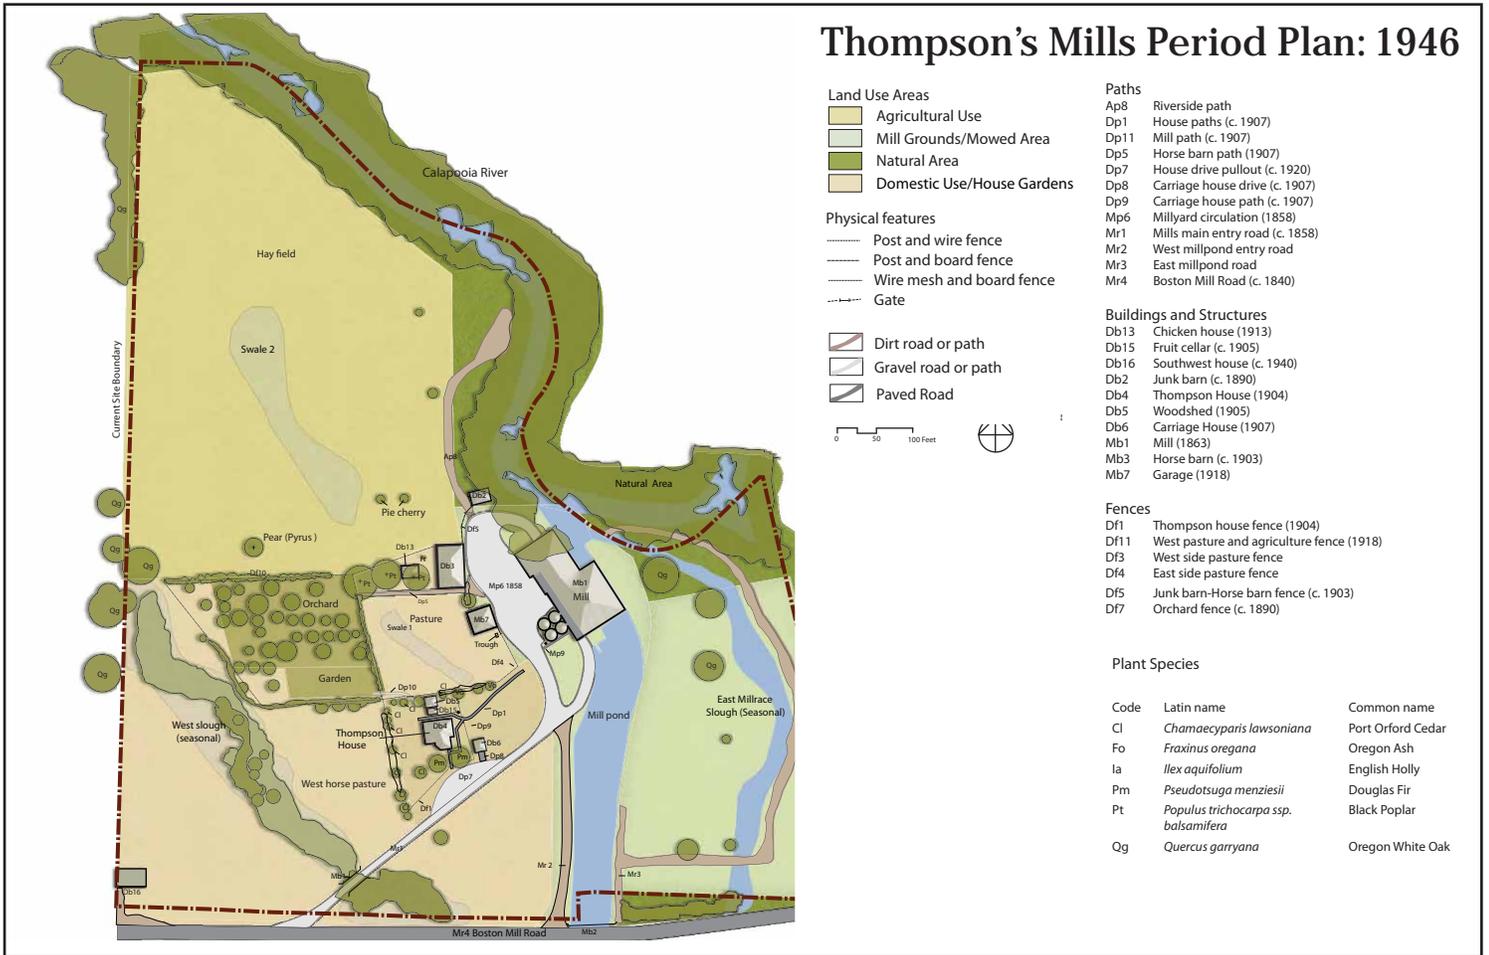
# Thompson's Mills Period Plan: 1946

- Land Use Areas**
- Agricultural Use
  - Mill Grounds/Mowed Area
  - Natural Area
  - Domestic Use/House Gardens
- Physical features**
- Post and wire fence
  - Post and board fence
  - Wire mesh and board fence
  - Gate
  - Dirt road or path
  - Gravel road or path
  - Paved Road

- Paths**
- Ap8 Riverside path
  - Dp1 House paths (c. 1907)
  - Dp11 Mill path (c. 1907)
  - Dp5 Horse barn path (1907)
  - Dp7 House drive pullout (c. 1920)
  - Dp8 Carriage house drive (c. 1907)
  - Dp9 Carriage house path (c. 1907)
  - Mp6 Millyard circulation (1858)
  - Mr1 Mills main entry road (c. 1858)
  - Mr2 West millpond entry road
  - Mr3 East millpond road
  - Mr4 Boston Mill Road (c. 1840)

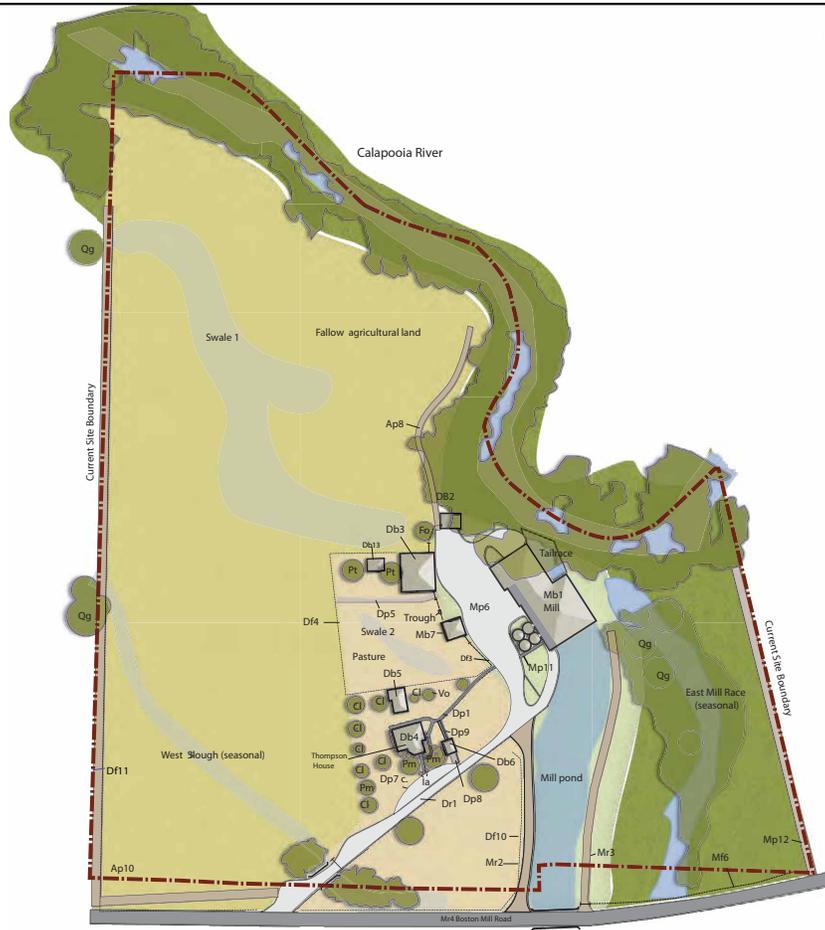
# Thompson's Mills Period Plan: 1979

## Land Use Areas

- Agricultural Use
- Mill Grounds/Mowed Area
- Natural Area
- Domestic Use/House Garden

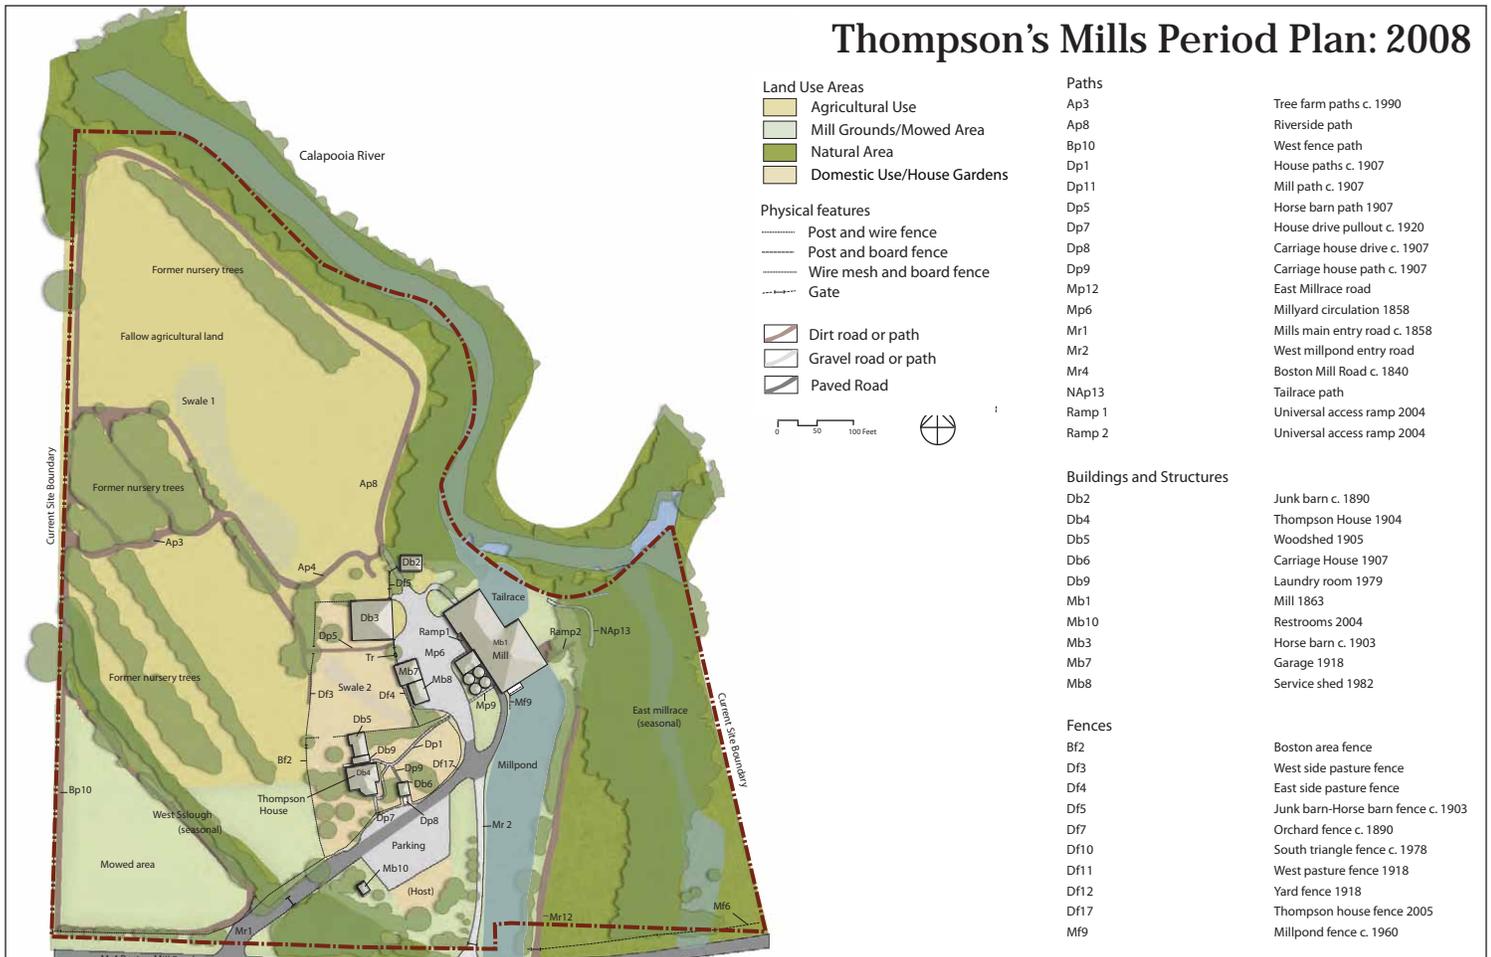
# Thompson's Mills Period Plan: 2008

- Land Use Areas**
- Agricultural Use
  - Mill Grounds/Mowed Area
  - Natural Area
  - Domestic Use/House Gardens

- Physical features**
- Post and wire fence
  - Post and board fence
  - Wire mesh and board fence
  - Gate

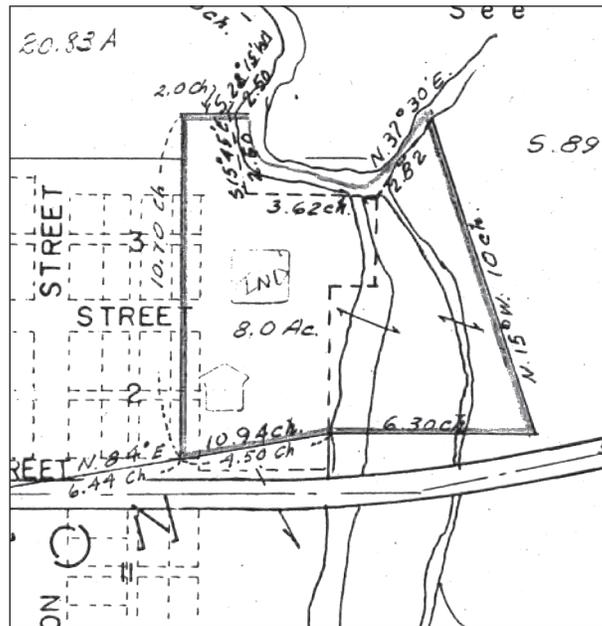
Fig. 2 Platte of Boston, from *Historical Atlas of Marion and Linn County, OR 1878*, superimposed on current site map. TMSHA Archives

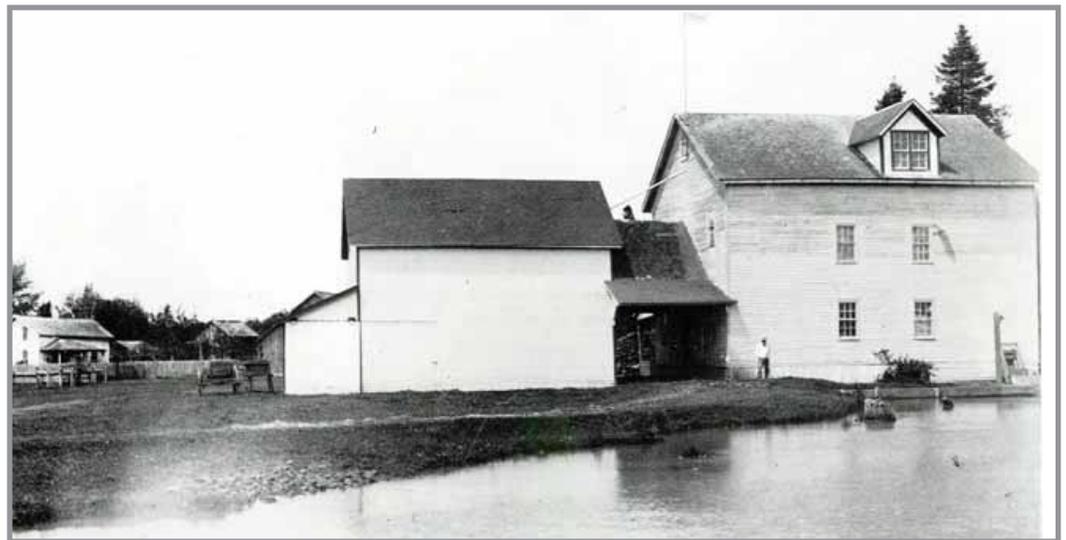
Fig. 3. Mill with Simmons House, c. 1900. Photo 2004.1.6 TMSHS archives.

| 1900 | Grew | Large Douglas firs were growing along the river behind the mill.<br>(1900 mill and Simmons House. 2004.1.P.0003 TMSHS digital archives.) |

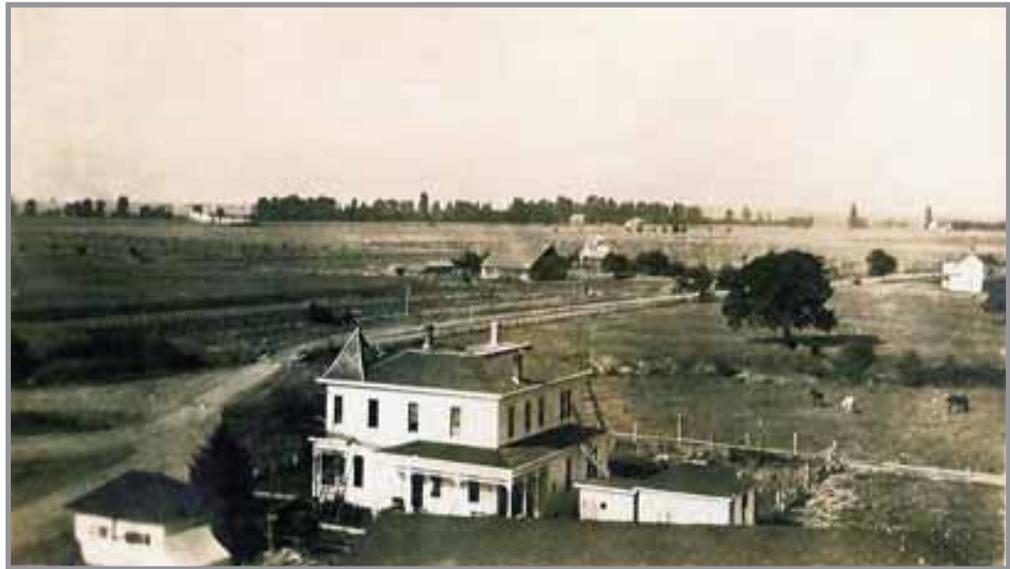
Fig. 5. 1904 Thompson house from Mill roof. Note concrete path around house. TMSHS digital archives.

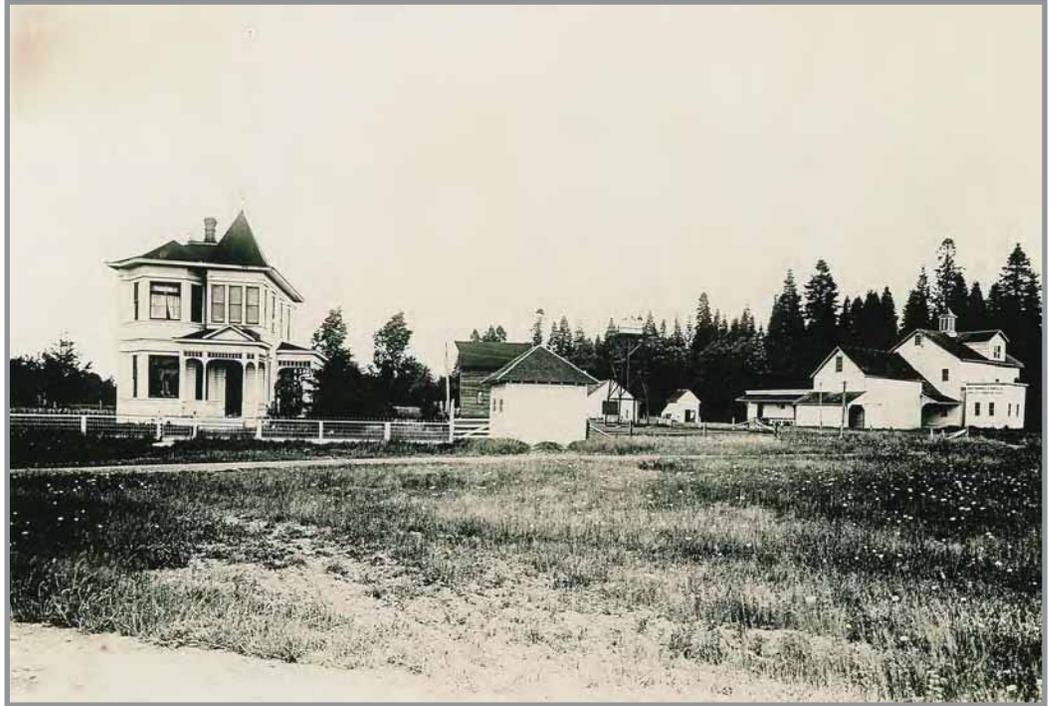
Fig. 6. Circa 1907 Thompson house.

Queen Anne style Thompson House built for Martin Thompson. The foundation stone was quarried in the Cascade Mountains. The house had a board and wire fence around the yard, which was open and grassy, with dirt or possibly brick paths. This fence had bushes along it, and a gate to the east porch, leading into a post and board fenced area which included the pasture, between the house and the mill. The east porch was a work space, where the well water pump was located, along with a sink and a mangle for laundry. Laundry was hung to dry in the north and west yards of the house (the “back” yard). There was a woodshed on the north side of the house, and an outhouse behind that. There was a telephone or telegraph pole in front of the fence along the drive (to the east of the front gate), and power pole for an electric line from the mill to the house. Past the house the road was rutted dirt, below the grade of the yard. There was no turnout before the gate. (1904 House with woman at gate. Photo 2004.1.P.0005 TMSHS digital archives; Thompson interview 2004; Townsend and Dubay oral interview July 13 2008)

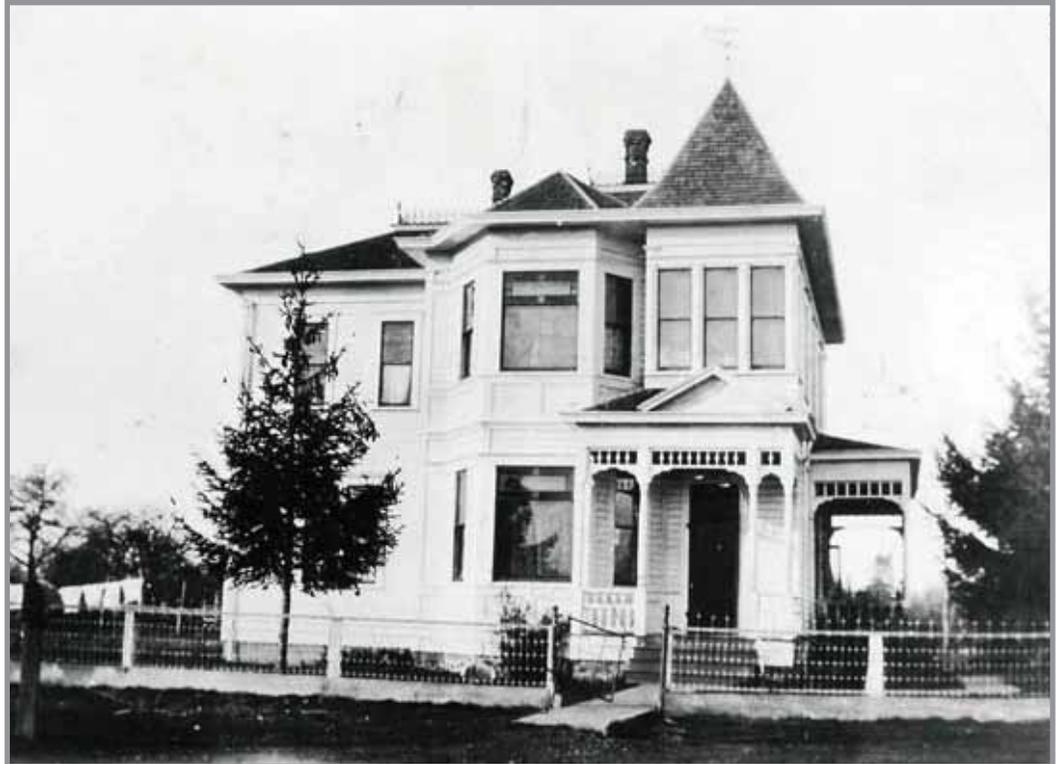
Fig. 7. Circa 1915 Thompson House Photo 2004.1.24 TMSHS digital archives.

- 1910 Enlarged The Thompson House was expanded with a west addition to provide housing for eight mill employees. At about this time the house paths were paved, possibly when the concrete foundation for the addition was poured (Thompson Chronology. photo 2004.1.19.jpg, 2004.1.24.jpg, TMSHS archives)

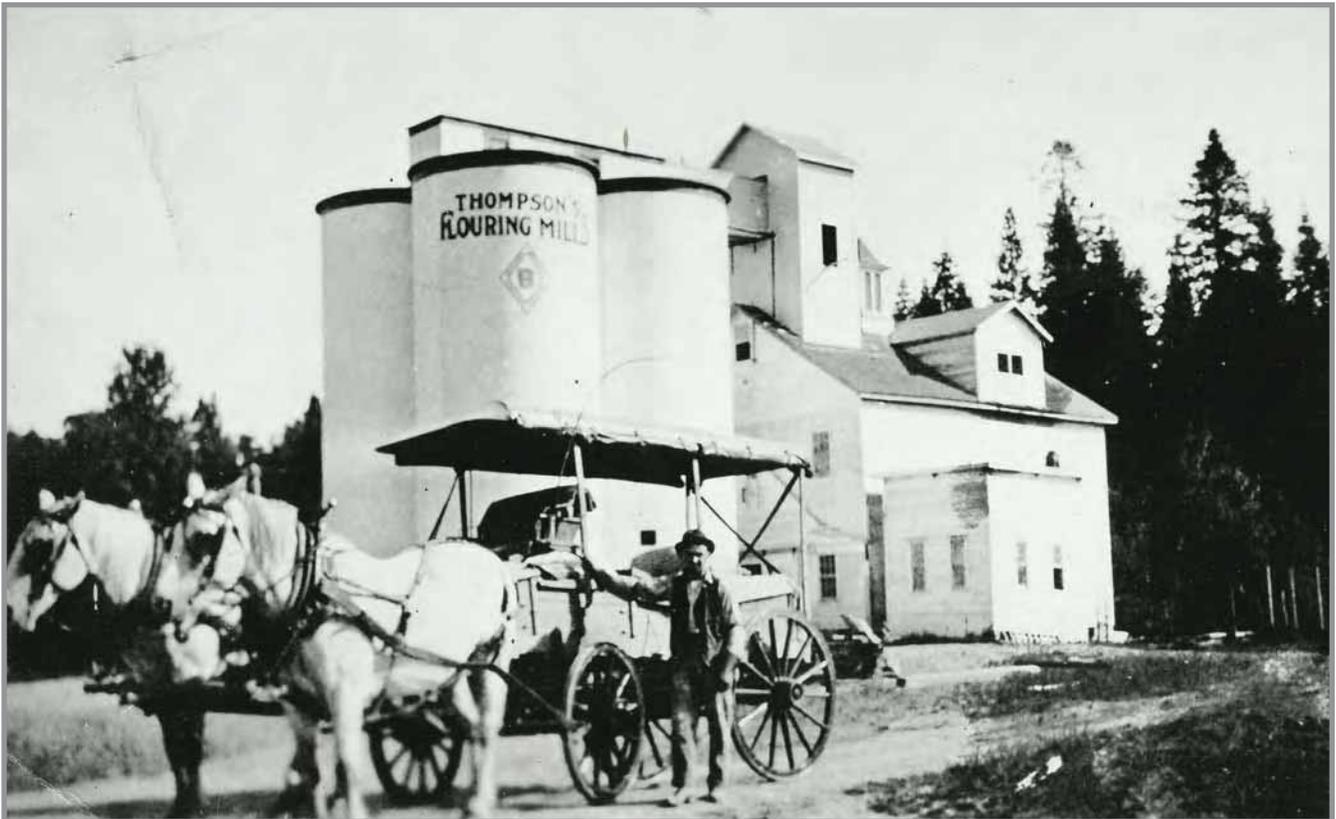
Fig. 10 Circa 1917 Mill with delivery cart, new silos.

- 1916 Repaired Expenses for auto repair and tire tubes were recorded.(Ledgers TMSHS archives)
- 1917 Enlarged The 1890s storage building was moved to the northwest side of the mill, in order to make room for four concrete grain silos - these were the first slip-form concrete silos in Oregon. At this time they bore the logo B inside a diamond for Thompson's Best Flour. A third-story tower and passageway to the top of the grain silos was added. Two additional storage sections were also built, on the north side of the mill, and the covered loading dock extended along the southwest side. A new concrete dam or headgate was built. Deliveries were made using a covered cart and two grey draft horses, which the kids also sometimes rode to school. A concrete horse trough may have been poured at this time at the base of the water tower (Photos. 1917 Mill with Surrey. 1918 Mill north storage. 1918 mill north kids on a horse 2004.6.P.0028 TMSHS digital archives. )

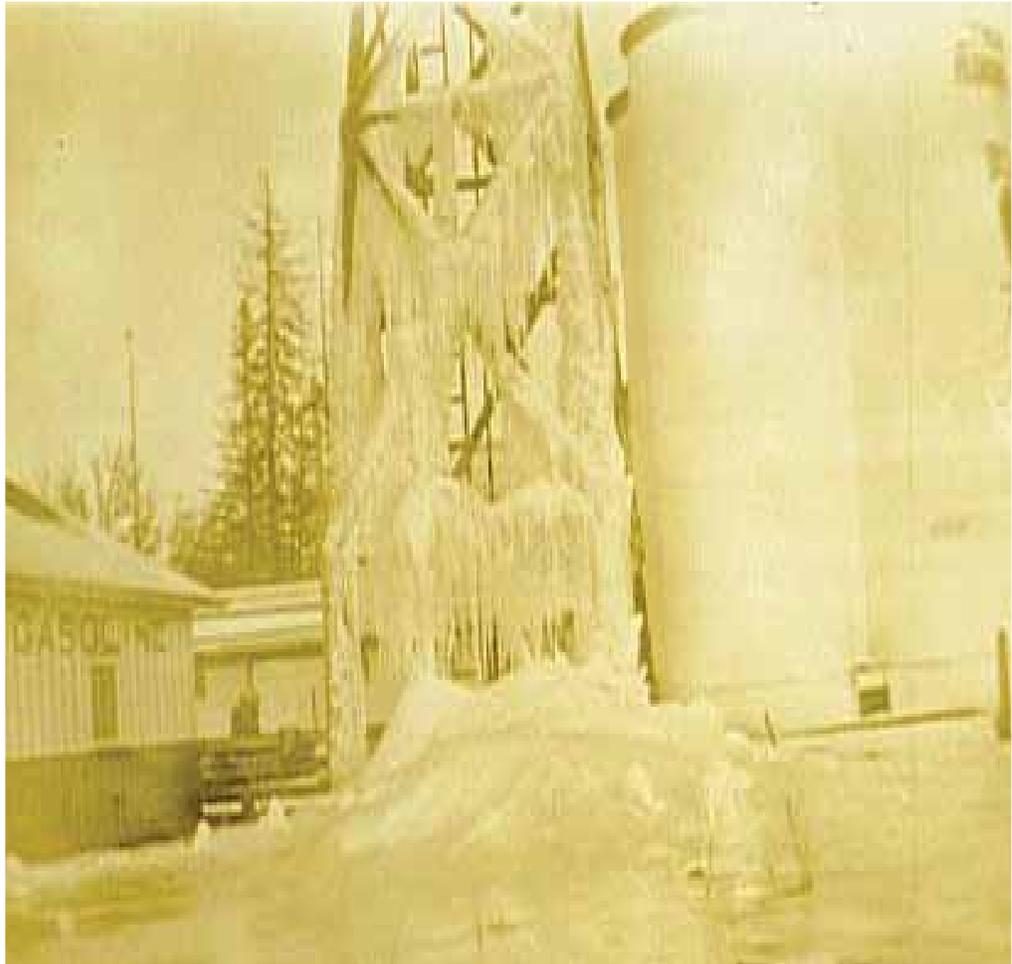
Fig. 15 c. 1937. Water tower in ice storm. Photo 2004.6.P.0014 TMSHS digital archives.

- 1937 Destroyed The original water tank fell over in an ice storm in the middle of the night, damaging the garage roof. It was replaced by a water tank above the silos sometime after 1939. (Eunice interview 2004. TMSHS archives. Photo c. 1940 mill.)

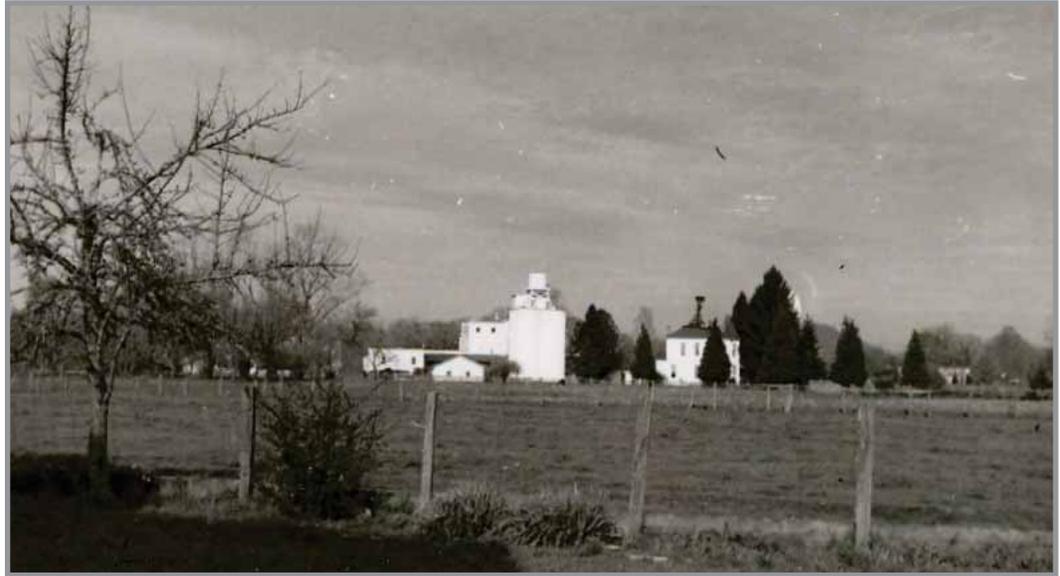
Fig. 16 Mill from the Farwell house, 1960. TMSHS archives 2005.4.P.0008. The orchard is visible on the left, and there is an osprey nest in one of the firs in the background.

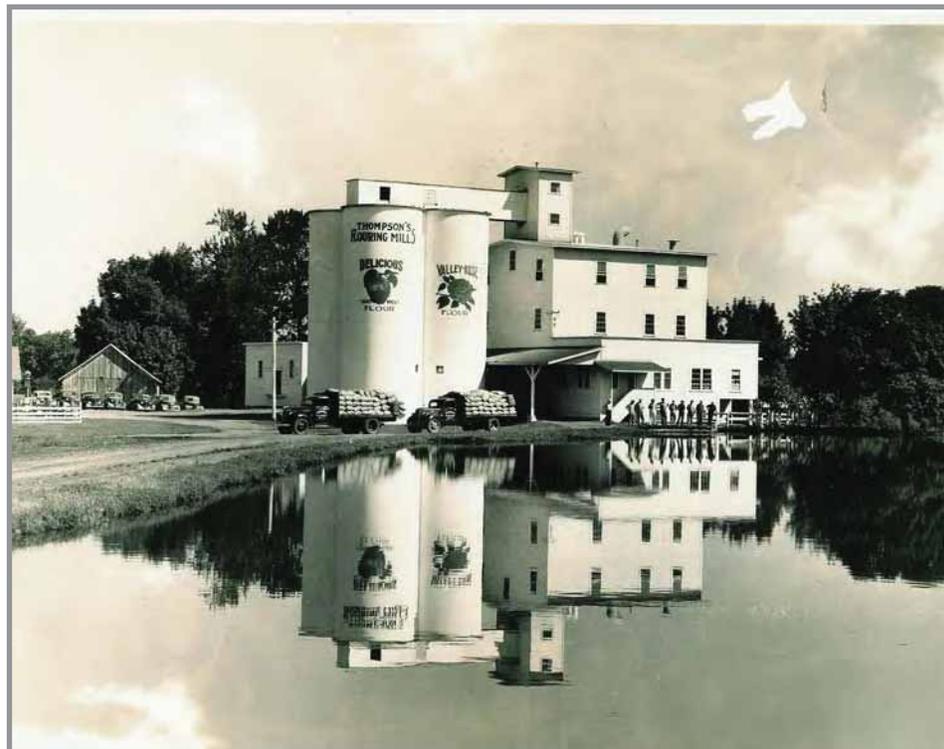
Fig. 17. Circa 1939 mill from the bridge over the millrace. The view is the most frequently taken shot of the mill. This photo was used as the cover of the mill calendar in 1940, and was recreated for the 1960 calendar. The visible gas pump can be seen in front of the garage. TMSHS archives.

- 1933 Built “In the early 1930s a 100’ concrete retaining wall was poured at the mill to eliminate erosion and provide a solid foundation. Additionally, another wall on the east side of the tail race, a concrete flume, and concrete foundation piers were poured during this same period. The mill race was broadened, deepened, and diked clear back to Farmer’s slough.” The warehouse was expanded, the roof of the mill elevated to provide more floor space on the top floor, and a new office incorporated into the mill building, replacing the office building. The small livestock shed to the north of the mill may have been removed at about this time. It was still present c. 1924. (Comprehensive Cultural Resources Management Plan 1987; Historic Structures Report; Photo 20046p17 TMSHS archives.)

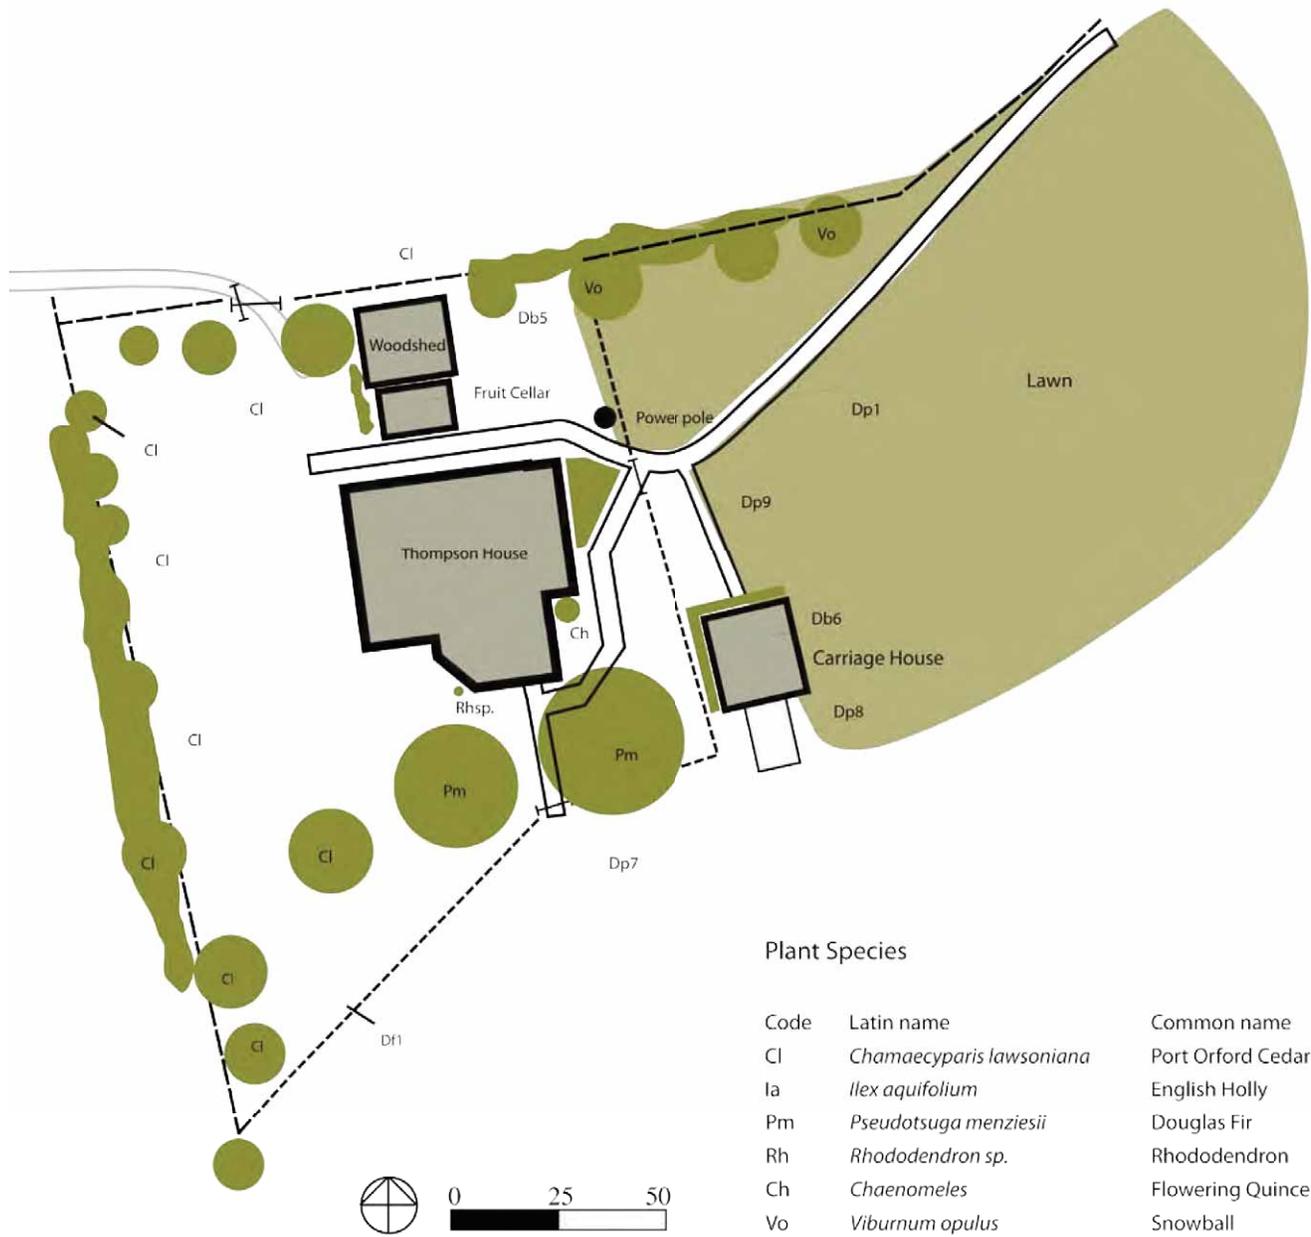
**Fig. 48 Diagram Analyzing Integrity of Vegetation Features at Thompson House Garden in 2008**
