MT HOOD HIGHWAY ROAD SAFETY AUDIT

Timberline Rd to Nottingham

Road Safety Audit (RSA)

Mt Hood Highway (US-26 and OR-35)
Mile Point 54.20 – 70.20

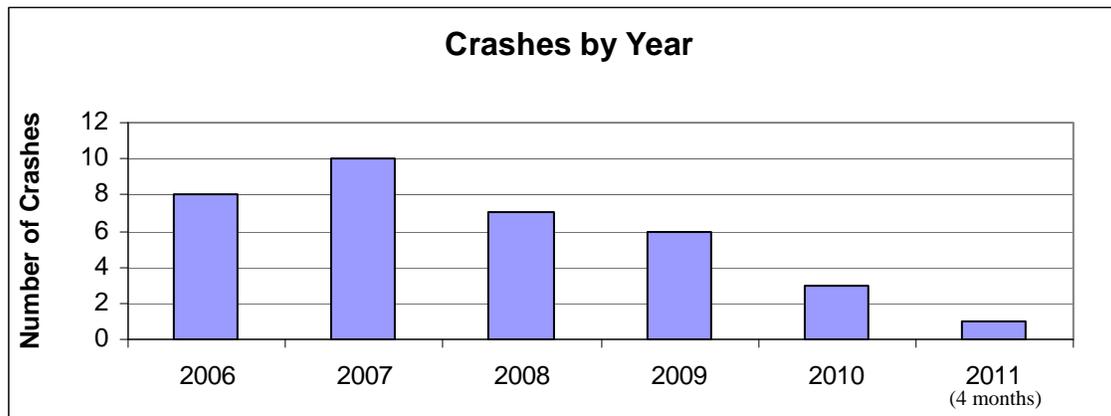
The numbers of crashes per year on US 26 from Timberline Rd to OR 35 for the last 5 years are illustrated in the figure that follows. This figure also shows the number of crashes for the first 4 months of 2011 to include all of the 2010-2011 winter recreation periods. There were 34 reported crashes for the 5 full years (2006-2010) time period with an average crash rate of approximately 0.95 crashes per million vehicle miles travelled. This is slightly higher than the statewide average for rural principal arterial highways of 0.70 crashes per million vehicle miles. There were no fatalities and only one injury A (severe injury) crash. There were no safety priority index (top 10%) locations. The average crash rate is relatively low for a higher elevation mountain pass highway with severe weather conditions in the winter. However 21 of the 34 reported crashes (62%) occurred with ice or snow pavement conditions. Fourteen of the 21 ice or snow crashes occurred on Friday, Saturday or Sunday mostly during high traffic volume/congestion periods on Friday or from 9AM to 6PM on Saturday or Sunday. The most common crash type with 11 crashes was fixed object/run off the road. As can be seen in the following bar chart the numbers of crashes per year appear to be decreasing.

Seven of the 34 crashes were at the Timberline Road intersection. This intersection was at the east end of the 2009 RSA. Concern was expressed about the limited sight distance for right turn drivers from Timberline Highway when there was a vehicle with the driver stopped waiting to

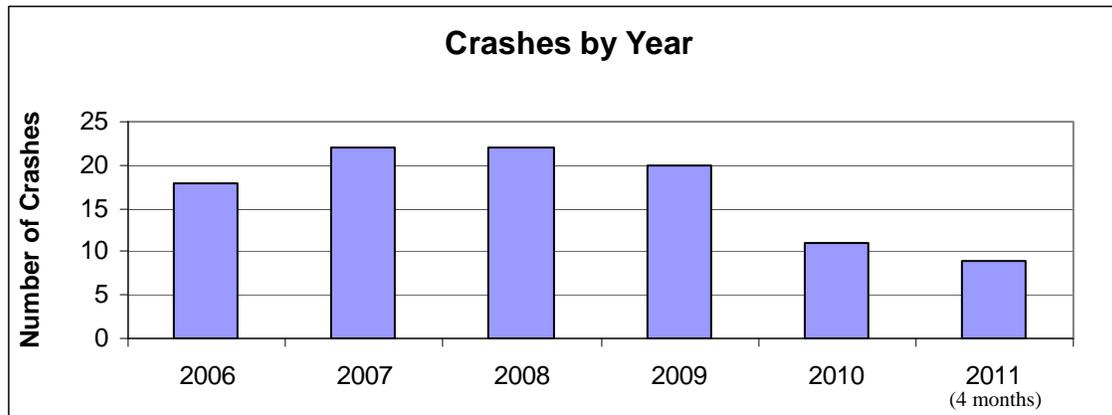
The numbers of crashes per year on OR 35 from US 26 to Nottingham for the last 5 years are illustrated in the figure (bar chart) that follows. This figure also shows the number of crashes for the first 4 months of 2011 to include all of the 2010-2011 winter recreation periods. There were 93 reported crashes for the 5 full years (2006-2010) time period with an average crash rate of approximately 2.57 crashes per million vehicle miles travelled. This is substantially higher than the comparable statewide average for rural principal arterial highways of 0.70 crashes per million vehicle miles. There were 2 fatalities in one crash and 9 injury A's (severe injuries) in 4 crashes. The average crash rate is similar to the high elevation mountain pass (2.65 in 2010) on the Santiam Highway (US 20) that also has severe weather conditions in the winter. Seventy three of the 93 reported crashes (78%) occurred with ice or snow pavement conditions. Fifty-six of the 73 winter crashes were on Friday, Saturday or Sunday and 45 were from 6AM to 6PM. Forty of these involved failure to maintain traffic lane or run off the road. Speed too fast for conditions was listed as the most common causative factor in 67 of the 93 crashes. As can be seen in the following bar chart a trend for the number of crashes per year isn't readily apparent. The trend appeared to be downward in 2010 but was up in 2011 based on the 4 months of available crash data.

There were 2 fatalities and 5 injury A's in one head on crash on ice at MP 69.66. Two of the injury A crashes were separate motorcycles on different curves with dry pavement in July. There also was a SB injury A with snow on the road involving Fixed Object. The other injury A crash involved a left turn on snow from Mt. Hood Meadows (Sahalie Falls Lp). The majority of the severe crashes were also located at the 4 high safety priority index (SPIS) sites on OR 35.
