Indian Creek Aquatic Restoration

Oregon Wildlife Heritage Foundation

Narrative Summary:

Photographs:

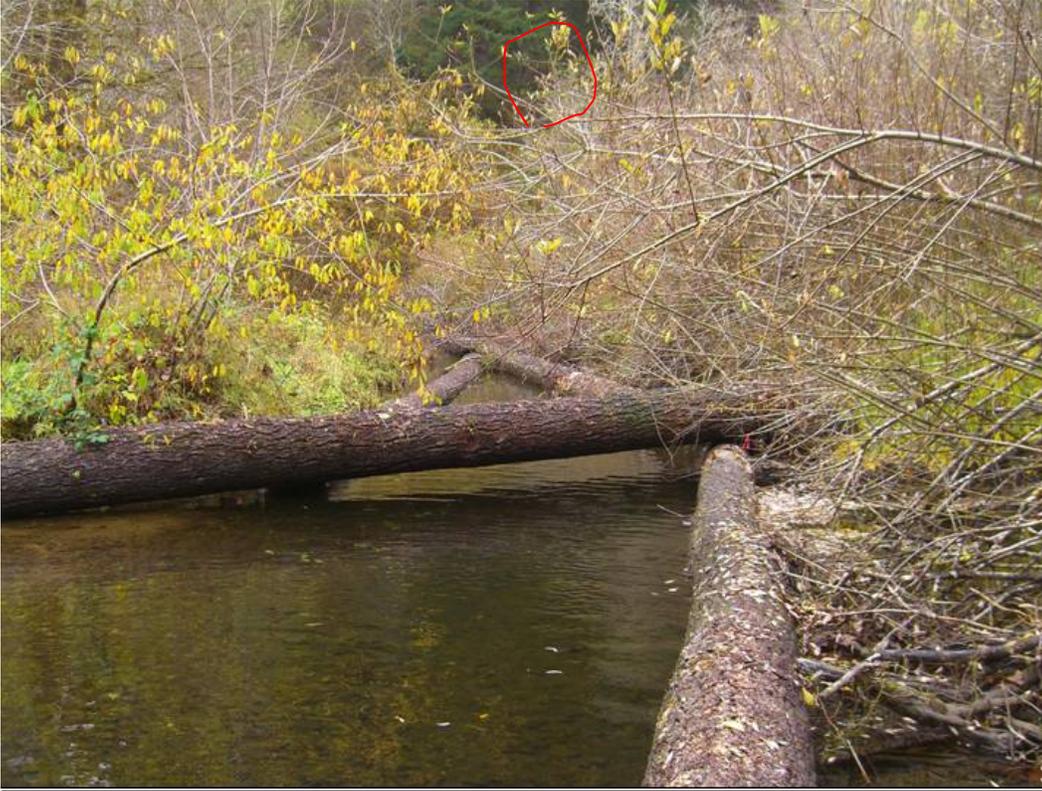
North Fork Indian Creek (Part 10)
Site #18, looking upstream – 2007 (2)

New Comments: Some recent scour was observed from newly placed logs.

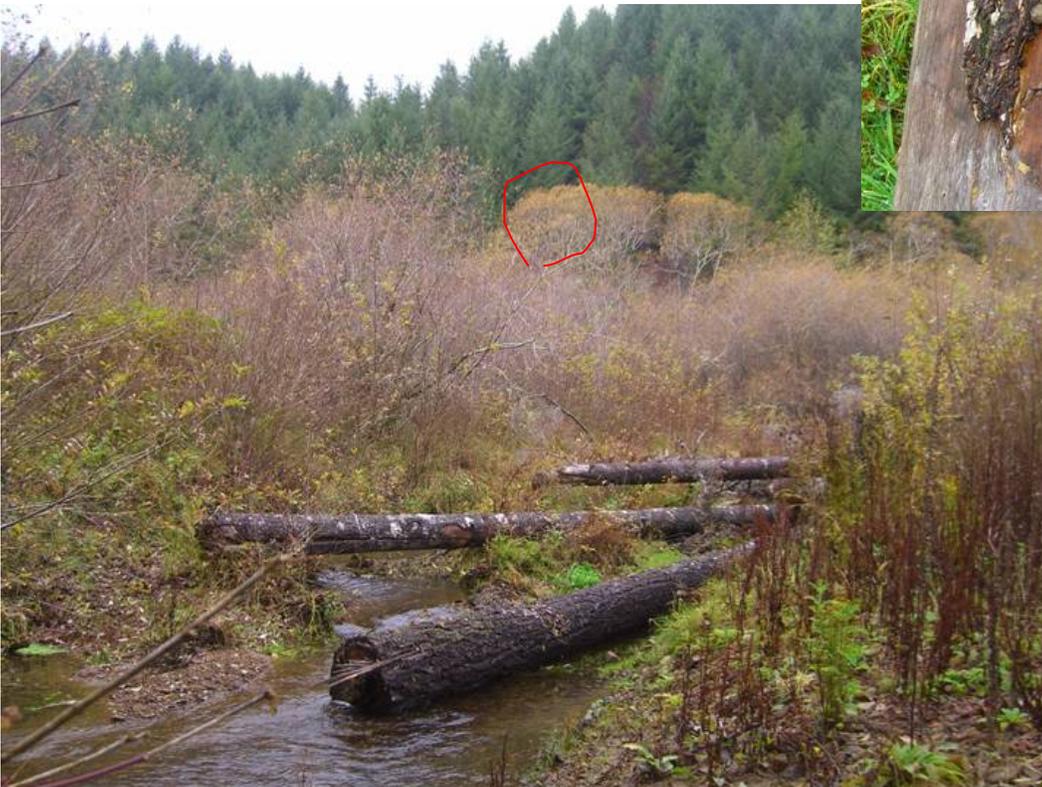
Site #19, looking upstream – 2007 (2)

New Comments: A couple of existing logs from a previous habitat project located on the right bank have swung downstream since the reference photos were taken.

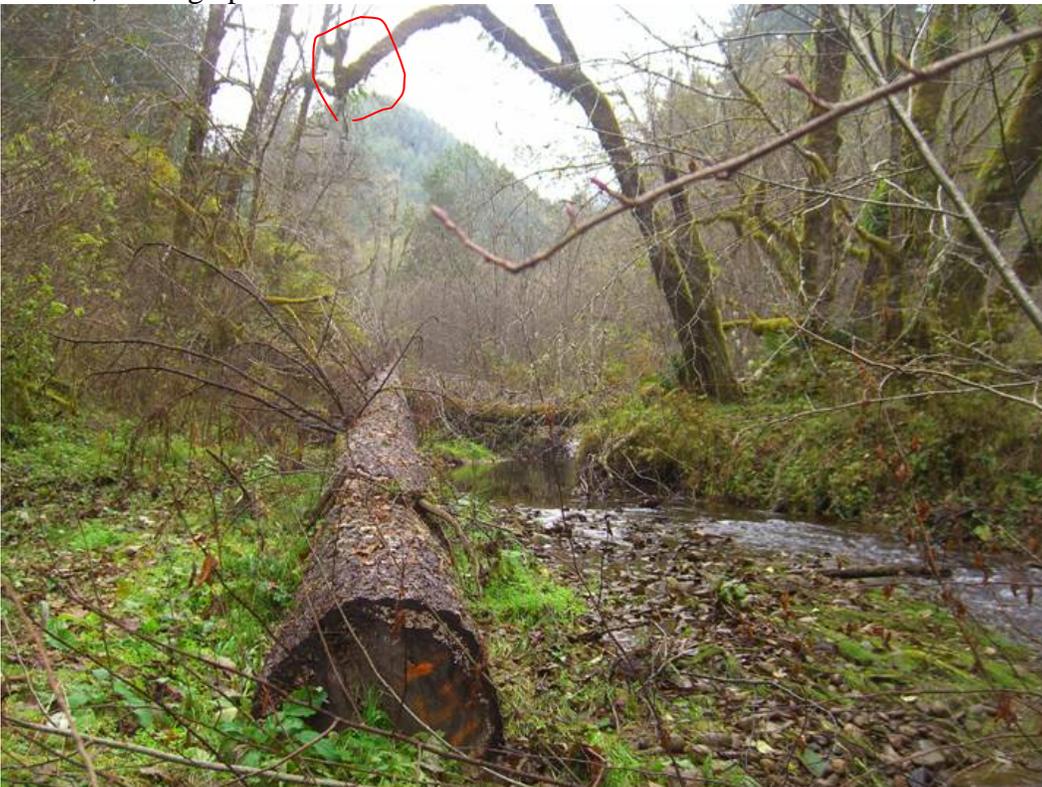
Site #4, looking upstream – 2007

New Comments: The structure has affected the channel enough to develop a point bar at the downstream end of this structure, causing the stream to become more sinuous.

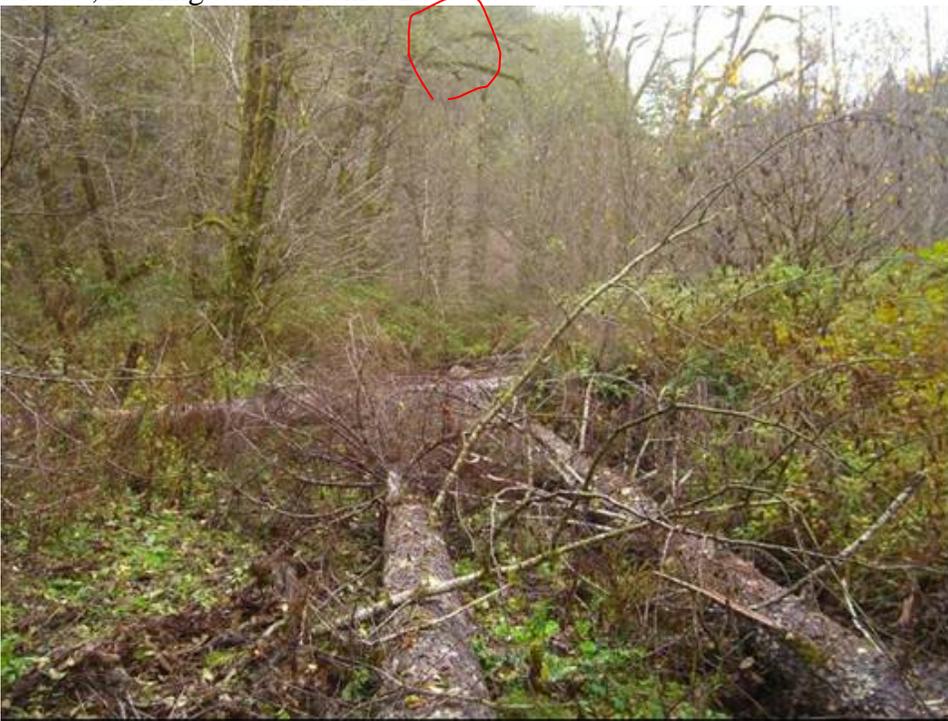
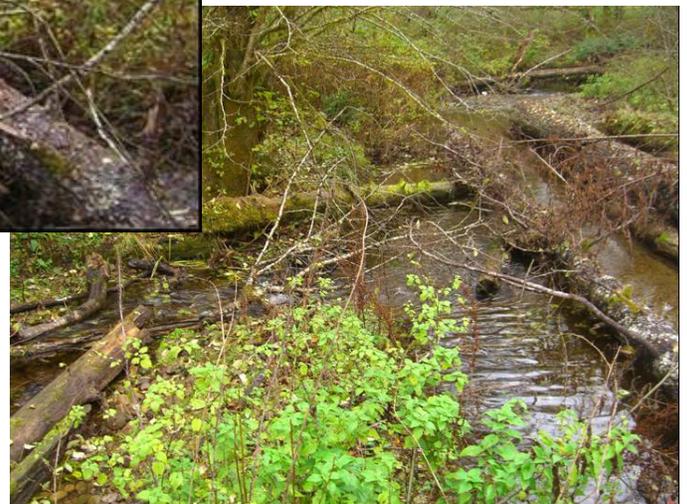
Site #5, looking downstream – 2007

New Comments: The trees have changed the stream dynamics significantly by collecting sediment and creating a side channel. The photo on the right shows the area right where the channel splits.

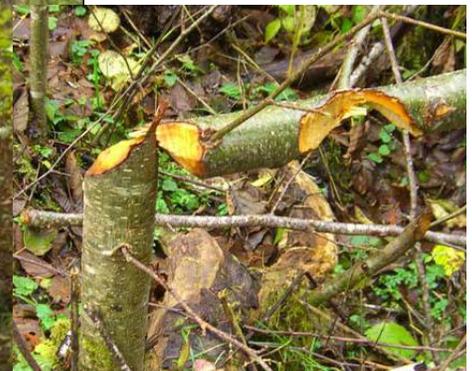
The photo above shows the 6 inch DBH alder that the eager beaver munched down right below this structure site.

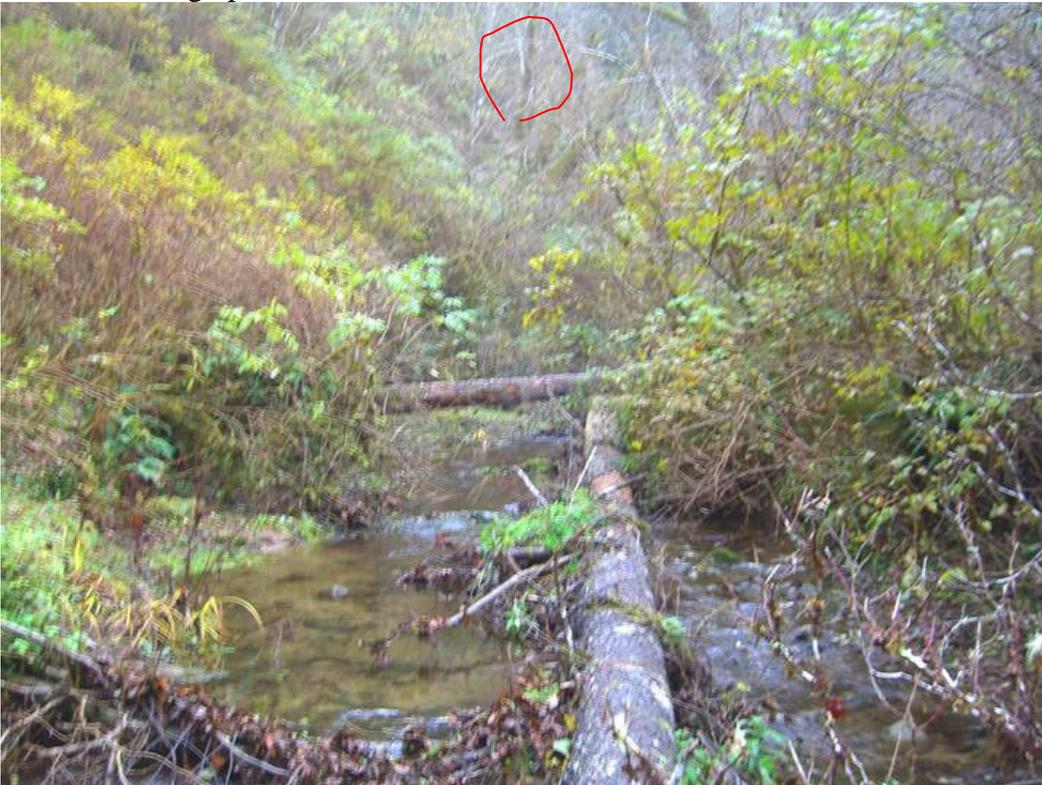
Site #9, looking upstream – 2007

New Comments: There was small woody debris collected around the new trees in addition to some beaver cuttings that were scattered in here. There is tributary that comes in on the left side, so we look forward to see future debris collection at this site.

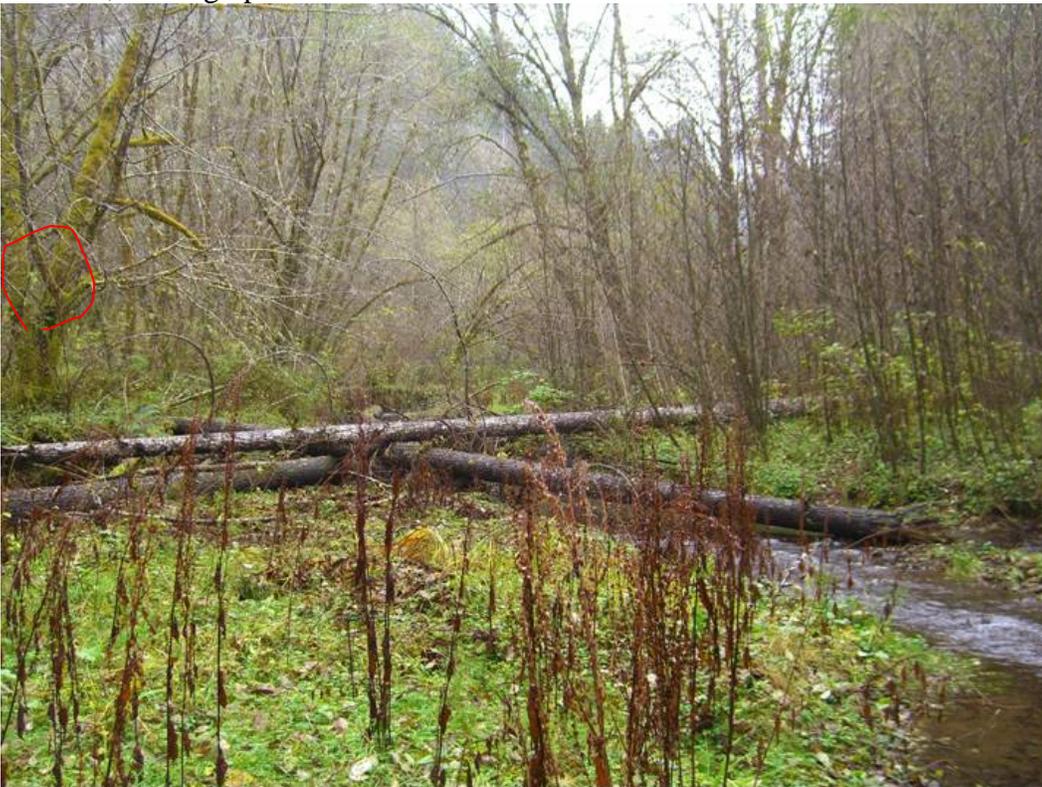
Site #25, looking upstream – 2007

New Comments: The structure is helping regain the floodplain interaction by causing the high flow water to move into the low-level floodplains on both side of the bank.

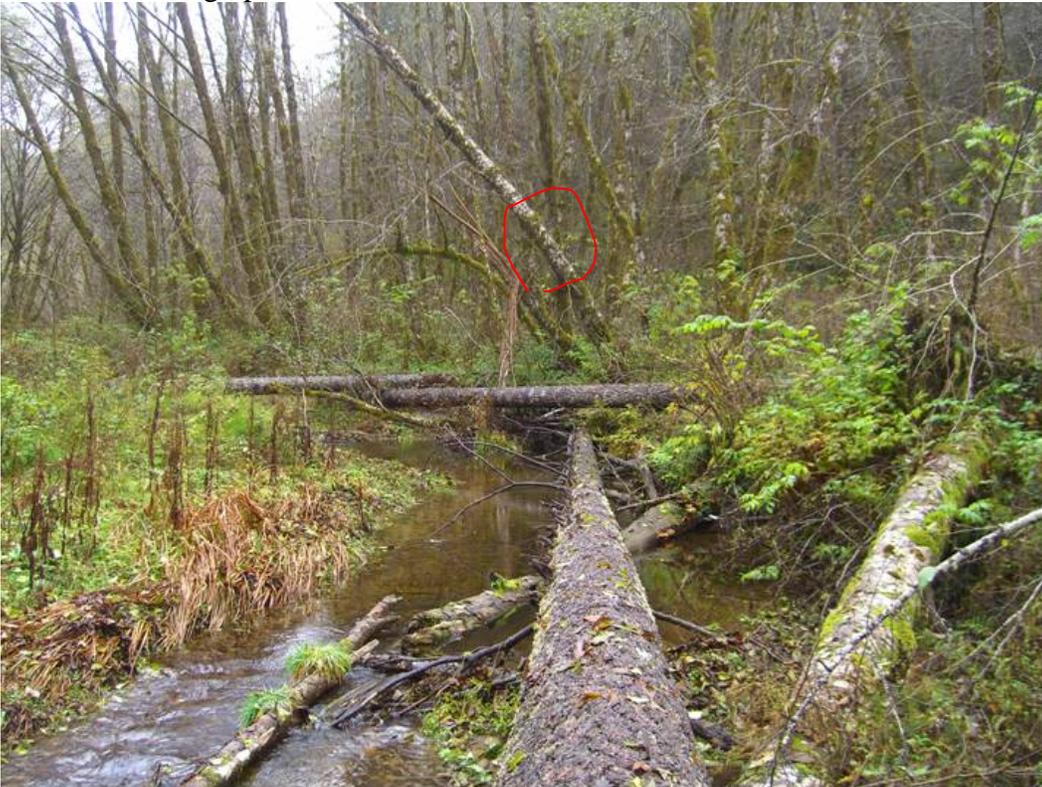
Site #27, looking upstream – 2007

New Comments: The tree in the center here has helped scour deep pools in this channel unit. The amount of gravel decreased from this site downstream; in future years, we'll monitor how much gravel will be added to these downstream sites. The angle of the photo is slightly different, but it shows the same general area.

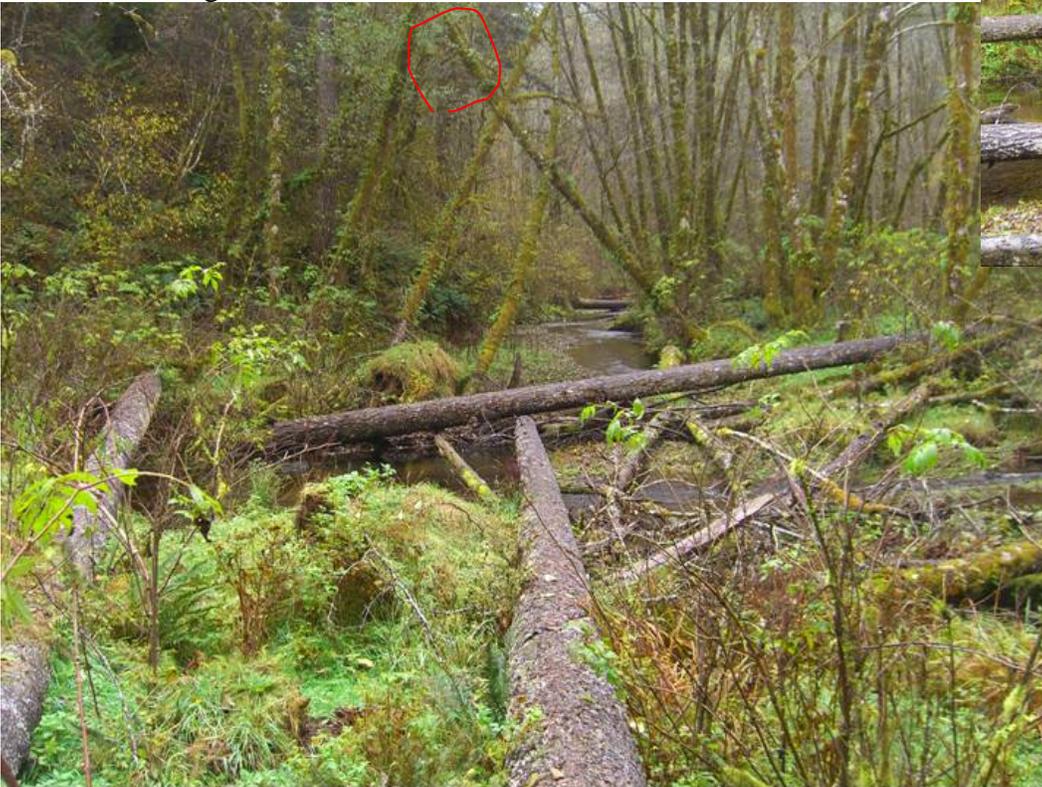
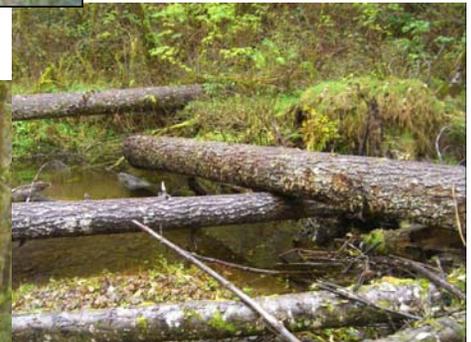
Site #28, looking downstream – 2007

This photo above shows the wood that are helping scour the deep pool.

New Comments: There is a mid-channel island that is forming under the right hand tree and the deep pool under the left hand tree is maintaining and increasing its depth as a result of the wood scouring.

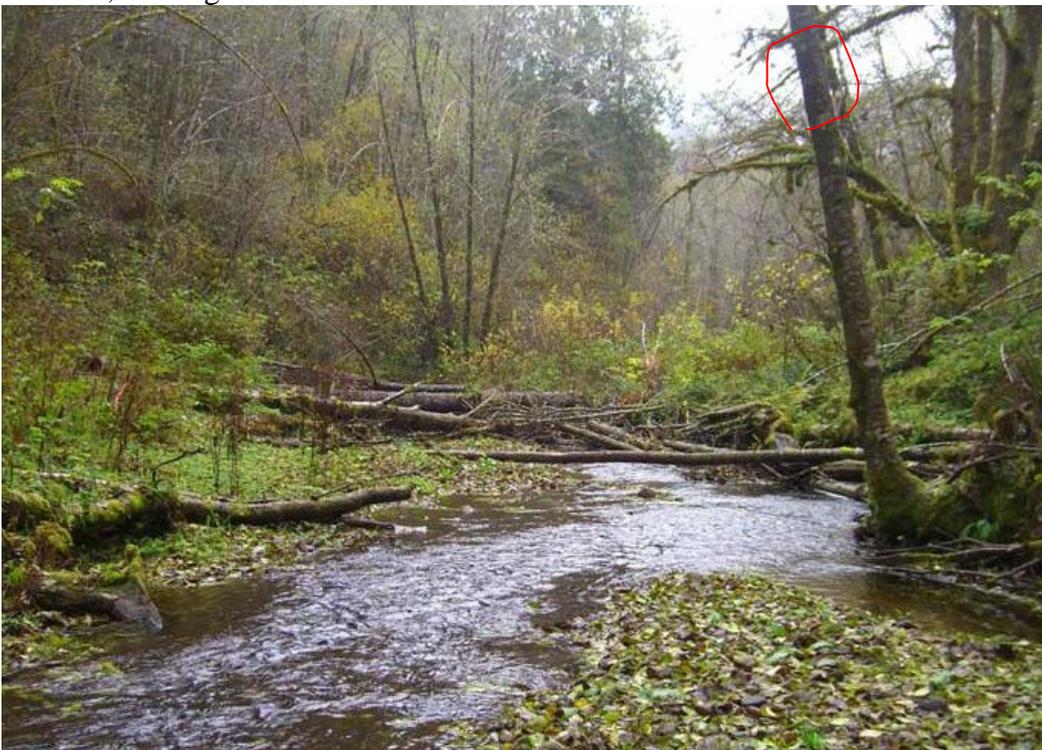
Site #30, looking downstream – 2007

New Comments: the channel seems to be encouraging the formation of the mid-channel island and side-channels upstream as a result of slowing down the water.

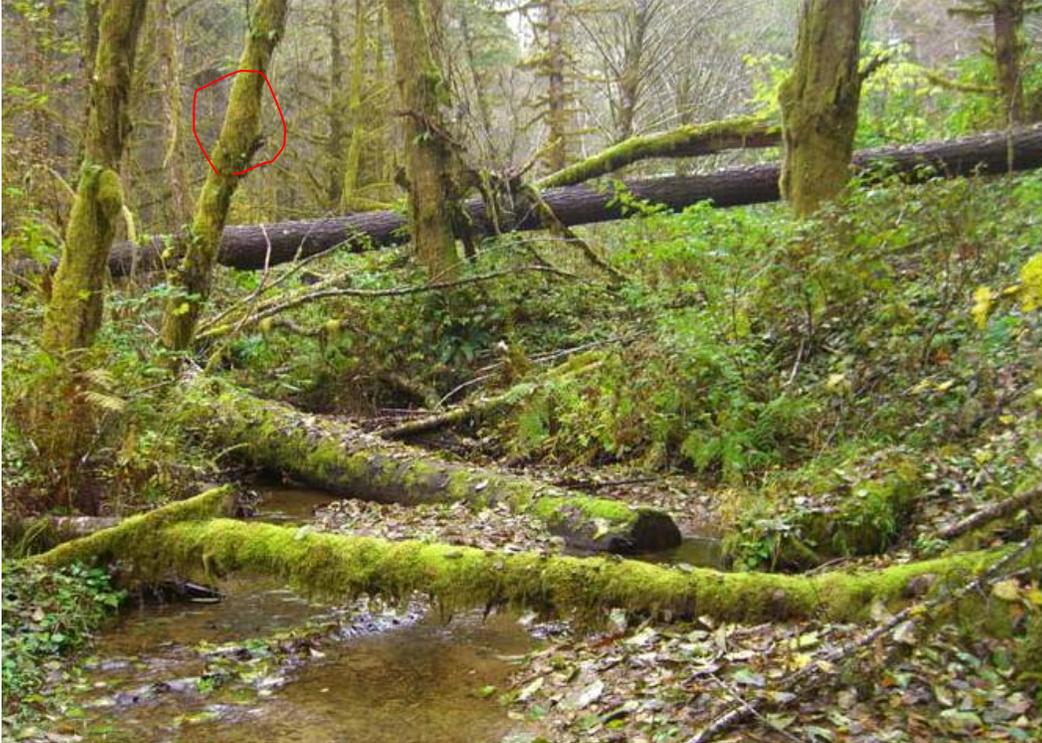
Site #11 looking upstream – 2007

New Comments: The structure is starting to collect sediment and detritus all around these trees and changing the way this site looked drastically. I almost did not recognize it was the same site.
