Eastern Oregon
Regional Airport
at Pendleton

**2014 Pavement Evaluation / Maintenance
Management Program**

**Final Report – Individual Airports
Functional Category 1, Eastern Climatic Zone**

November 2014

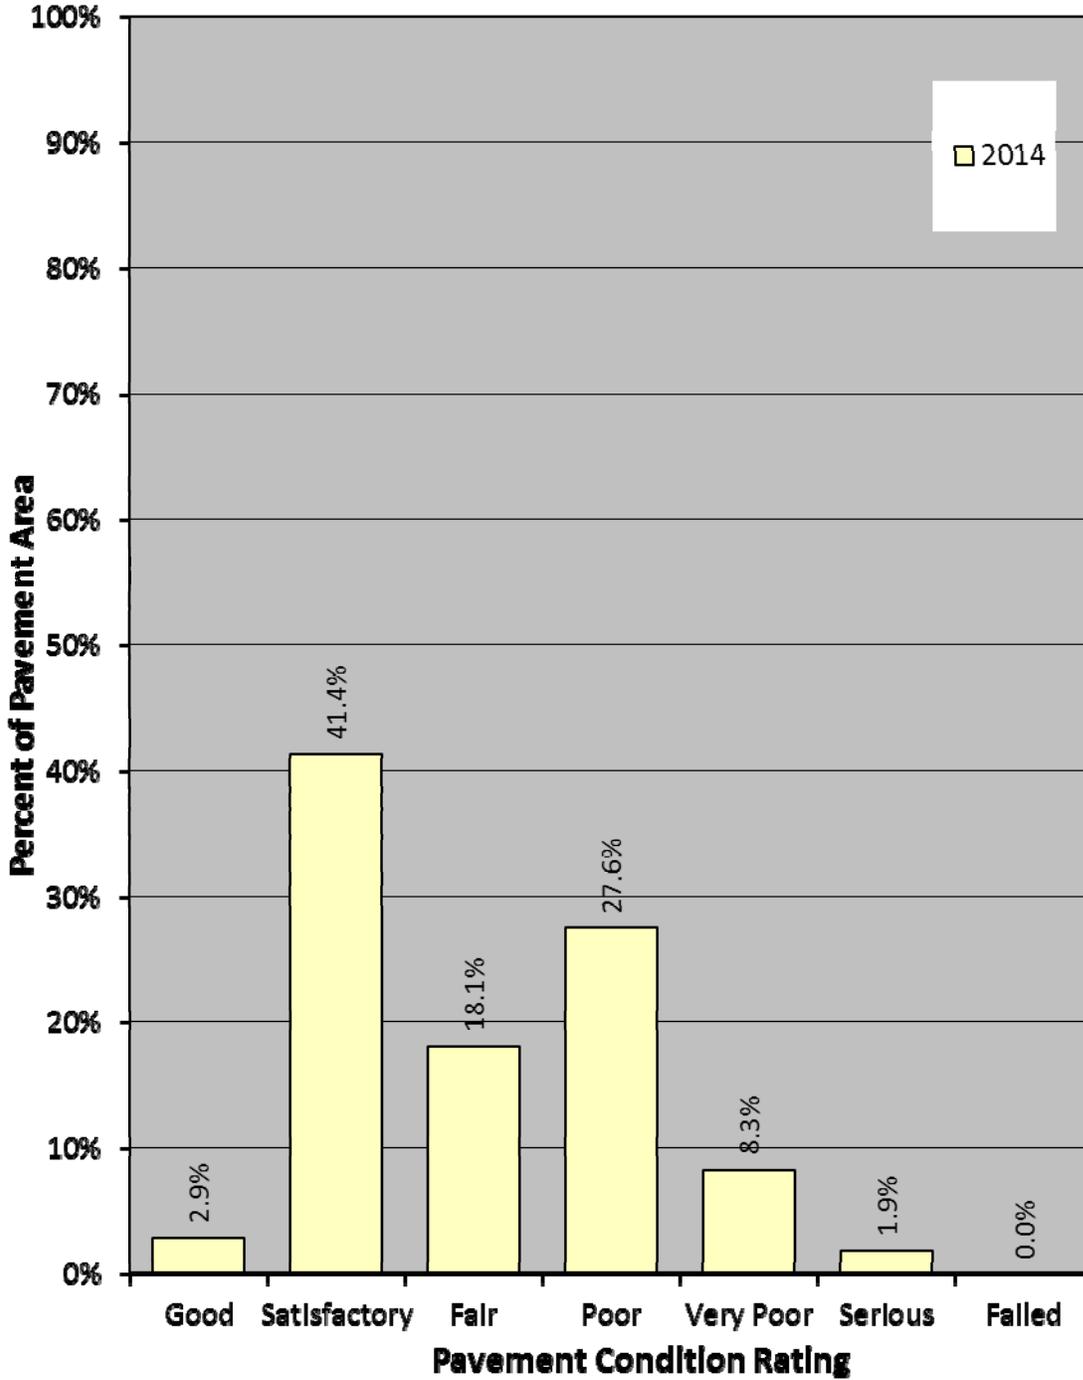
**Figure PE-4. Distribution of Pavement Condition
Eastern Oregon Regional Airport at Pendleton**

The primary distresses observed during the inspection of asphalt concrete pavements were: block cracking, weathering, longitudinal and transverse cracking, raveling, alligator cracking, patching, bleeding, depressions and rutting. The primary distresses observed during the inspection of portland cement concrete pavements were: joint spalls, linear cracking, corner breaks, joint seal damage, corner spalls, small patches, scaling, and shrinkage cracks.
