**Canyon Creek Meadows  
Dam Evaluation Report  
Grant County, Oregon  
Sections 28 and 29, T15S, R33E, W.M.**

**August 2012**

**Report Date:** August 29, 2012

**Project Number:** 2923018

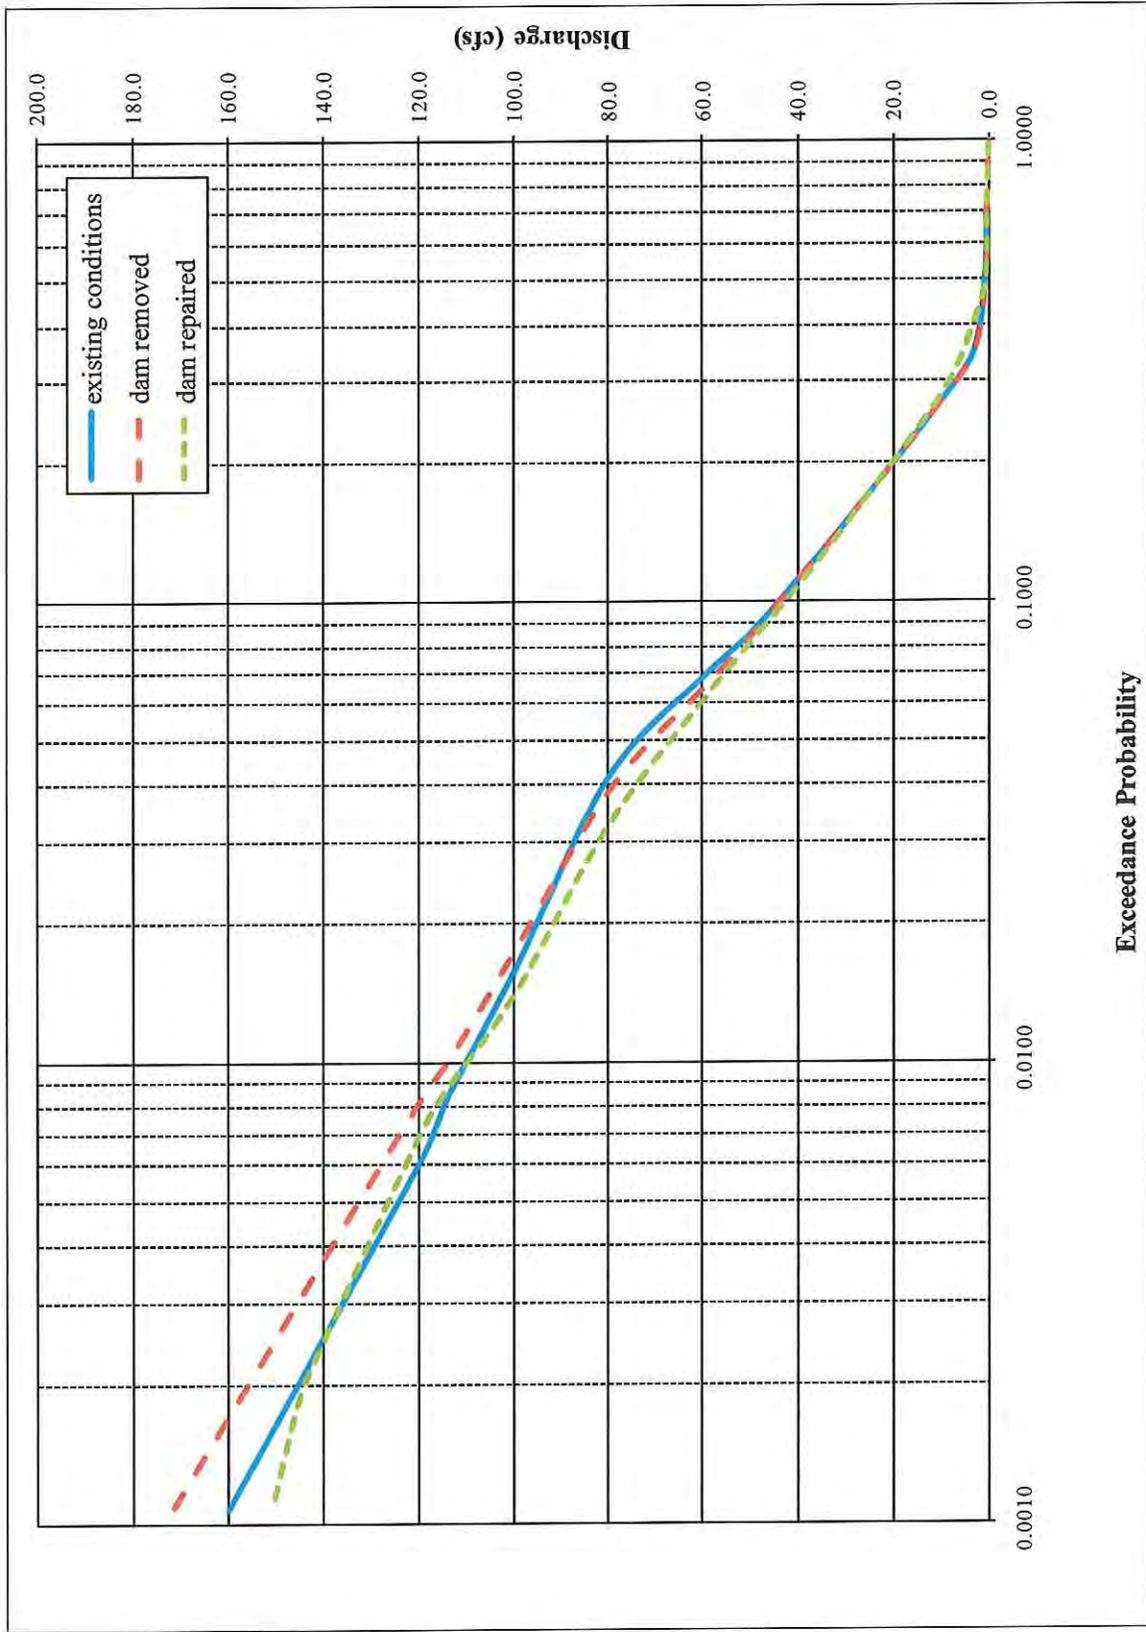
Figure 11. Flow Duration for Canyon Creek below the Middle Fork Confluence

Figure 11 shows the flow duration curves for Canyon Creek below the confluence with the Middle Fork. The curves have a similar shape as those at the dam outlet, but there is less of a difference in exceedence probabilities for the three scenarios. The drainage area controlled by the dam is approximately 25 percent of the total drainage area upstream of this location. The additional flow from the Middle Fork is reducing the influence of the altered hydrology at the dam. However, for this location storage in the reservoir for the existing condition and dam repaired scenario is causing flows ~125 cfs to occur less often than if the dam were removed.

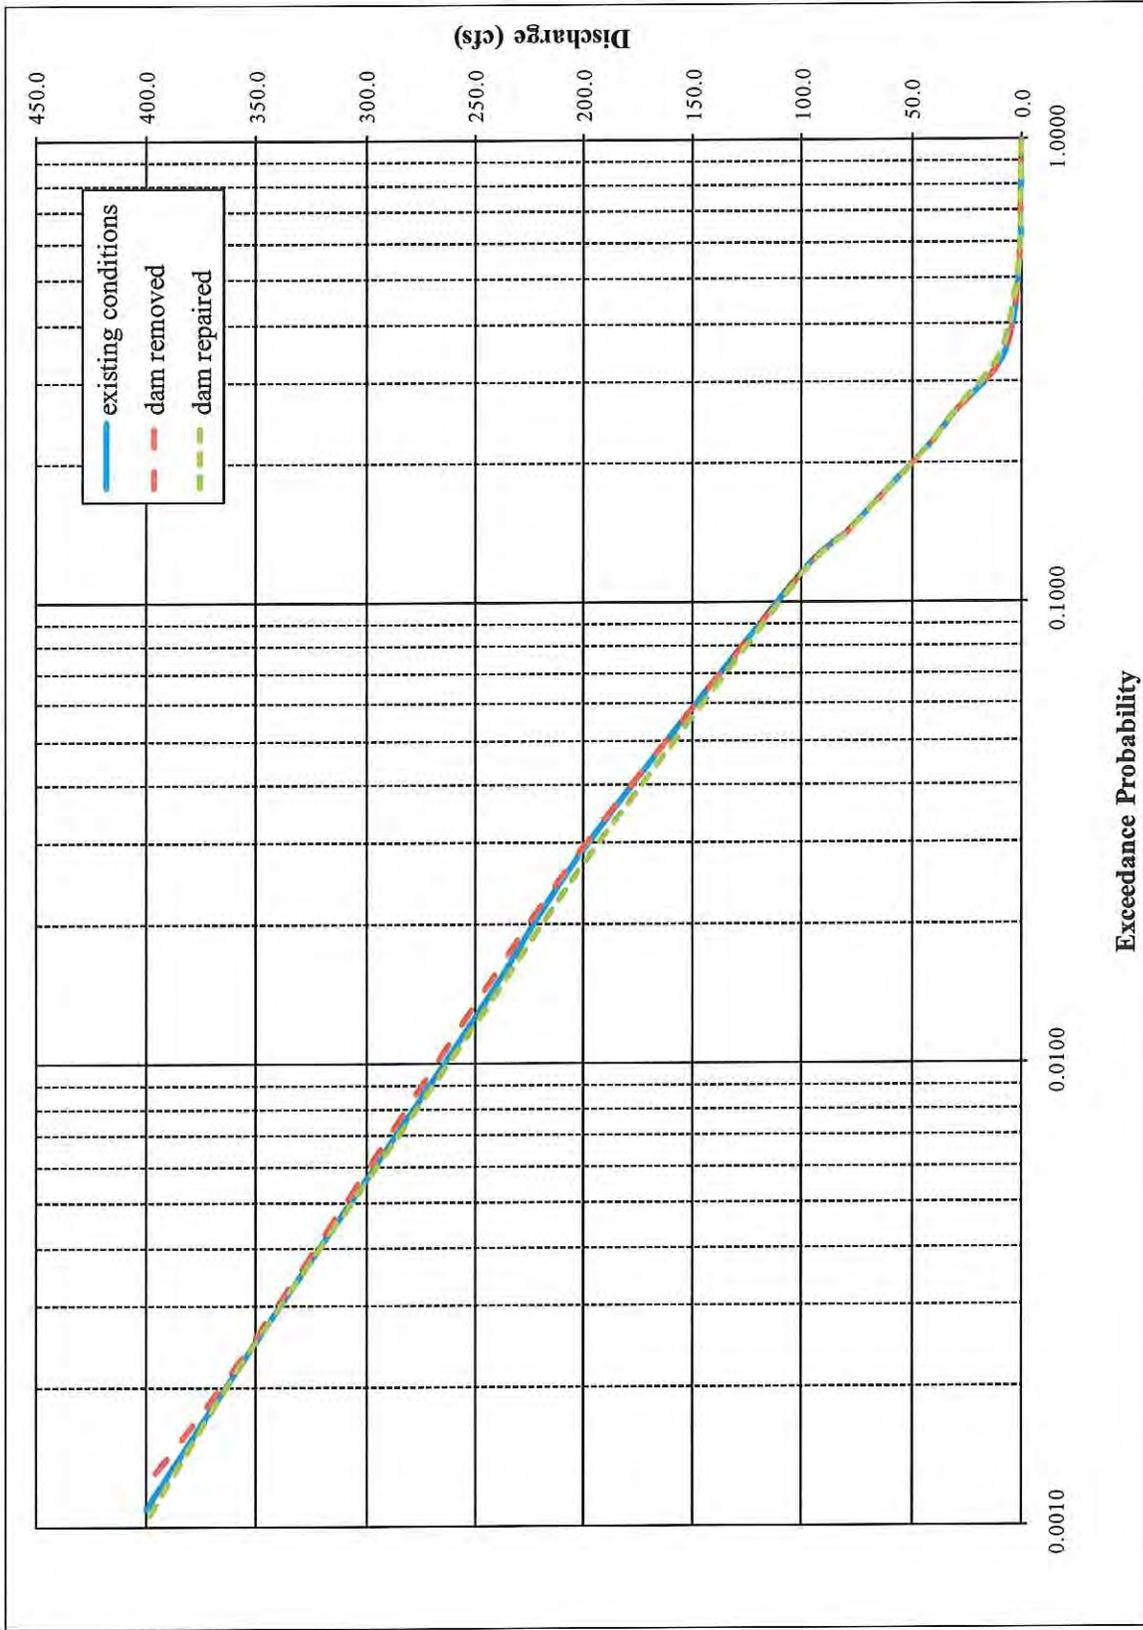
Figure 12. Flow Duration for Canyon Creek below the East Fork Confluence

Figure 12 shows the flow duration curves for Canyon Creek below the confluence with the East Fork. As seen in the figure, the curves are nearly identical. The drainage area controlled by the dam is approximately 10 percent of the total drainage area upstream of this location. The altered hydrology that results from the dam does not significantly influence the hydrology of Canyon Creek at or downstream of this location.

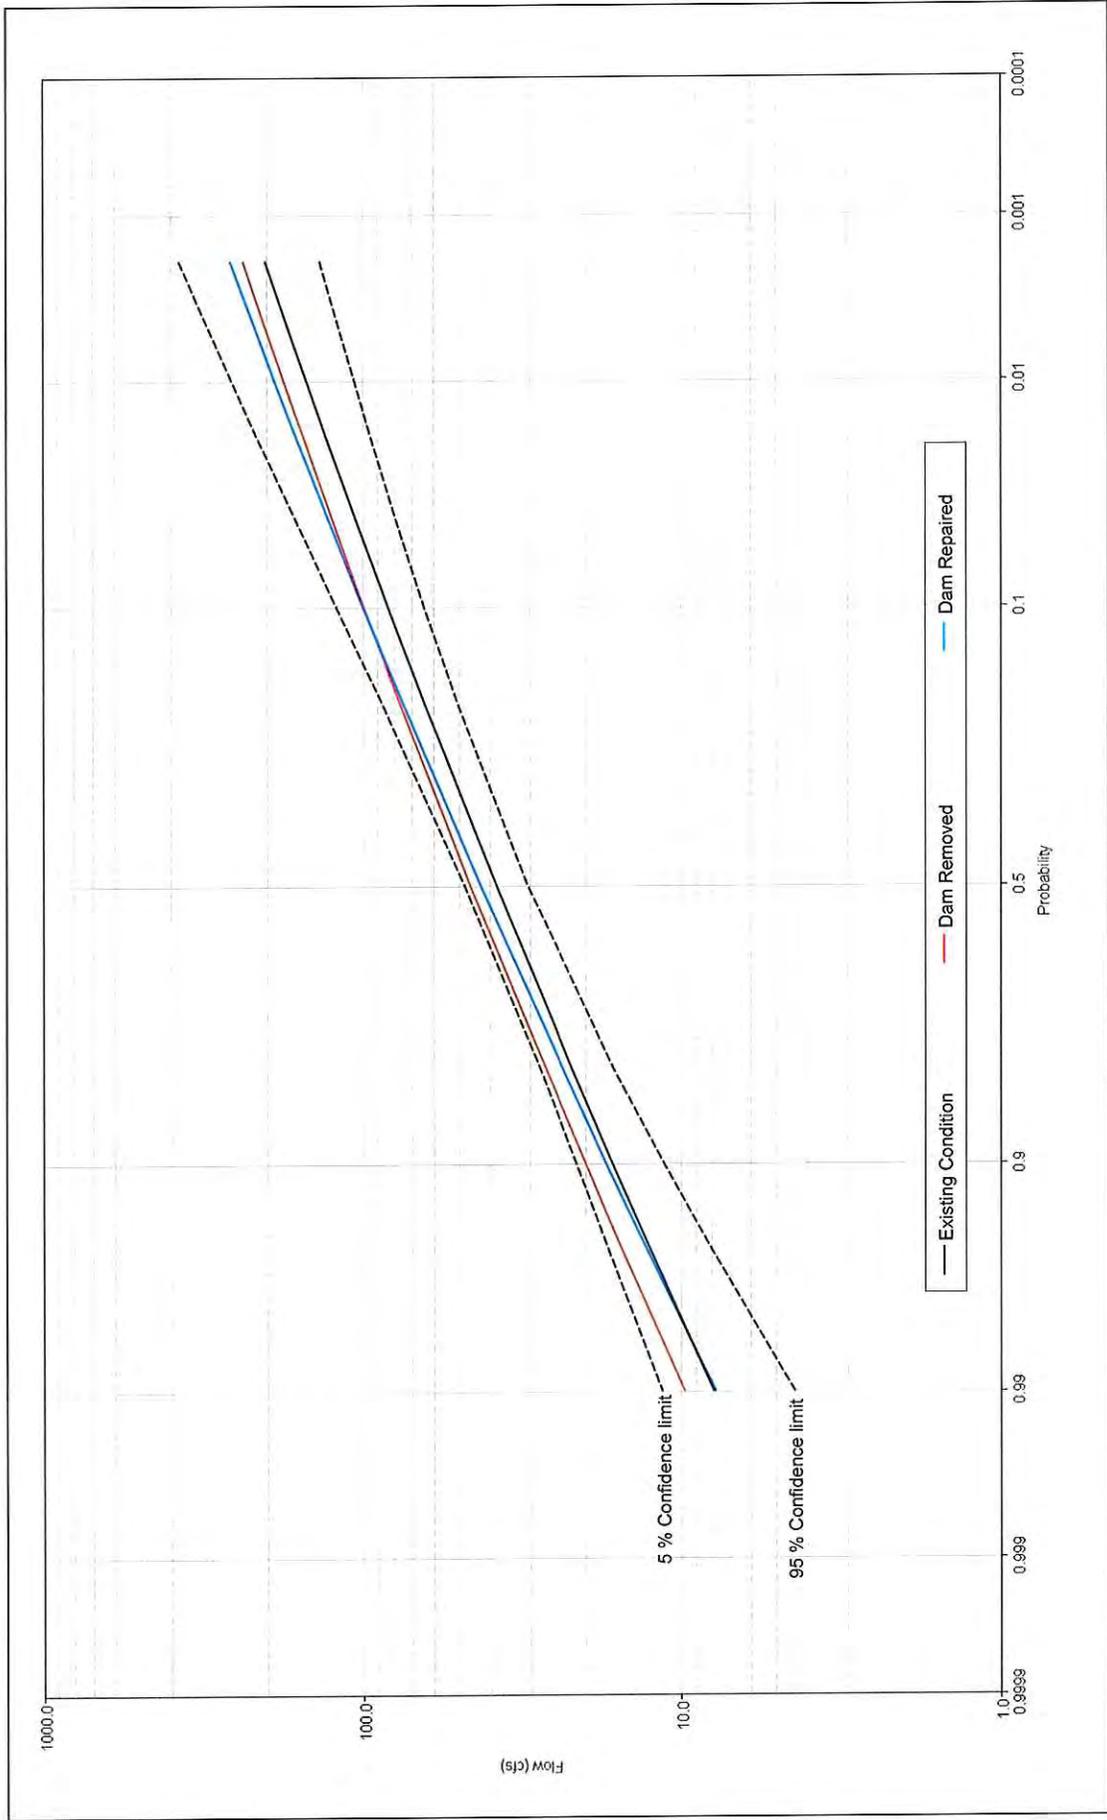
**Figure 13. Flood Frequency Analysis for Canyon Creek below the Canyon Creek Meadows Dam**

As seen in Figure 13, the flood frequency curves for the dam removed and dam repaired scenarios are slightly different than for the existing condition. However, as seen in the figure, the flood frequency curves for both scenarios fall within the 5- and 95-percent confidence limits of the existing conditions flood frequency curve. Therefore, there is considered to be no significant difference between the flood frequency relationships of the three scenarios evaluated. In other words, neither the existing dam nor the repaired dam provides a discernible flood control benefit.
