Lava Butte Wildlife Crossing Monitoring Project

Prepared for: ODOT

Prepared by: Leslie Bliss-Ketchum & Christian Parker

Prepared on: June 30th 2015 Finalized: October 8th, 2015

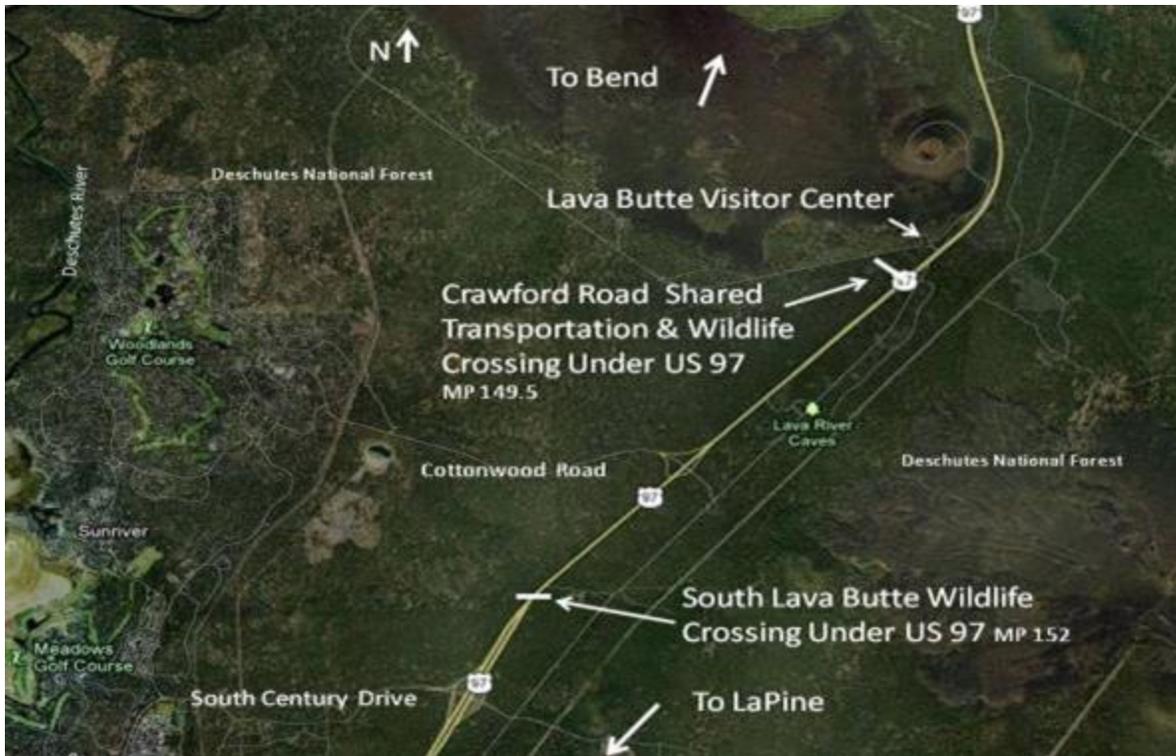
Figure 1. The Lava Butte Wildlife Crossings study area, south of Bend, Oregon.

One set of the crossing structures, the Crawford Road Bridges are located near the Lava Lands Visitor Center, at MP 149.55, and the other set of crossing structures the South Lava Butte Bridges are at MP 152.0 (Figure 1). Additional measures installed to encourage wildlife use of the structures and deter them from accessing the busy highway include rocks, logs, and native plantings under the crossings to encourage small animal use; four miles of wildlife exclusionary fencing (8 feet high) on both sides of the highway; four wildlife escape ramps; and six ElectroBraidTM mats to prevent wildlife from entering the road right of way at intersections. The main goal of this monitoring project was to evaluate the effectiveness of these structures and other measures for wildlife.
