APPENDIX C: Story of June 28 – 29, 2006 thunderstorm in Mays and Jensen.

APPENDIX D: Vegetative monitoring changes from 2005 and 2007

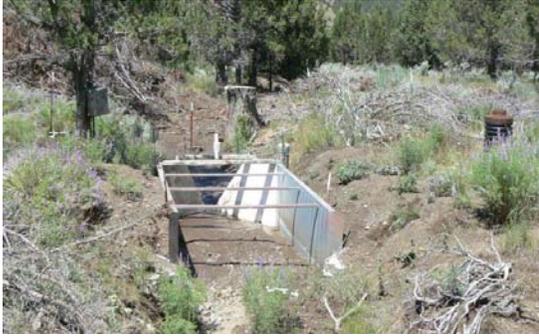
Jensen flume 4 days after summer thunderstorm, notice sediment deposits in the floor of the flume.

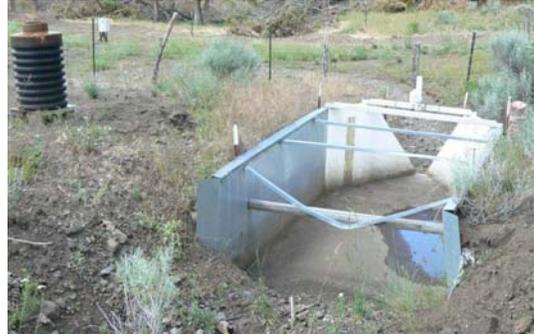
Mays flume 4 days after the same storm. Floor of flume has dusting of sediment but floor is already dry.

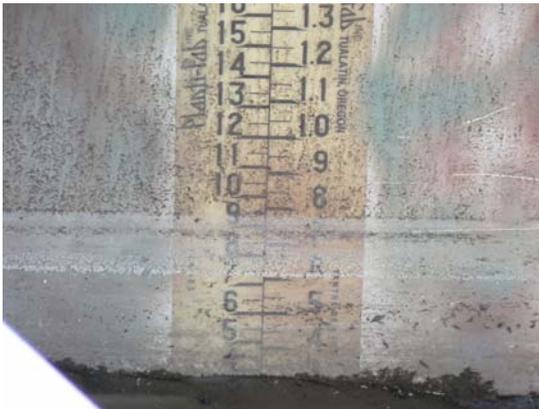
Staff gauge in Jensen flume showed that actual flow may have been as high as 22.86 cm (9 inches). The bottom of the photo shows the height of mud in the flume.

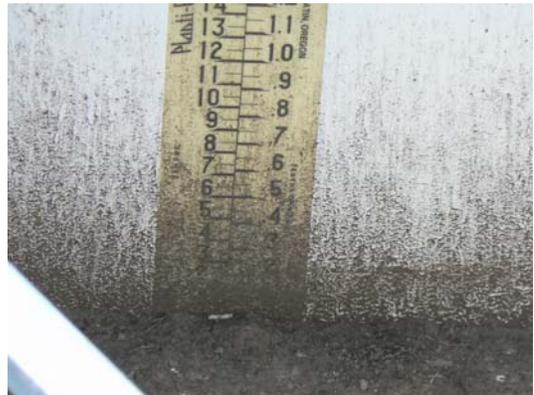
Staff gauge in Mays flume showed that rain drop splatter scattered mud on the walls of the flume but no flow line is visible.

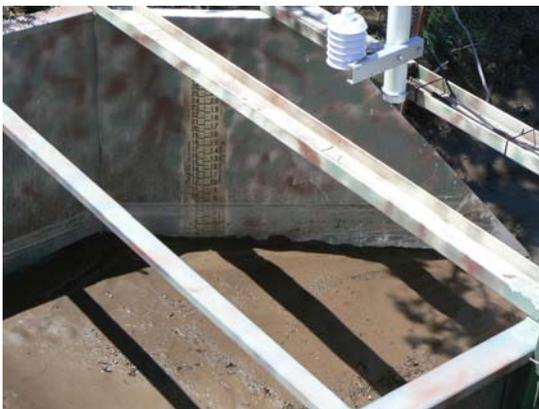
The sensor posed over the throat of the flume is an ultrasonic sensor, measuring the changes in distance between the sensor and bottom of flume. Sediment deposits are evident on the flume floor and measure 10 cm (4 inches).

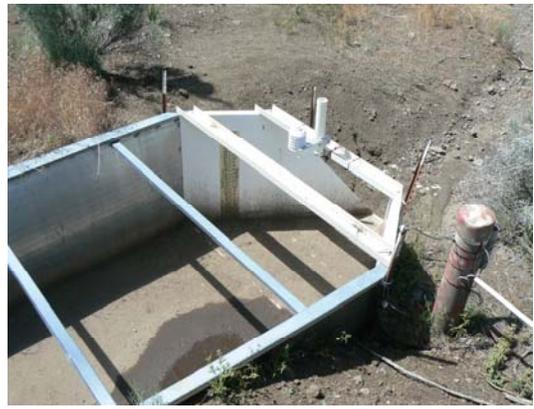
The ultrasonic sensor in Mays recorded no changes in depth of flow. Sediments on the flow of the flume are less than 31 mm (1/8 inch) deep.

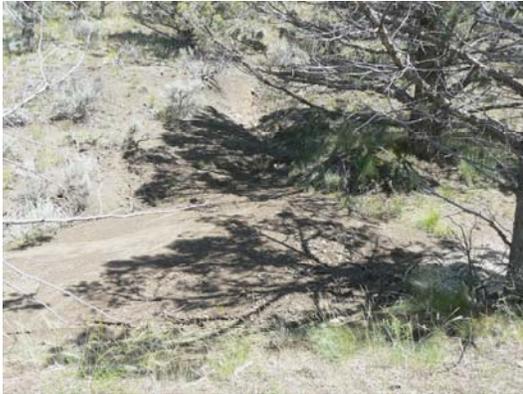
Channel deposits in Jensen. This deposit was laid across channel cross-section number 4. The stake on the far side of the channel was buried with deposits to the top of the stake. Channel cross section here is 338 cm (133 inches).

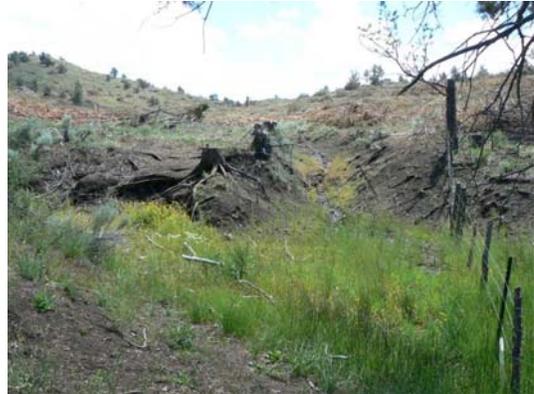
The channels of Mays showed no evidence of large flows or sediment deposits. This photo shows vegetation and a small amount of channel flow just above Mays' flume. Flow disappears before crossing through the fence.

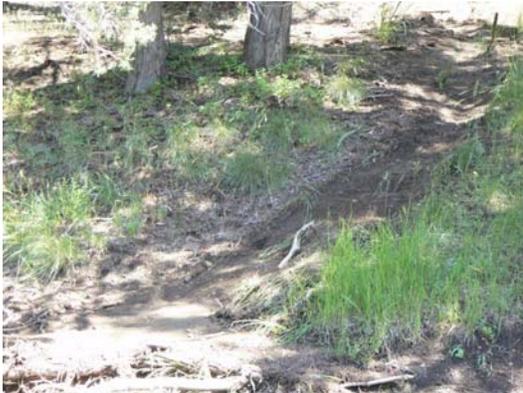
Near Jensen cross-section number 22, overland flow was evident. Overland flow moved sediment and organic material into the channel.

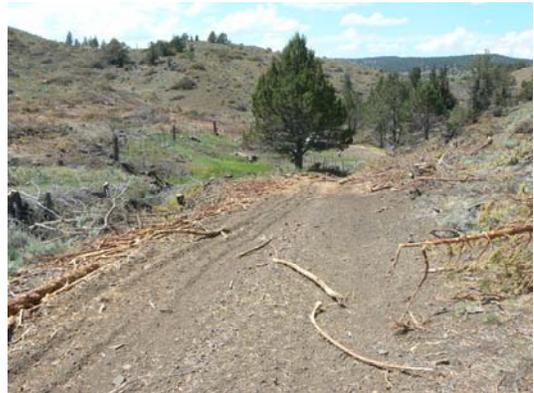
This road was used as a skid trail. Just days before the storm, road condition was soft, with several inches of loose soil on top.

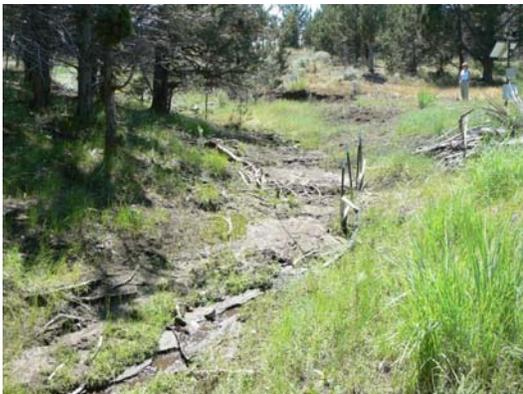
Channel deposits were numerous in Jensen following the storm. These deposits were placed near Jensen spring.

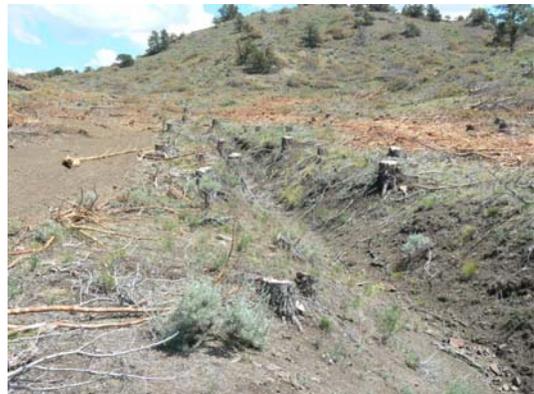
One of two channels monitored in Mays. Road used for skidding is on the right. Evidence of channel flow was minimal.

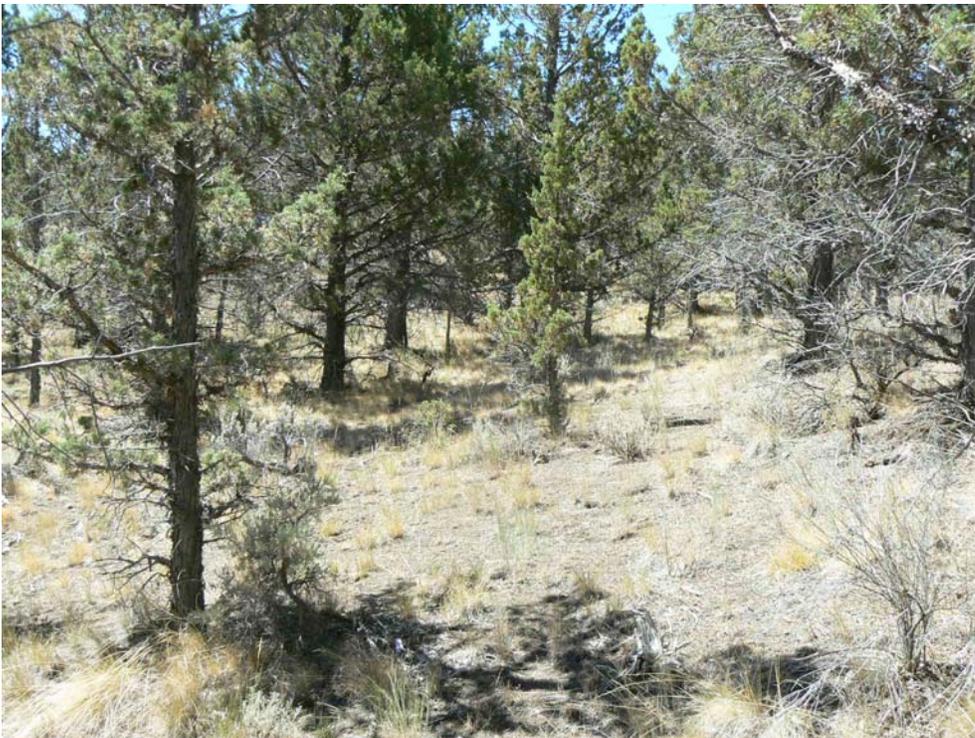
General view of the understory condition in Jensen. Grasses are mature and mostly dormant. Slope is generally easterly. There is very little “greenness” left.

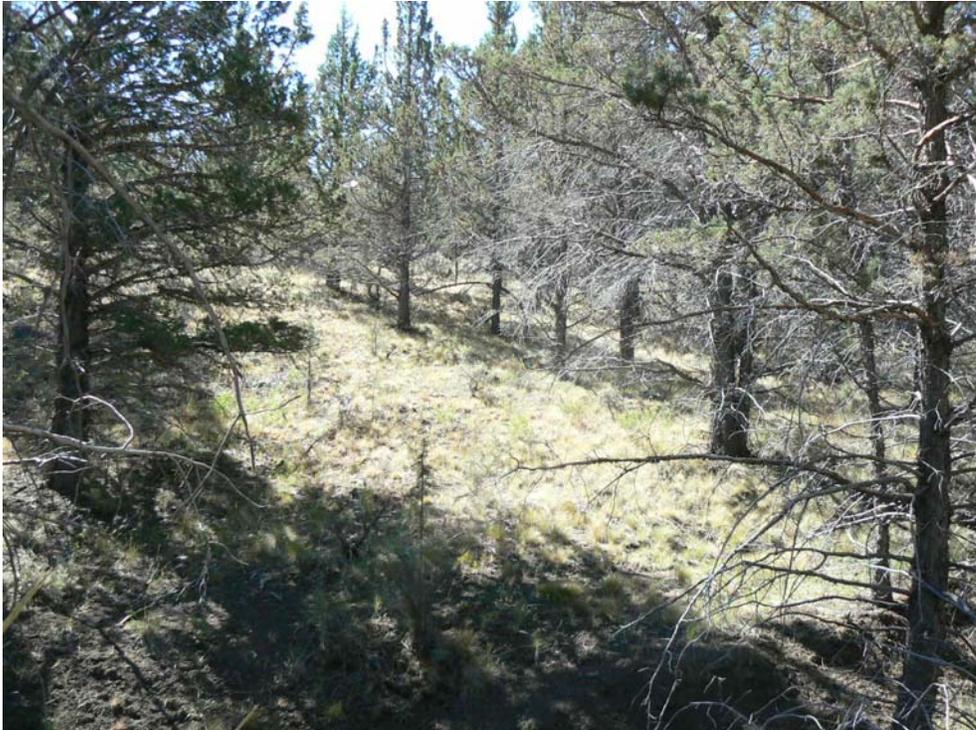
Jensen watershed, another view of understory, north slope.

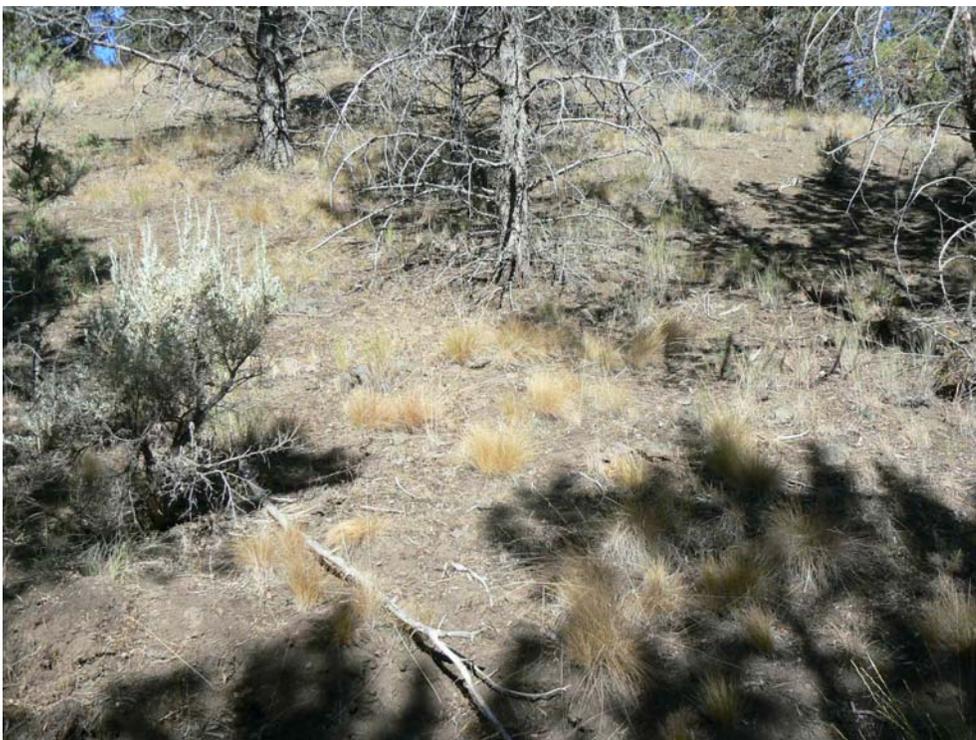
Jensen watershed, a south slope, very few reproductive culms are evident.

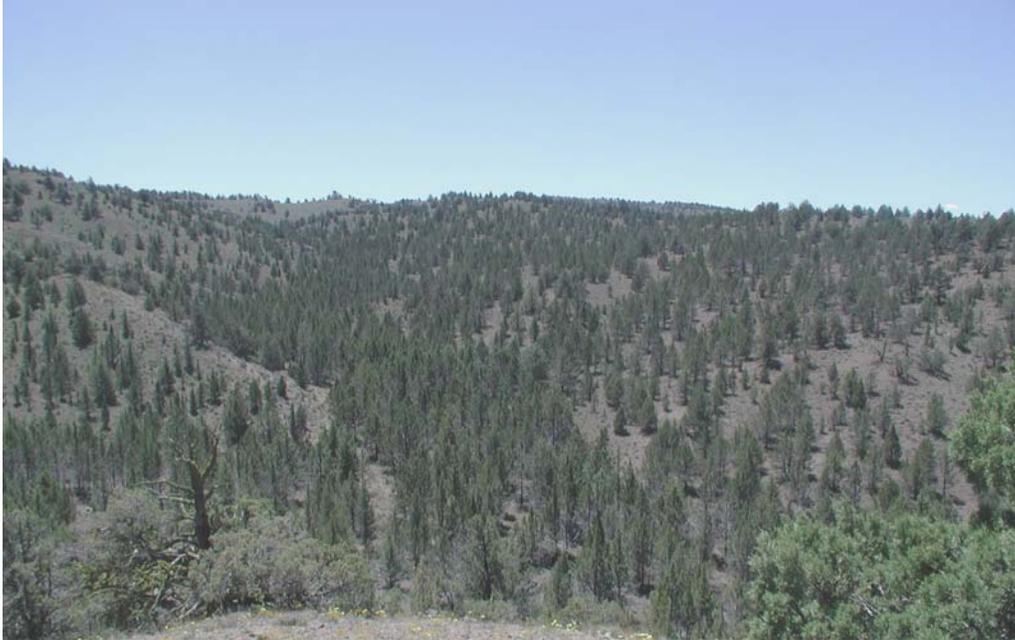
Mays watershed overview, pre treatment (July, 2005)

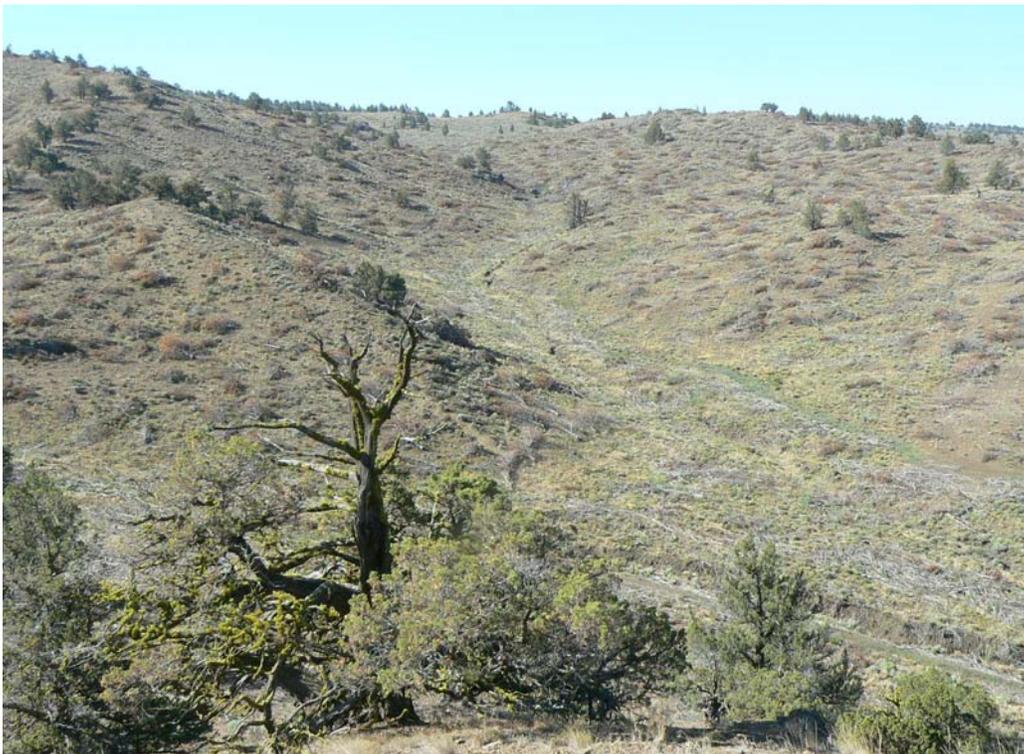
Mays watershed overview, post treatment (July, 2007).

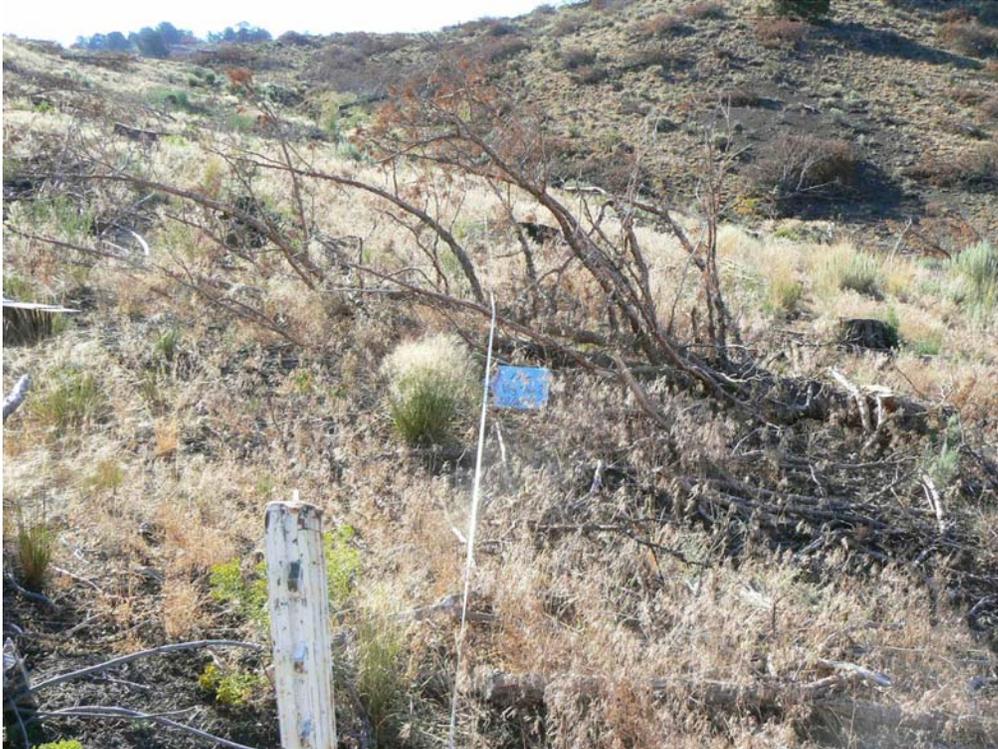
Mays watershed, south slope highlighting the flush of cheatgrass.

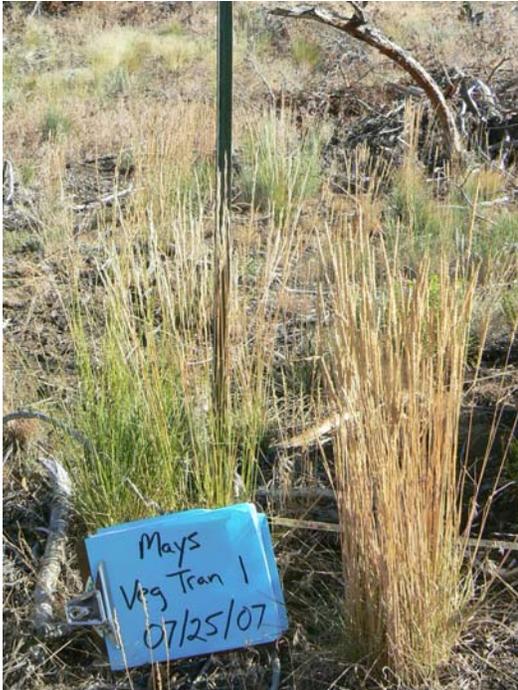
Mays watershed - Reproductive culms on Junegrass and Big blue.

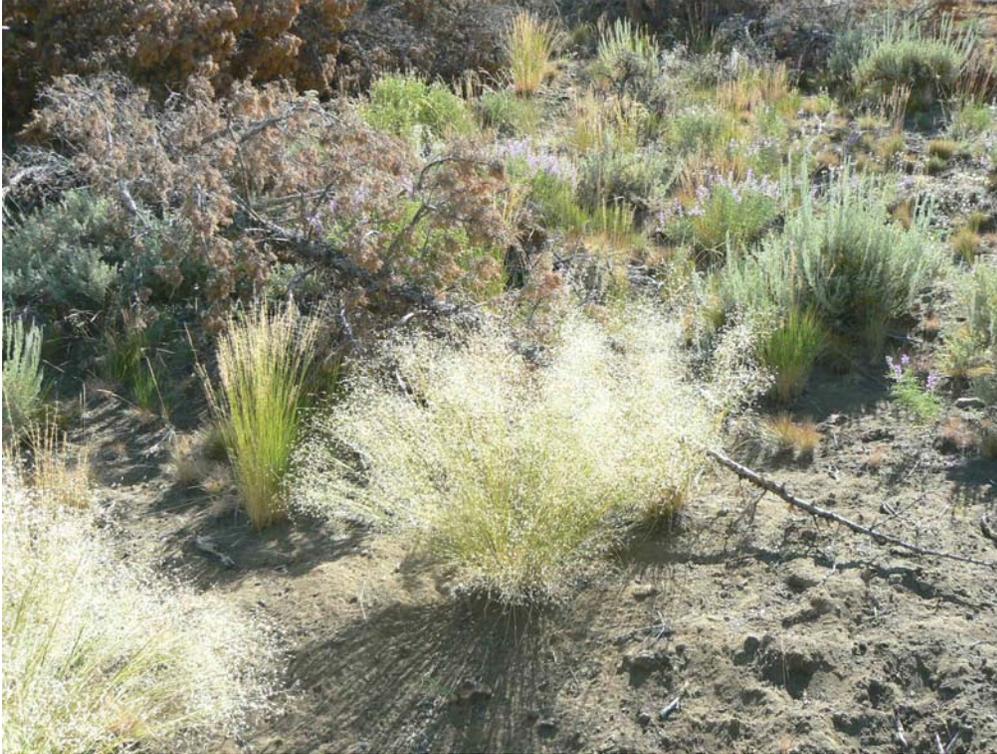
Mays watershed – Reproductive culms on bluebunch wheatgrass and Indian ricegrass. Also visible is the reproductive release of mountain big sagebrush.

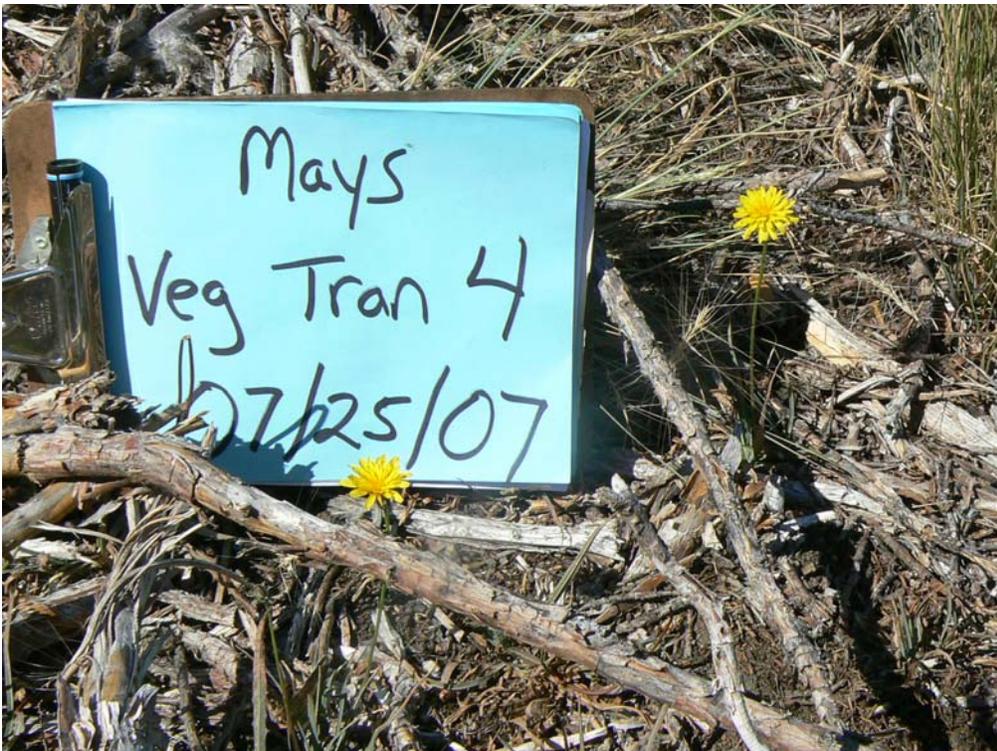
Mays watershed - Increase in perennial forb cover was noted. *Crepis* in bloom.

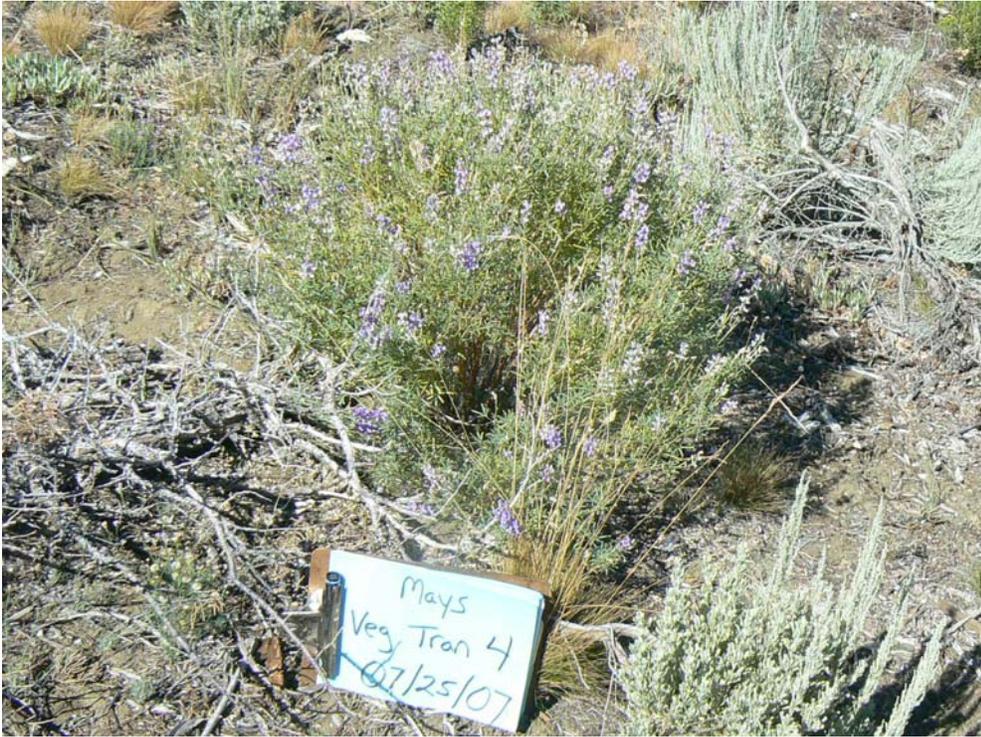
Mays watershed – Lupine spp. in bloom in late July.
