Pavement  
Evaluation/  
Maintenance  
Management Program  
2013

Oakridge State  
Airport

**2013 Pavement Evaluation / Maintenance  
Management Program**

**Final Report – Individual Airports  
Functional Category 5, Eastern Climatic Zone**

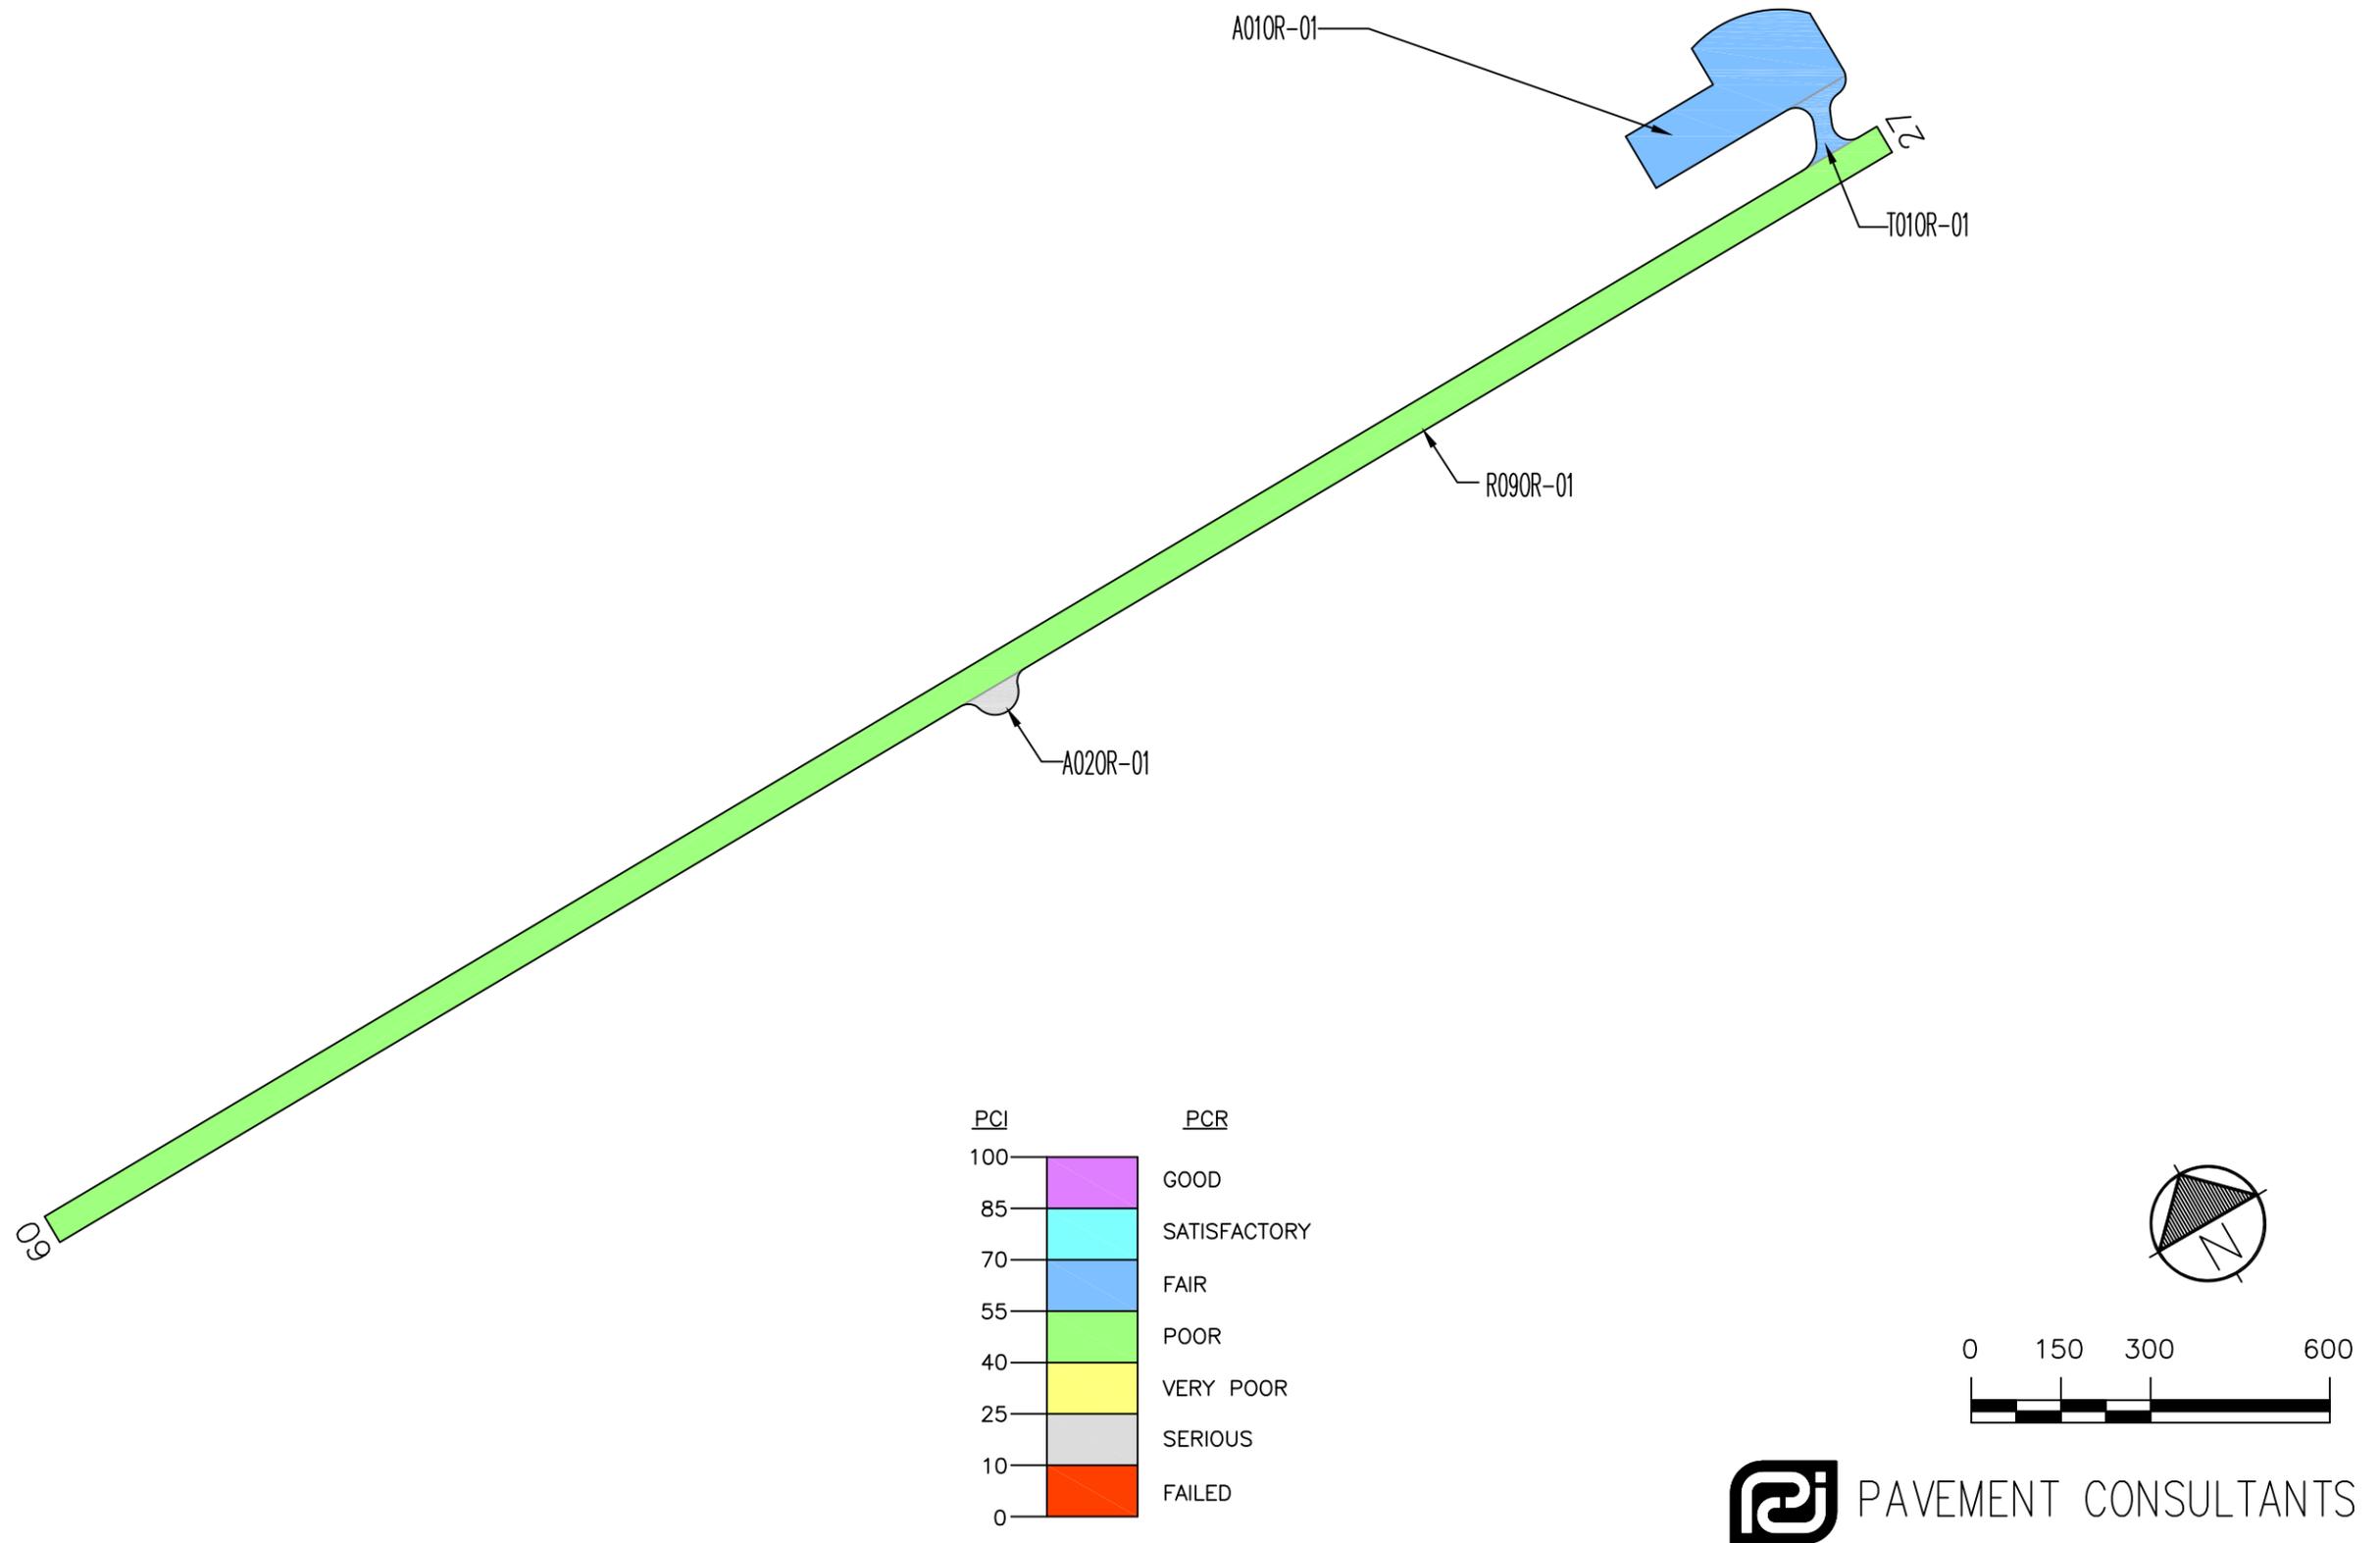
Figure OR-3. Pavement Condition in October 2013.  
Oakridge State Airport

The Branch Condition Report in Appendix 1 summarizes current pavement condition by branch while the Section Condition Report in Appendix 2 lists pavement condition by section. The current PCR is shown graphically in Figure OR-3.

Section PCIs at Oakridge State Airport range from a low of 25 (a PCR of “Serious”) to a high of 67 (a PCR of “Fair”). The area-weighted average PCI for all airport pavements is 52, corresponding to an overall PCR of “Poor”. Figure OR-4 shows how much pavement area is associated with each Pavement Condition Rating category and also shows pavement condition distribution from the inspections conducted in 2005 and 2009.

The primary distresses observed during the inspection were: block cracking, with isolated occurrences of longitudinal and transverse cracking, and raveling.
