## OR-8 ROAD SAFETY AUDIT Tualatin Valley Highway at SW 185<sup>th</sup> Avenue

Mile Point 6.45 – 6.73

Audit Date: December 5-7, 2011

# DRAFT Road Safety Audit Report

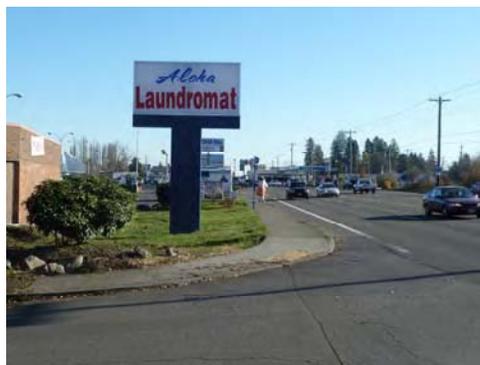
Visibility for roadway users is limited or compromised in several locations. Views are diminished by vegetation near the northbound slip lane on SW 185<sup>th</sup> Ave and at the Aloha Mall accesses on the north side of the highway to the west of SW 185<sup>th</sup> Ave. At least one business was observed to have a portable sign near a driveway that limited the view of exiting motorists. Large parked vehicles in the Aloha Mall parking lot limit intersection sight lines at SW 187<sup>th</sup> Ave.

Restricted sight distance at SW 187<sup>th</sup> Ave.

- Consider relocating portable signs and maintaining vegetation to improve sight triangles consistent with county ordinances or state highway access permits. RSA team recommends addressing in an ongoing fashion.

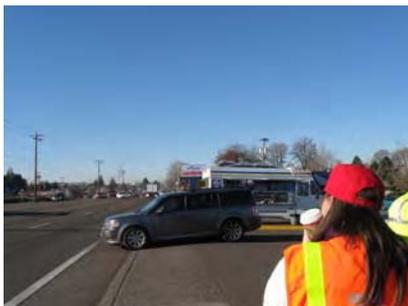
Traffic conditions are complex in the subject area. During off-peak conditions, vehicles exiting driveways and cross streets were observed to accept narrow gaps in traffic to execute left turns. The density of driveways causes gaps in traffic flow to be filled and drivers' wait times may be longer than anticipated. Eventually, drivers become impatient and accept narrower gaps that may result in mainline traffic needing to slow down to avoid a crash. Traffic speeds during mid-day conditions may result in serious injury crashes. During peak conditions, vehicles cut between stopped cars to execute turns. However, even when one lane of traffic is stopped, the other may be moving. The RSA team concluded that the left-turn movements at SW 182<sup>nd</sup> Ave have a particularly high safety risk due to the severity typically associated with these crashes.

Vehicle waits for gap in traffic to execute left turn.

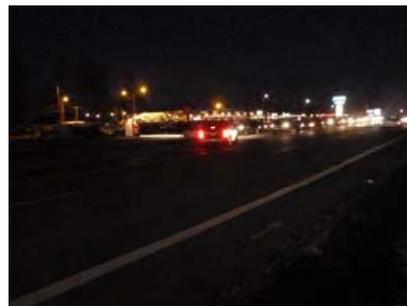
Vehicles execute left turns in front of stopped traffic.

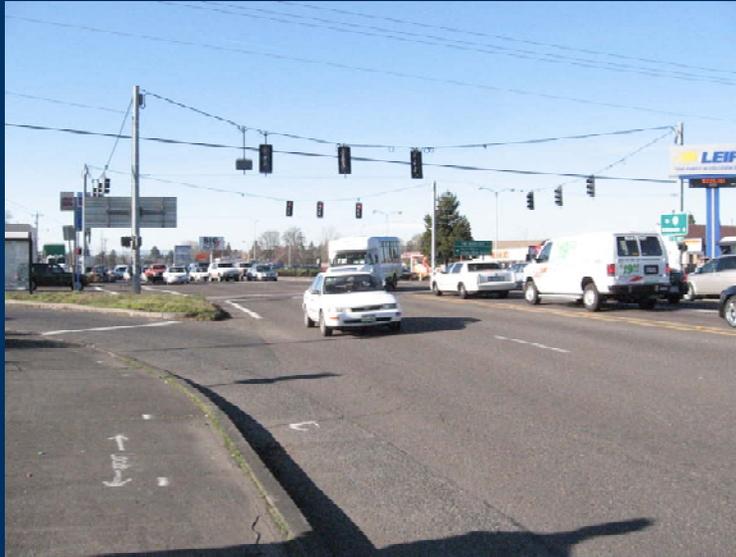
## Left Turns onto TV Highway

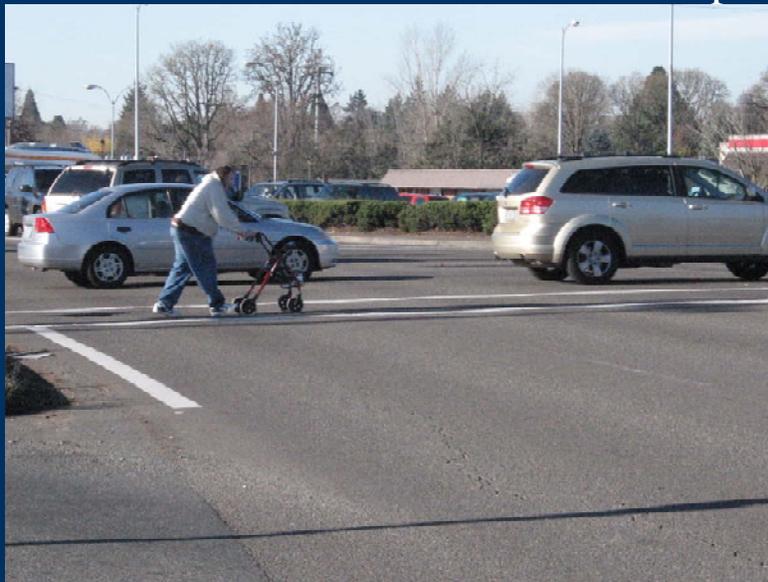
## Pedestrians Cross Slower Than 4 fps

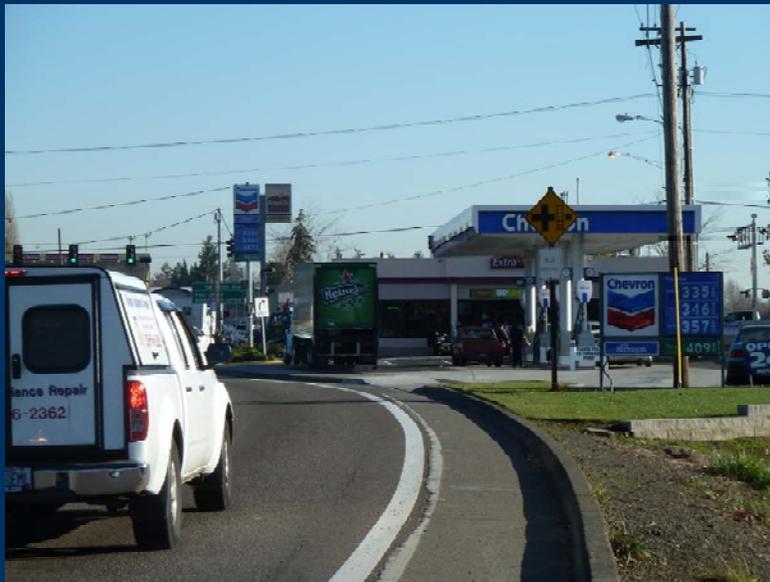
### Curvature Problems:

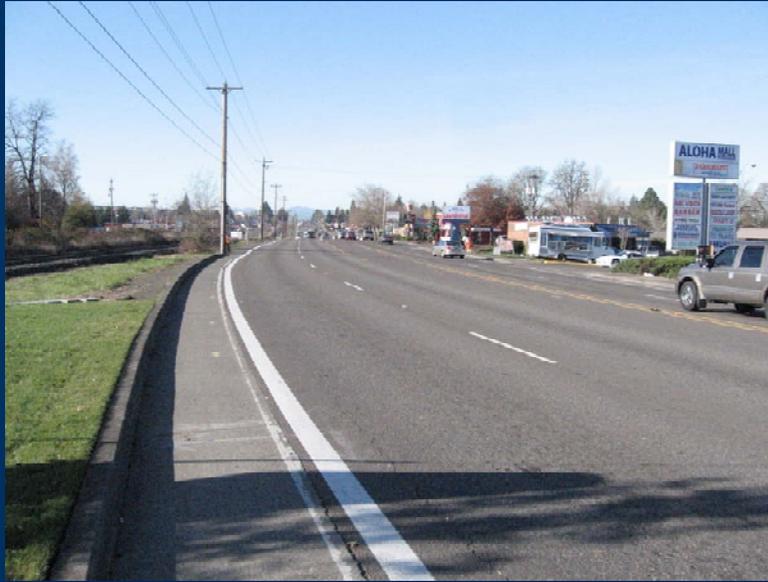
## Vertical and Horizontal Alignment

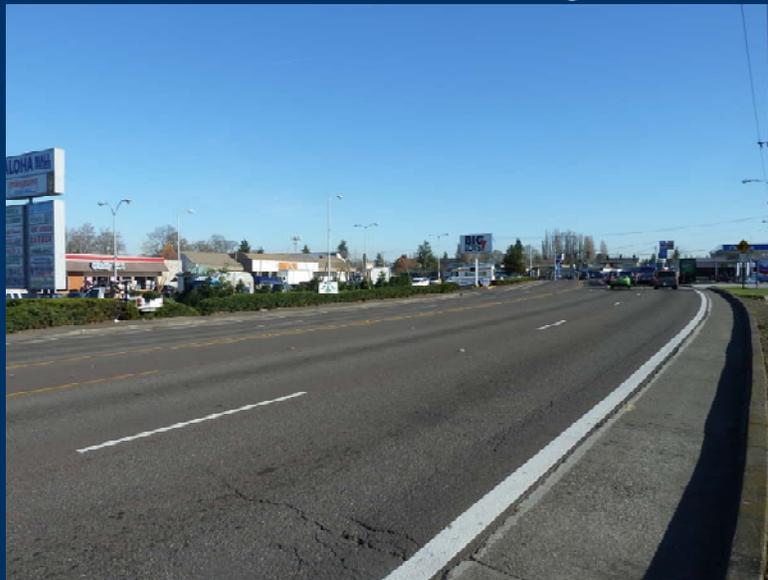
## Vertical and Horizontal Alignment

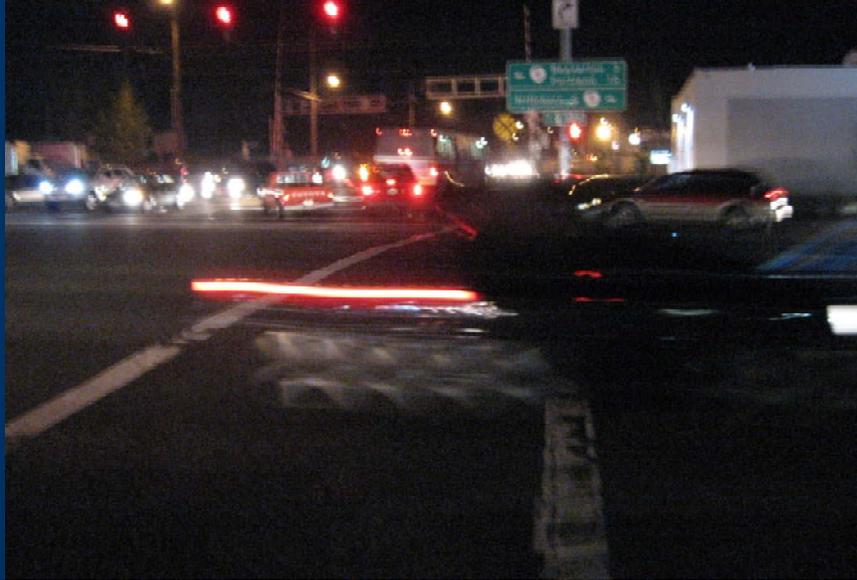
## Intersection Blockage / RR & Bus Stop

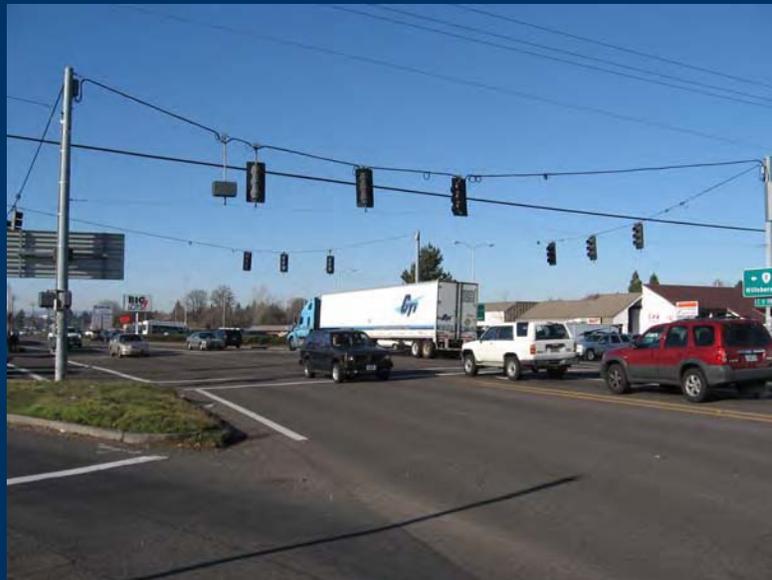
## Truck Traffic

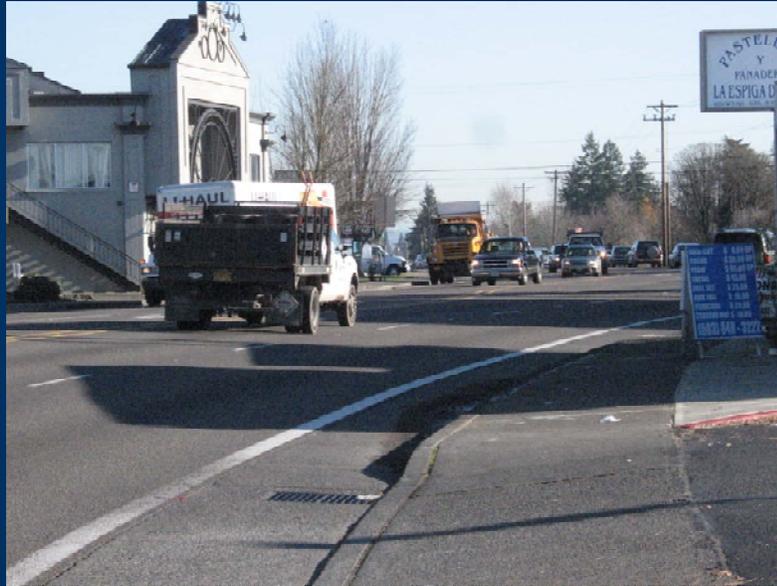
## Truck Traffic / Curvature

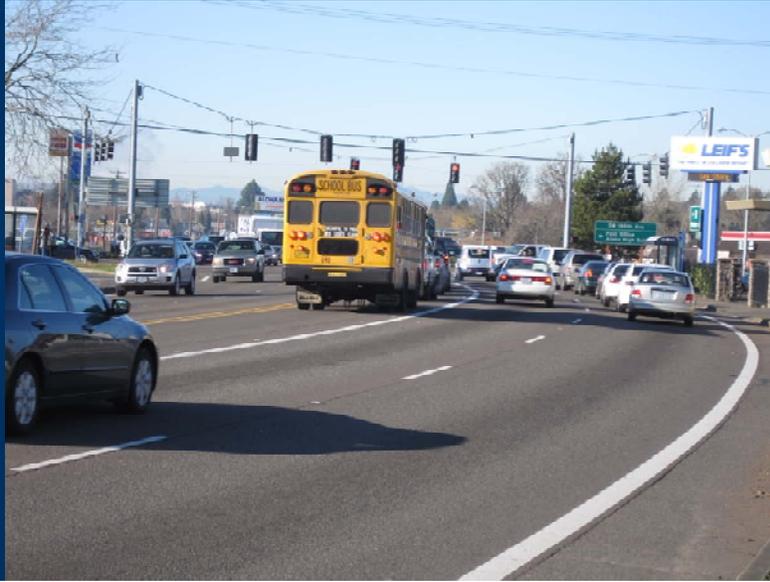
## School Buses

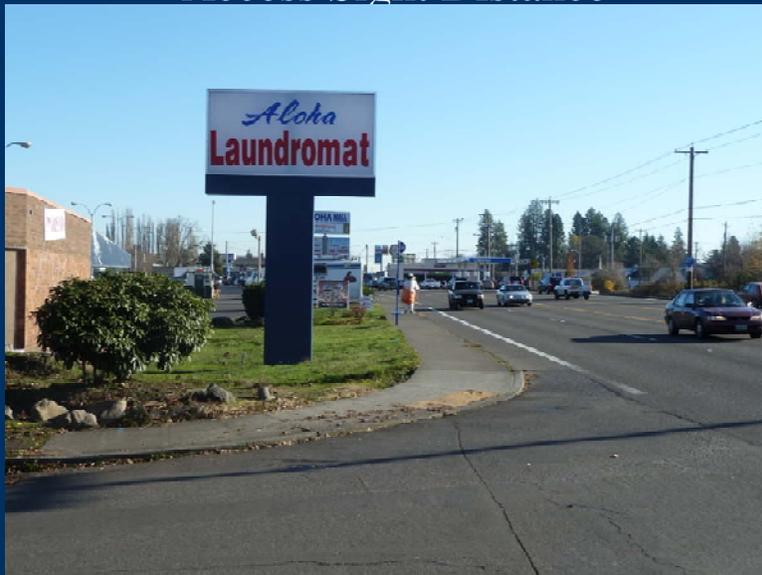
## Access Sight Distance

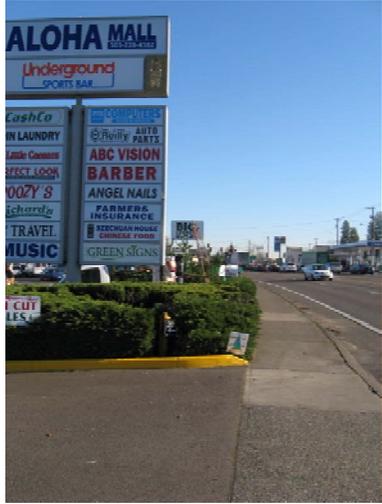
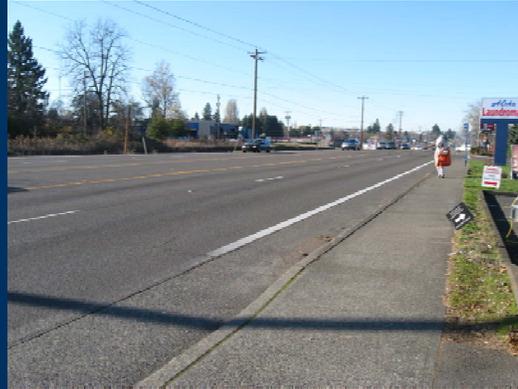
# Access Sight Distance

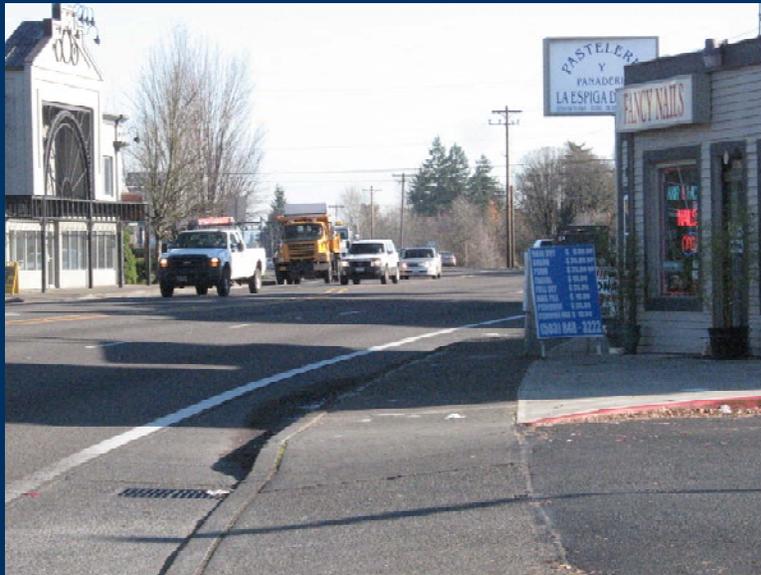
# Access Sight Distance

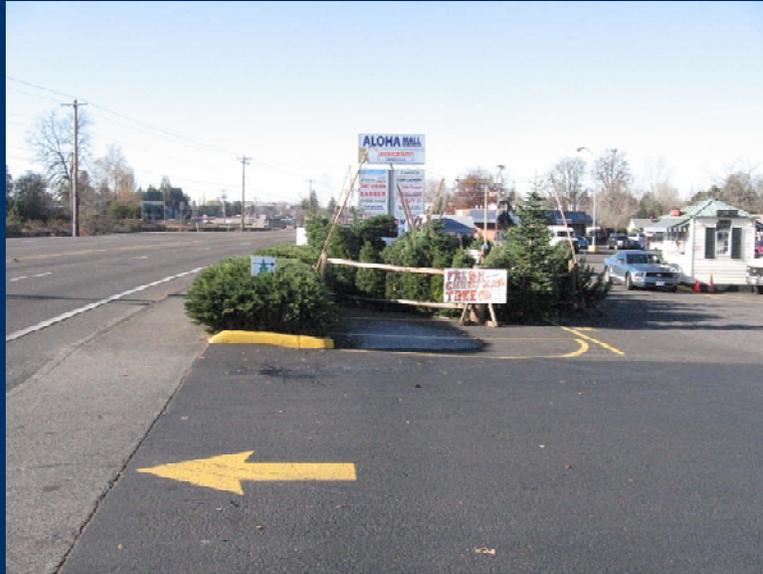
## Access Sight Distance

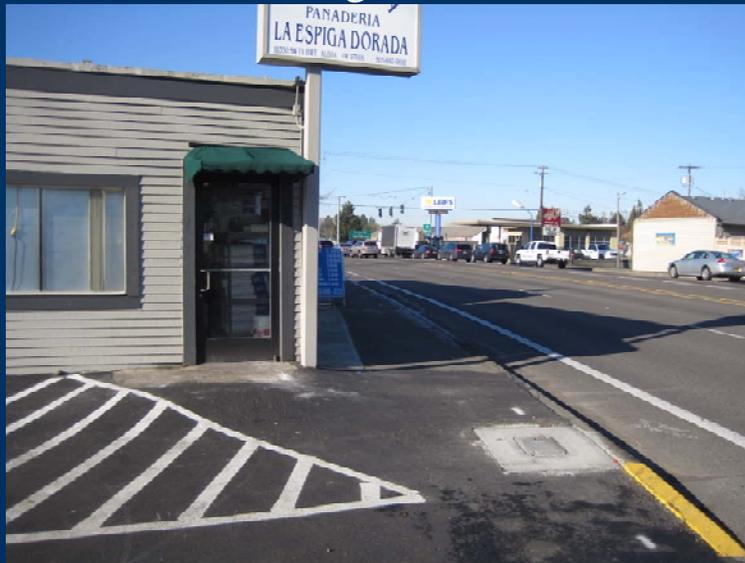
## Access Sight Distance

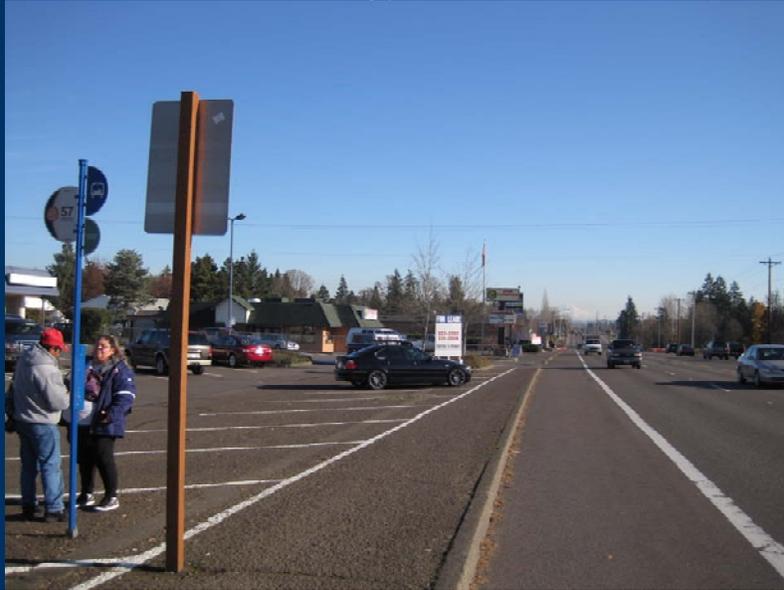
## Access Sight Distance

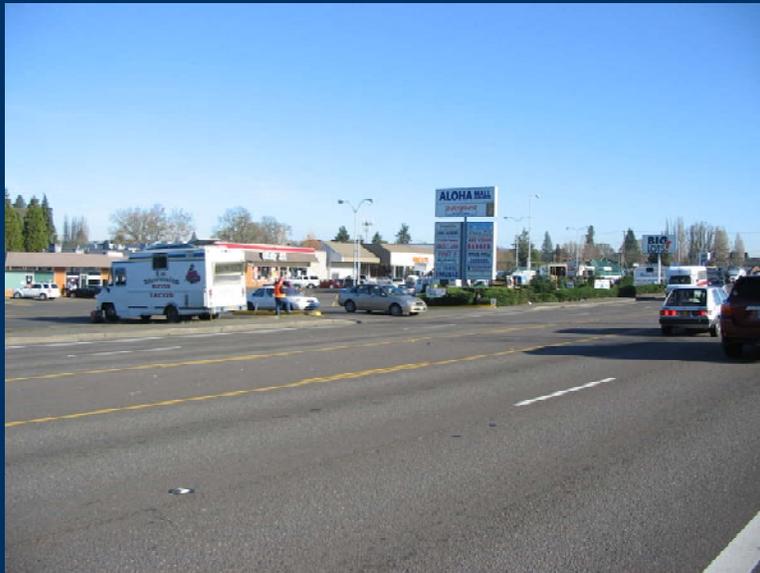
## Access Sight Distance

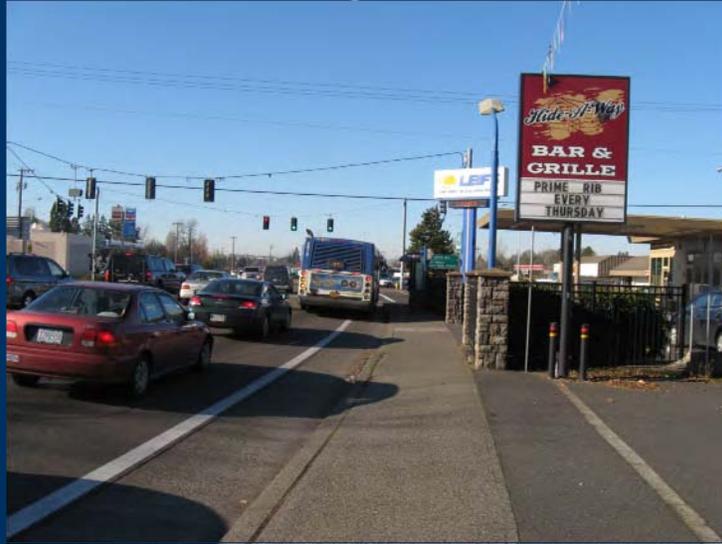
## Access Sight Distance

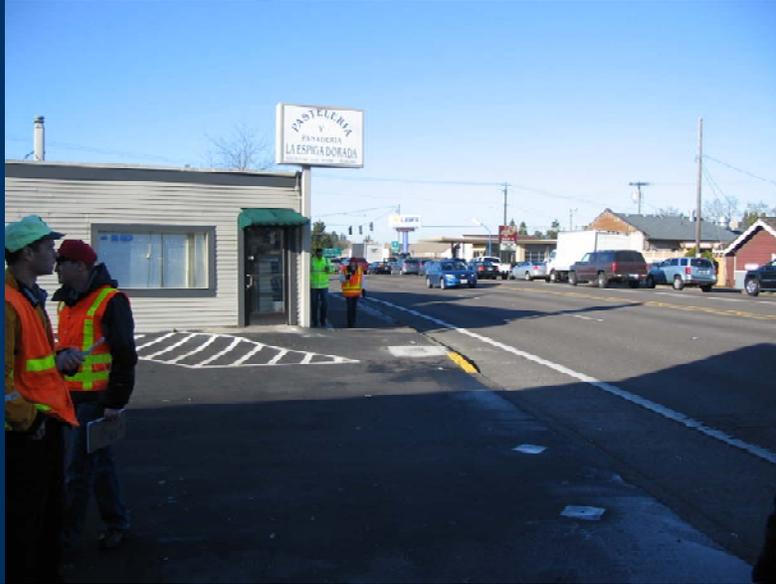
# Access Sight Distance / Sidewalk

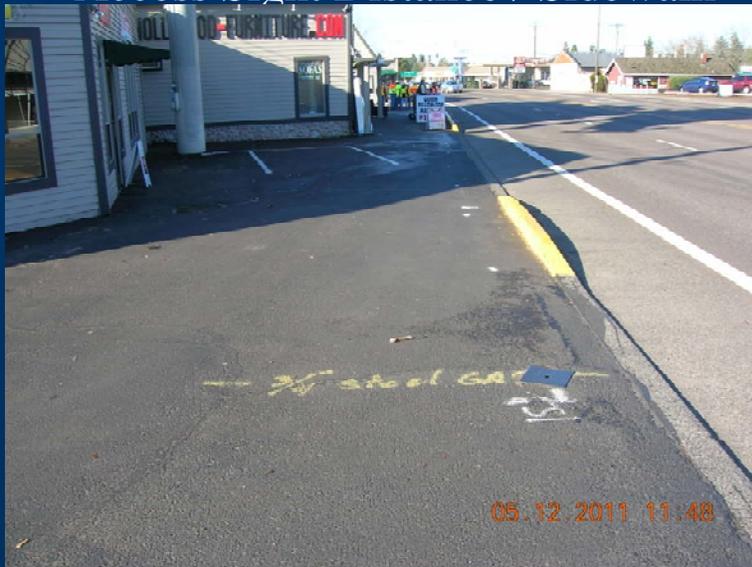
# Access Sight Distance / Sidewalk

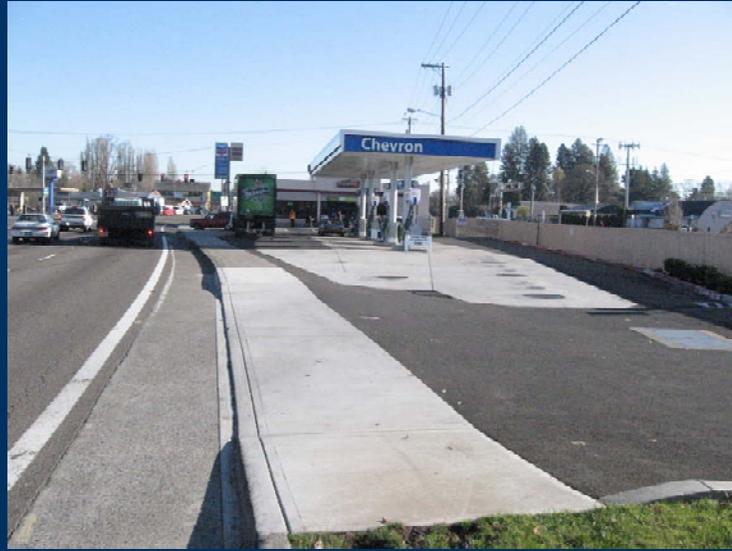
## Access at Chevron
